**Hamilton Township (Mercer County)
Stormwater Basin Assessment Summary
Addendum (Year 4)**

Developed by the Rutgers Cooperative Extension Water Resources Program
Funded by Hamilton Township, Mercer County, New Jersey

December 2017

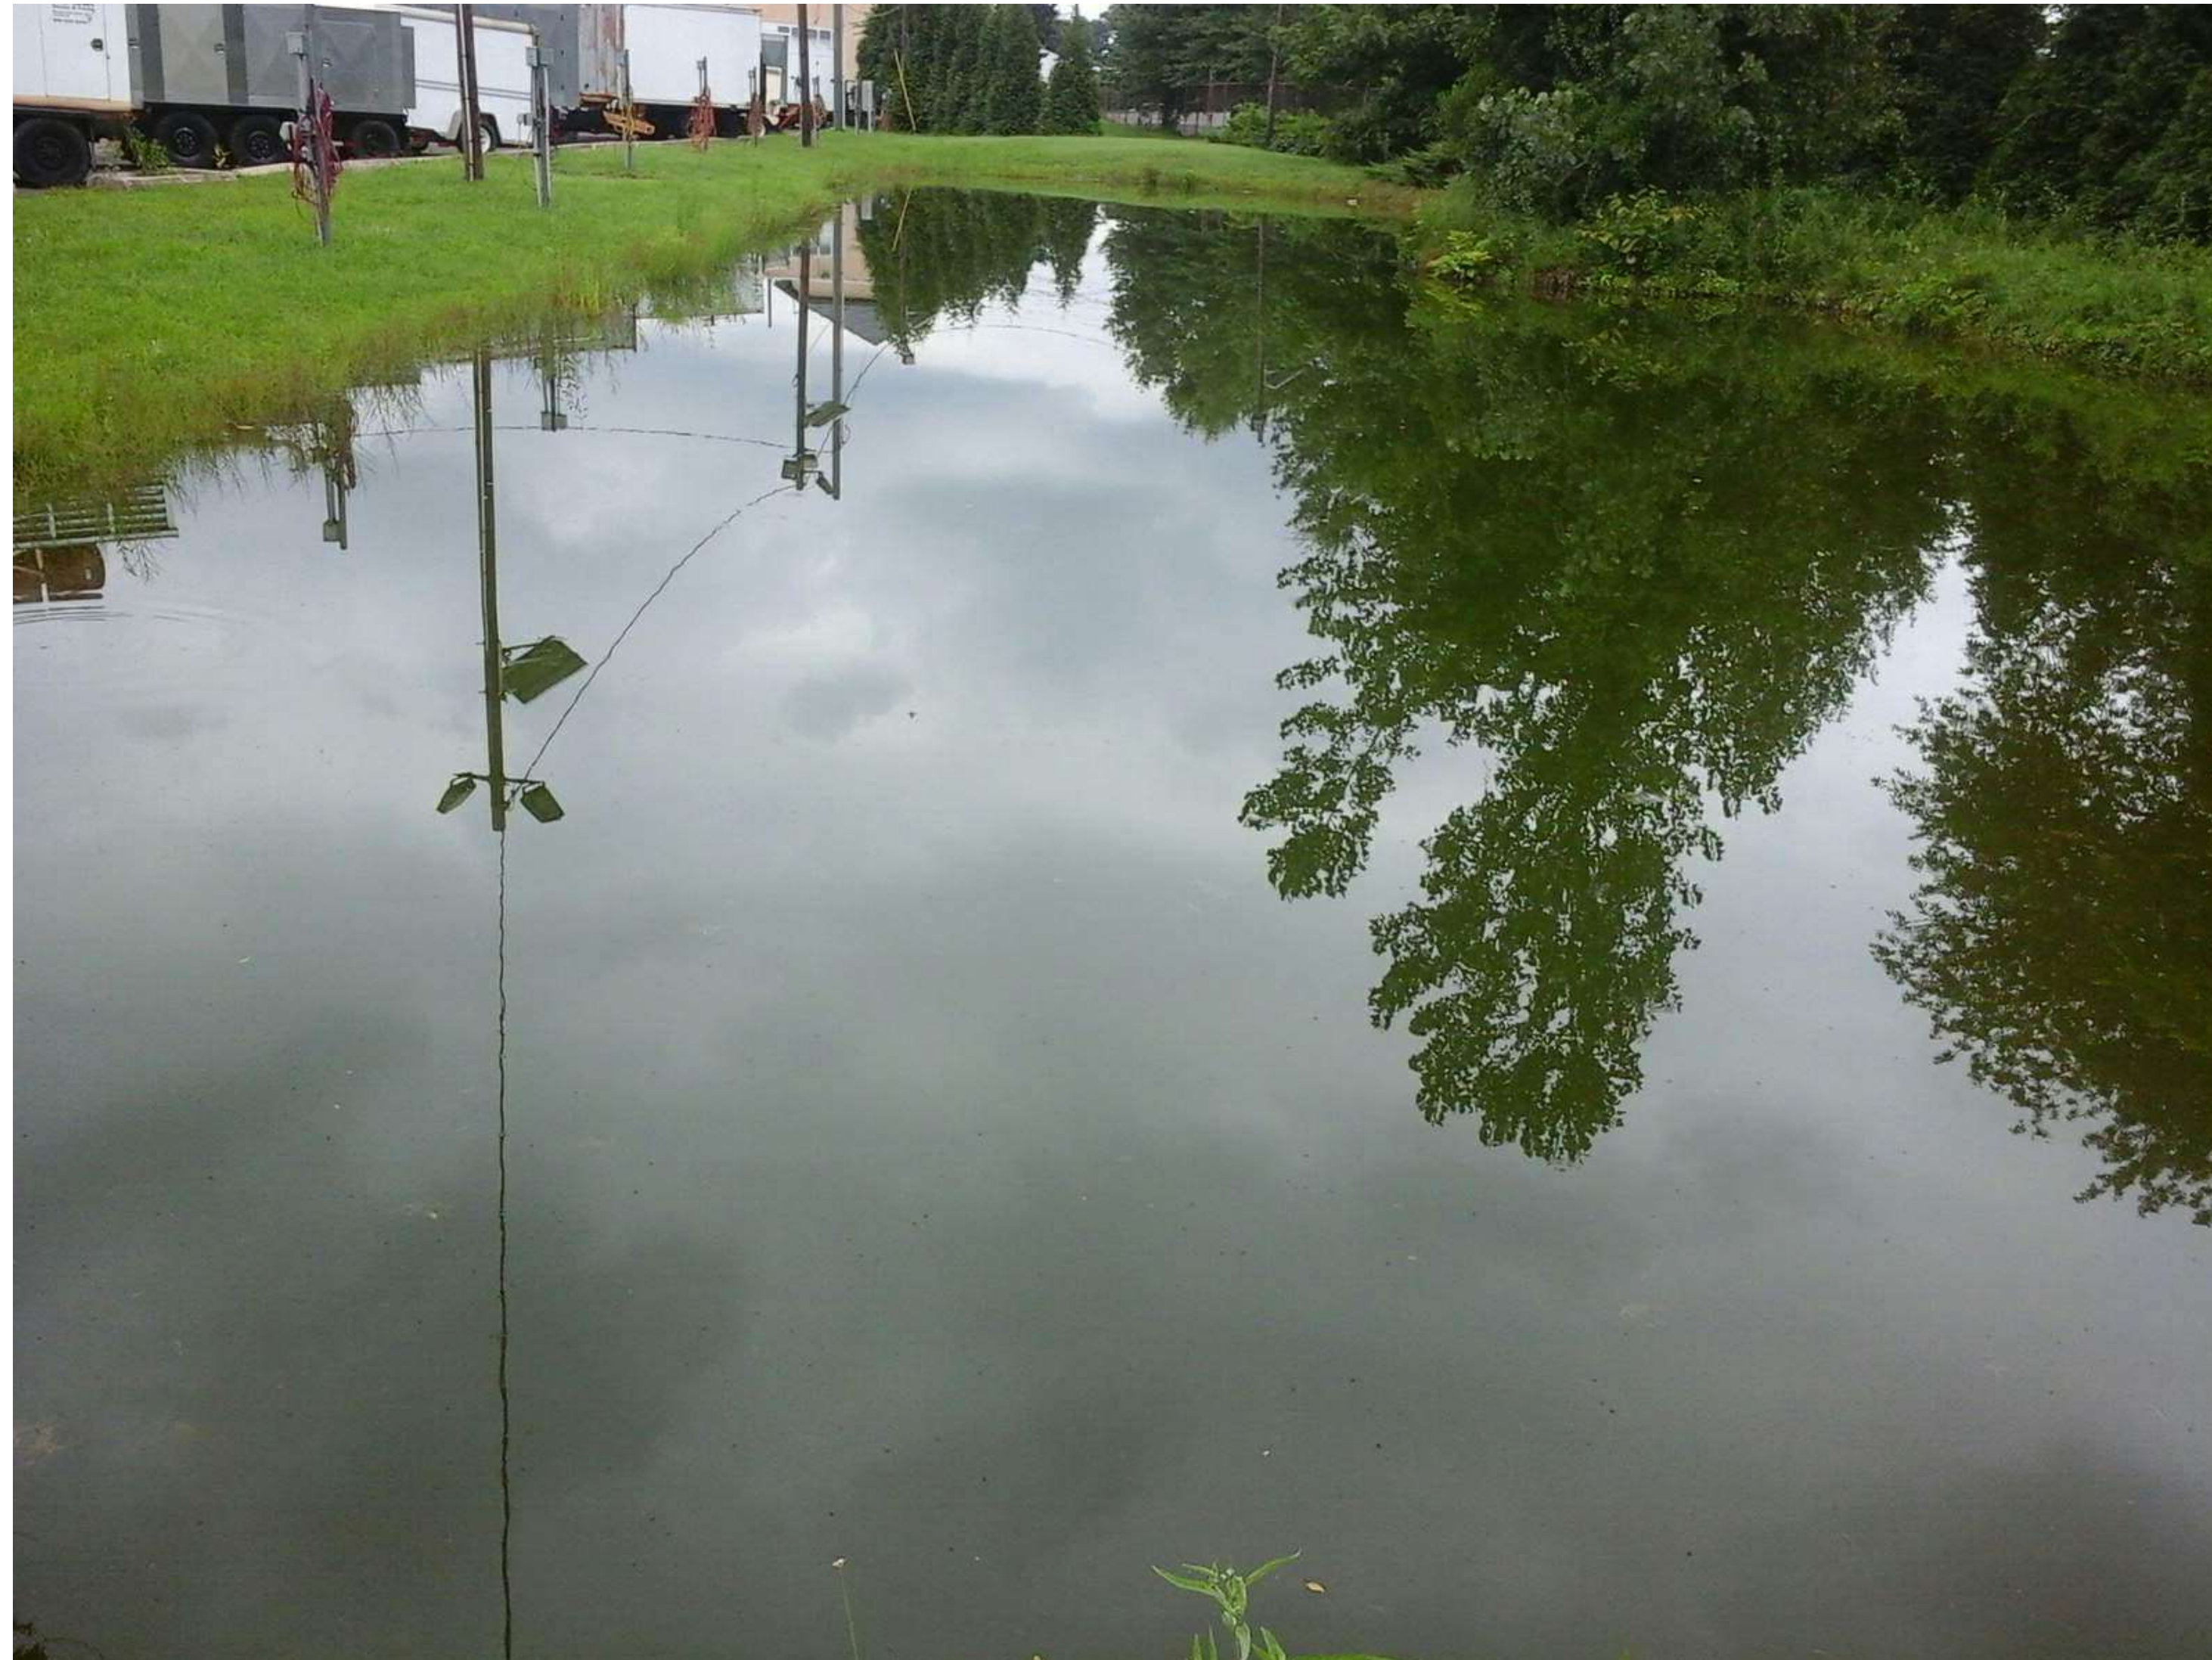
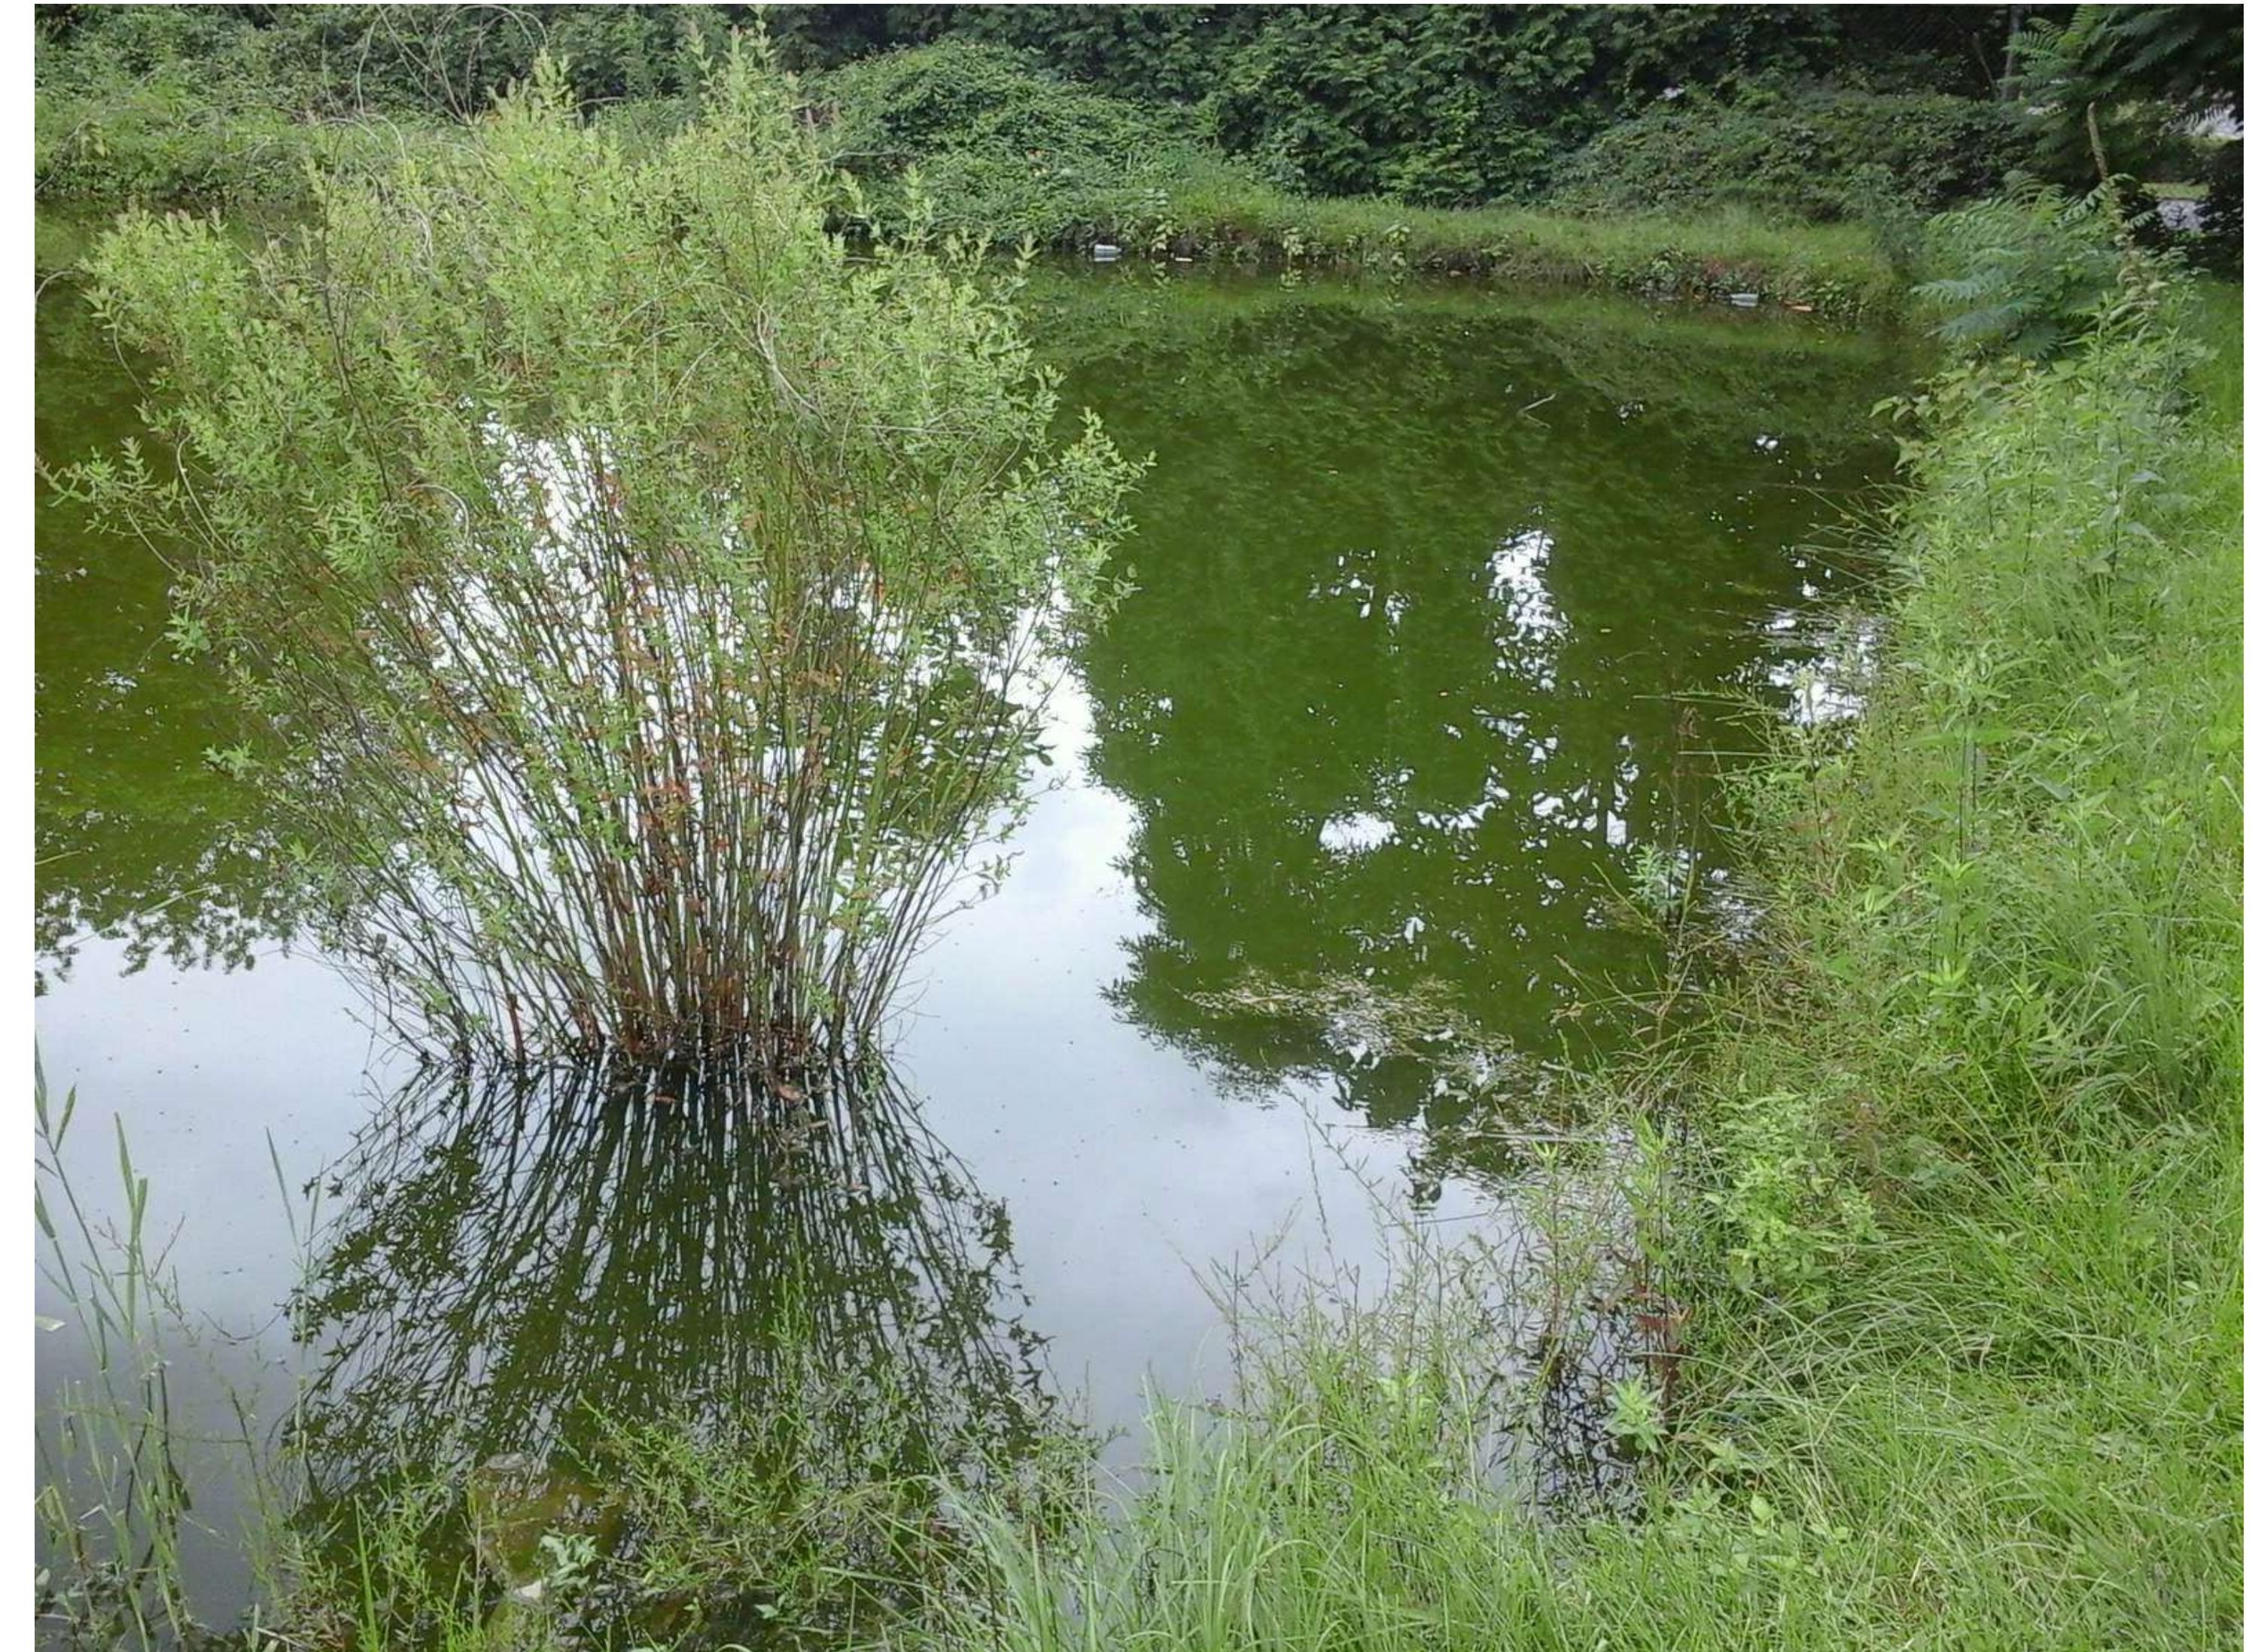
- Some cleaning of garbage and debris needed
- Receives runoff from adjacent parking lot
- Overall well maintained retention basin

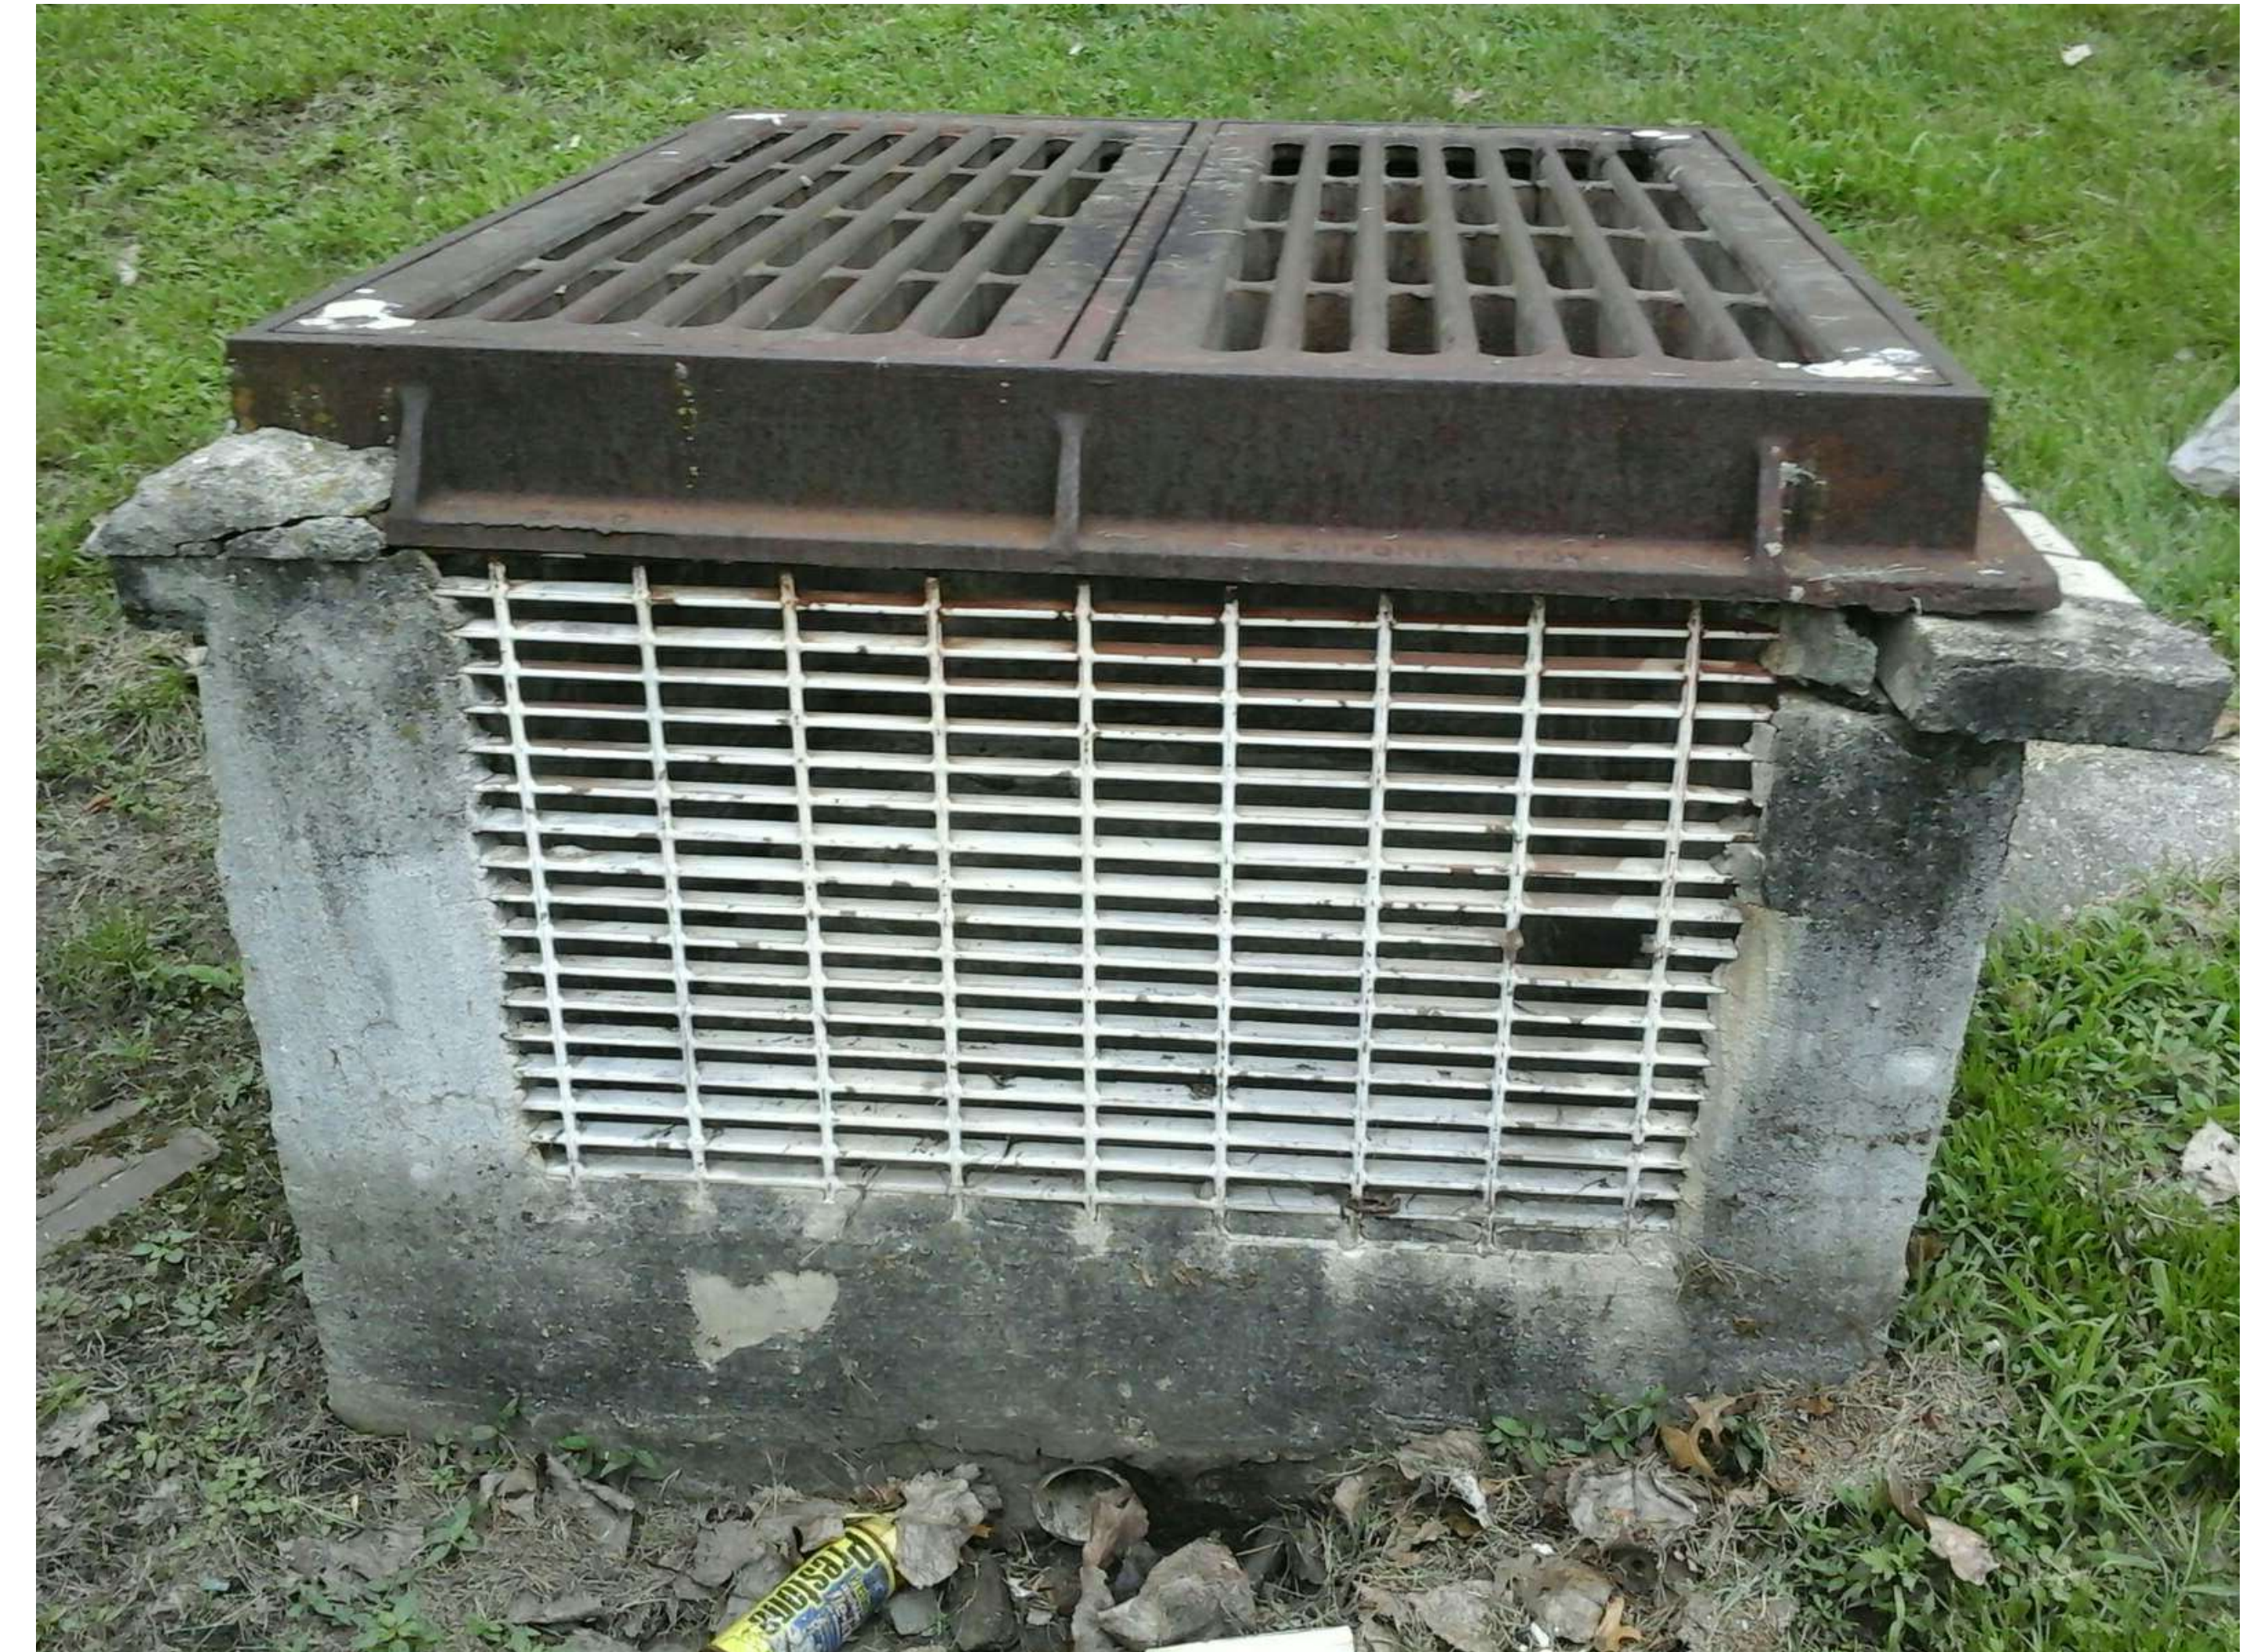
Inlet

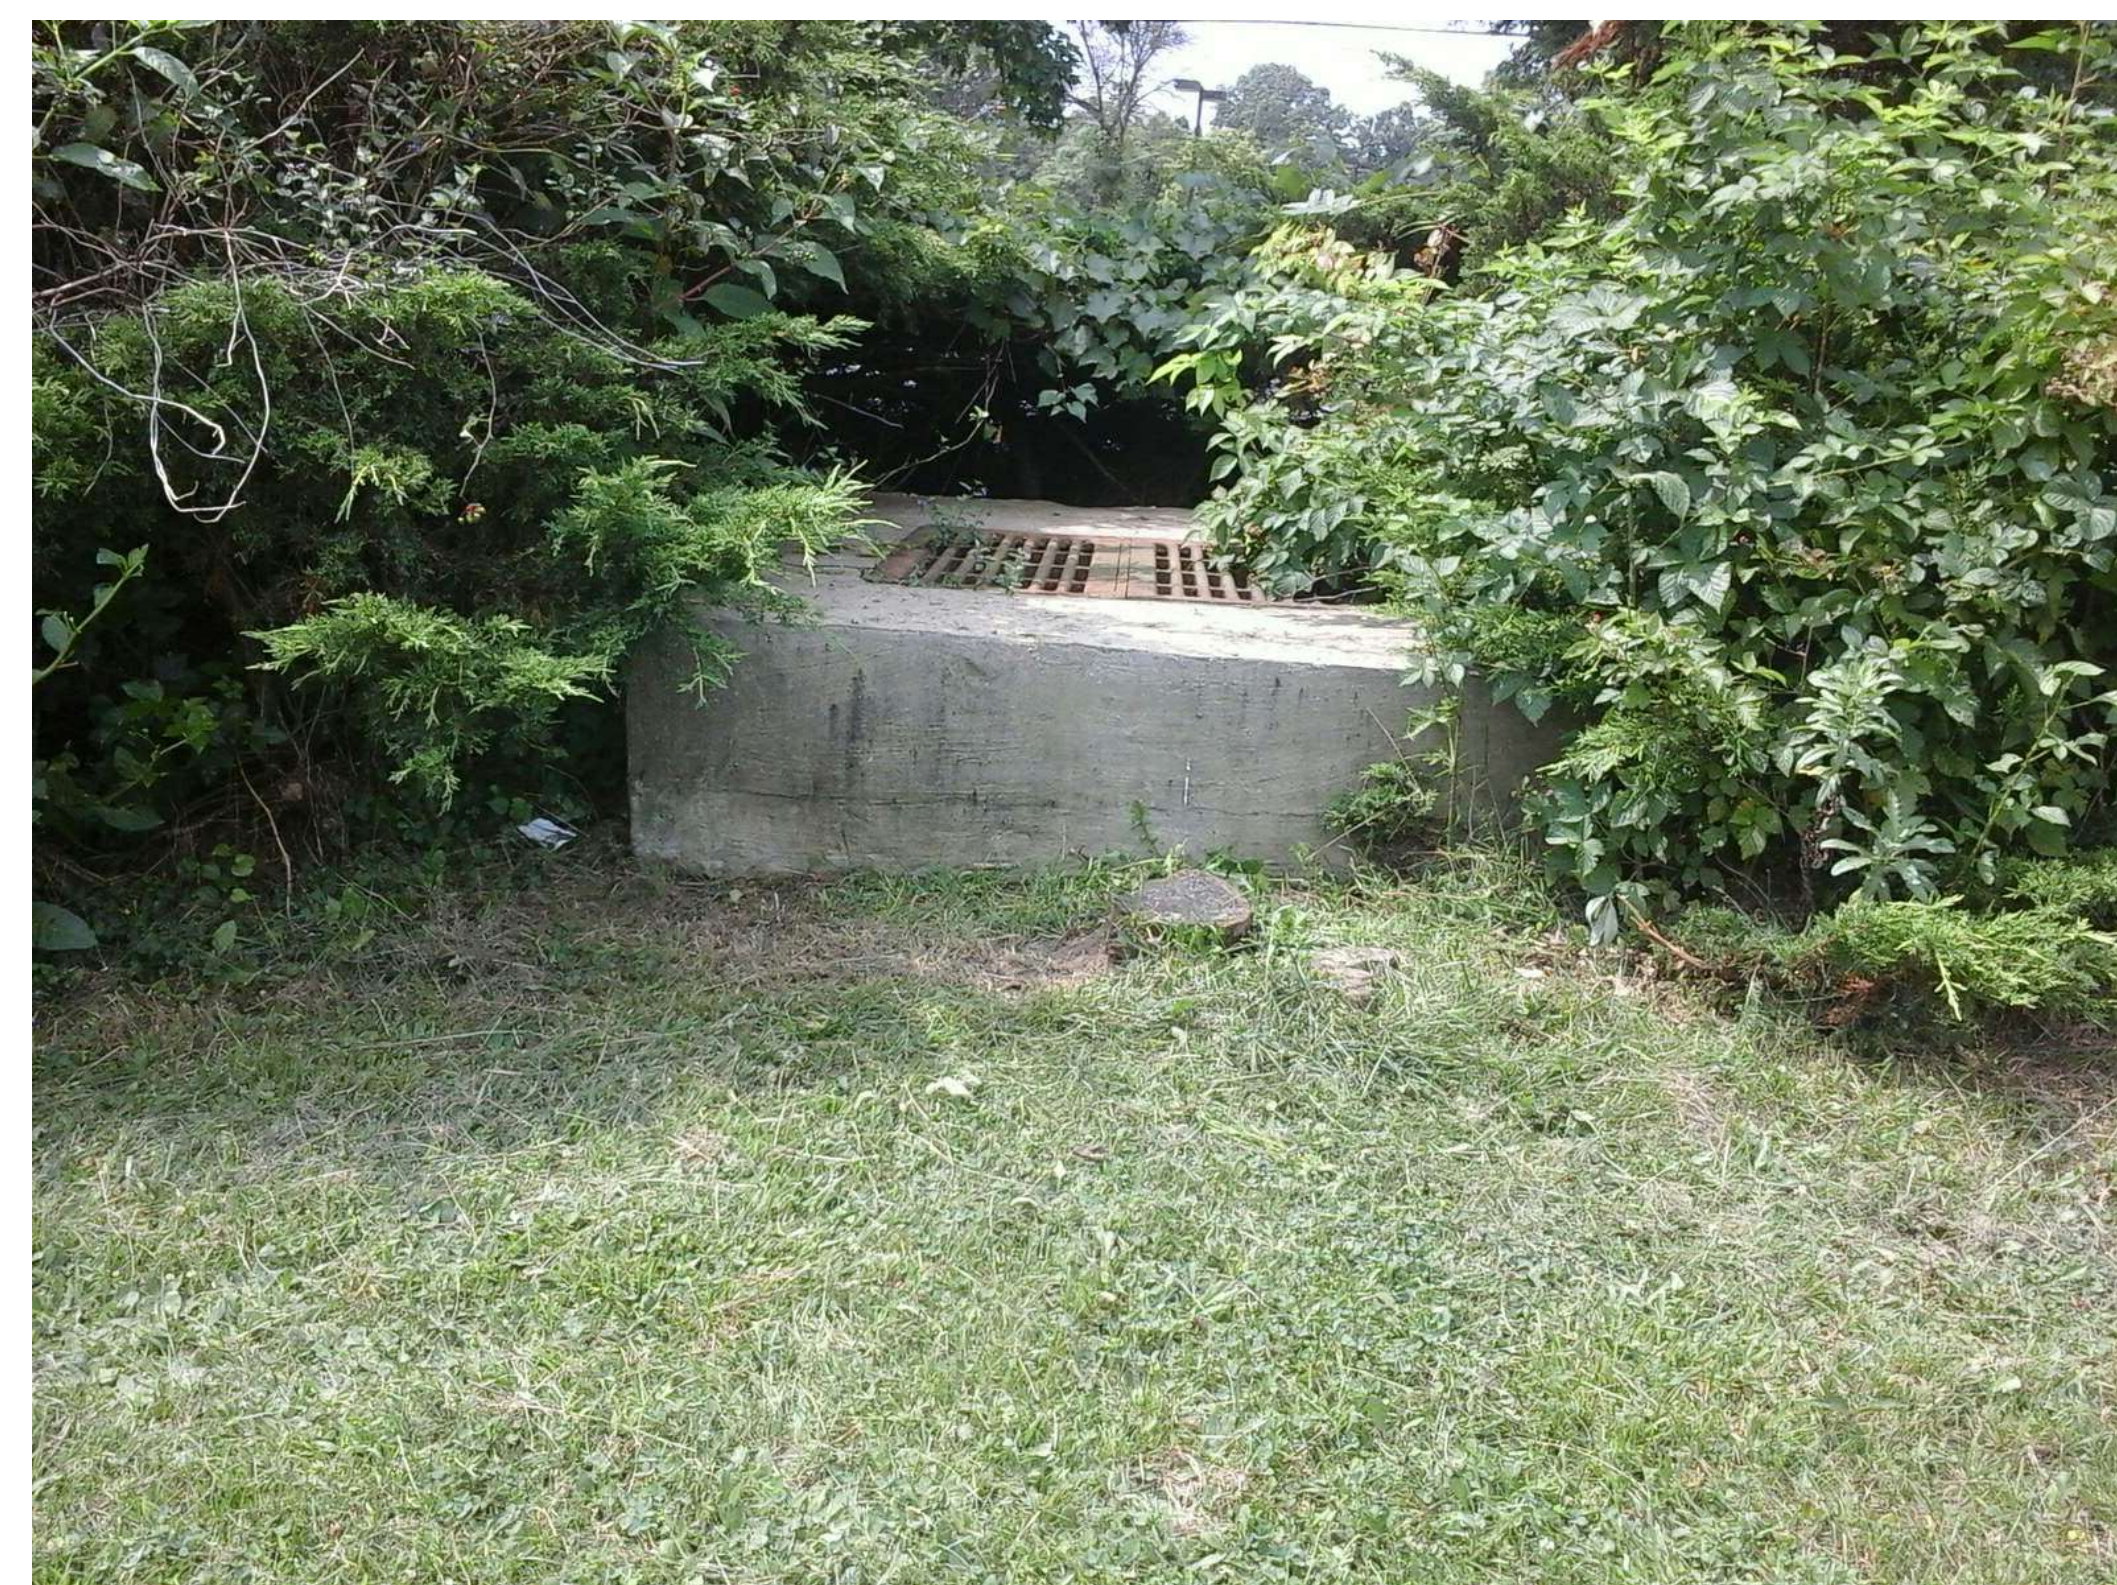
Outlet structure

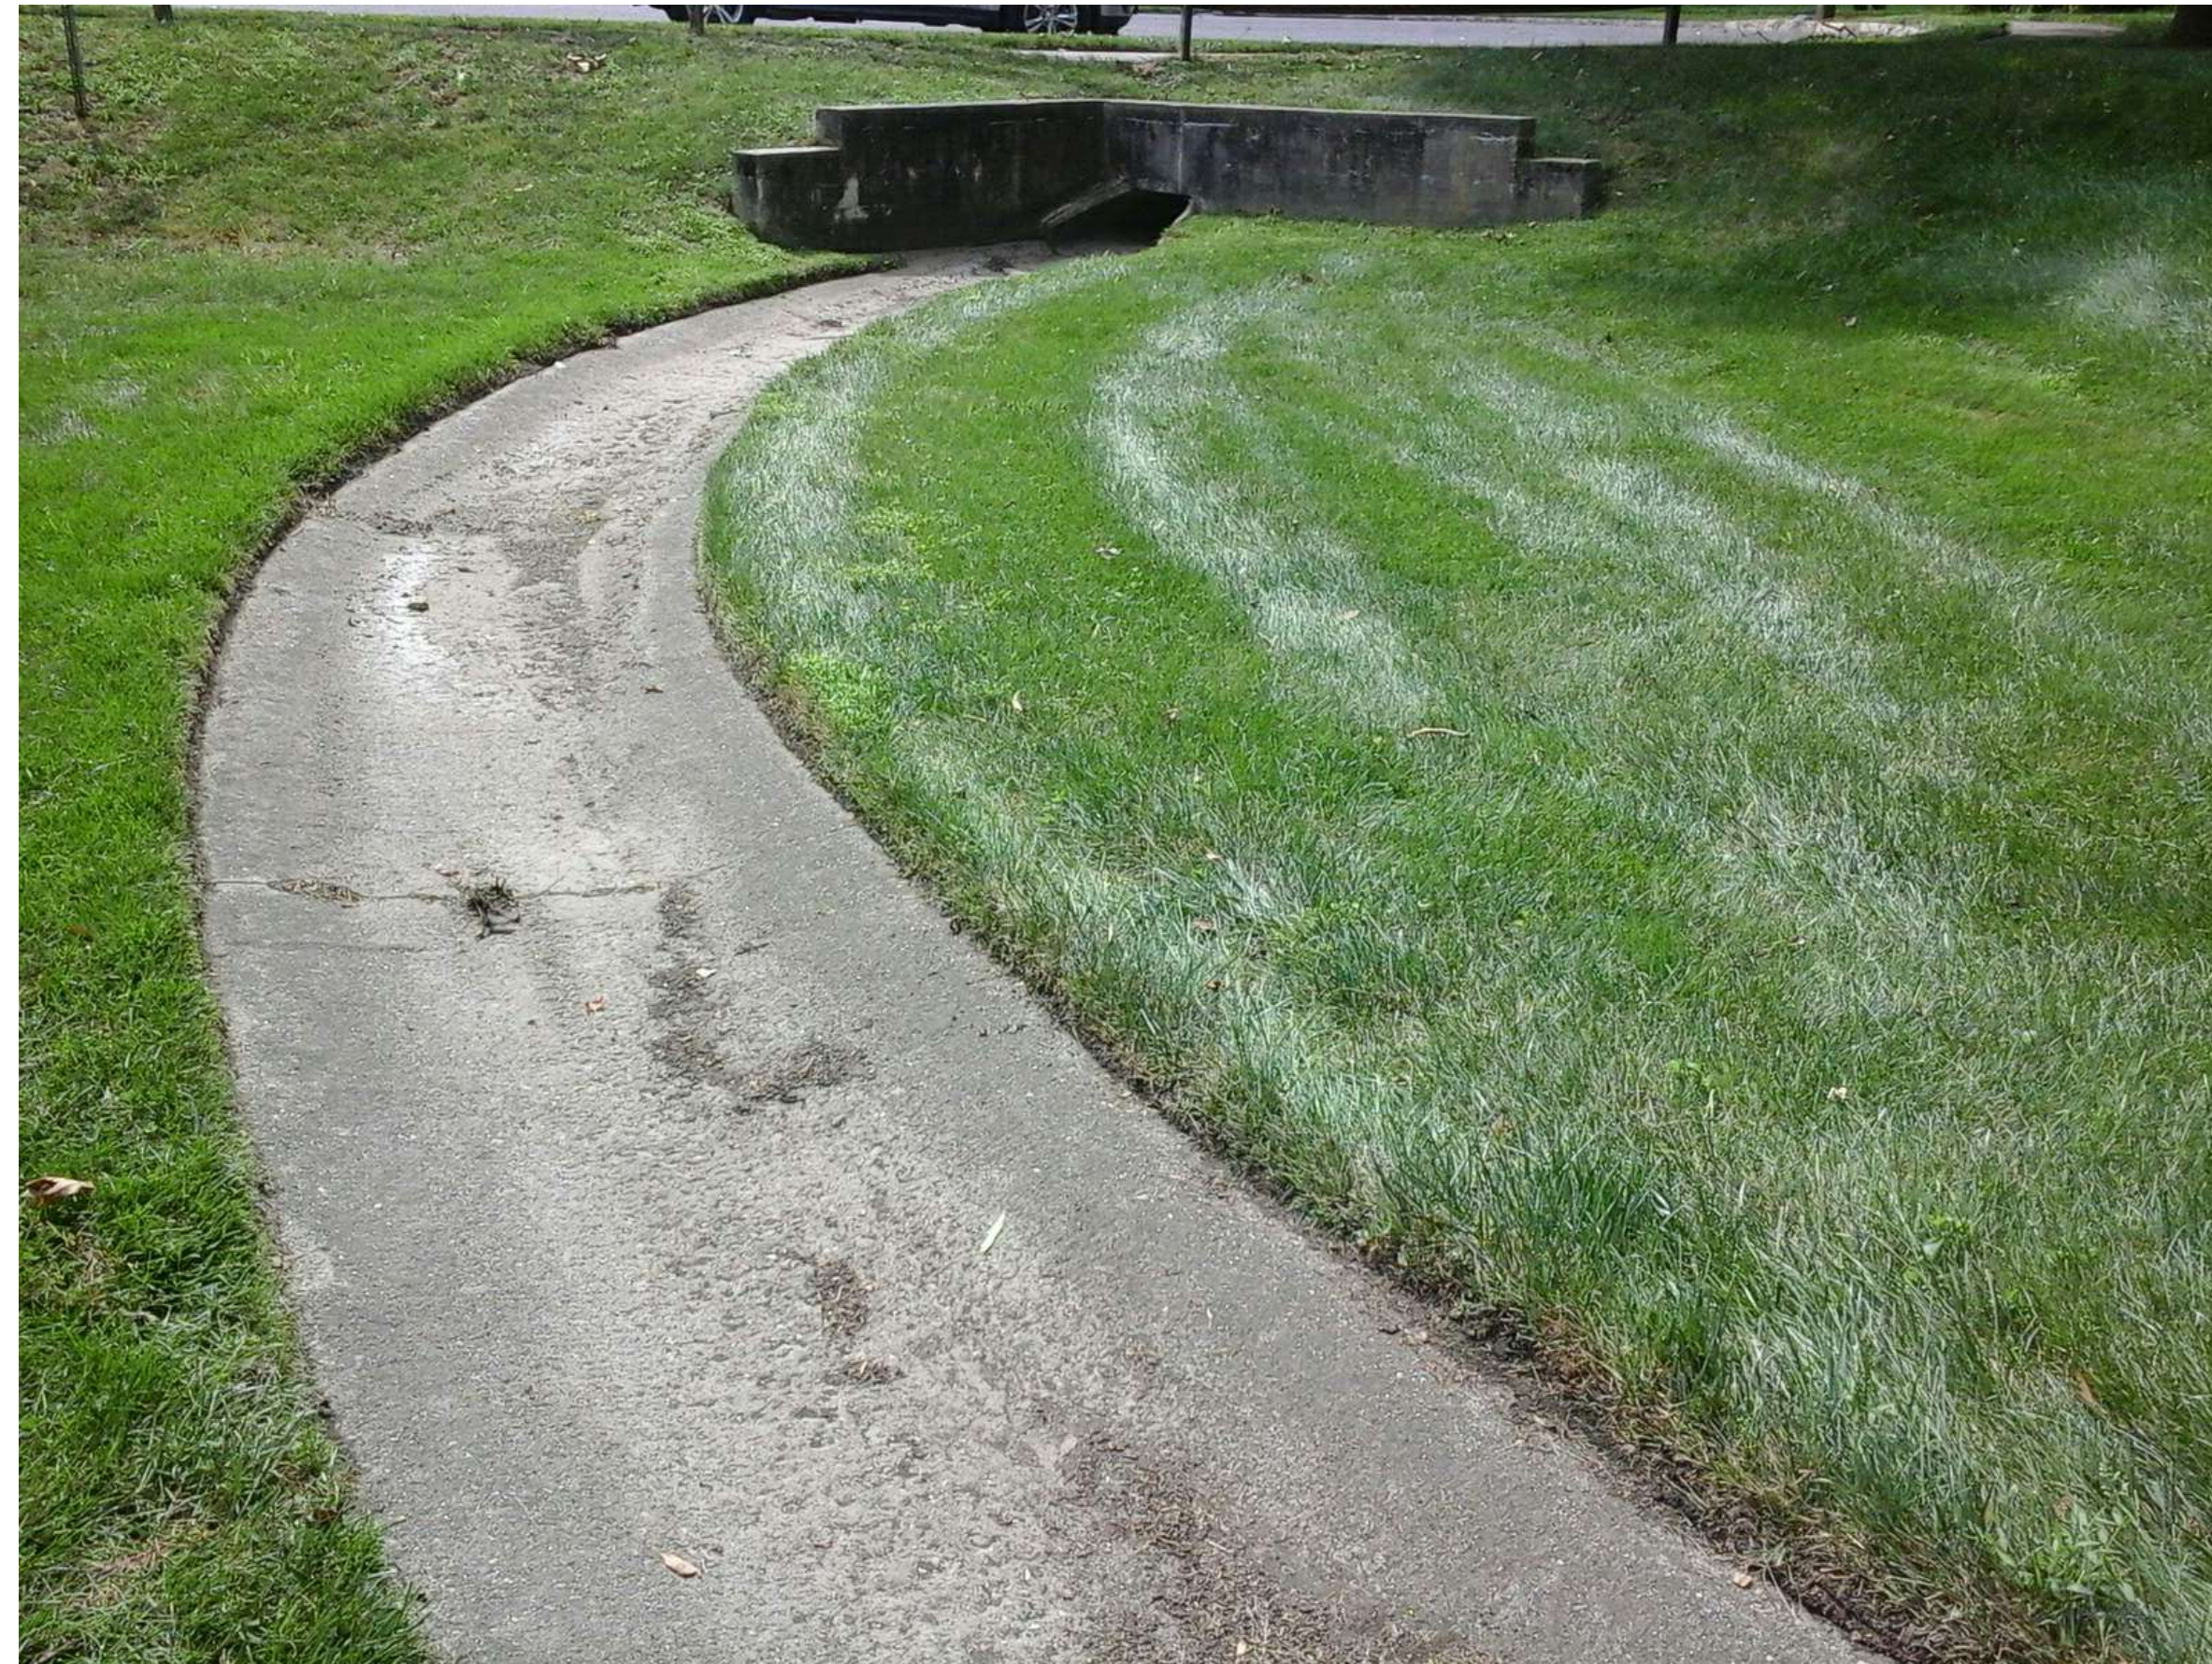
Low flow channel

- Replace low flow channels with stone to allow better infiltration
- Sediment in low flow channel and outlet

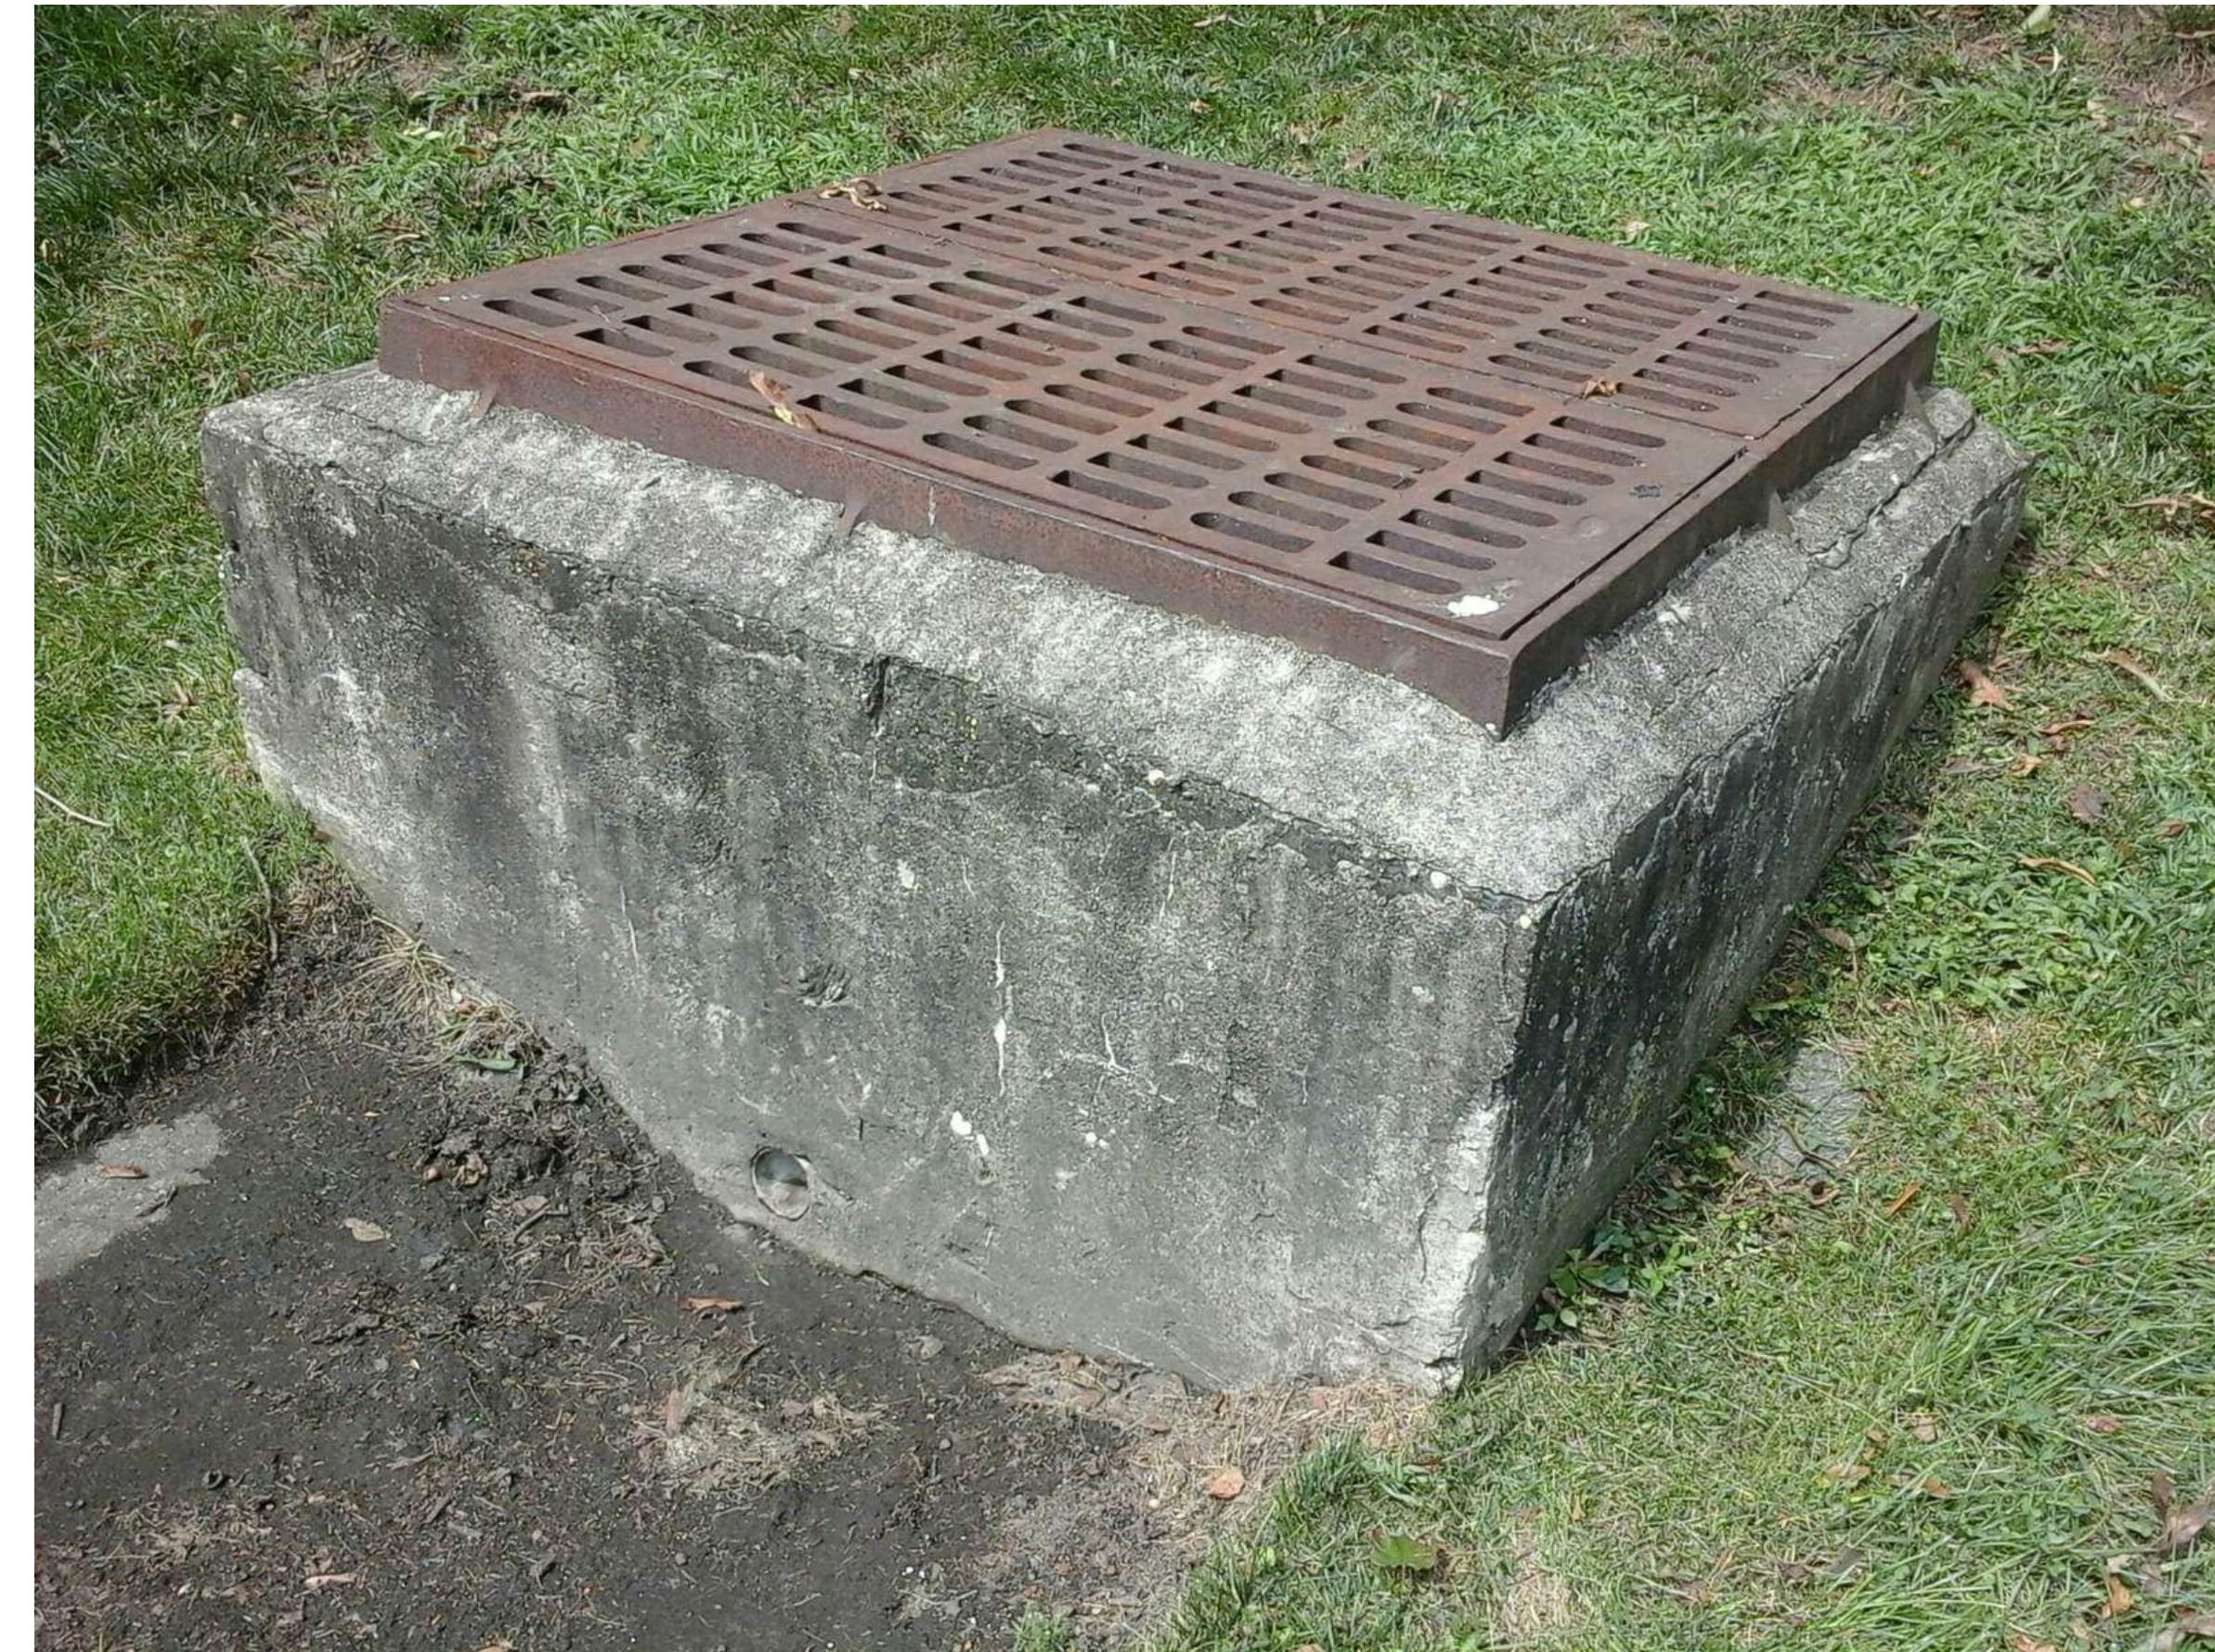
Outlet
