**Hamilton Township (Mercer County)
Stormwater Basin Assessment Summary
Addendum (Year 4)**

Developed by the Rutgers Cooperative Extension Water Resources Program
Funded by Hamilton Township, Mercer County, New Jersey

December 2017

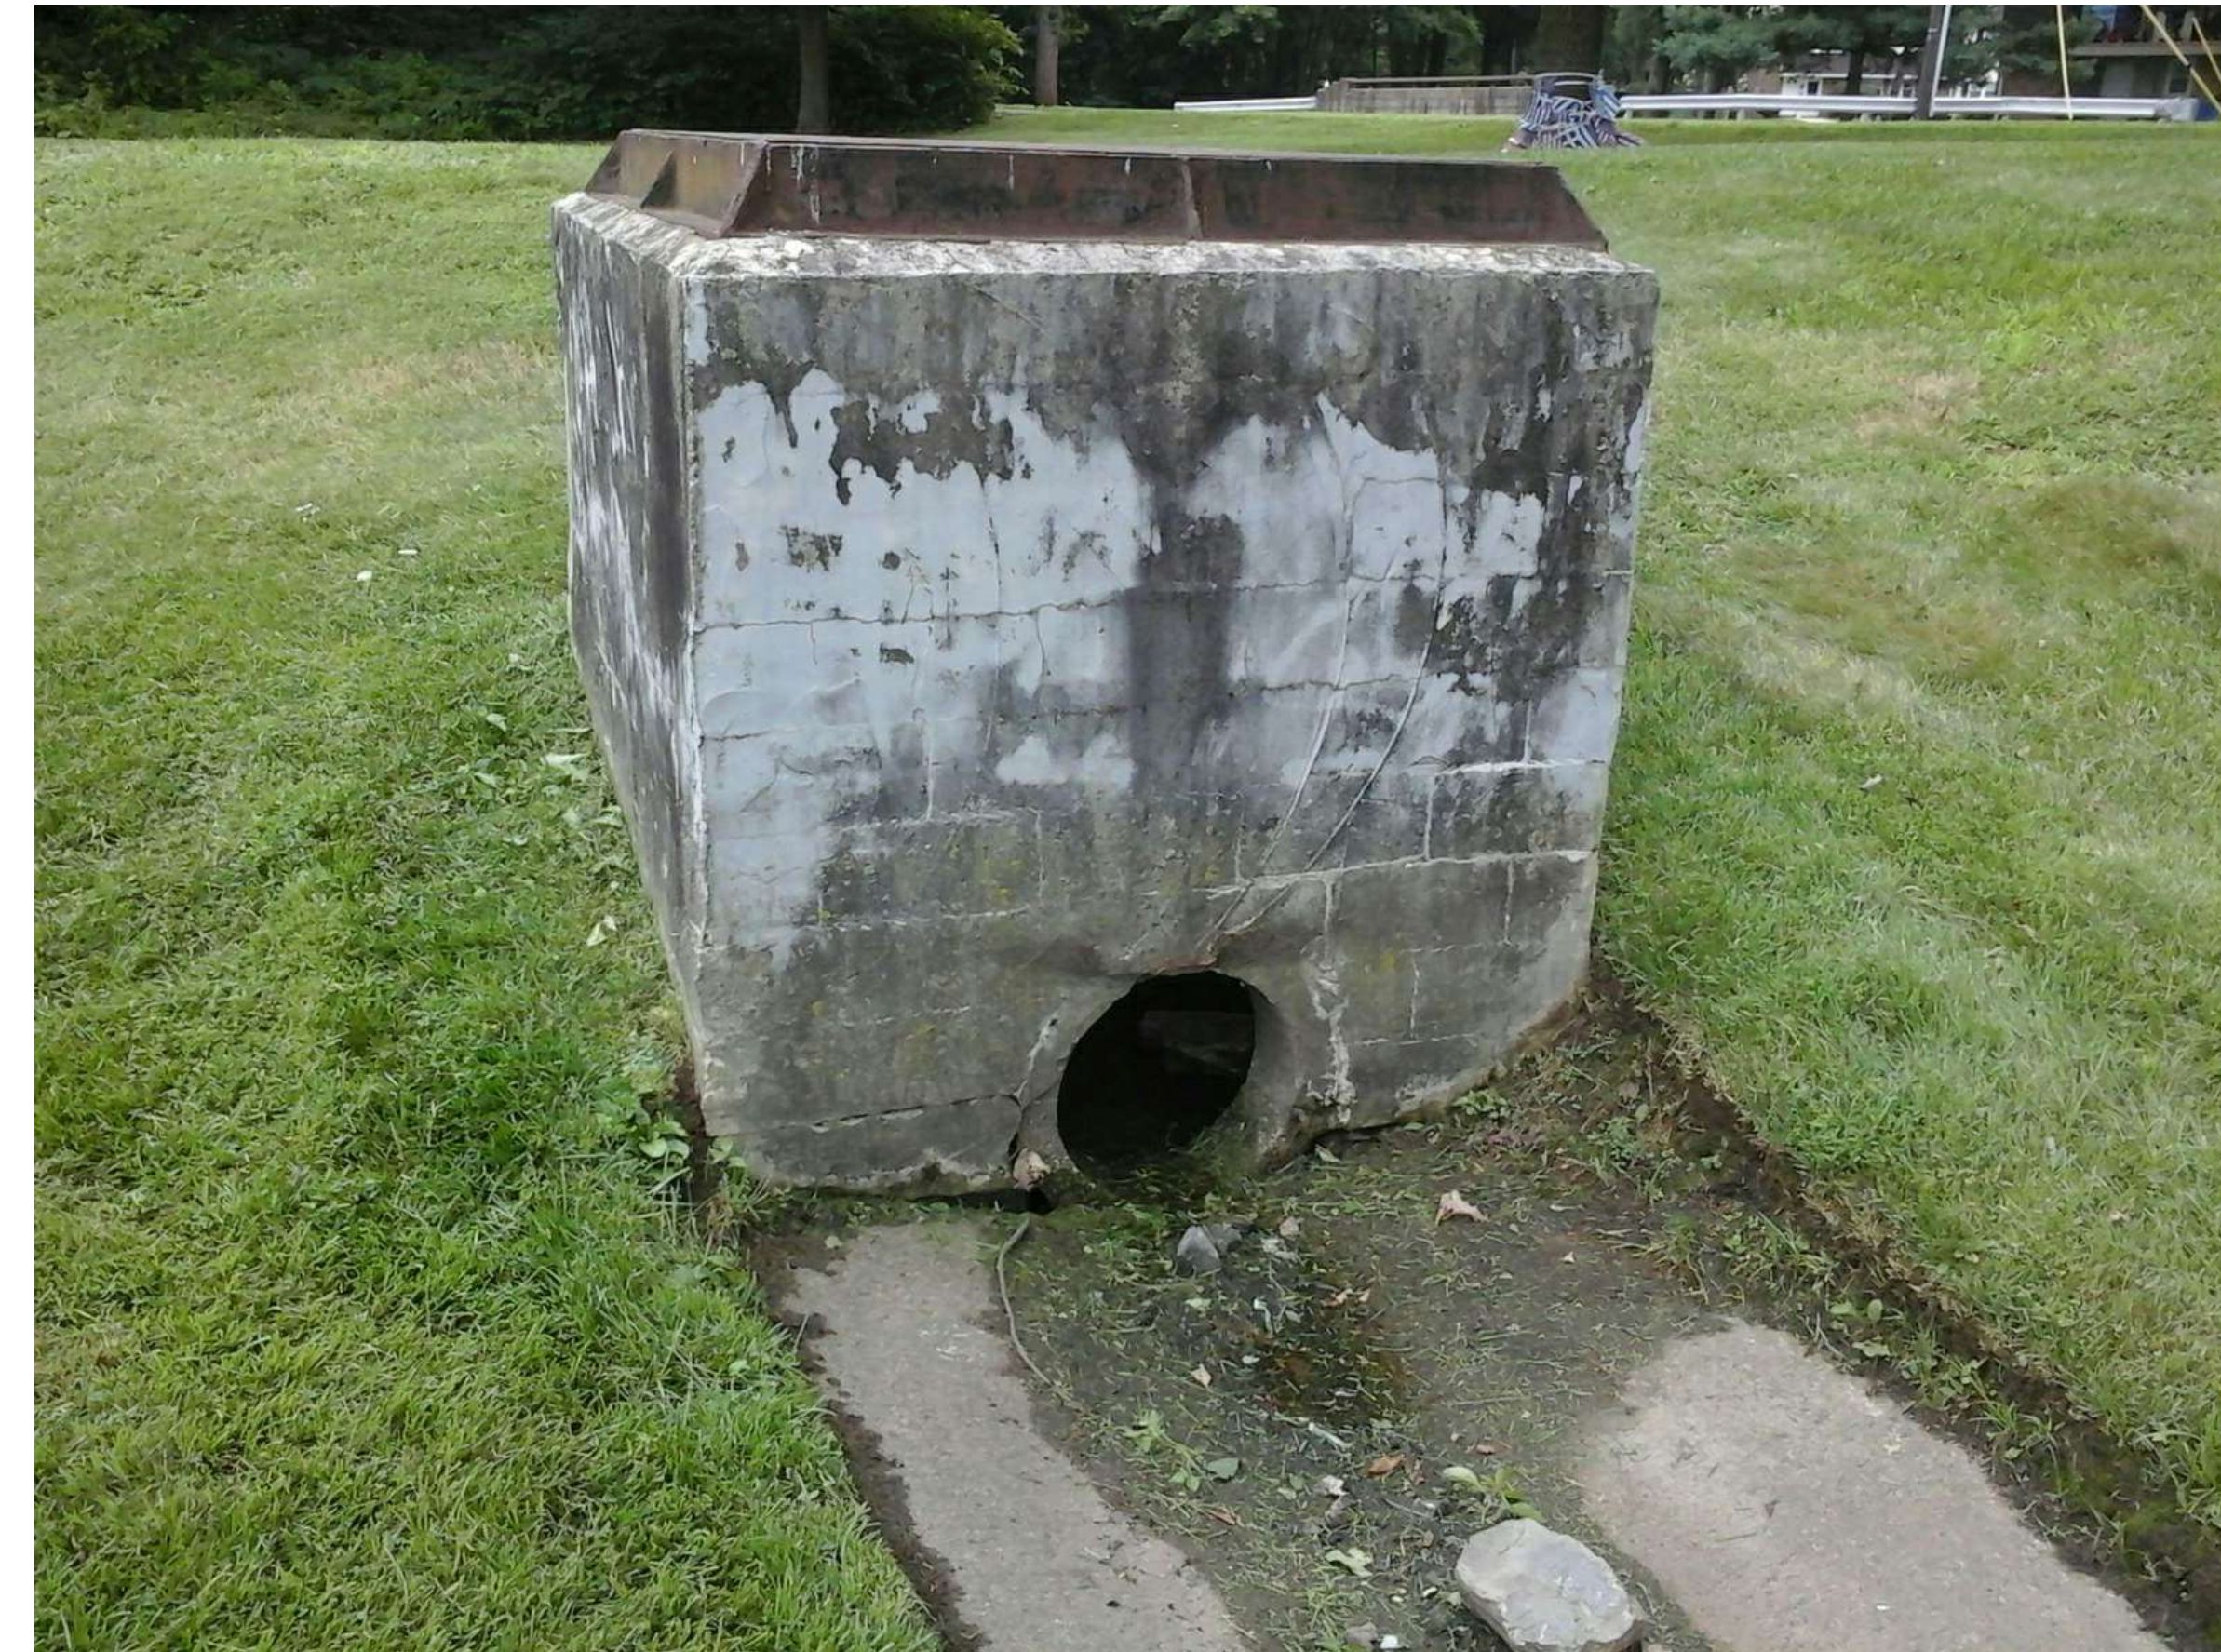
Outlet

- Standing water in outlet structure
- Establish meadows to provide habitat and enhance infiltration
- Replace low flow channels with stone channel for better infiltration
- Sediment in low flow channel and outlet

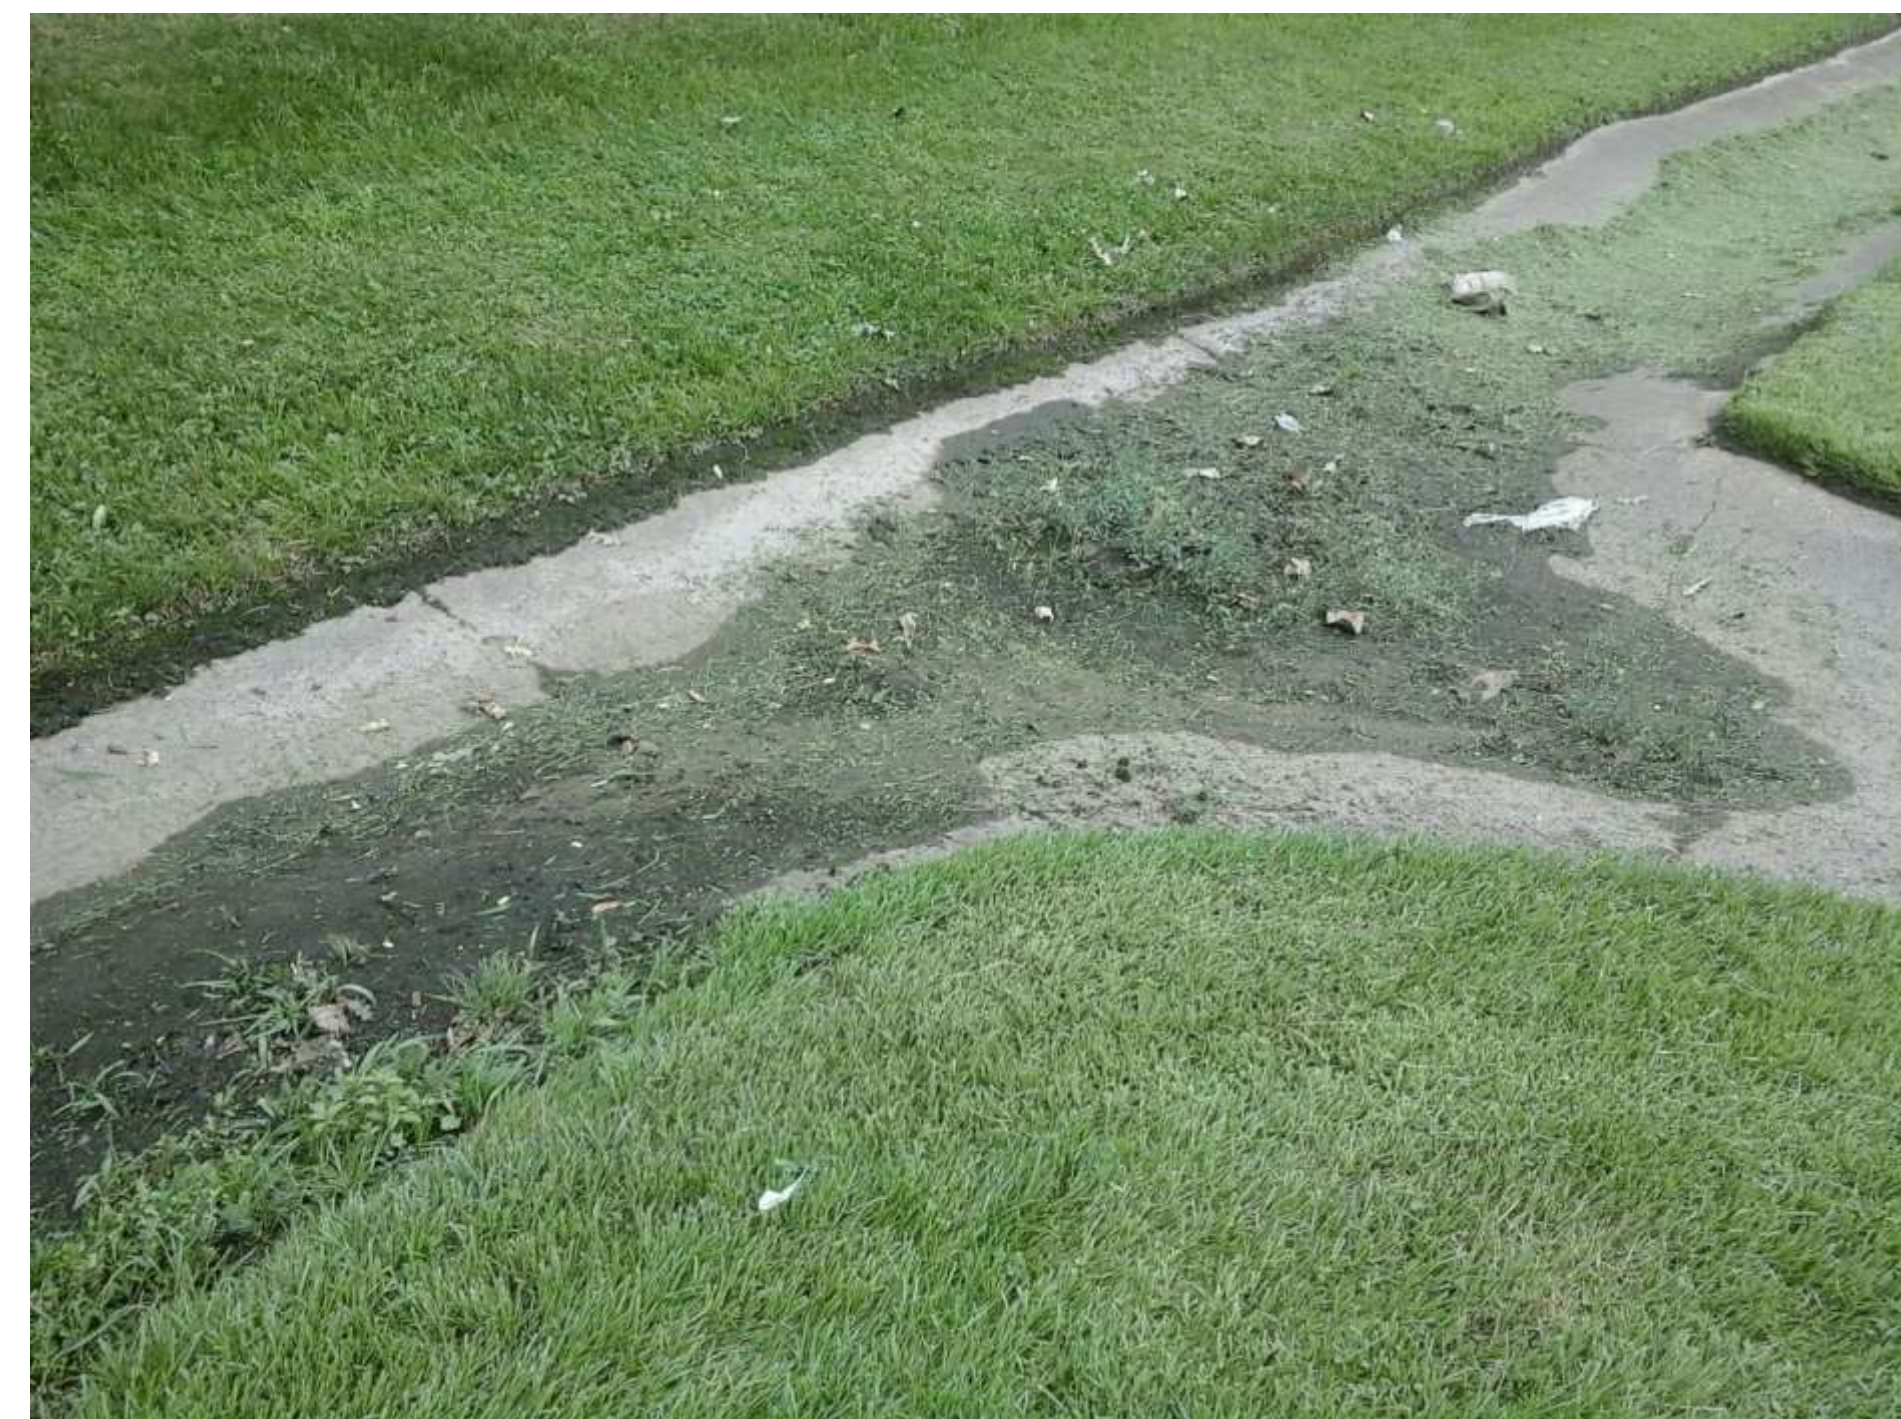
Low flow channel

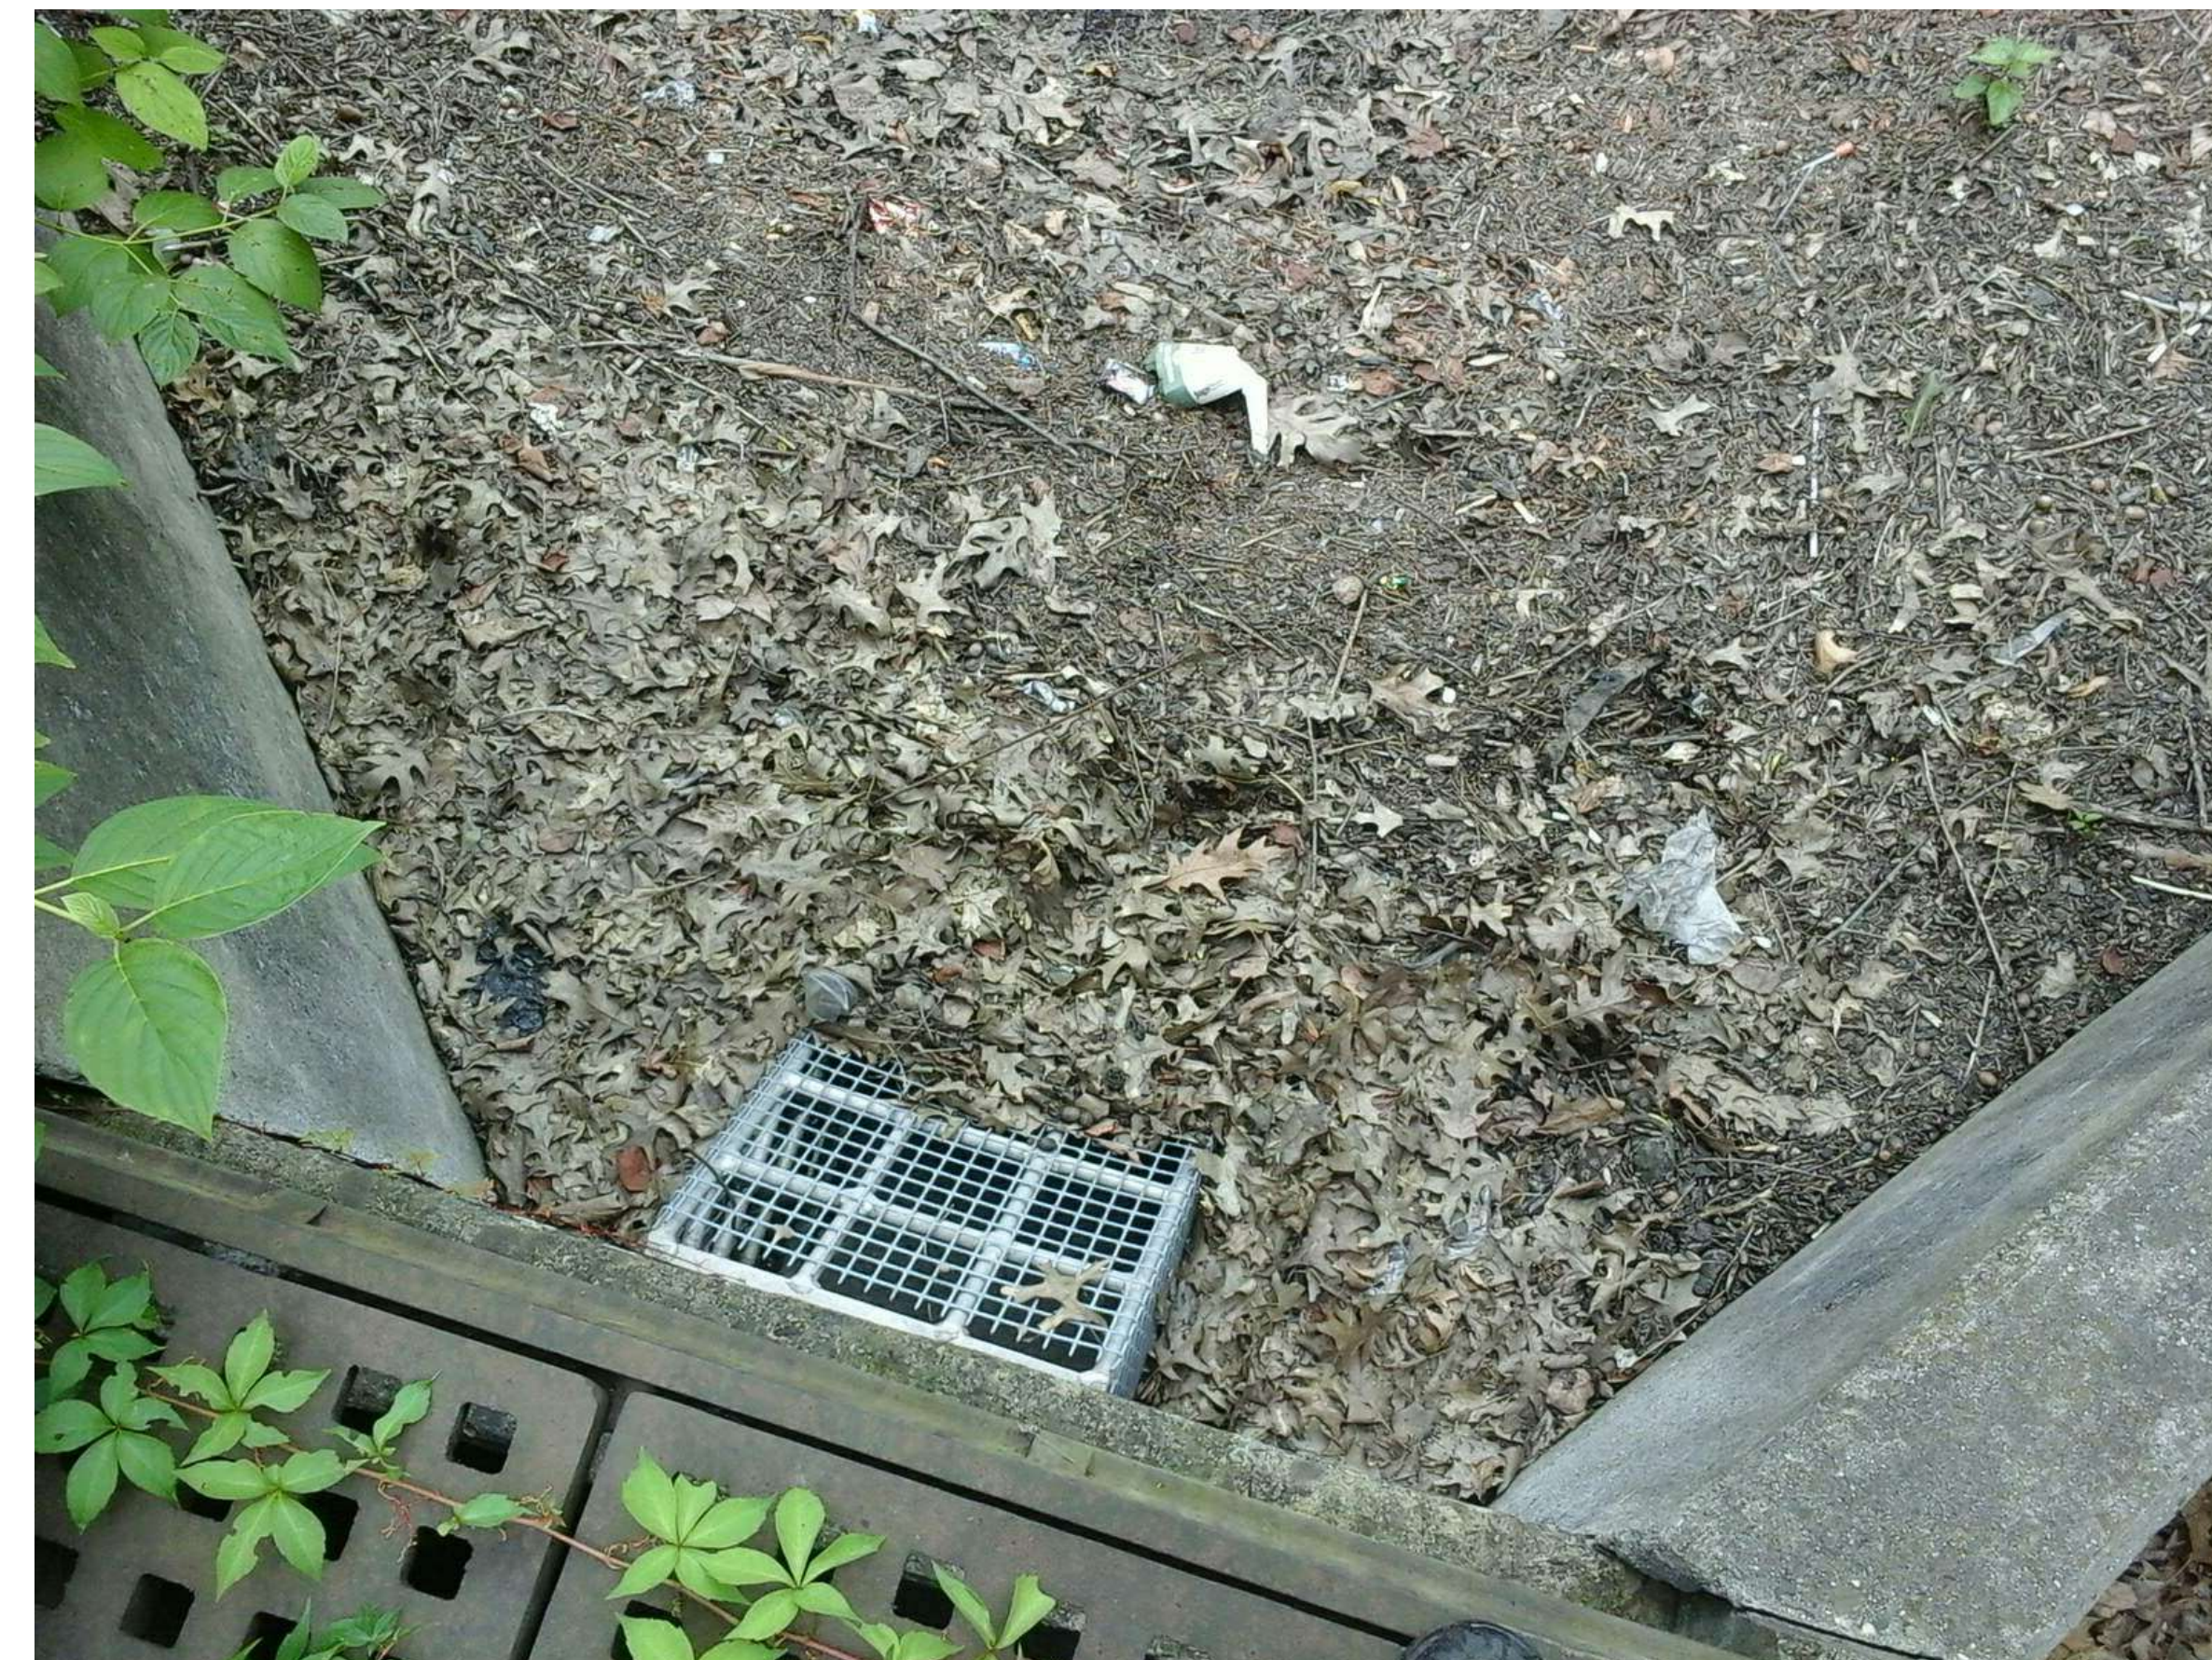
Outlet

- Sediment in low flow channel and outlet
- Establish meadows to improve habitat and infiltration
- Overall well maintained beside sediment buildup

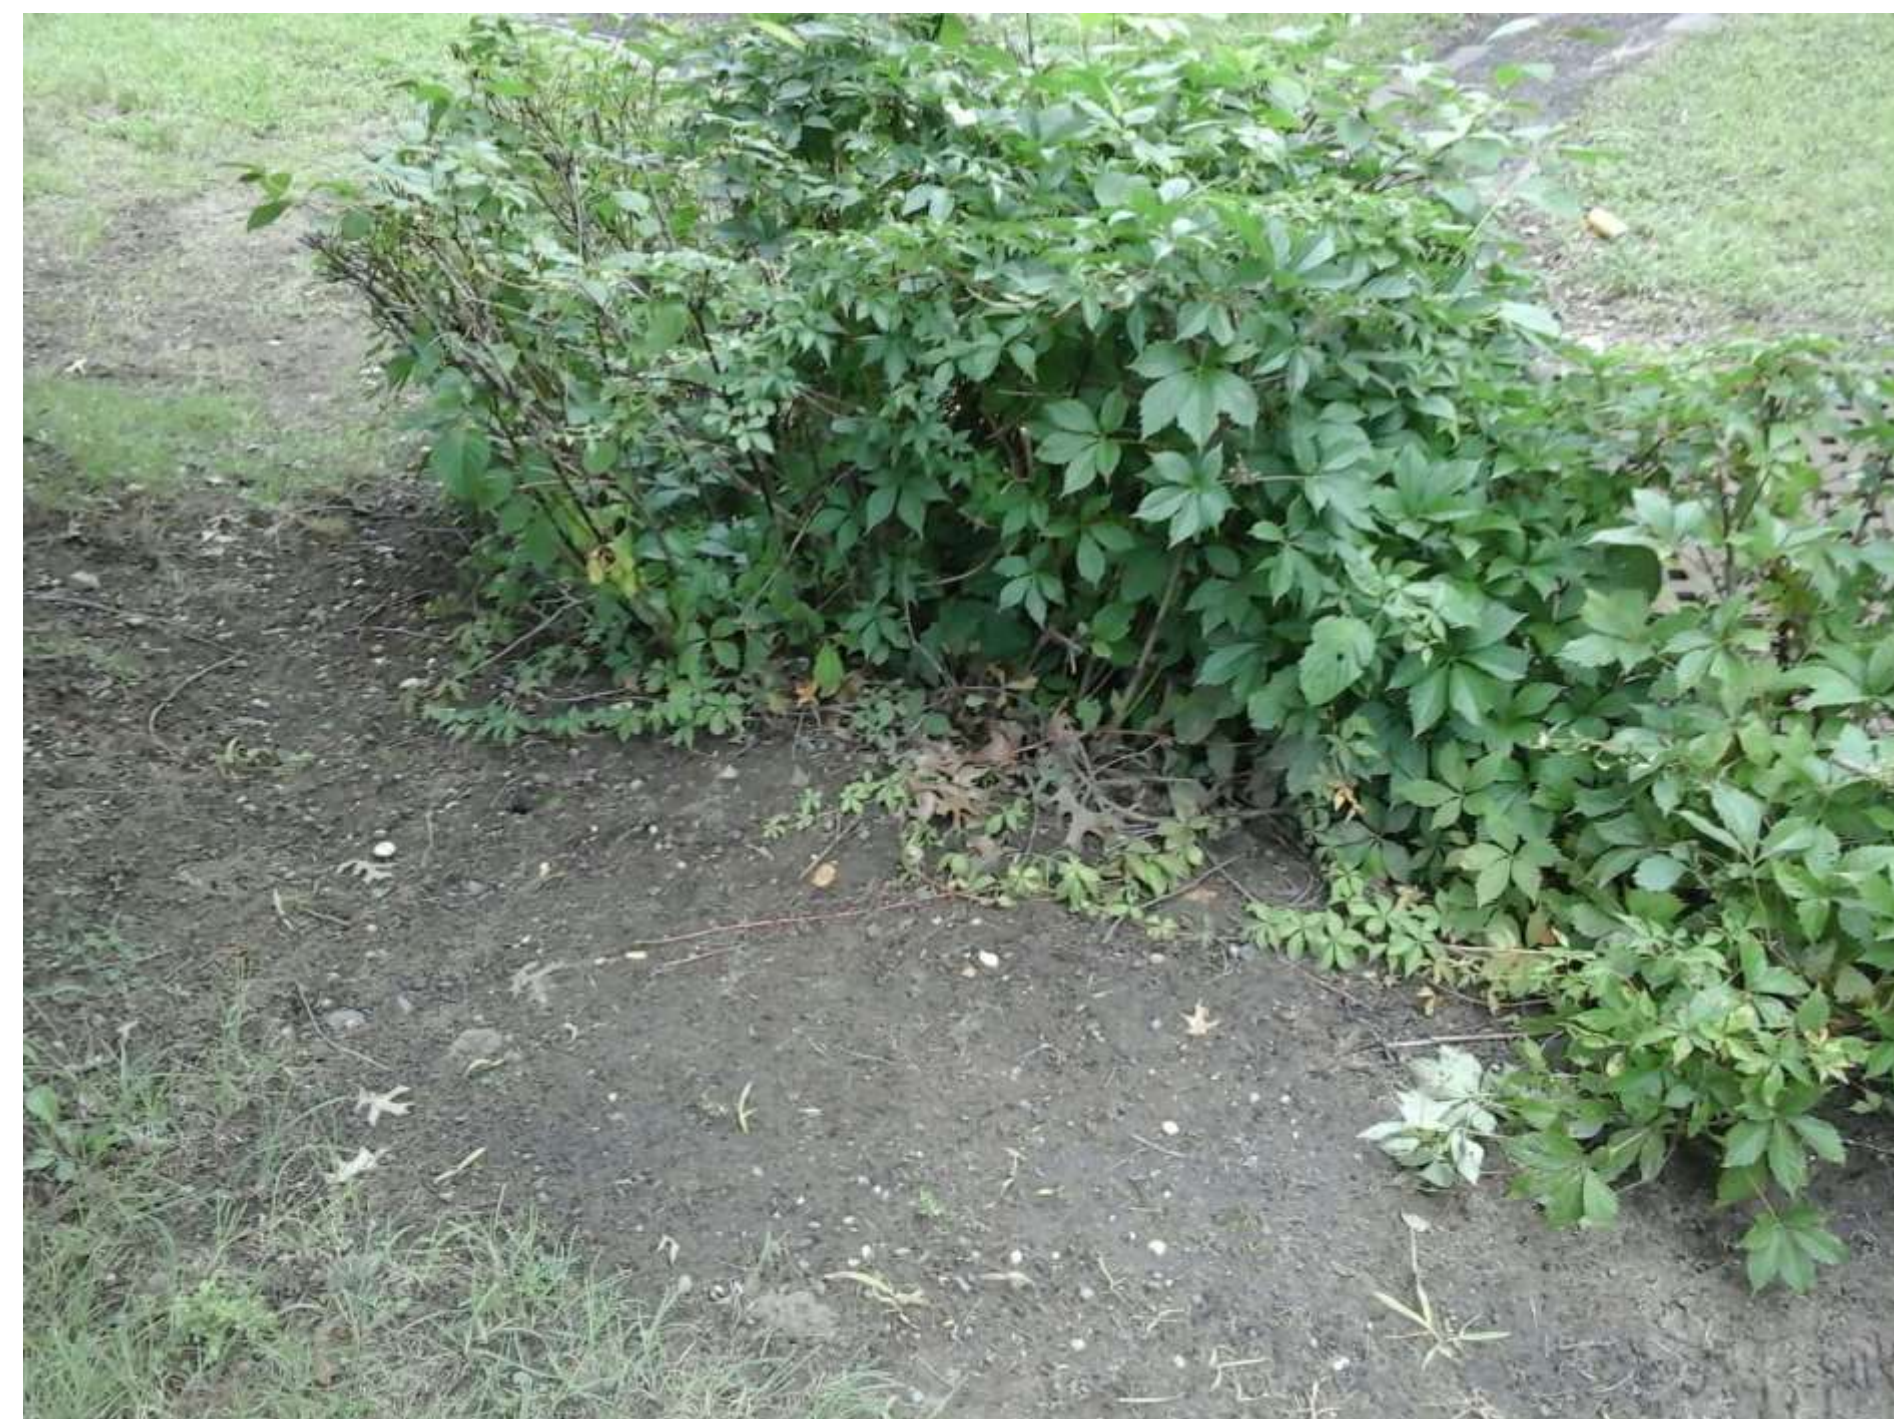
Low flow channel

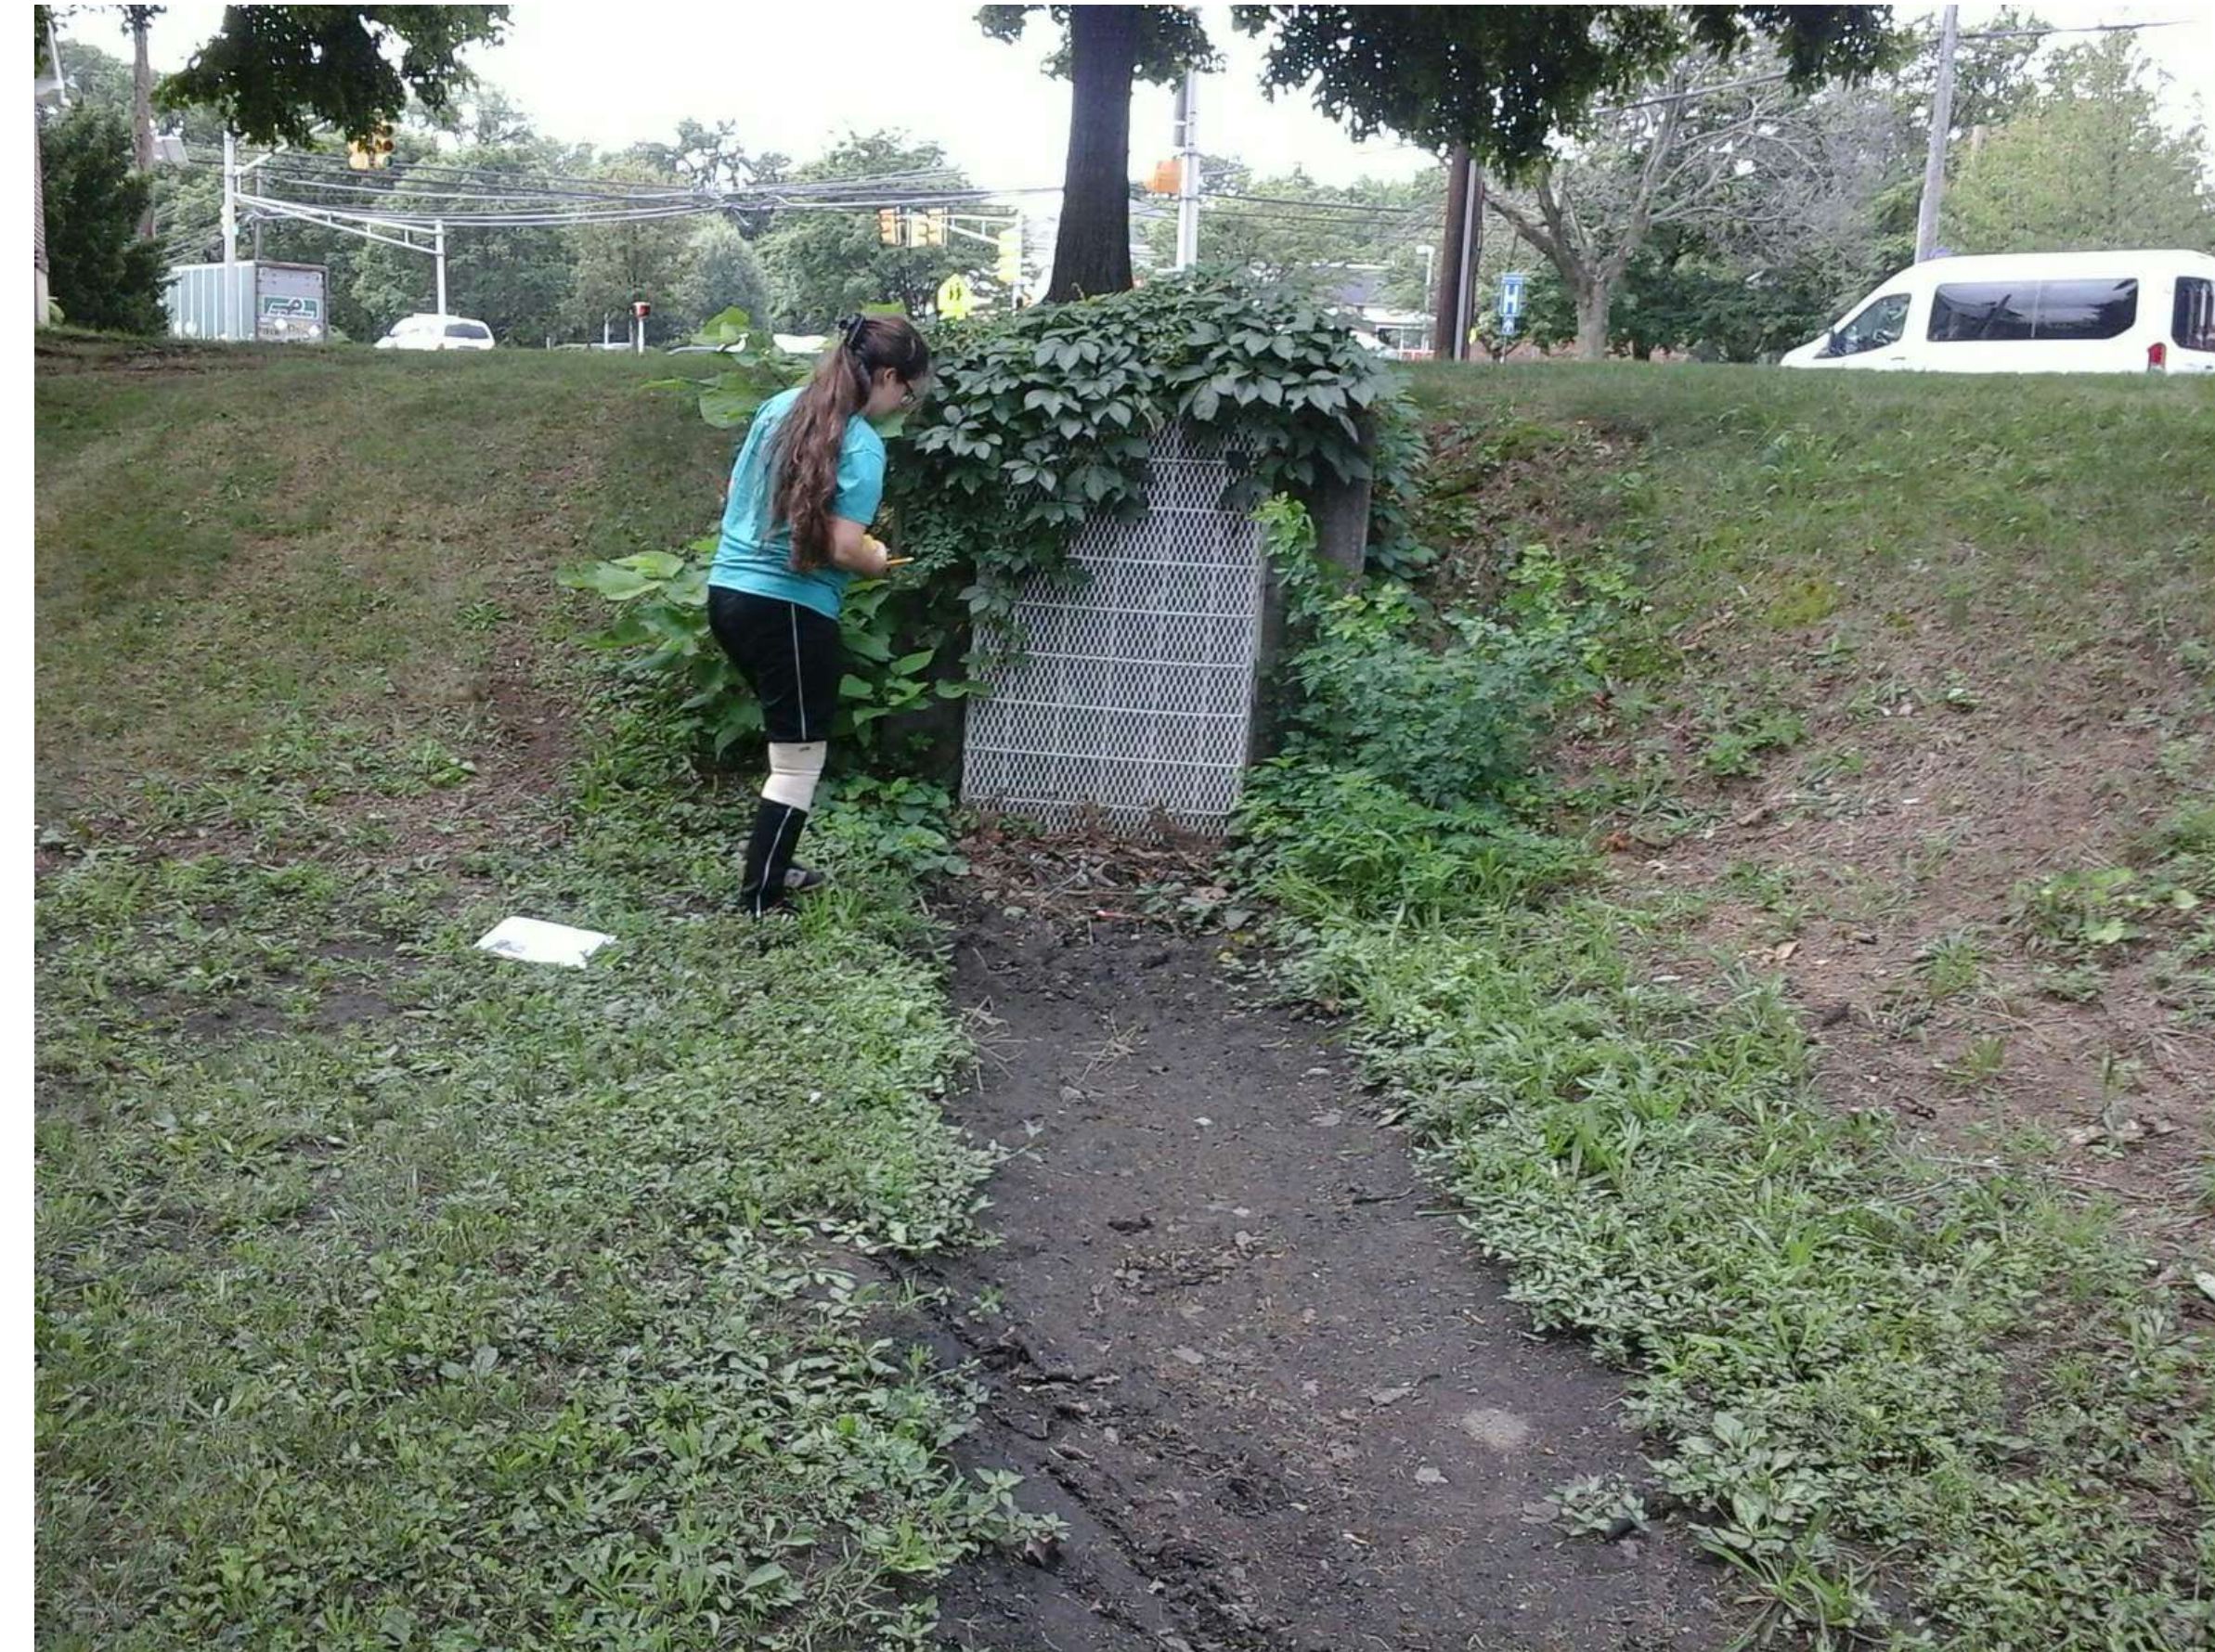
Outlet

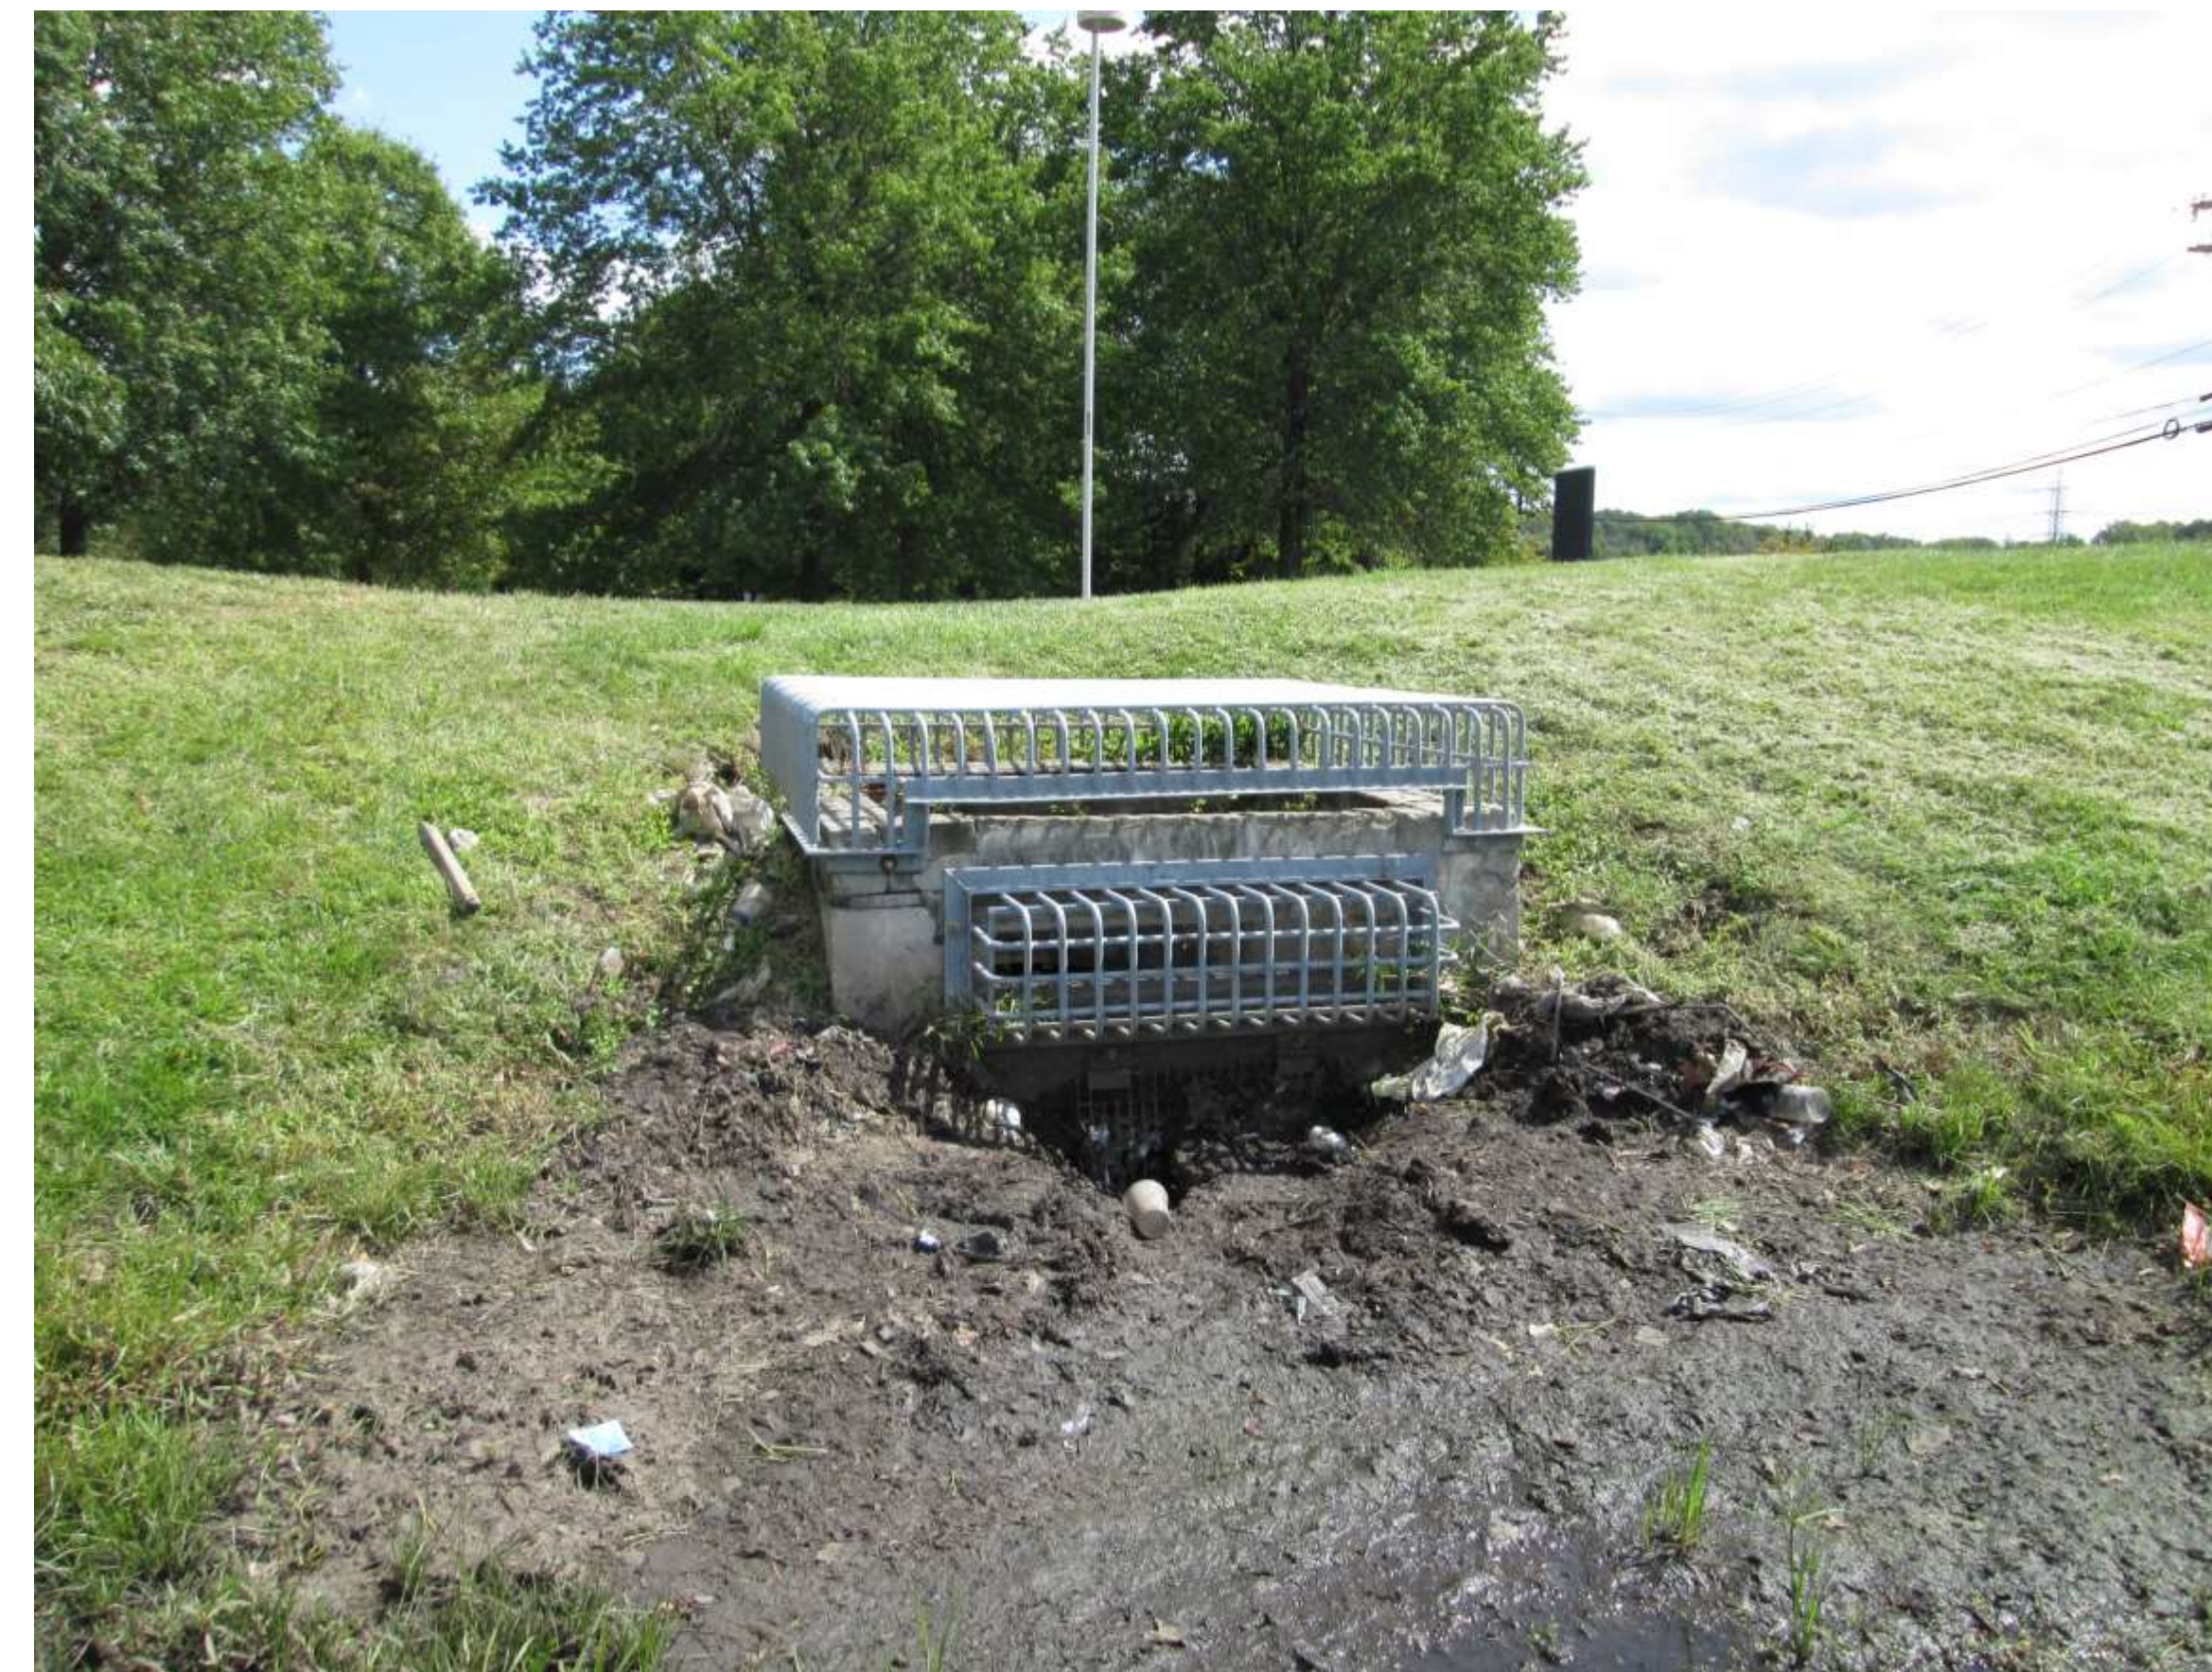
Outlet

- Sediment and litter inside and surrounding outlet
- Erosion of all inlet structures
- Retrofit low flow channels with stone channels and reduce mowing to allow for better infiltration

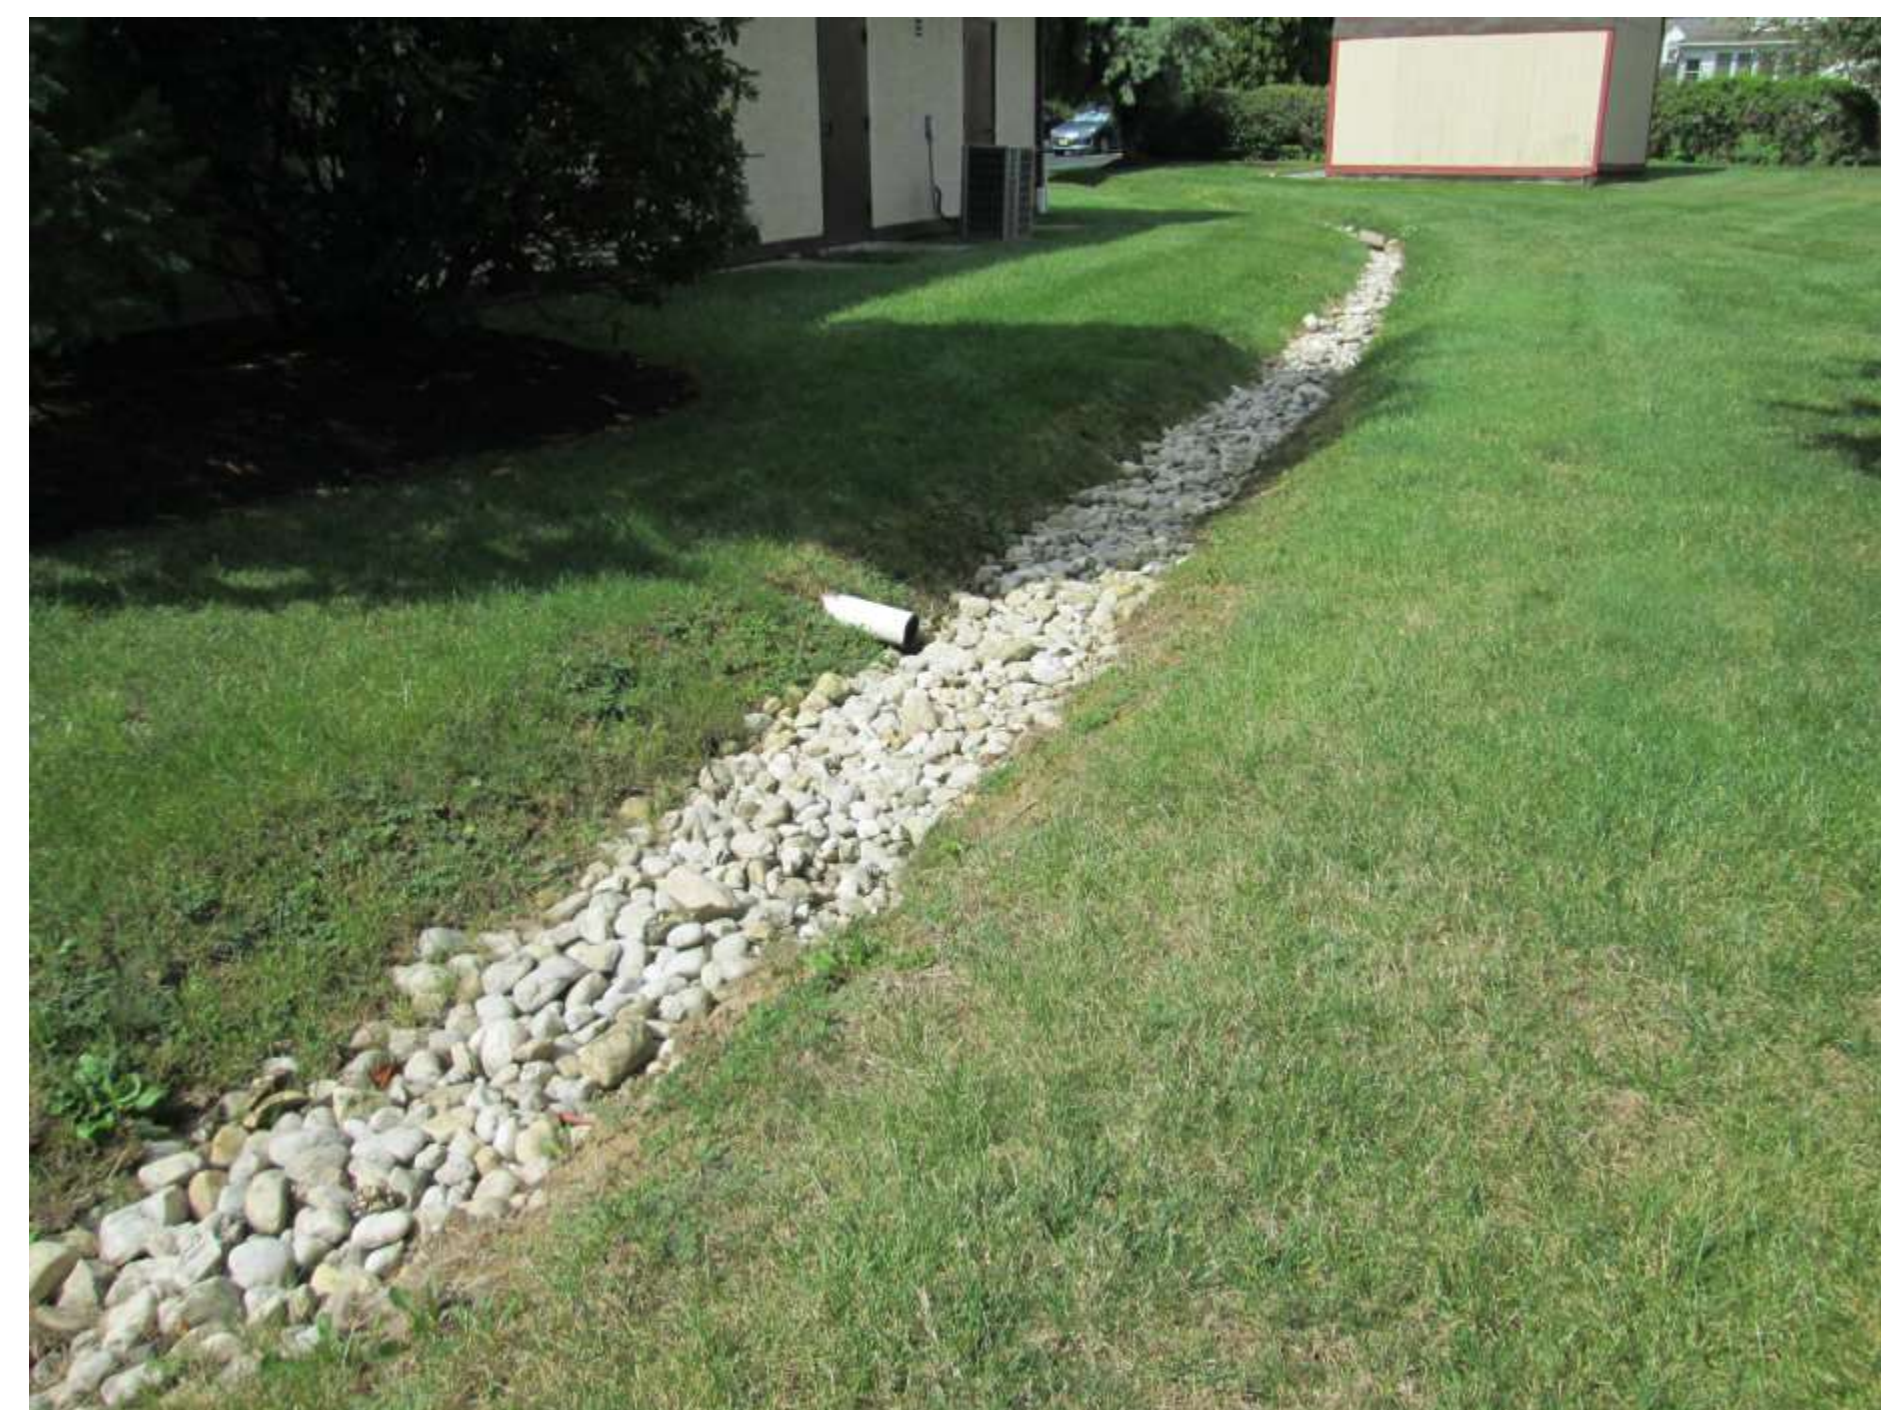
Downspout Inlet
