**Hamilton Township (Mercer County)
Stormwater Basin Assessment Summary
Addendum (Year 4)**

Developed by the Rutgers Cooperative Extension Water Resources Program
Funded by Hamilton Township, Mercer County, New Jersey

December 2017

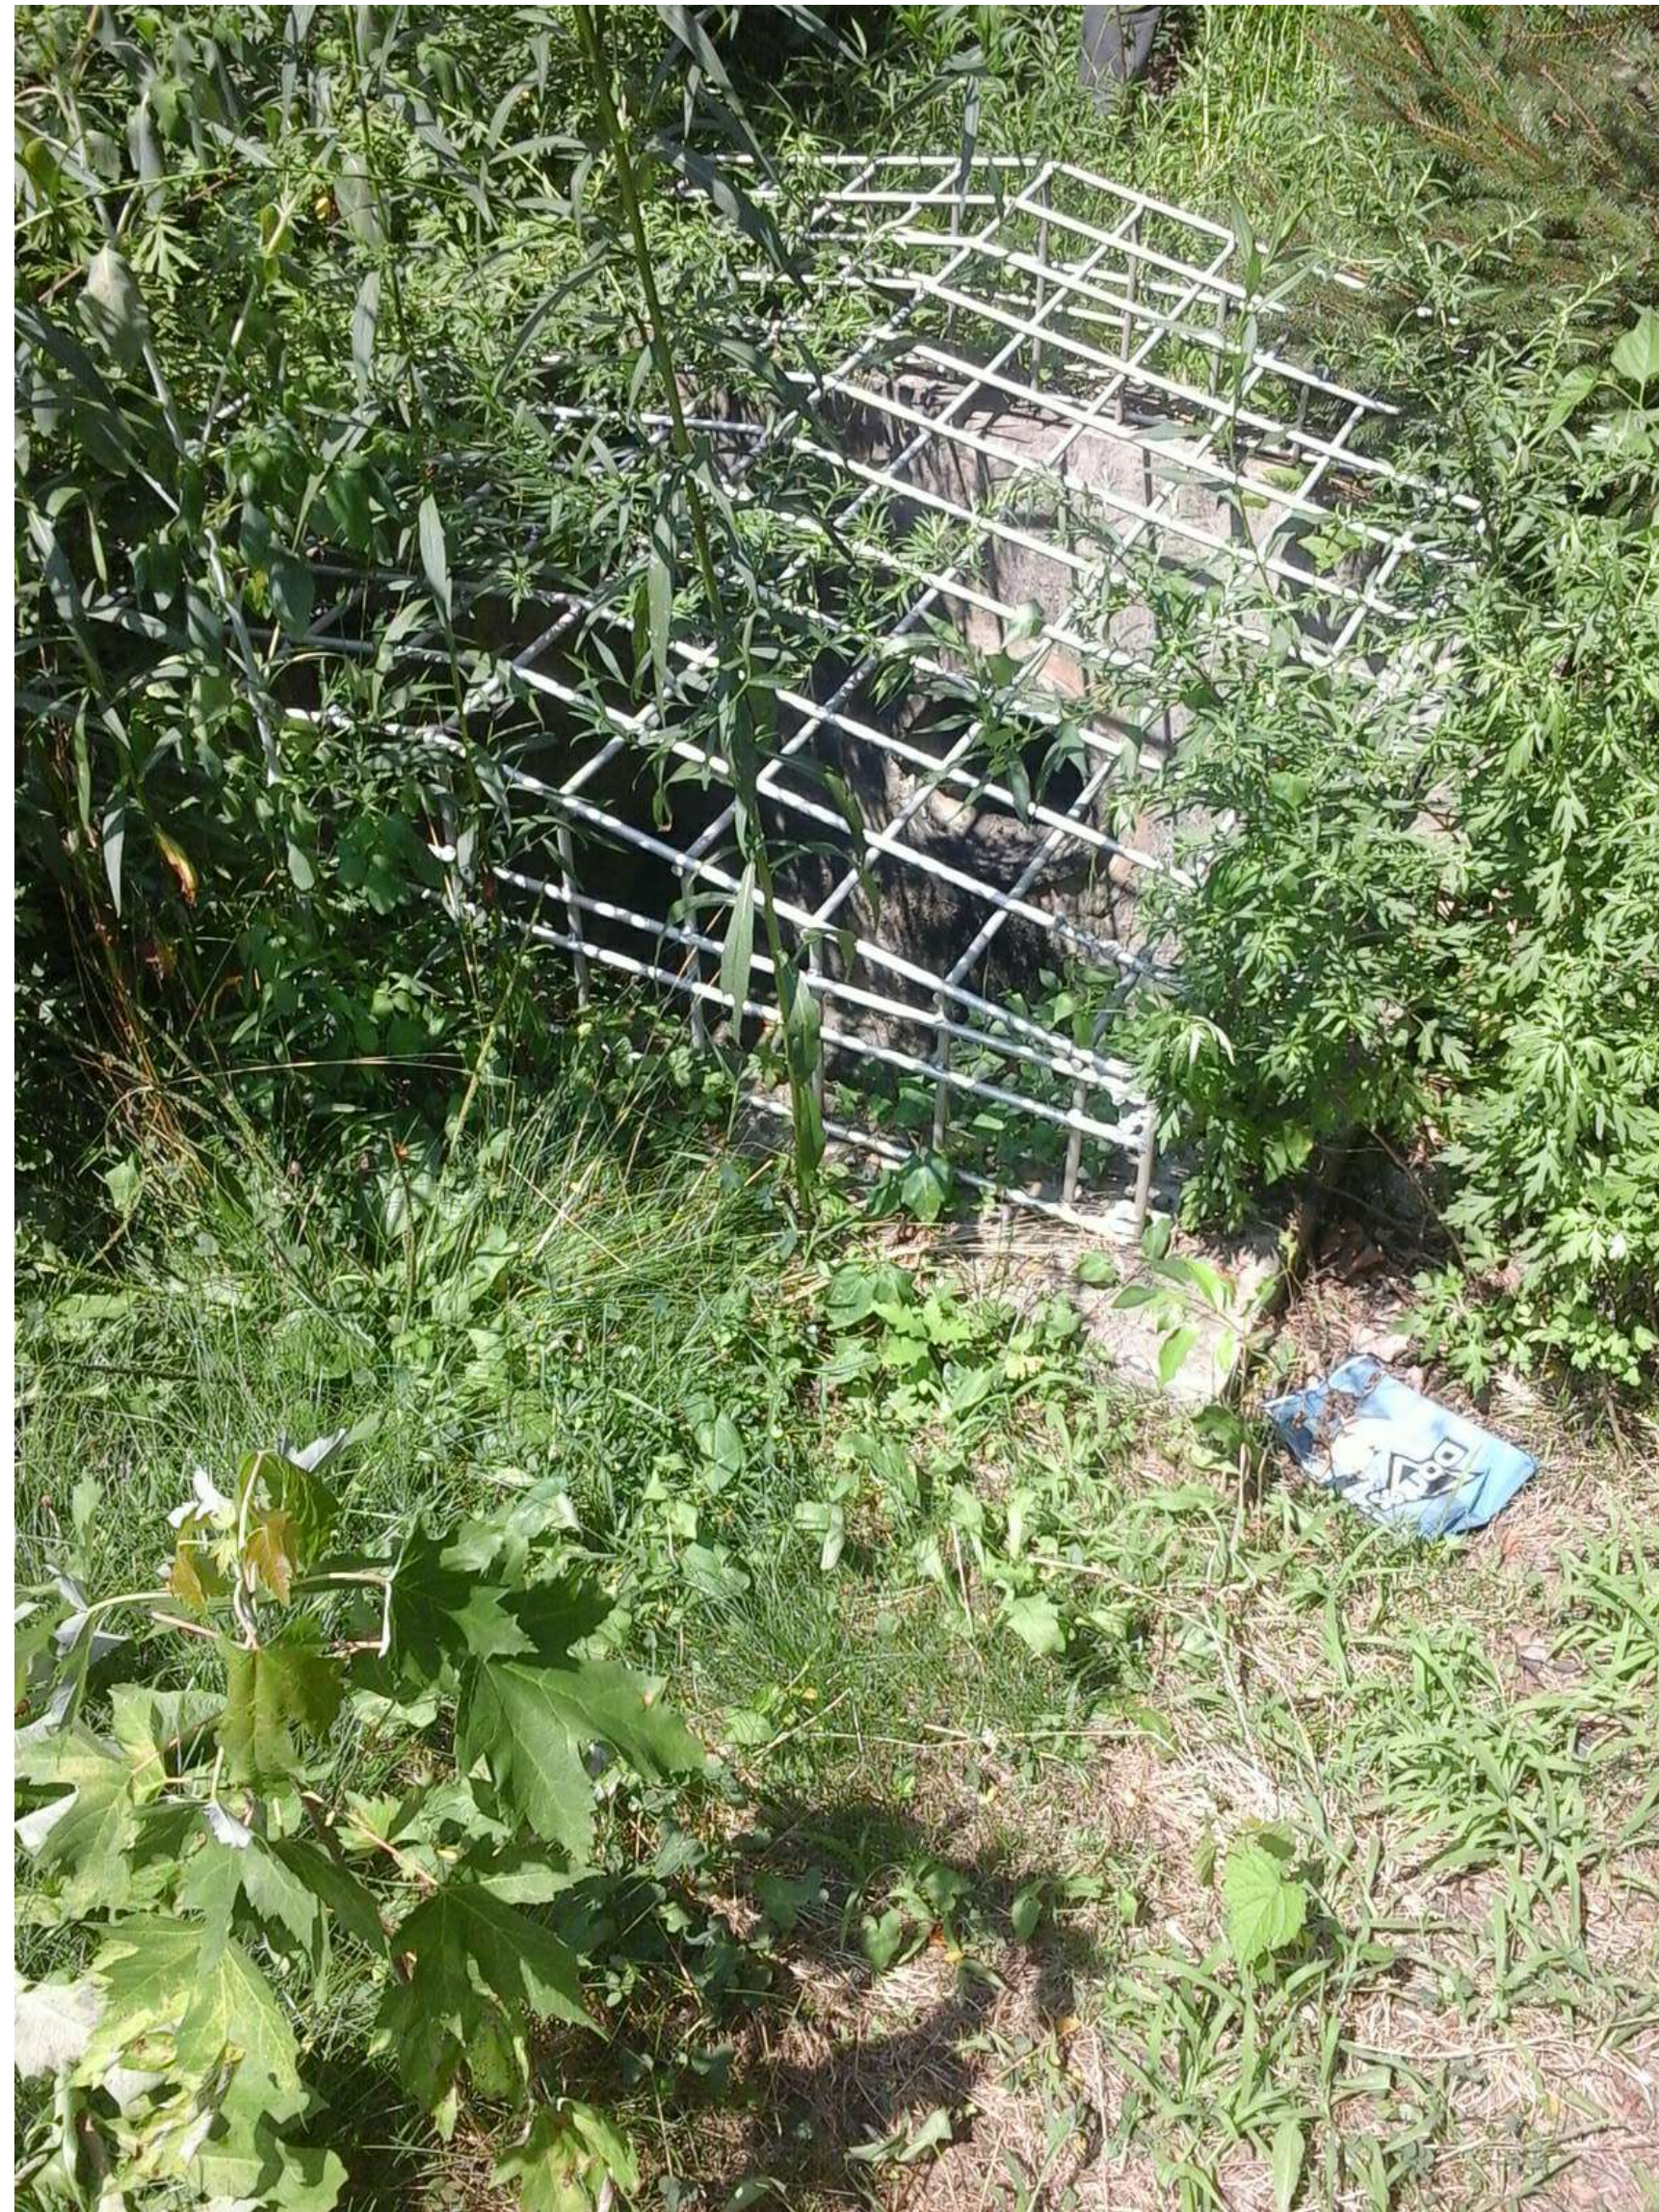
Outlet

- Vegetation overgrowing around outlet
- Replace low flow channel with stone lined outlet
- Remove weeds to promote naturalization with native plants

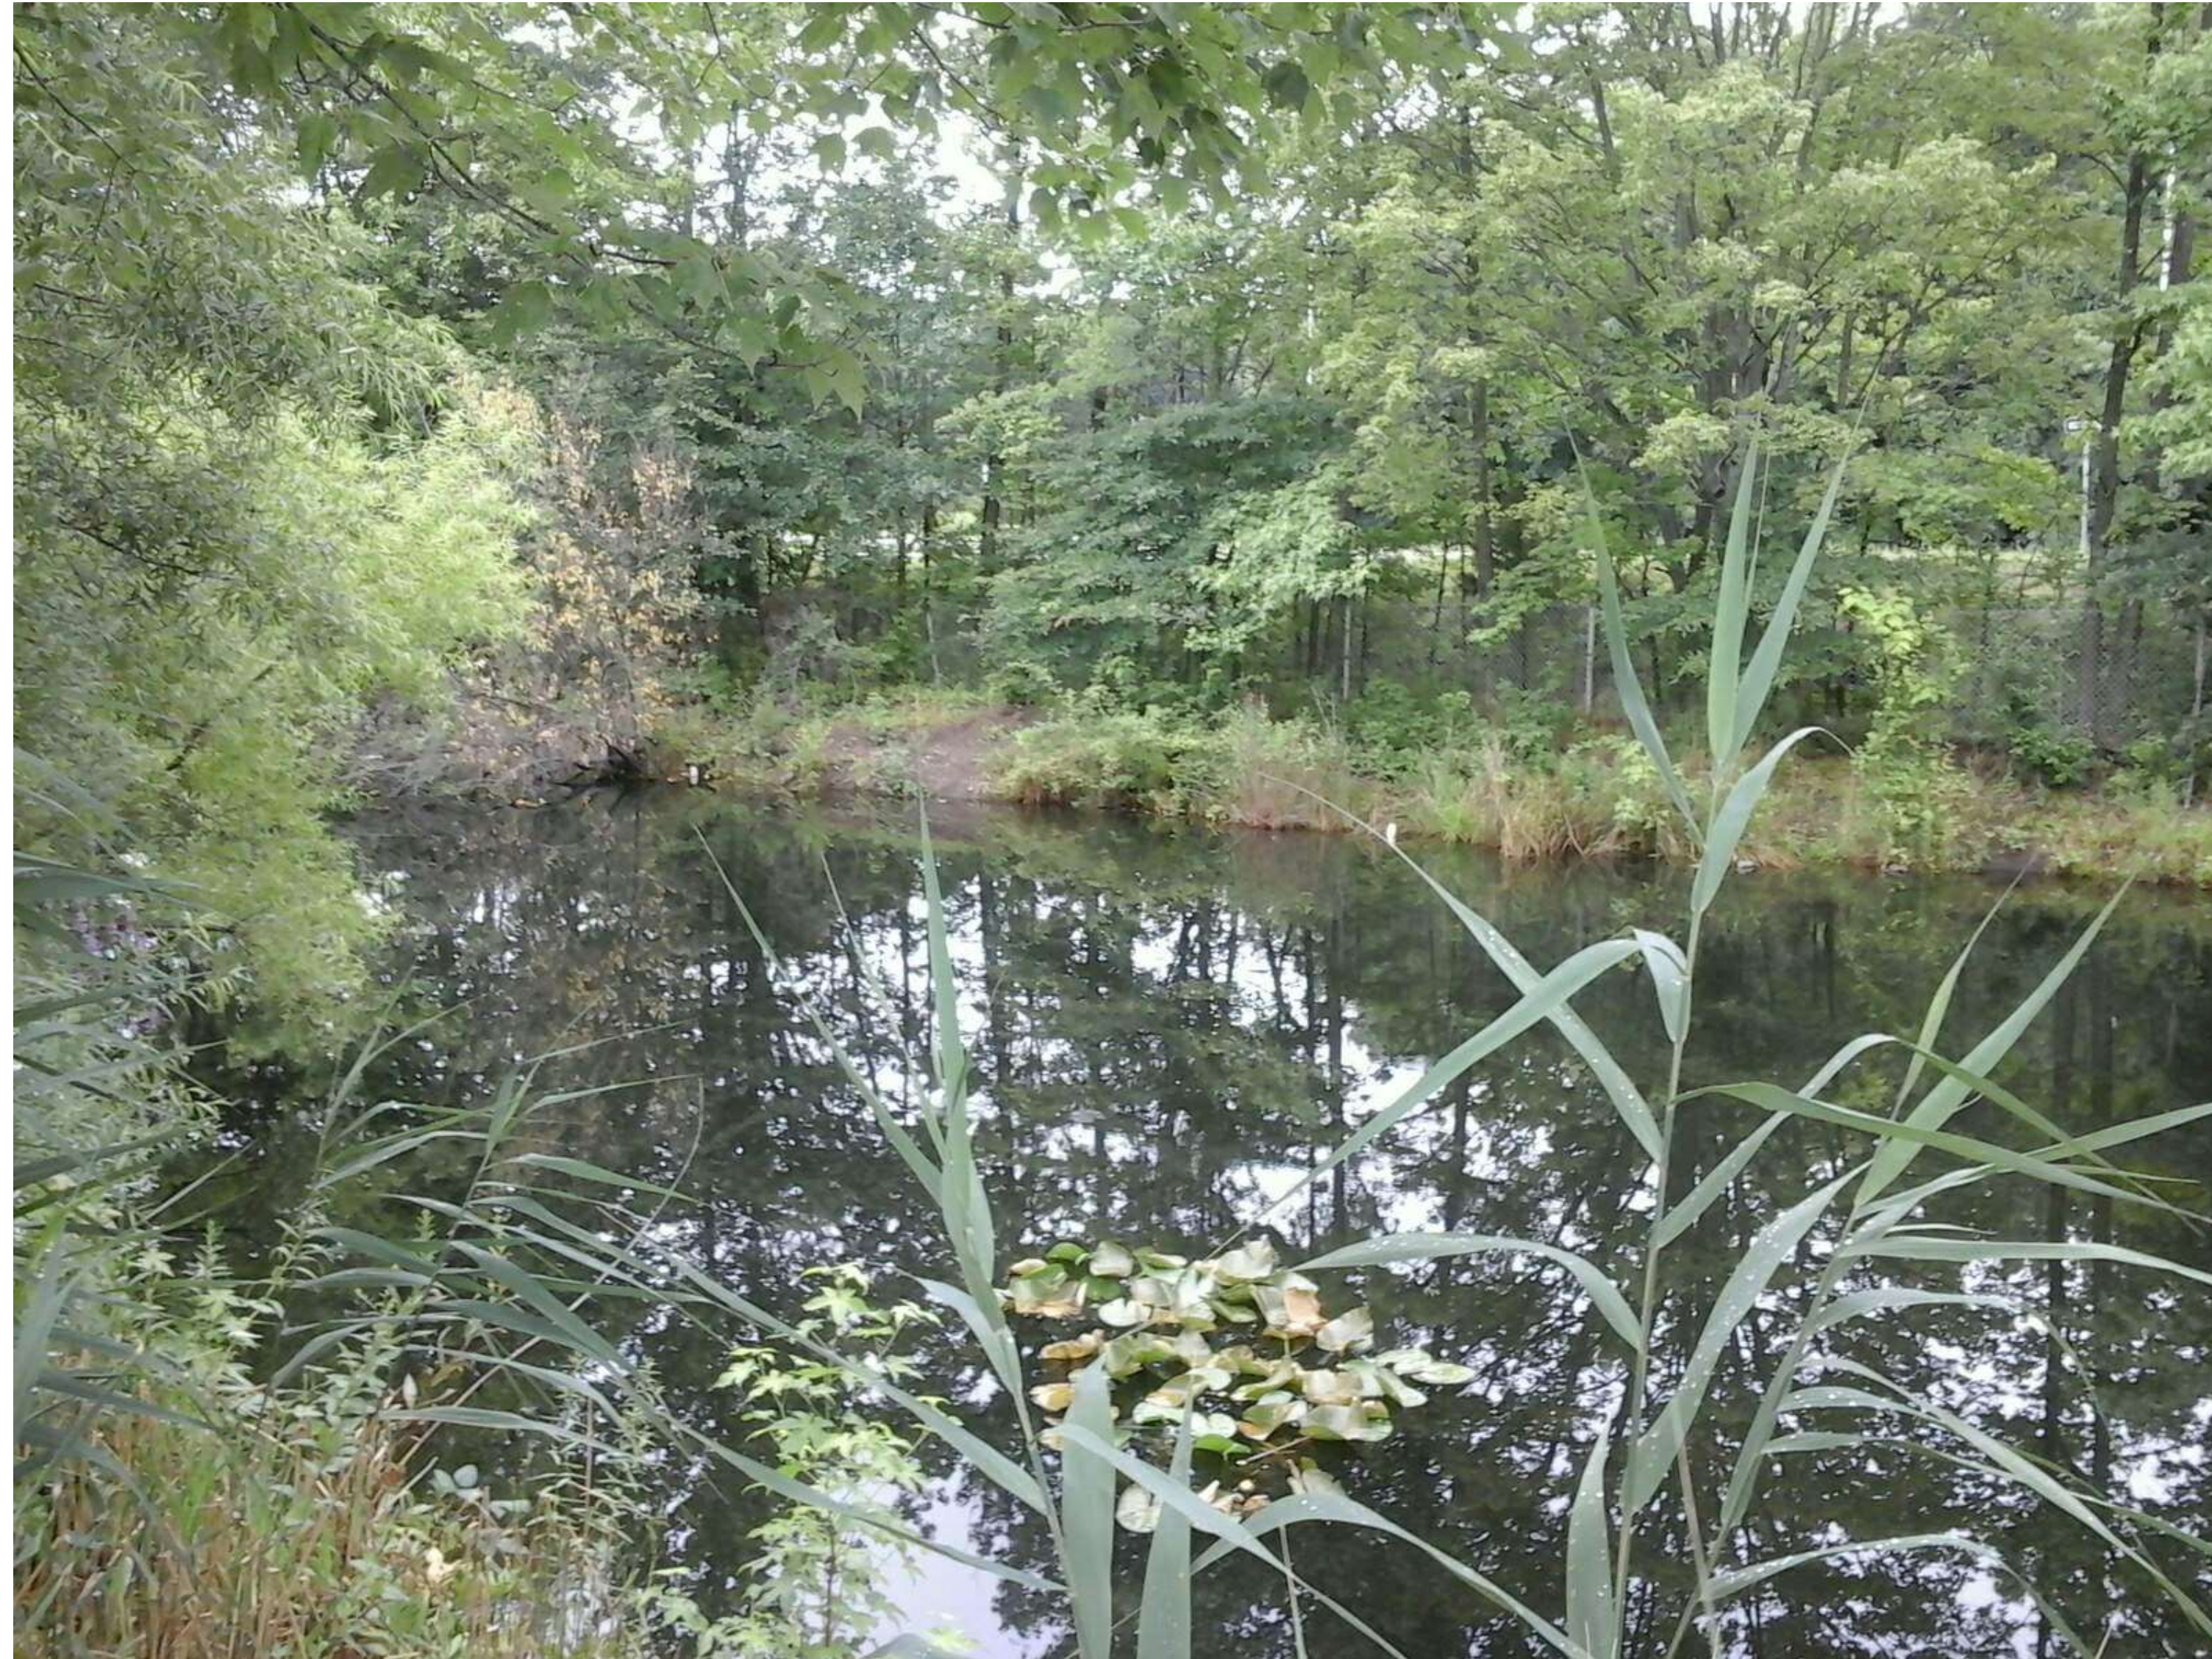
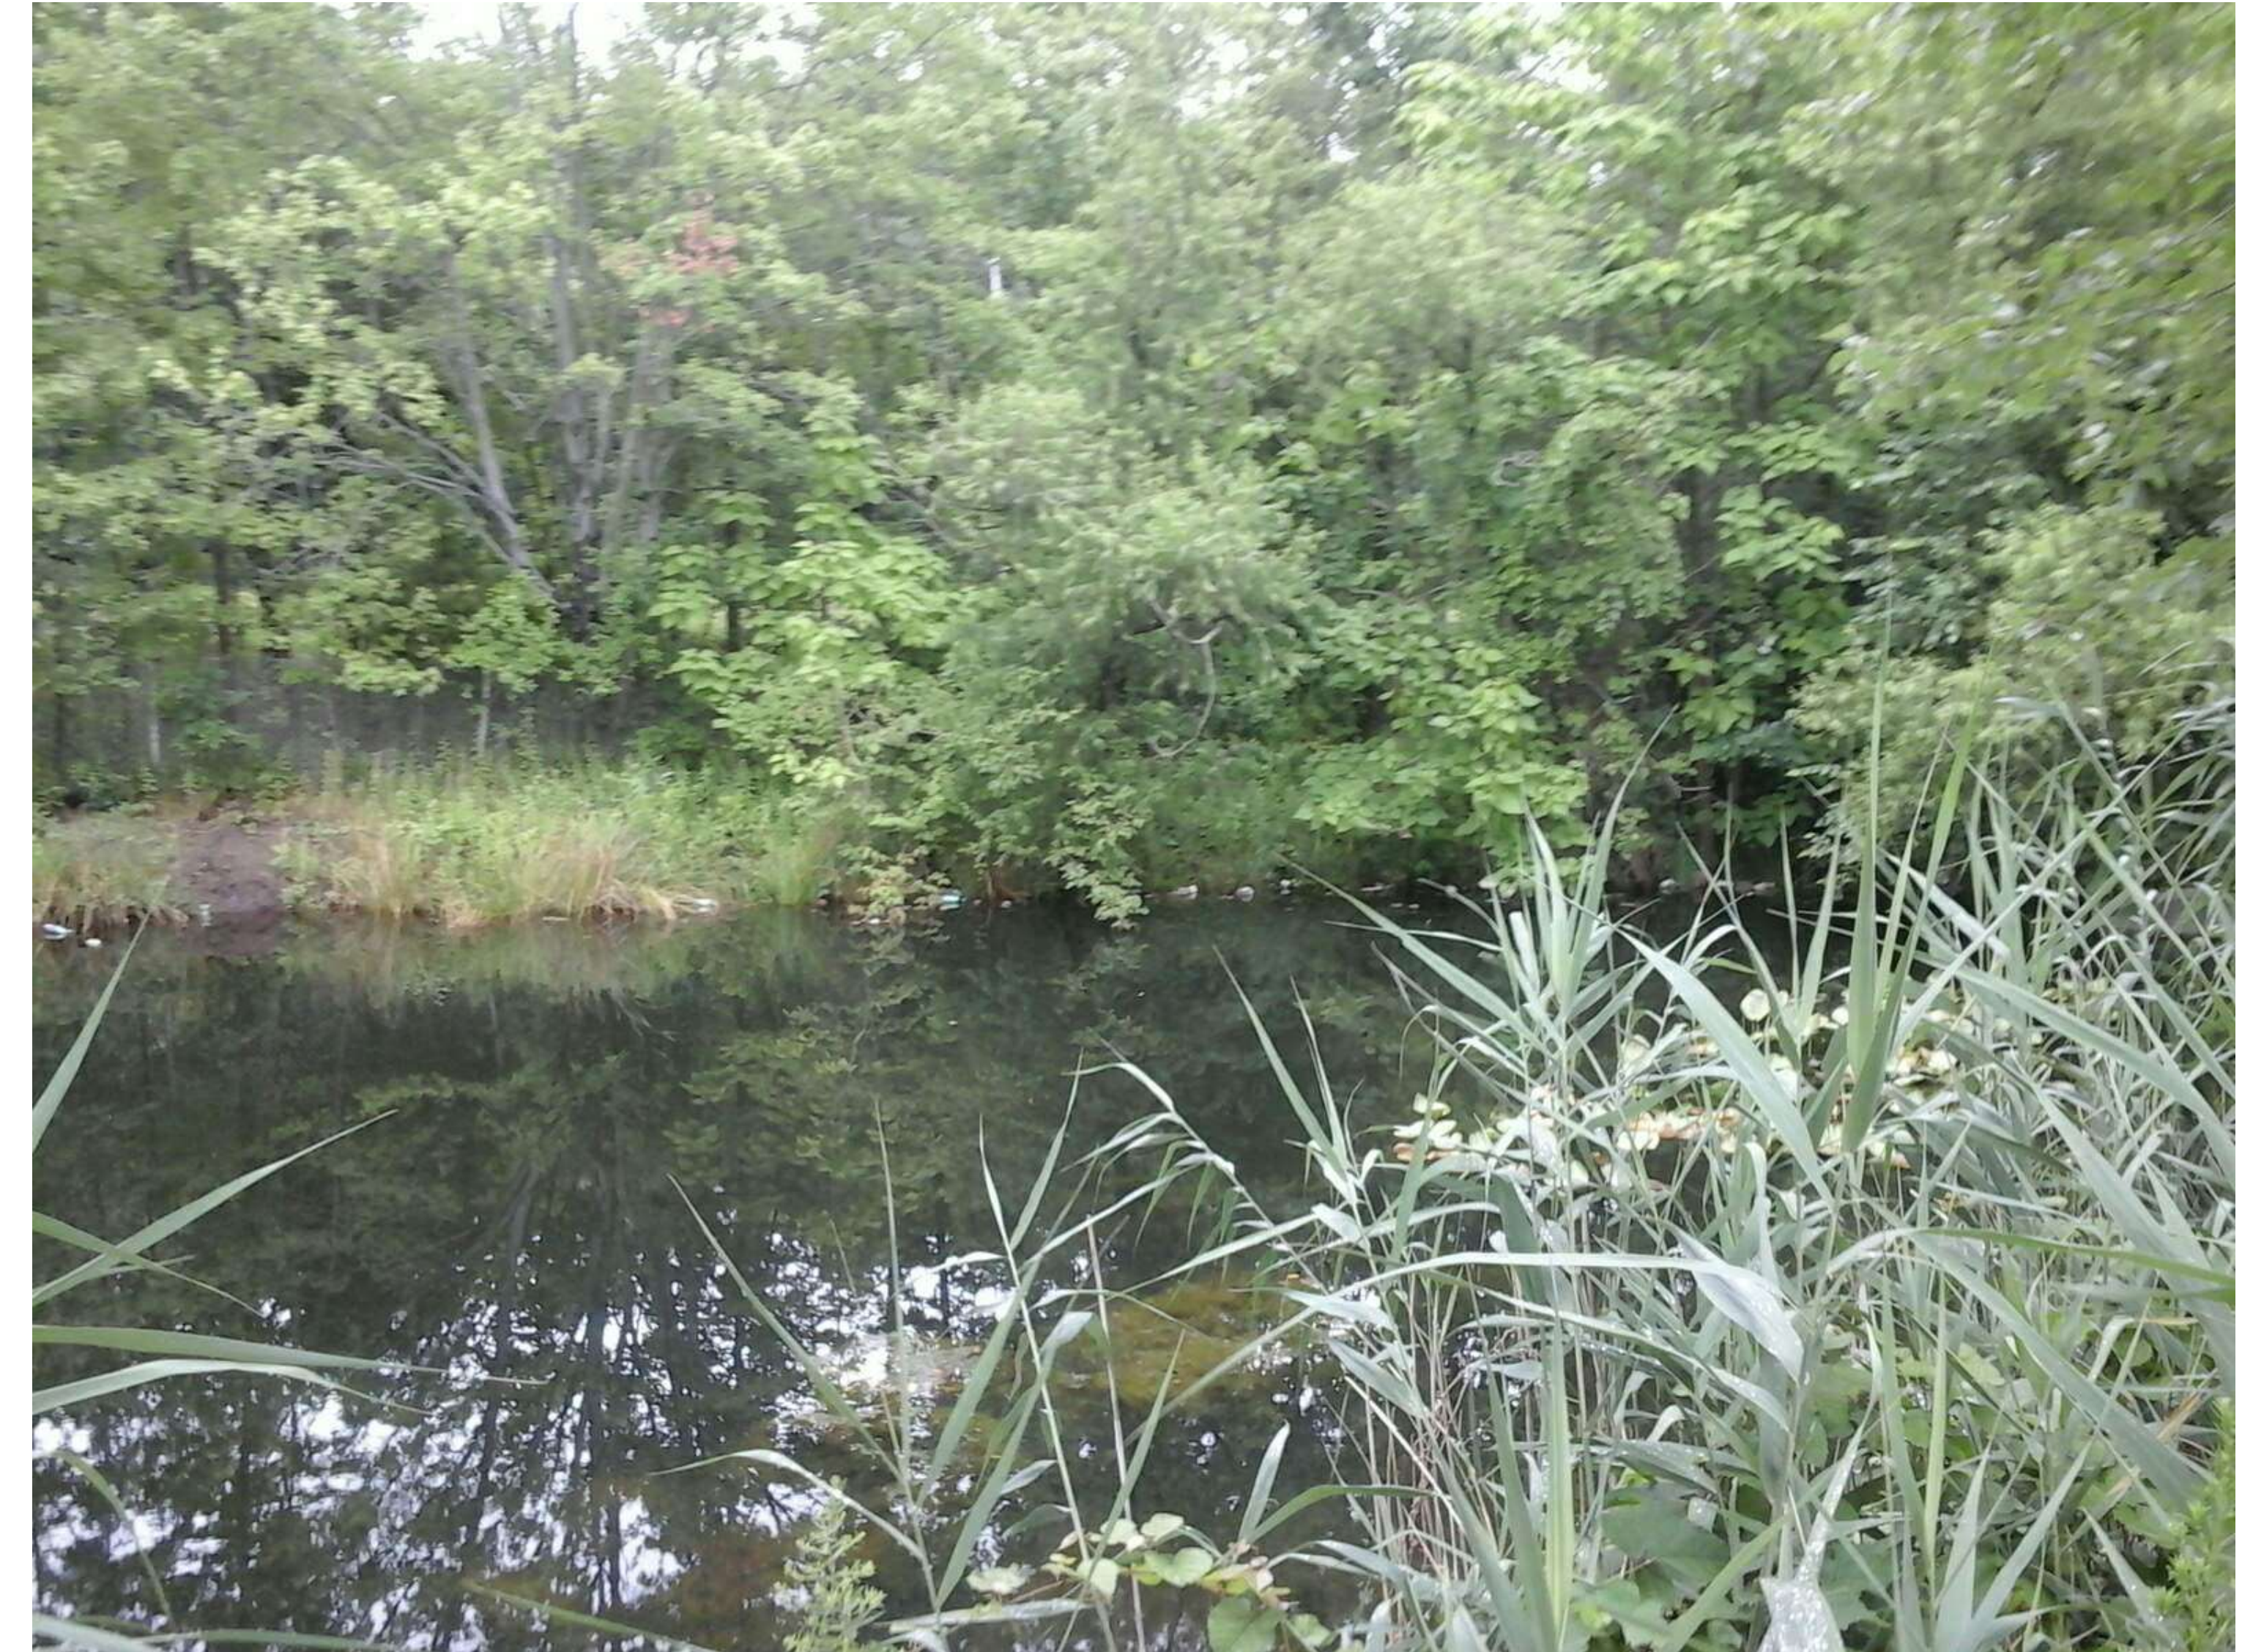
- Retention Basin
- No outlets apparent
- Some floating garbage that should be removed

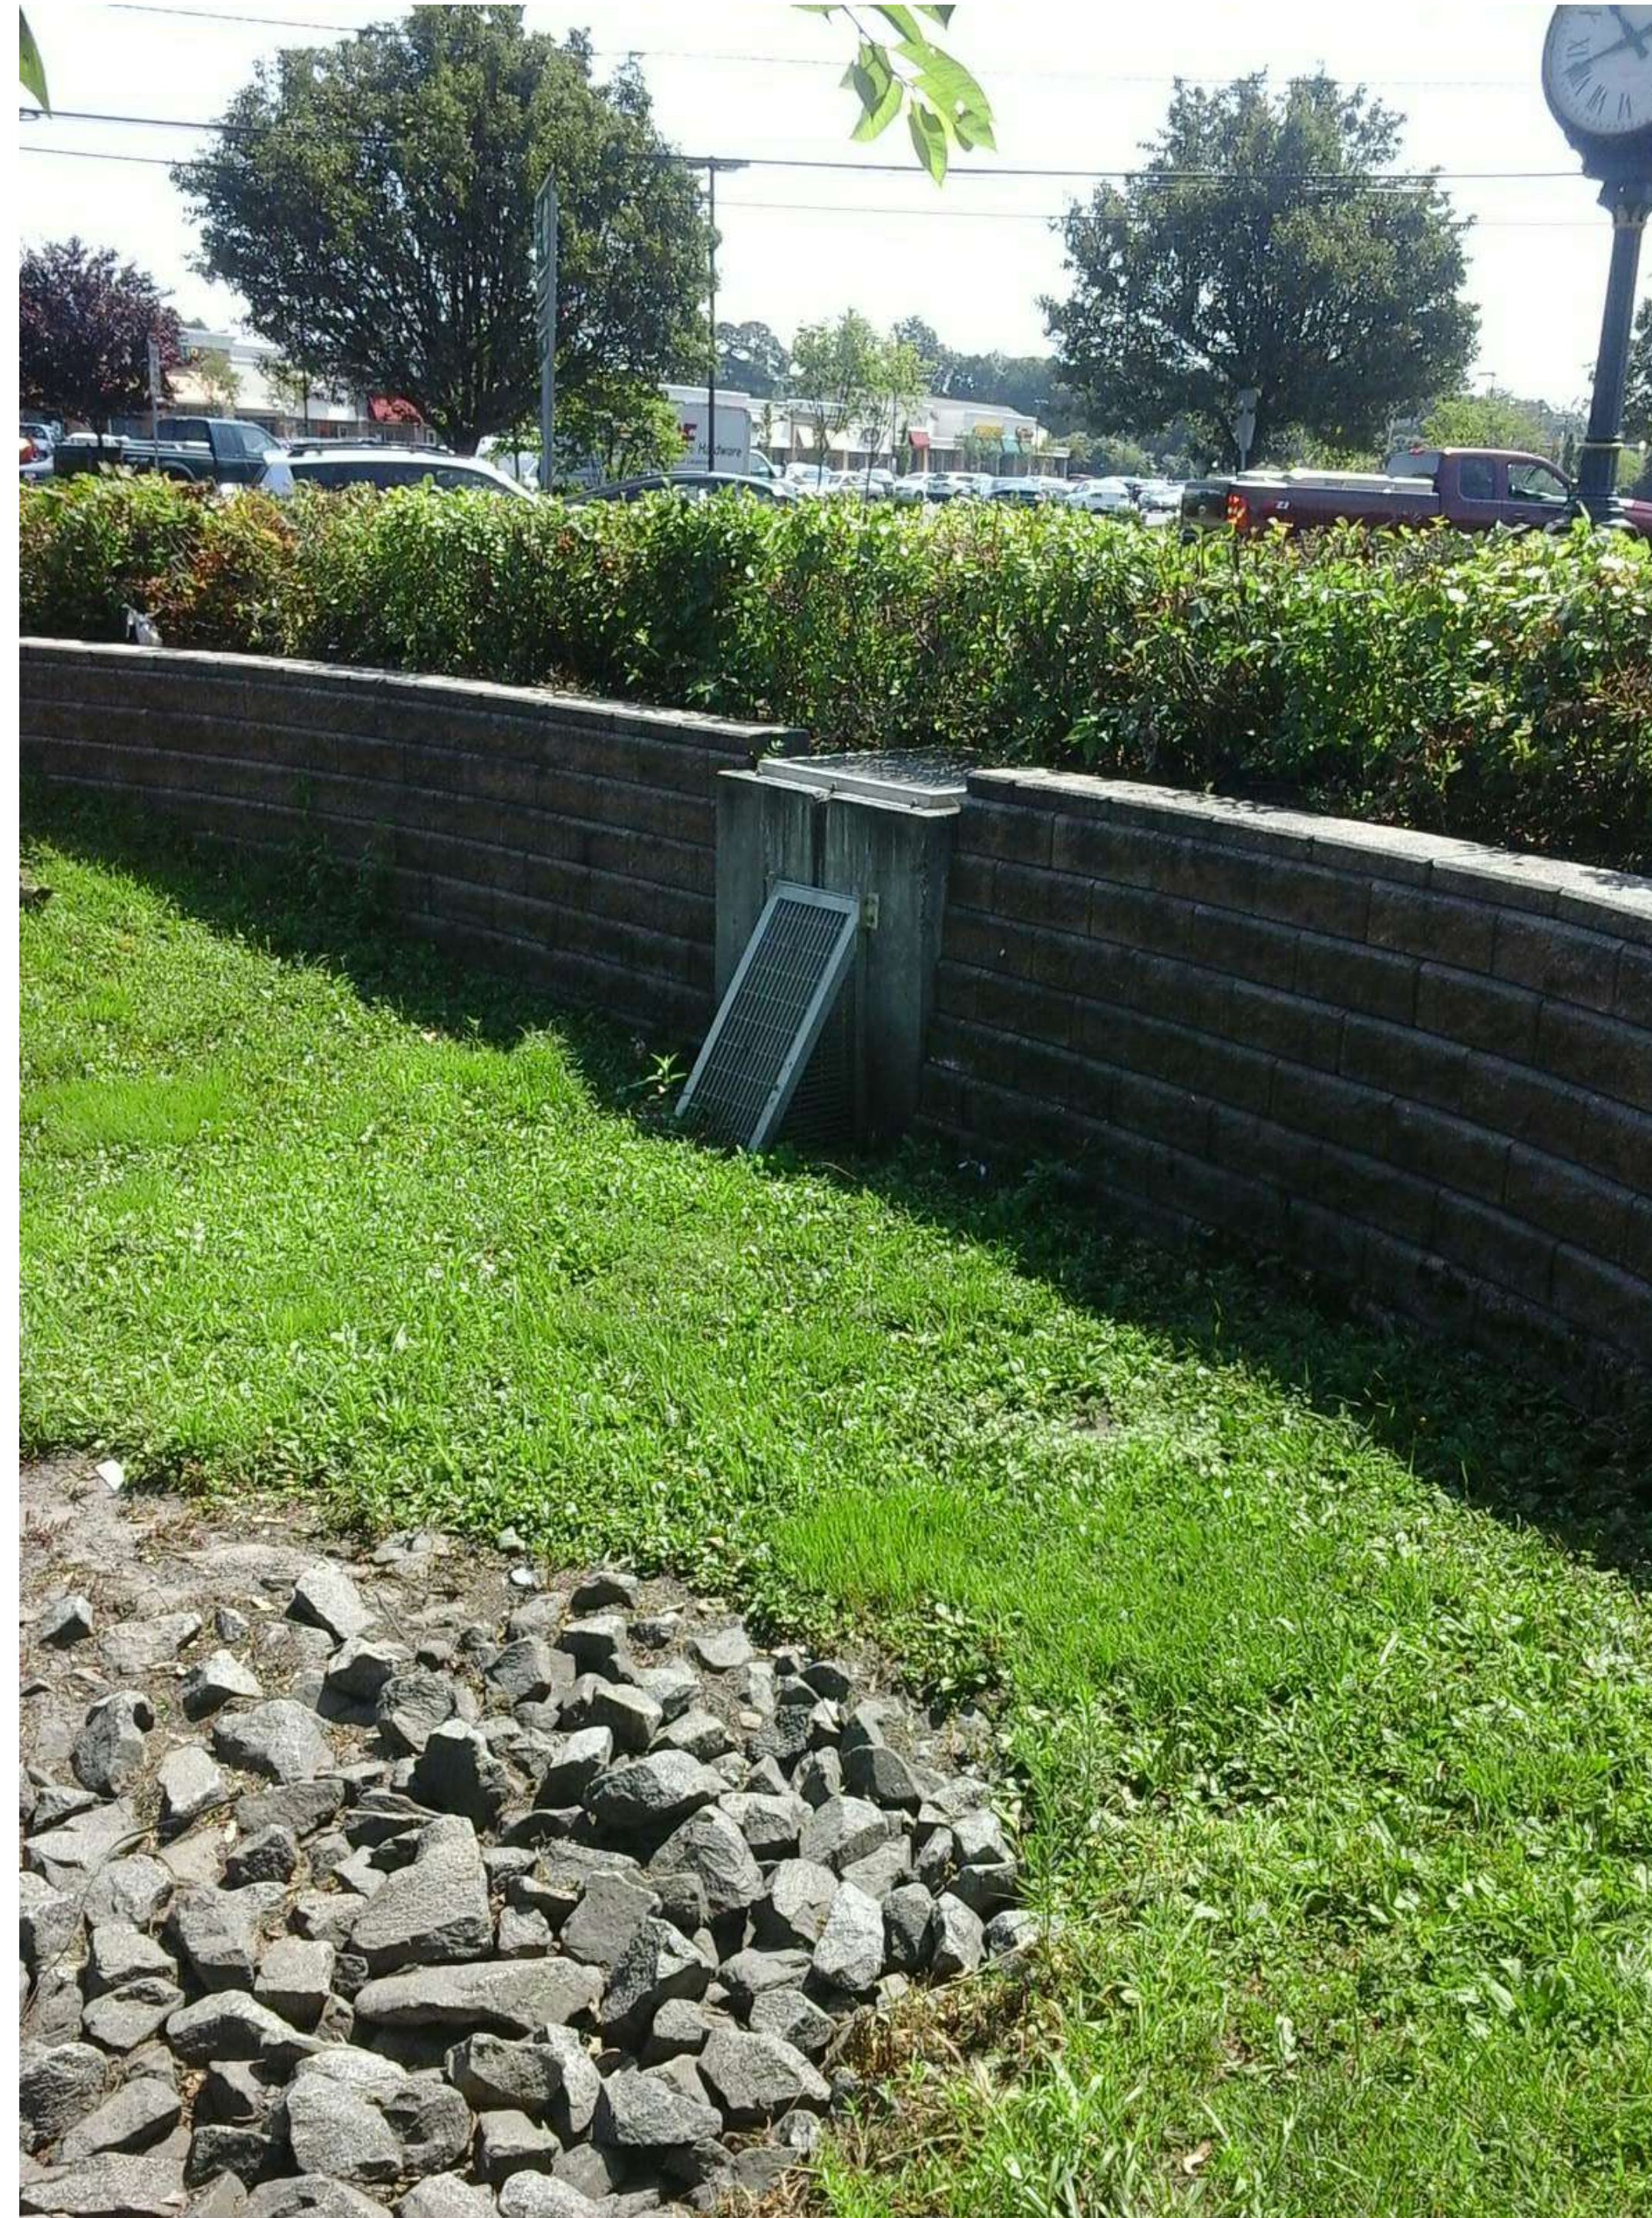
Outlet grate

- Minimal amounts of sediment near inlet and outlet structures
- Overall in good condition

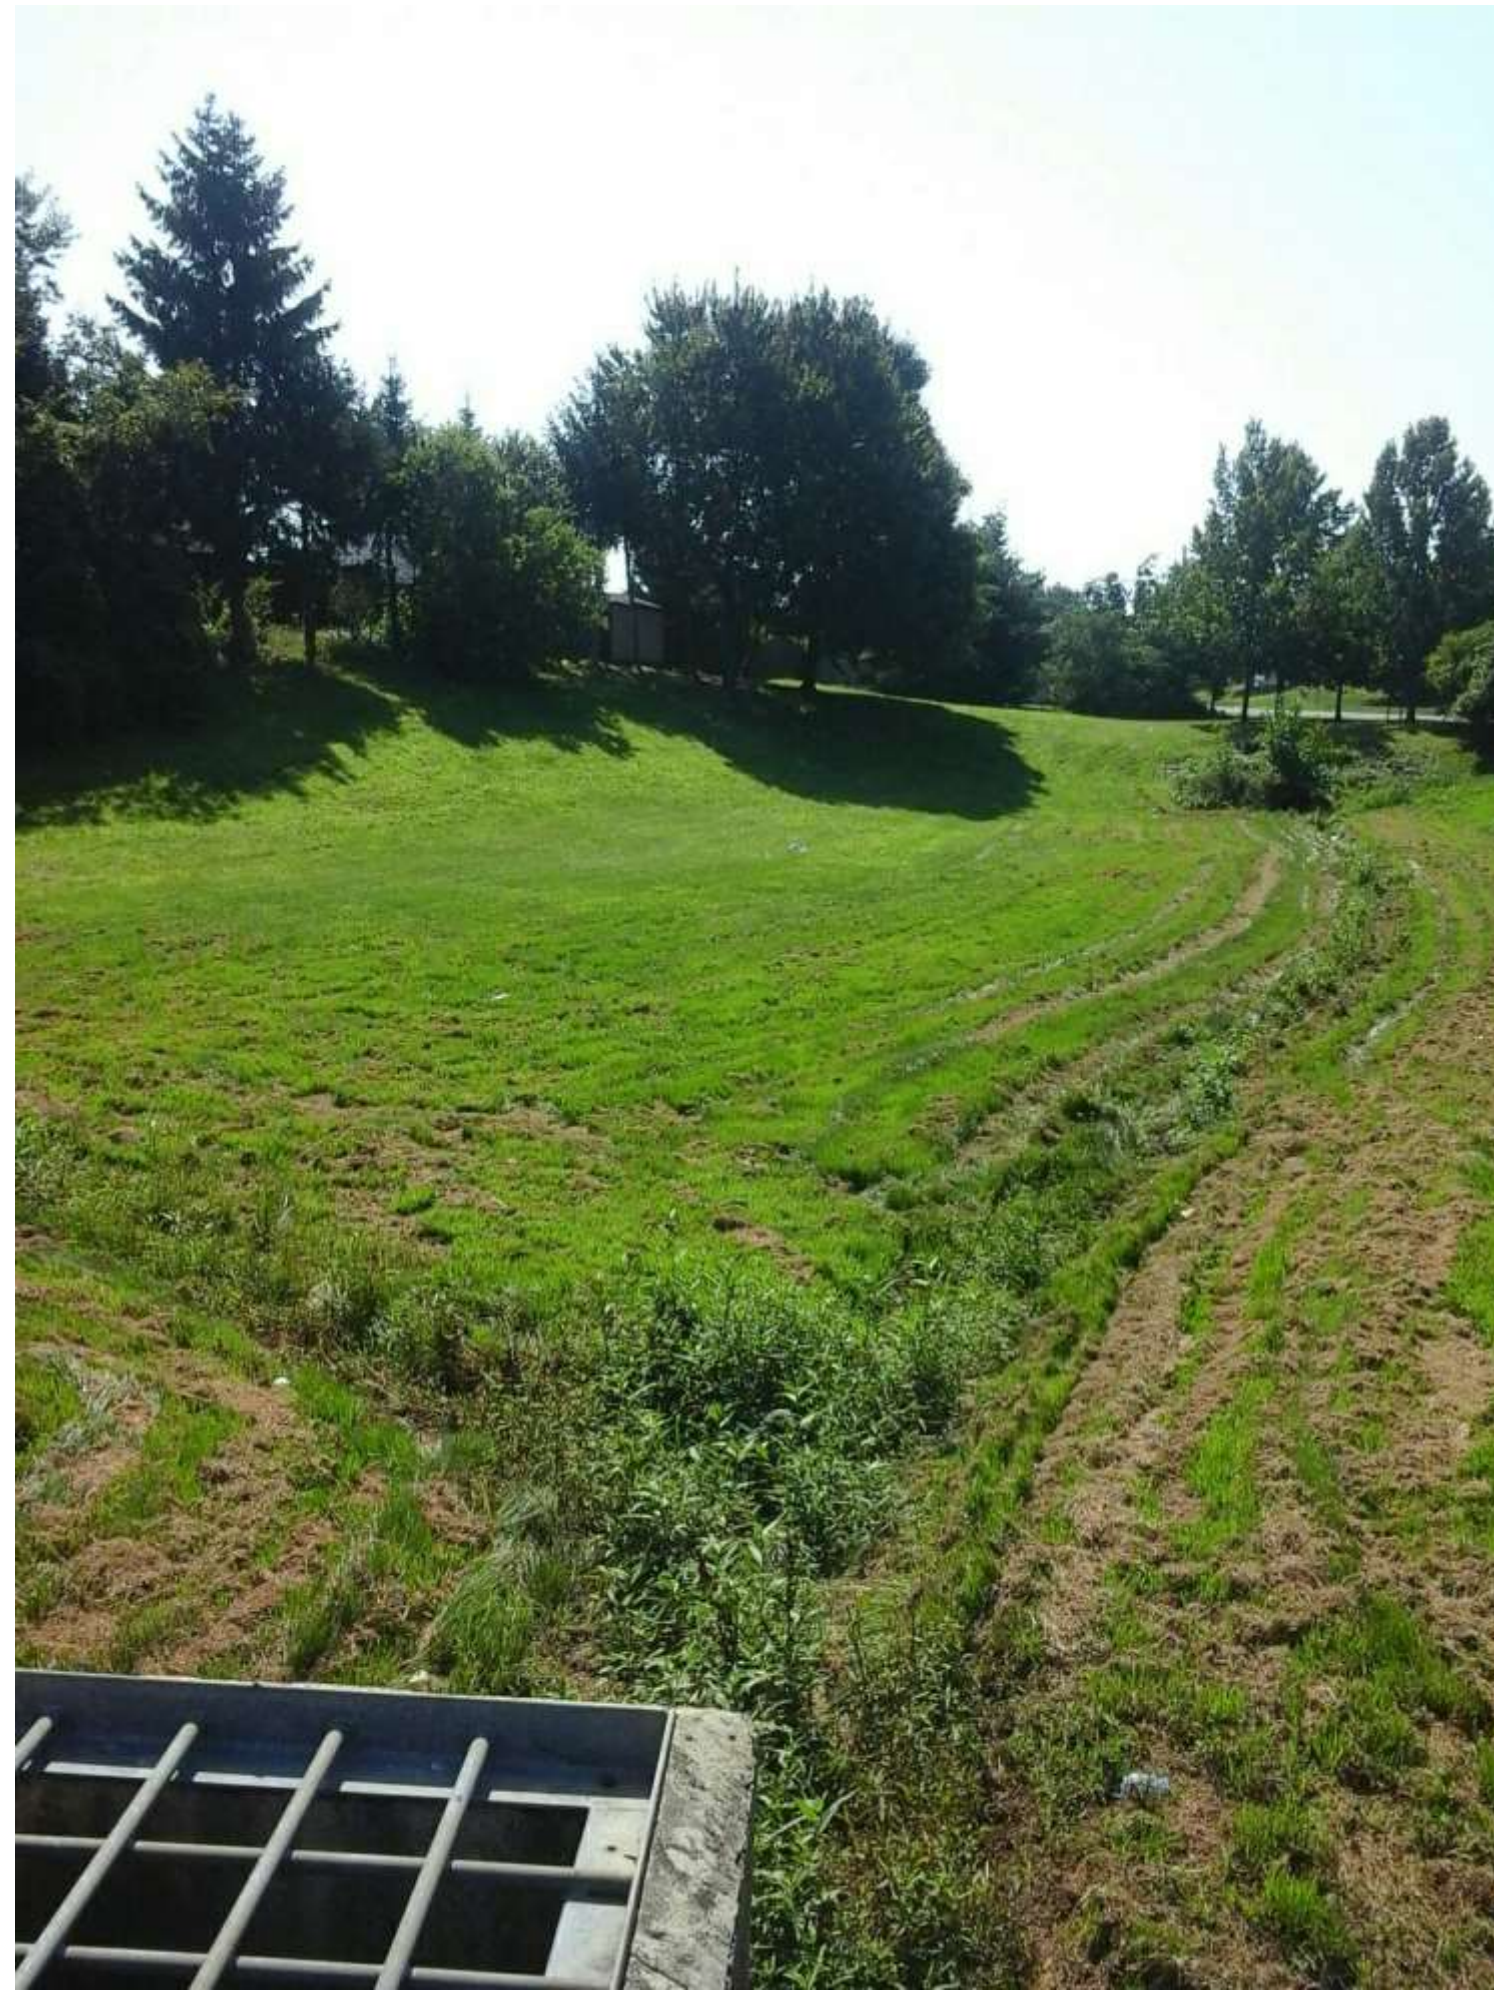
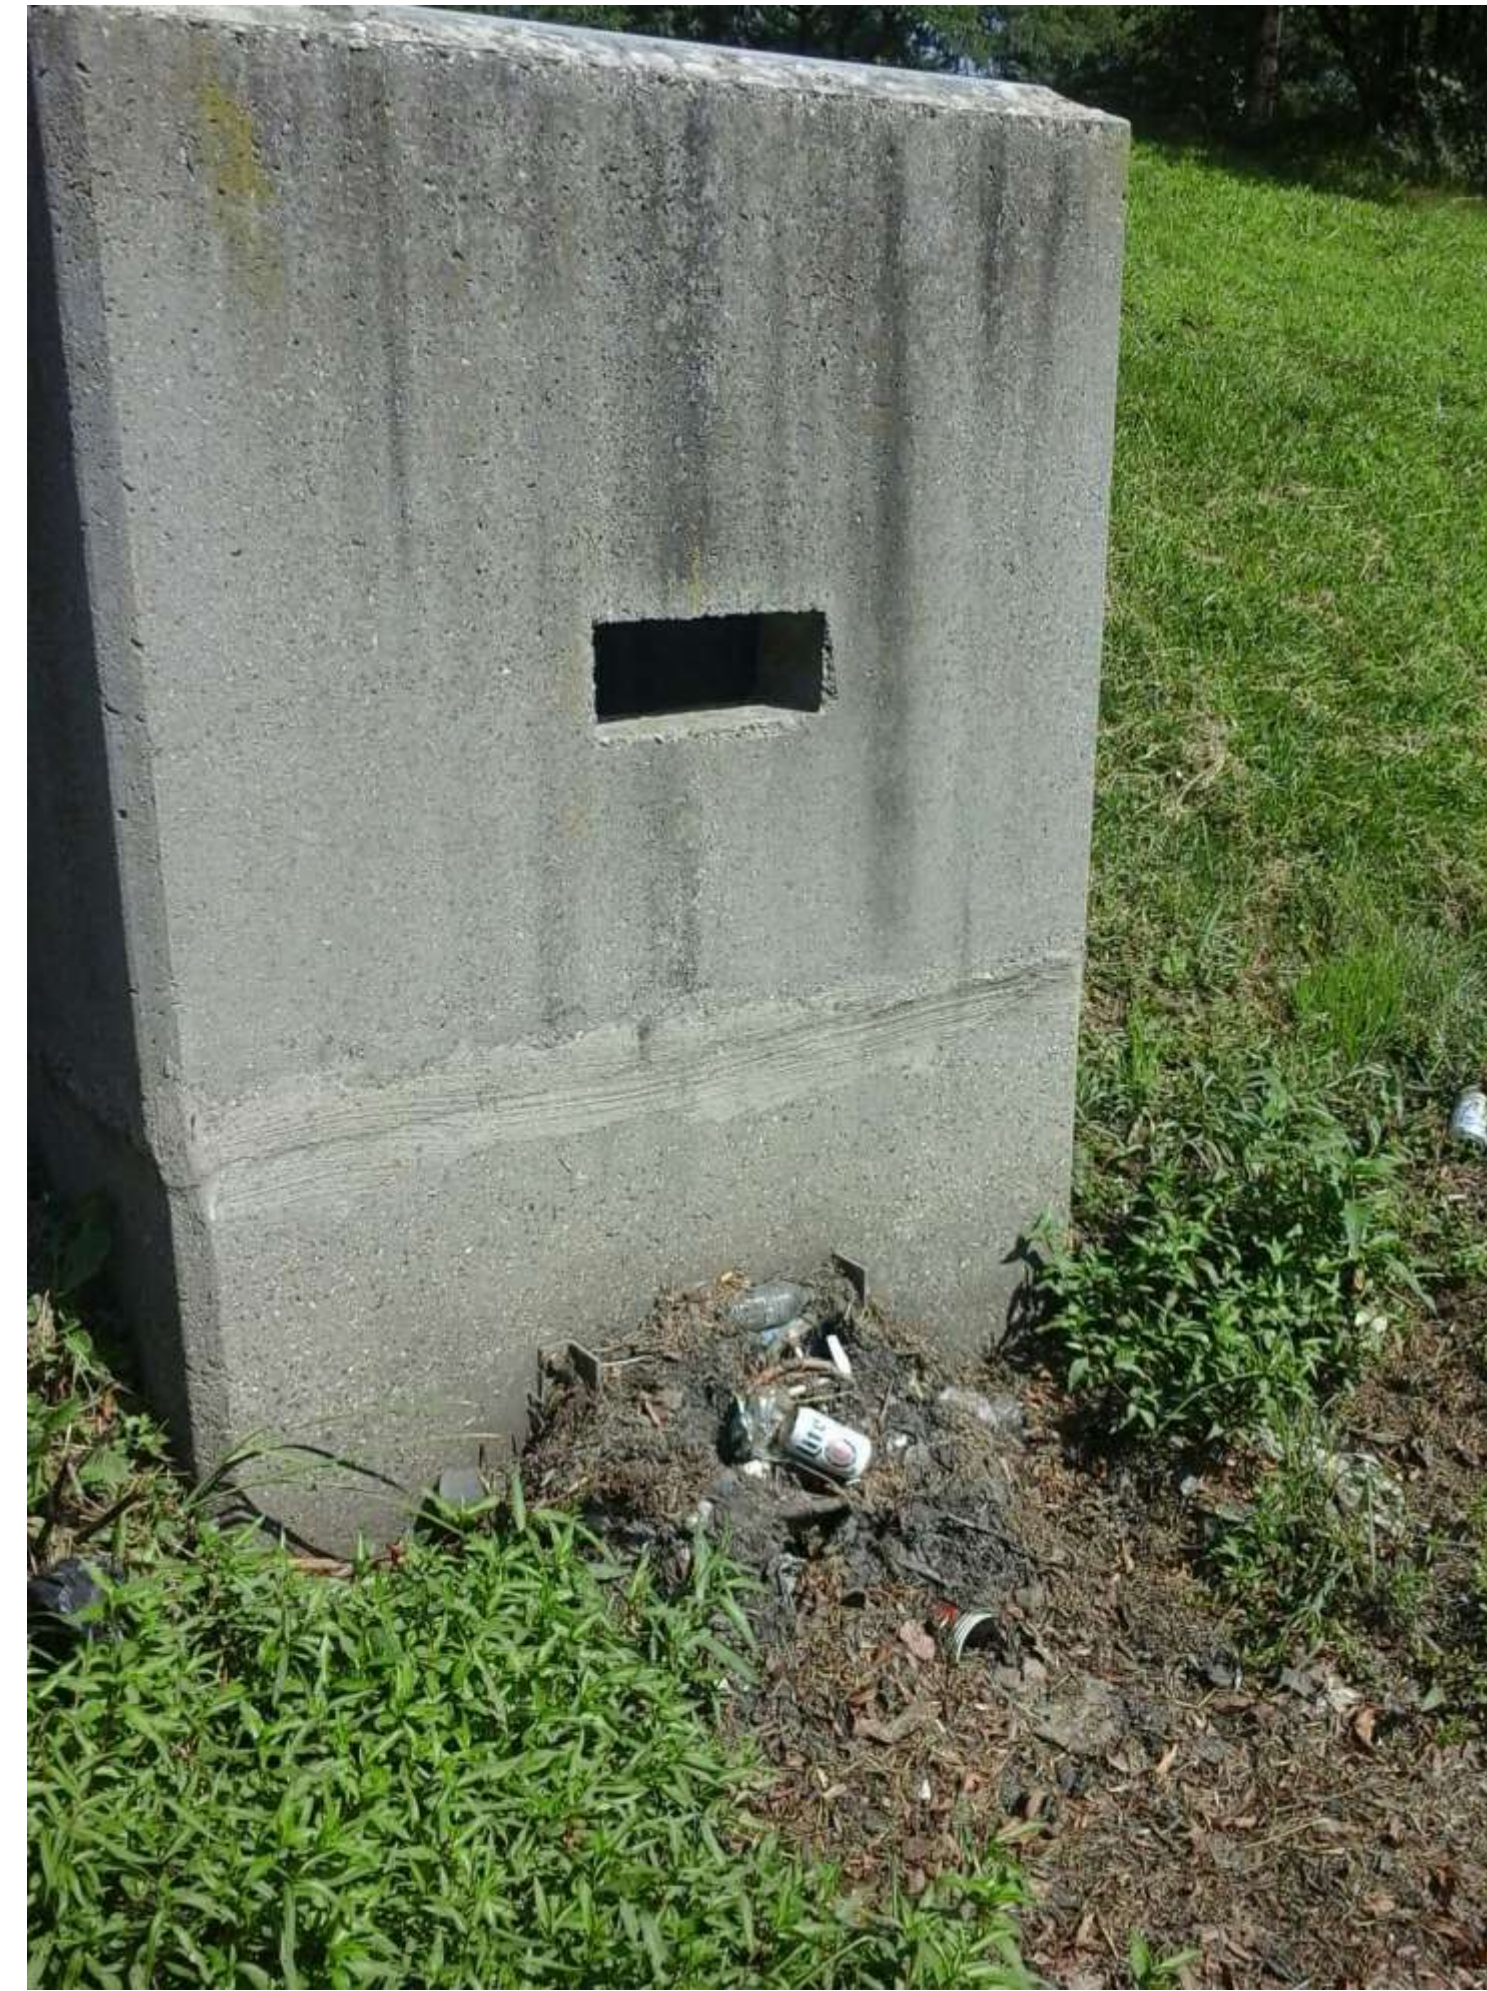
Overview of southern basin and basin outlet

- Sediment accumulation at outlets and in low flow channels for both basins
- Vegetation overgrowth at northern basin
- Reduce mowing and establish meadows to improve infiltration
