**Hamilton Township (Mercer County)
Stormwater Basin Assessment Summary
Addendum (Year 4)**

Developed by the Rutgers Cooperative Extension Water Resources Program
Funded by Hamilton Township, Mercer County, New Jersey

December 2017

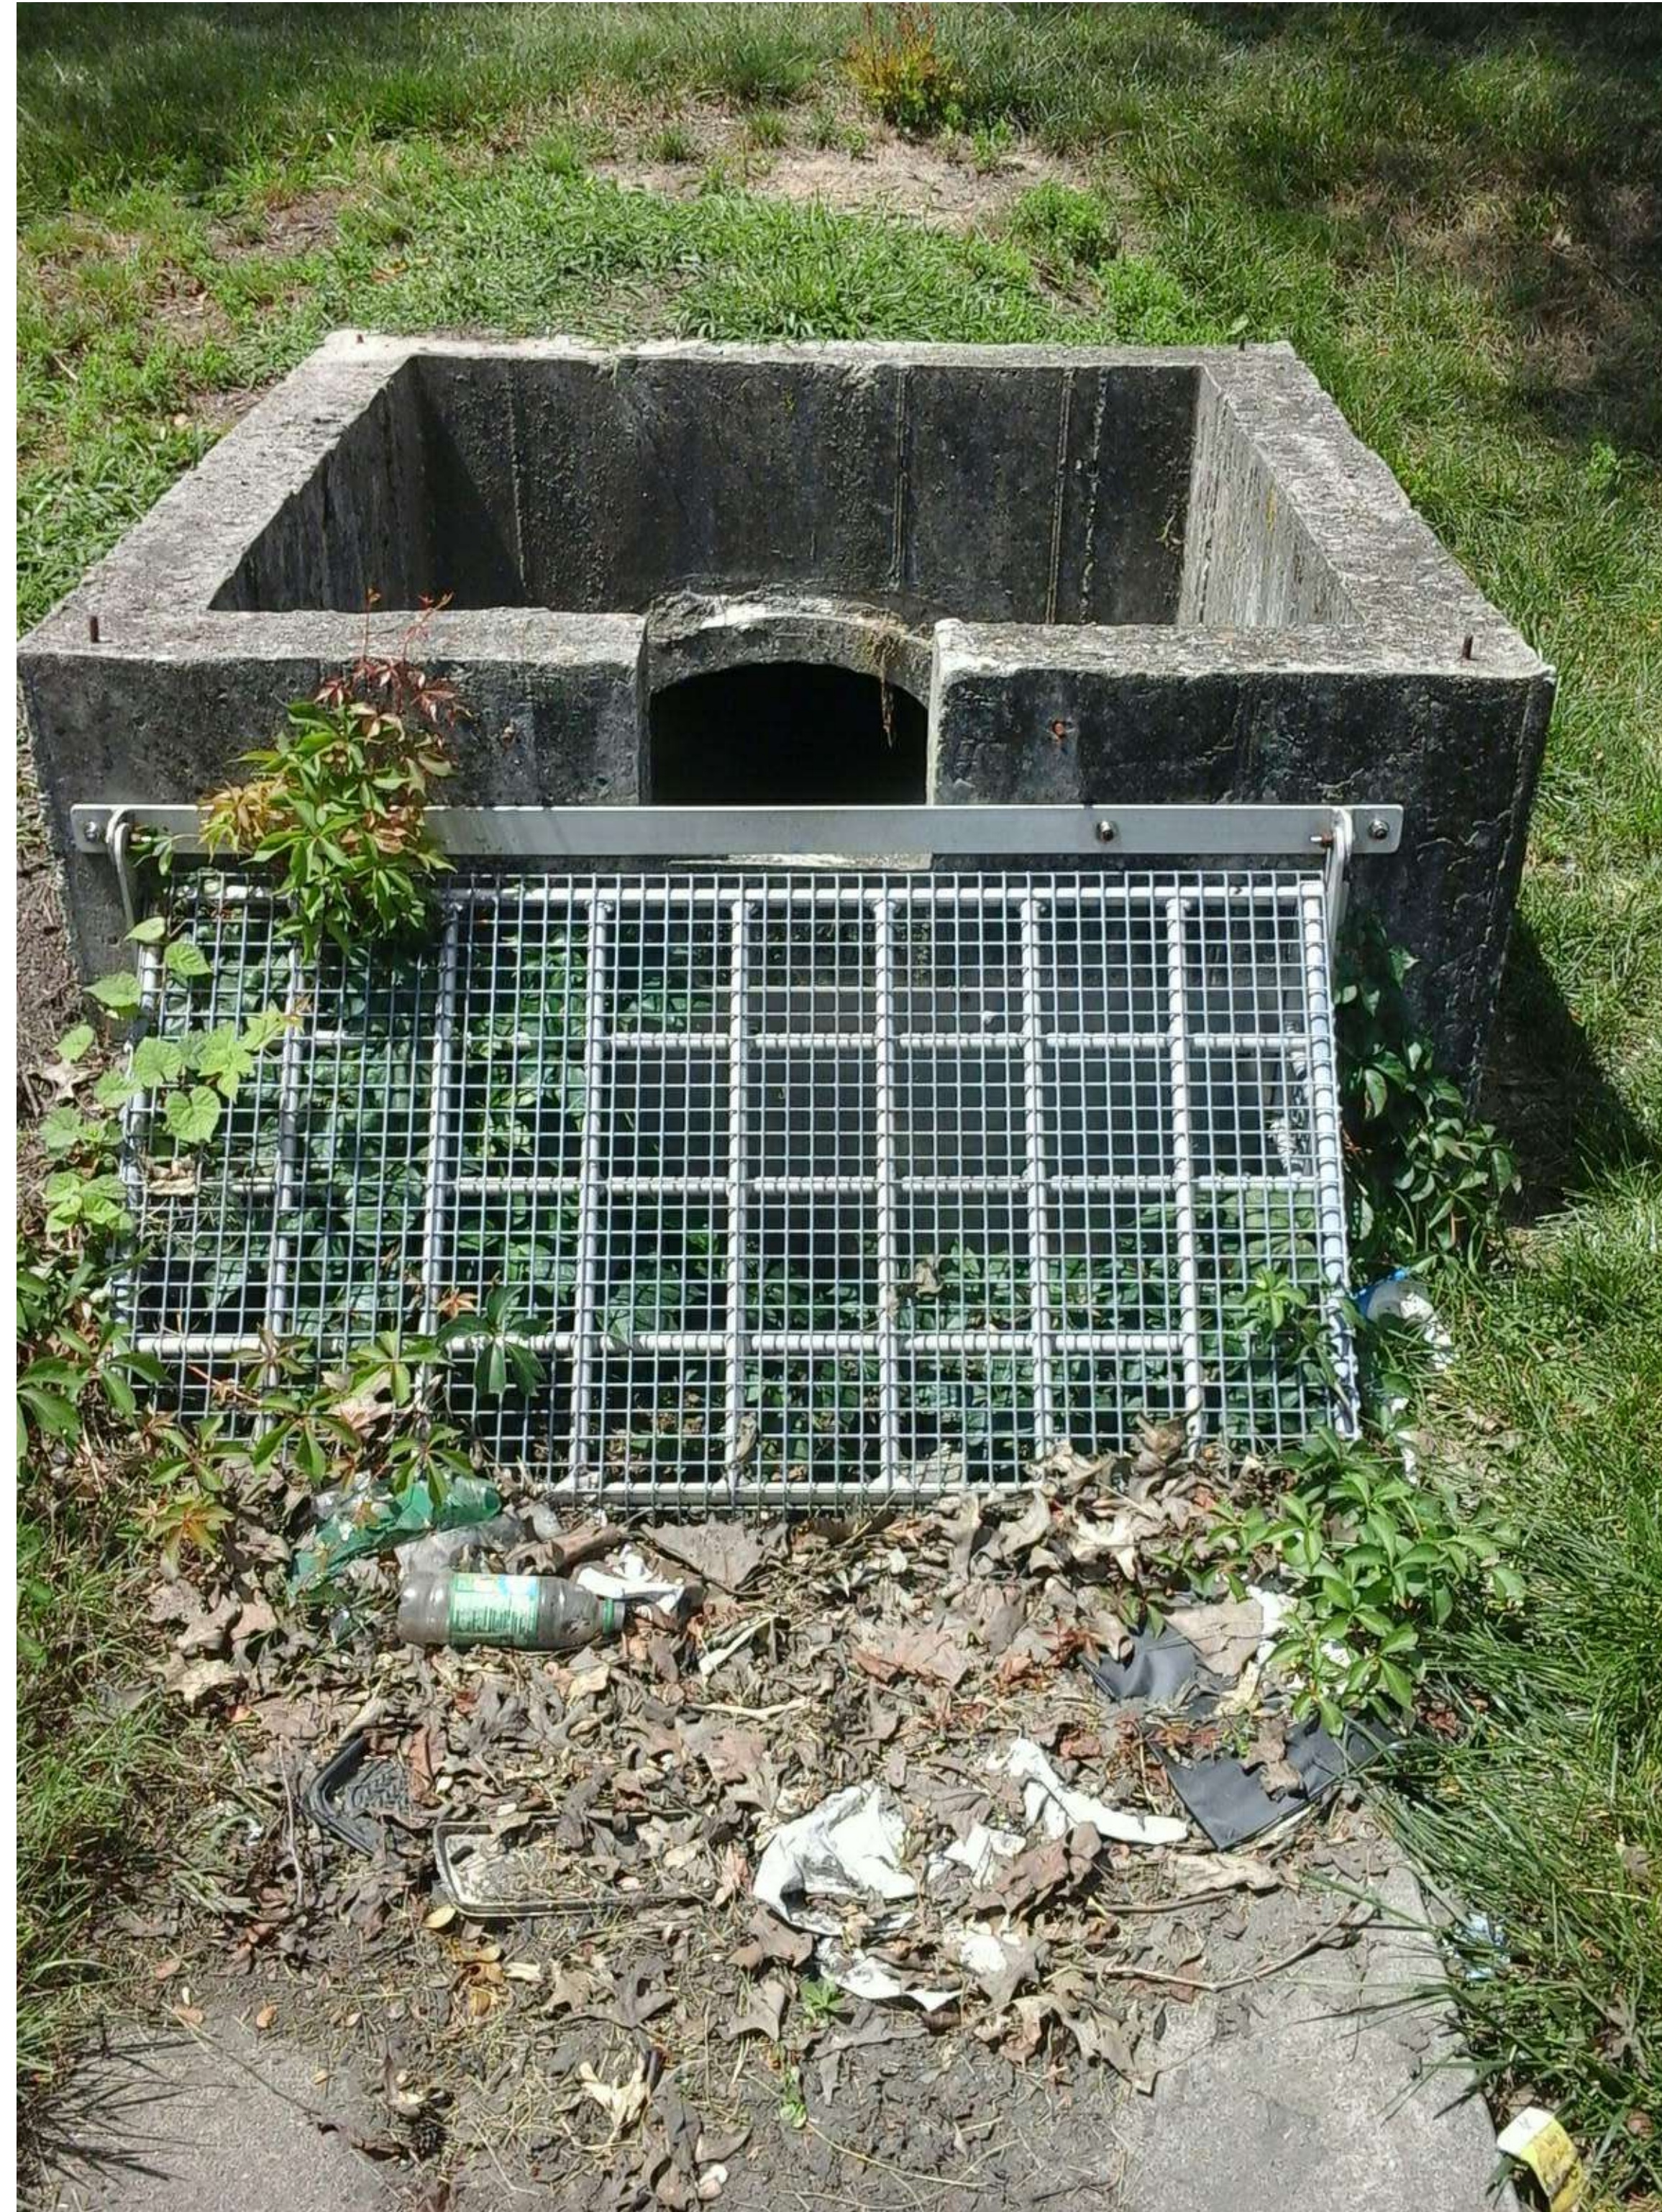
Outlet structure

- Sediment and trash accumulation at outlet
- Outlet structure missing cover
- Replace low flow channel with stone lined channel to increase infiltration

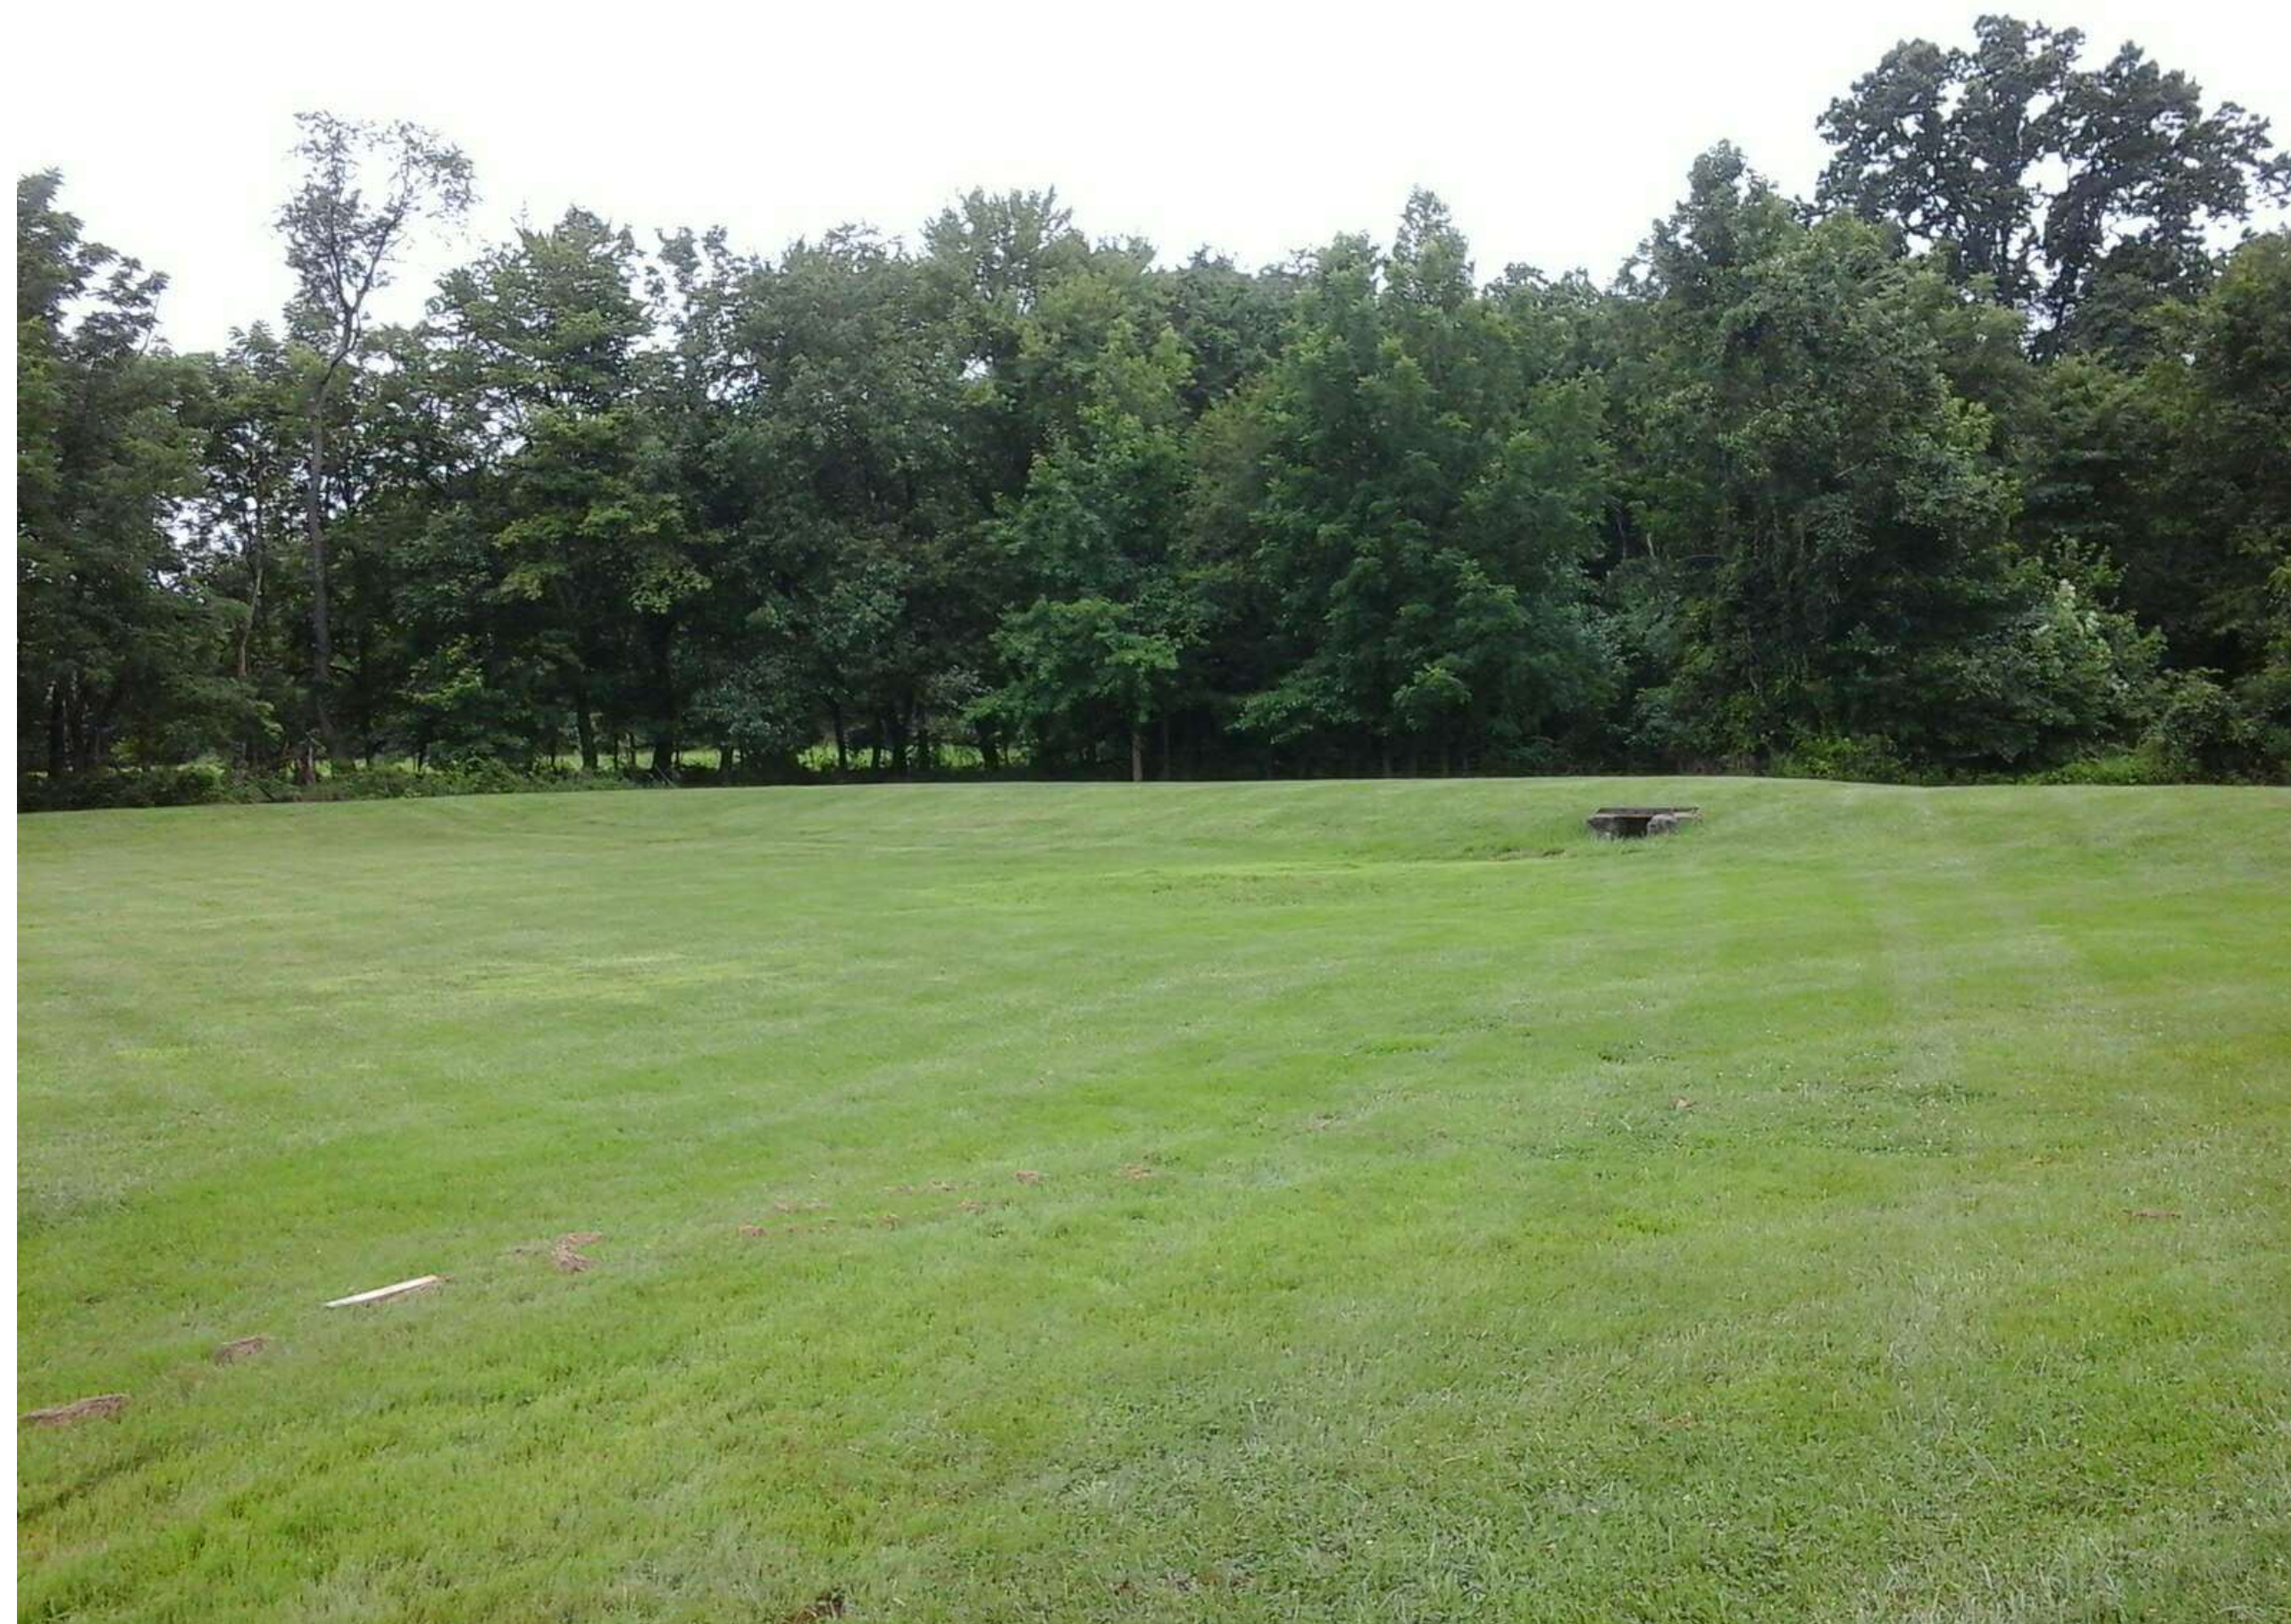
Basin overview looking south

- Standing water is present and can be prevented if naturalized into a meadow for better infiltration
- Vegetation overgrowth at outlet structure

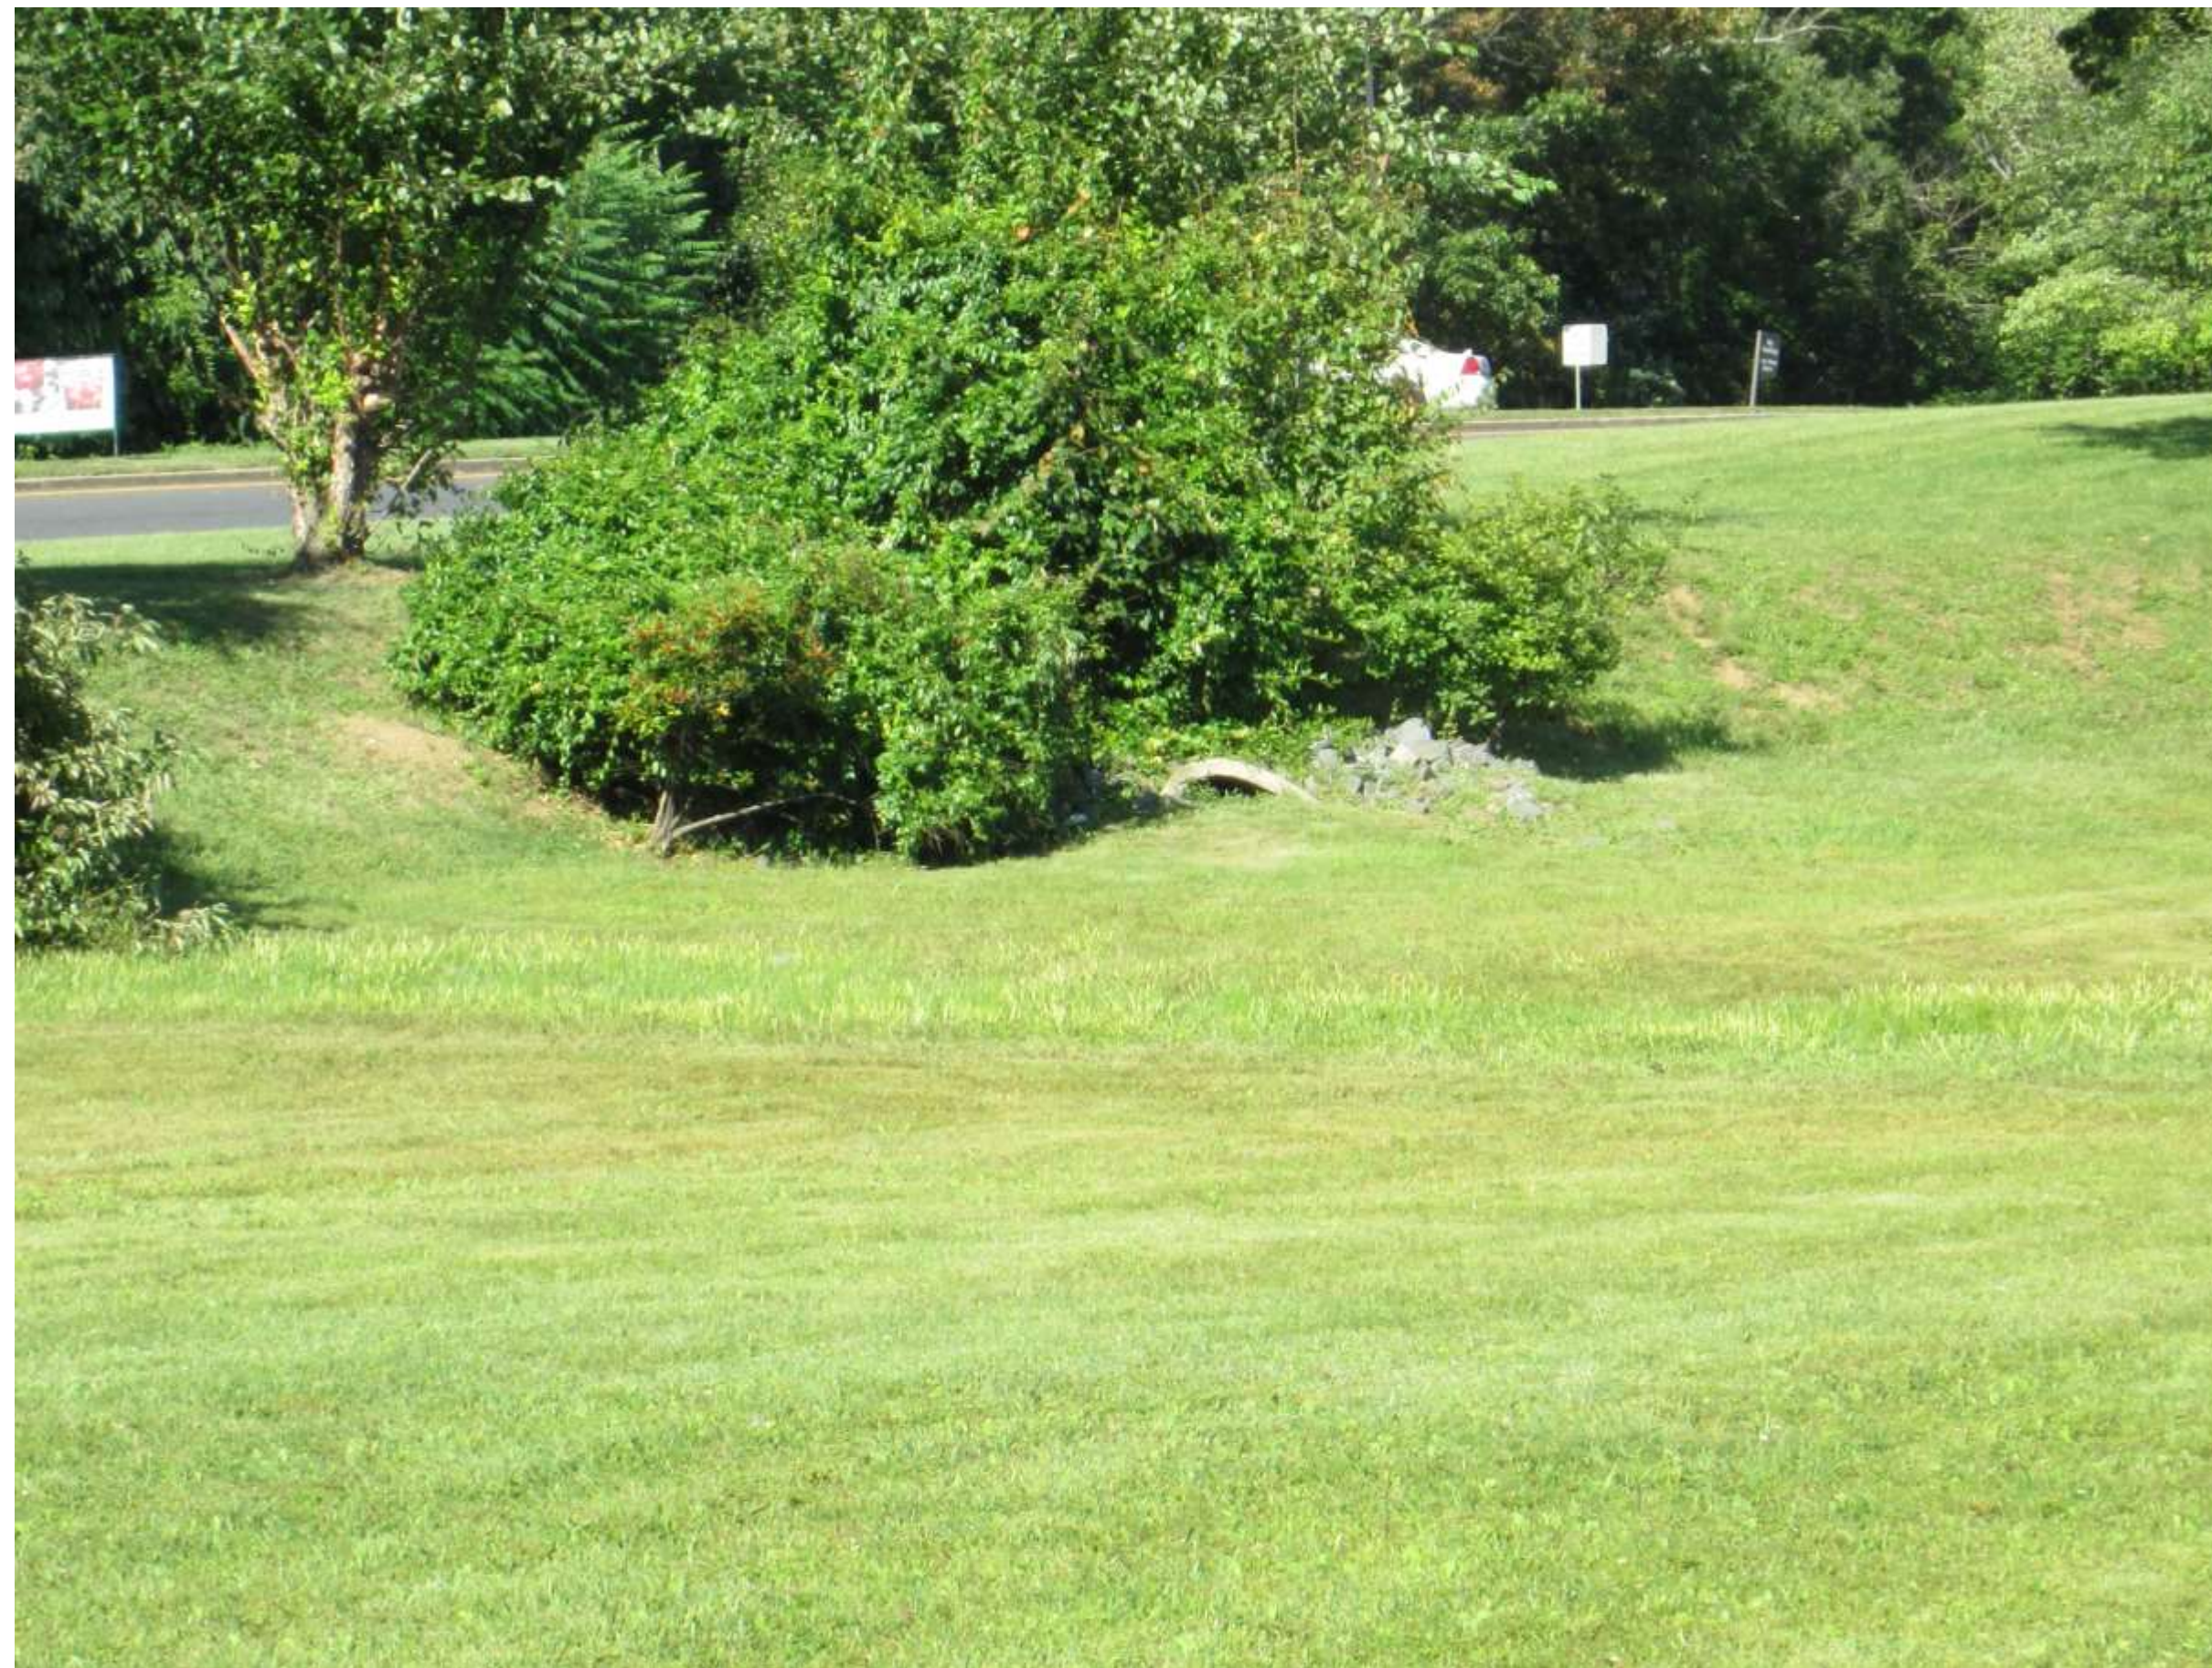
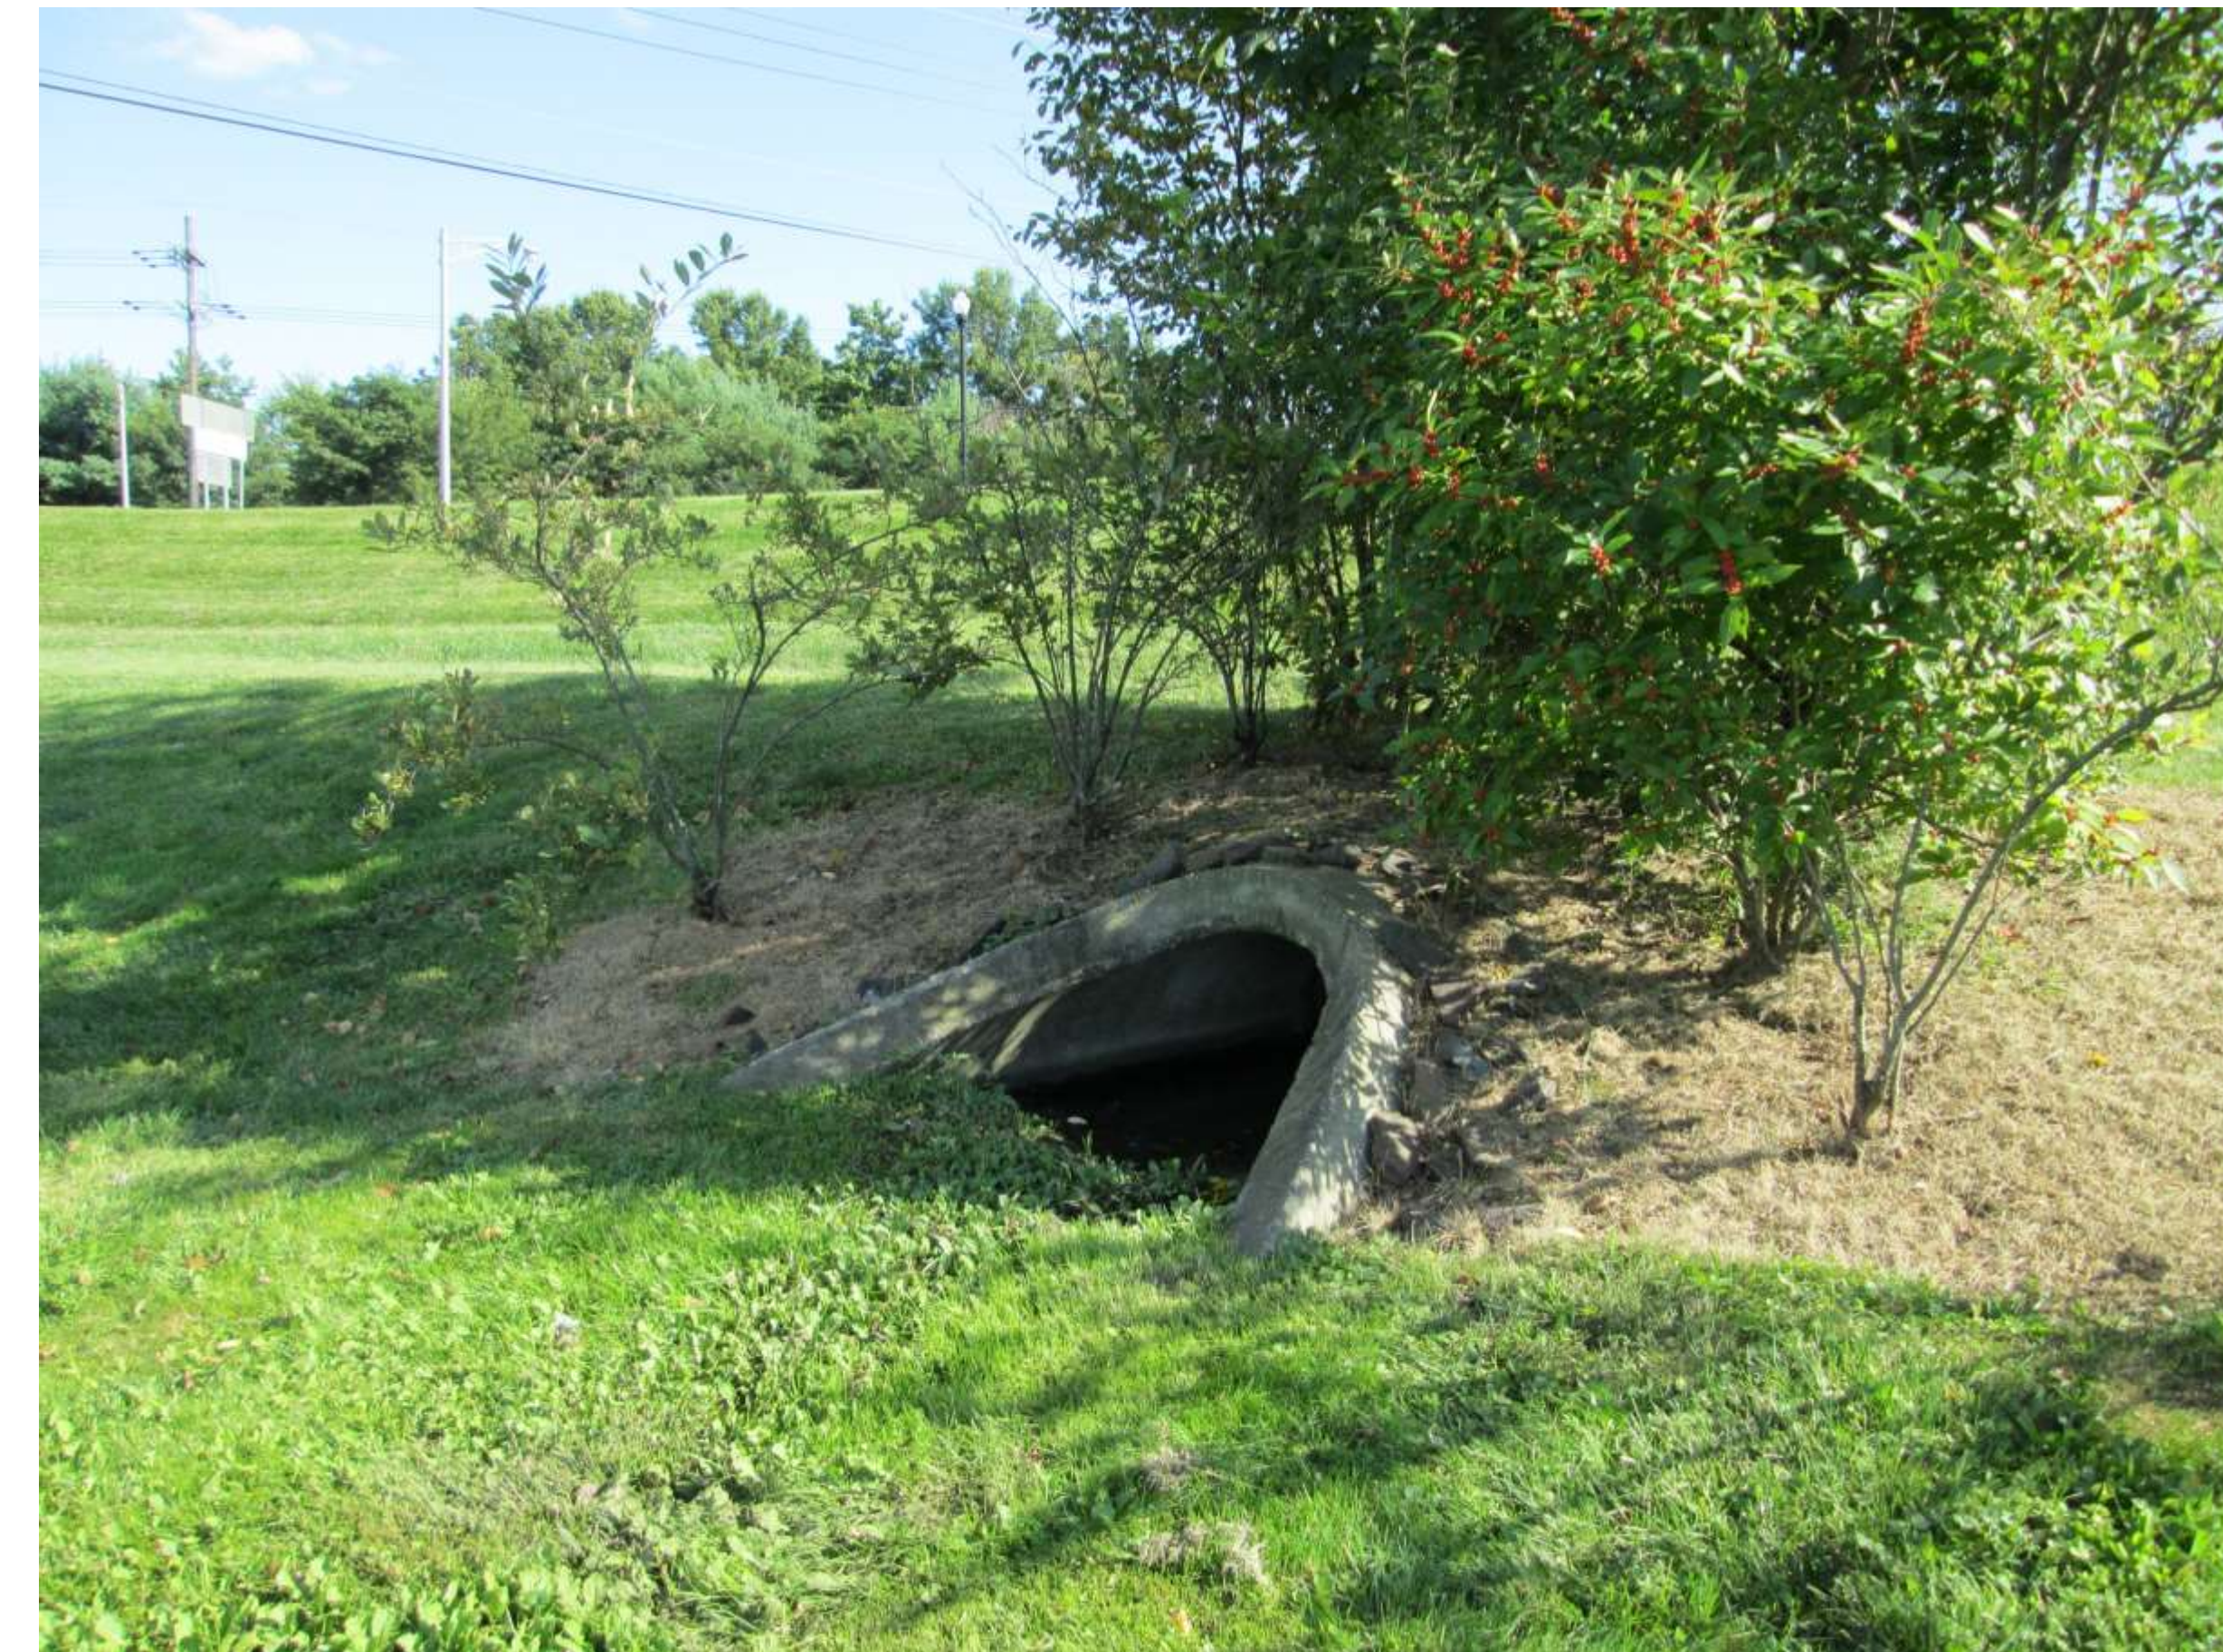
Inlet

- Some sediment accumulation near inlet structure
- Overall well maintained

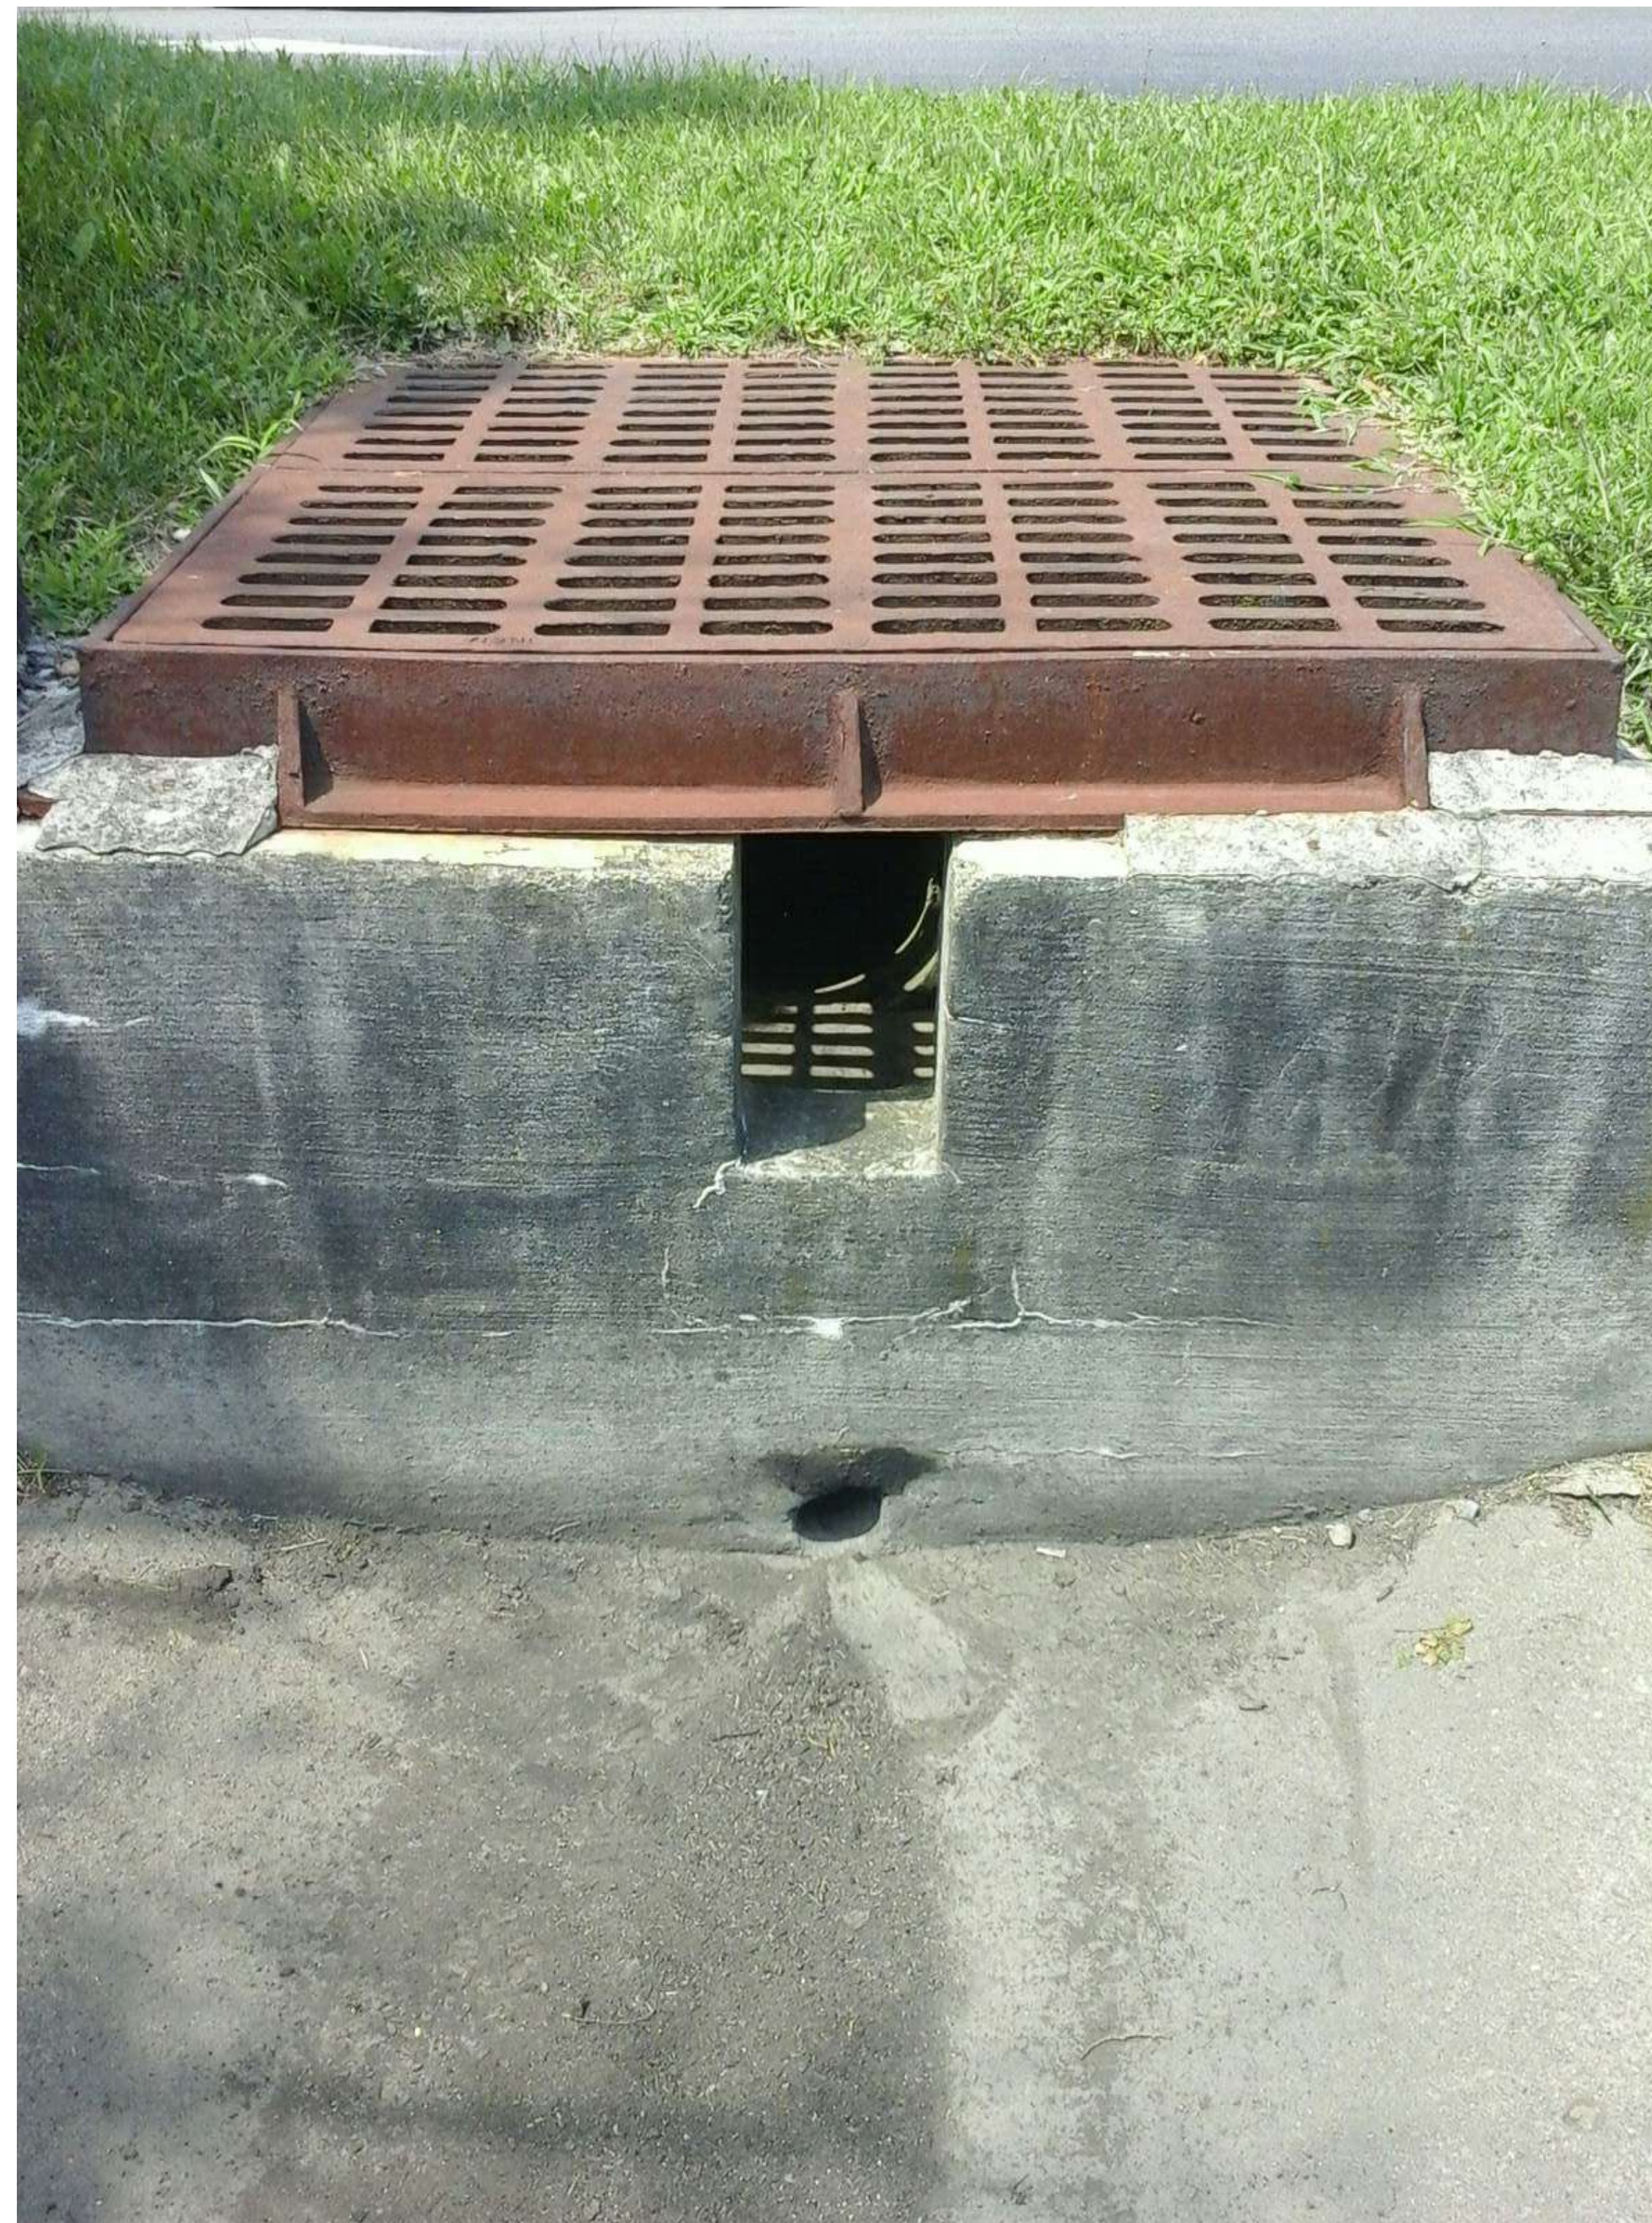
Outlet structure

- Rocks have fallen into the inlet
- Reduce mowing and replace low flow channel with stone lined channel to improve infiltration
- Overall well maintained

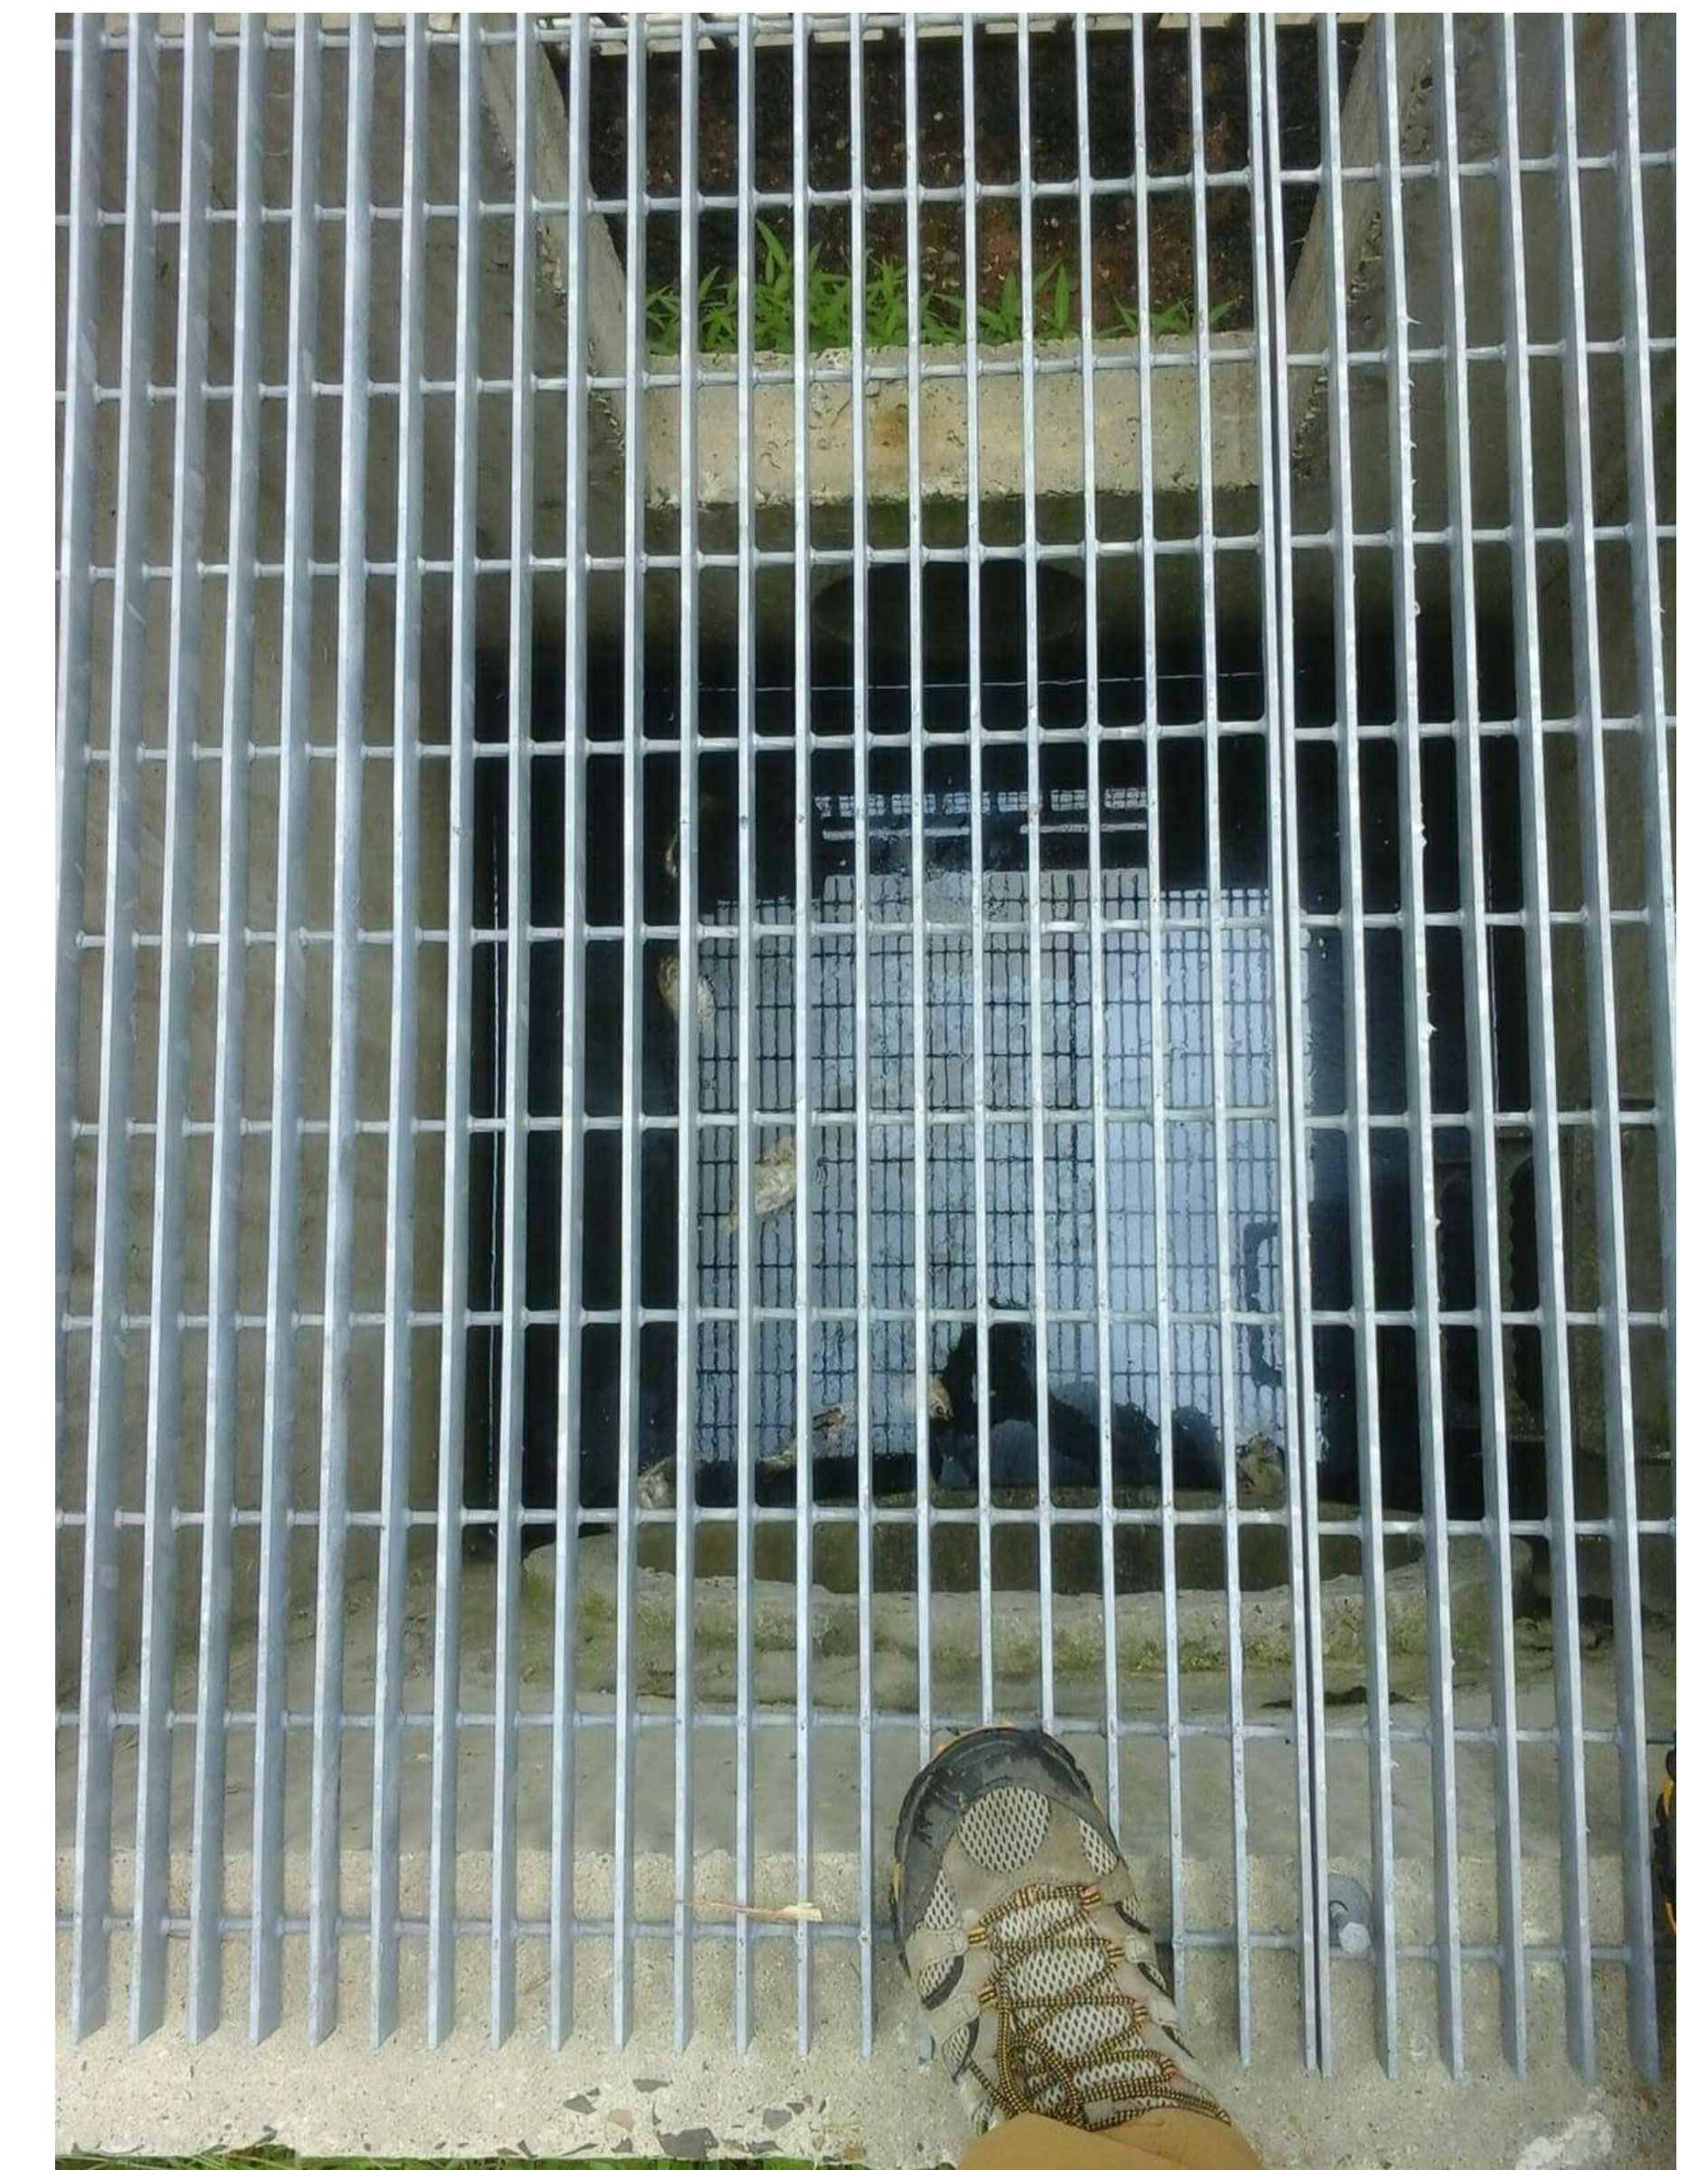
Fish in outlet structure
