**Hamilton Township (Mercer County)
Stormwater Basin Assessment Summary
Addendum (Year 4)**

Developed by the Rutgers Cooperative Extension Water Resources Program
Funded by Hamilton Township, Mercer County, New Jersey

December 2017

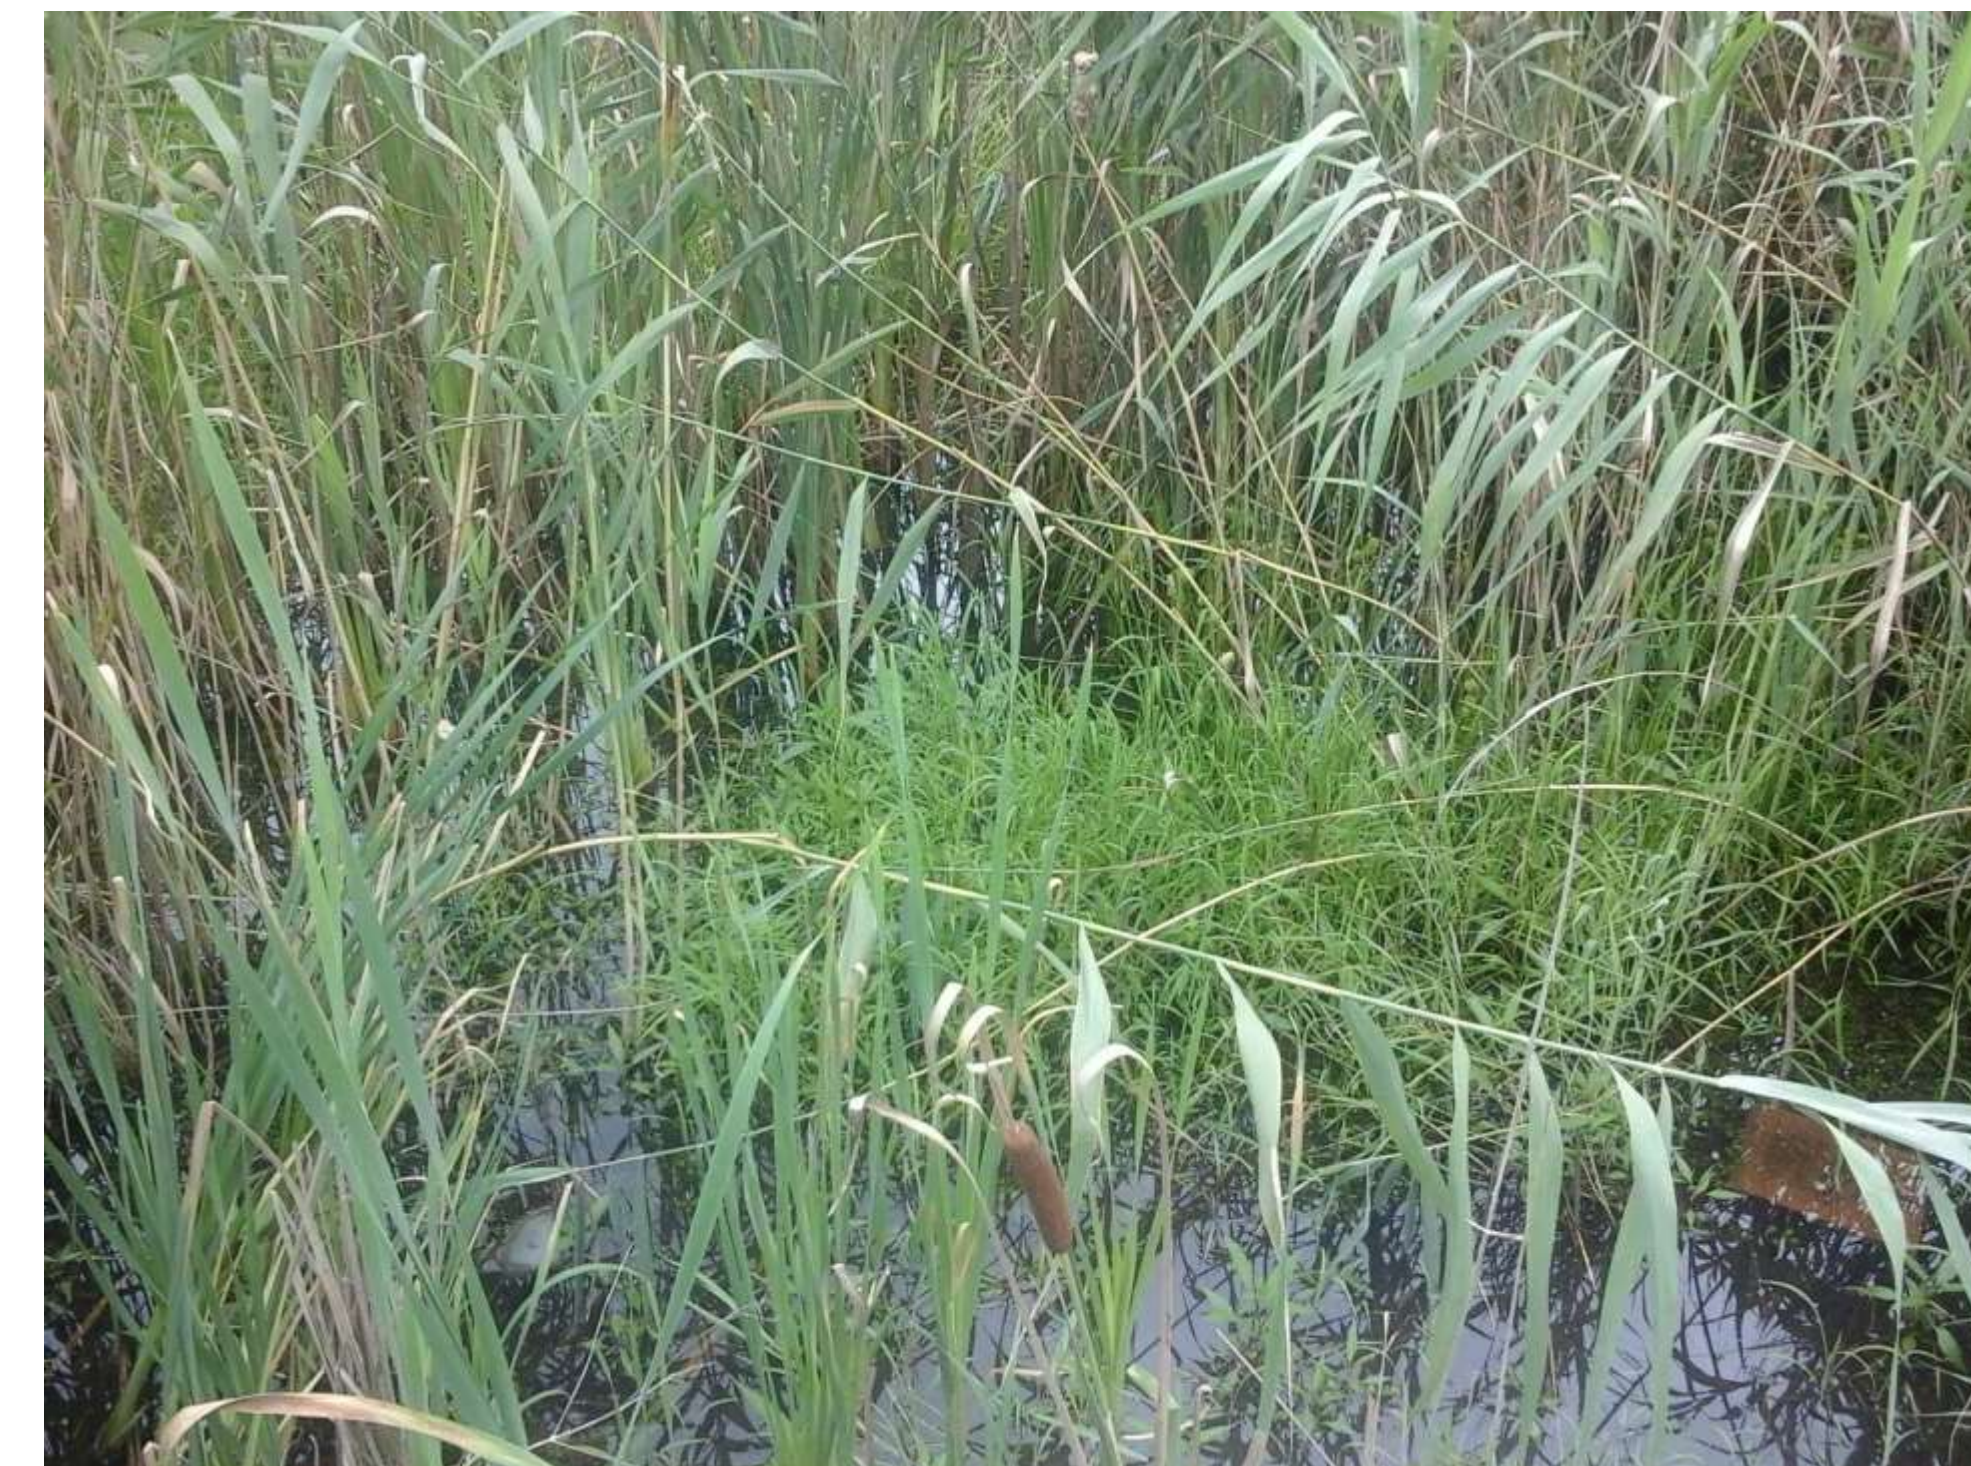
- Invasive phragmites growing in retention pond
- Otherwise well maintained

Invasive vegetation growth

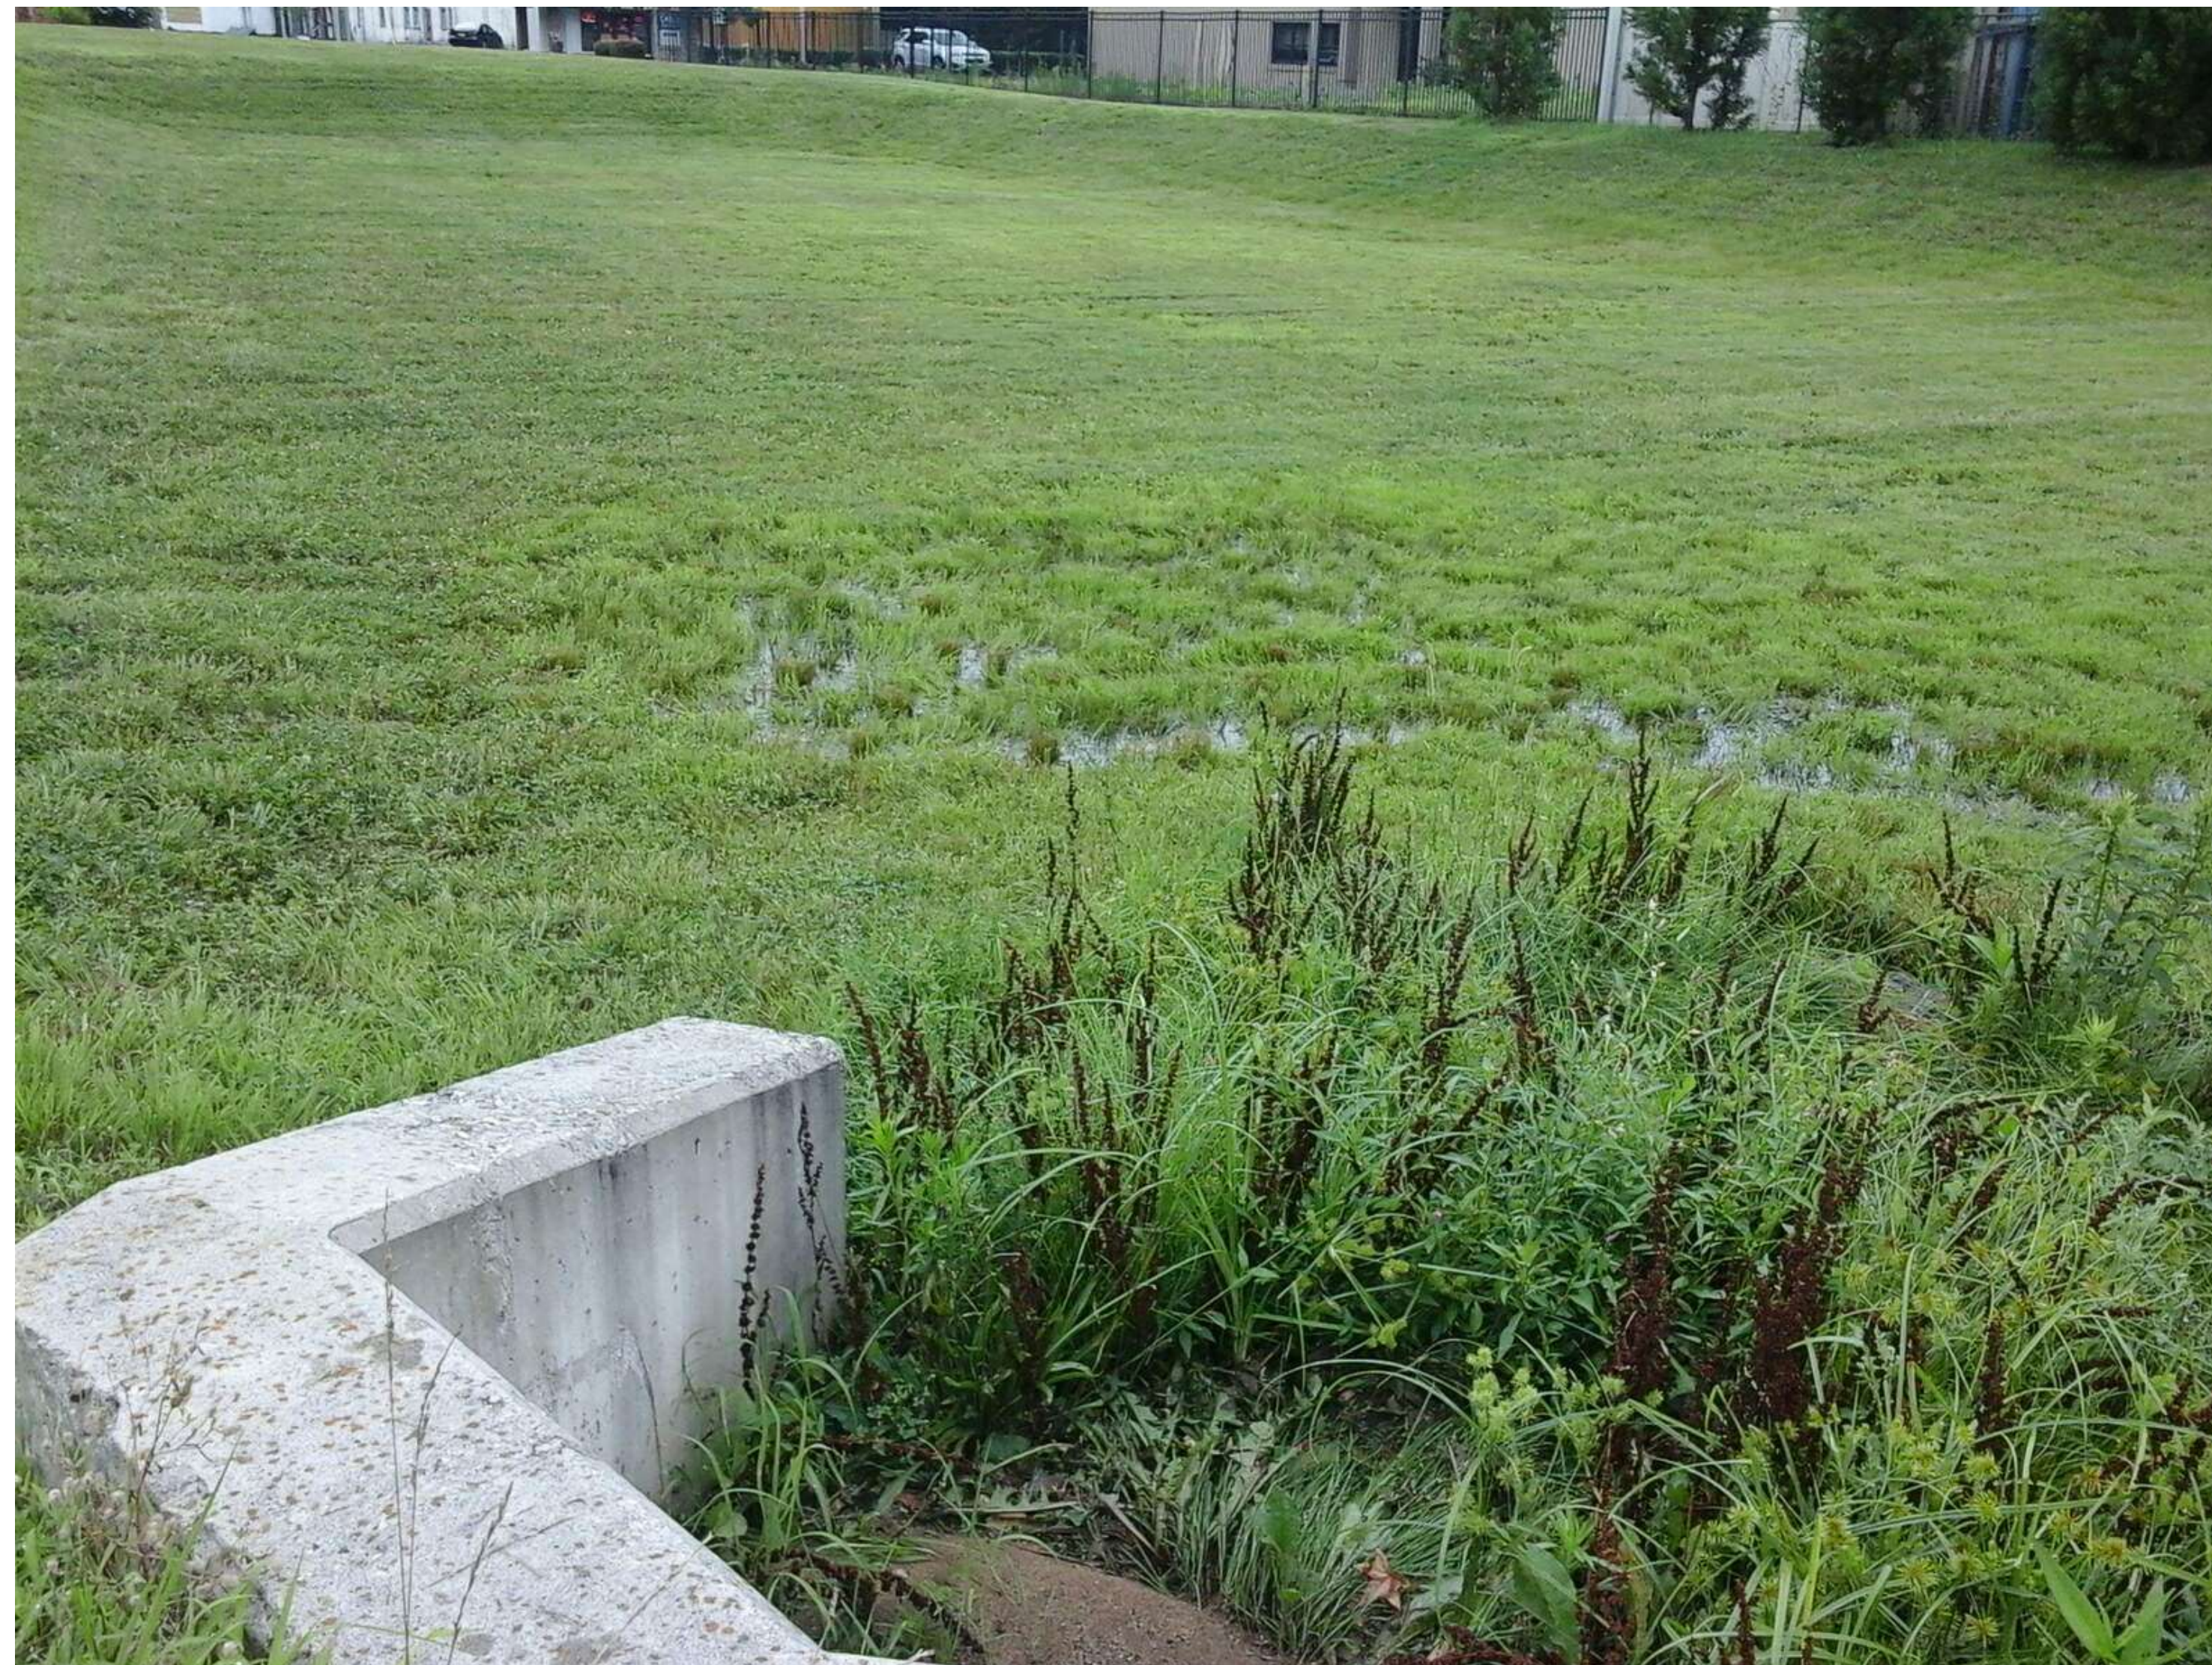
Inspecting outlet structure

- Infiltration basin with some natural vegetation growing
- Some standing water present
- Overall well maintained

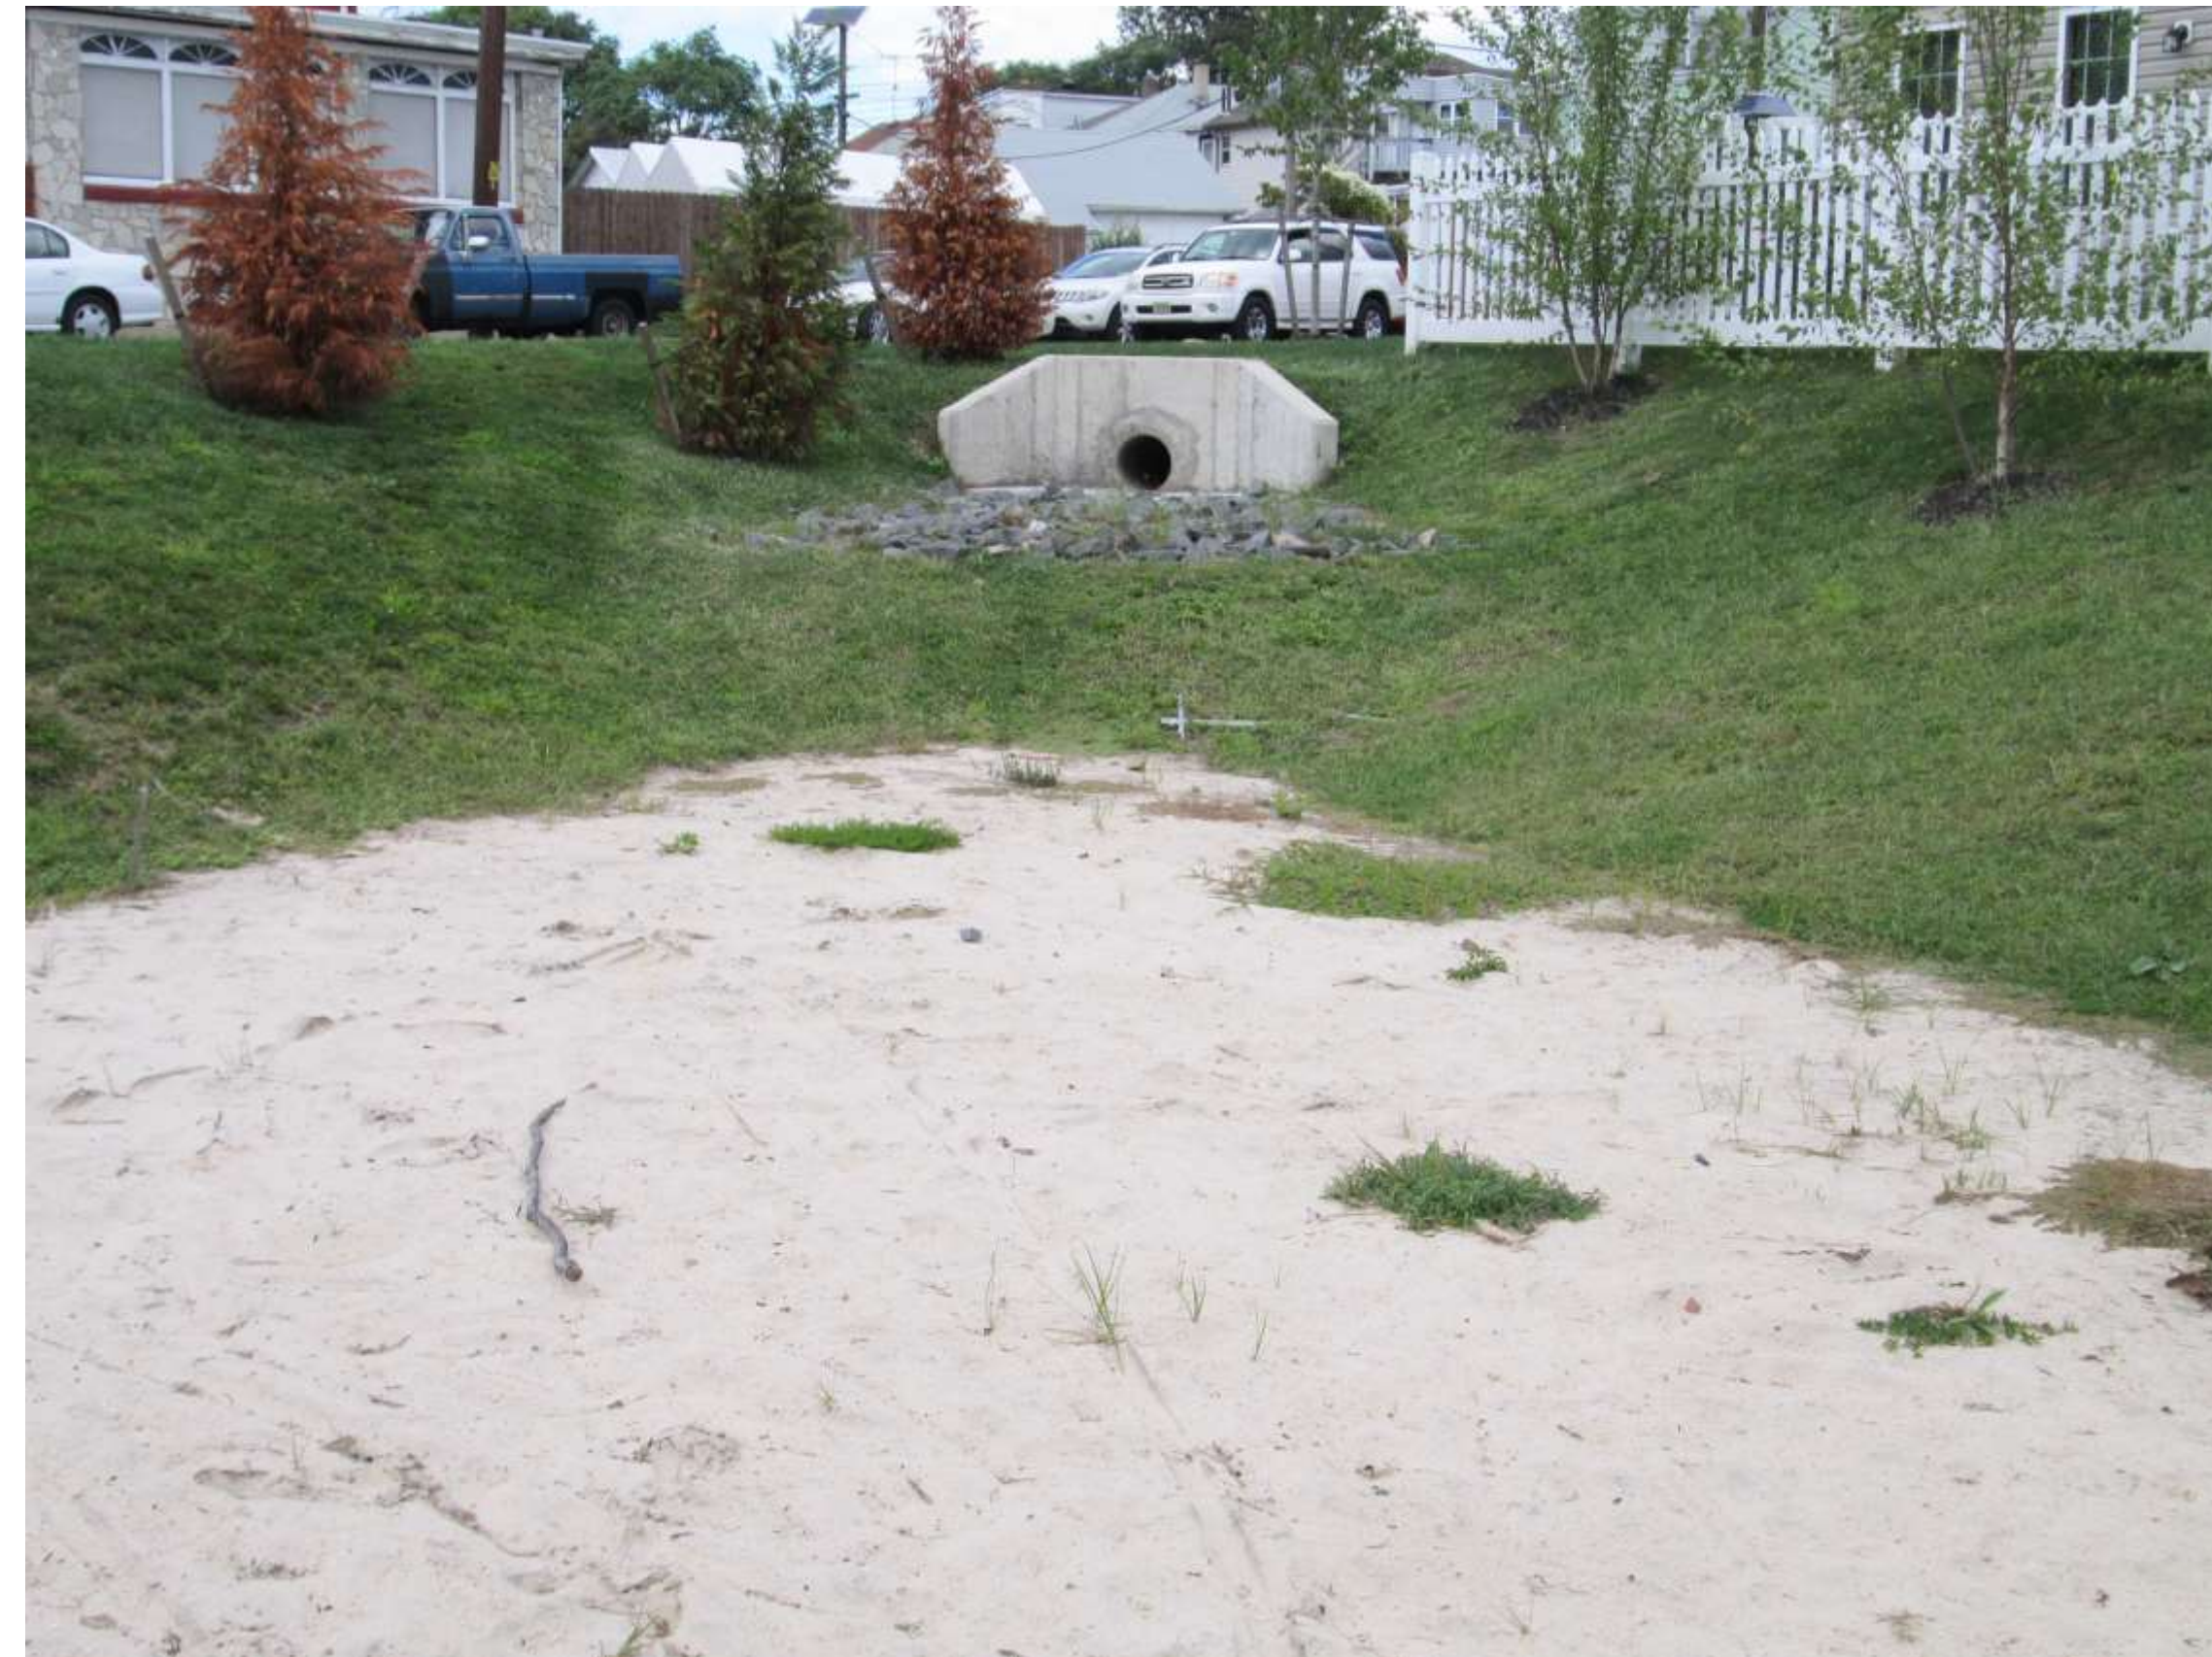
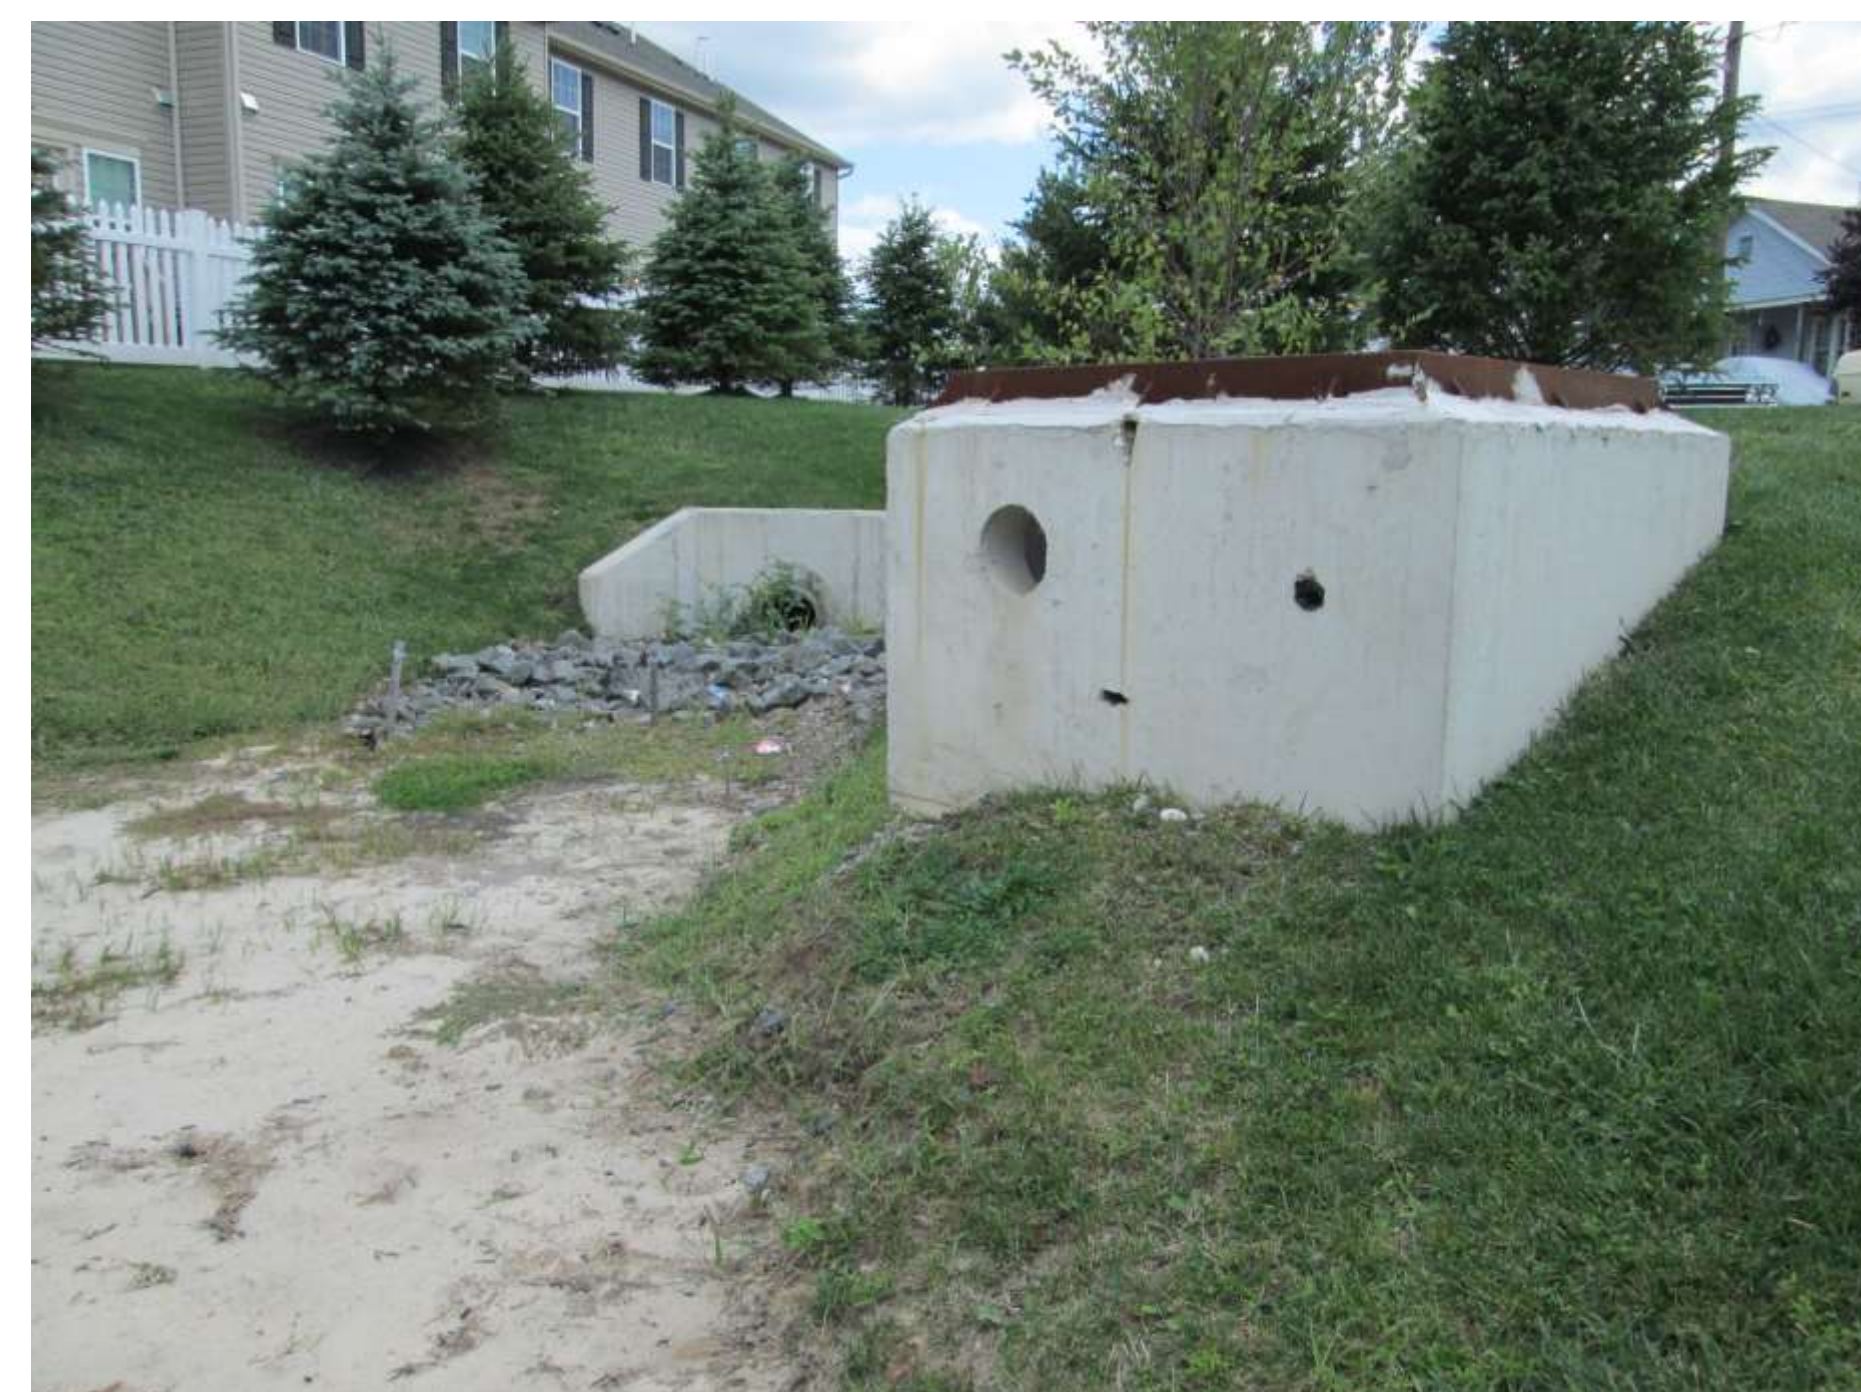
Overview of basin

- Newly constructed basin
- Sandy bottom likely to improve infiltration
- Some standing water in outlet structure
- Overall well maintained

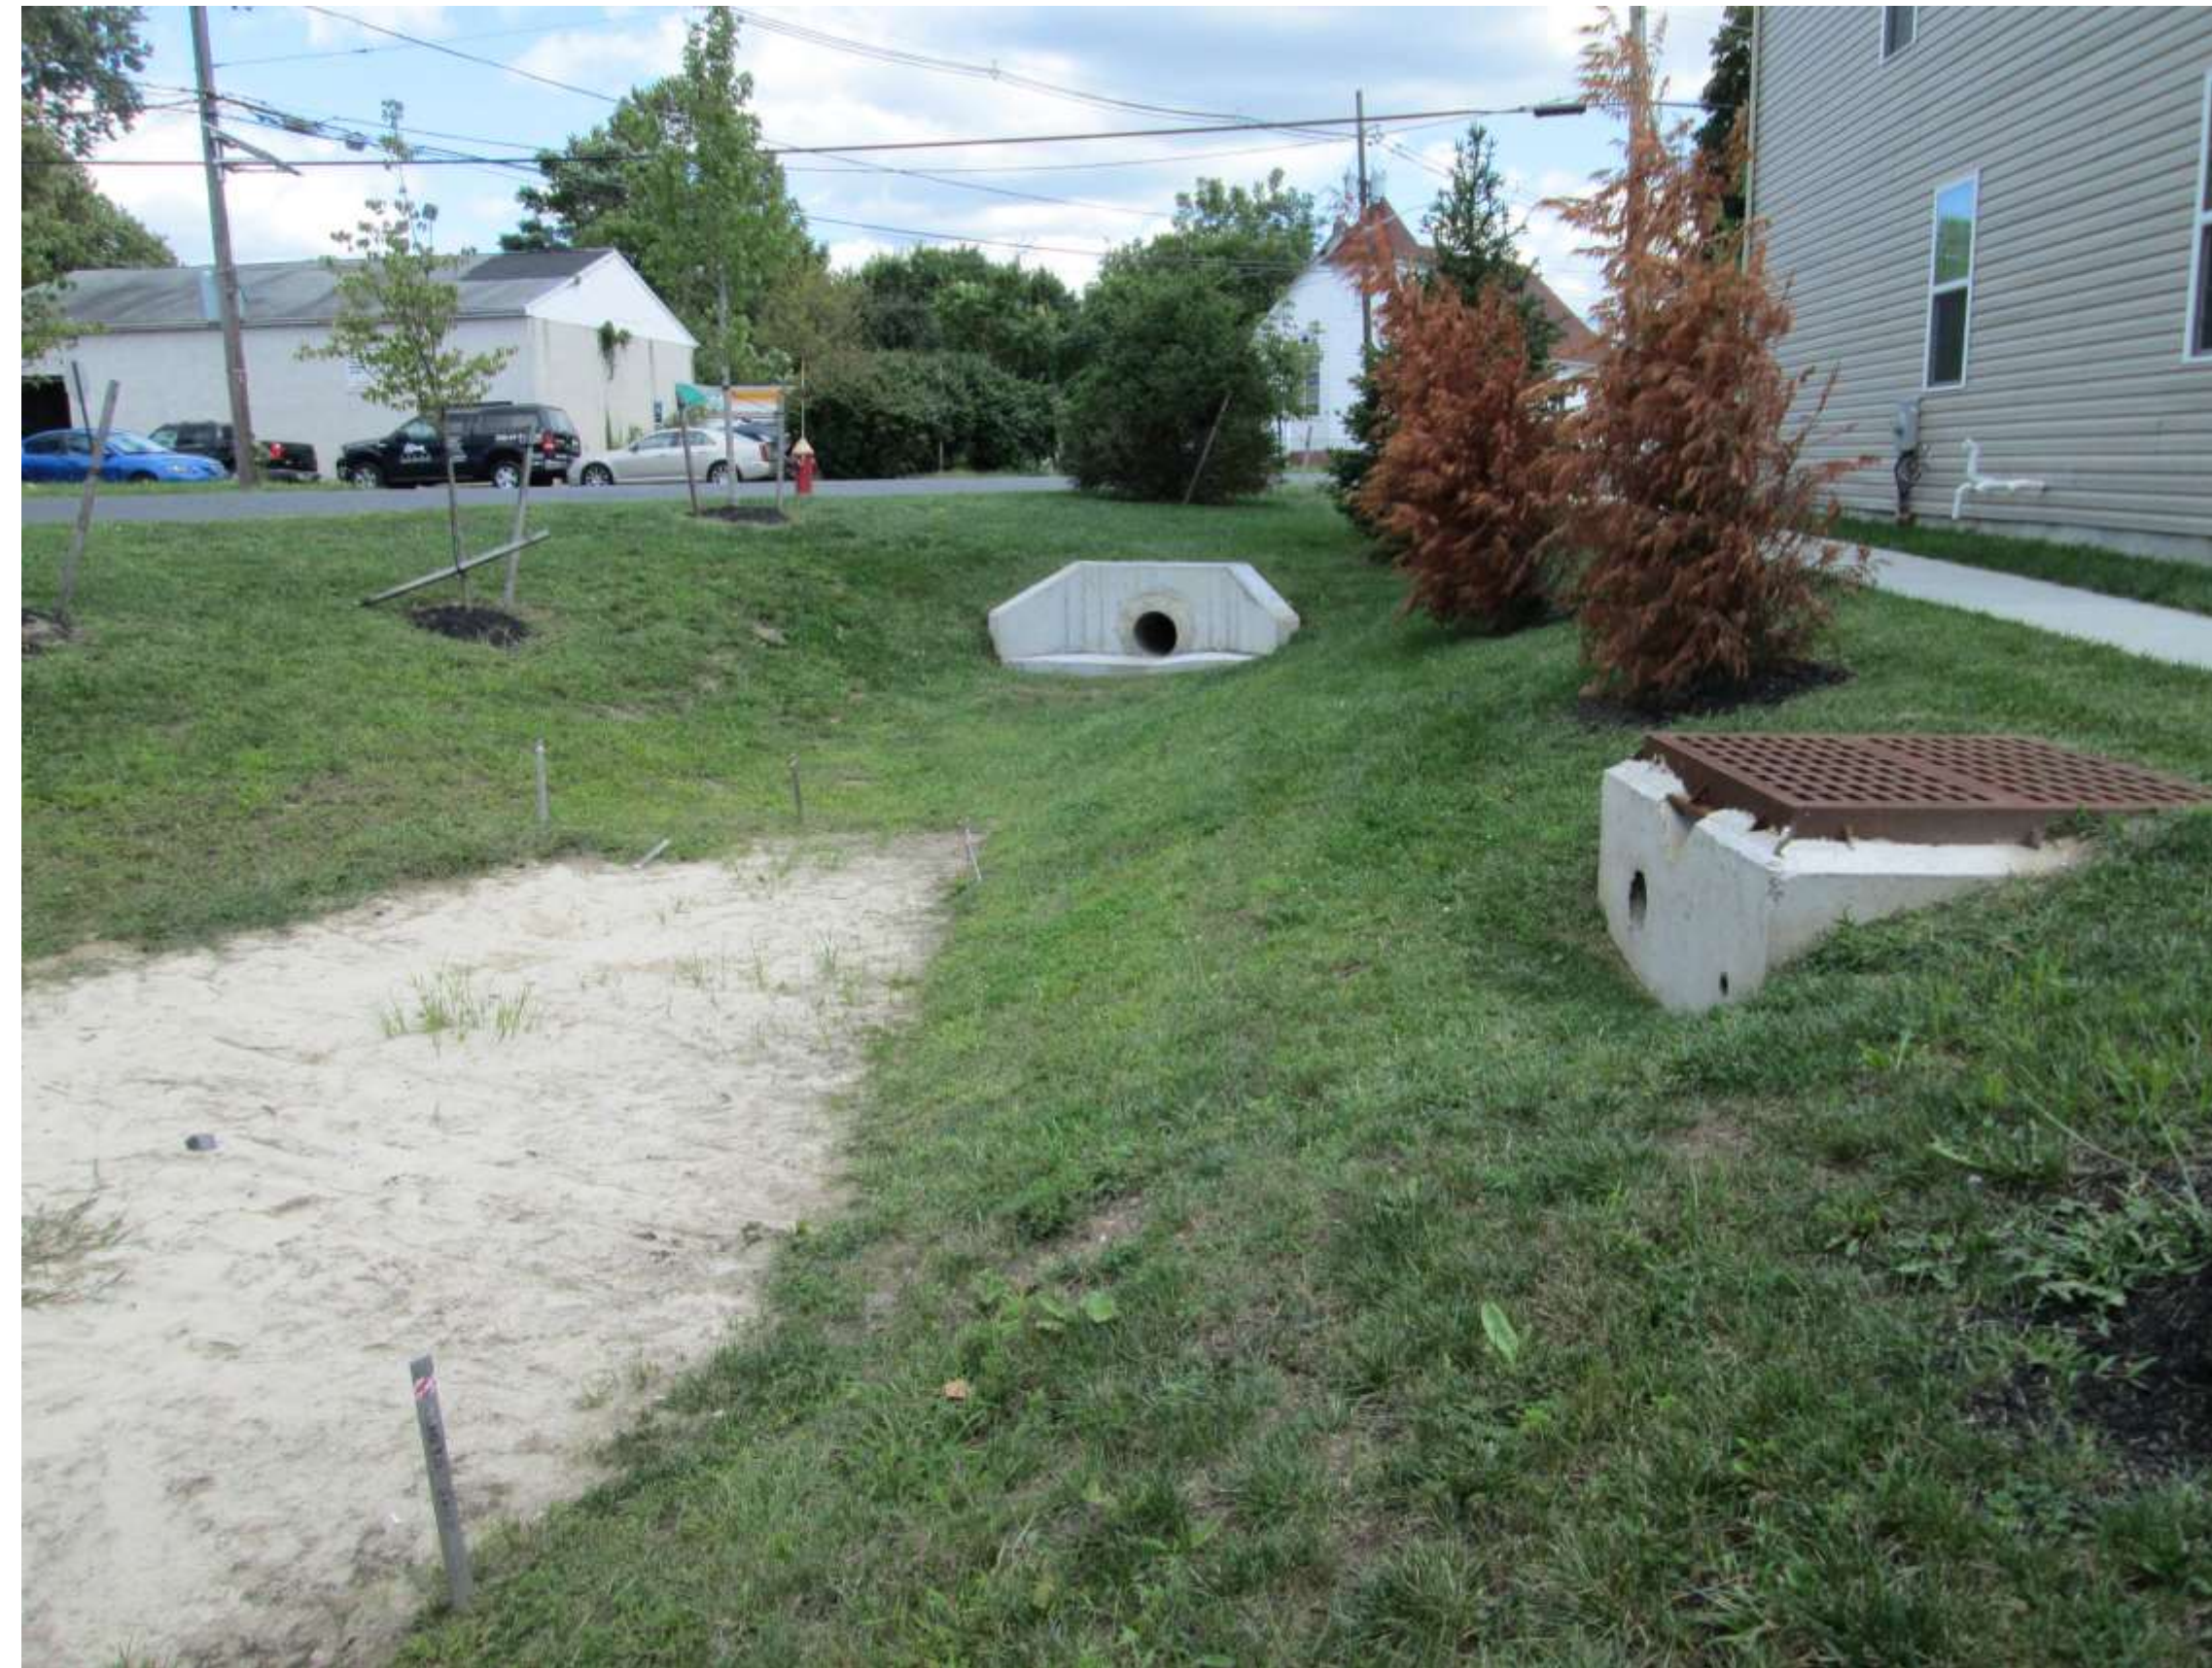
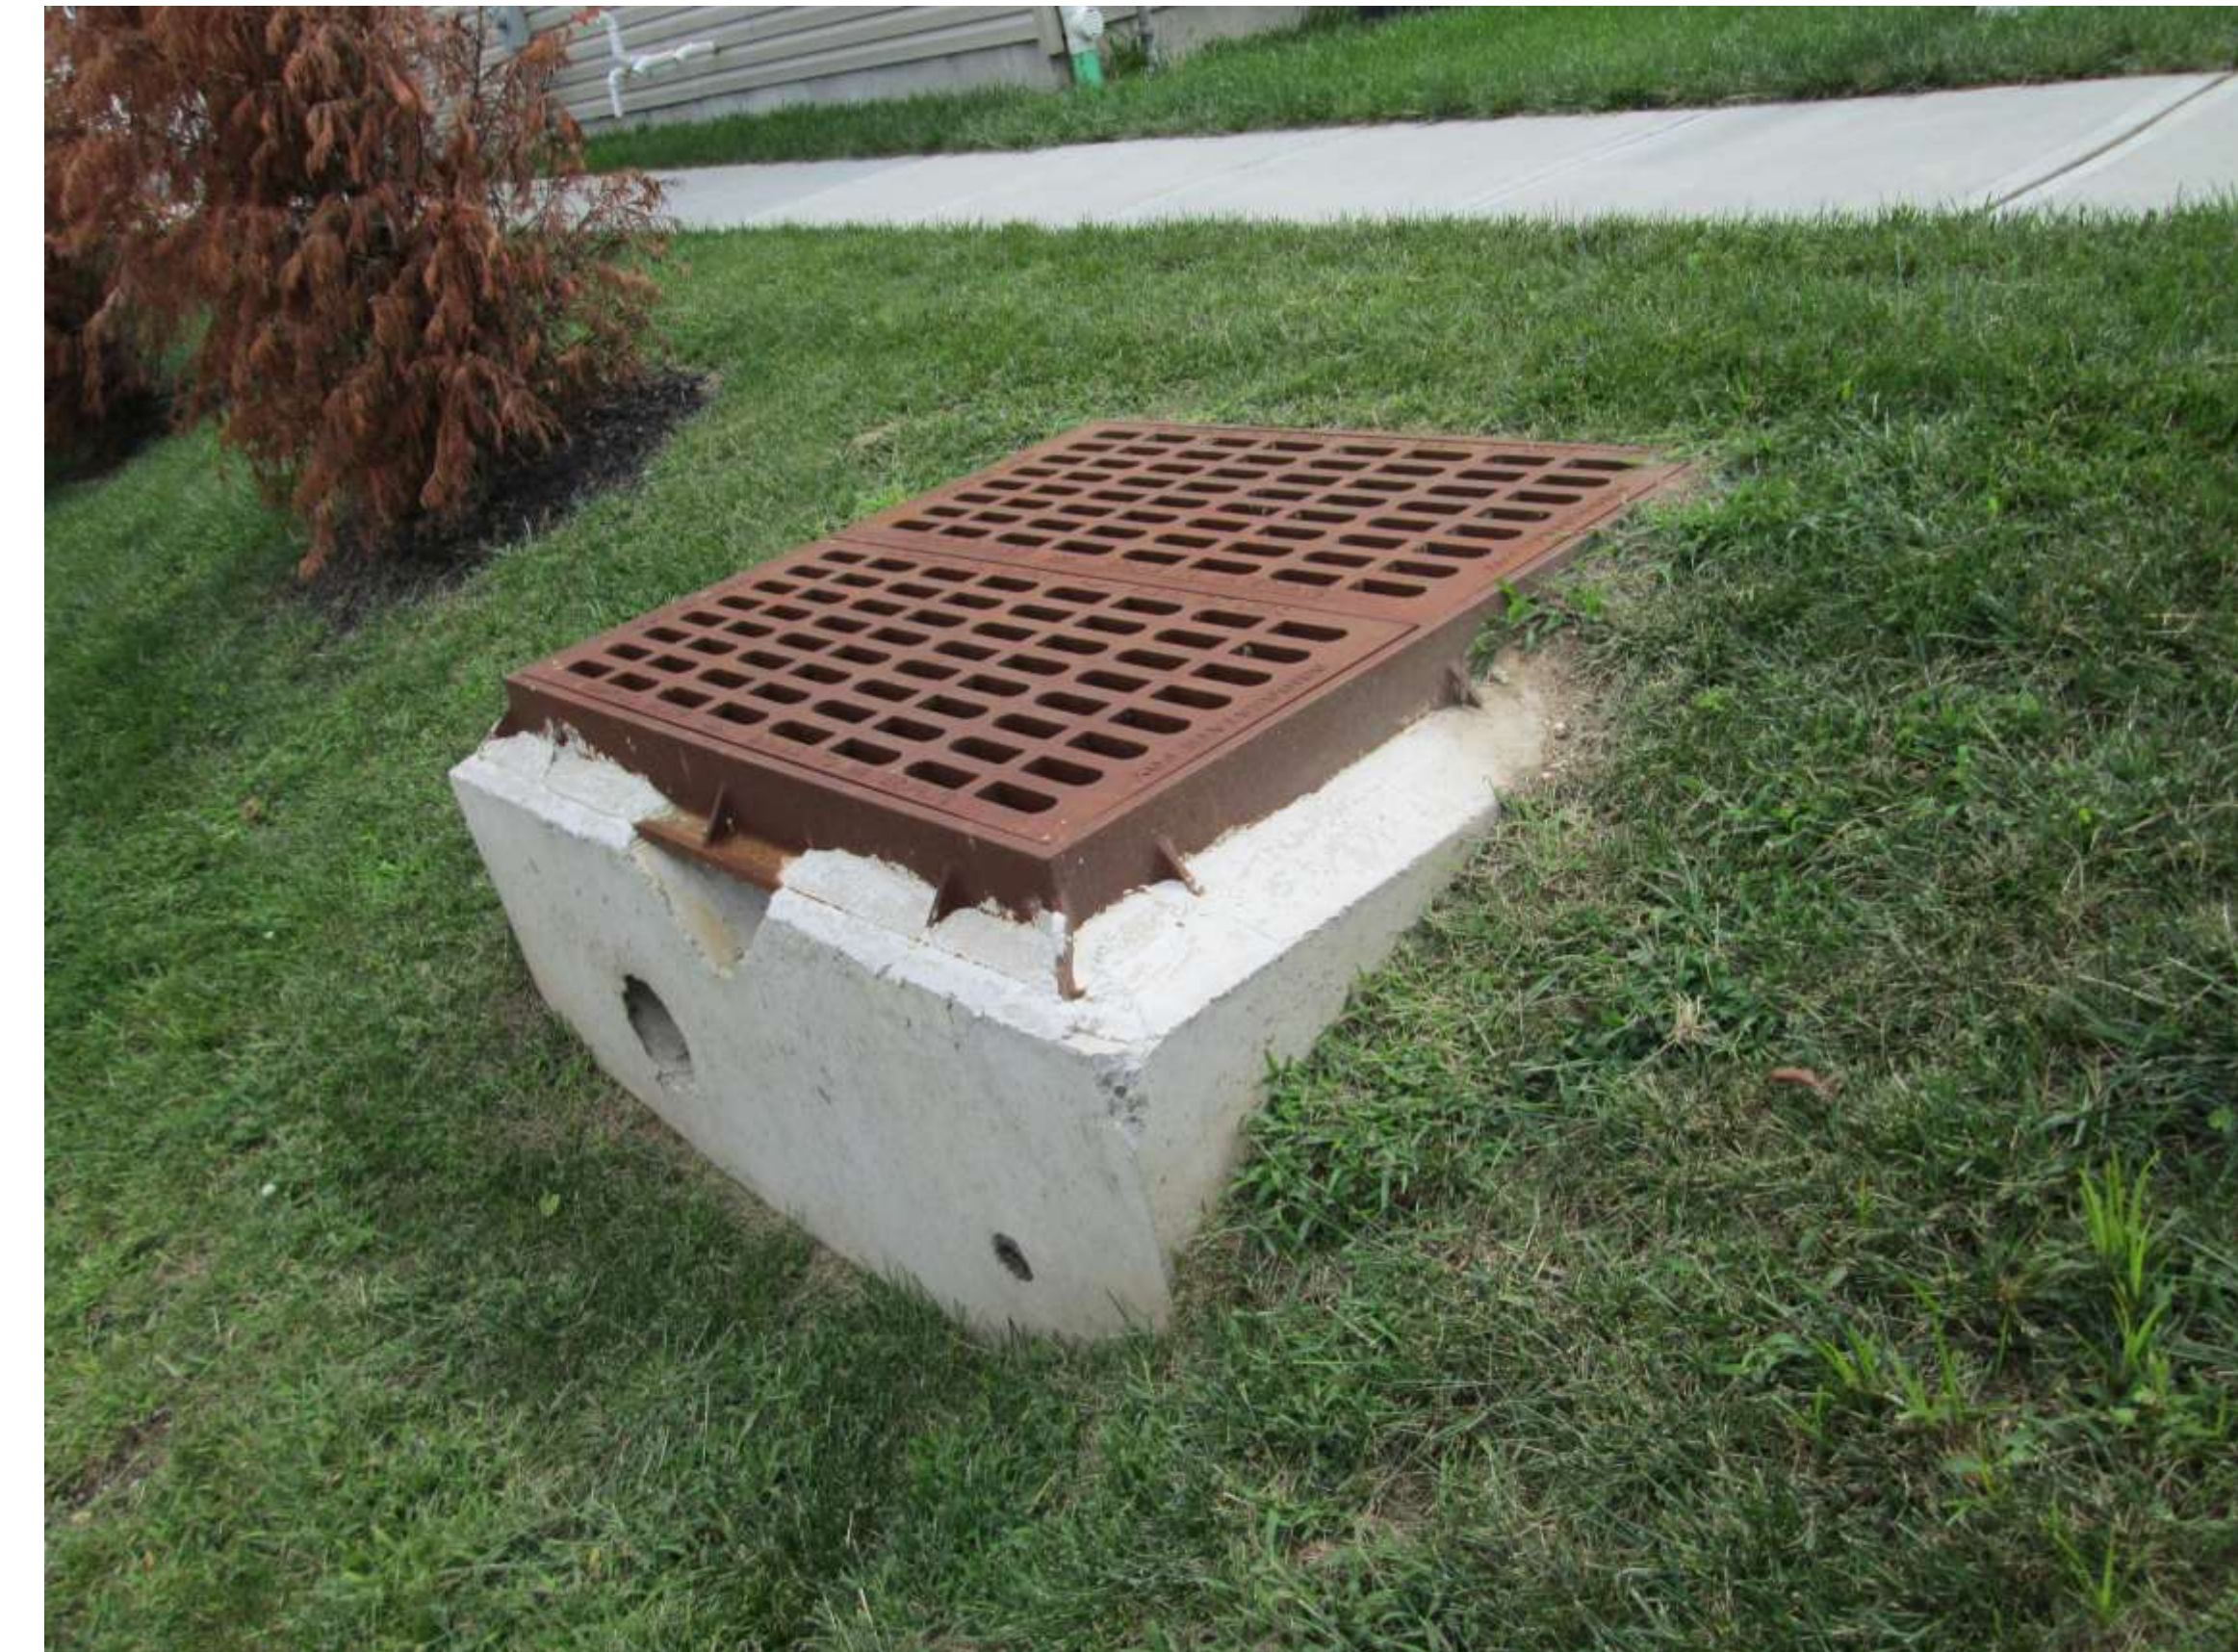
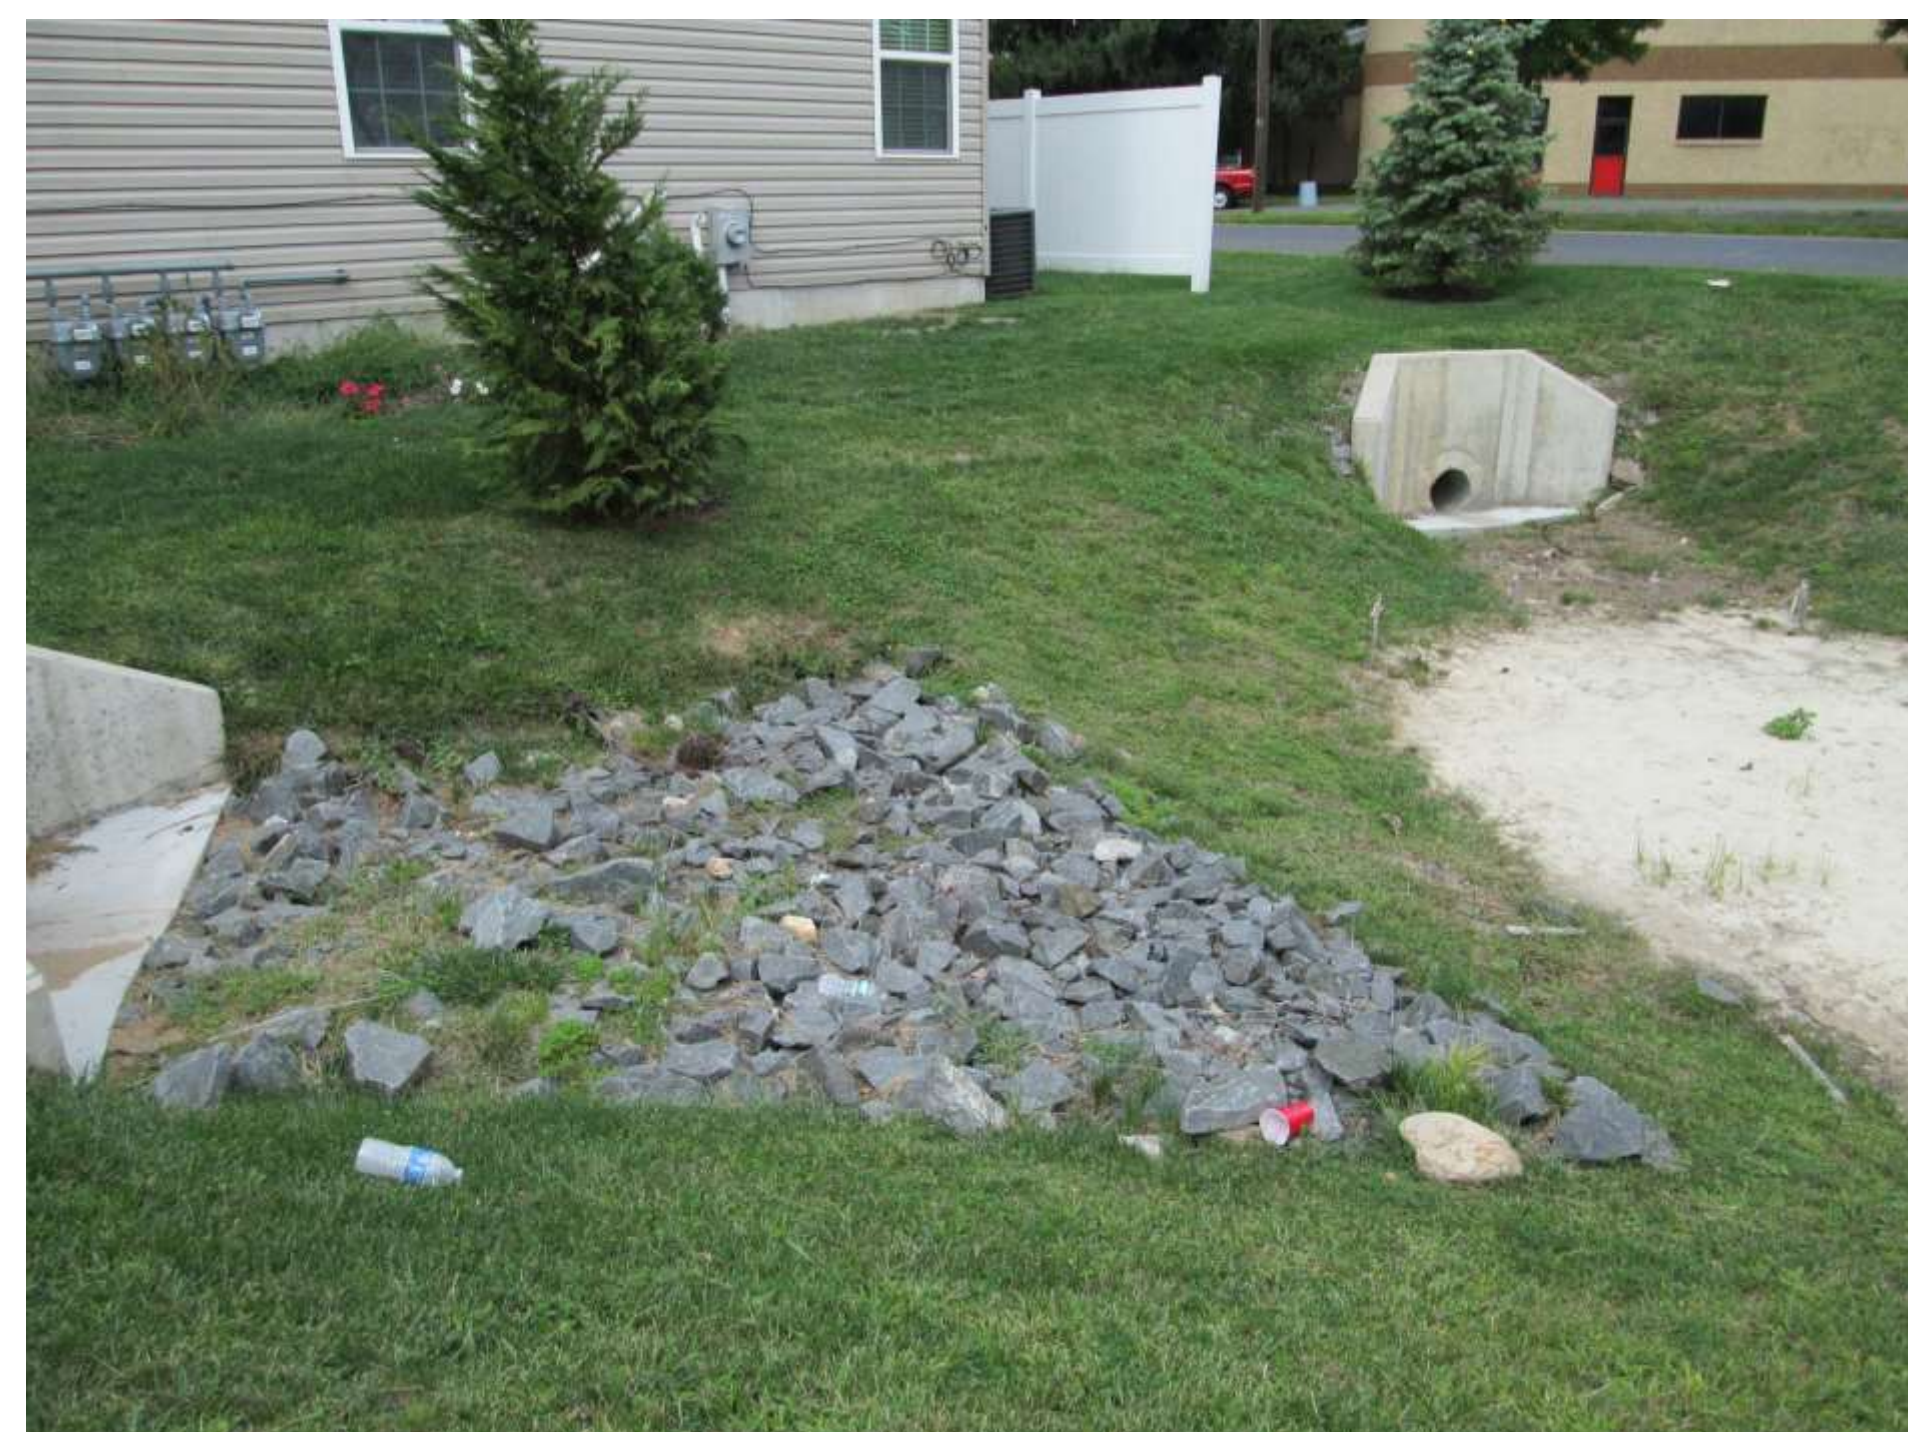
Outlet

- Newly constructed basin
- Sandy bottom likely to improve infiltration
- Some debris accumulated
- Overall well maintained
