**Hamilton Township (Mercer County)
Stormwater Basin Assessment Summary
Addendum (Year 4)**

Developed by the Rutgers Cooperative Extension Water Resources Program
Funded by Hamilton Township, Mercer County, New Jersey

December 2017

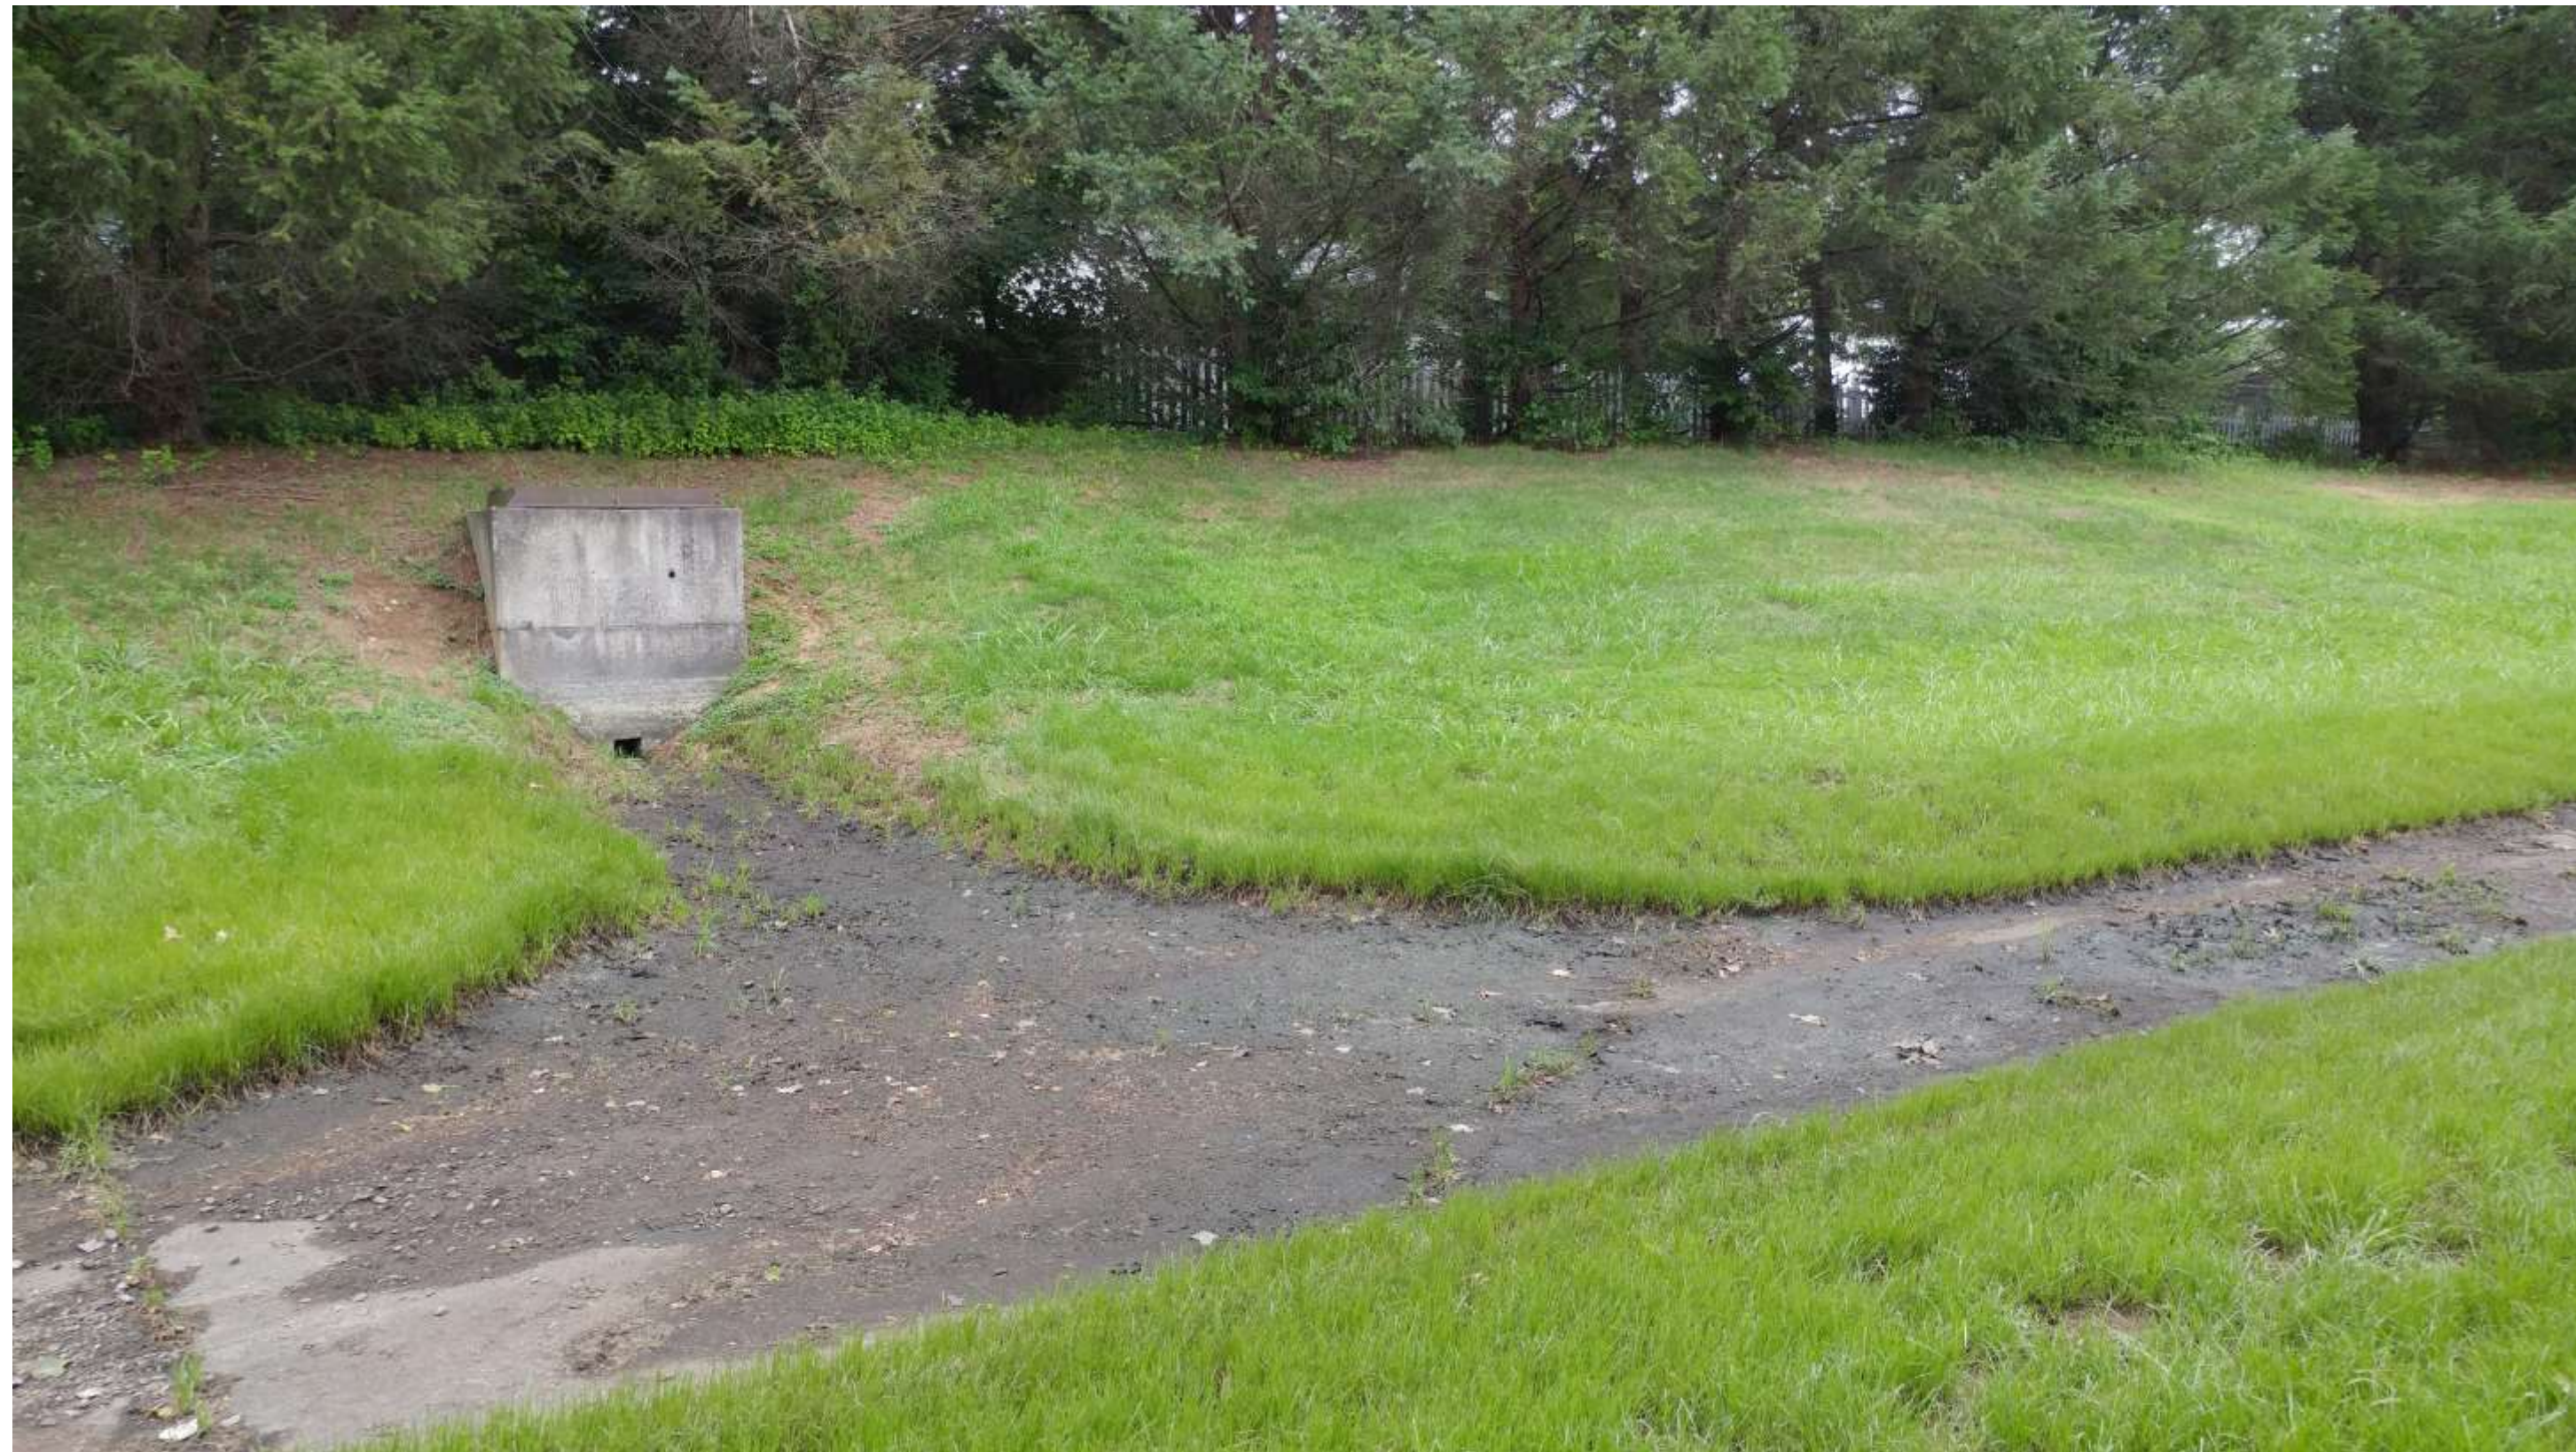
Outlet

- Sediment accumulating at outfall structure
- Concrete pads at some inlets are broken
- Replace channel with stone lined channel and reduce mowing to increase infiltration
- Otherwise well maintained

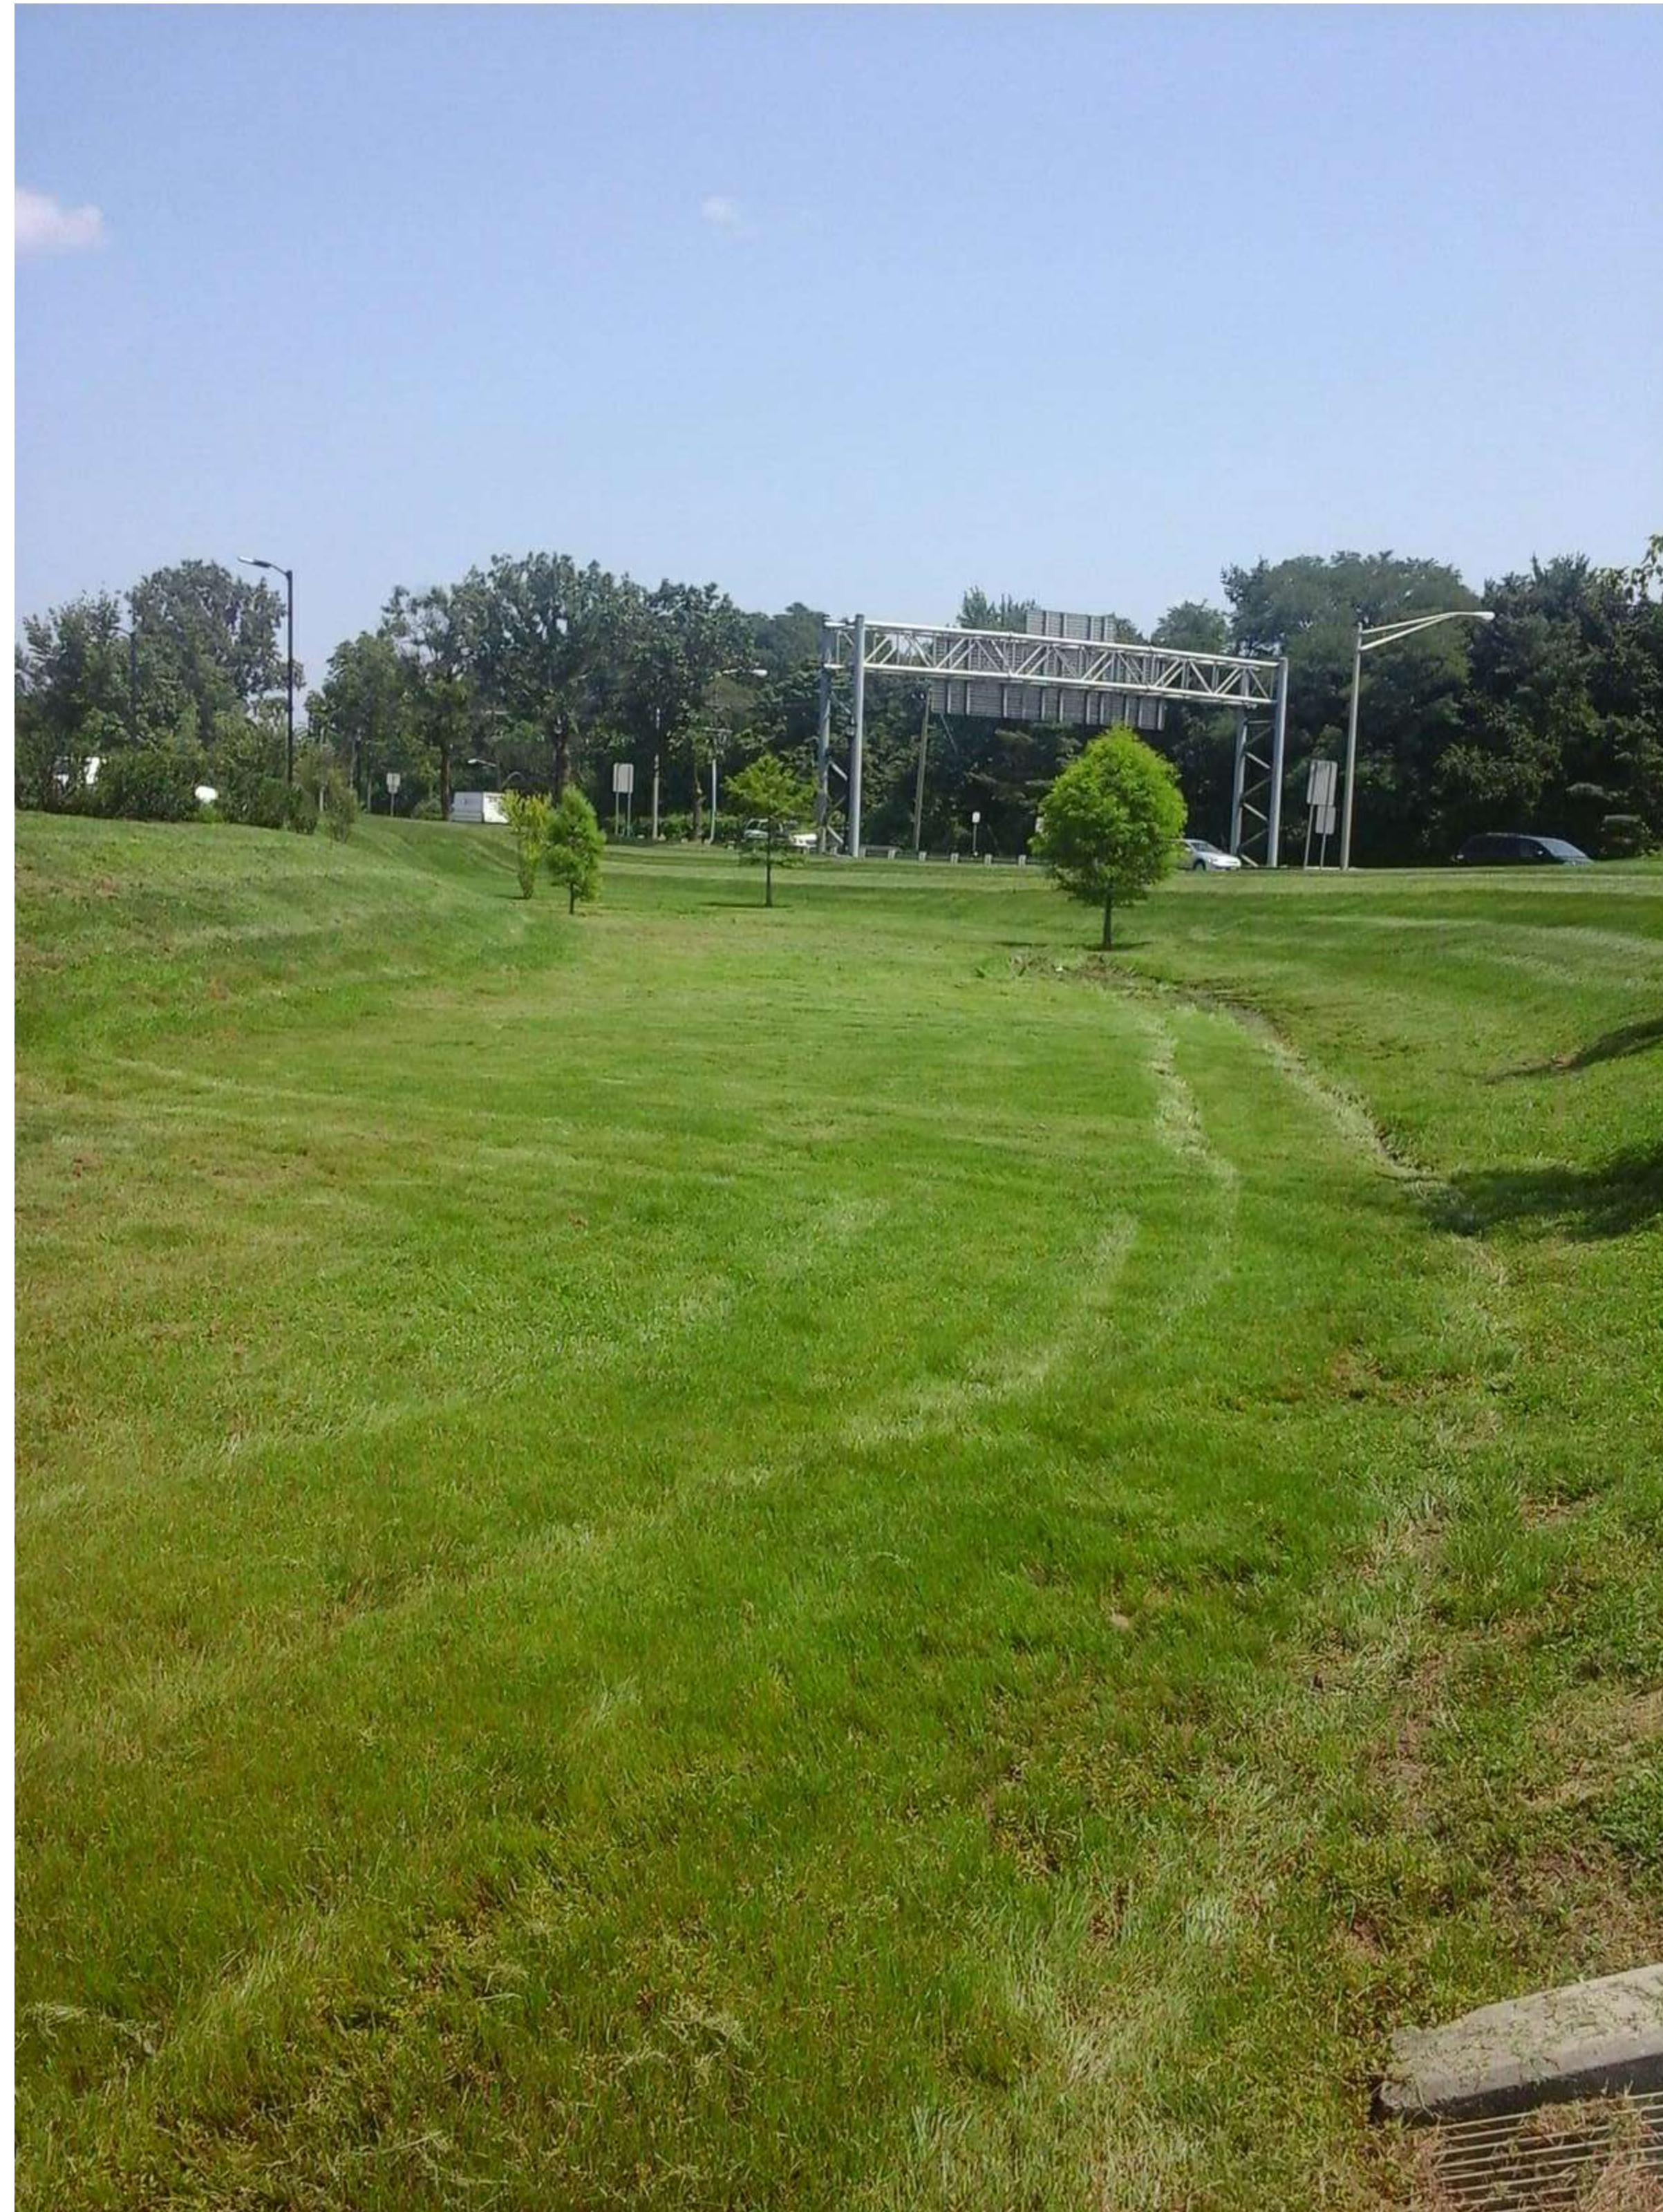
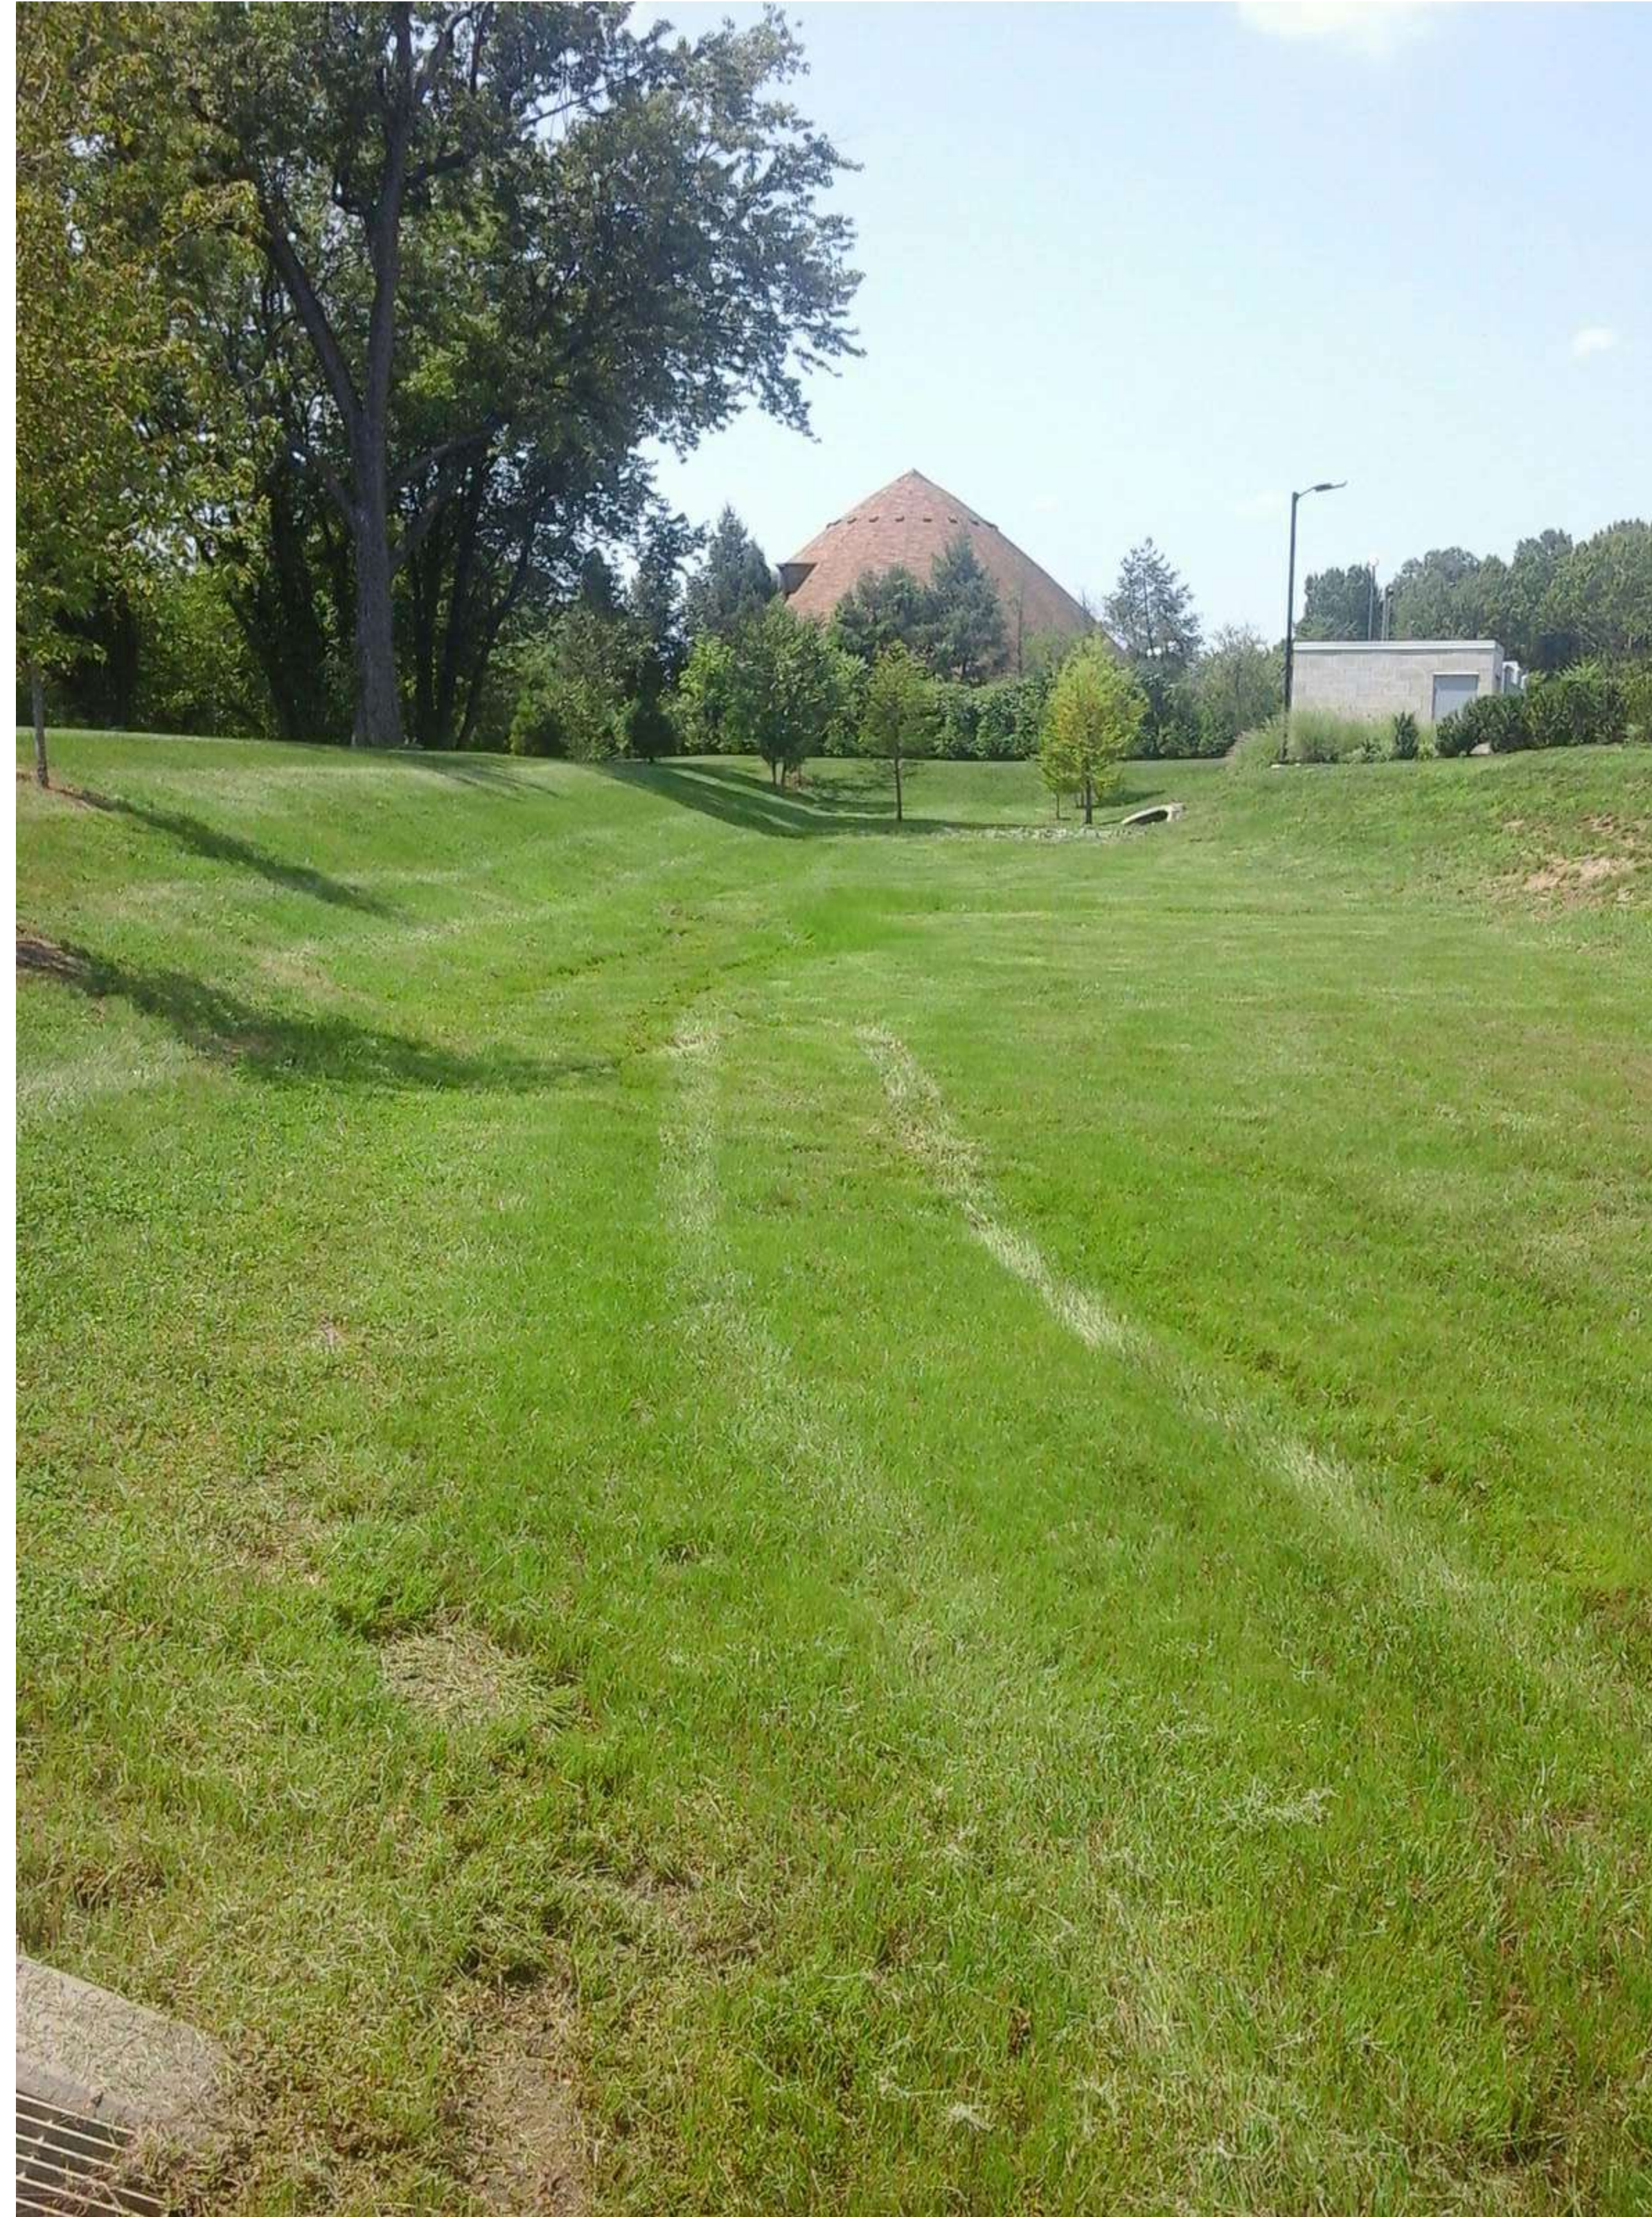
358. Homewood Suites by Hilton Hamilton Basin

Inlet

- Standing water present
- Reduce mowing and establish meadows, or plant more woody vegetation, to improve infiltration
- Otherwise well maintained

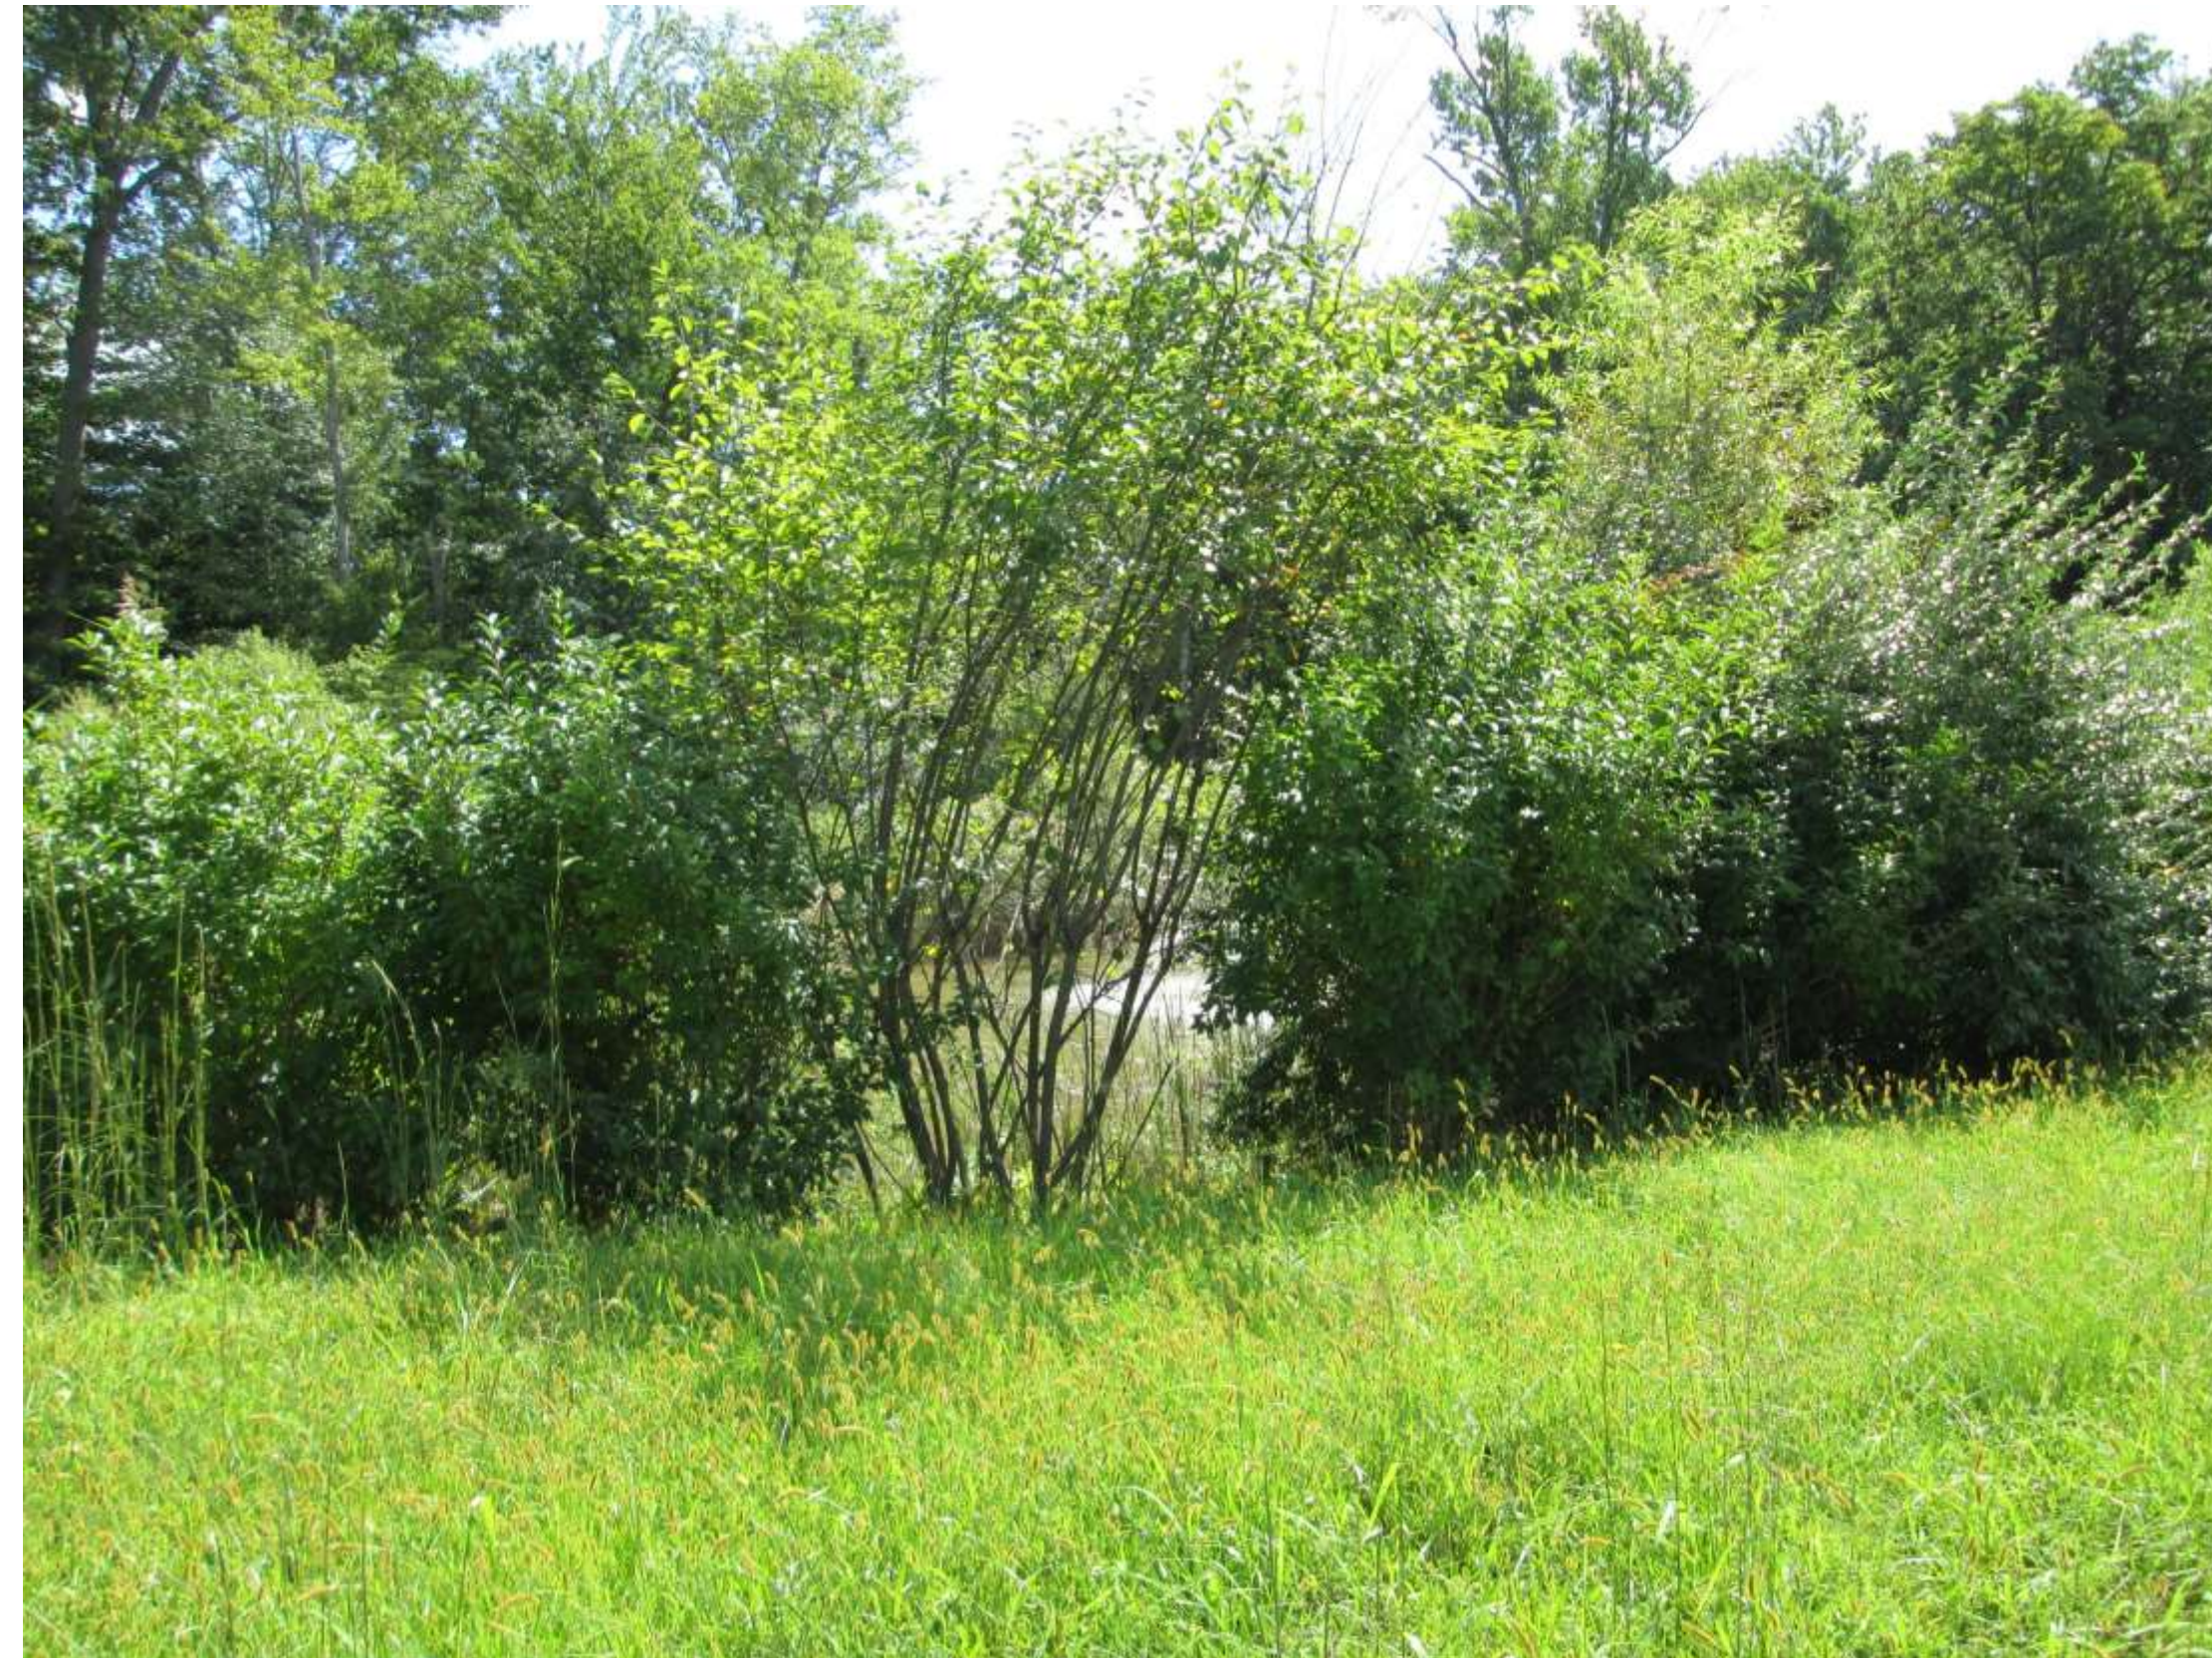
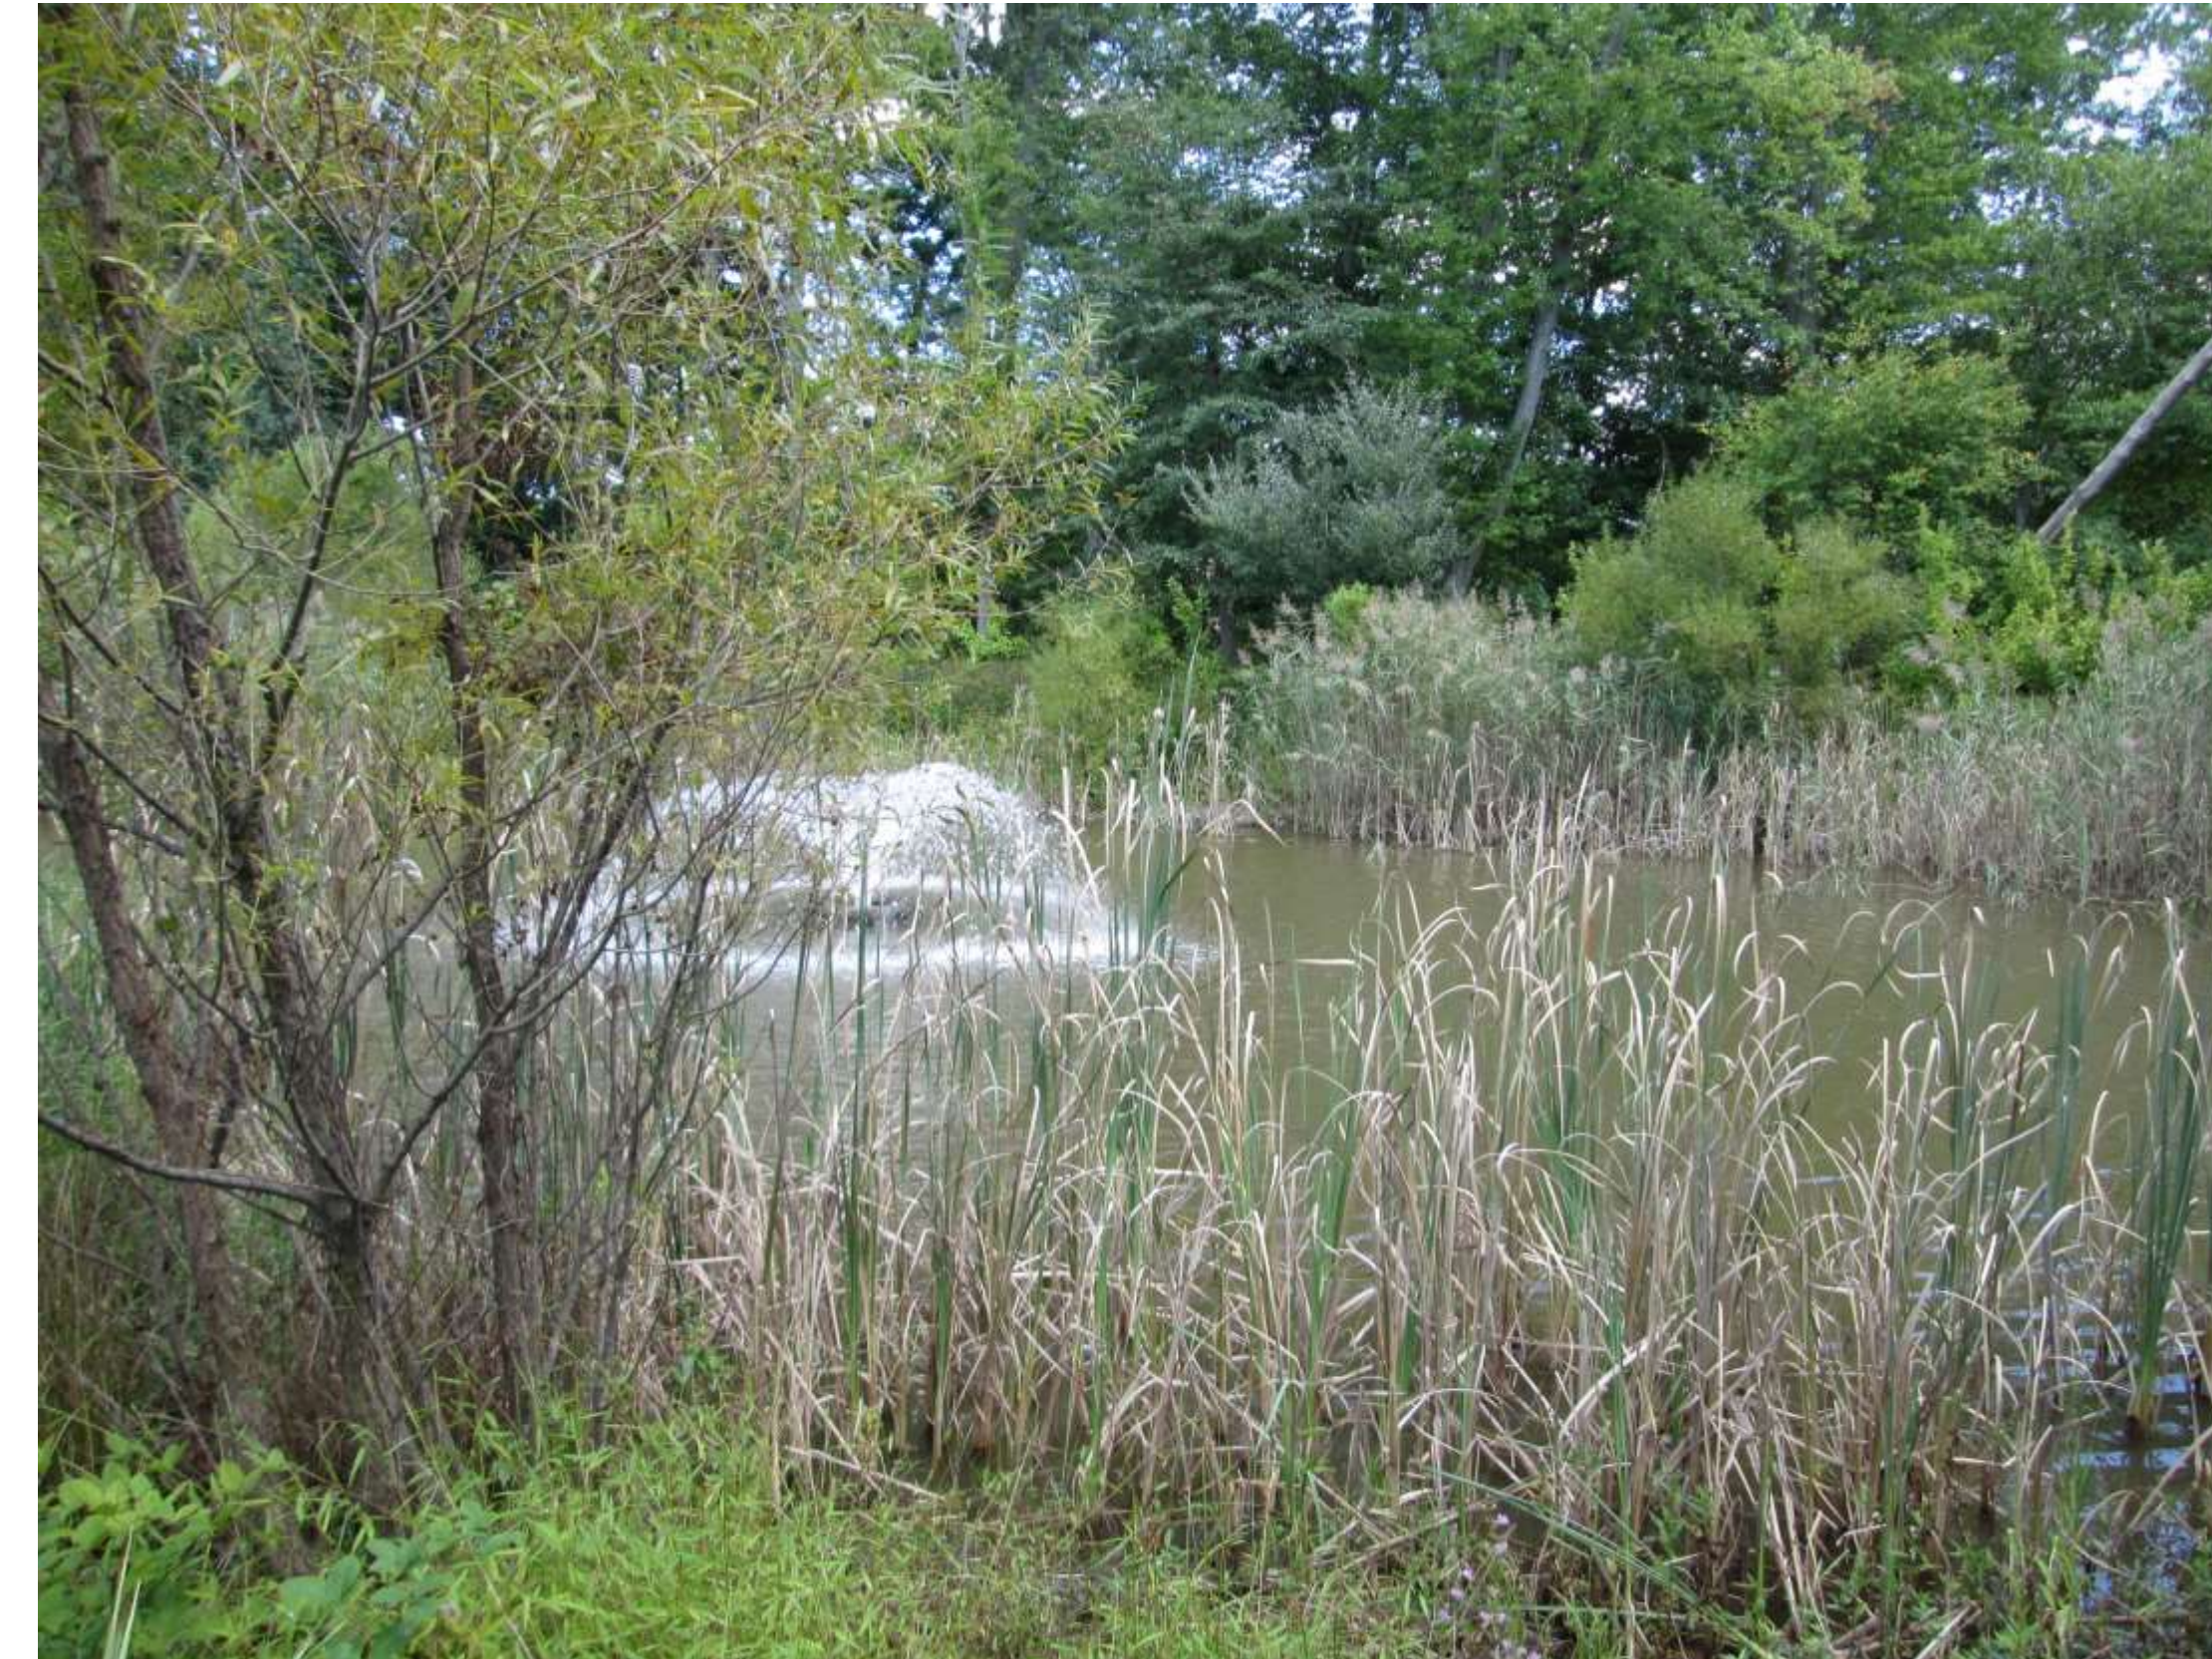
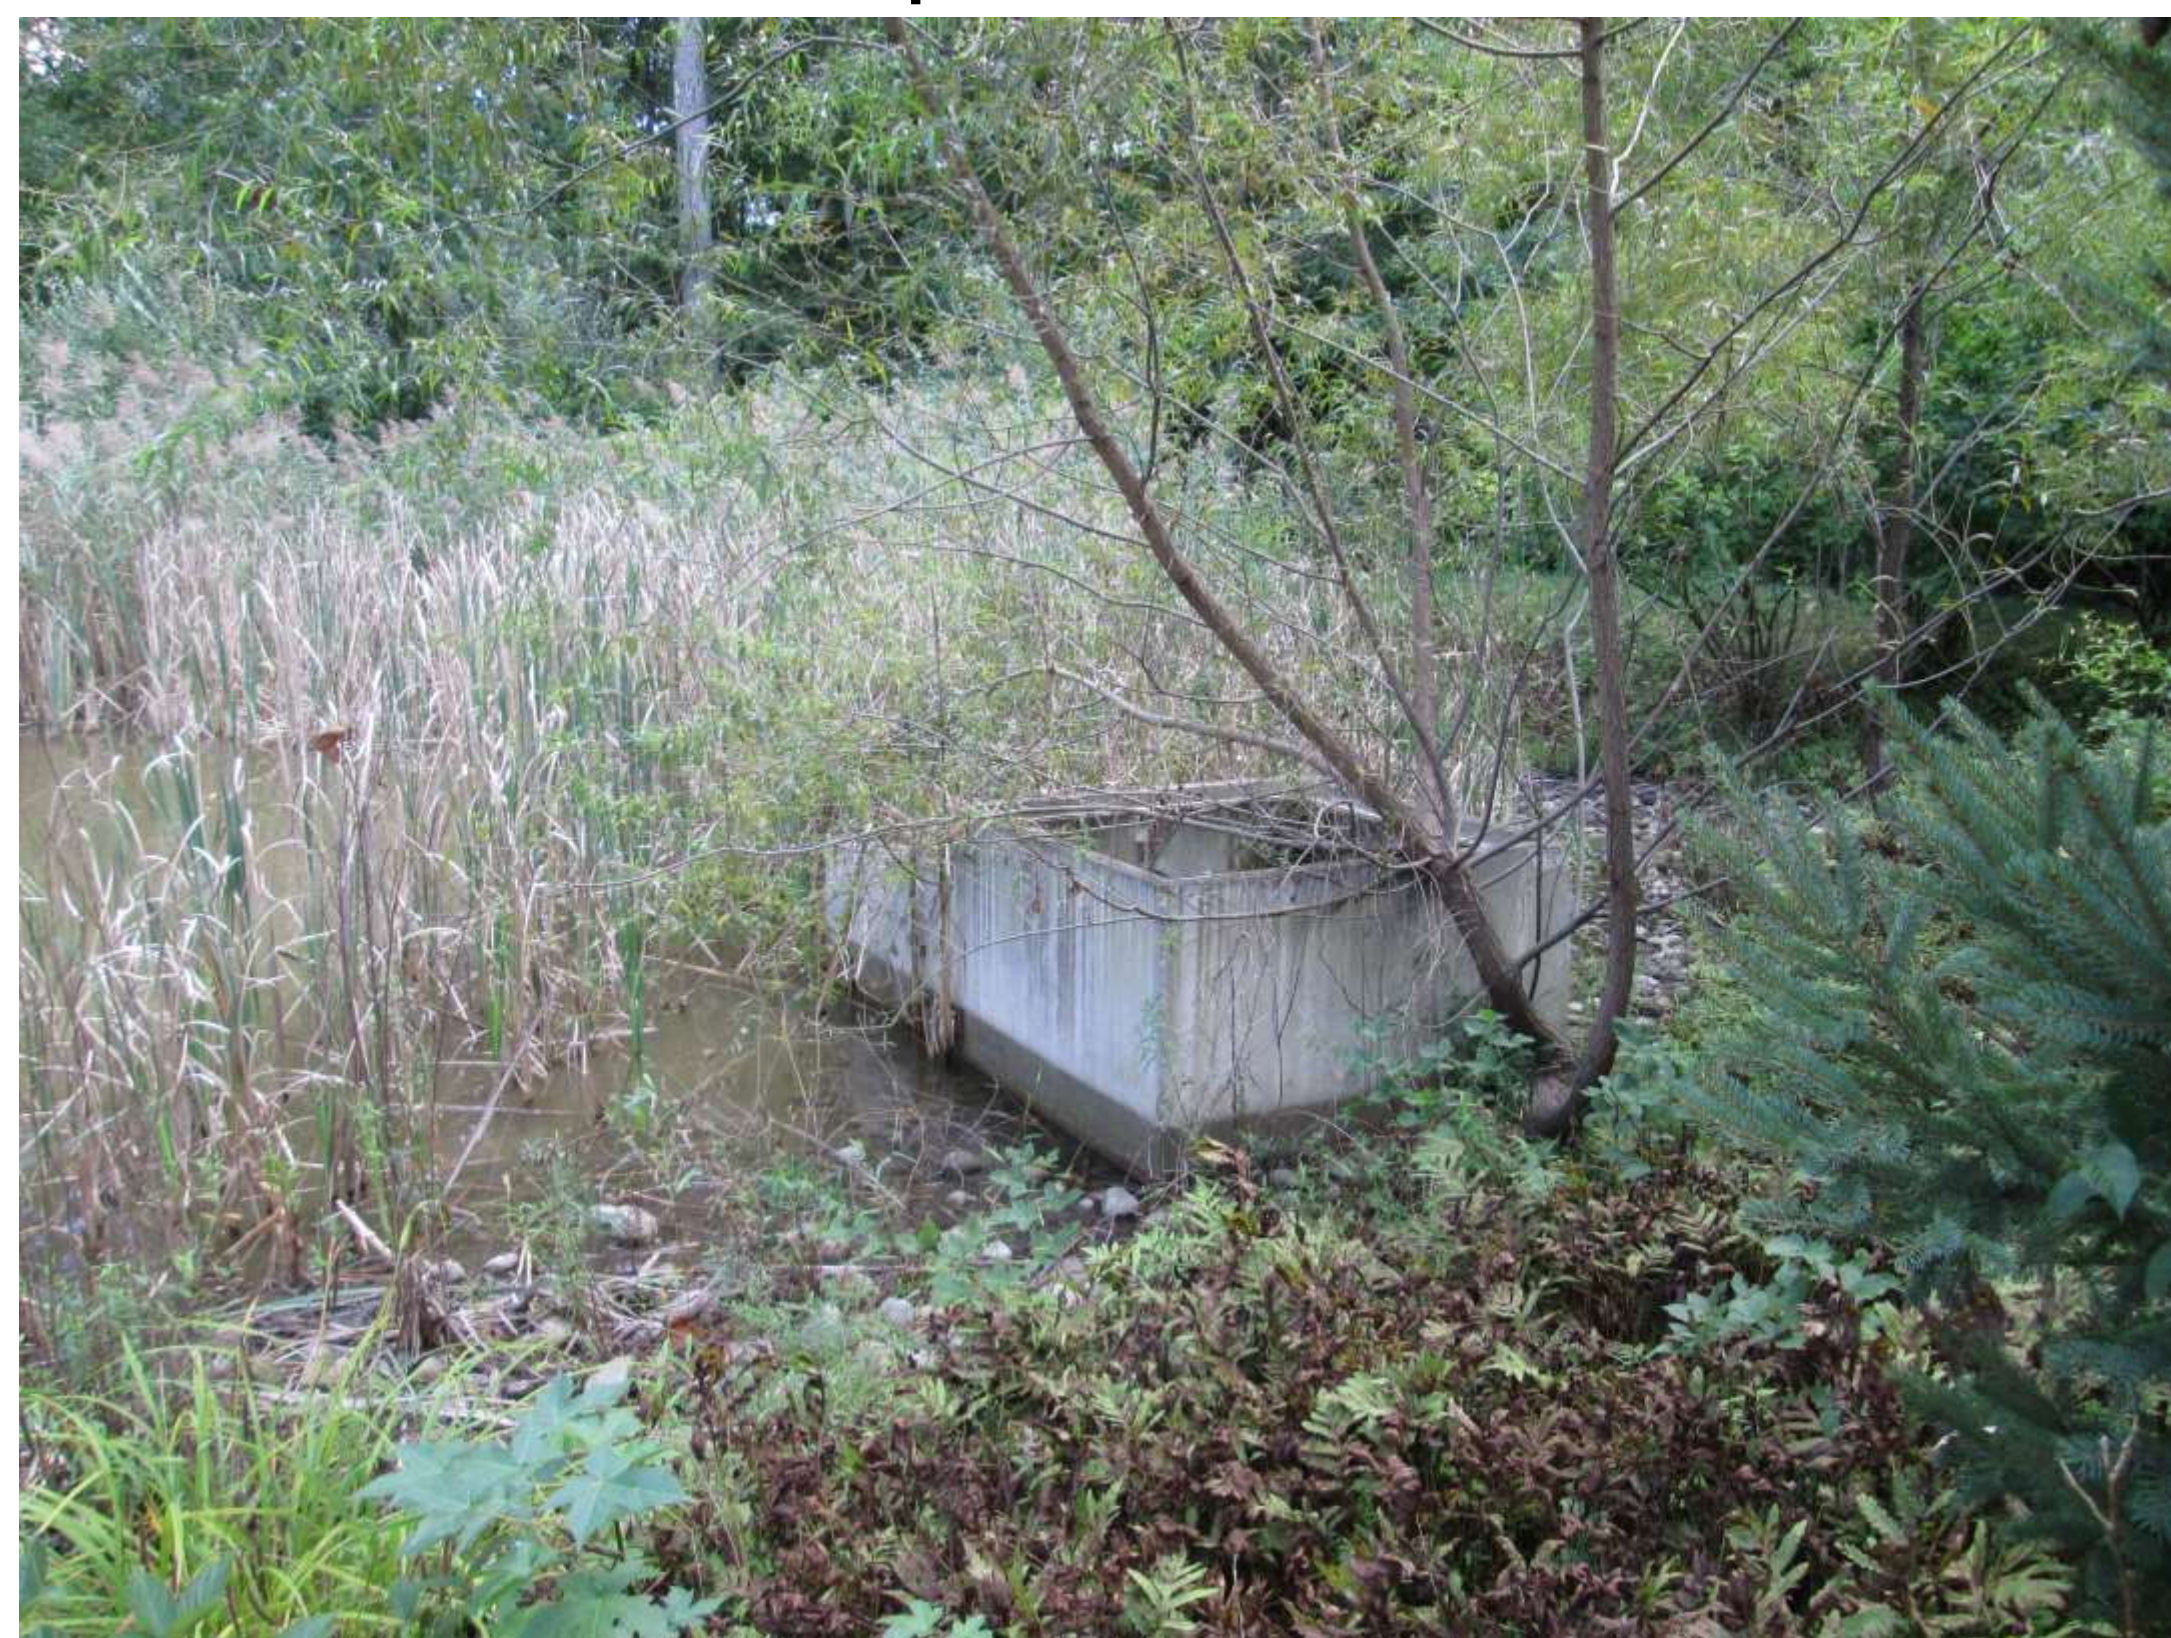
Hamilton Township
Stormwater Basin Assessment
362. Rose Everett Court Residential Basin

Riparian buffer

Water feature

Outlet

- Retention basin
- Naturalized with herbaceous and woody plants
- Outlet structure missing grate on top
