**Hamilton Township (Mercer County)
Stormwater Basin Assessment Summary
Addendum (Year 4)**

Developed by the Rutgers Cooperative Extension Water Resources Program
Funded by Hamilton Township, Mercer County, New Jersey

December 2017

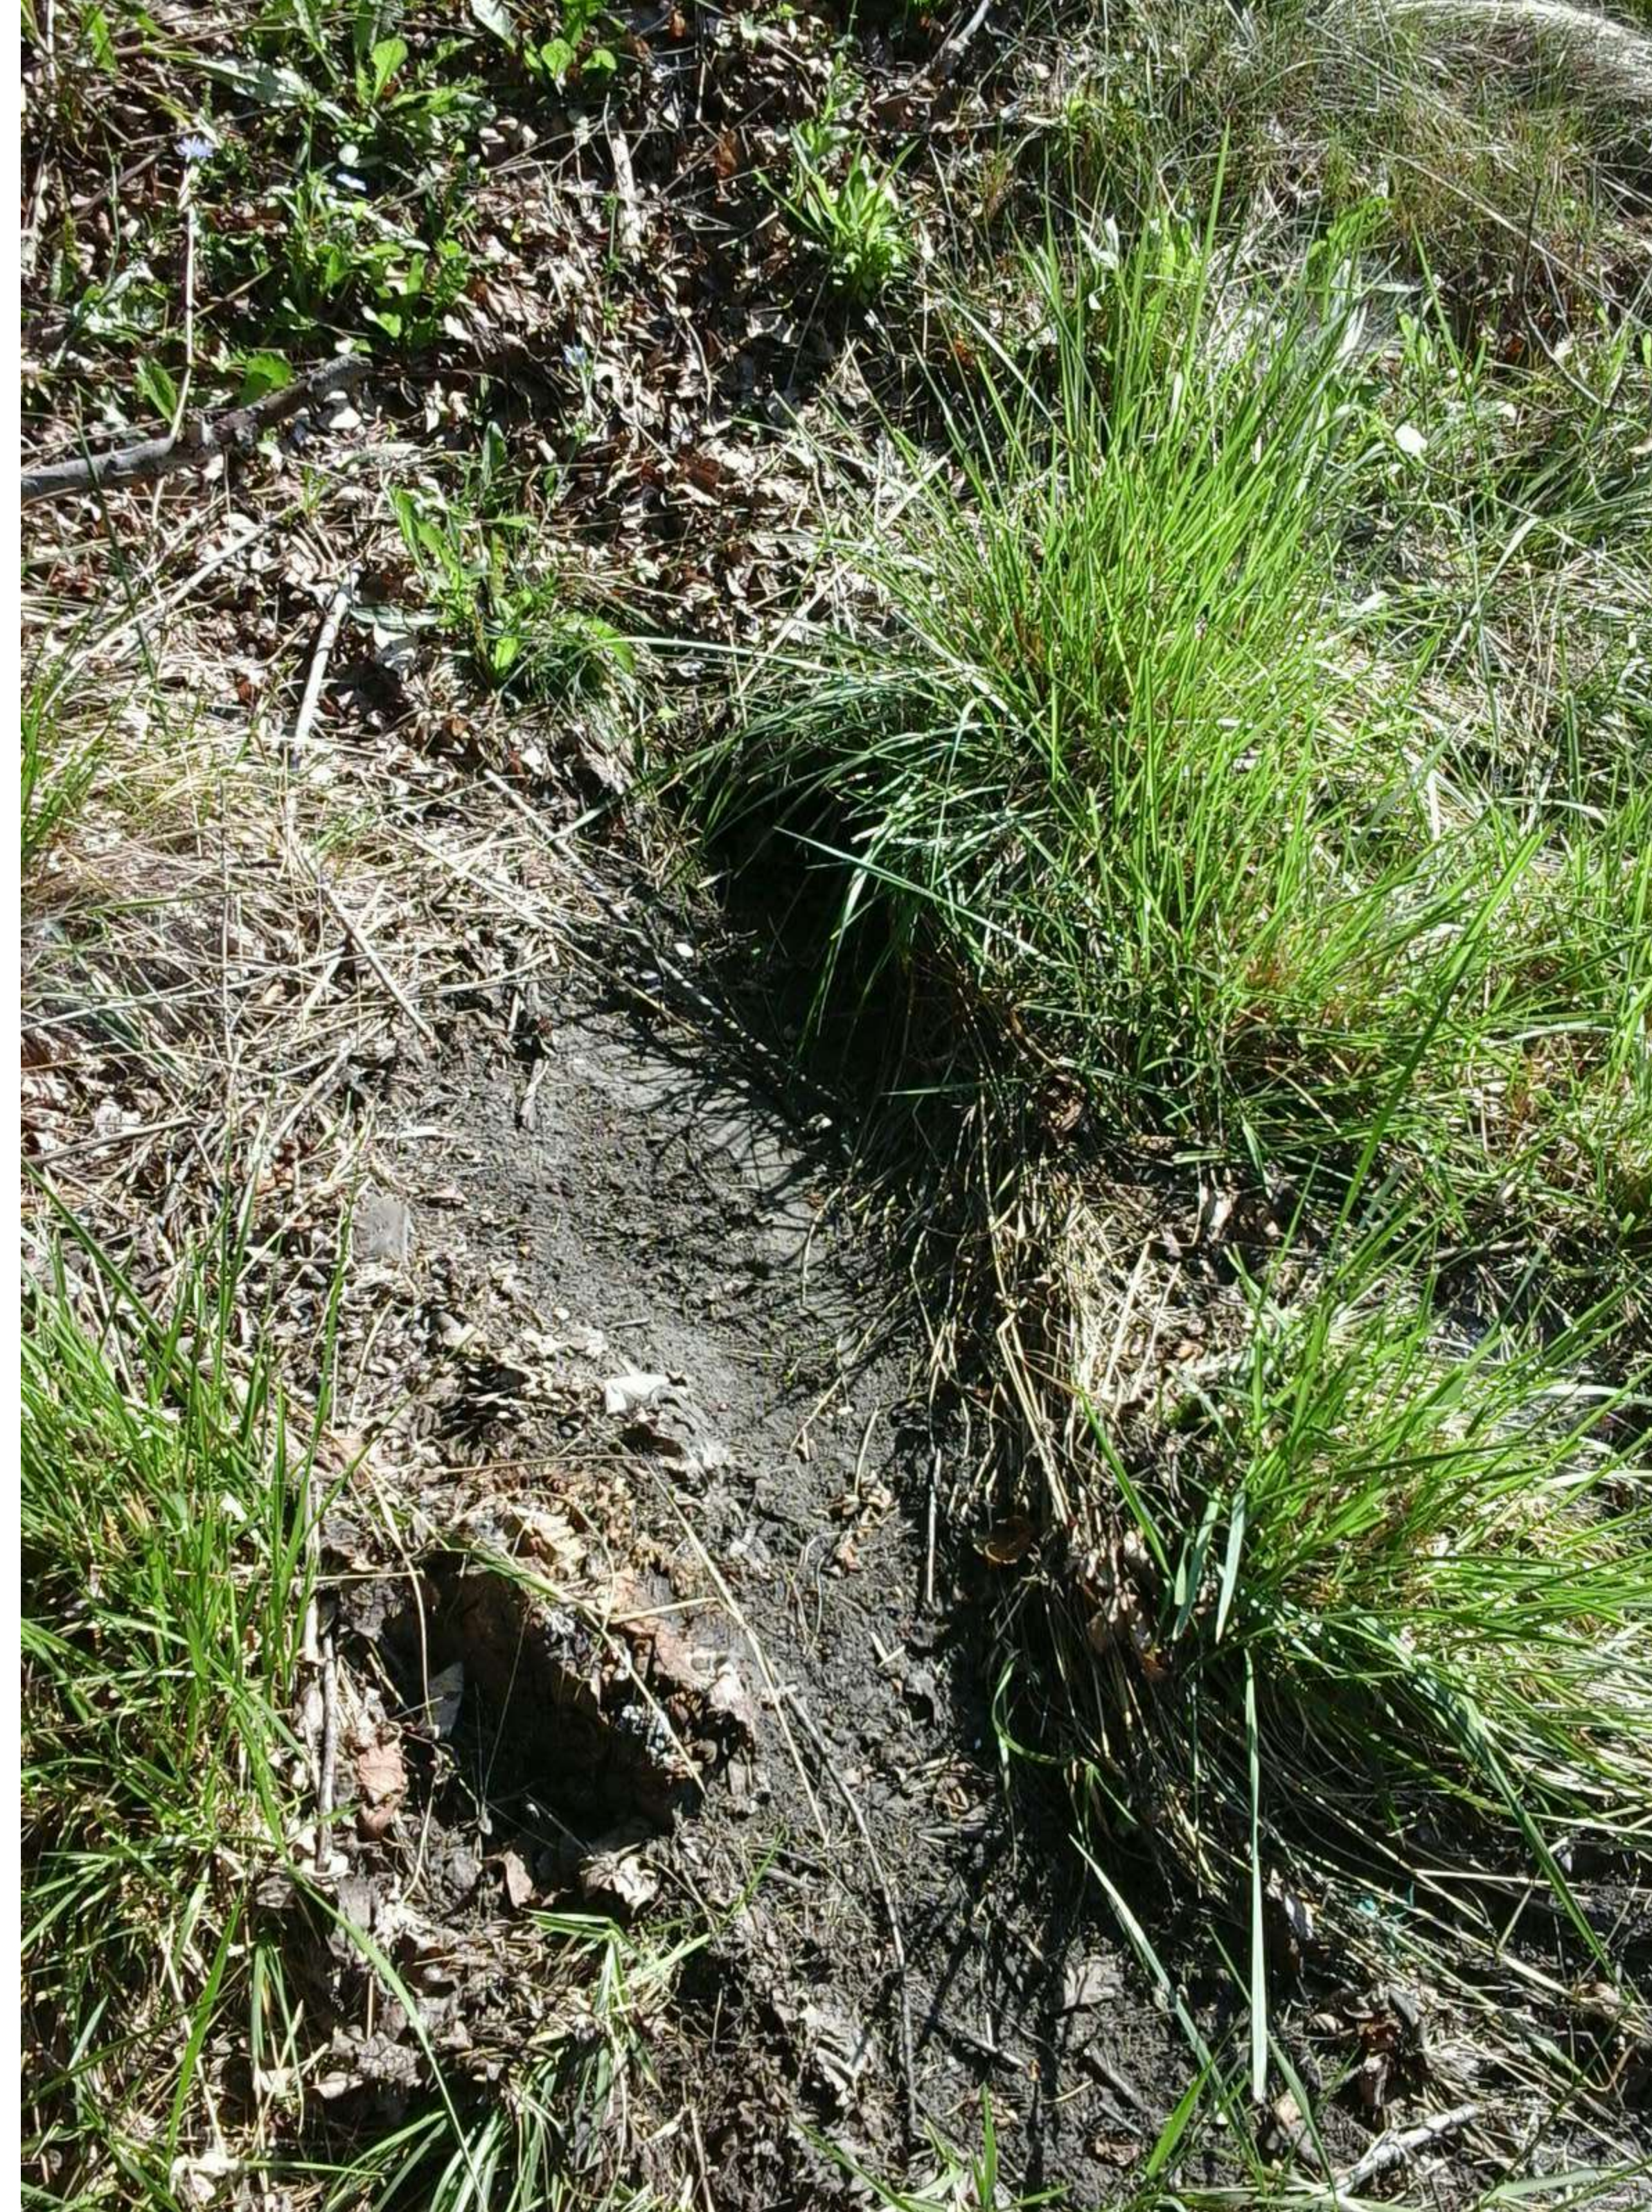
Buried inlet

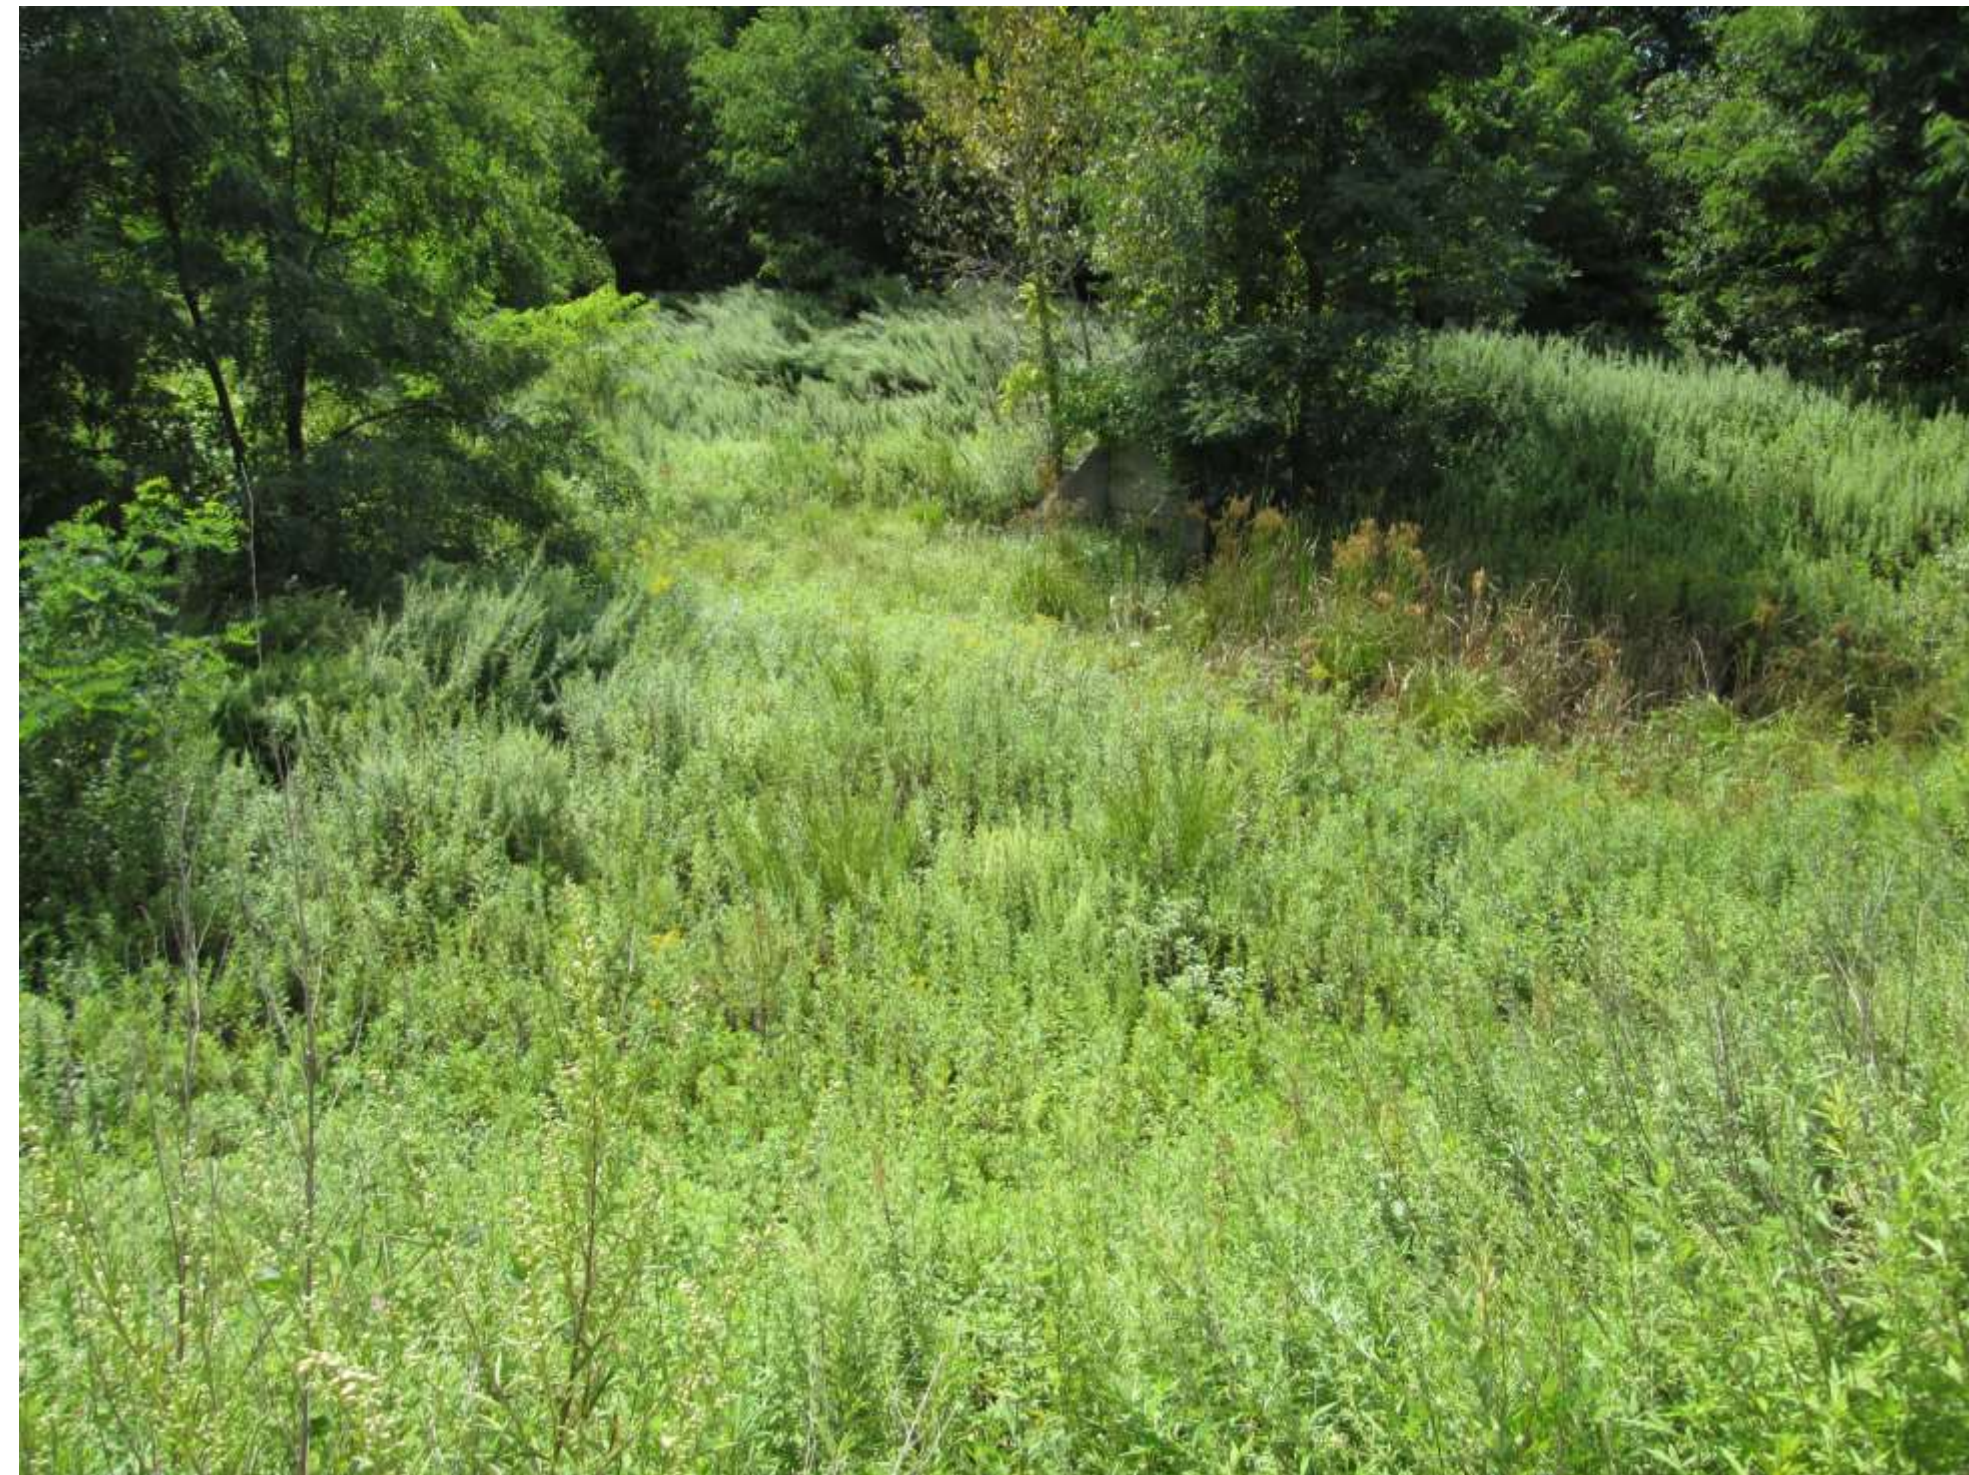
Southern basin overview and outlet structure

- Both basins have been left to fully naturalize
- Outlet structures are difficult to find and access
- Access to inlet and outlet structure should be mown once or twice a year

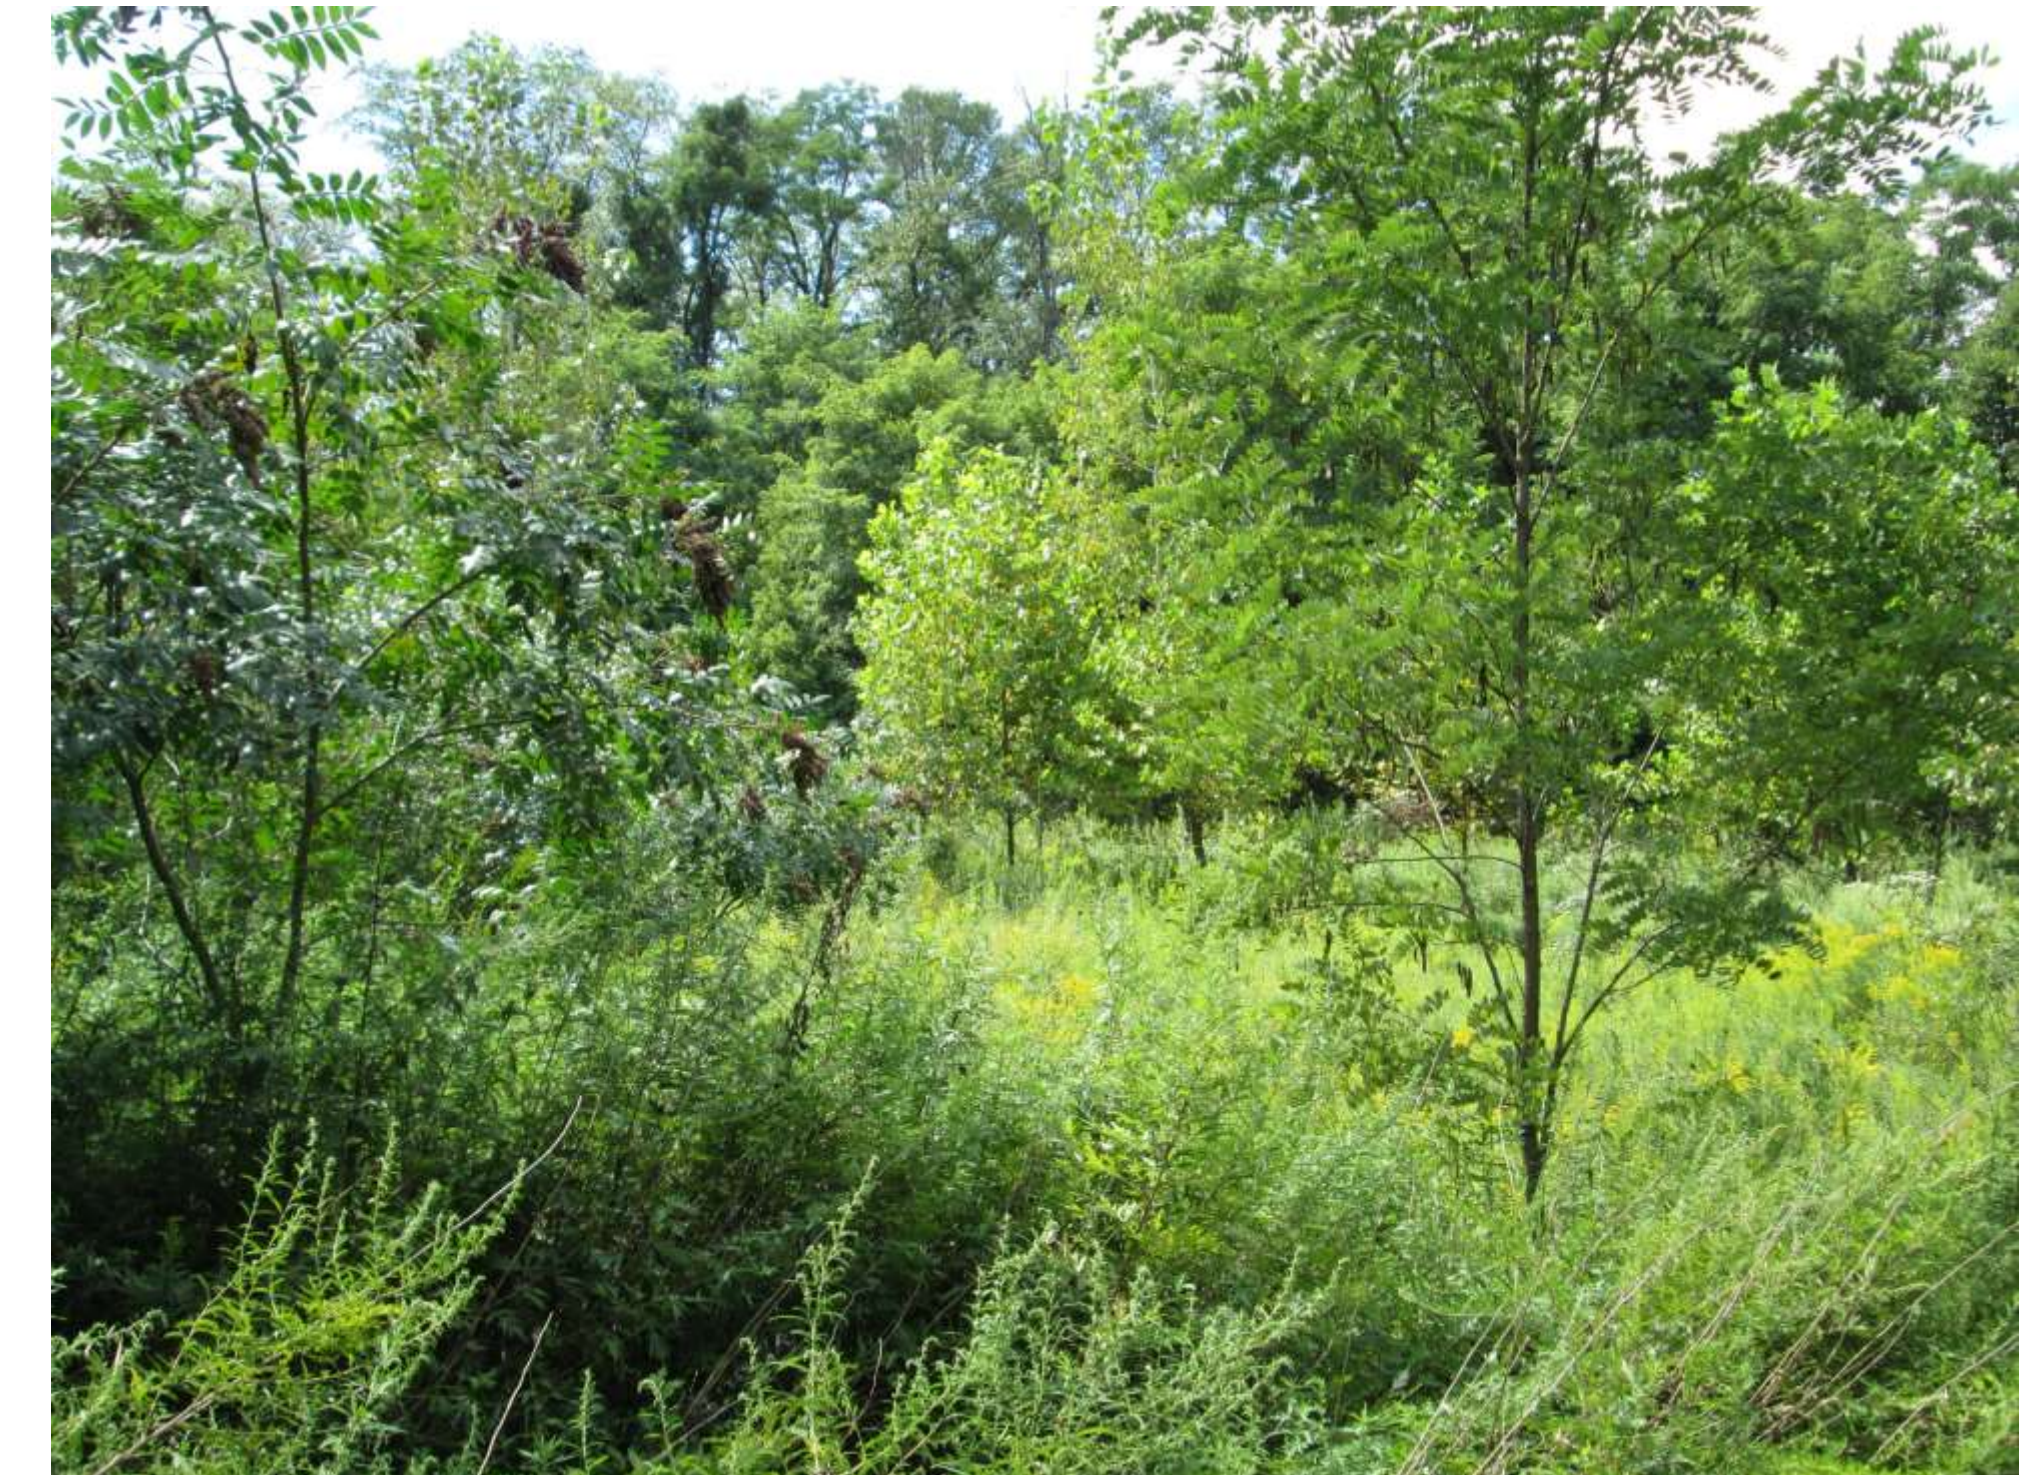
Northern basin overview and outlet structure

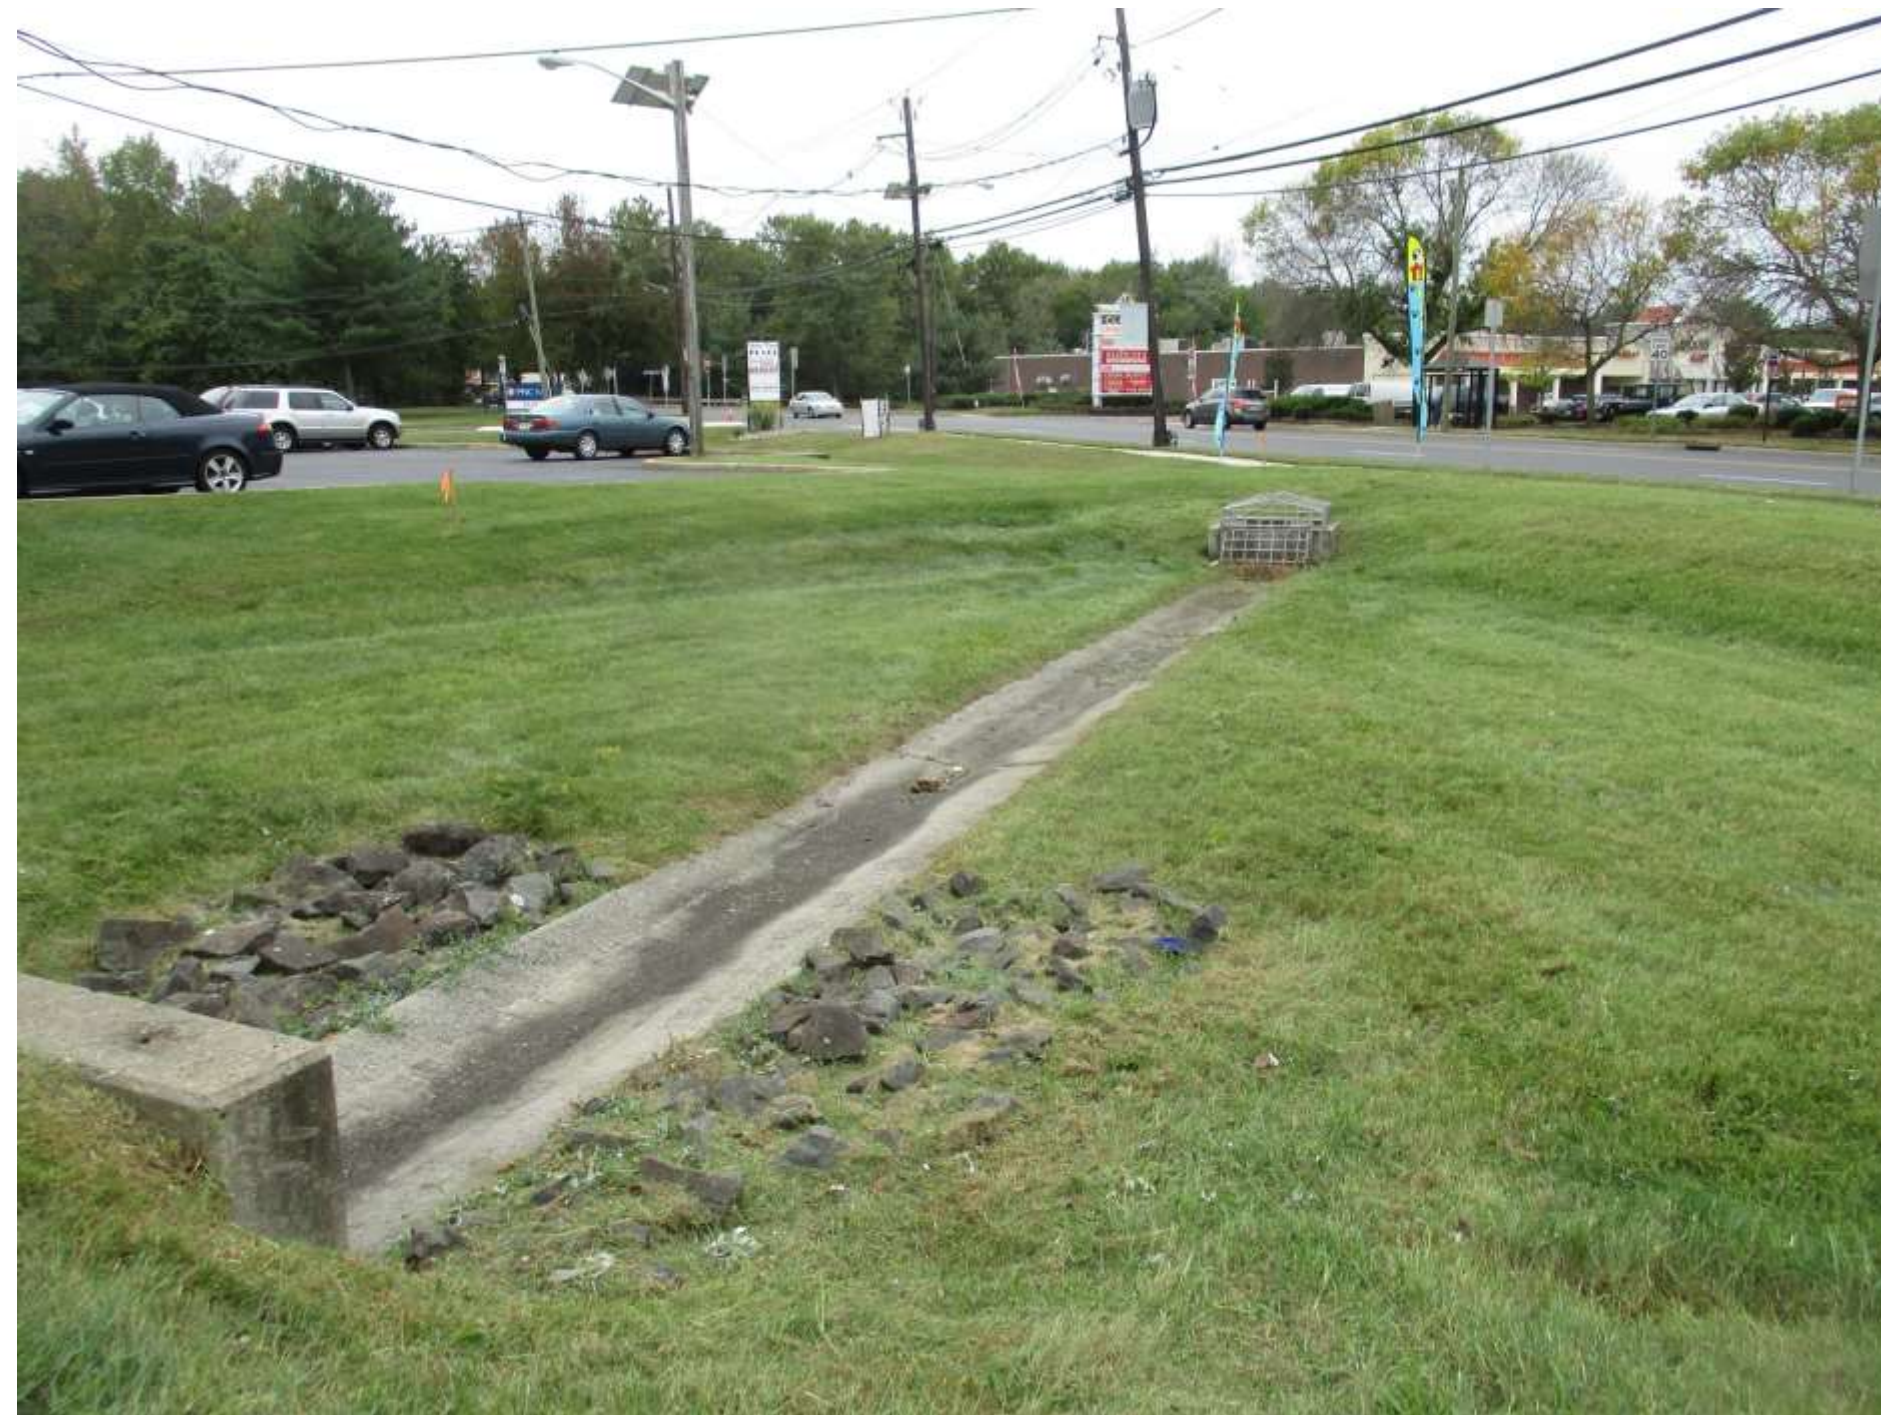
371 (northern basin) overview

- Sediment accumulation in 371 low flow channel
- 371 outlet is covered with sediment
- Erosion around 372 outlet structure causing a dangerous hole, impairing the function of the outlet
- Reduce mowing and replace low flow channel with stone lined channel to improve infiltration

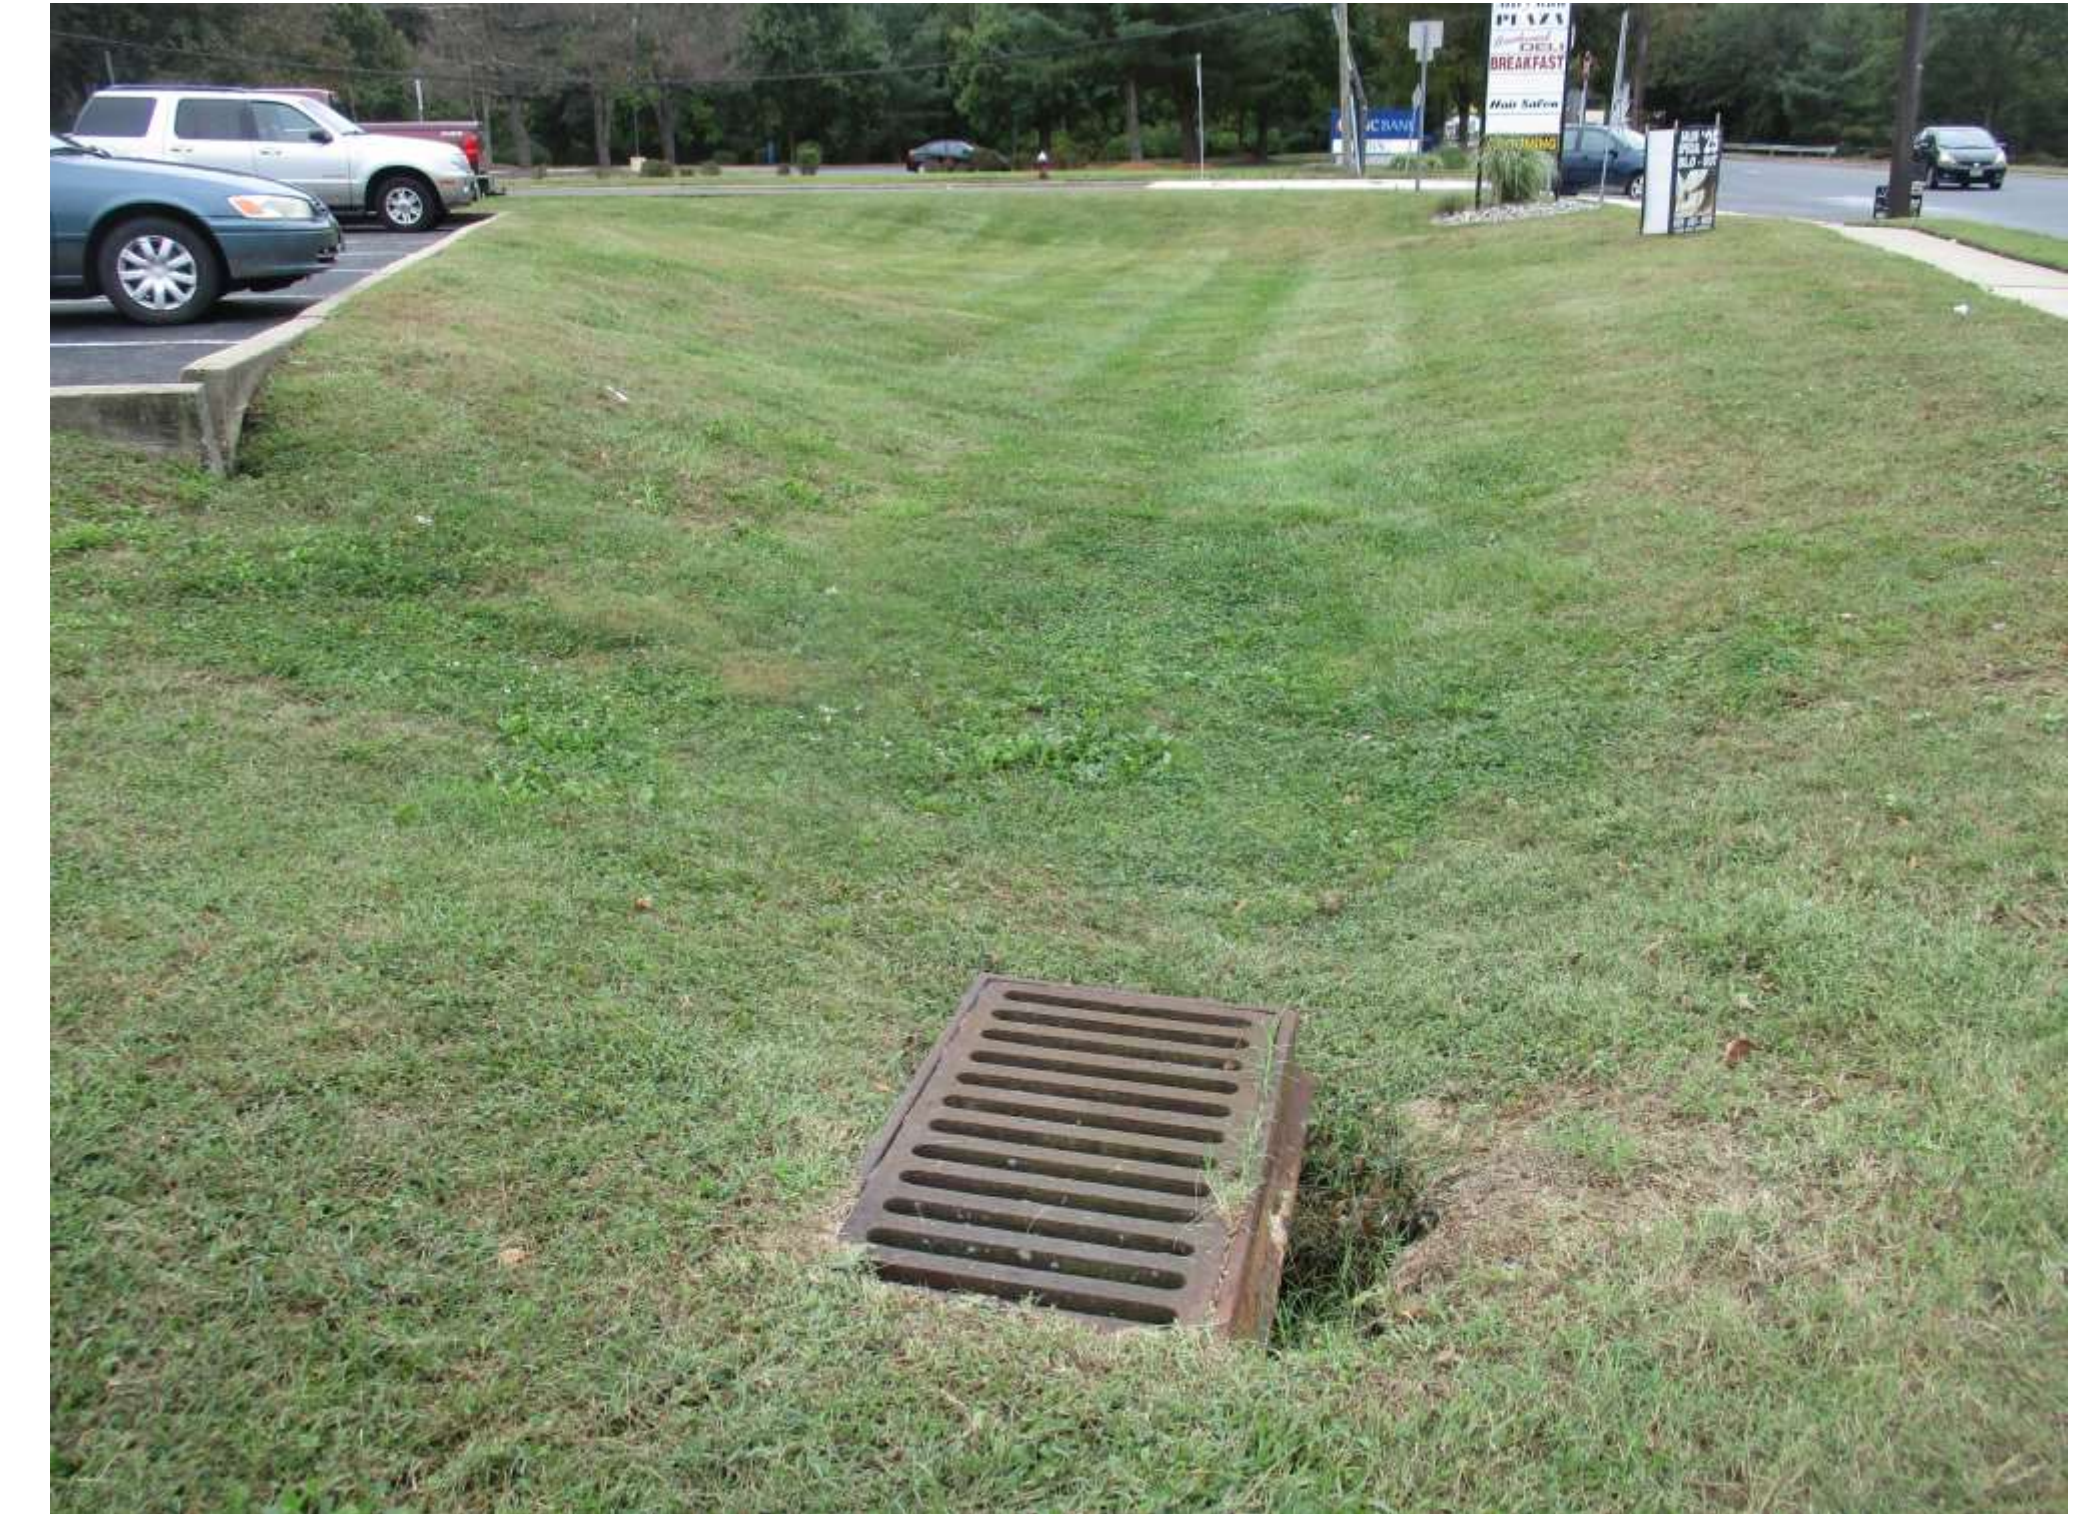
372 (southern basin) overview

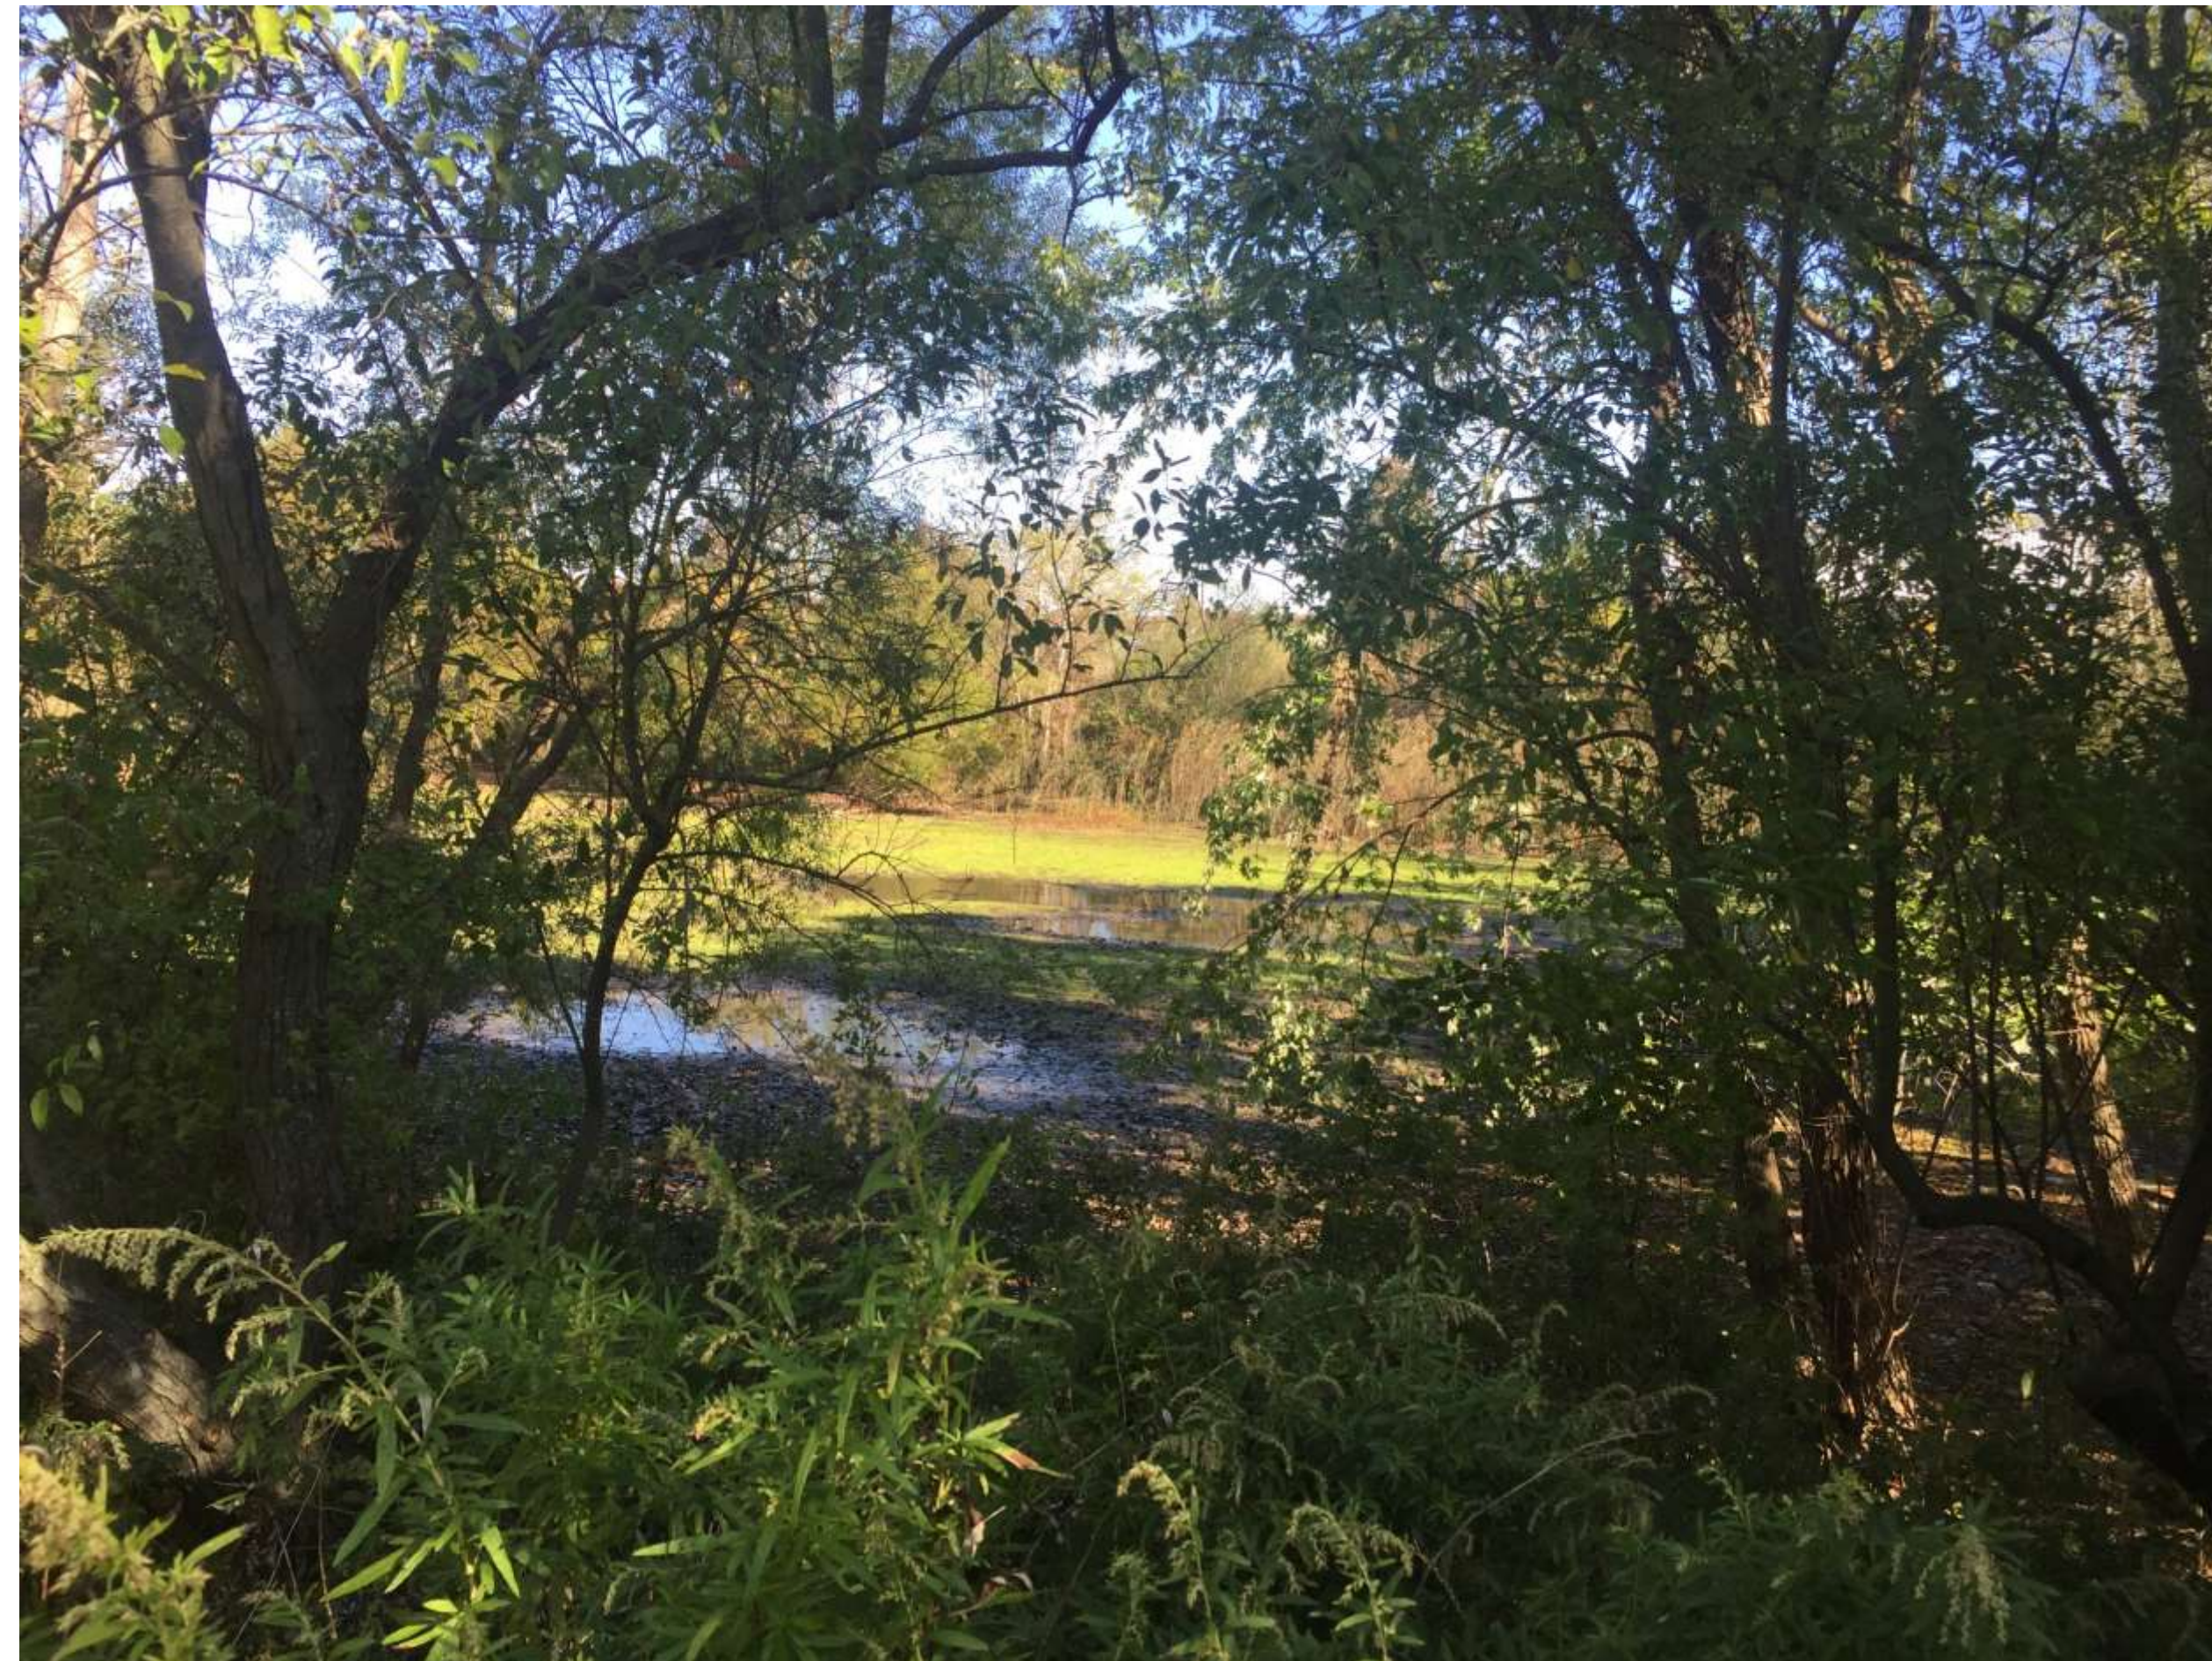
Overview

- Naturalized infiltration basin
- Standing water in basin bottom
- Overall well maintained

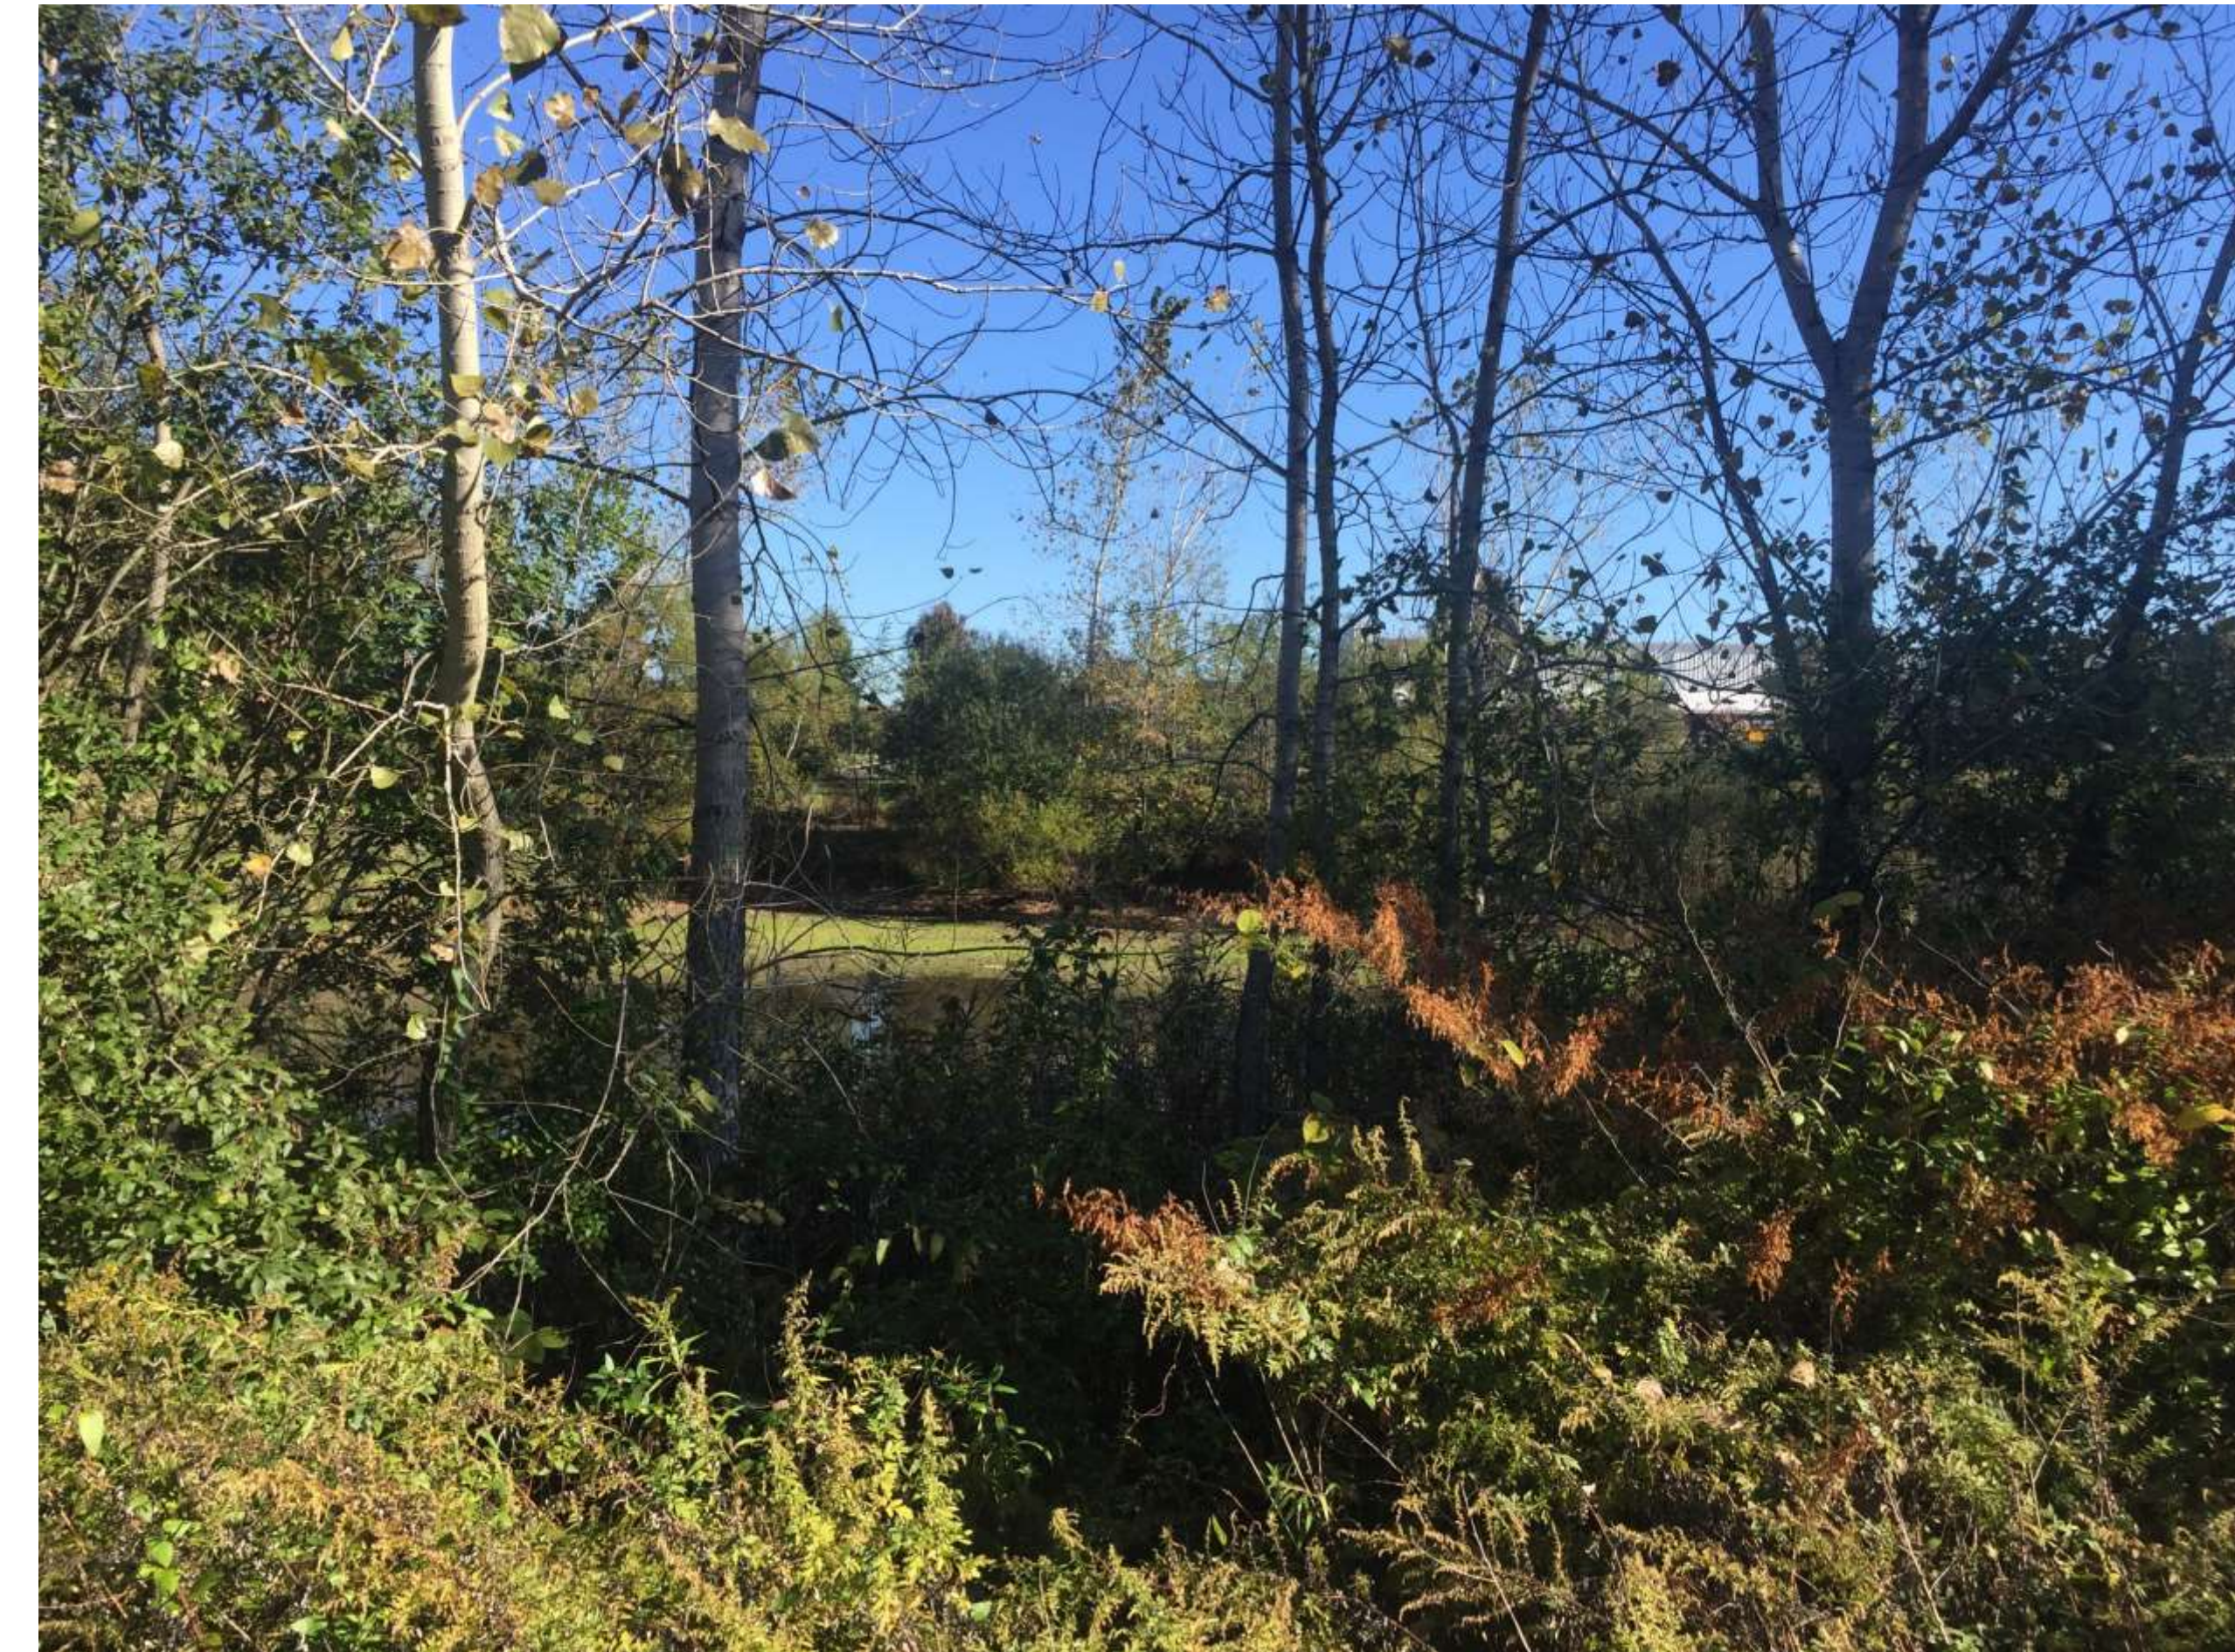
Overview
