**Hamilton Township (Mercer County)
Stormwater Basin Assessment Summary
Addendum (Year 4)**

Developed by the Rutgers Cooperative Extension Water Resources Program
Funded by Hamilton Township, Mercer County, New Jersey

December 2017

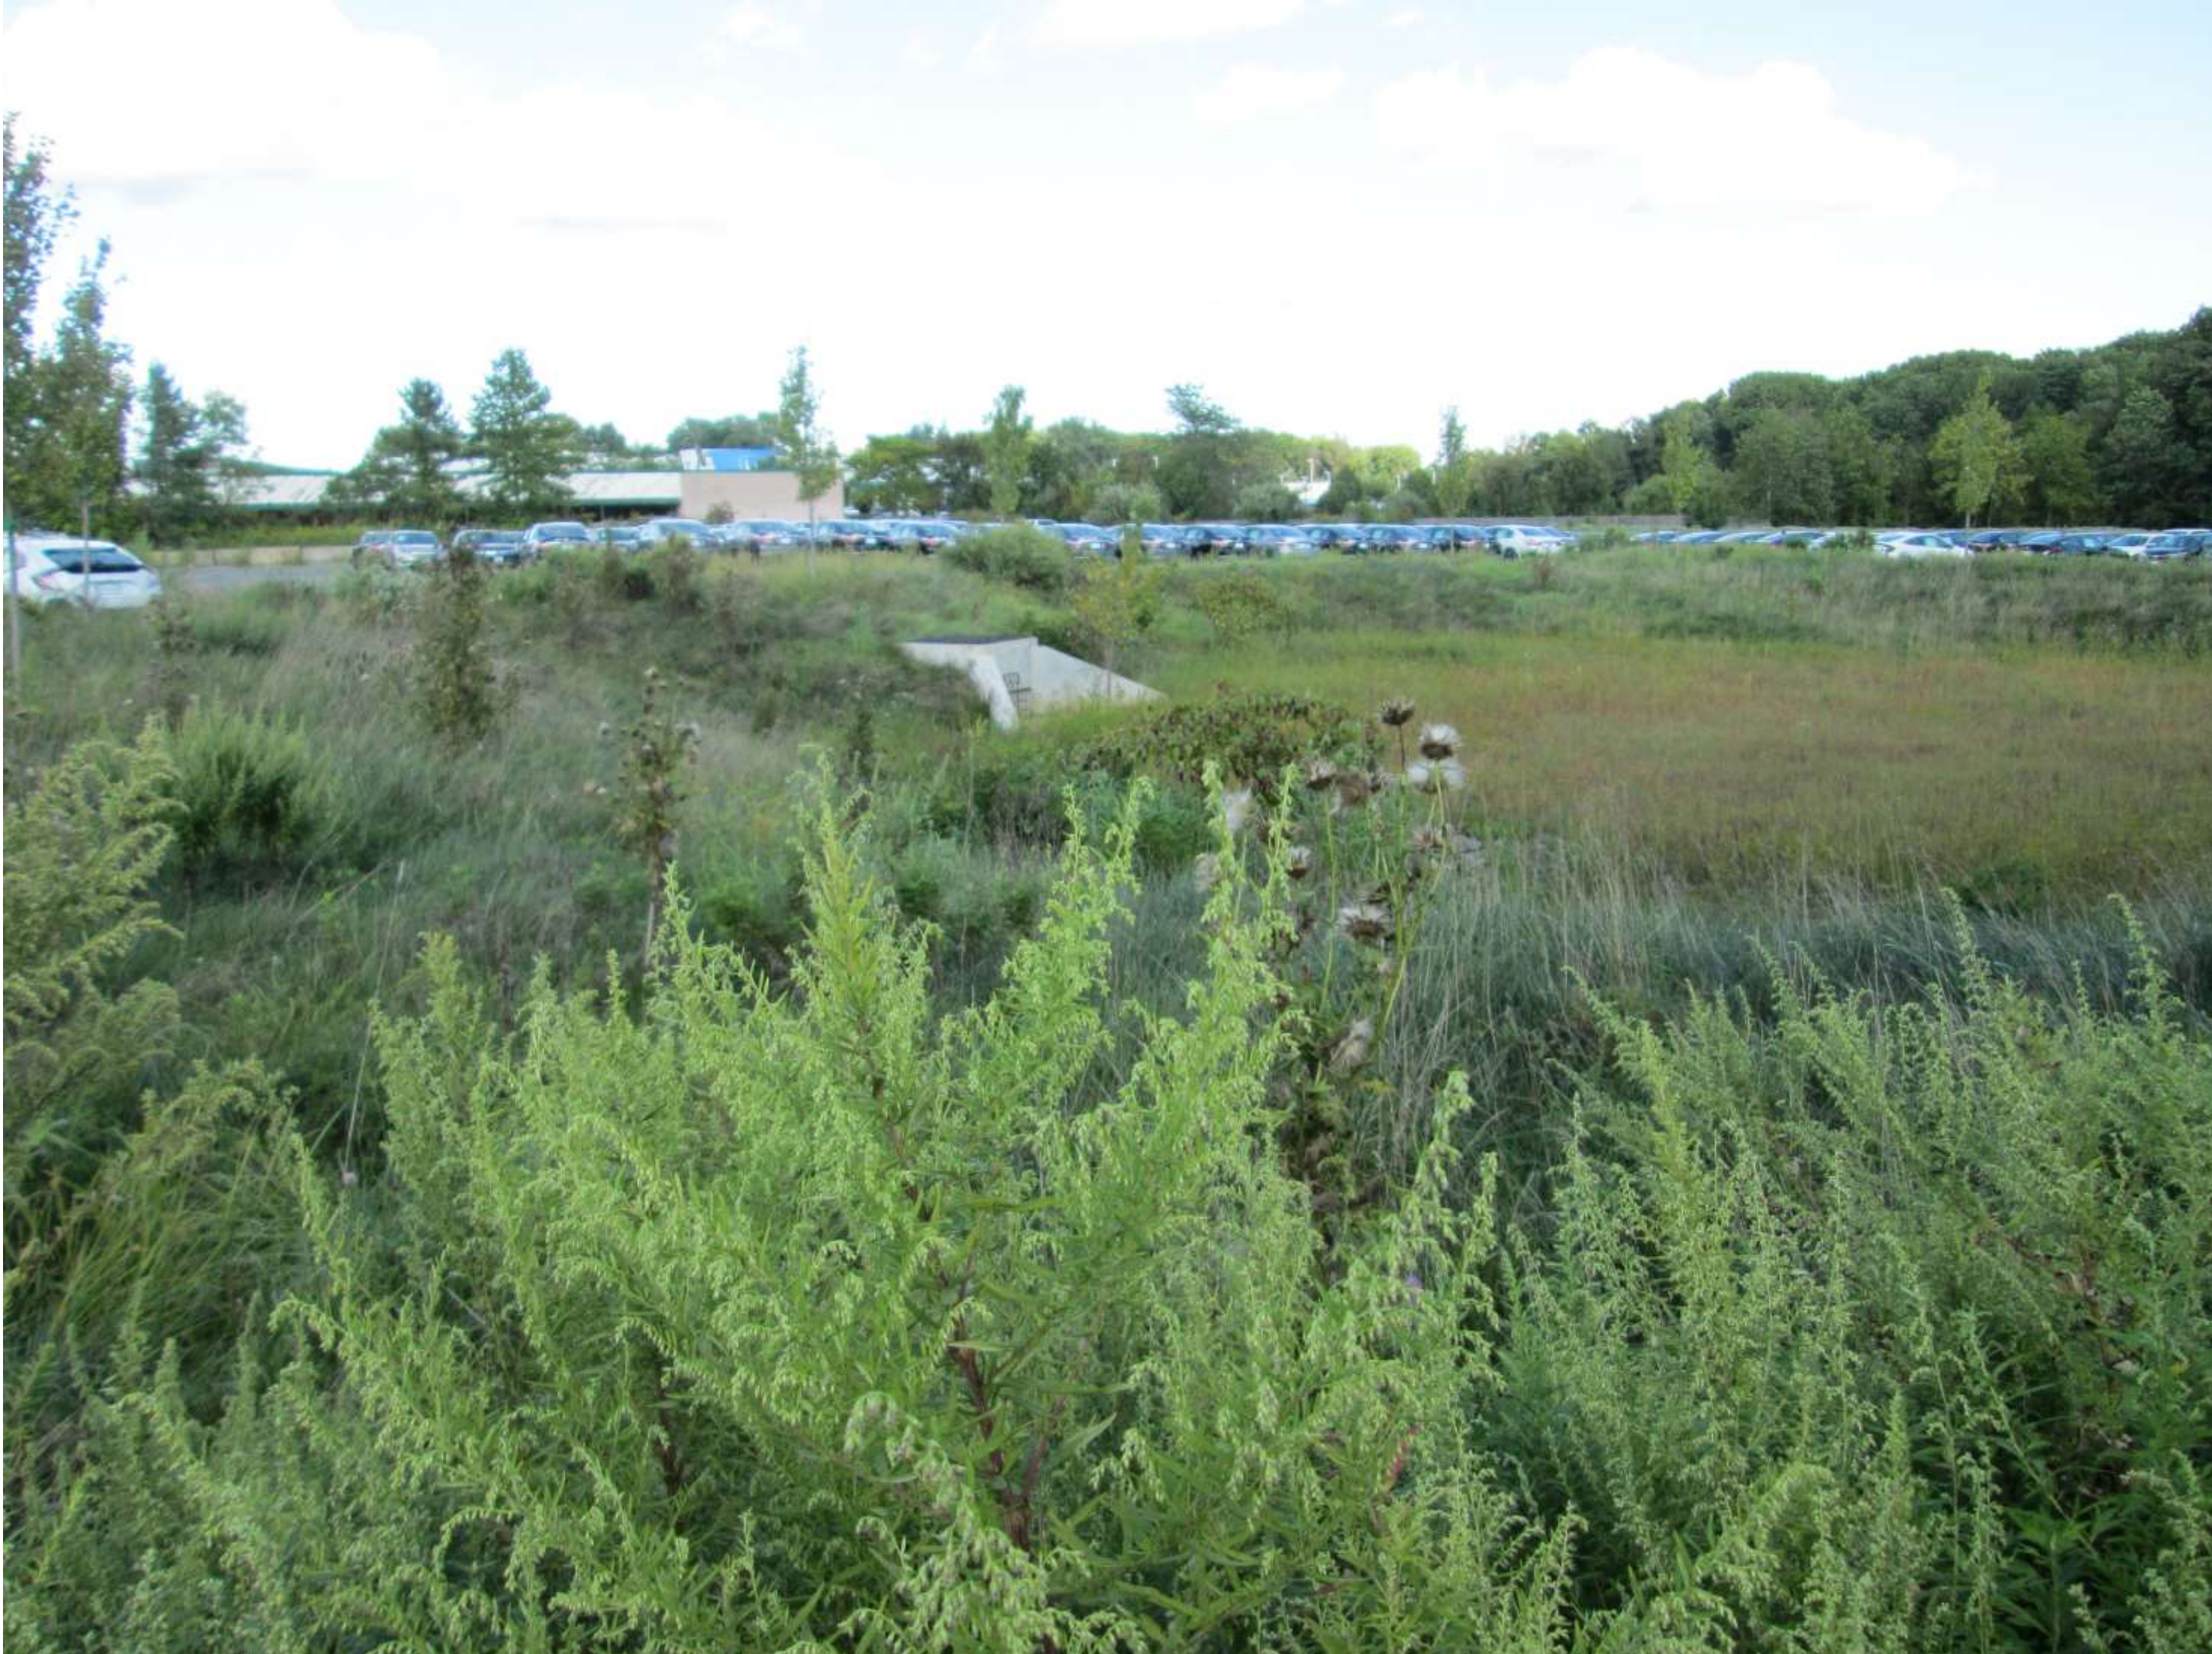
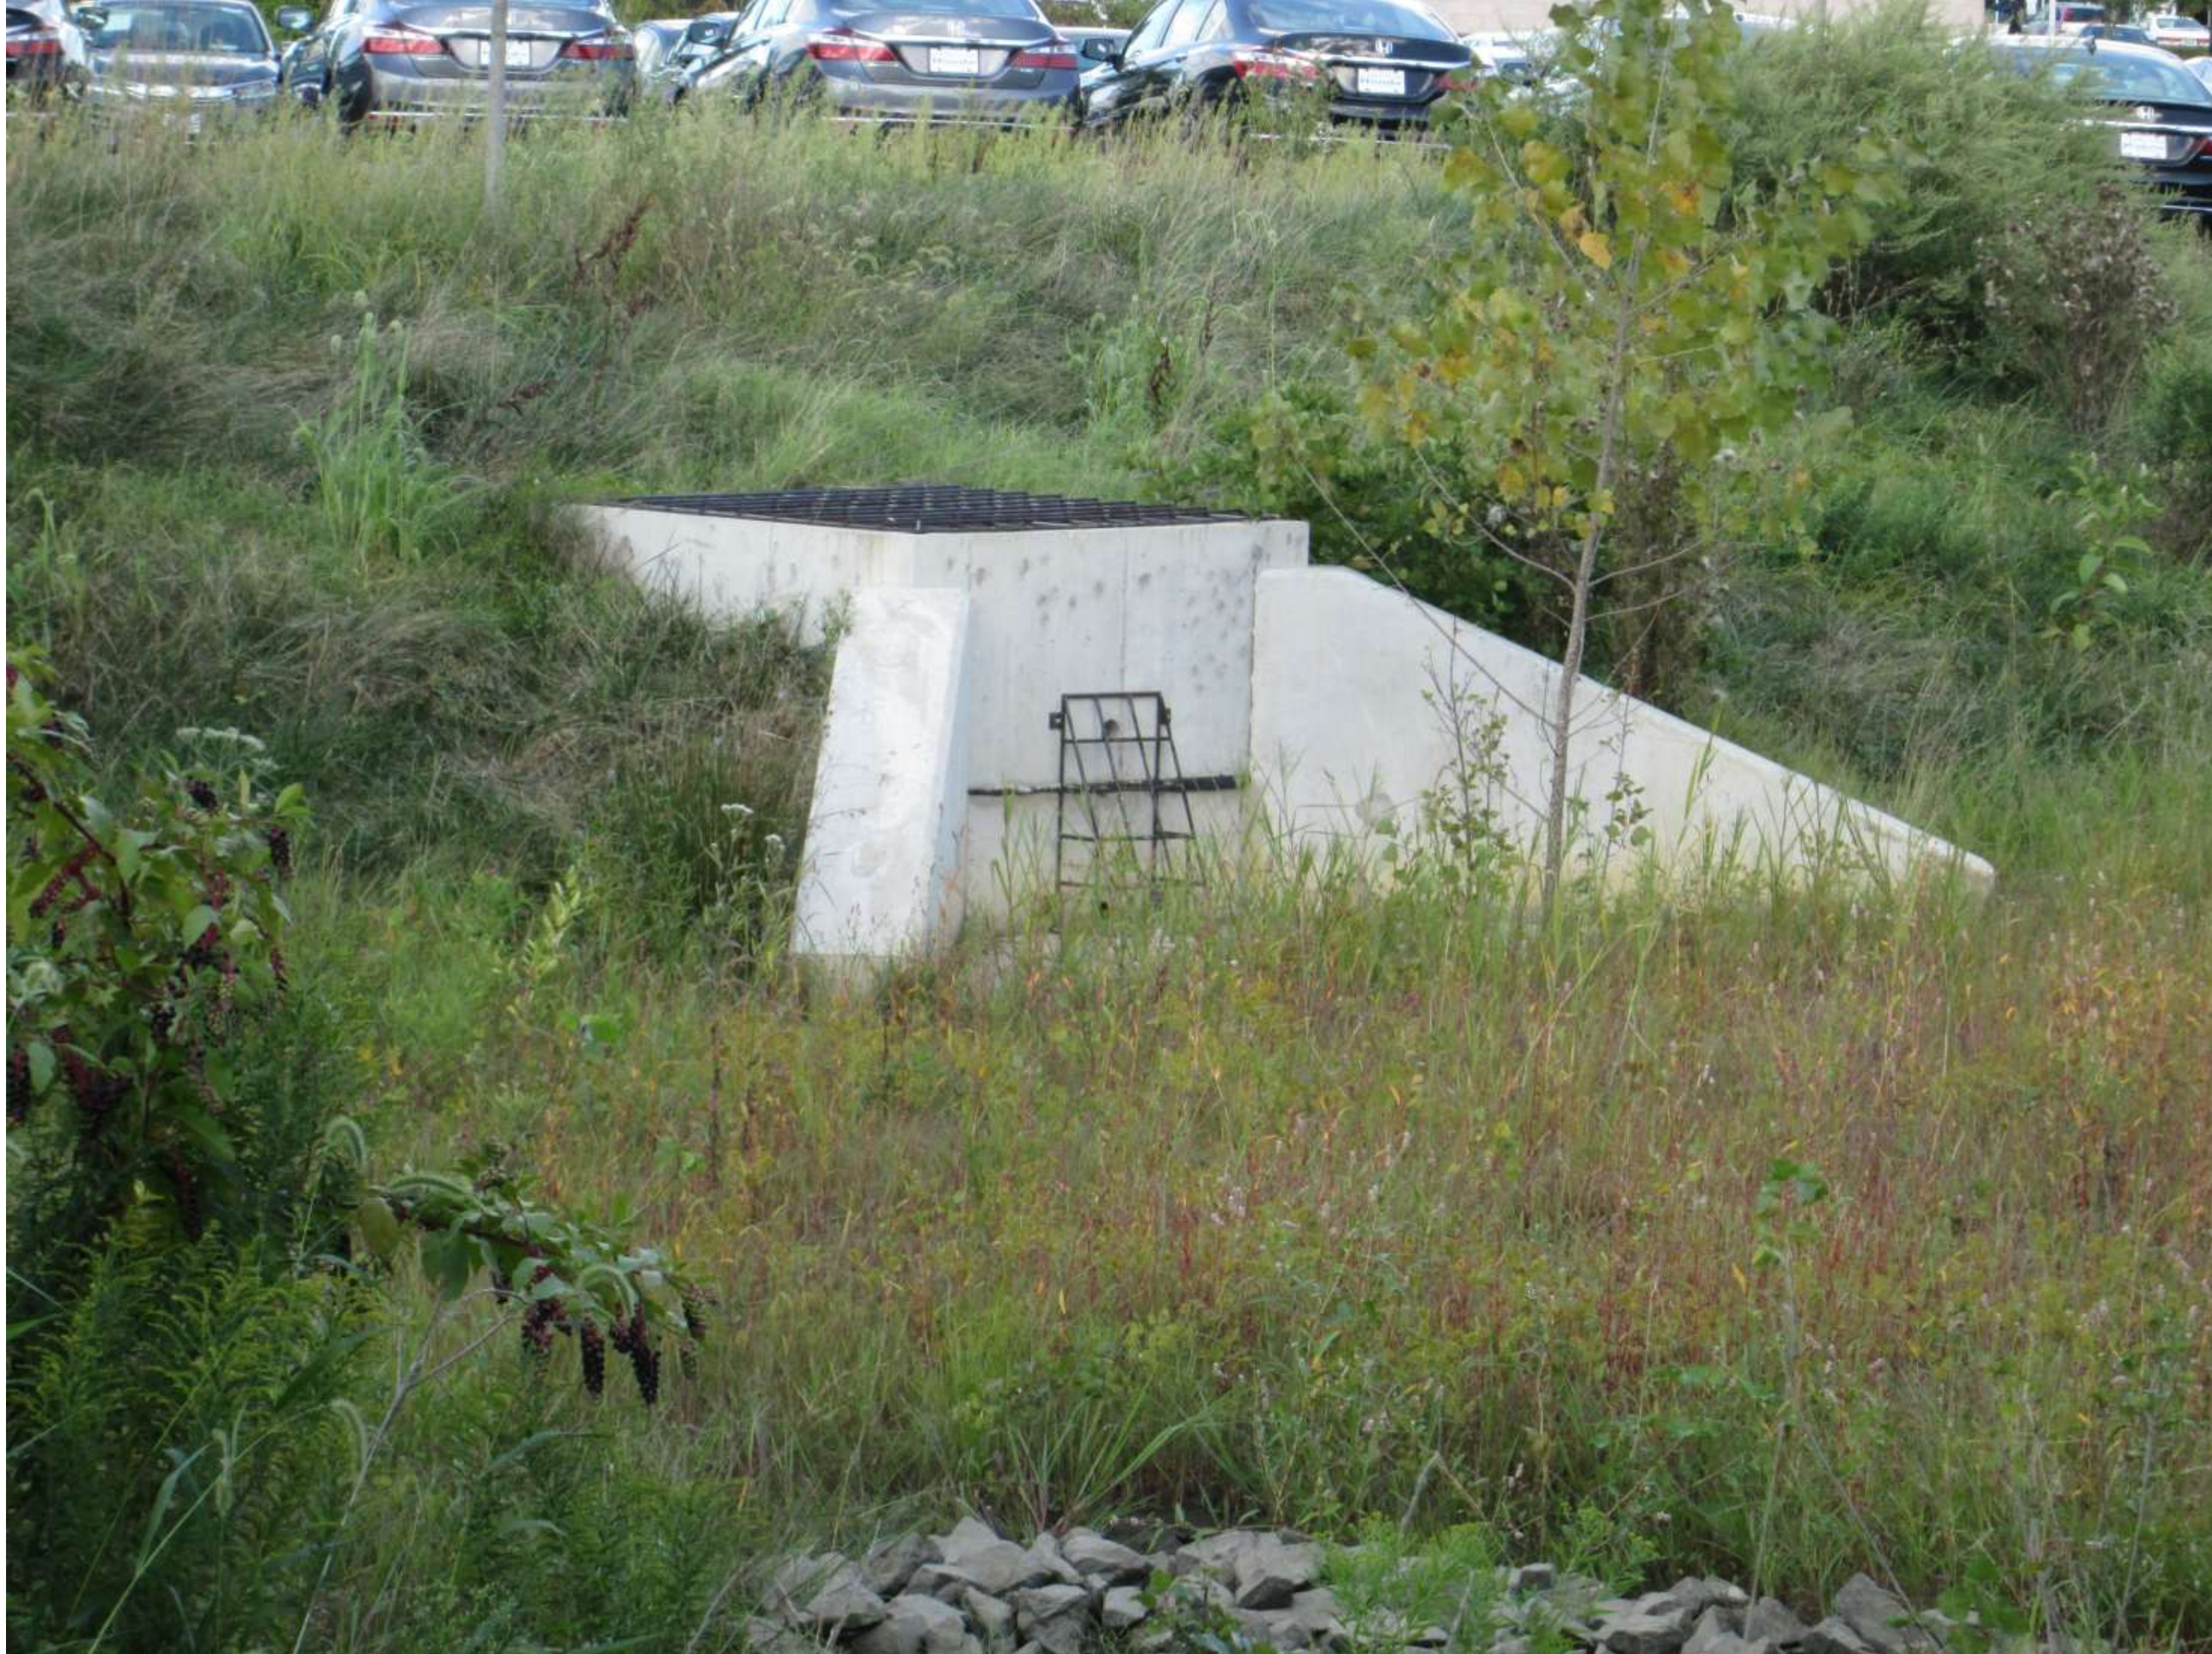
Outlet

- Notes:**
- Fenced off from surrounding areas
 - Naturalized basin
 - Overall well maintained

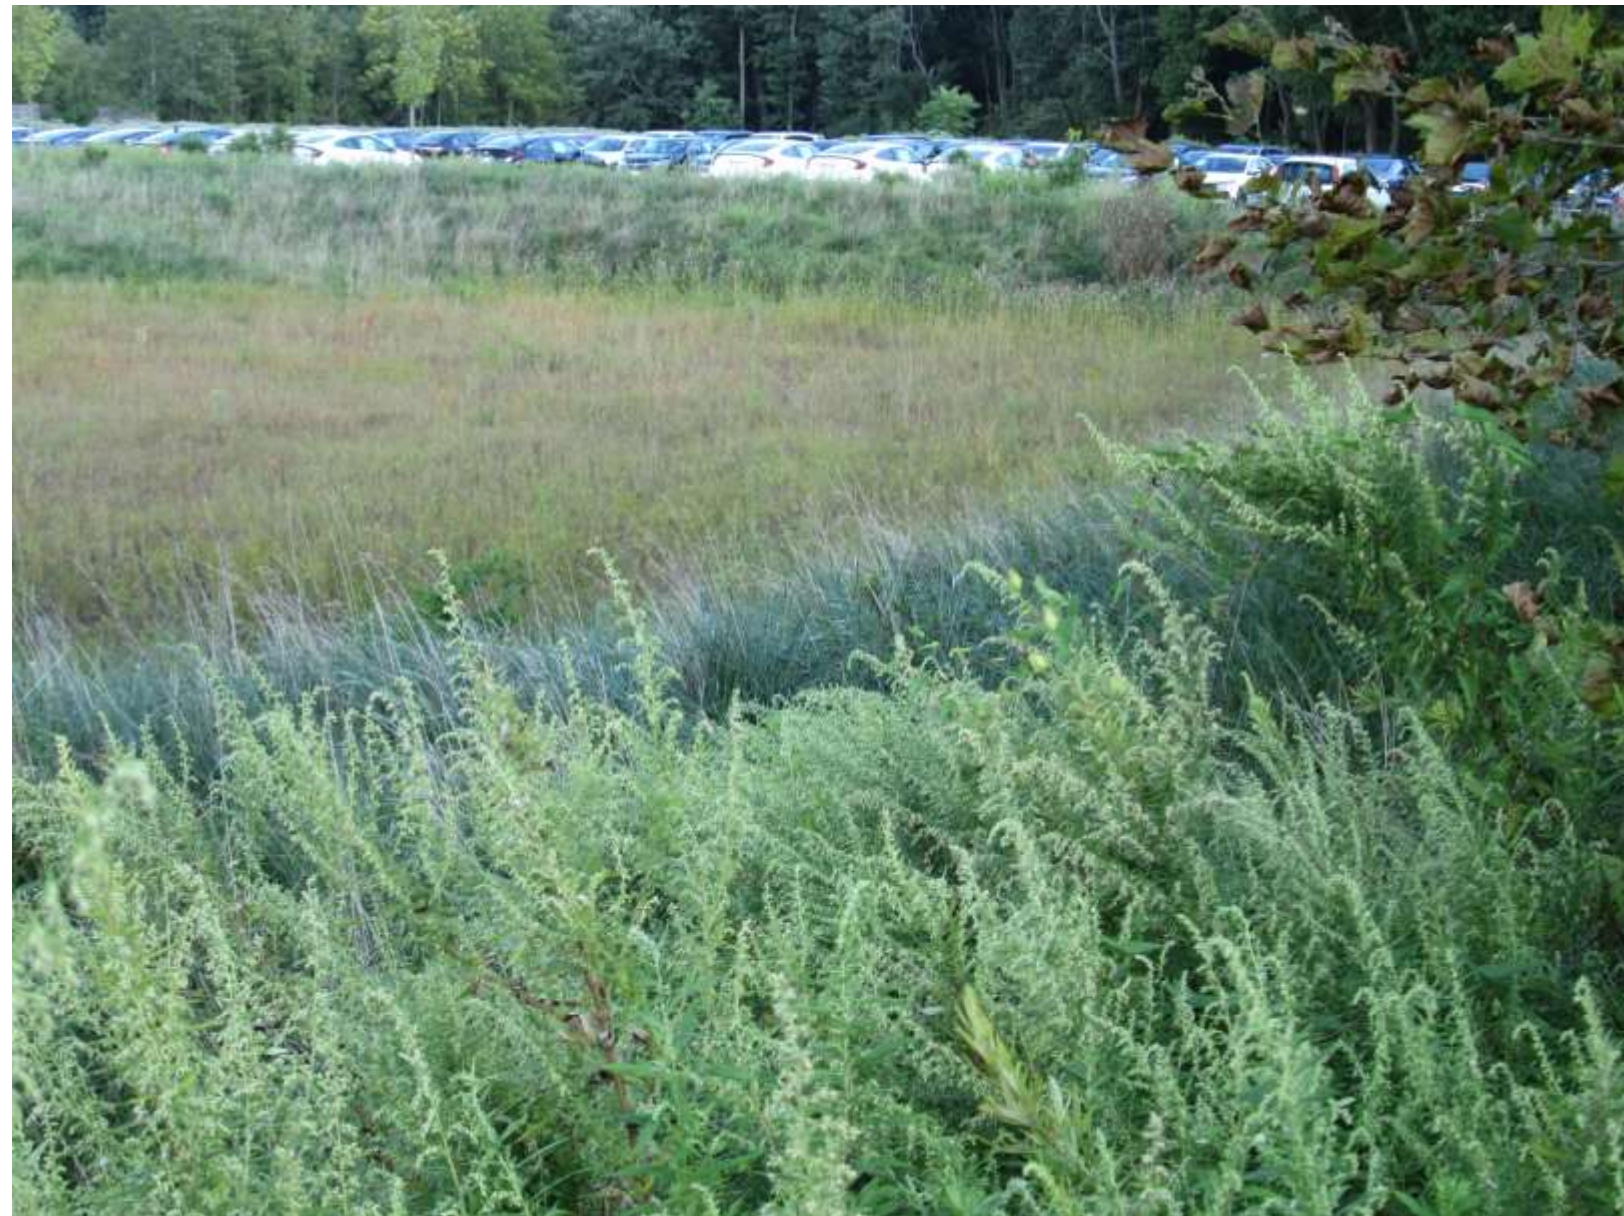
Overviews of basin

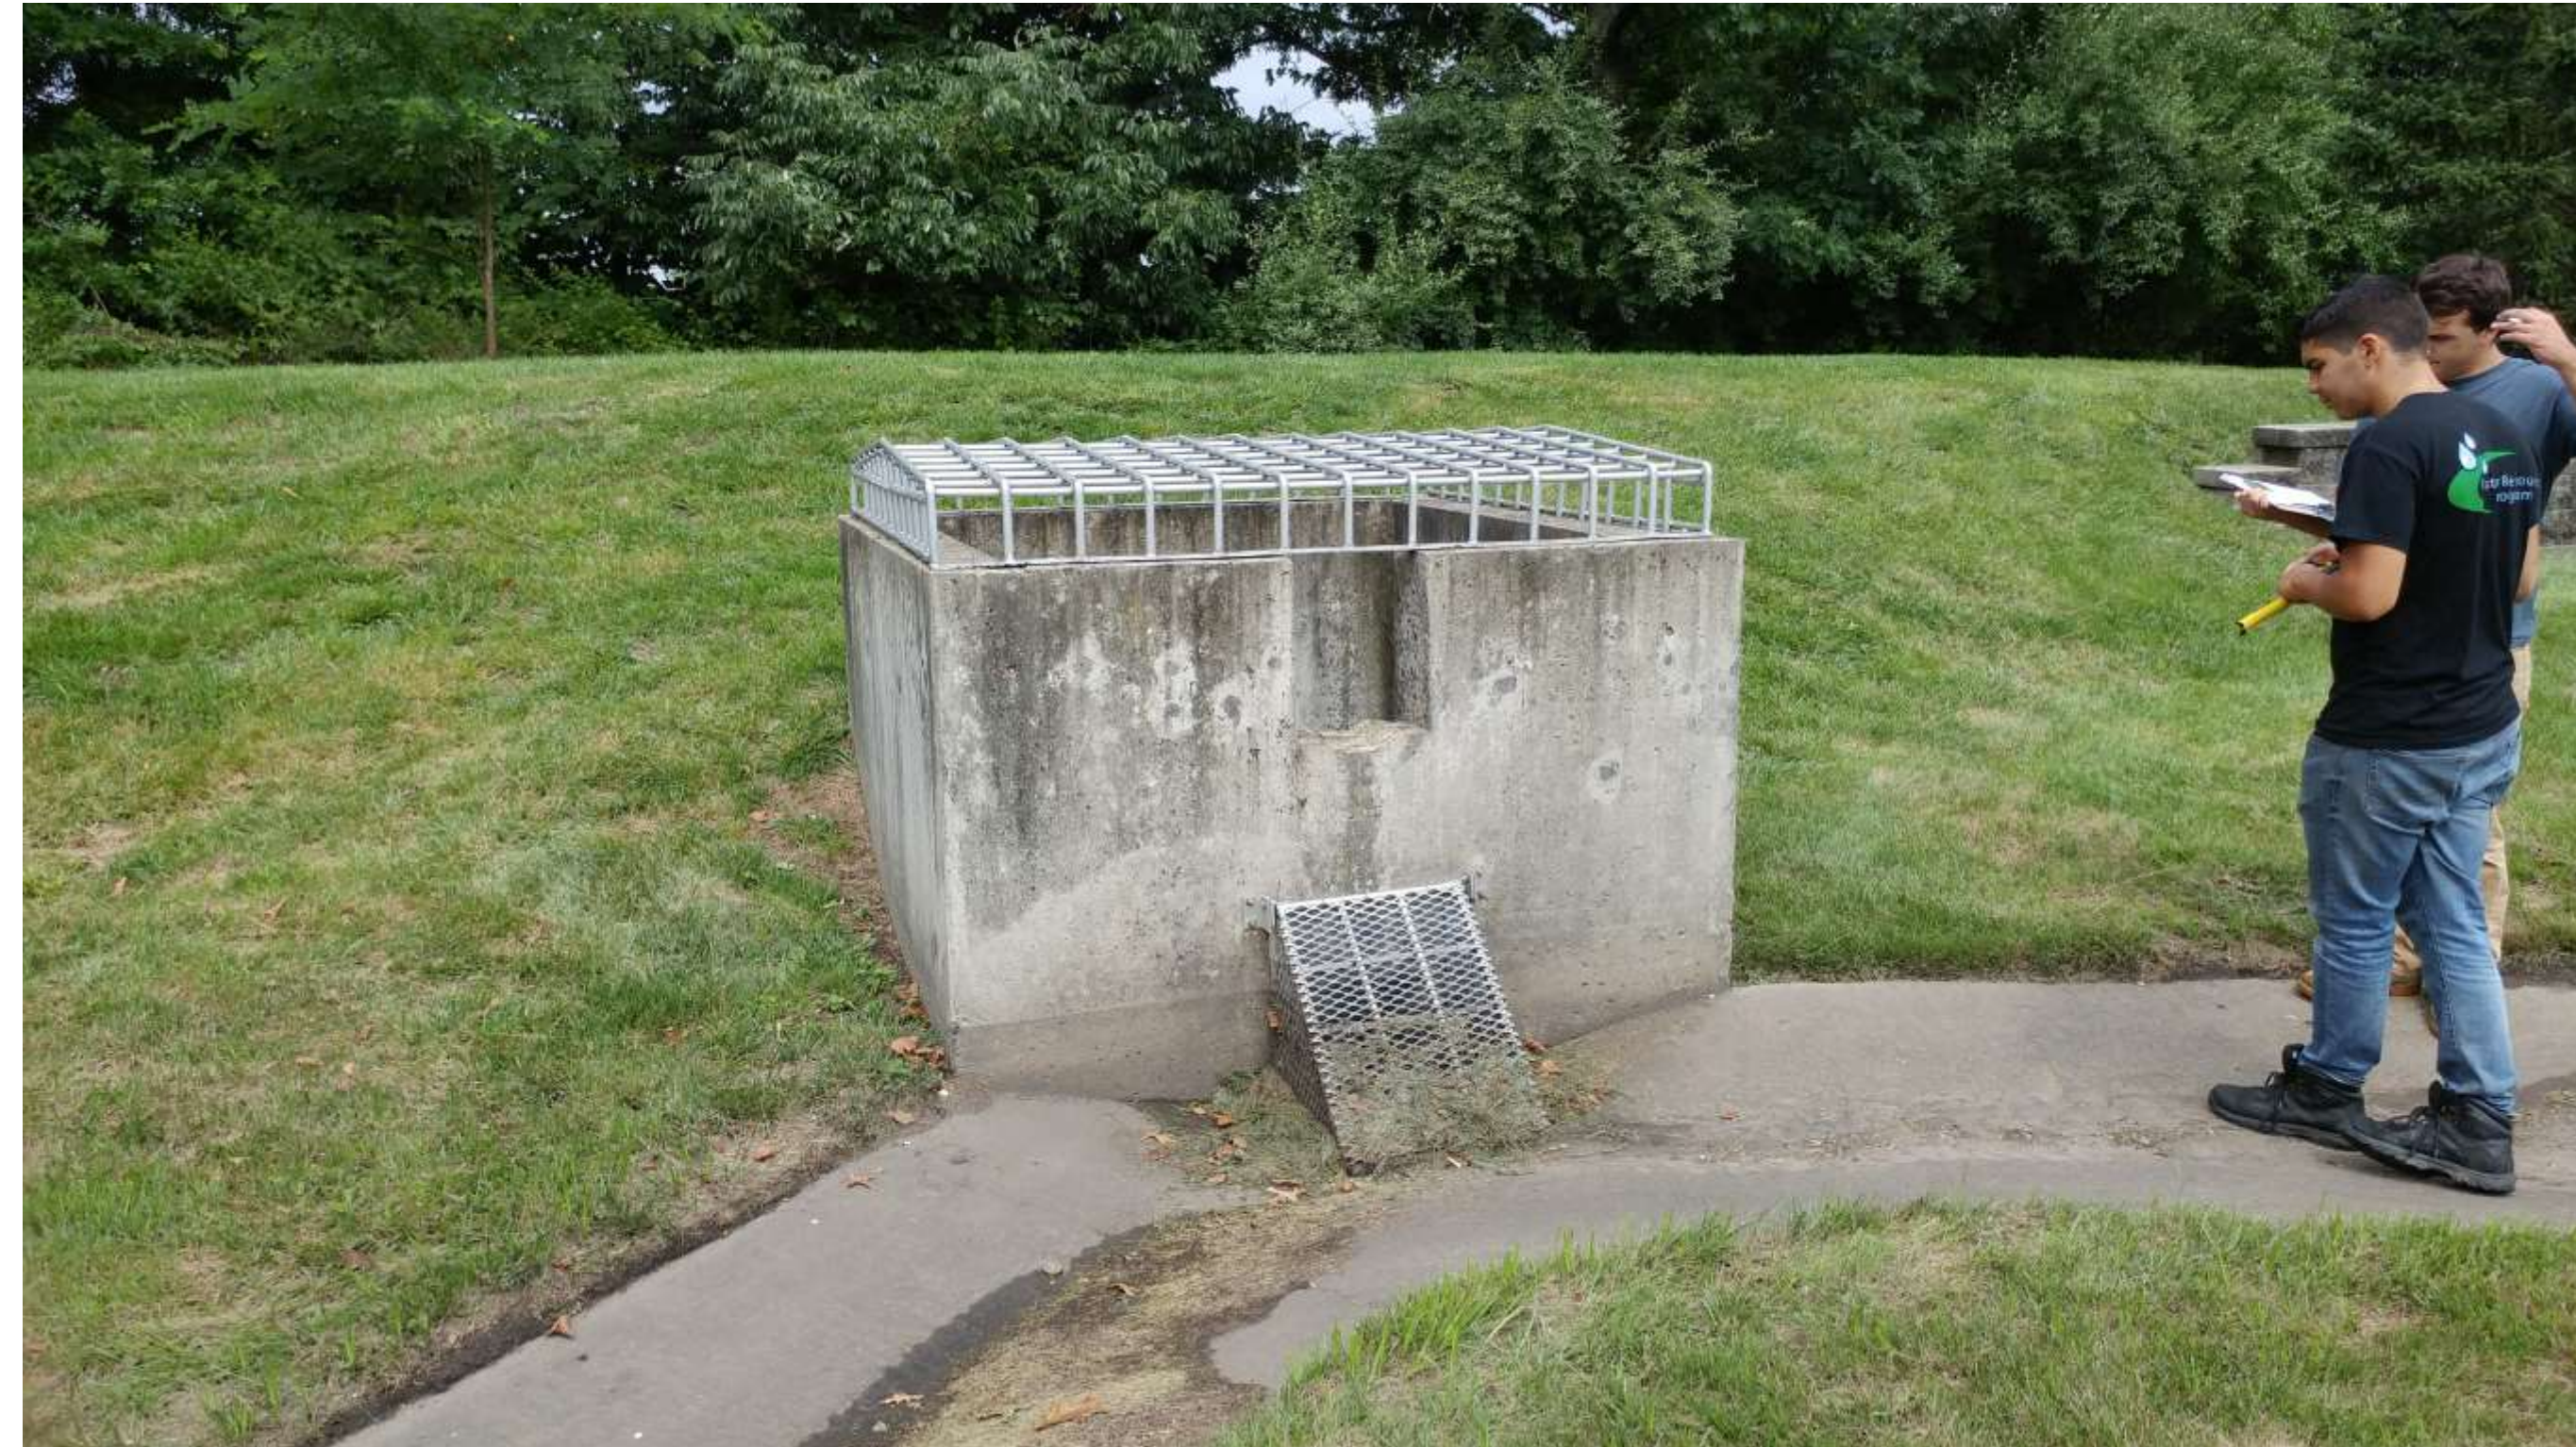
Outlet

- Sediment accumulation in low flow channels
- Some cleaning needed
- Replace low flow channels with stone lined channels to promote infiltration

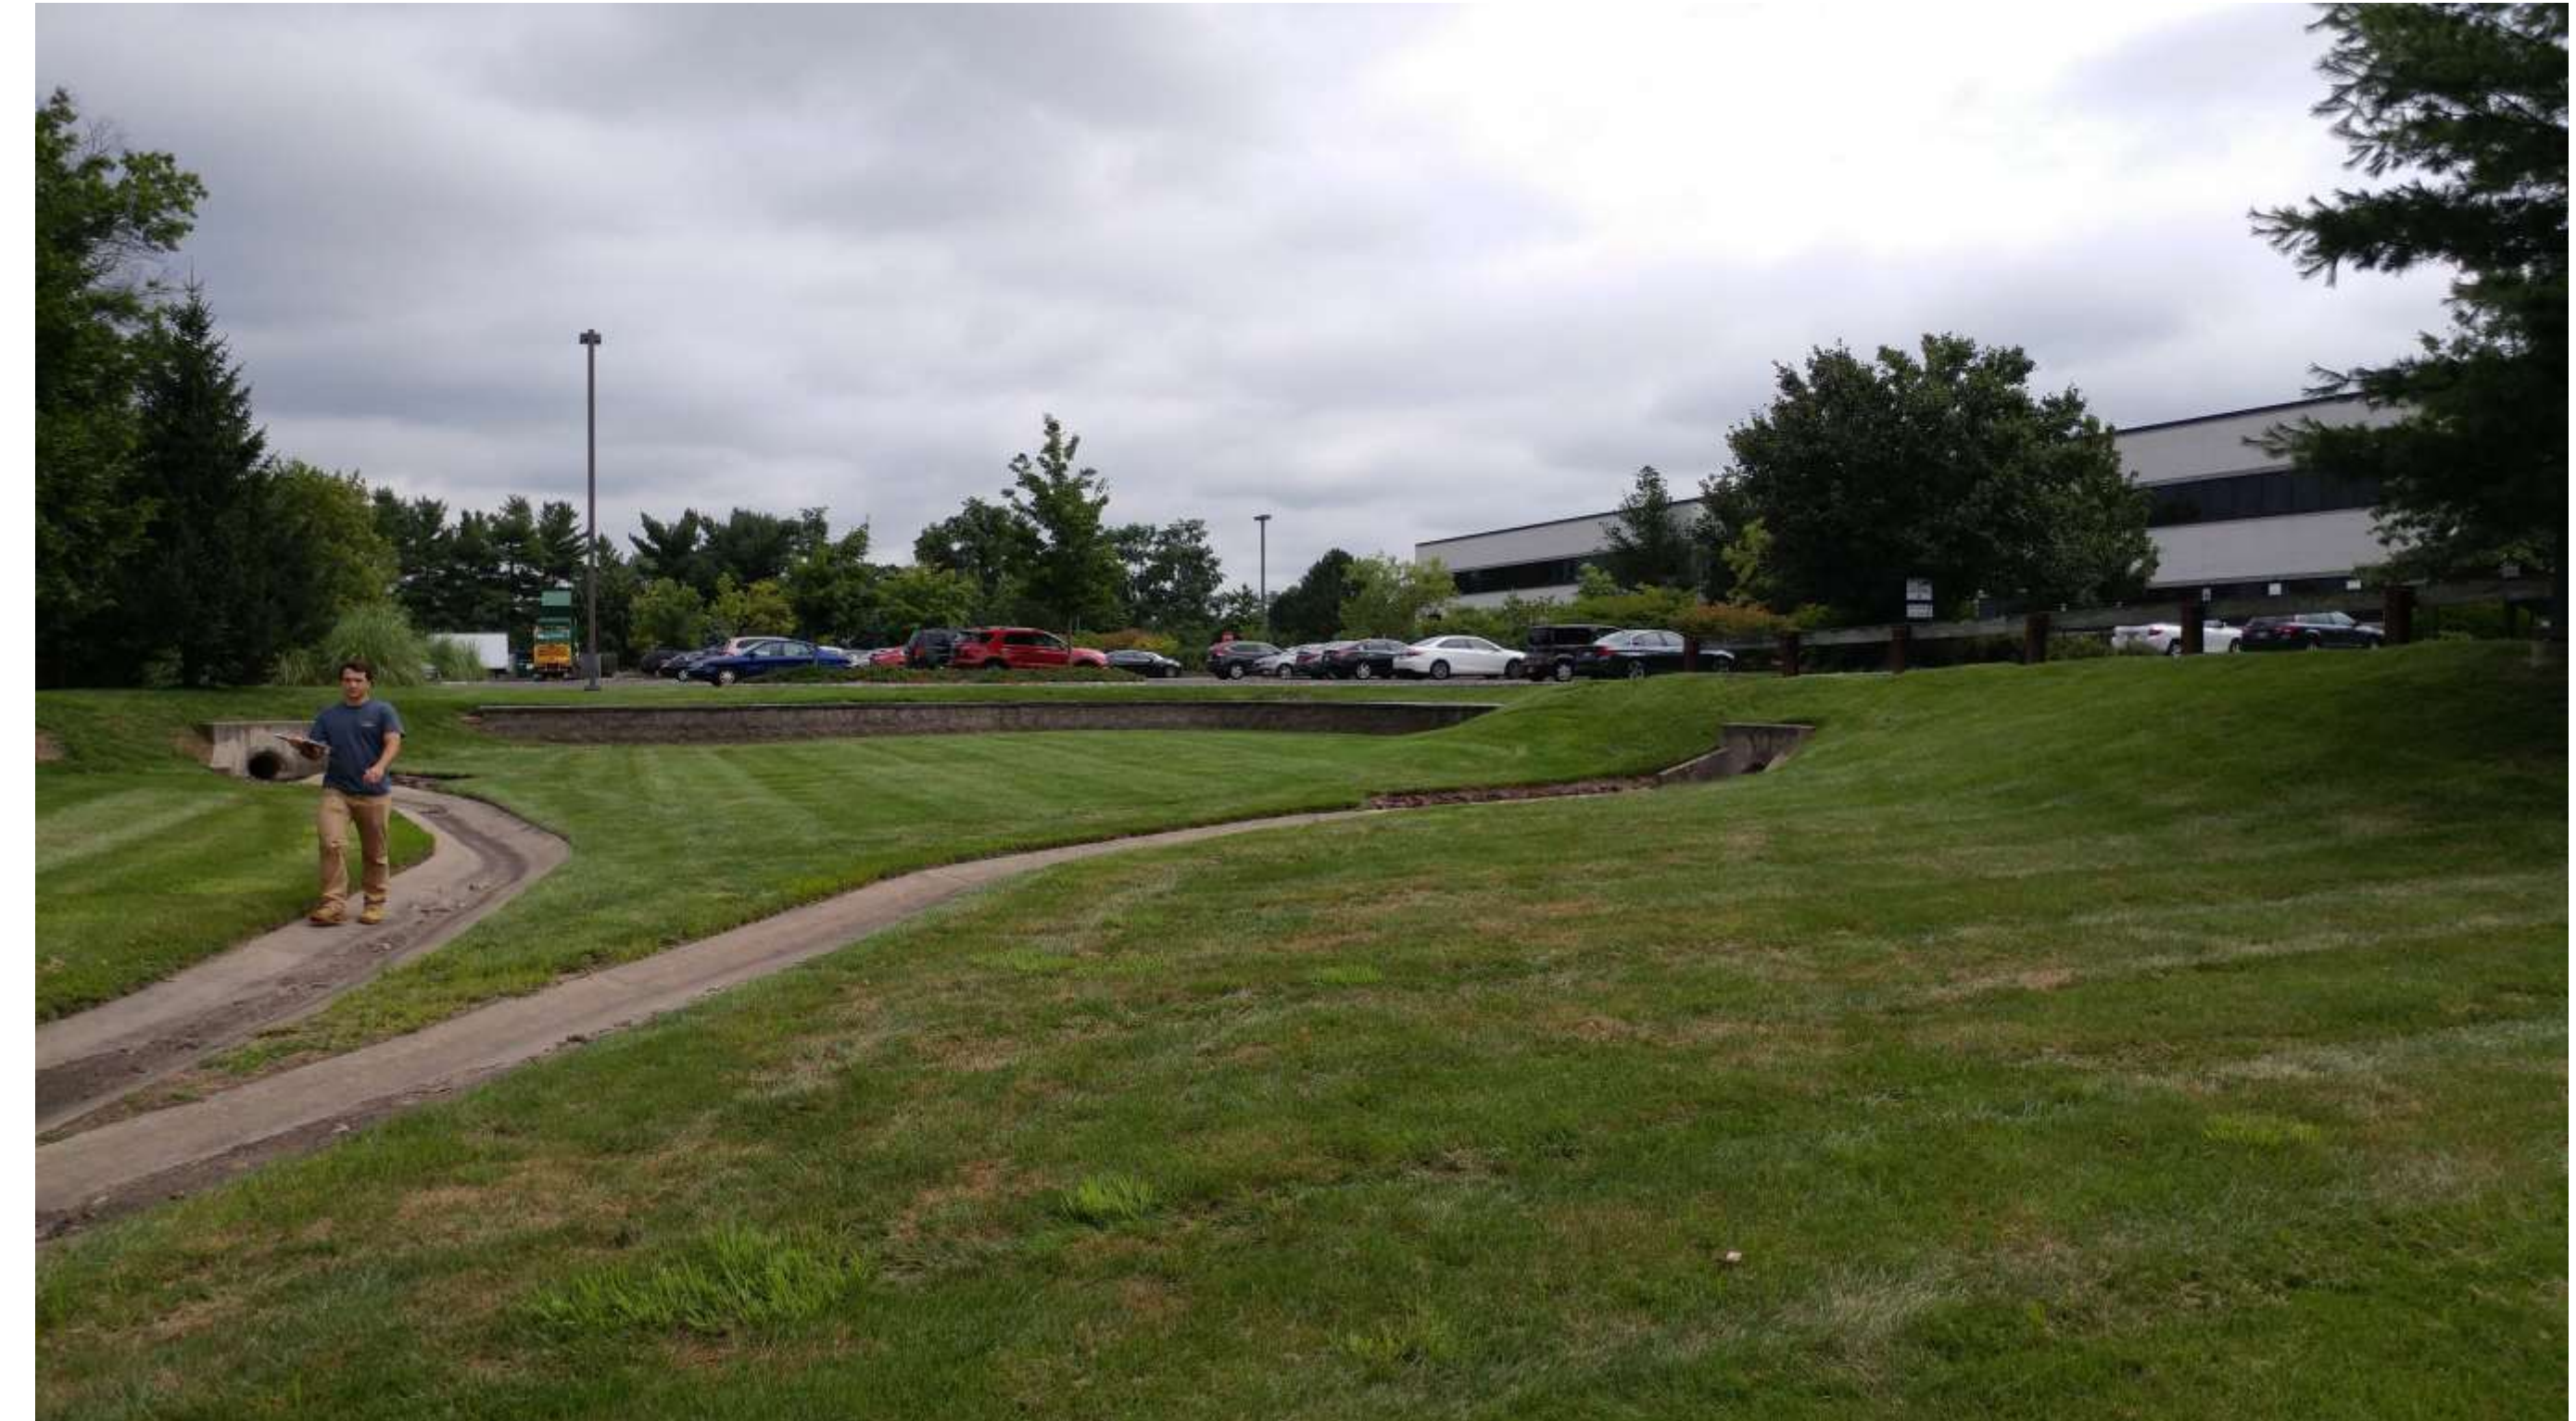
Basin overview

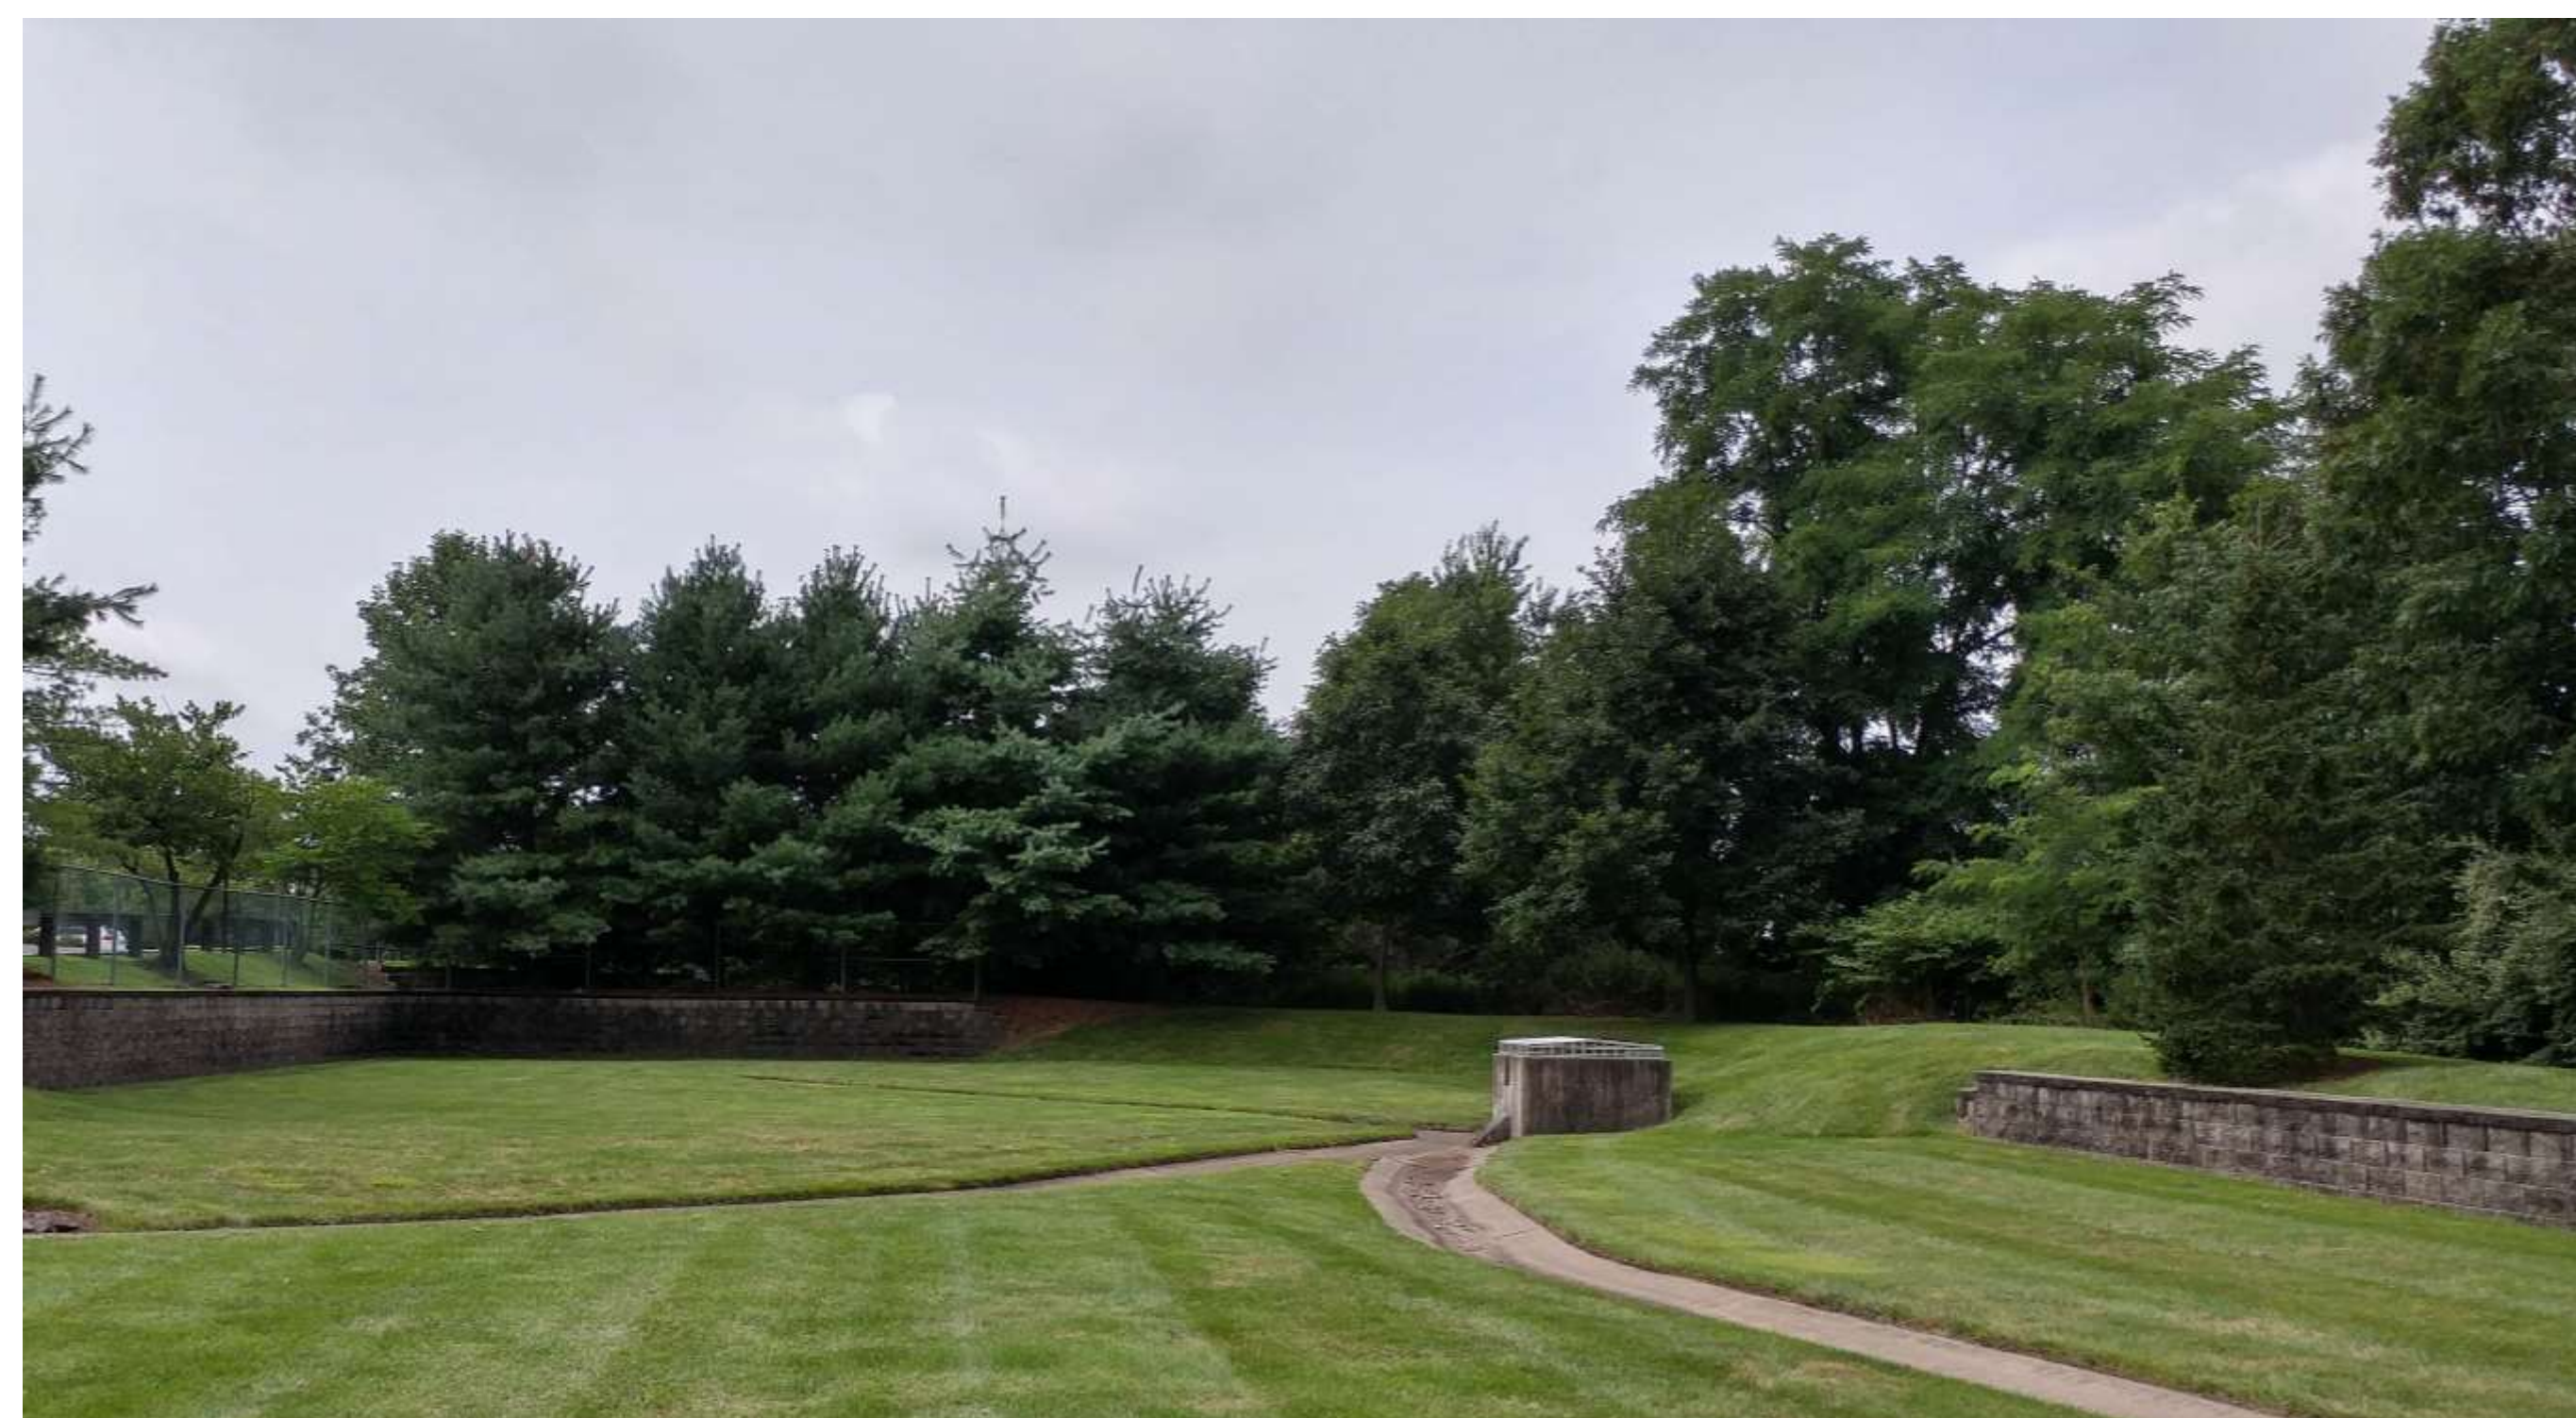
Basin overview
