**Hamilton Township (Mercer County)
Stormwater Basin Assessment Summary
Addendum (Year 4)**

Developed by the Rutgers Cooperative Extension Water Resources Program
Funded by Hamilton Township, Mercer County, New Jersey

December 2017

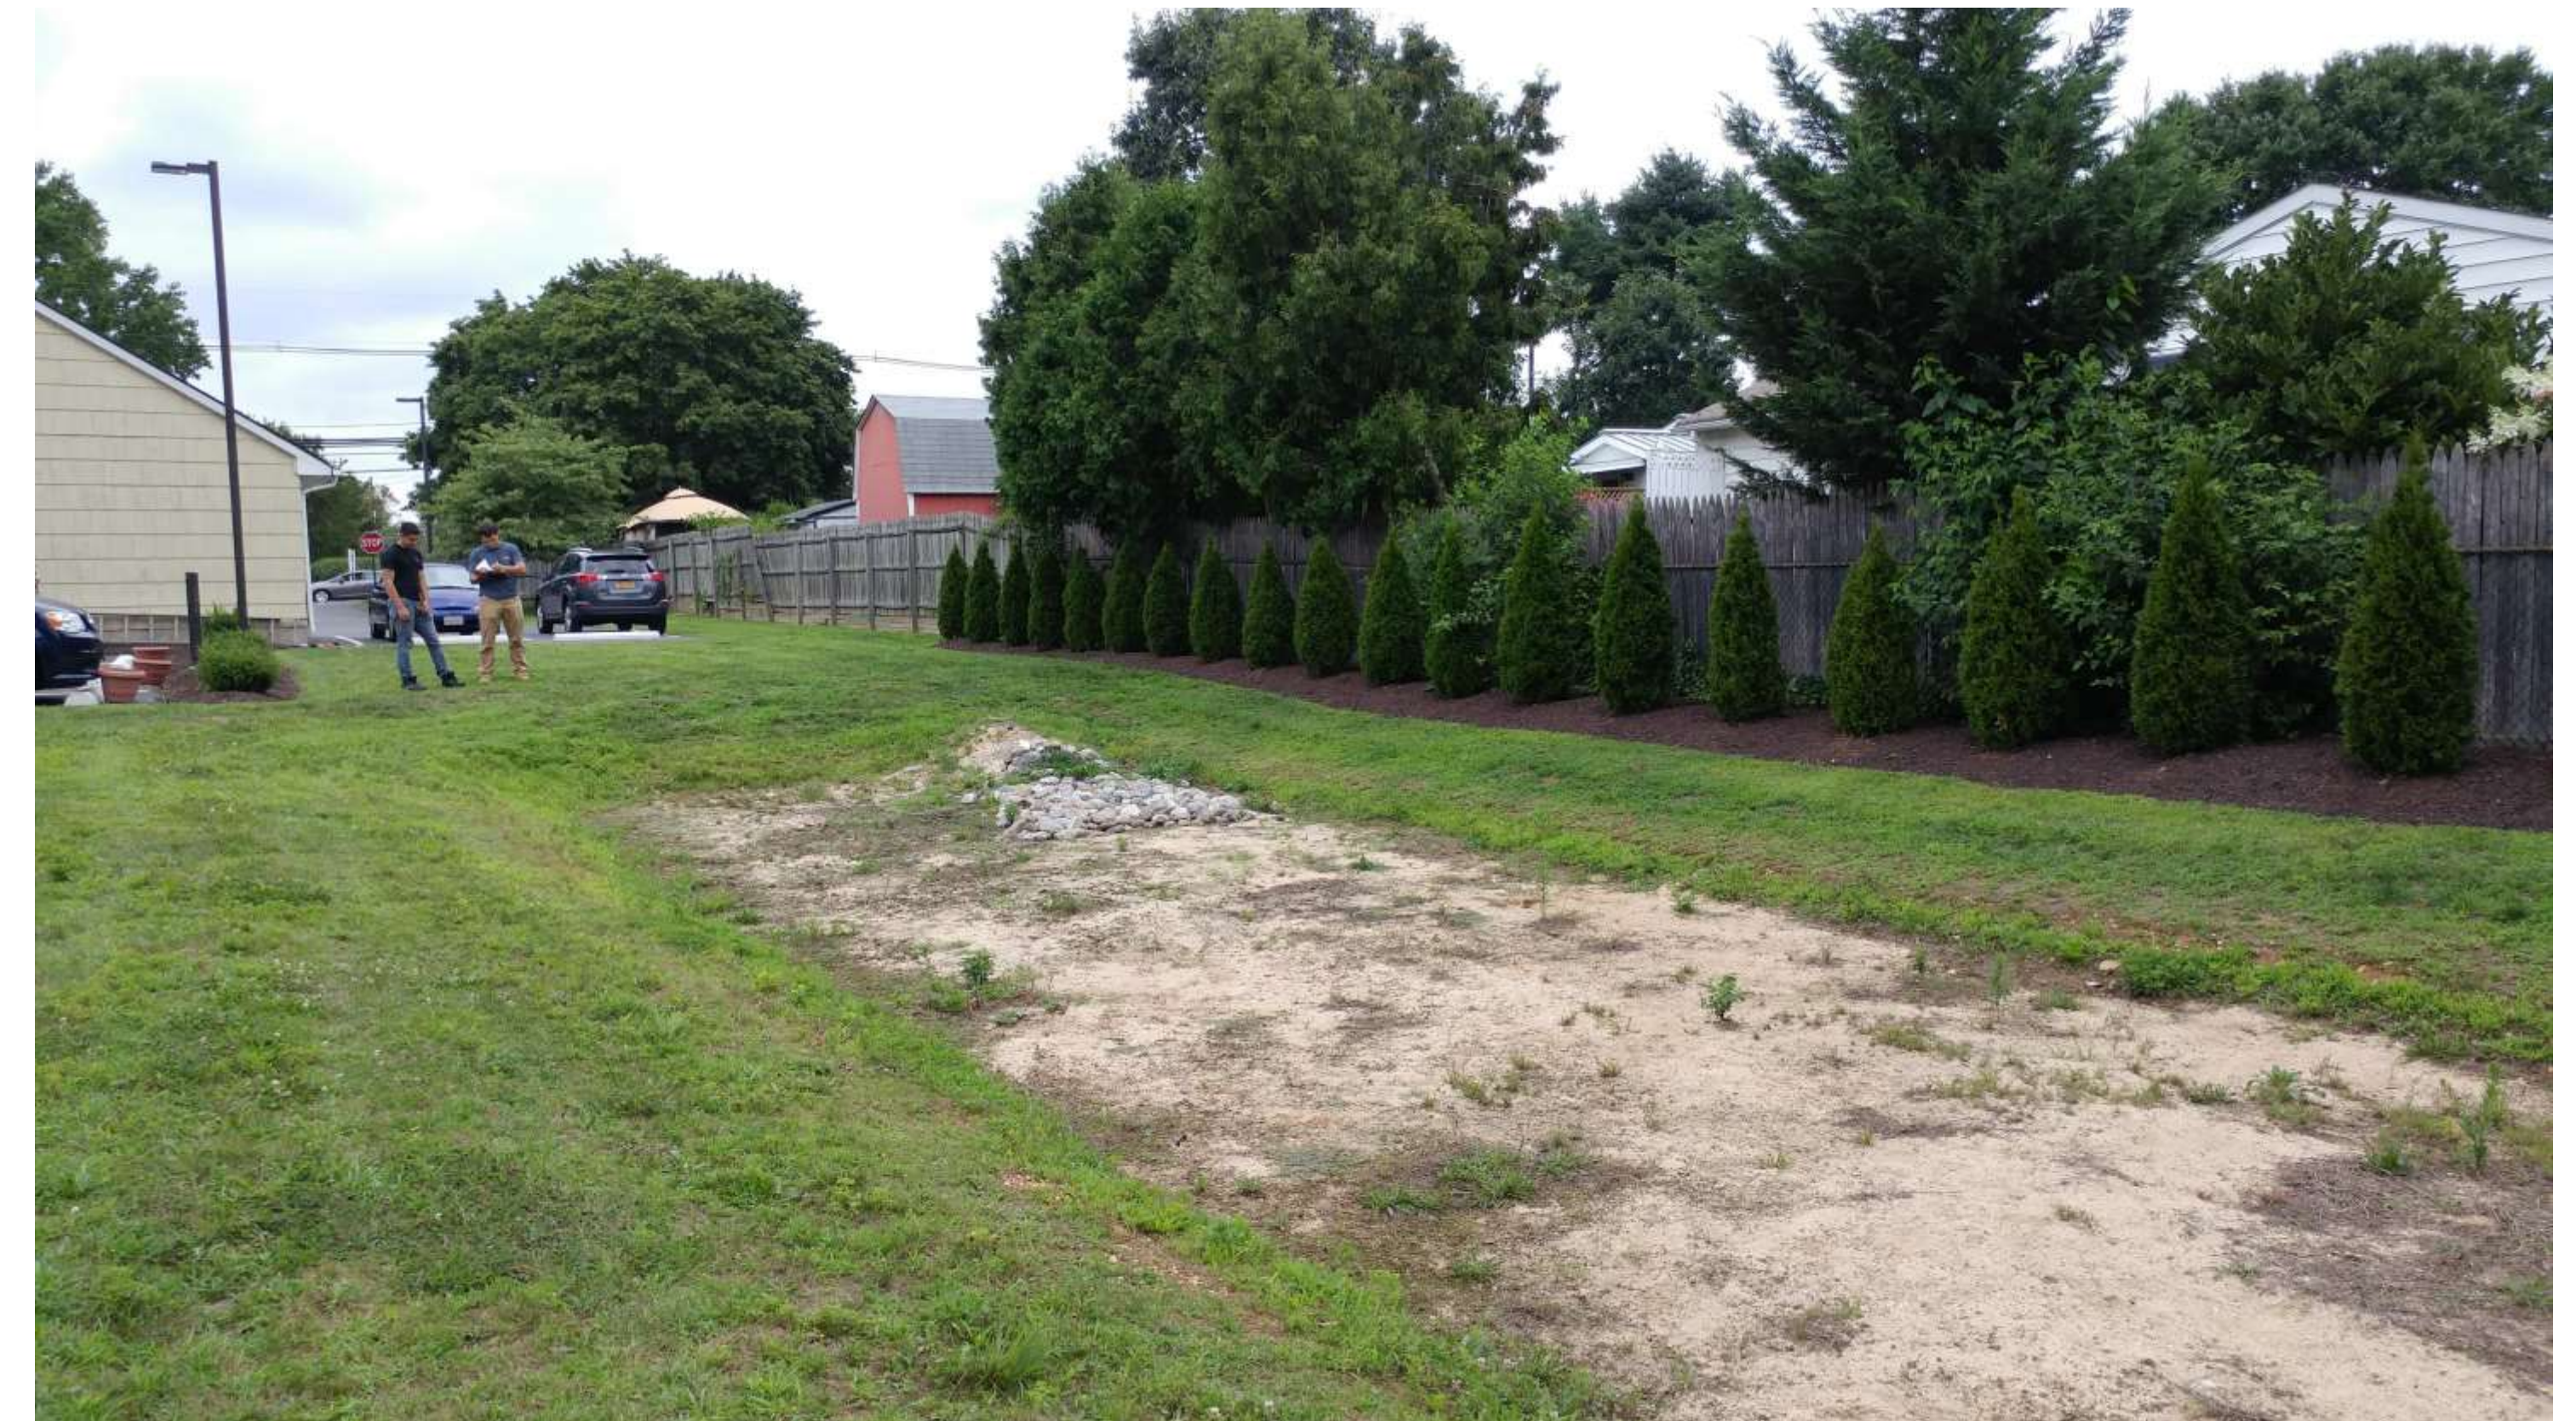
Basin overview

- Infiltration basin
- Can be naturalized with plants
- Overall well maintained

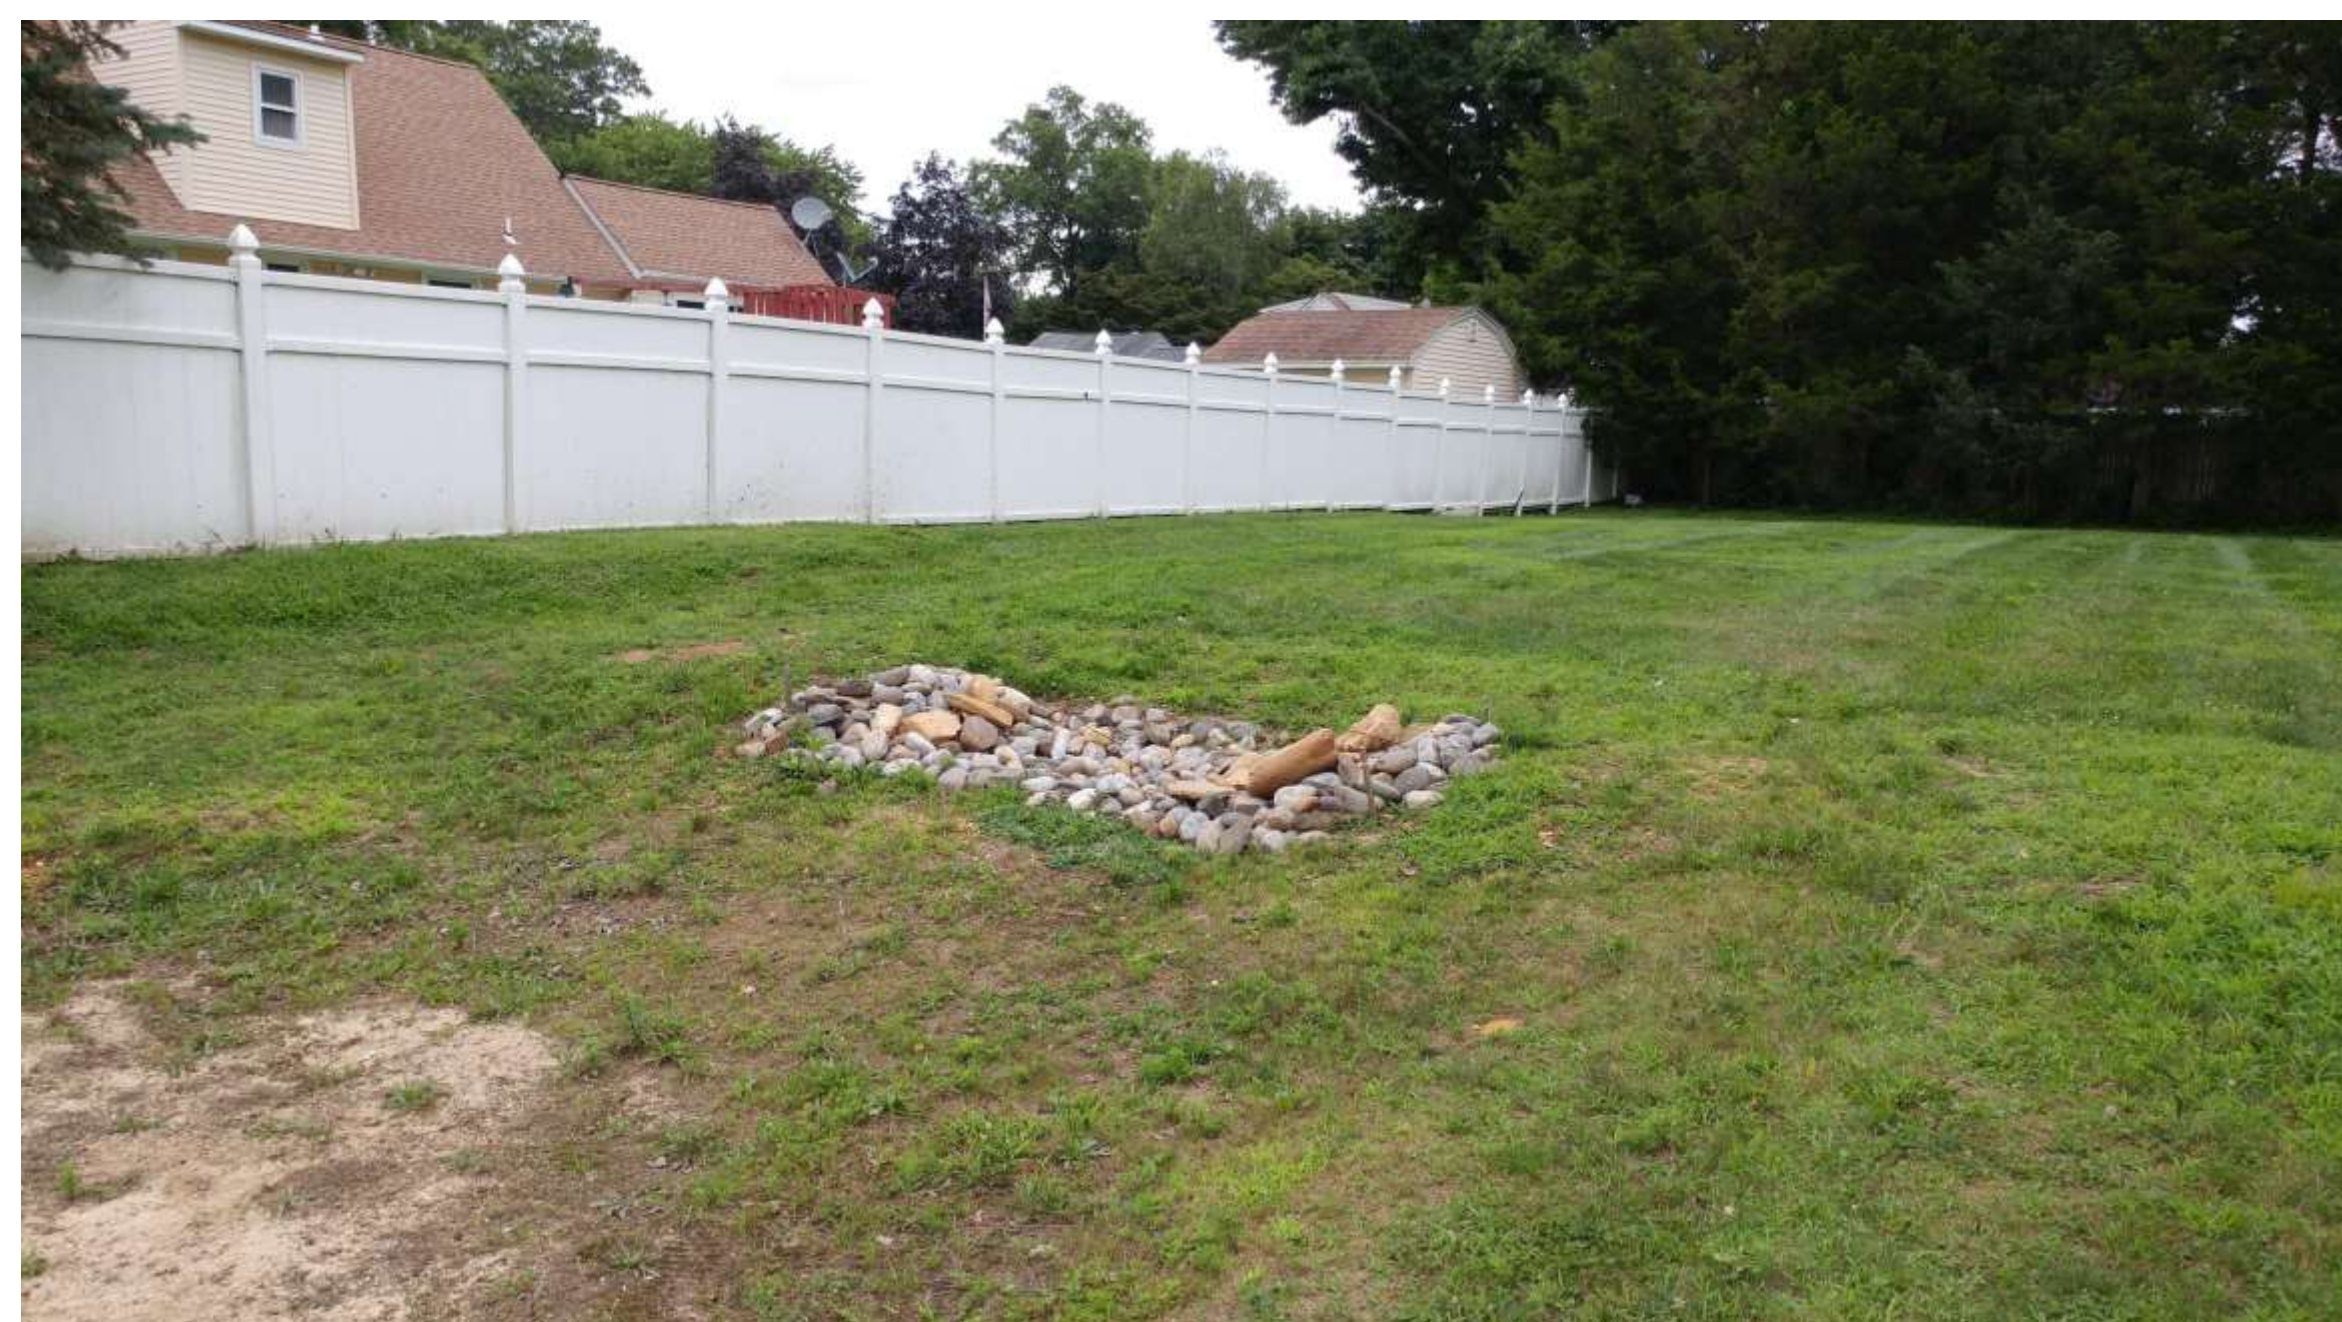
Spillway

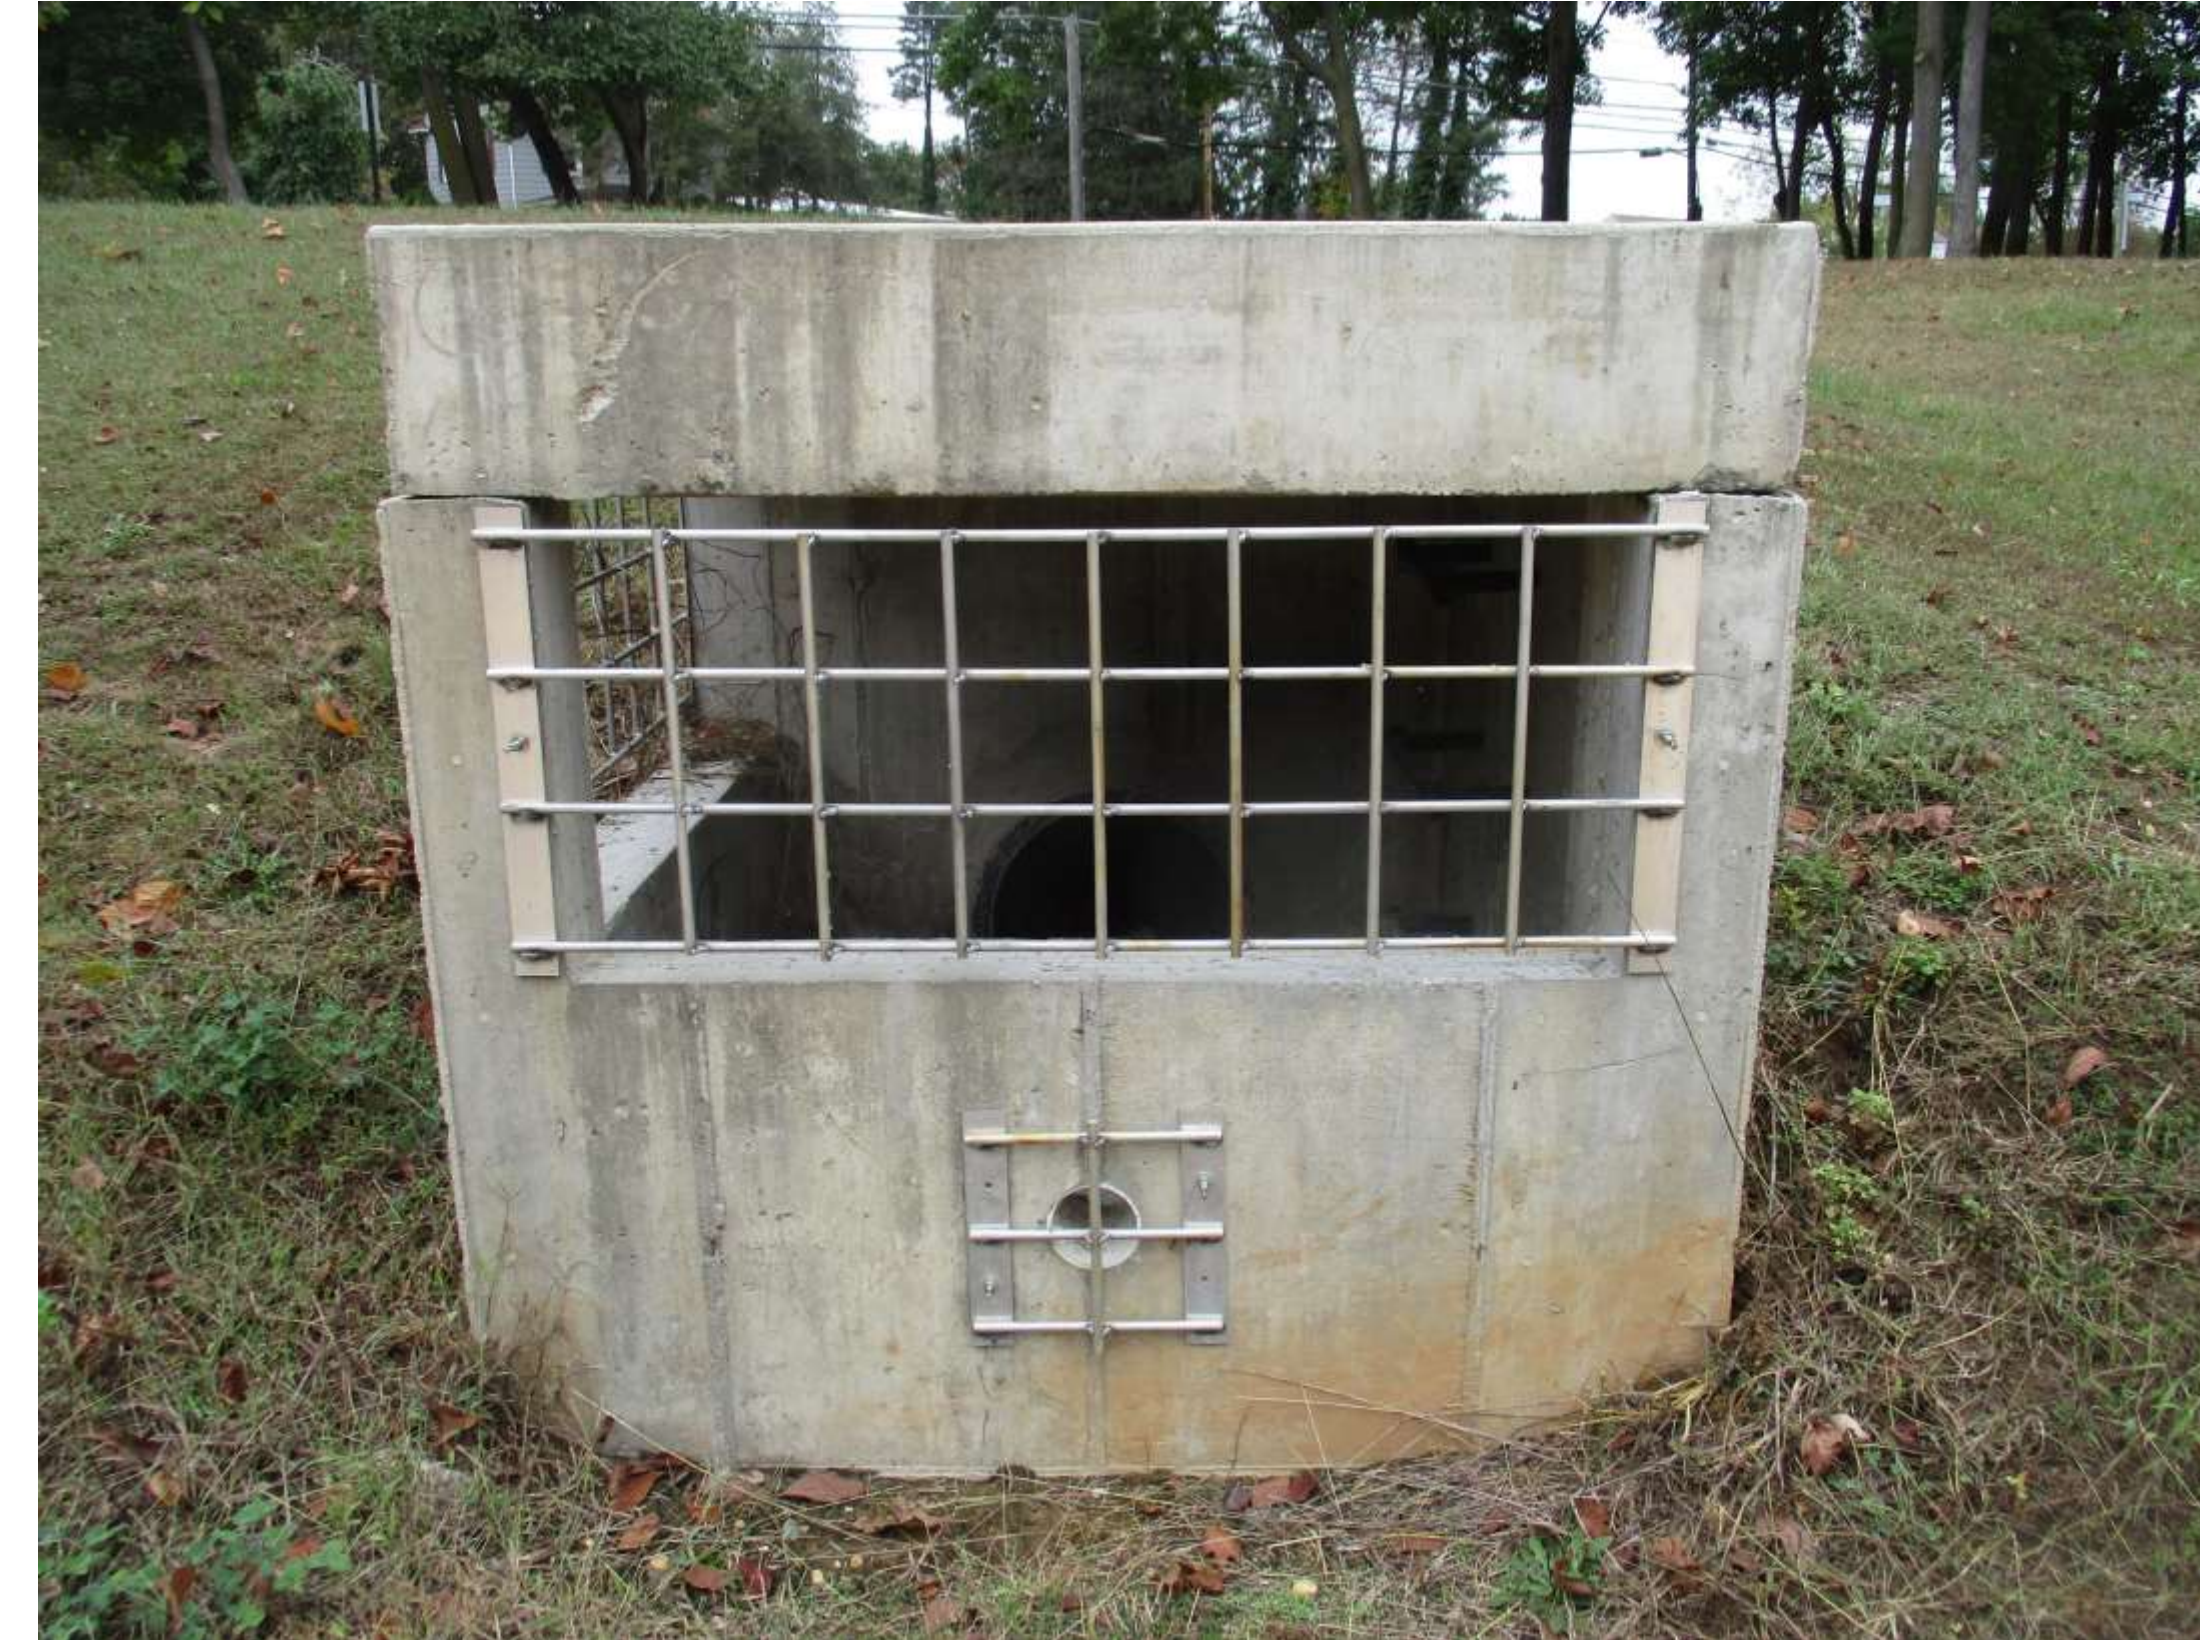
Outlet

- Sandy bottom, infiltration basin
- Overall well maintained

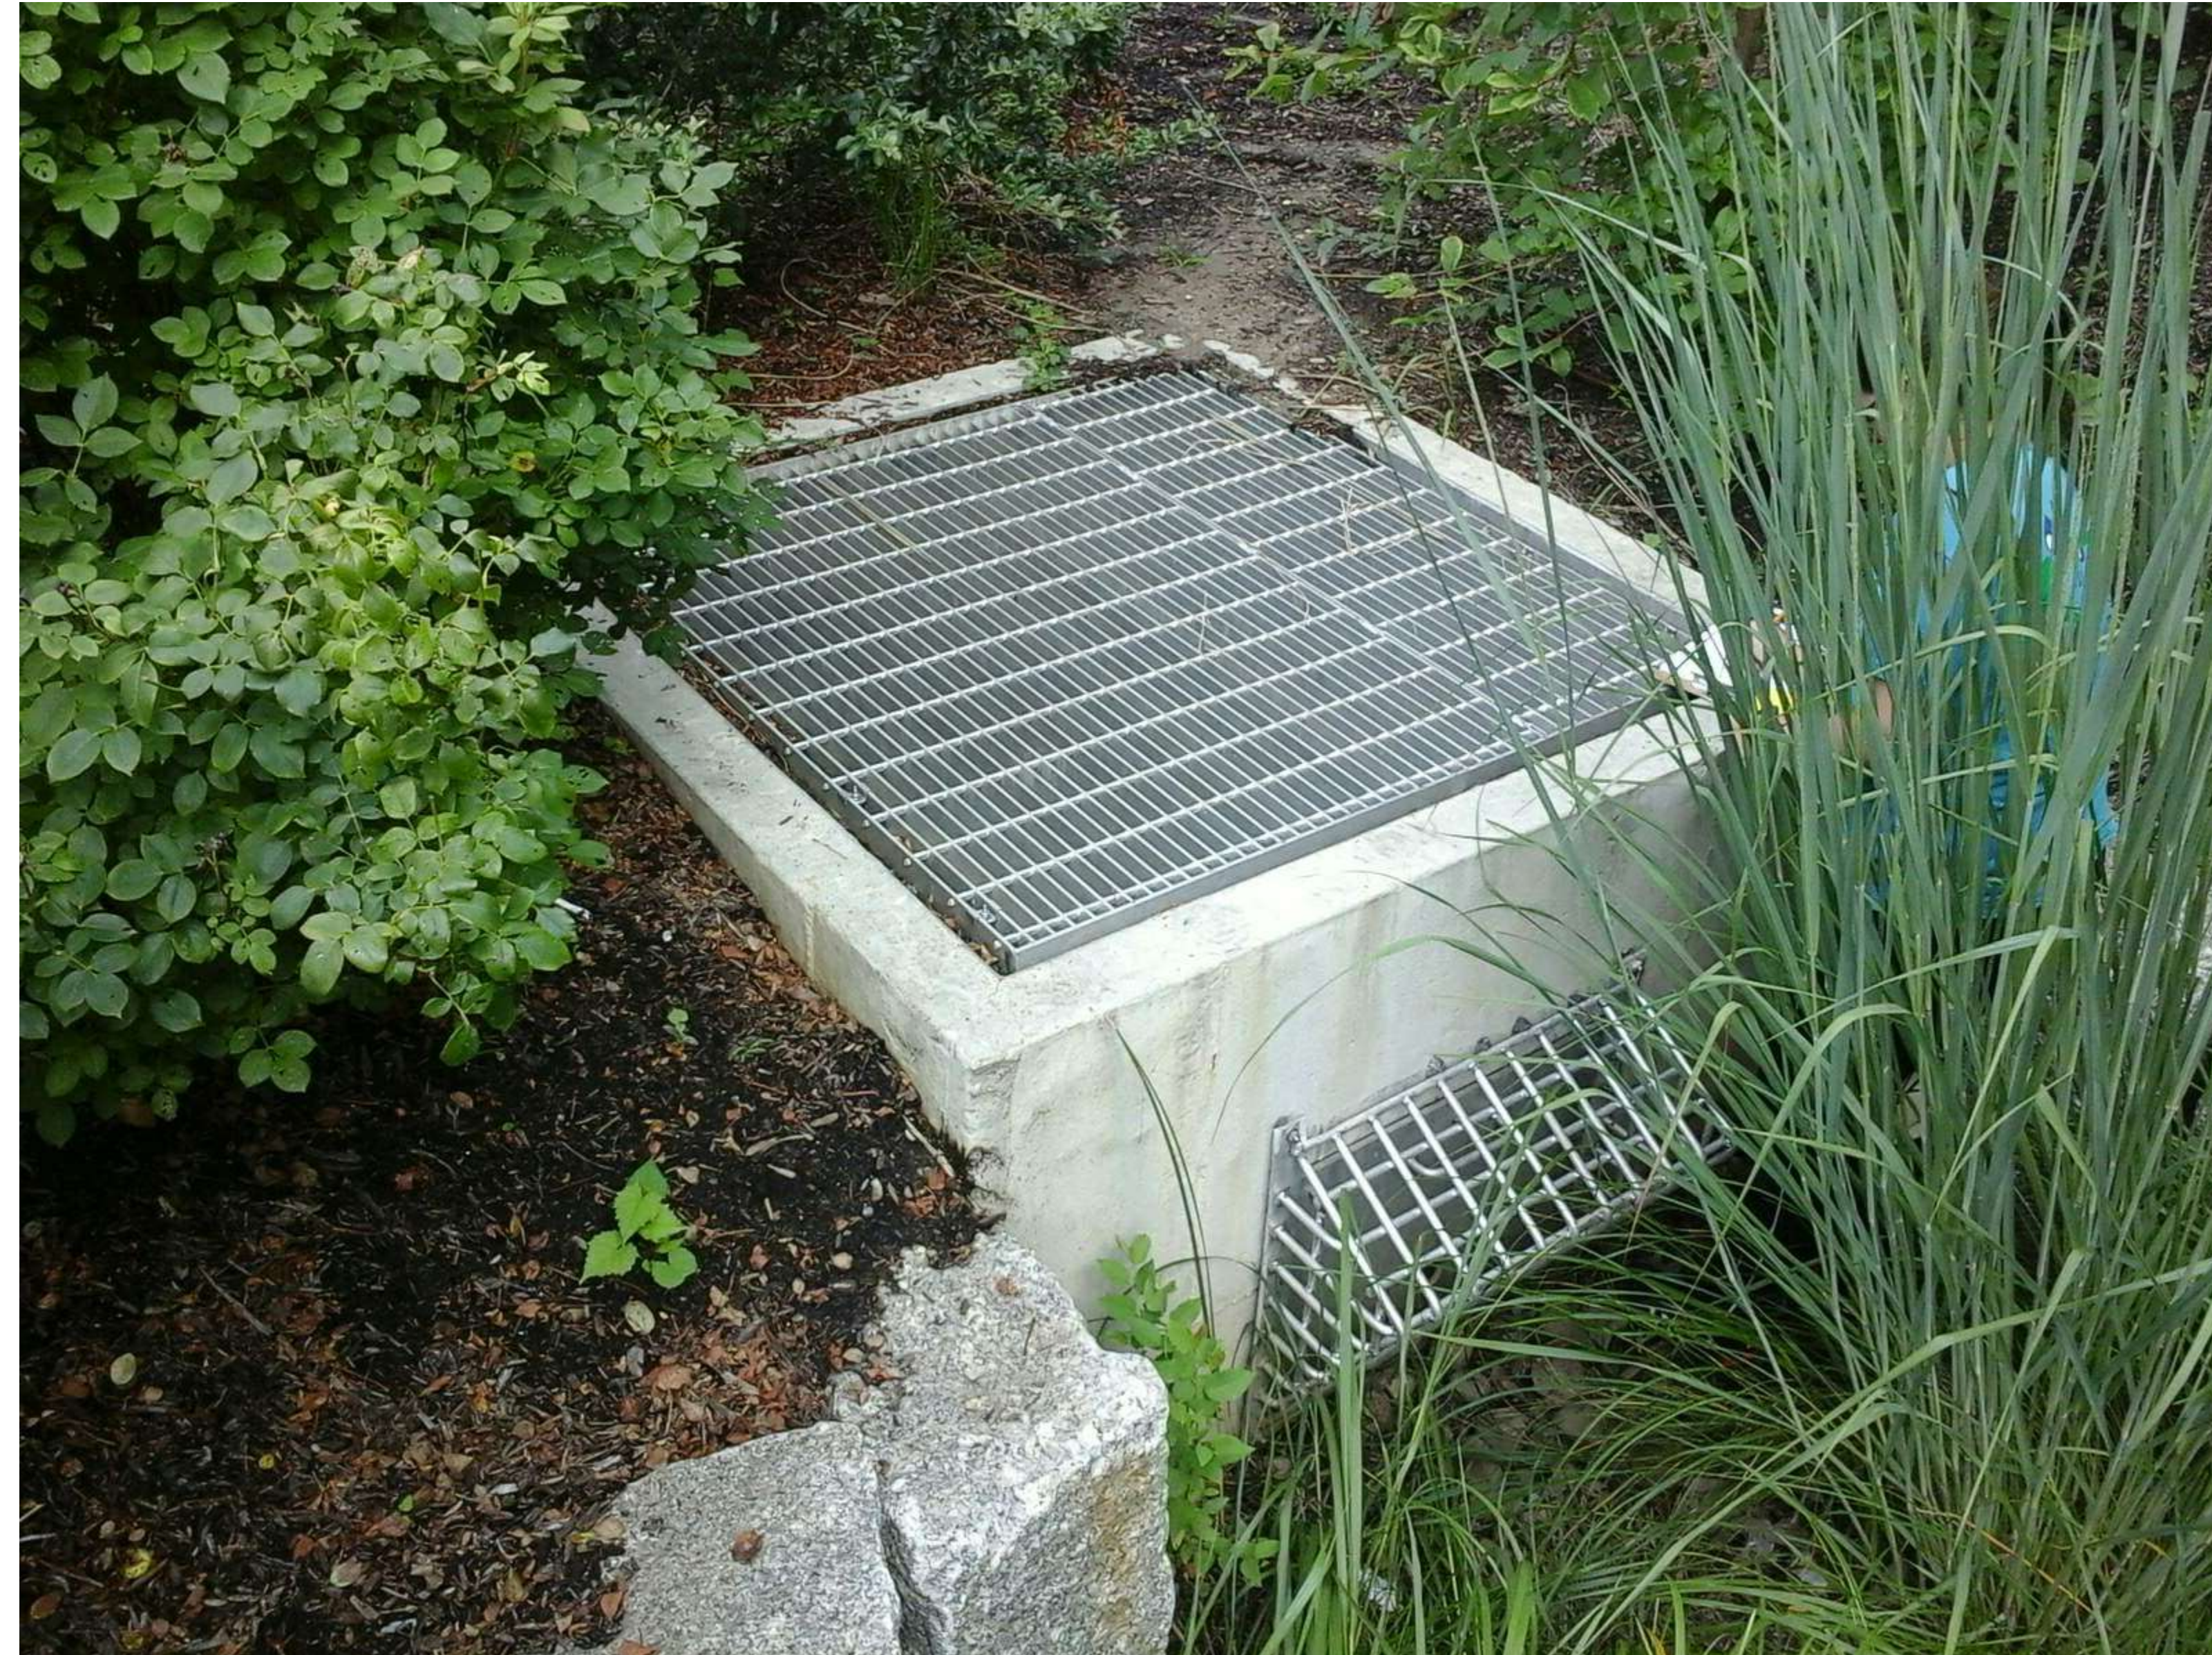
Outlet structure

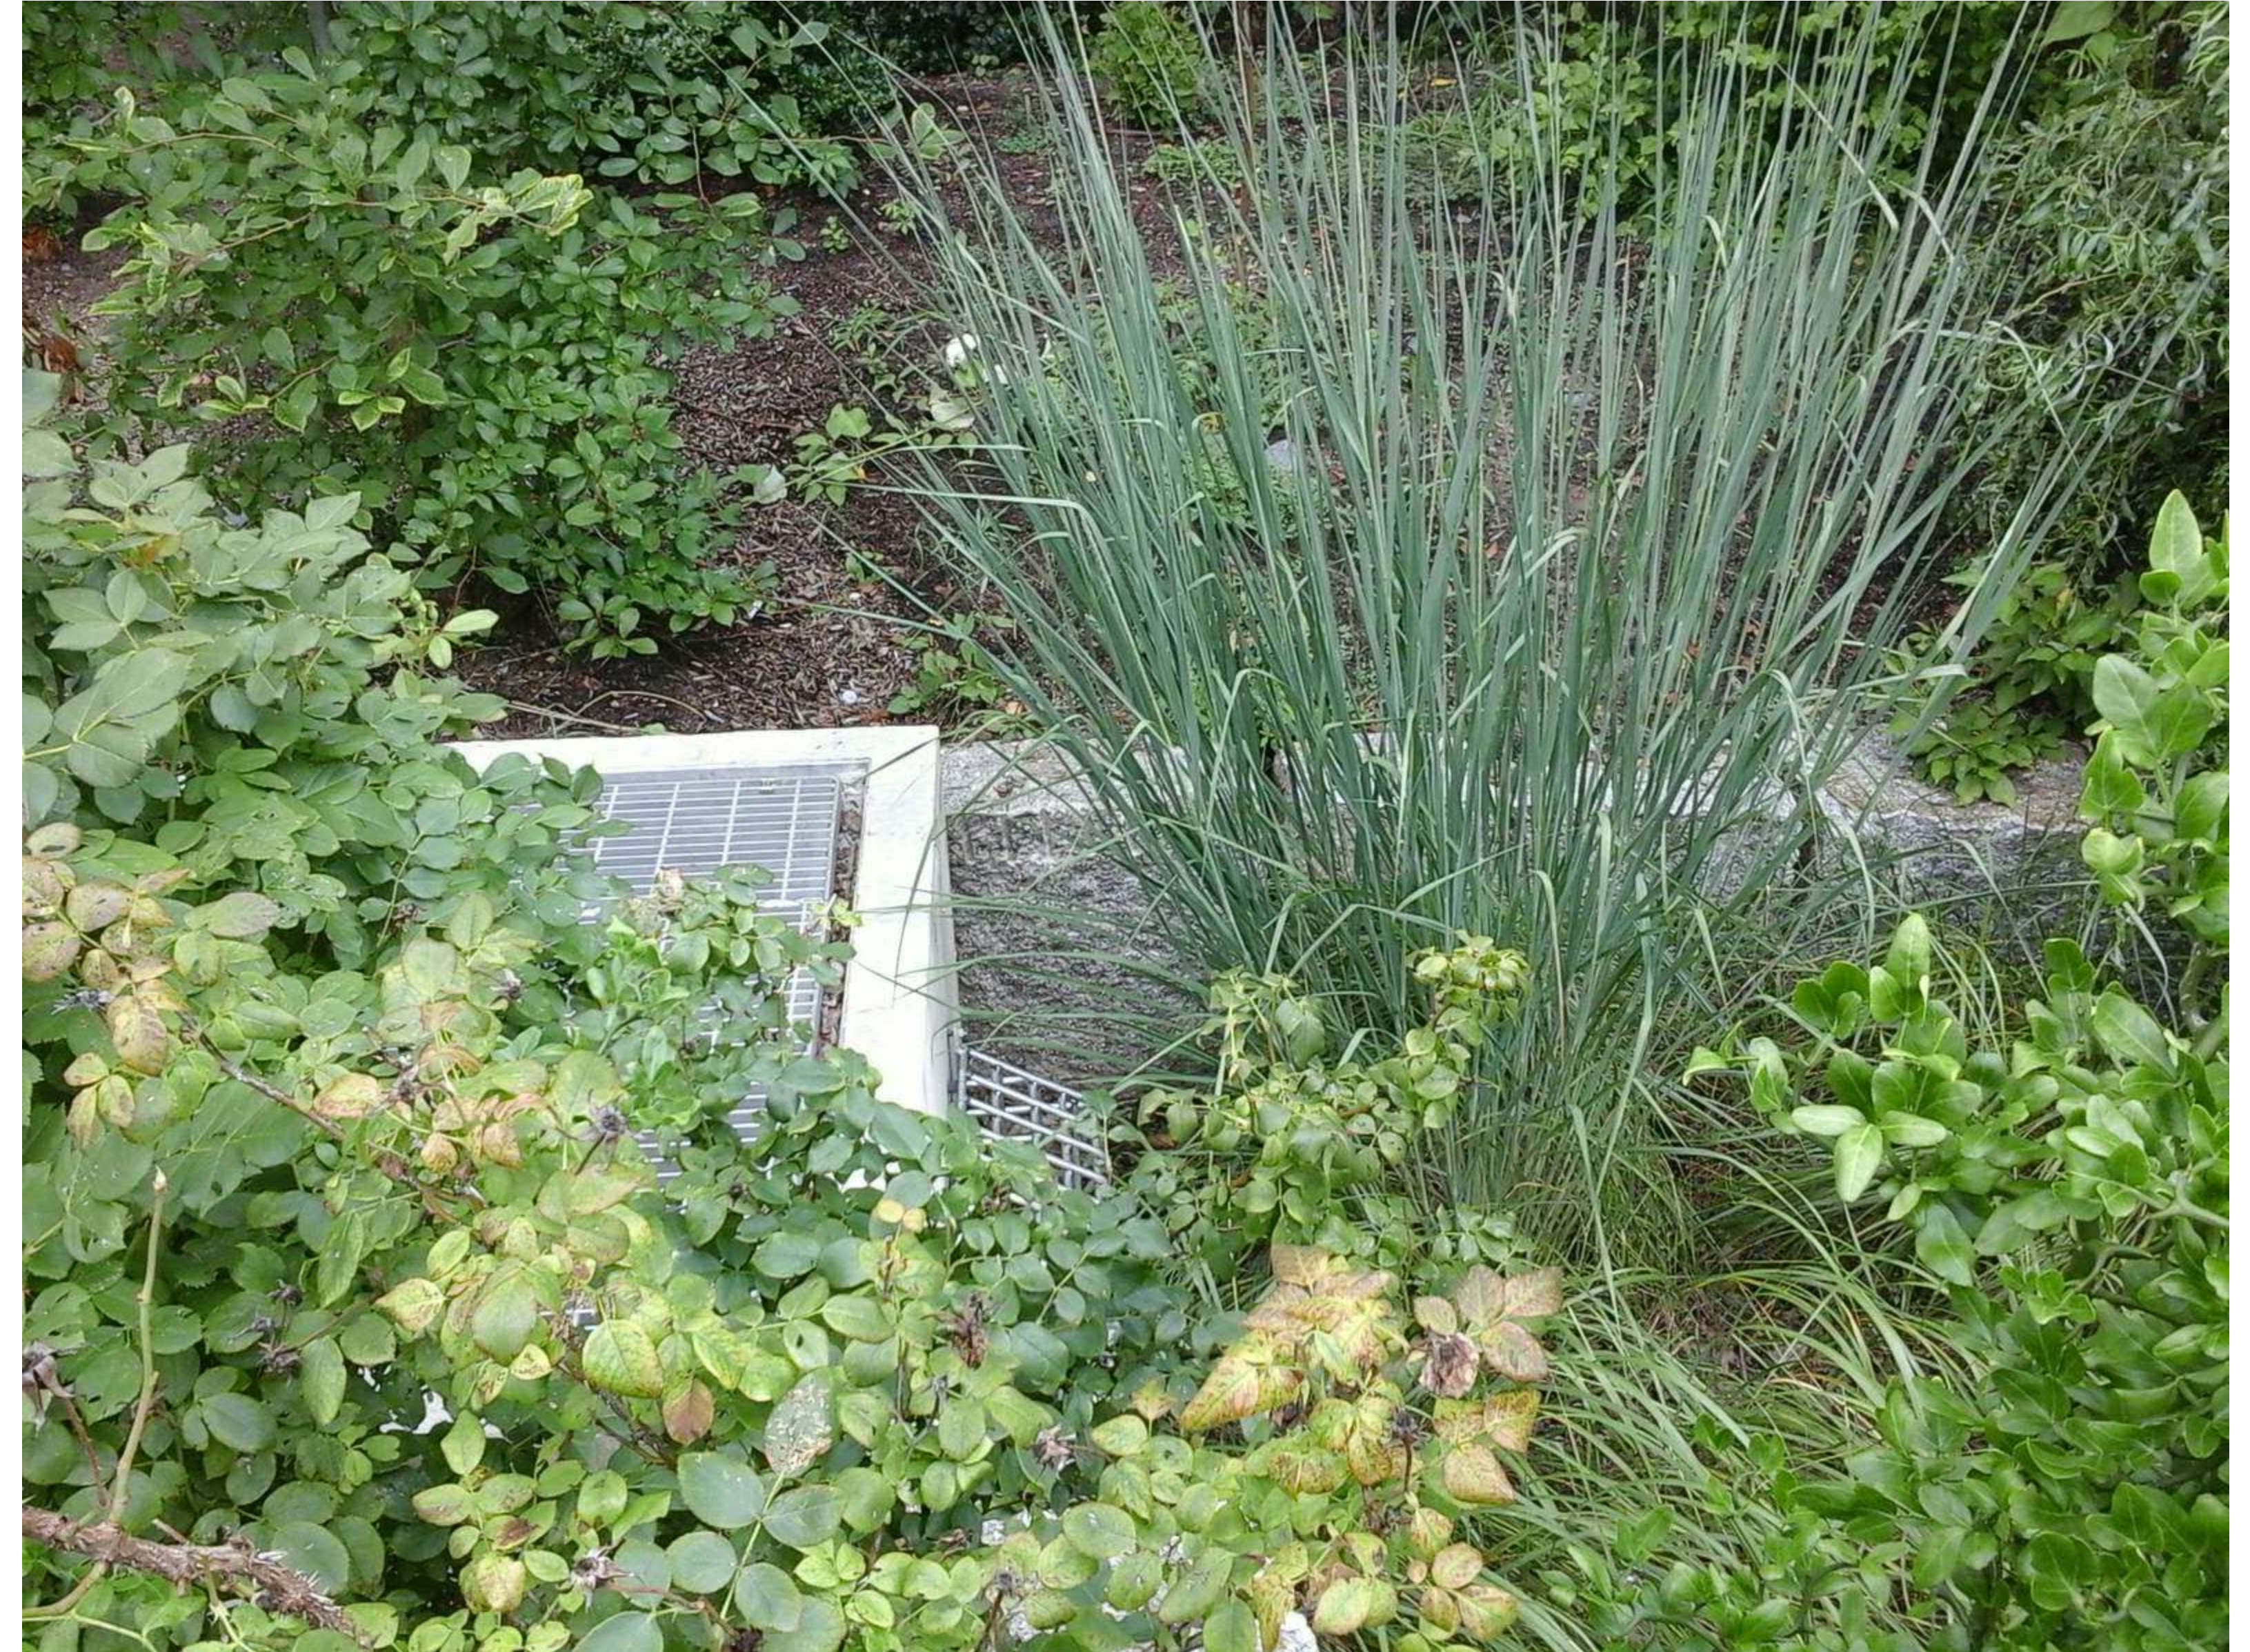
Outlet structure

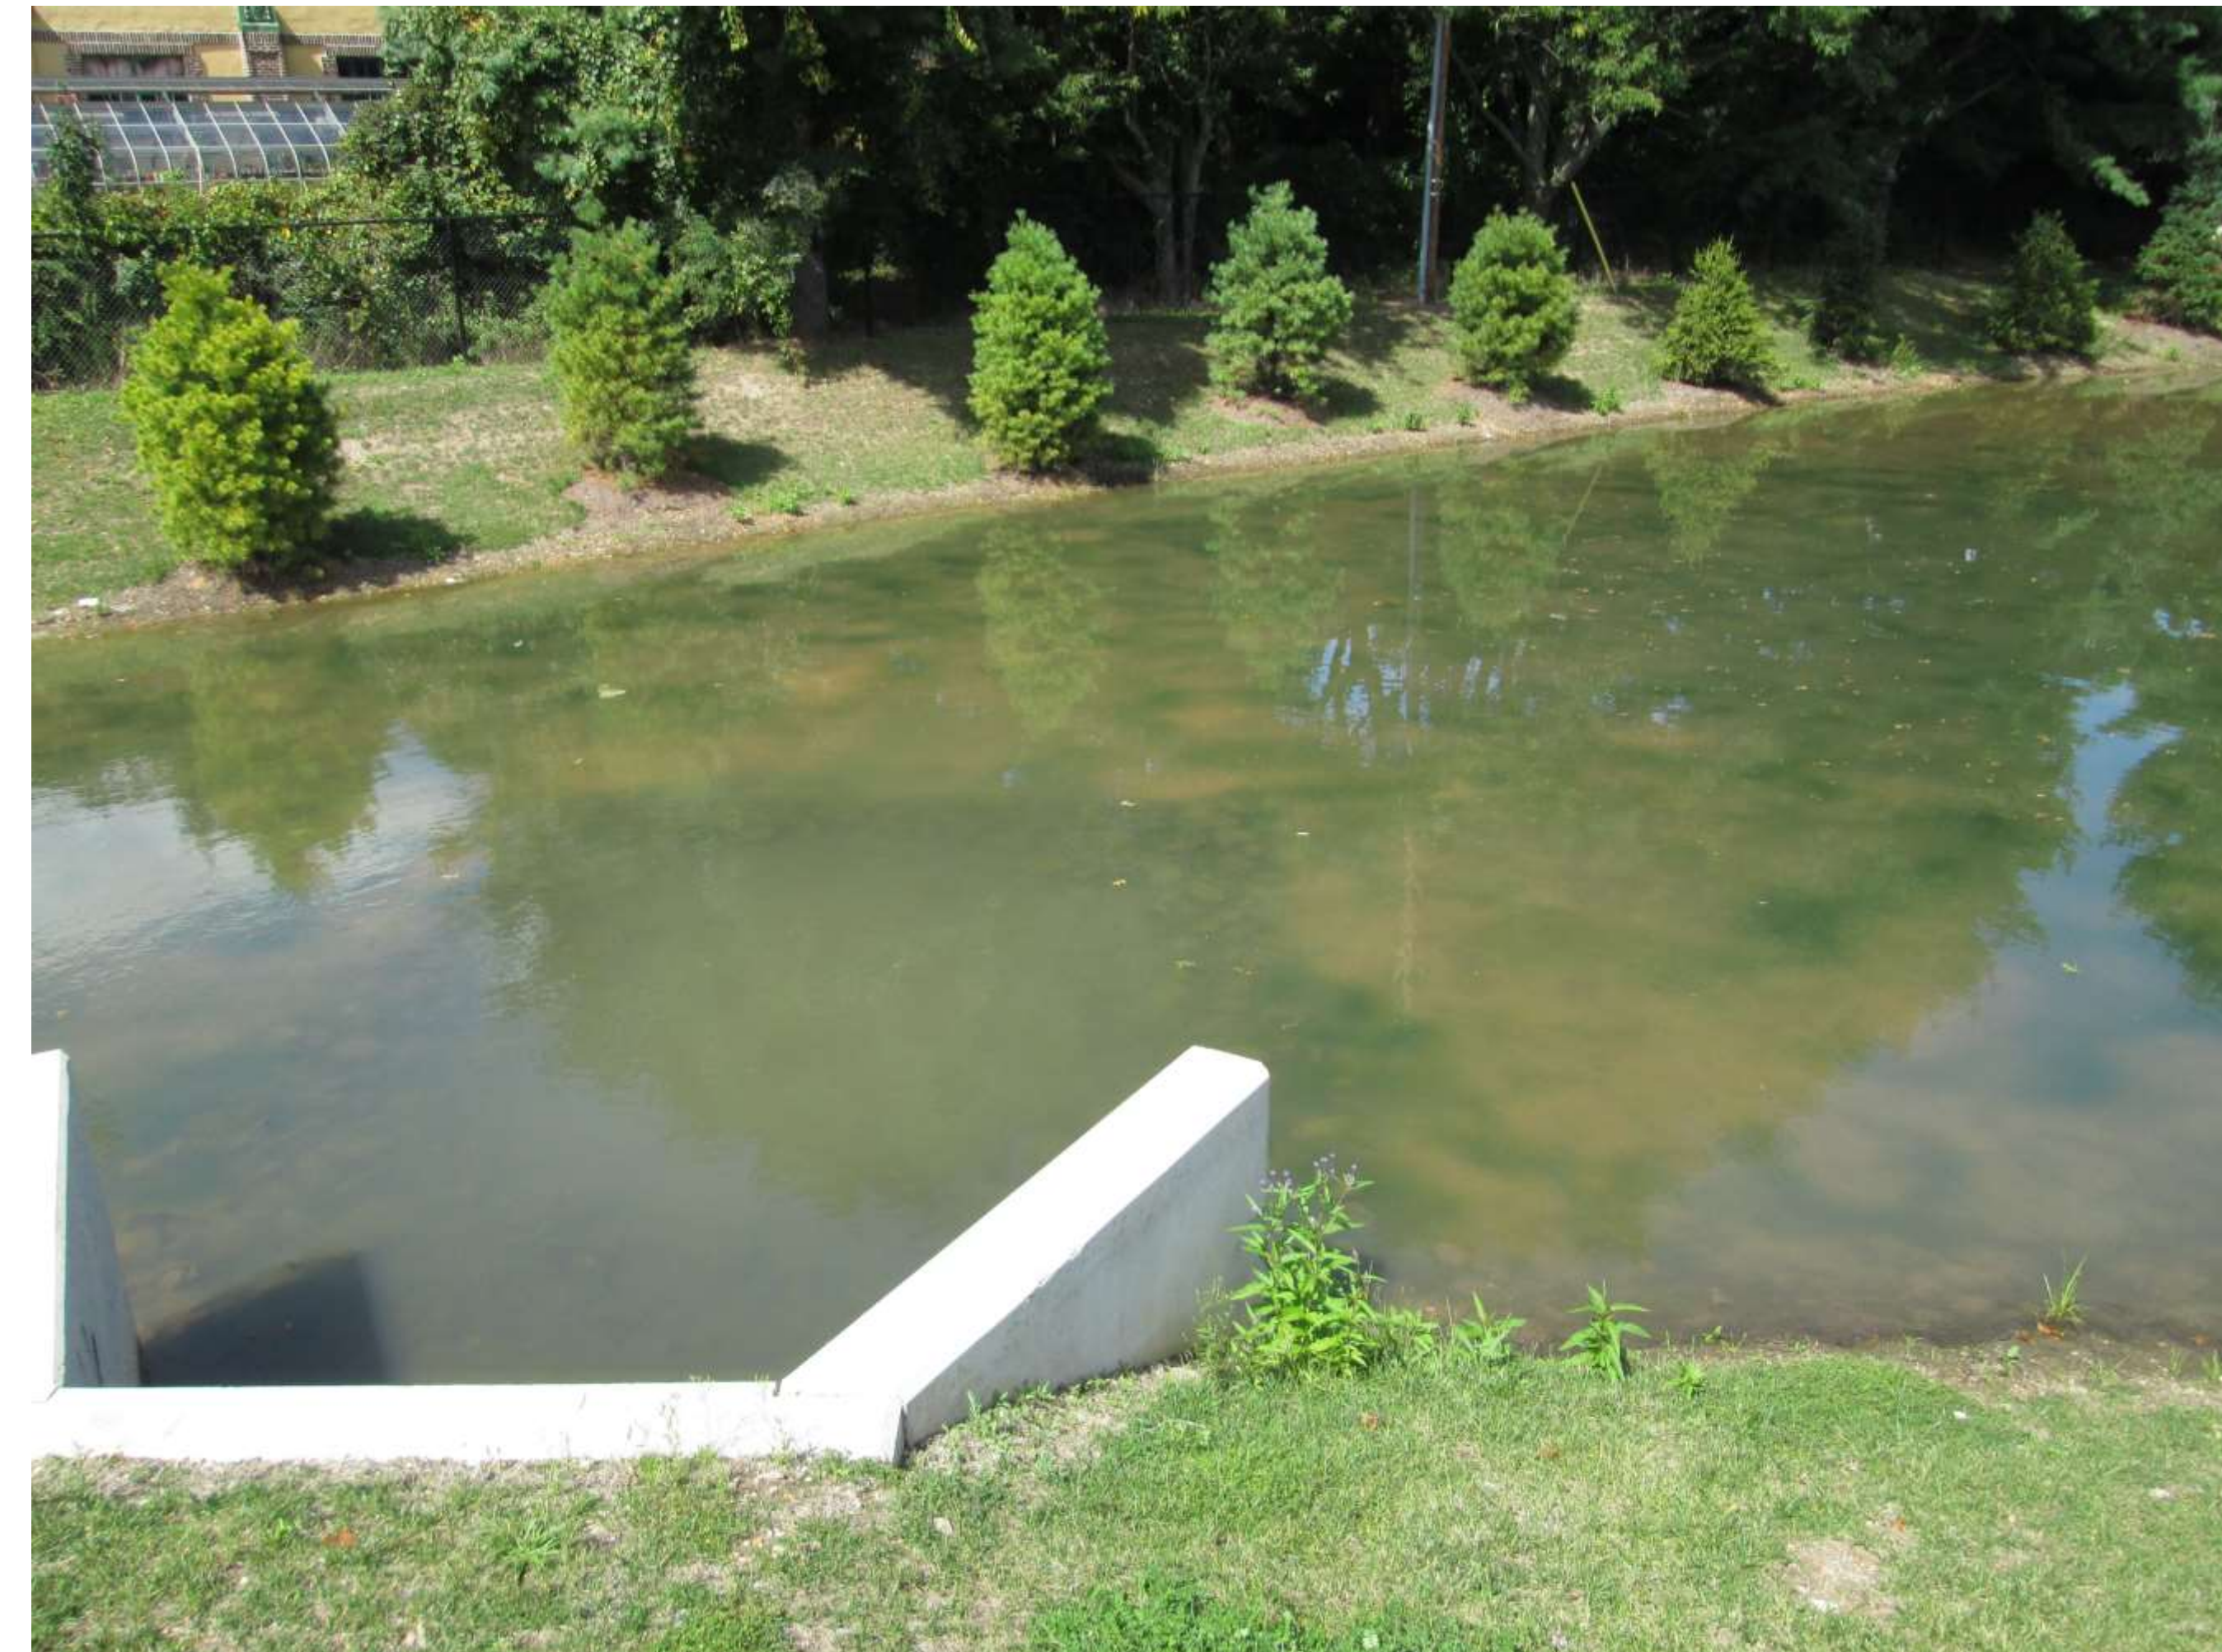
Inlet structure
