**Hamilton Township (Mercer County)
Stormwater Basin Assessment Summary
Addendum (Year 4)**

Developed by the Rutgers Cooperative Extension Water Resources Program
Funded by Hamilton Township, Mercer County, New Jersey

December 2017

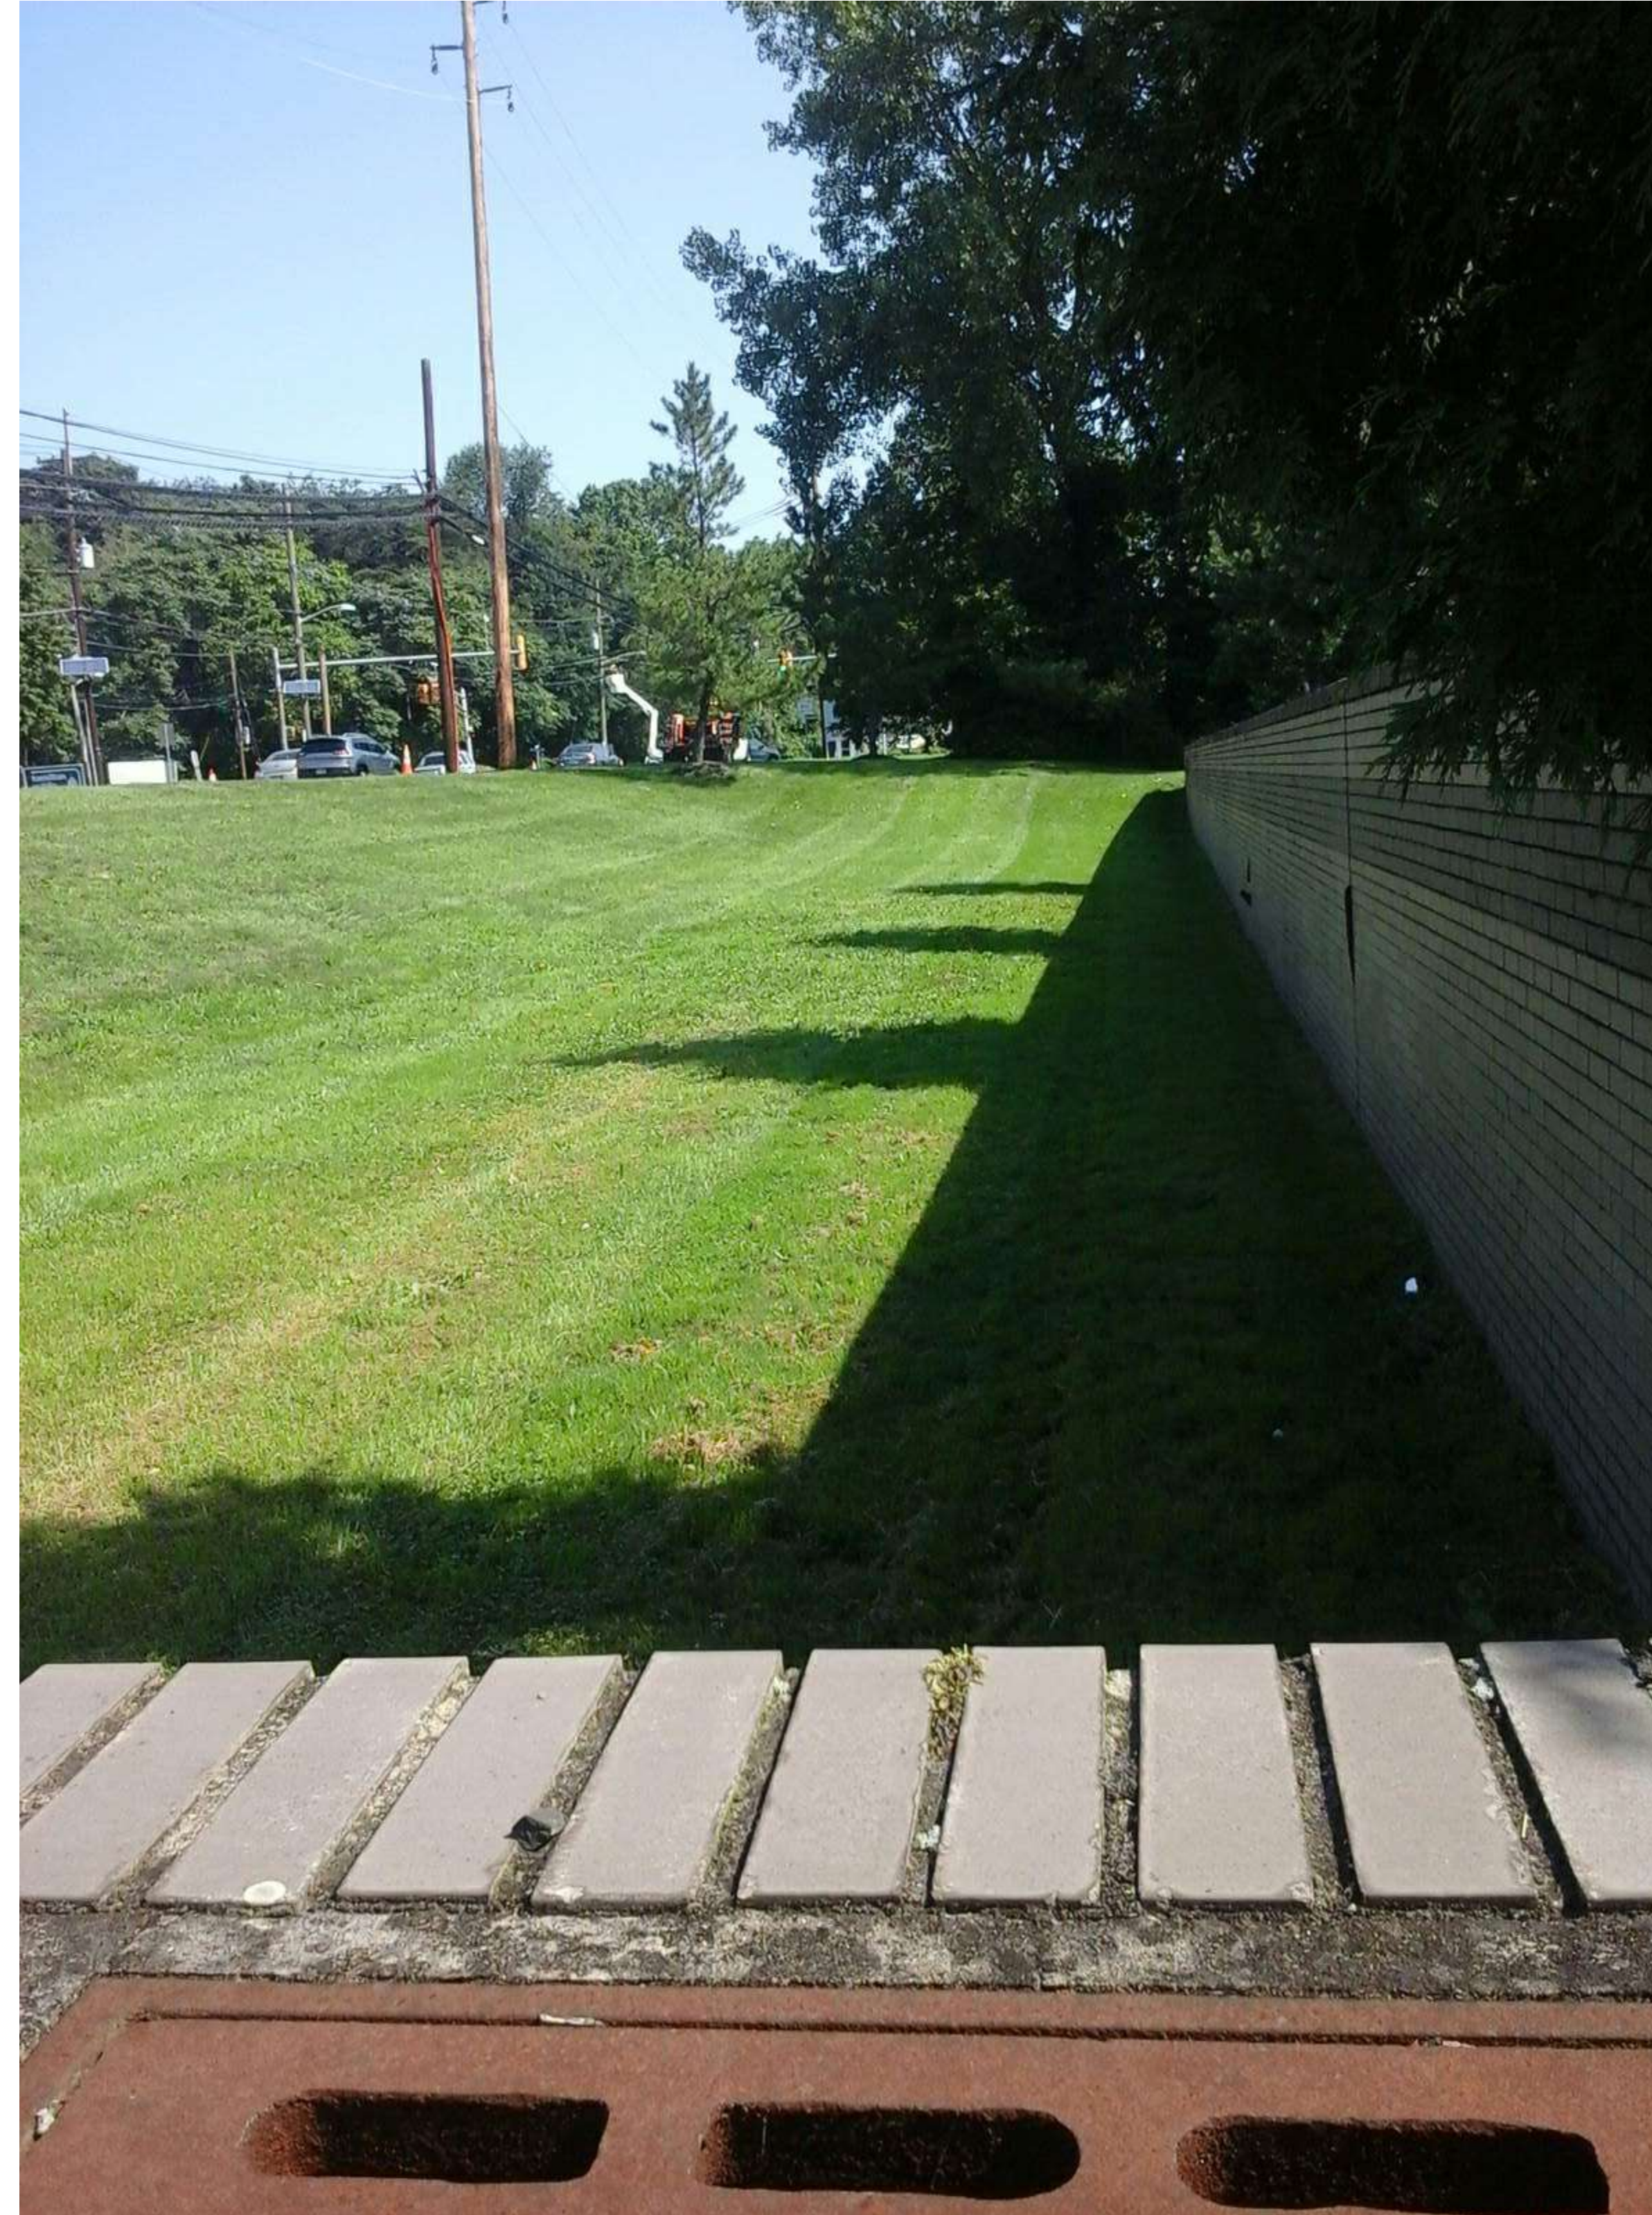
Outlet structure

- Minor sediment accumulation near inlet
- Reduce mowing and establish meadows to allow for better infiltration

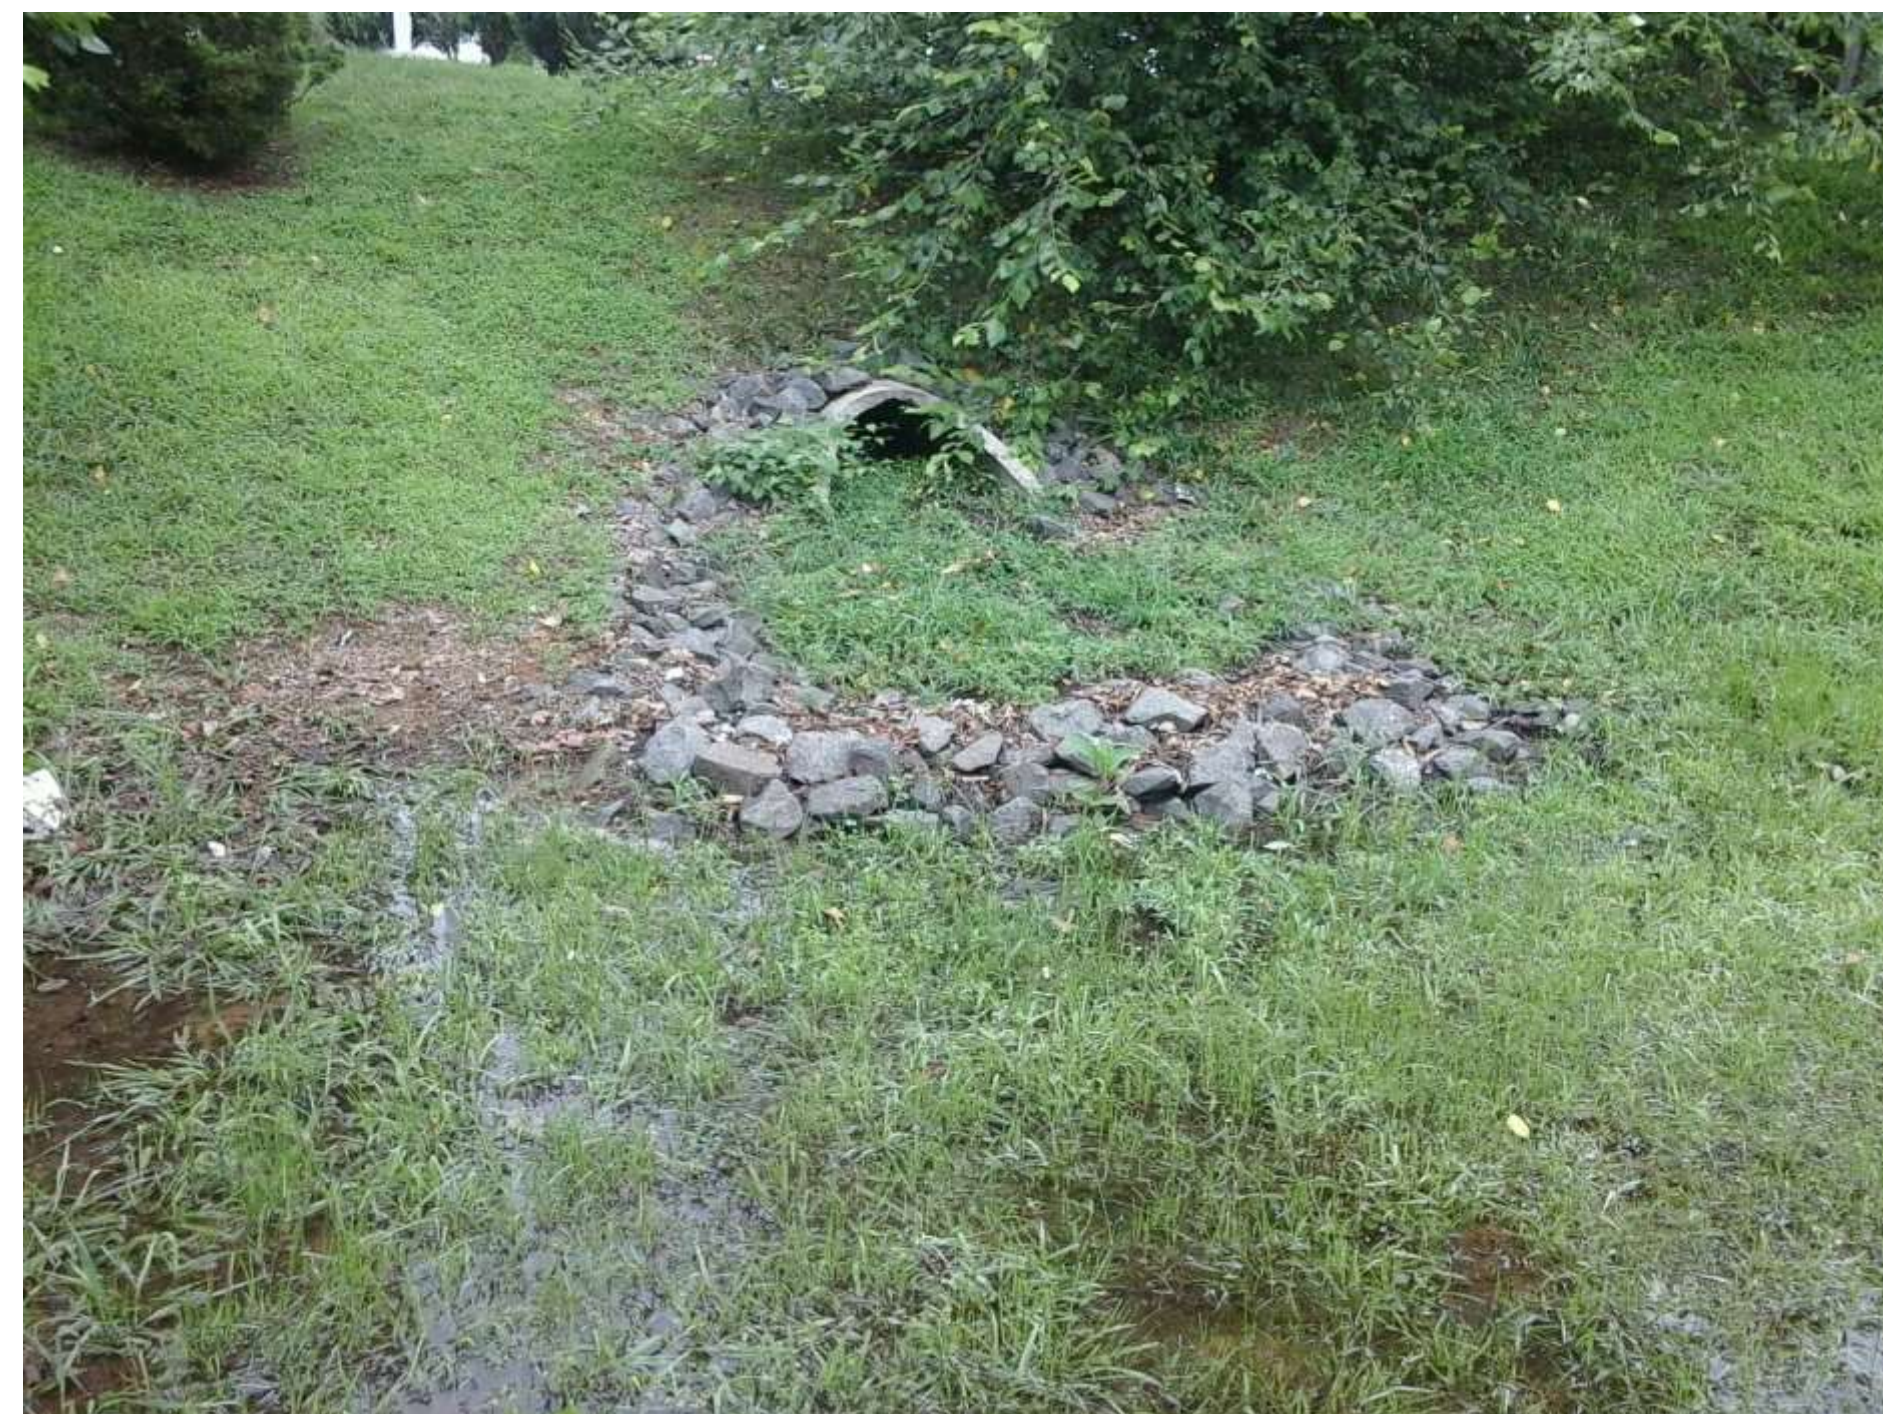
Inlet

- Sediment and standing water at inlet grate
- Some debris present, needs cleaning
- Reduce mowing to allow for better infiltration

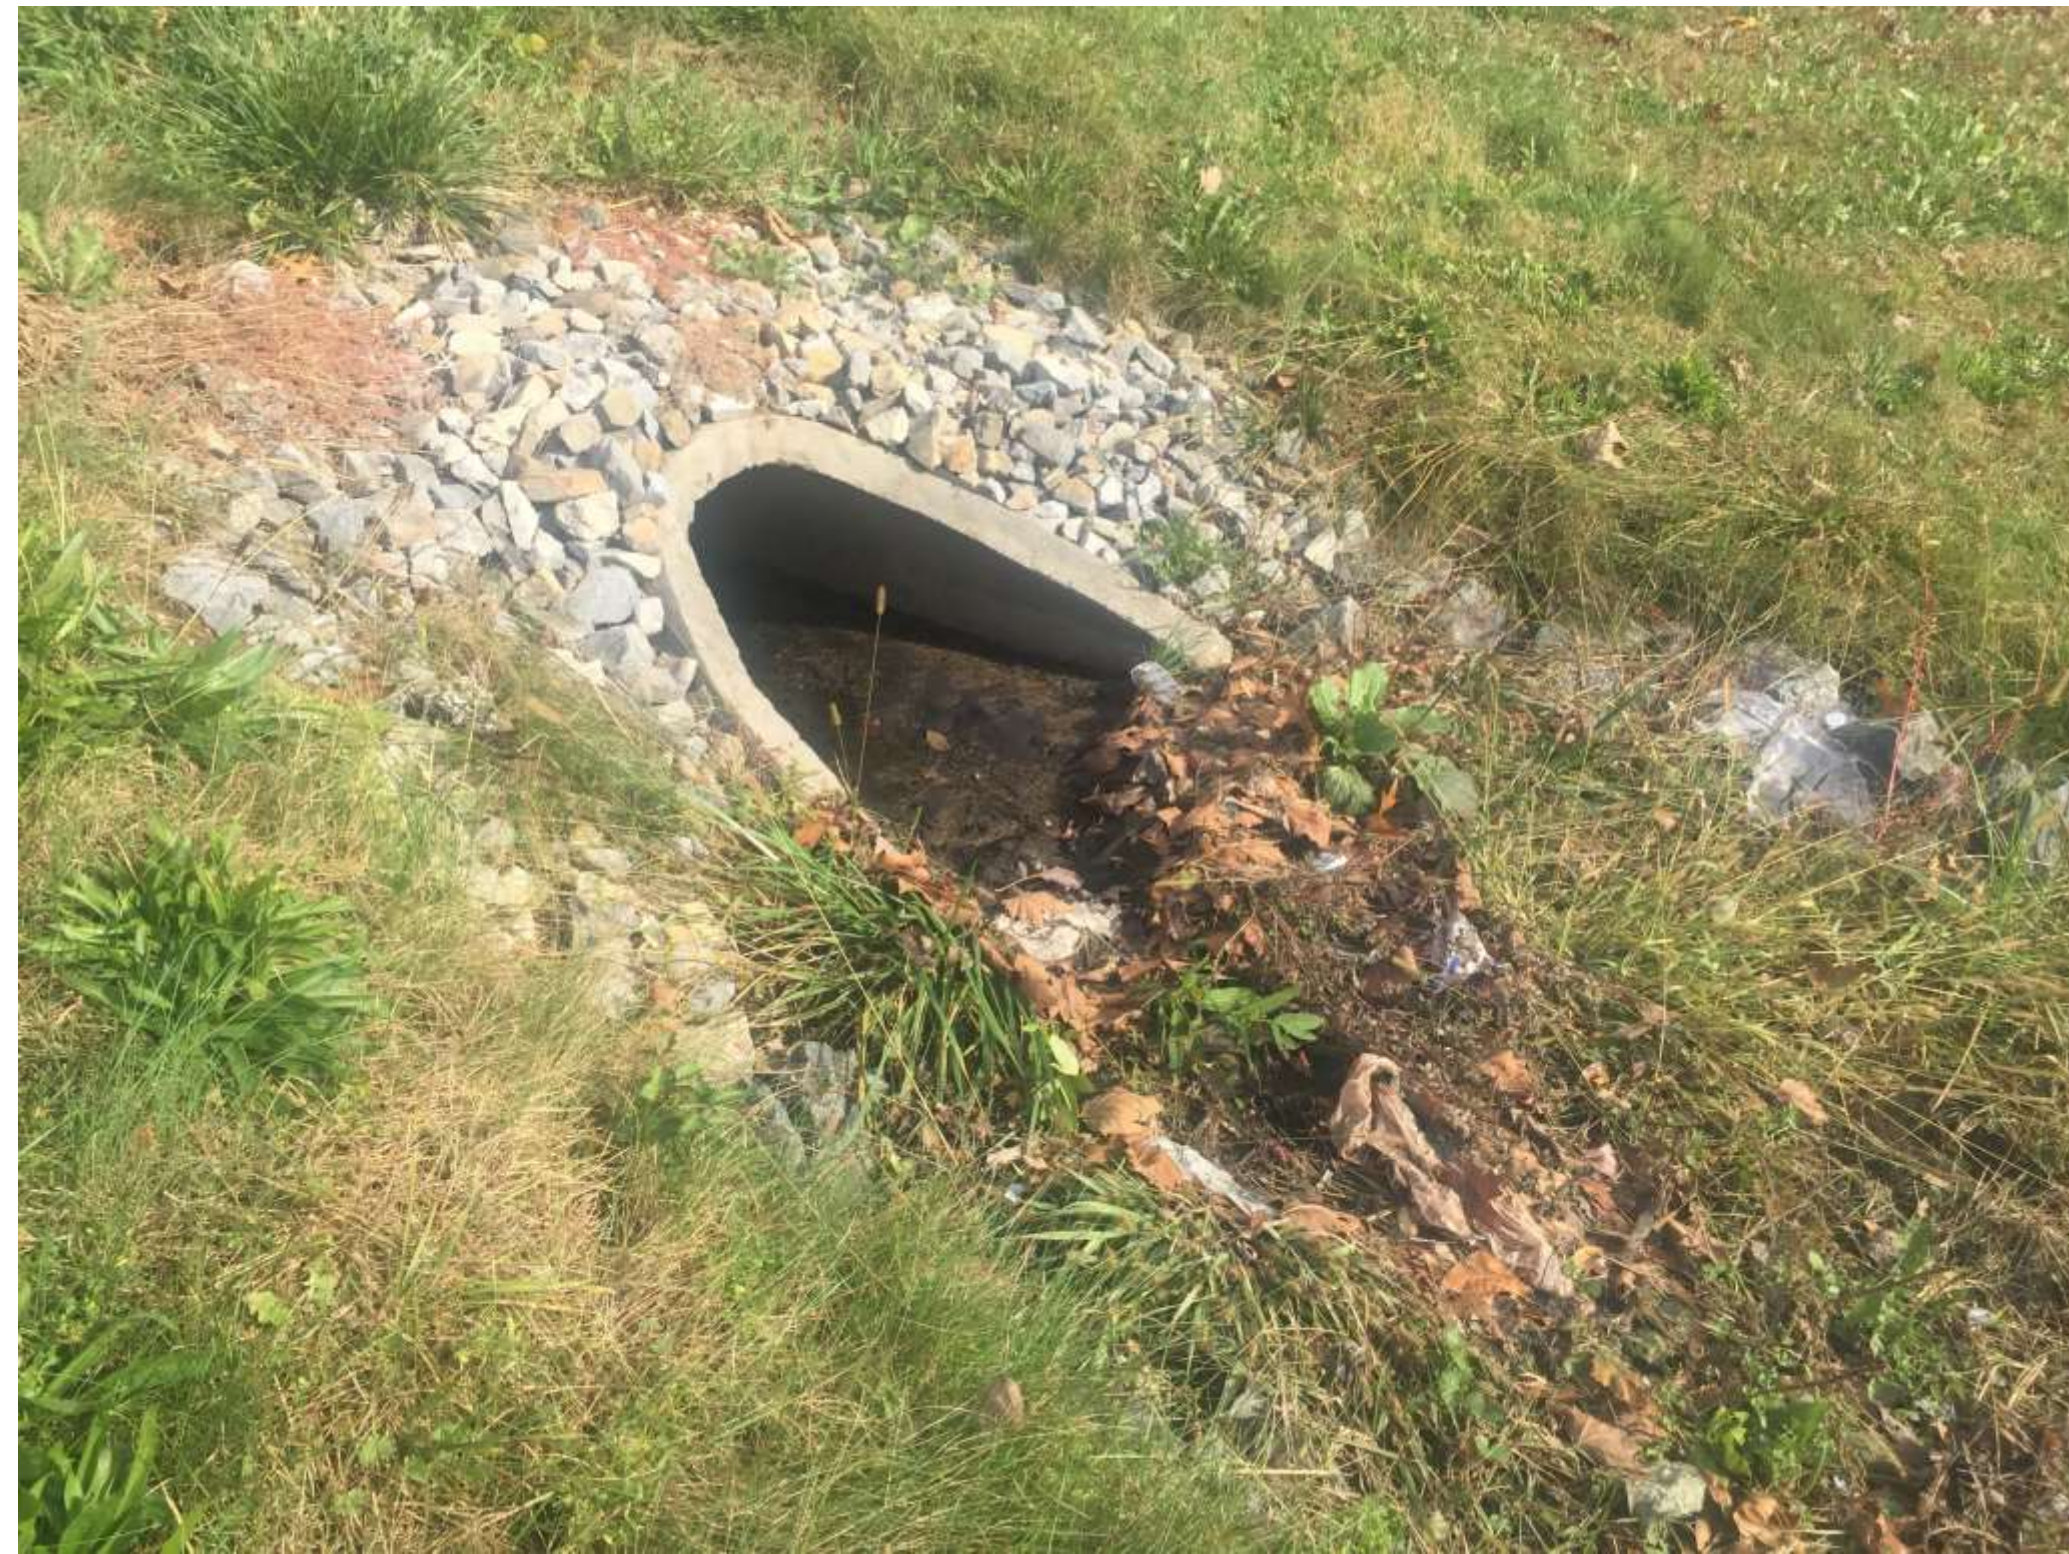
Inlet

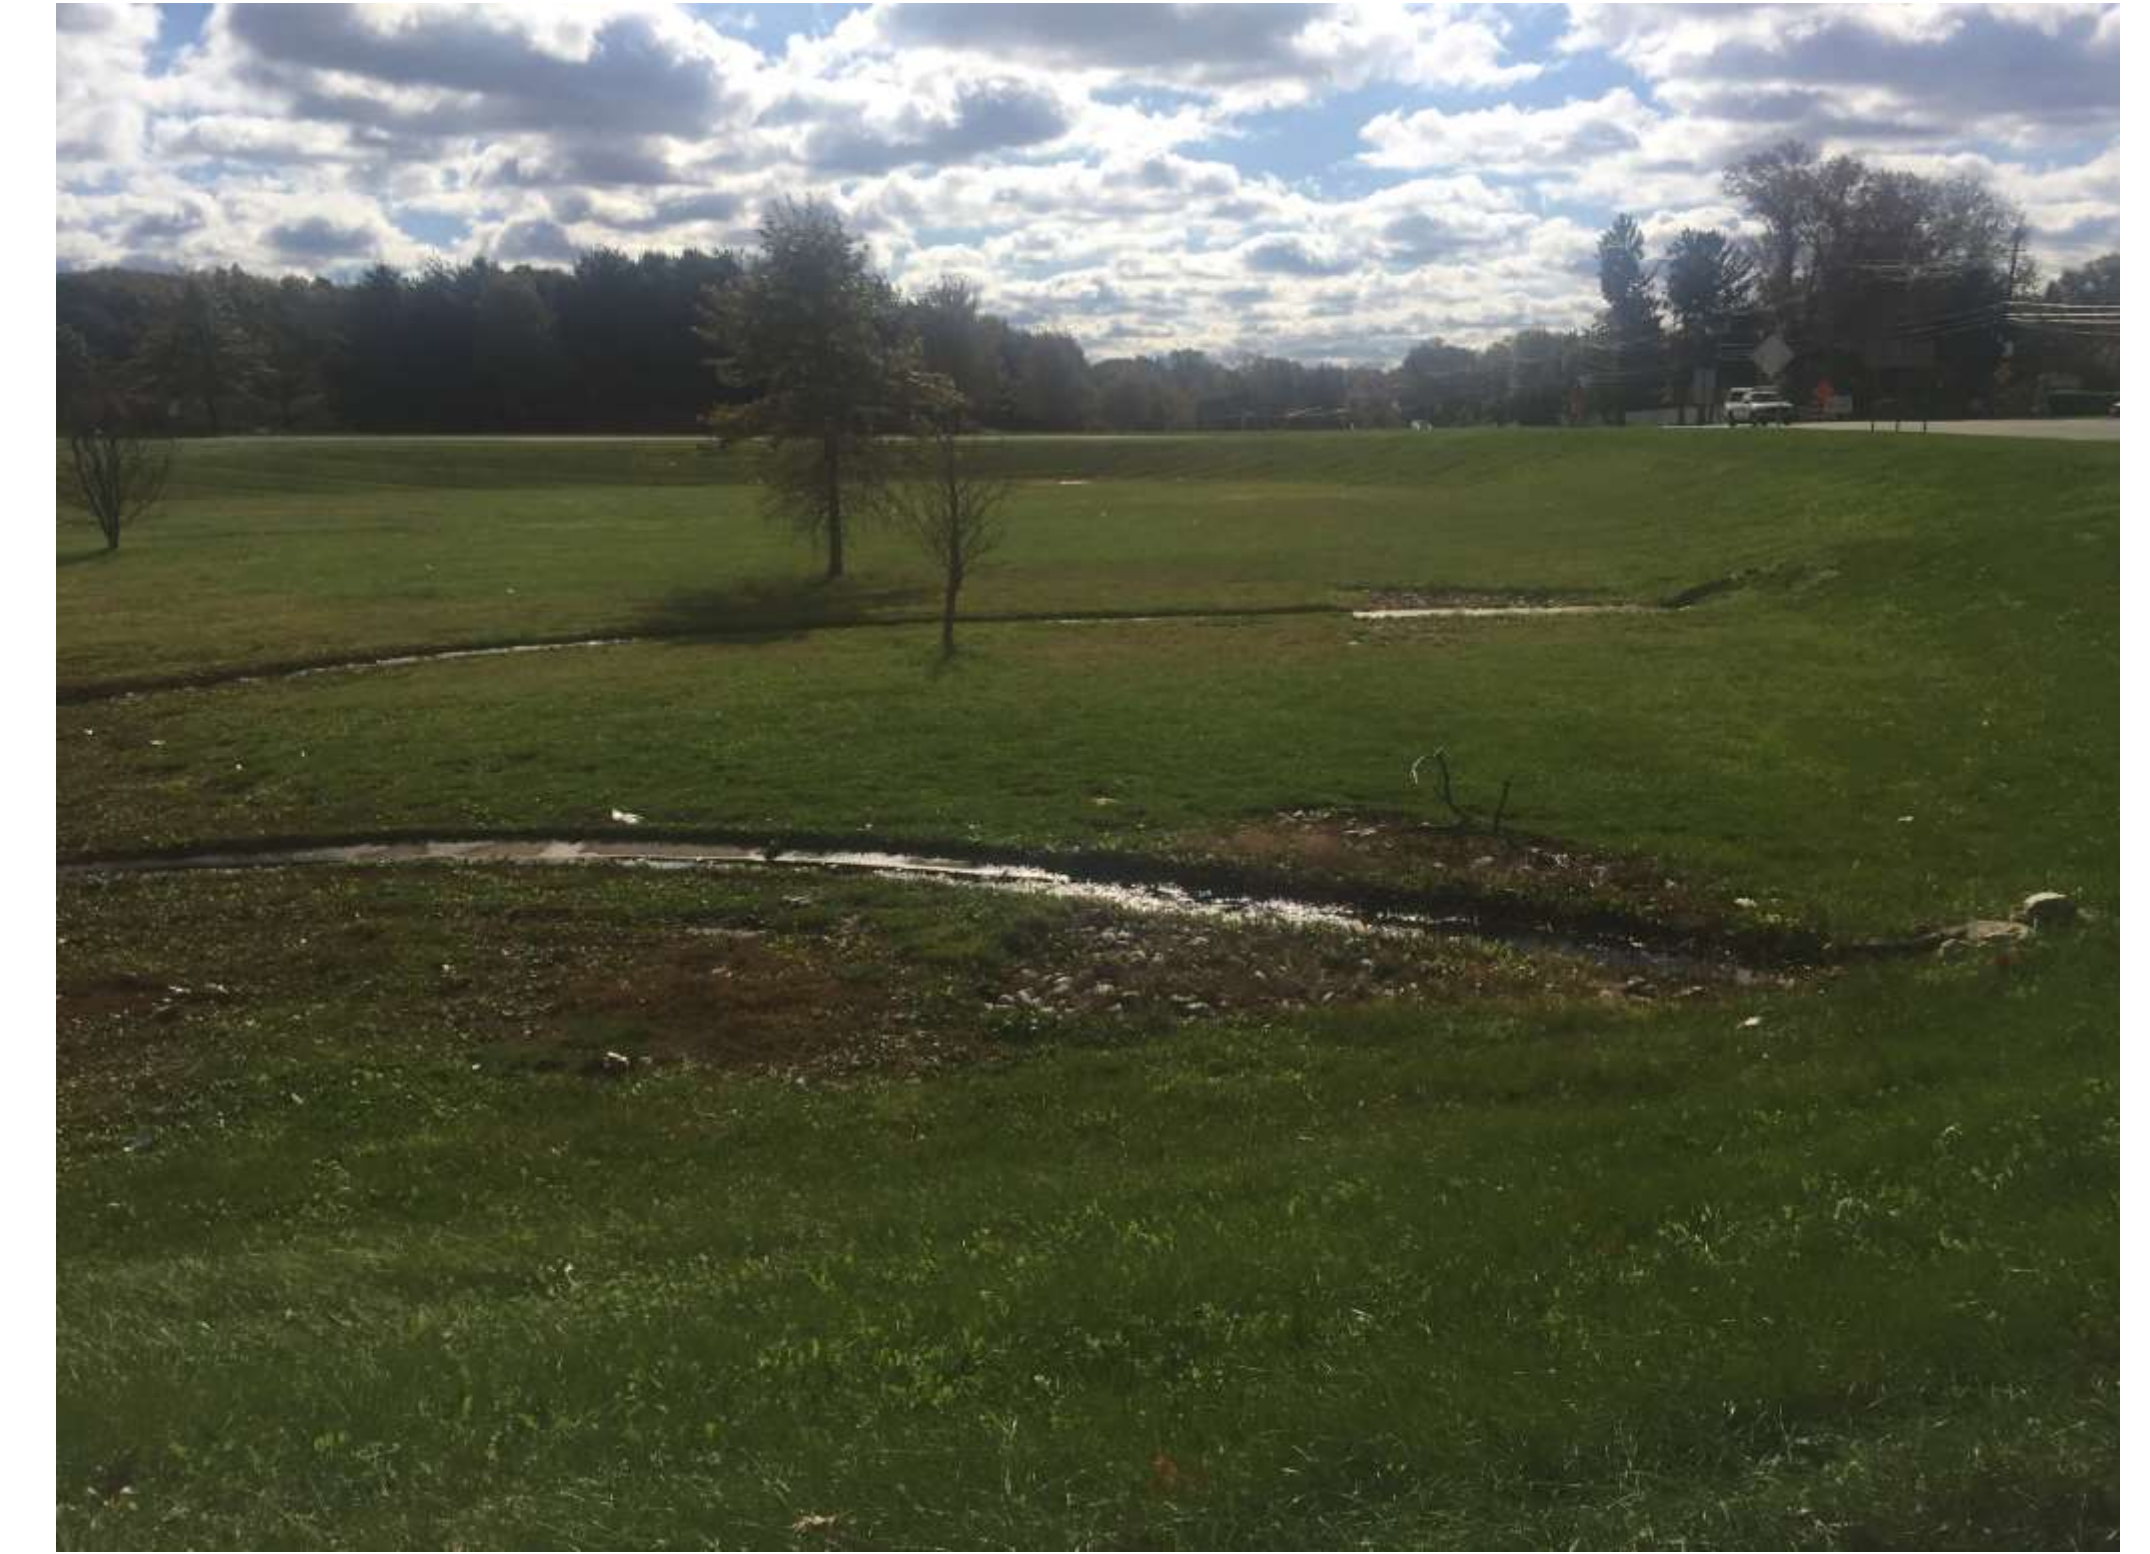
Low flow channels

- Sediment accumulation at inlets and low flow channels
- Standing water in low flow channels and outlet
- Remove low flow channels and replace with stone lined channels to improve infiltration
- Reduce mowing to improve infiltration

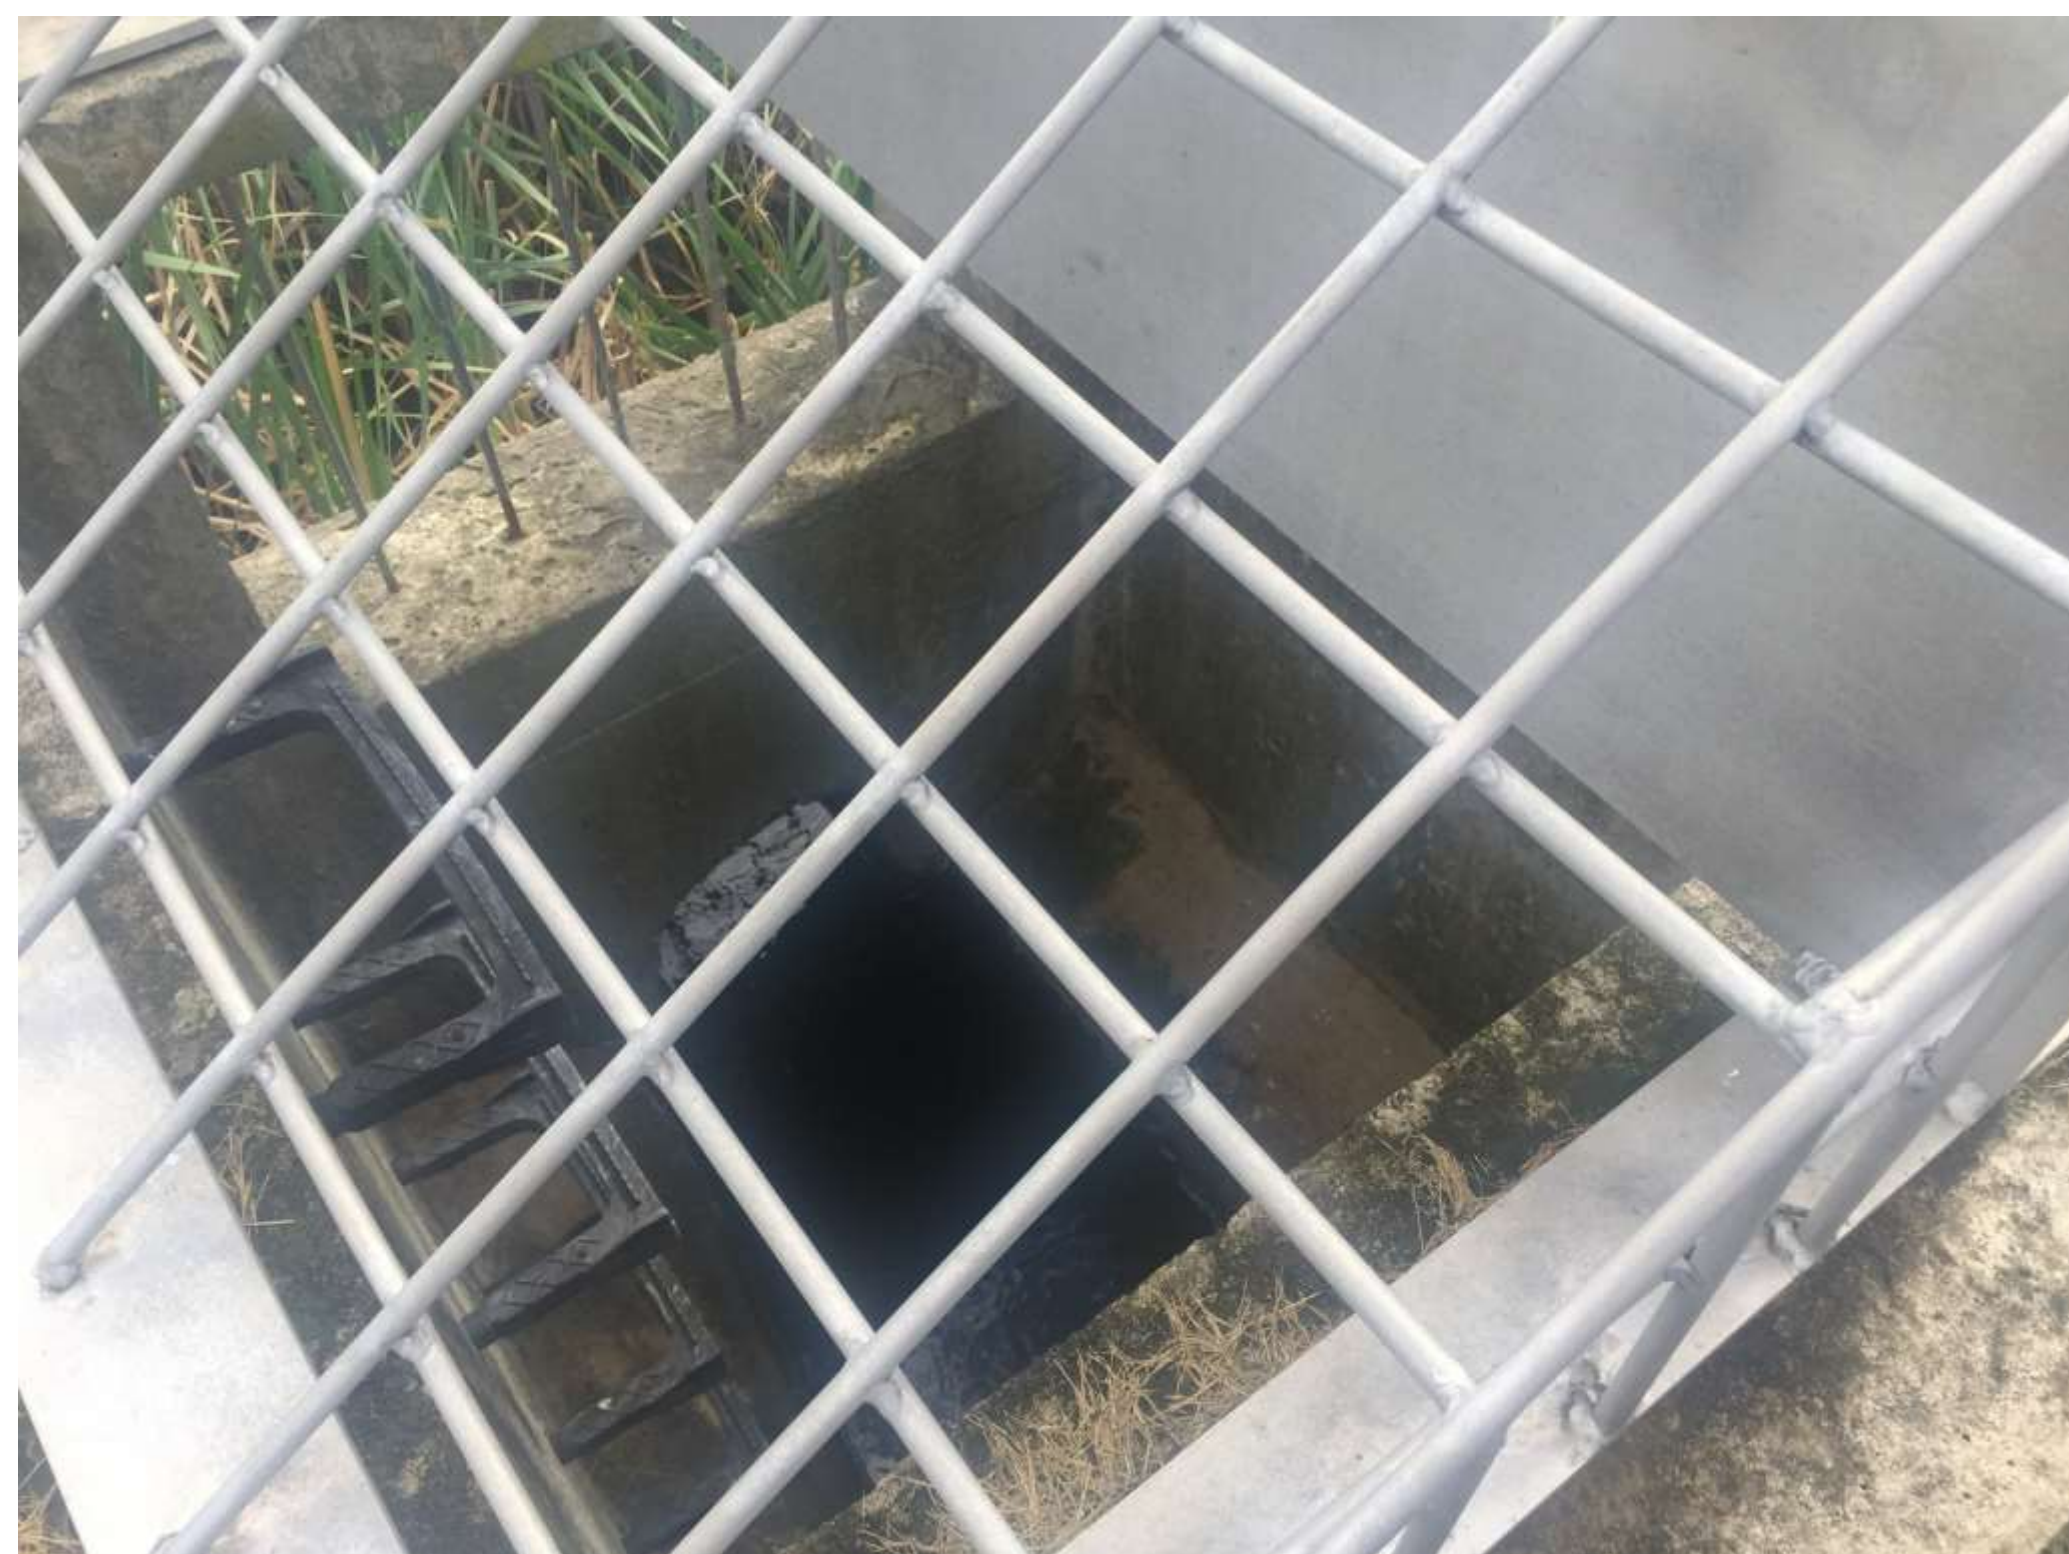
Outlet

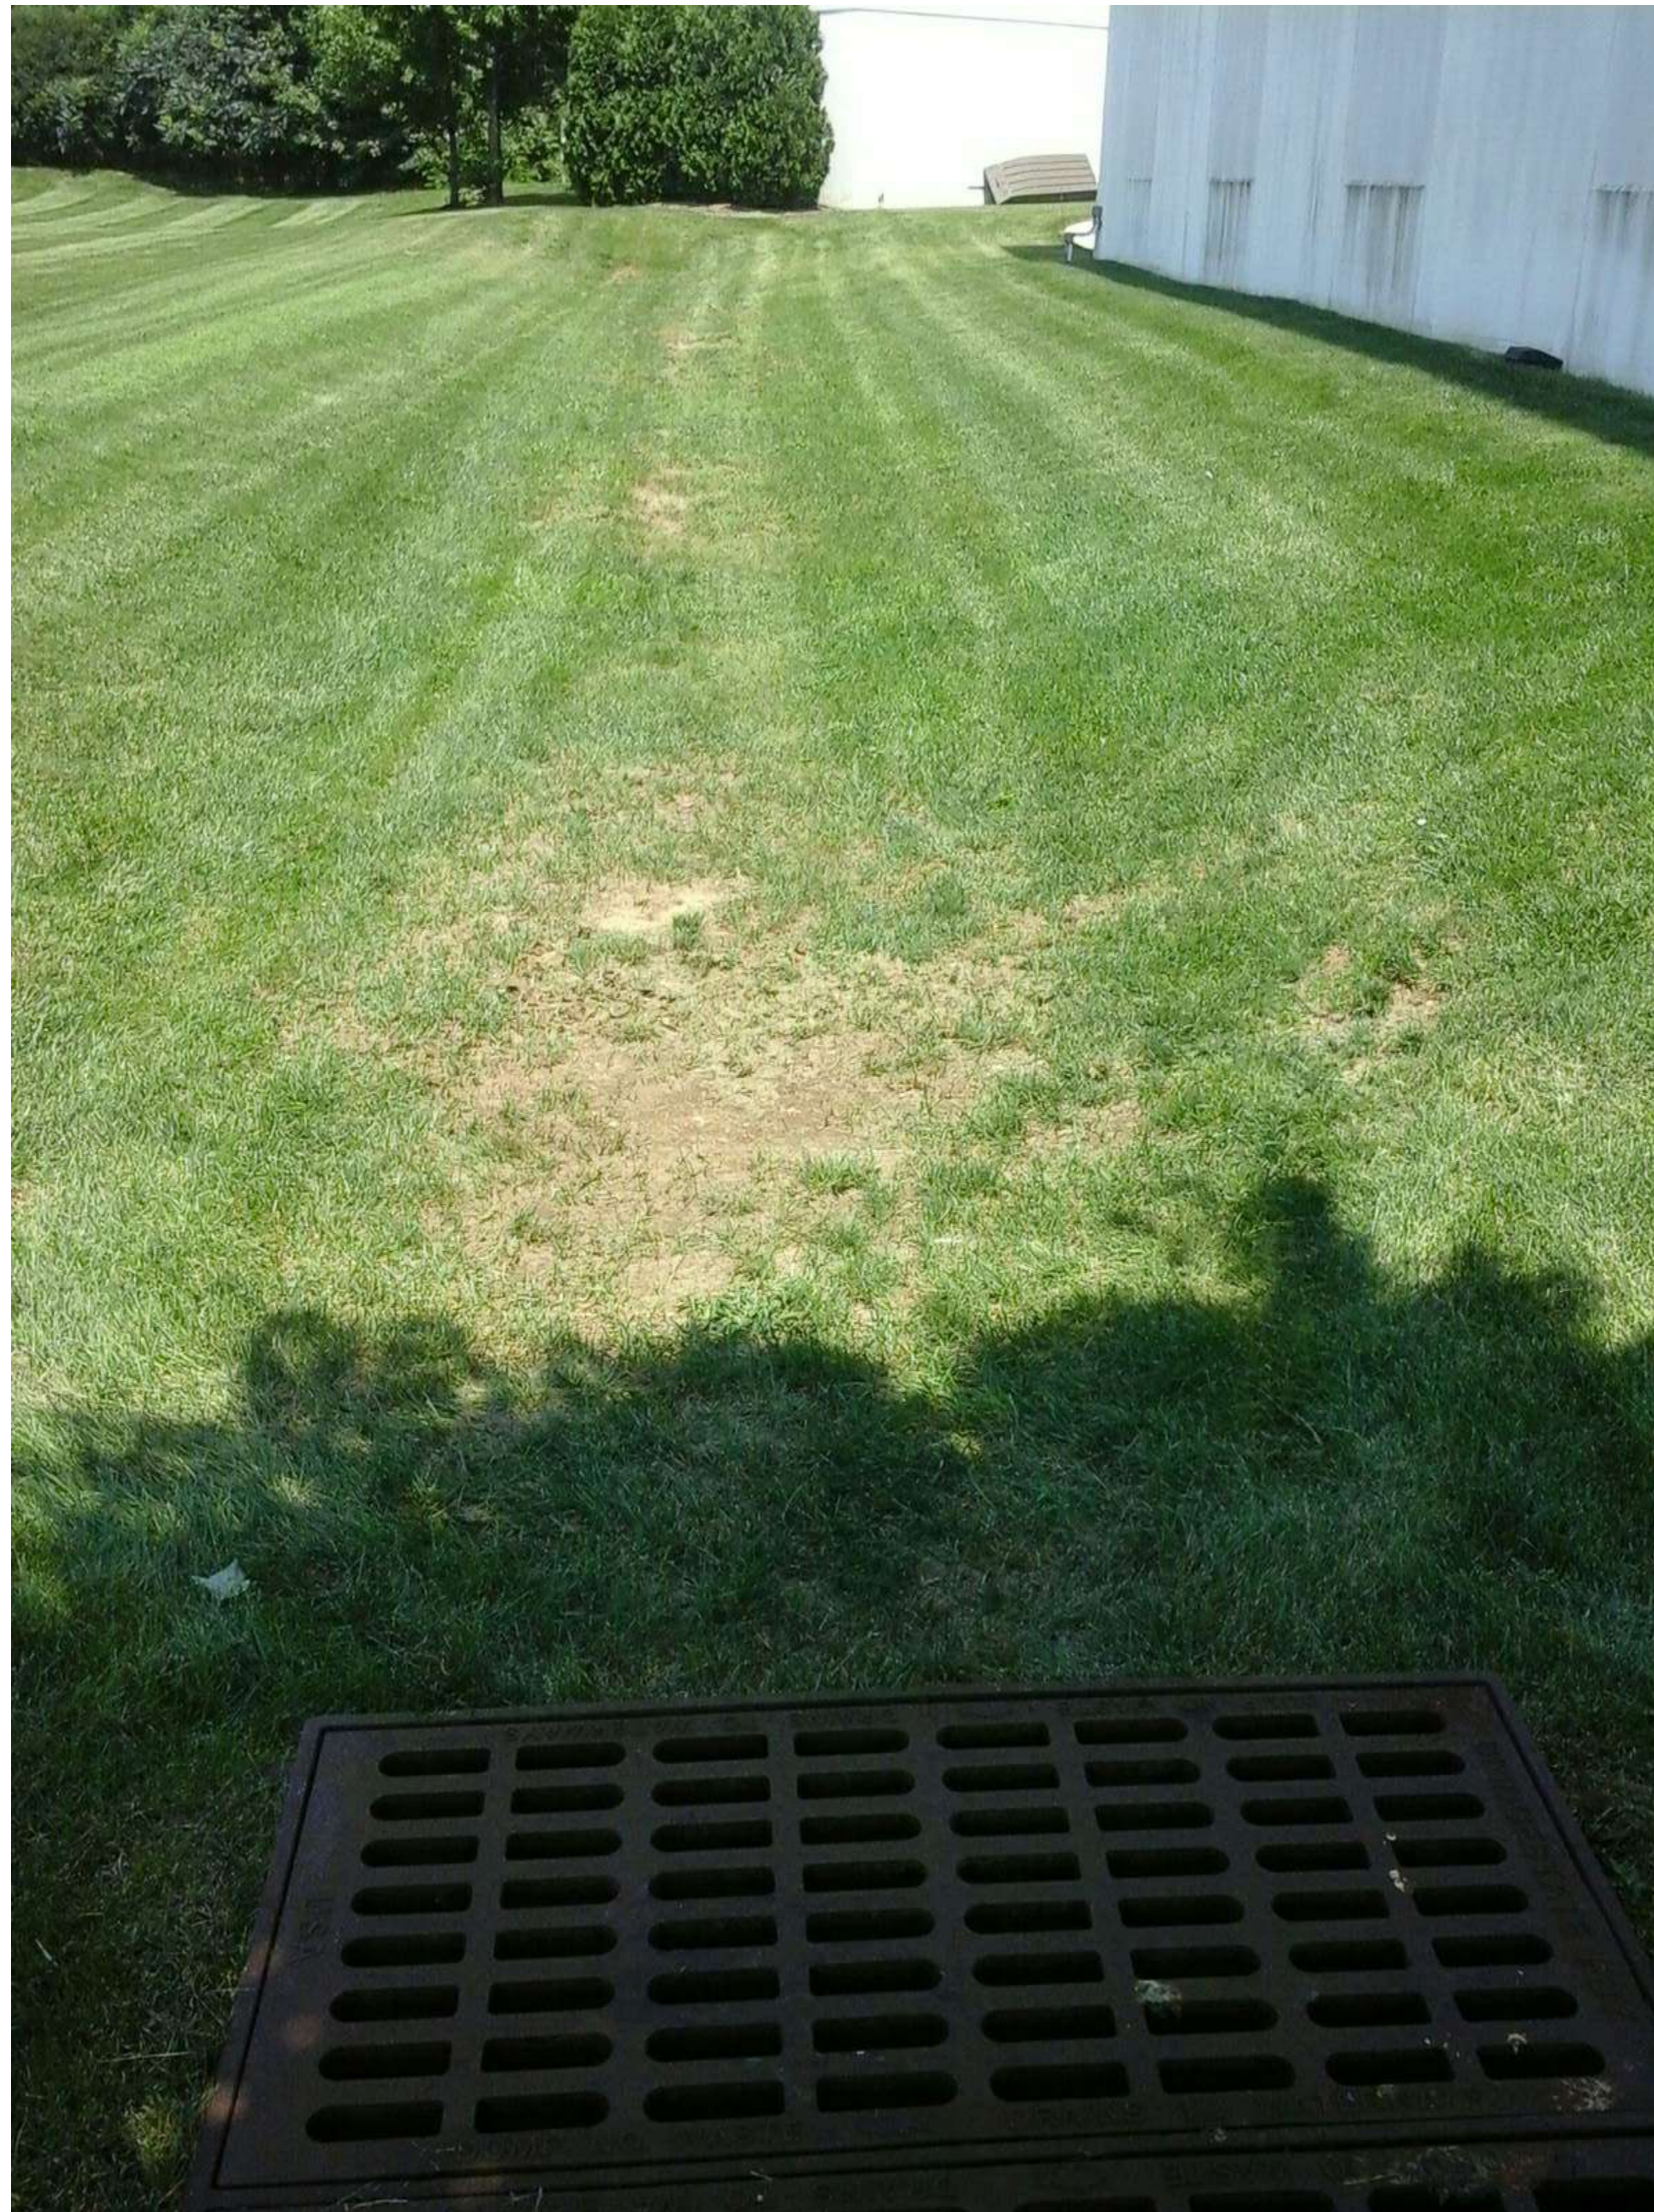
Basin bottom and outlet

- Infiltration basin
- Reduce mowing to improve habitat and reduce erosion
