**Hamilton Township (Mercer County)
Stormwater Basin Assessment Summary
Addendum (Year 4)**

Developed by the Rutgers Cooperative Extension Water Resources Program
Funded by Hamilton Township, Mercer County, New Jersey

December 2017

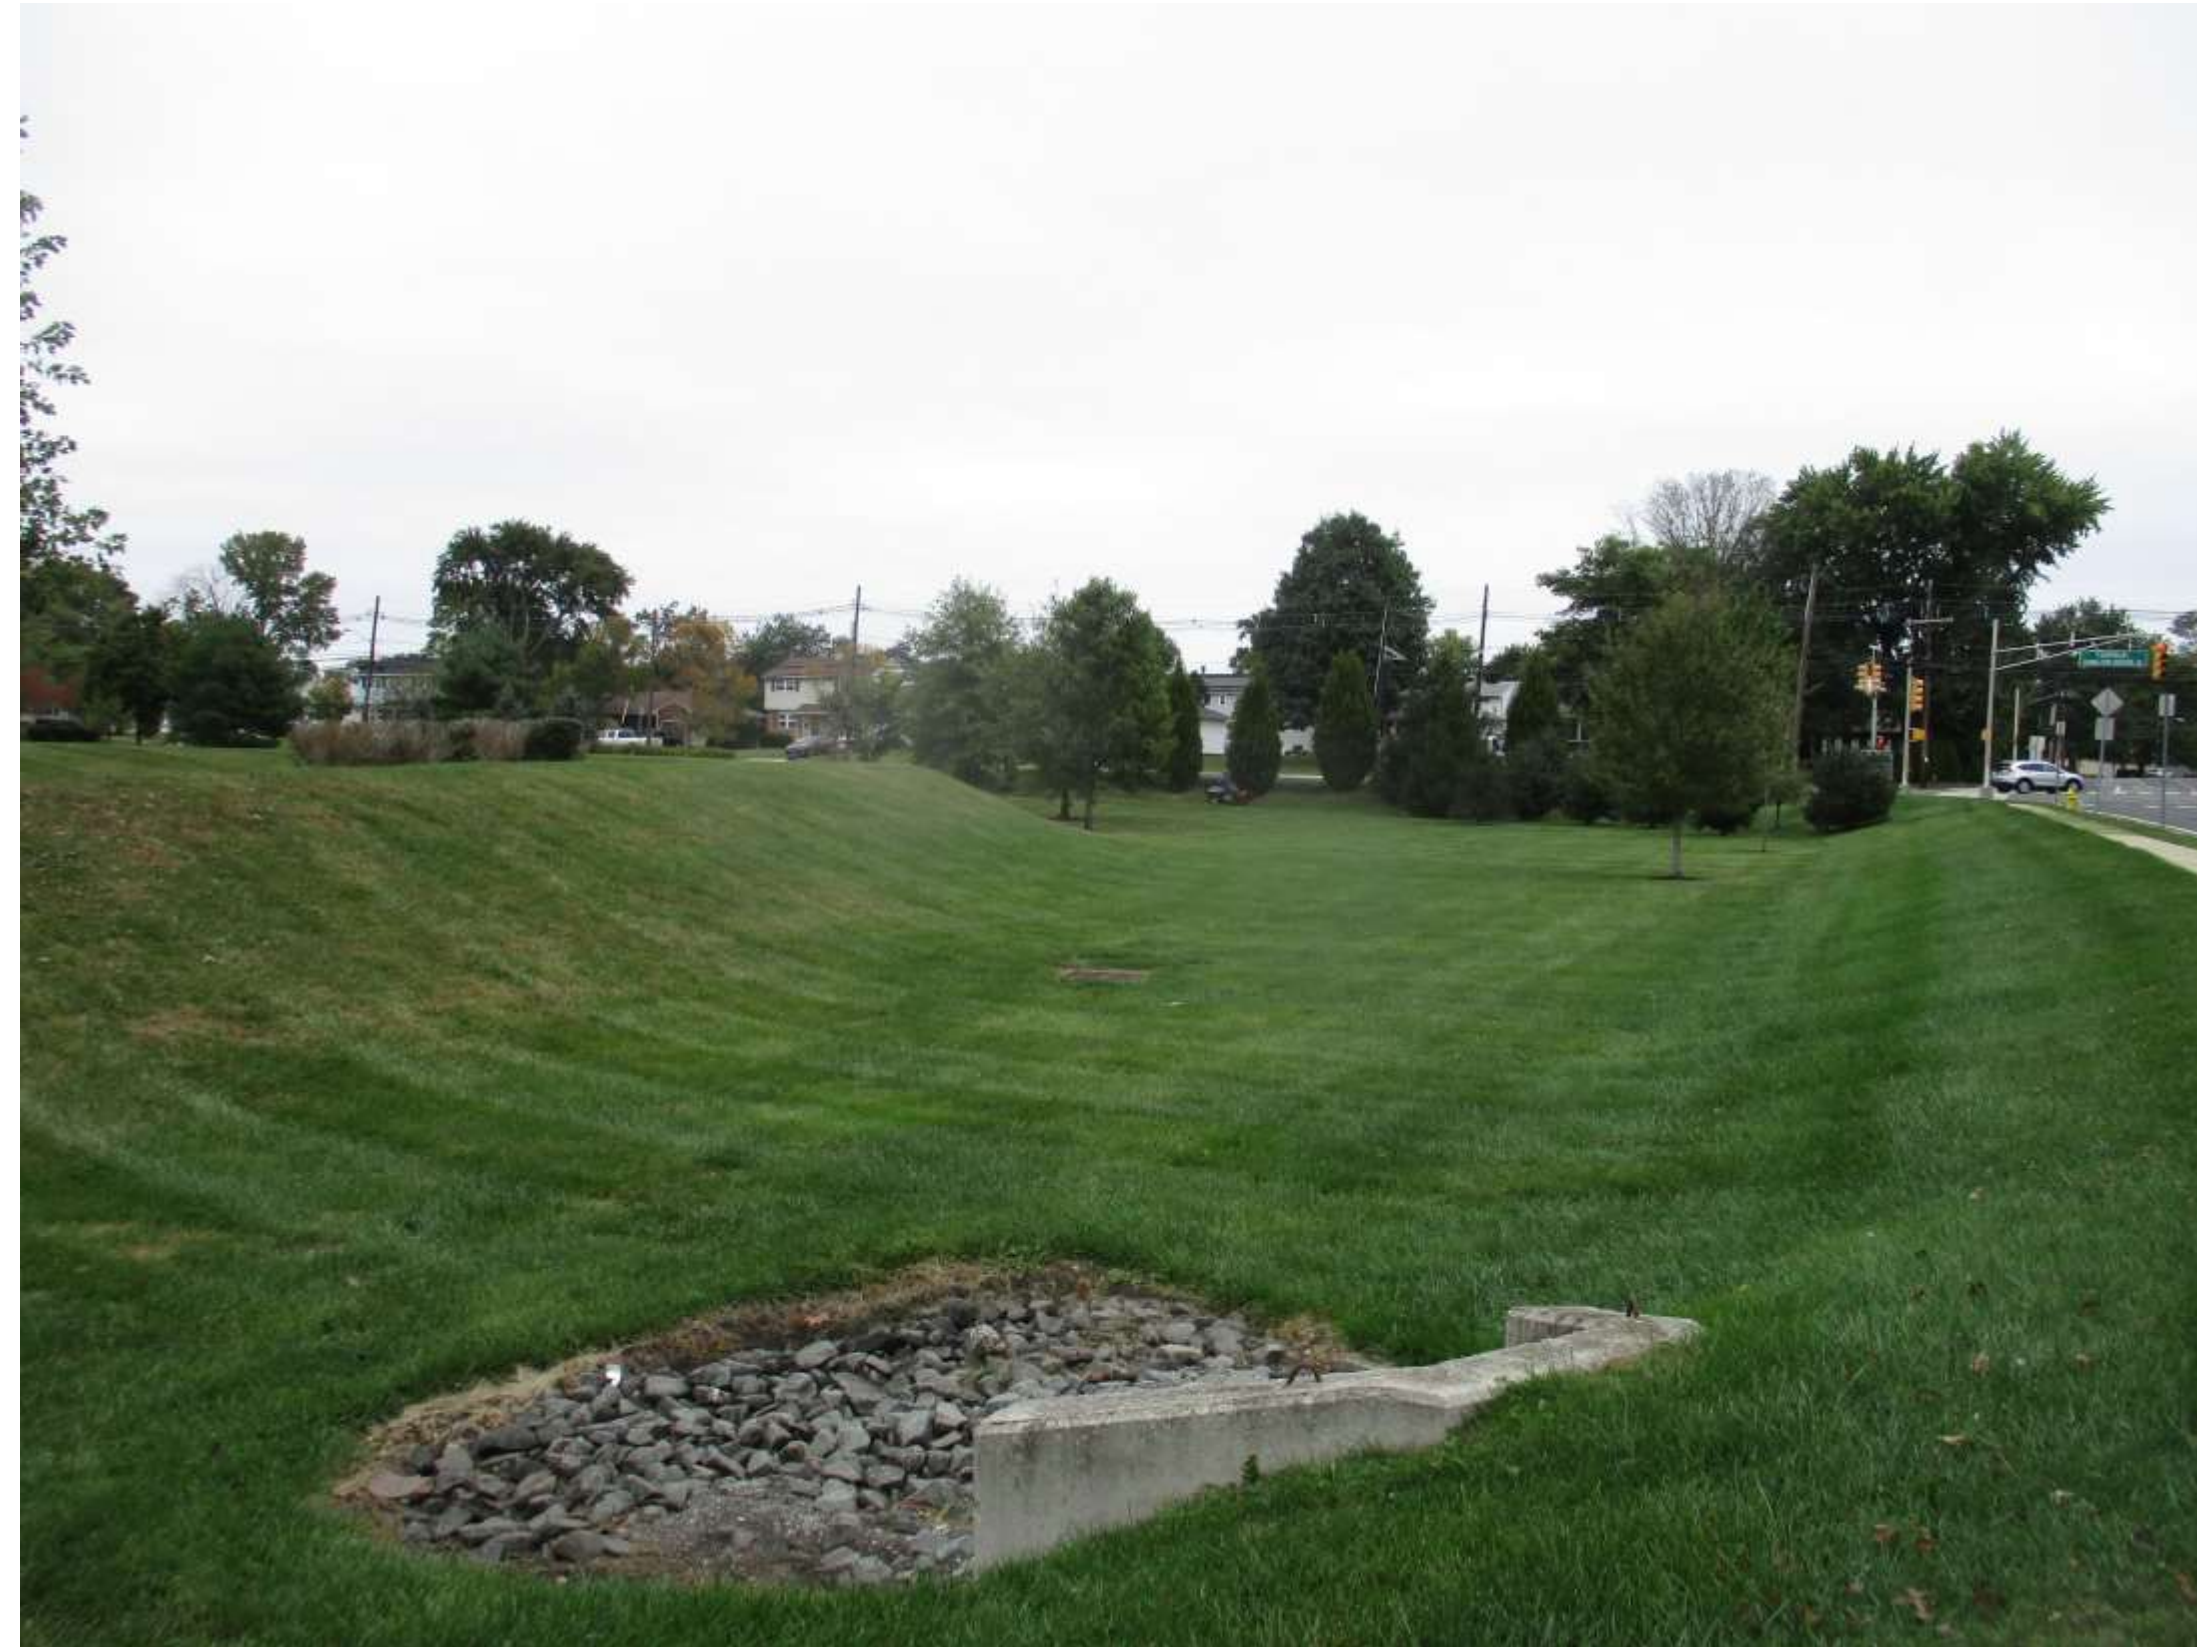
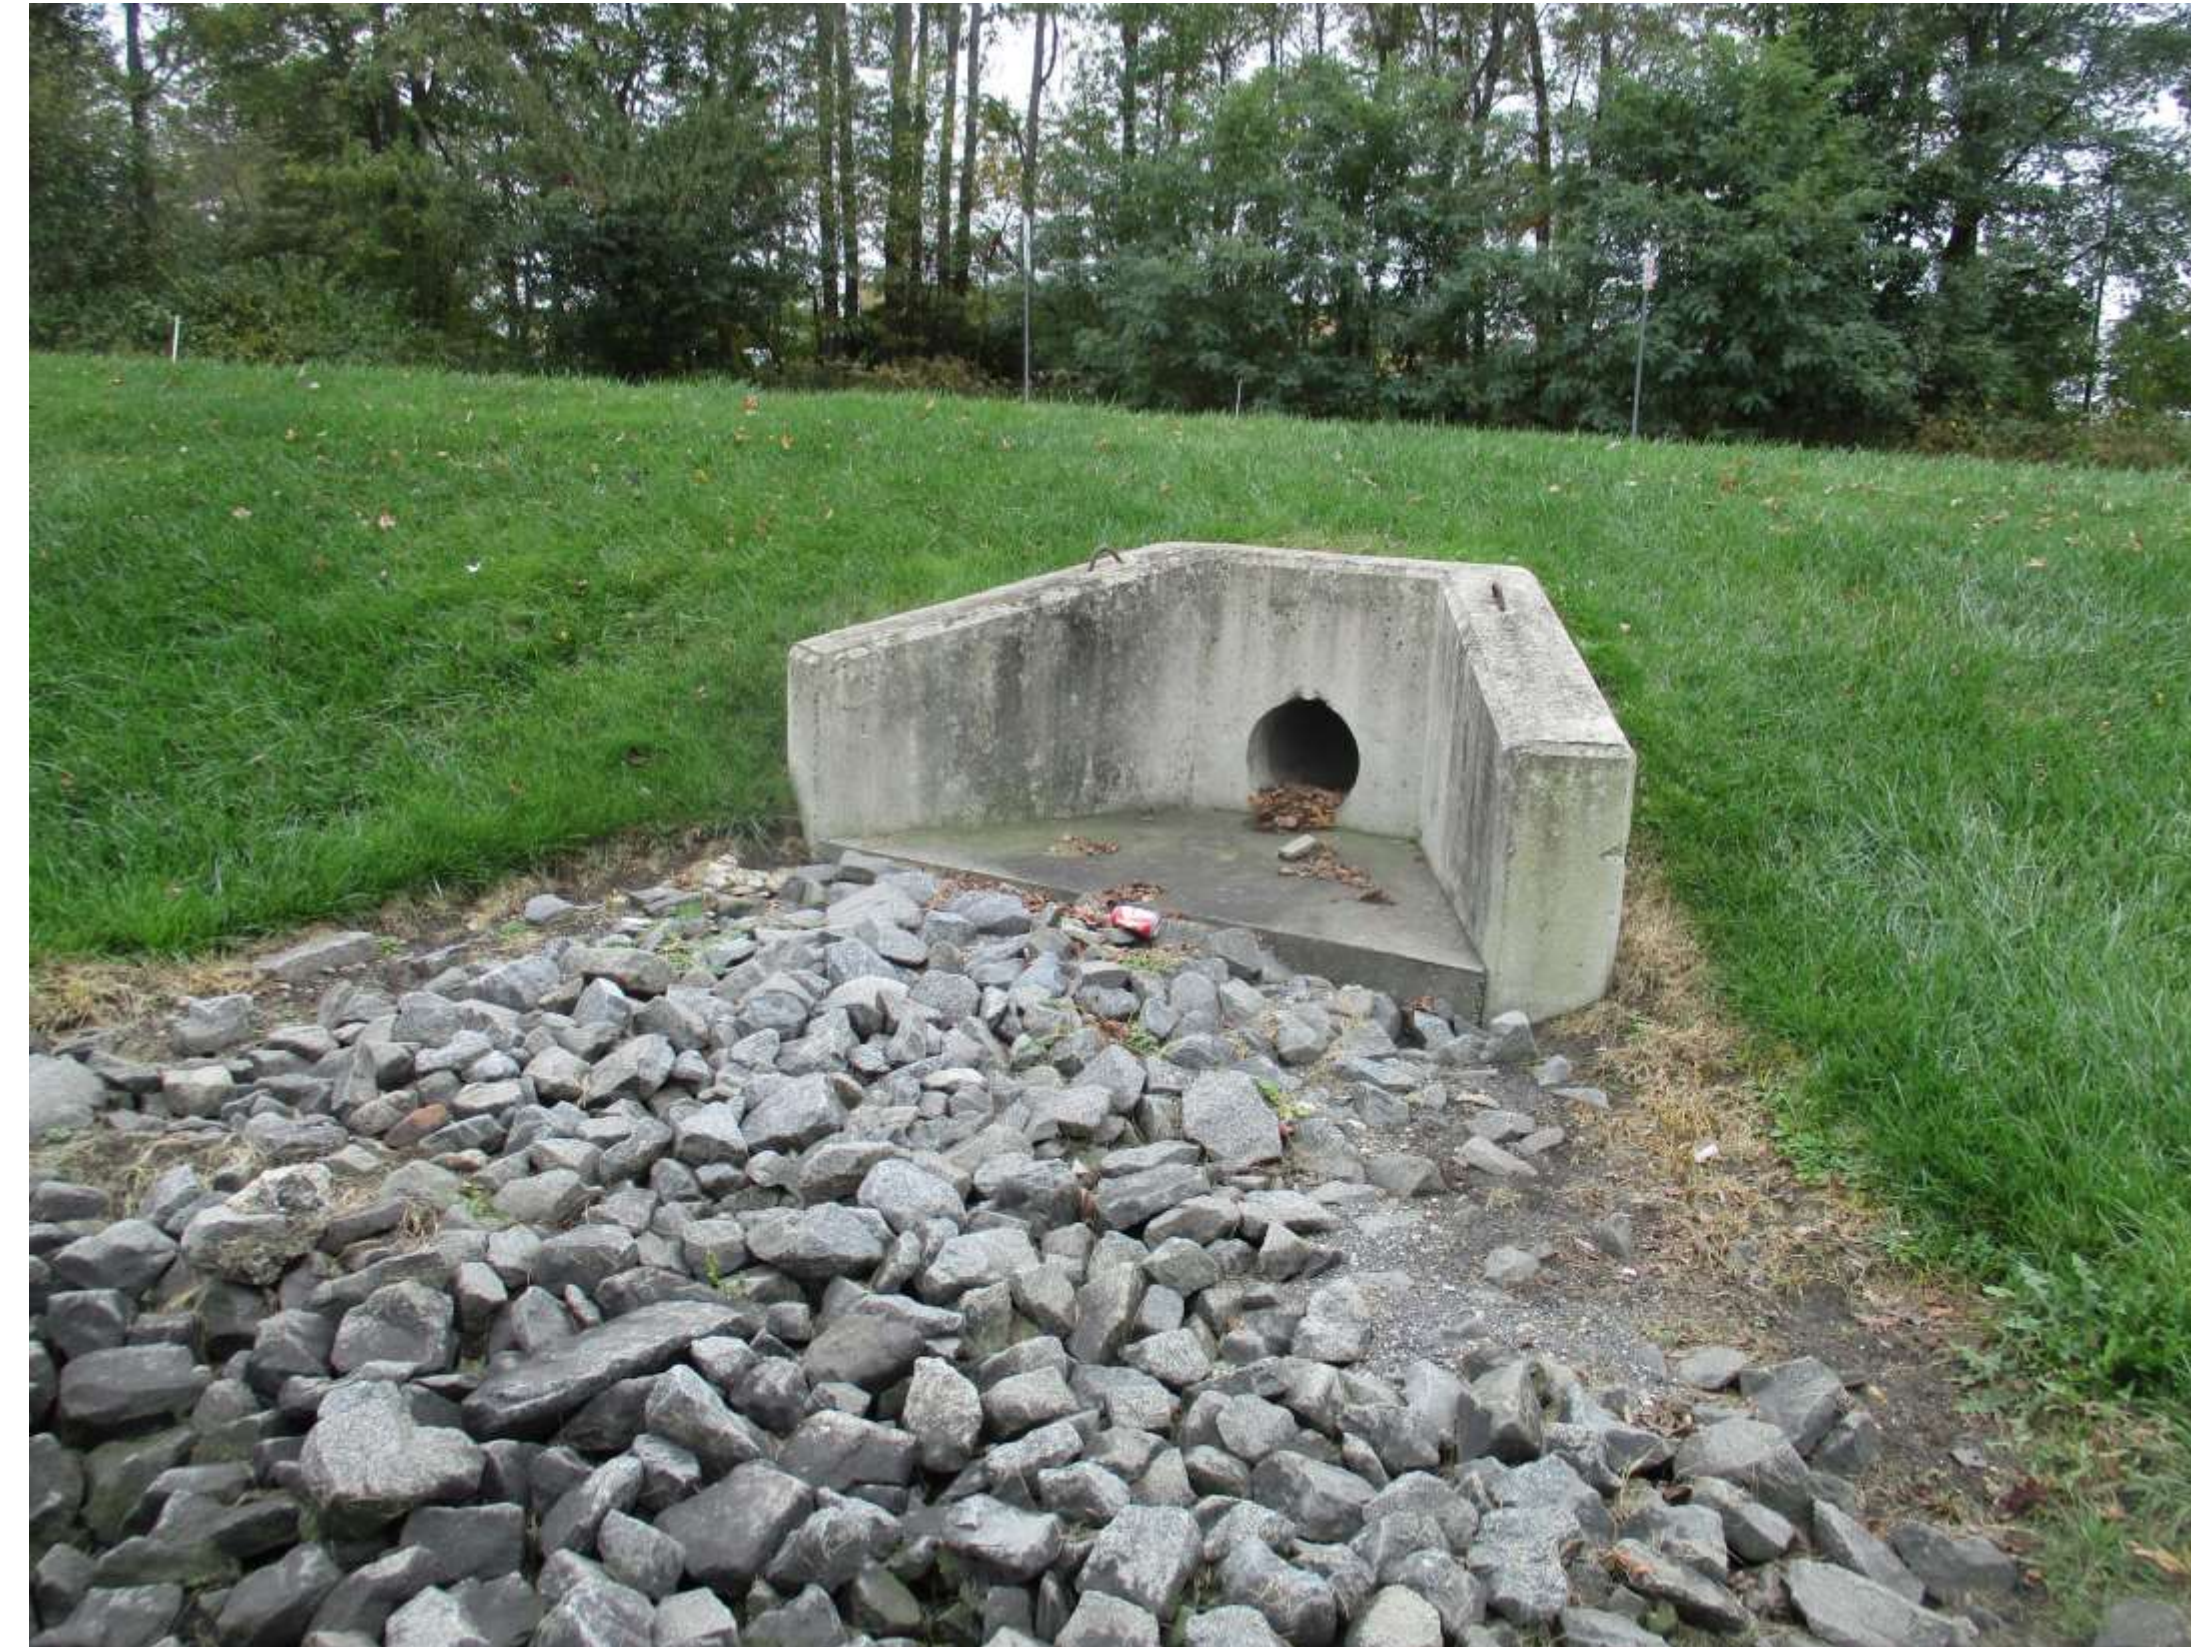
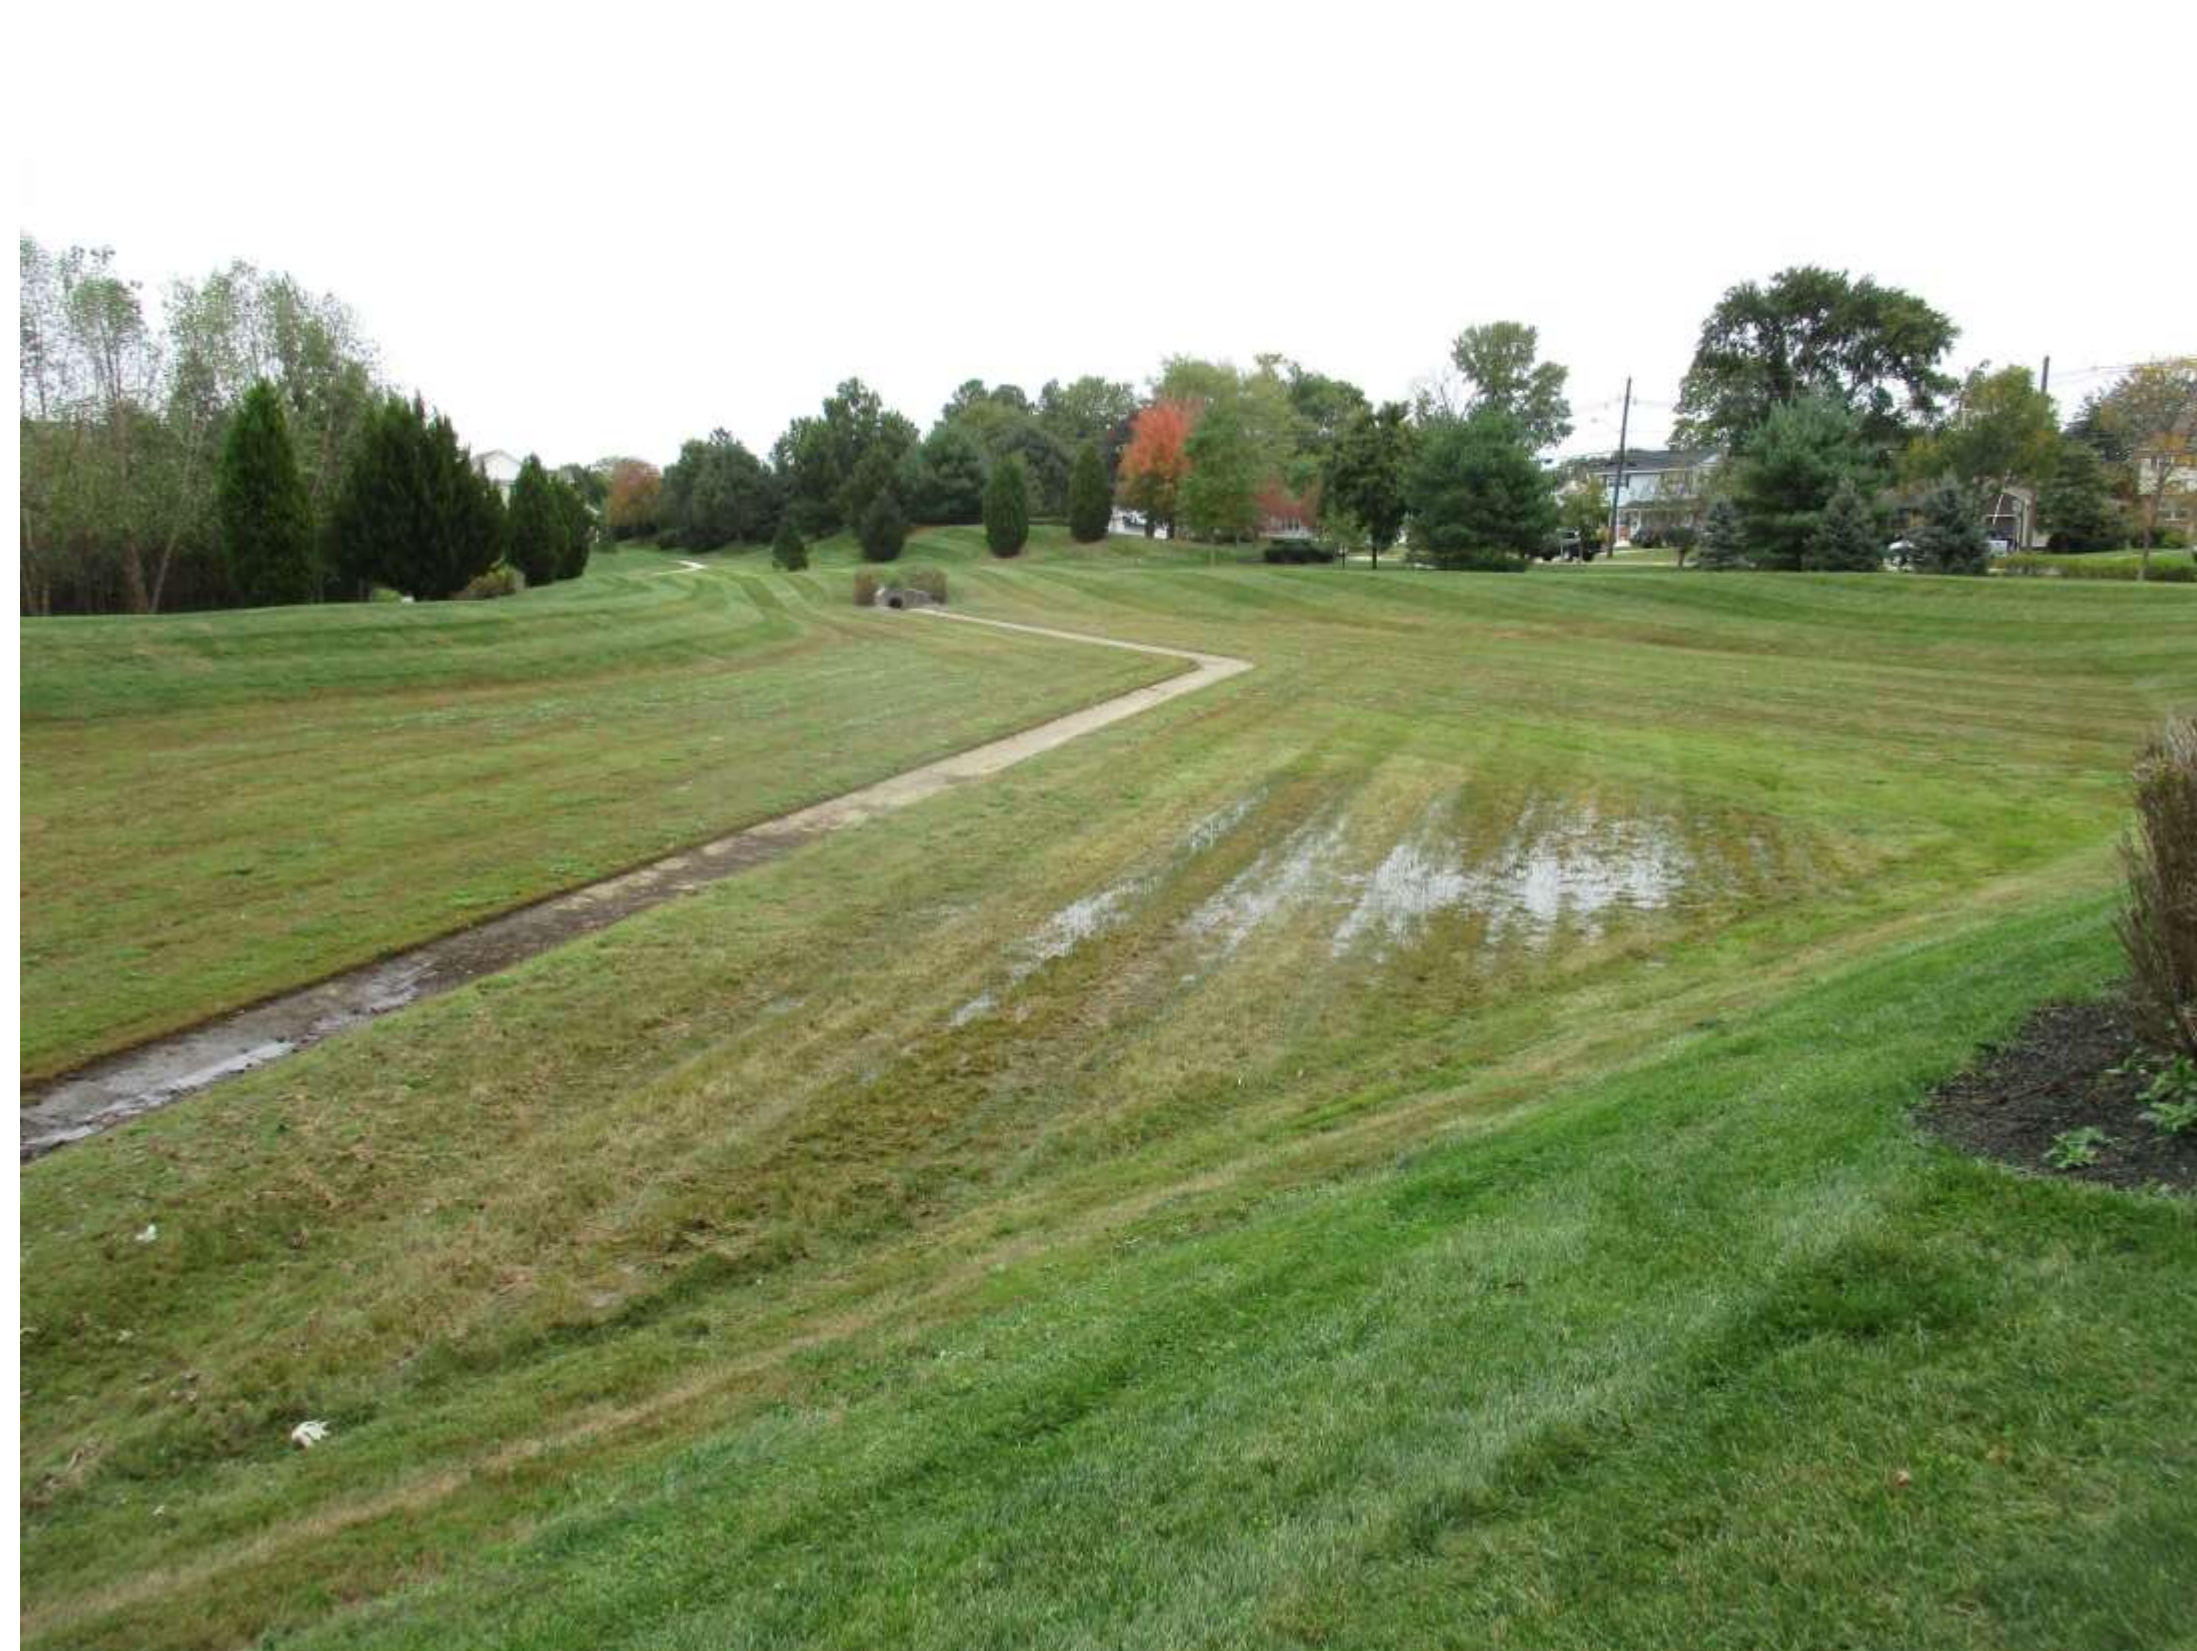
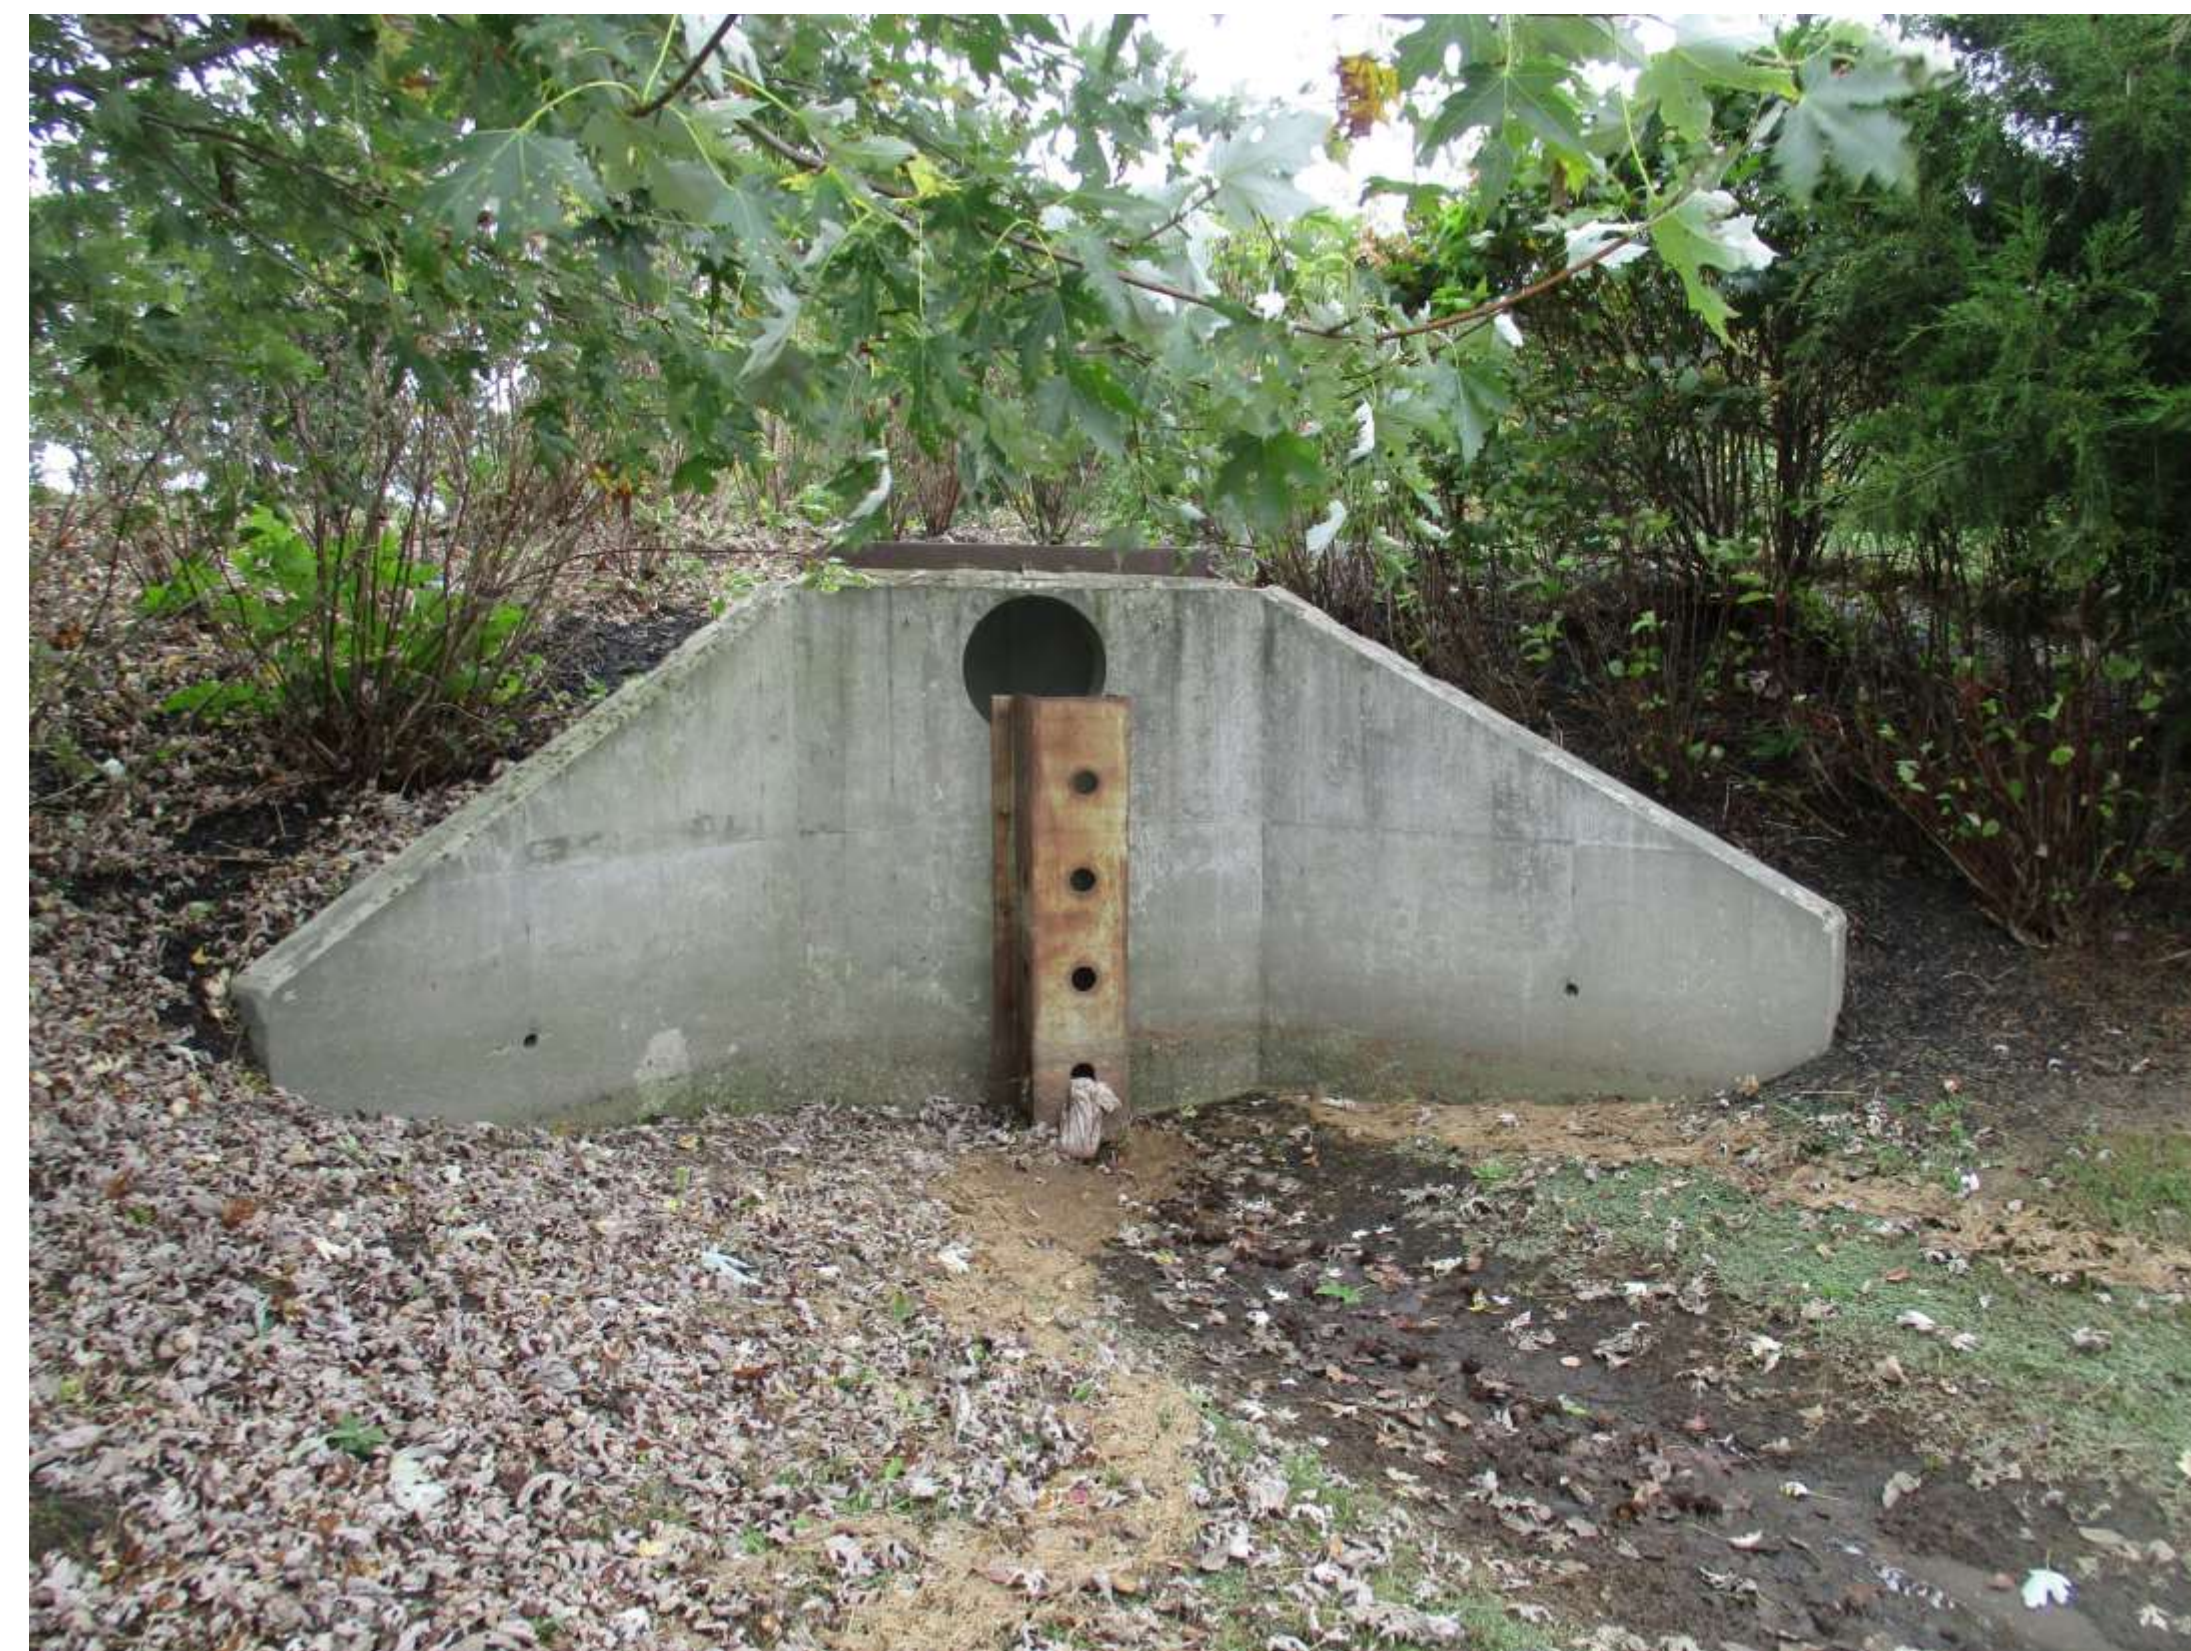
- Establish meadows to improve infiltration
- Mosquito eggs in standing water in outlet
