**Hamilton Township (Mercer County)
Stormwater Basin Assessment Summary
Addendum (Year 4)**

Developed by the Rutgers Cooperative Extension Water Resources Program
Funded by Hamilton Township, Mercer County, New Jersey

December 2017

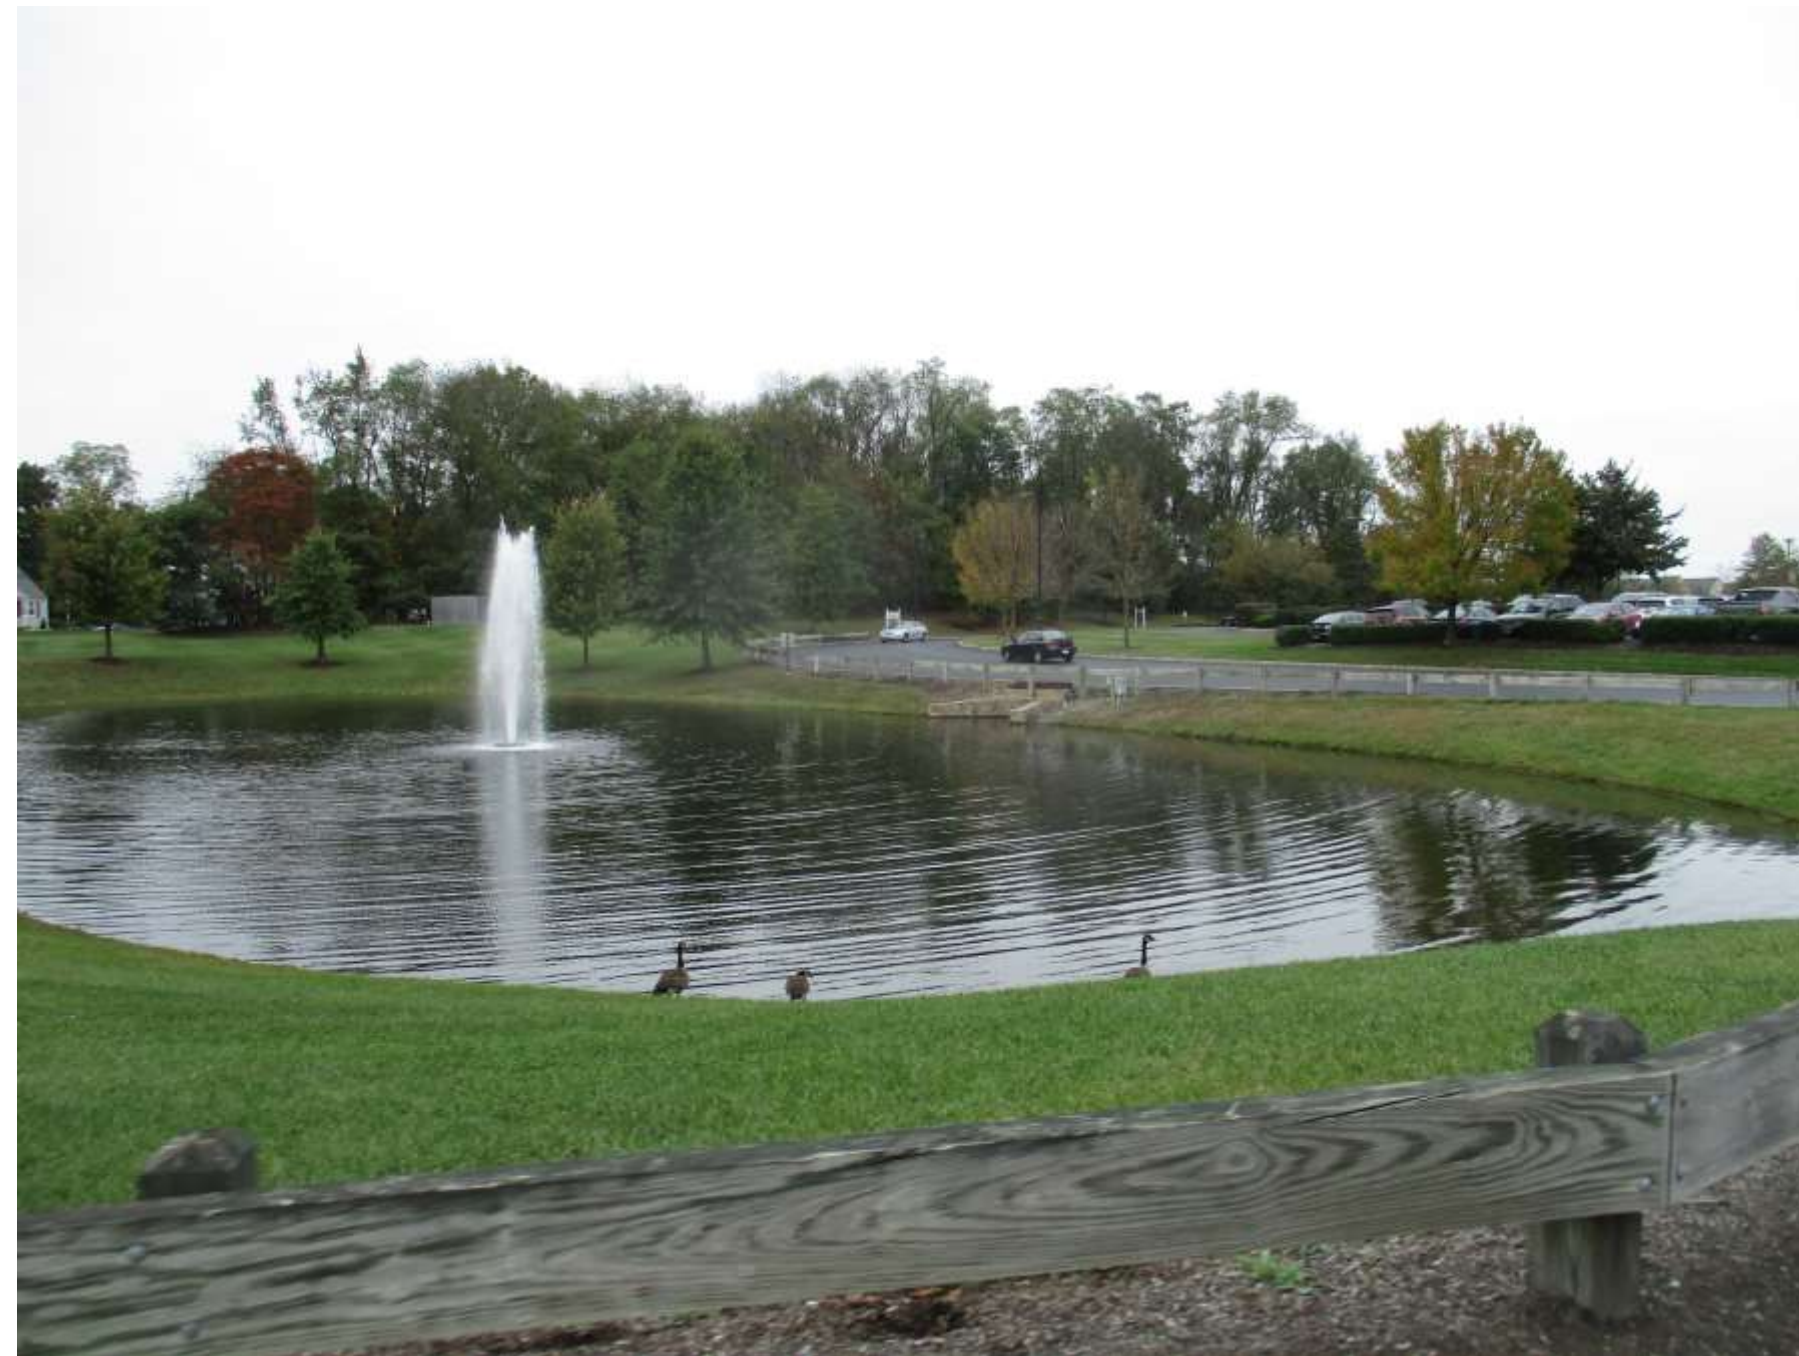
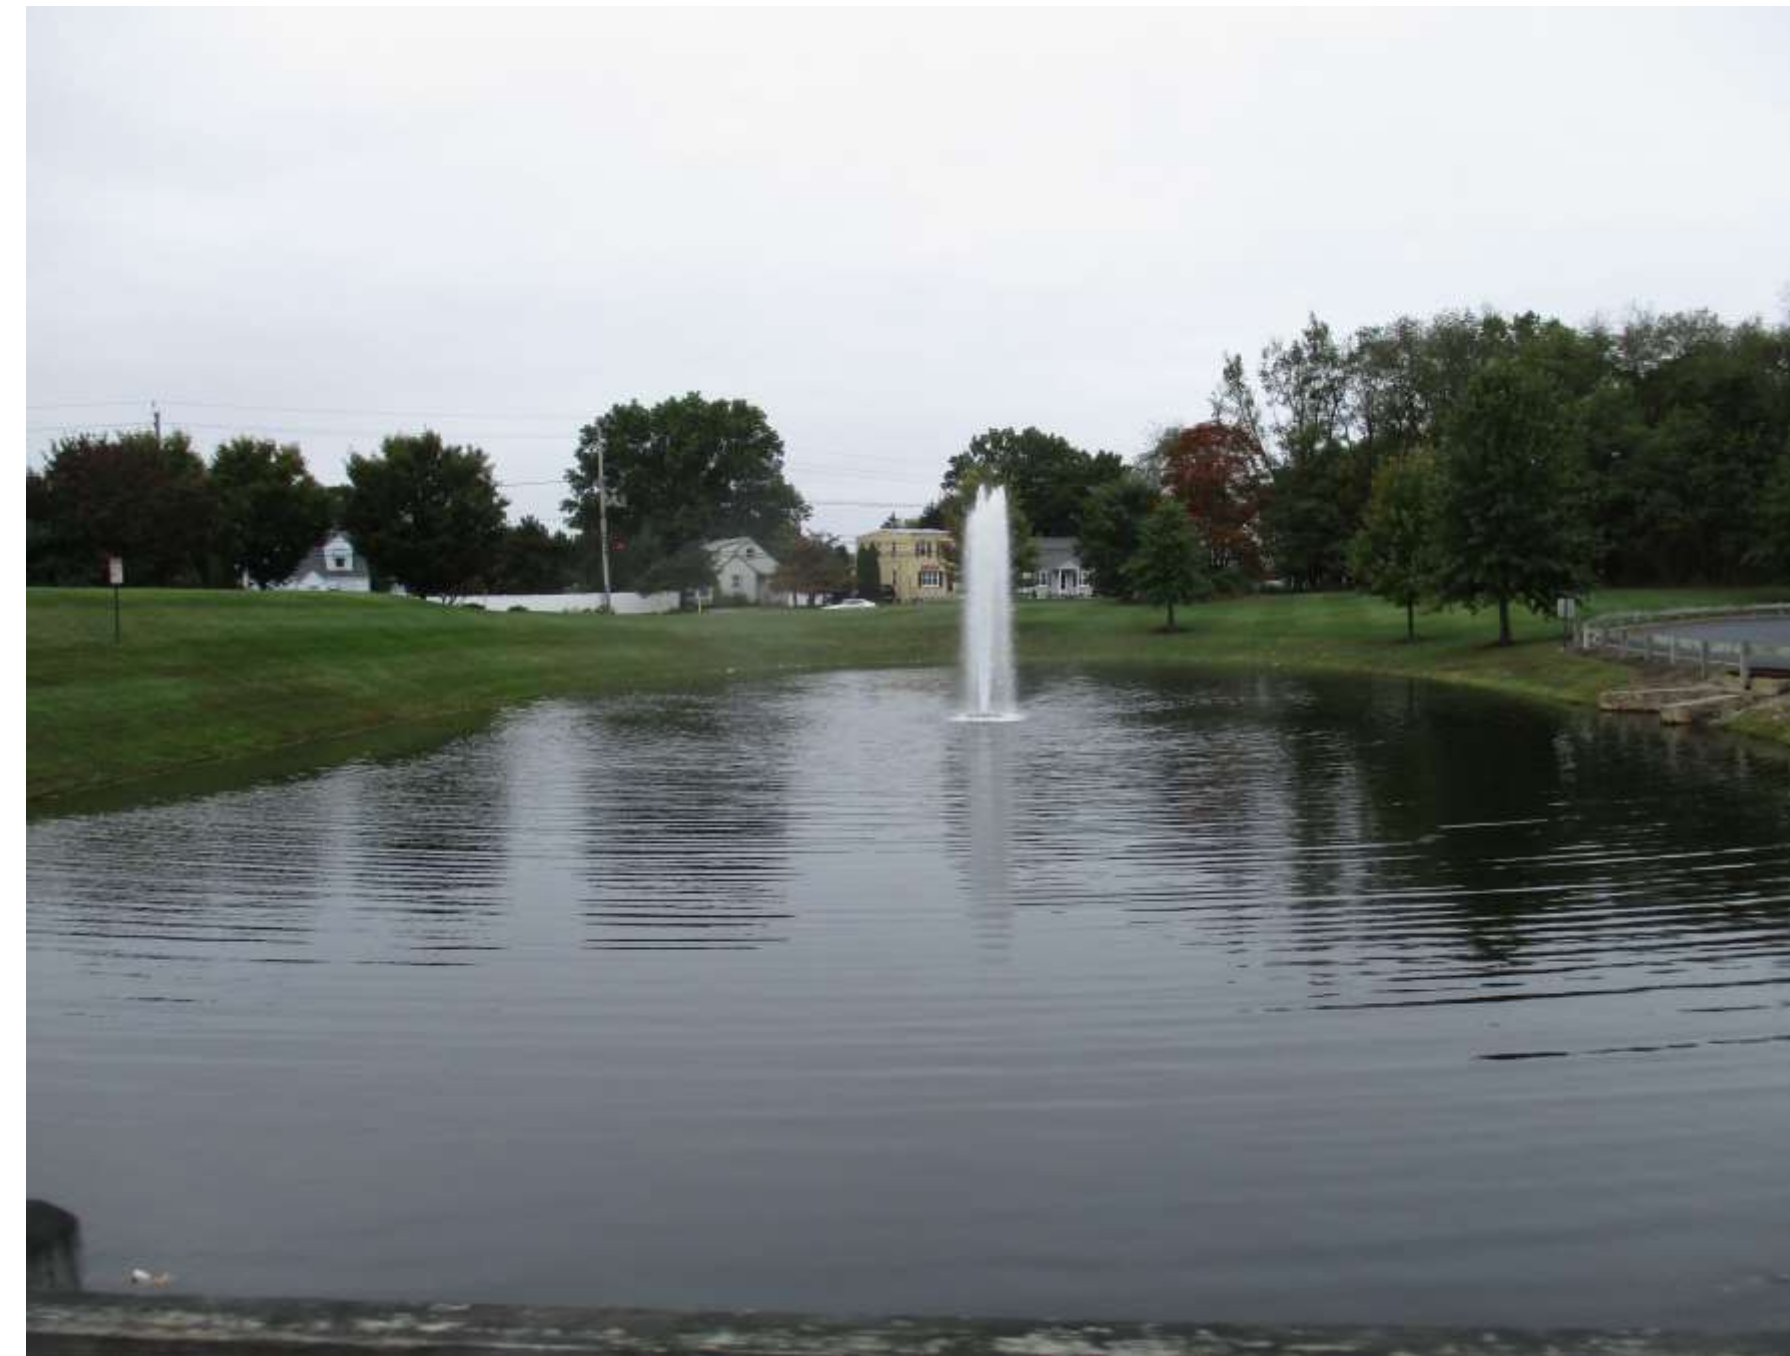
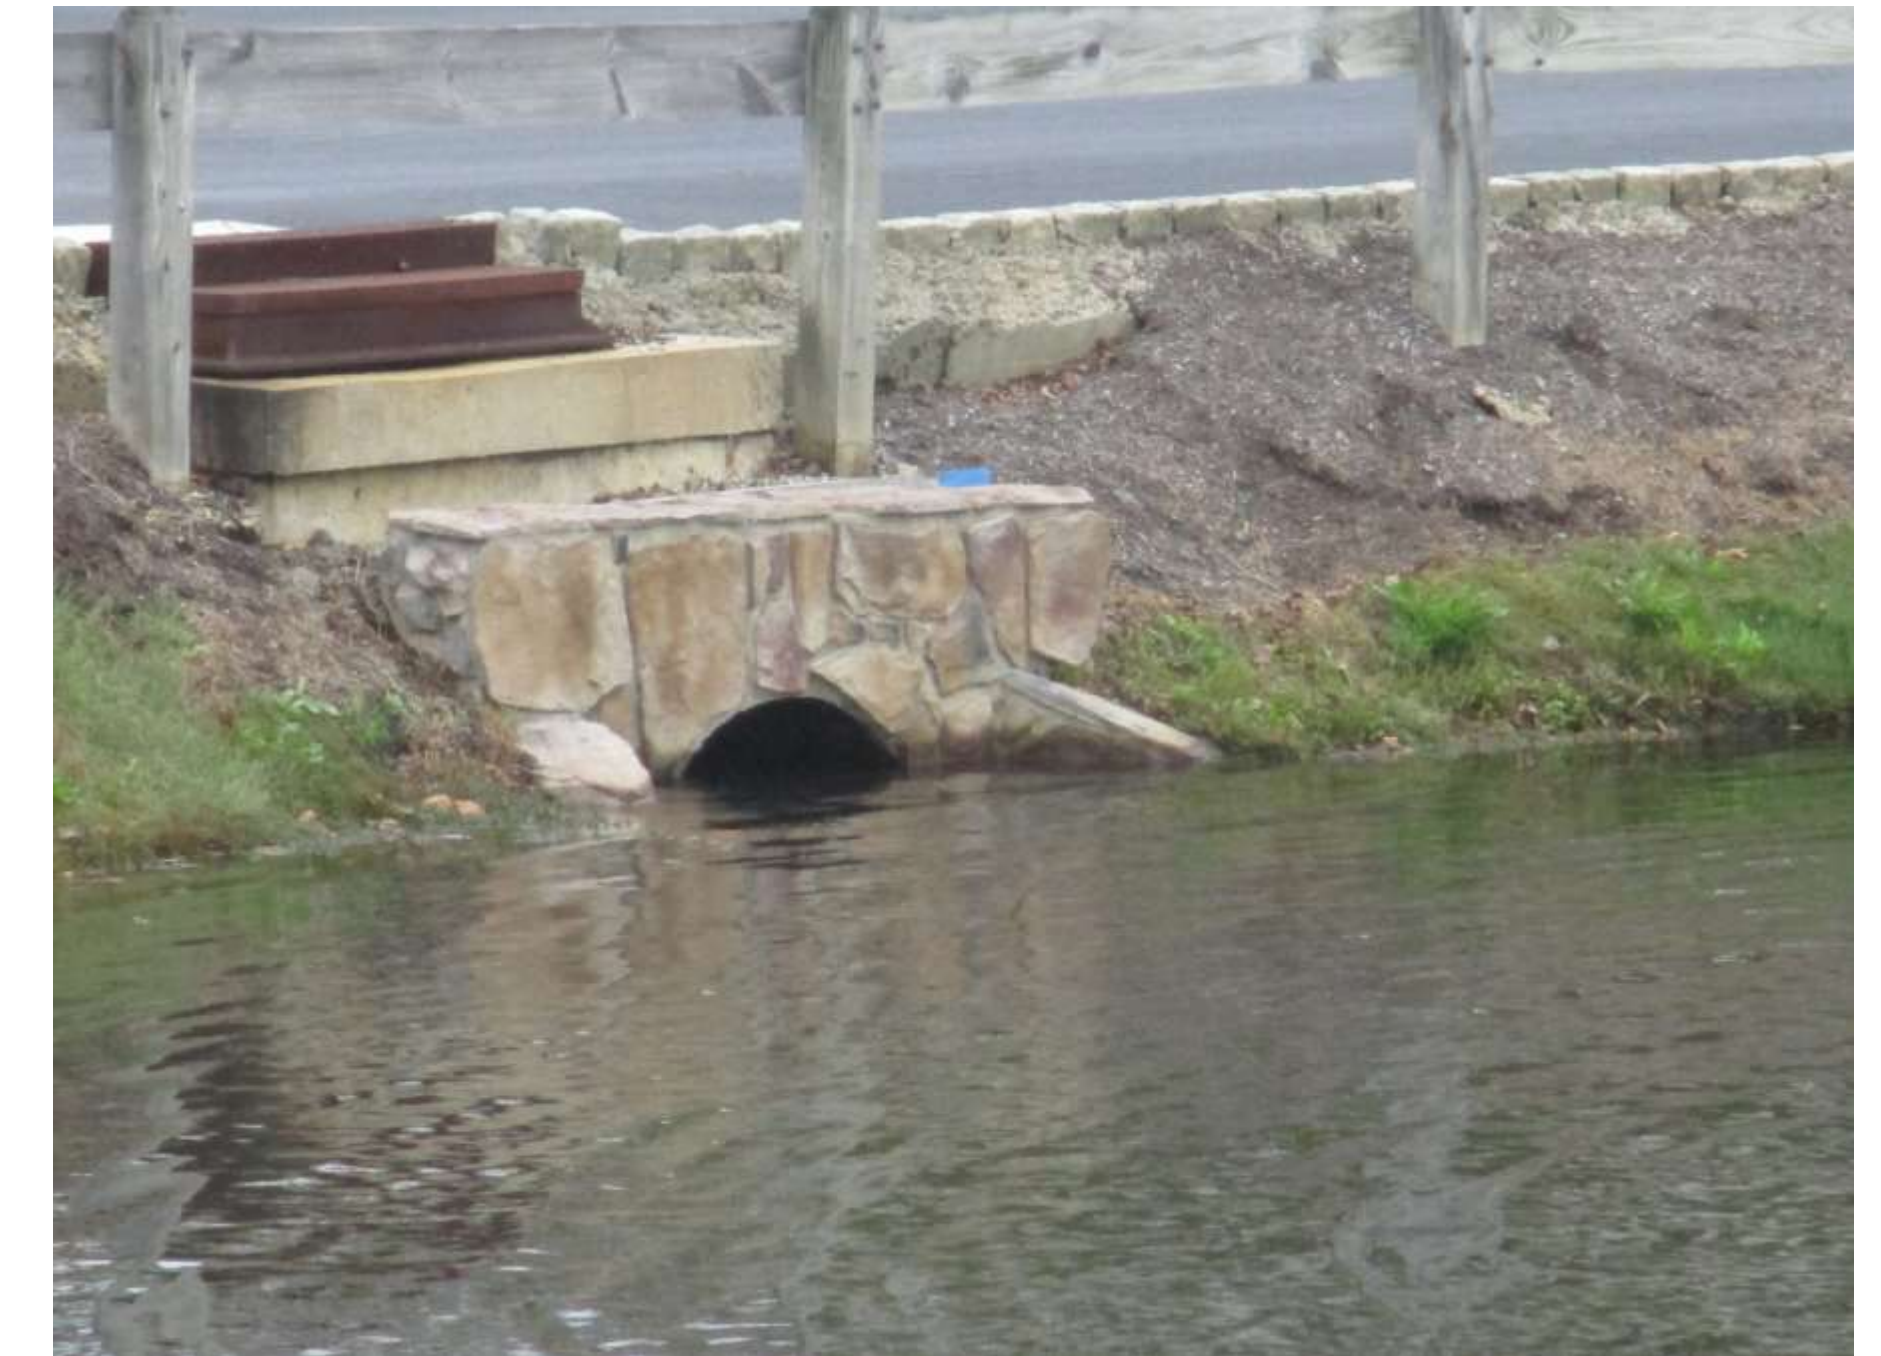
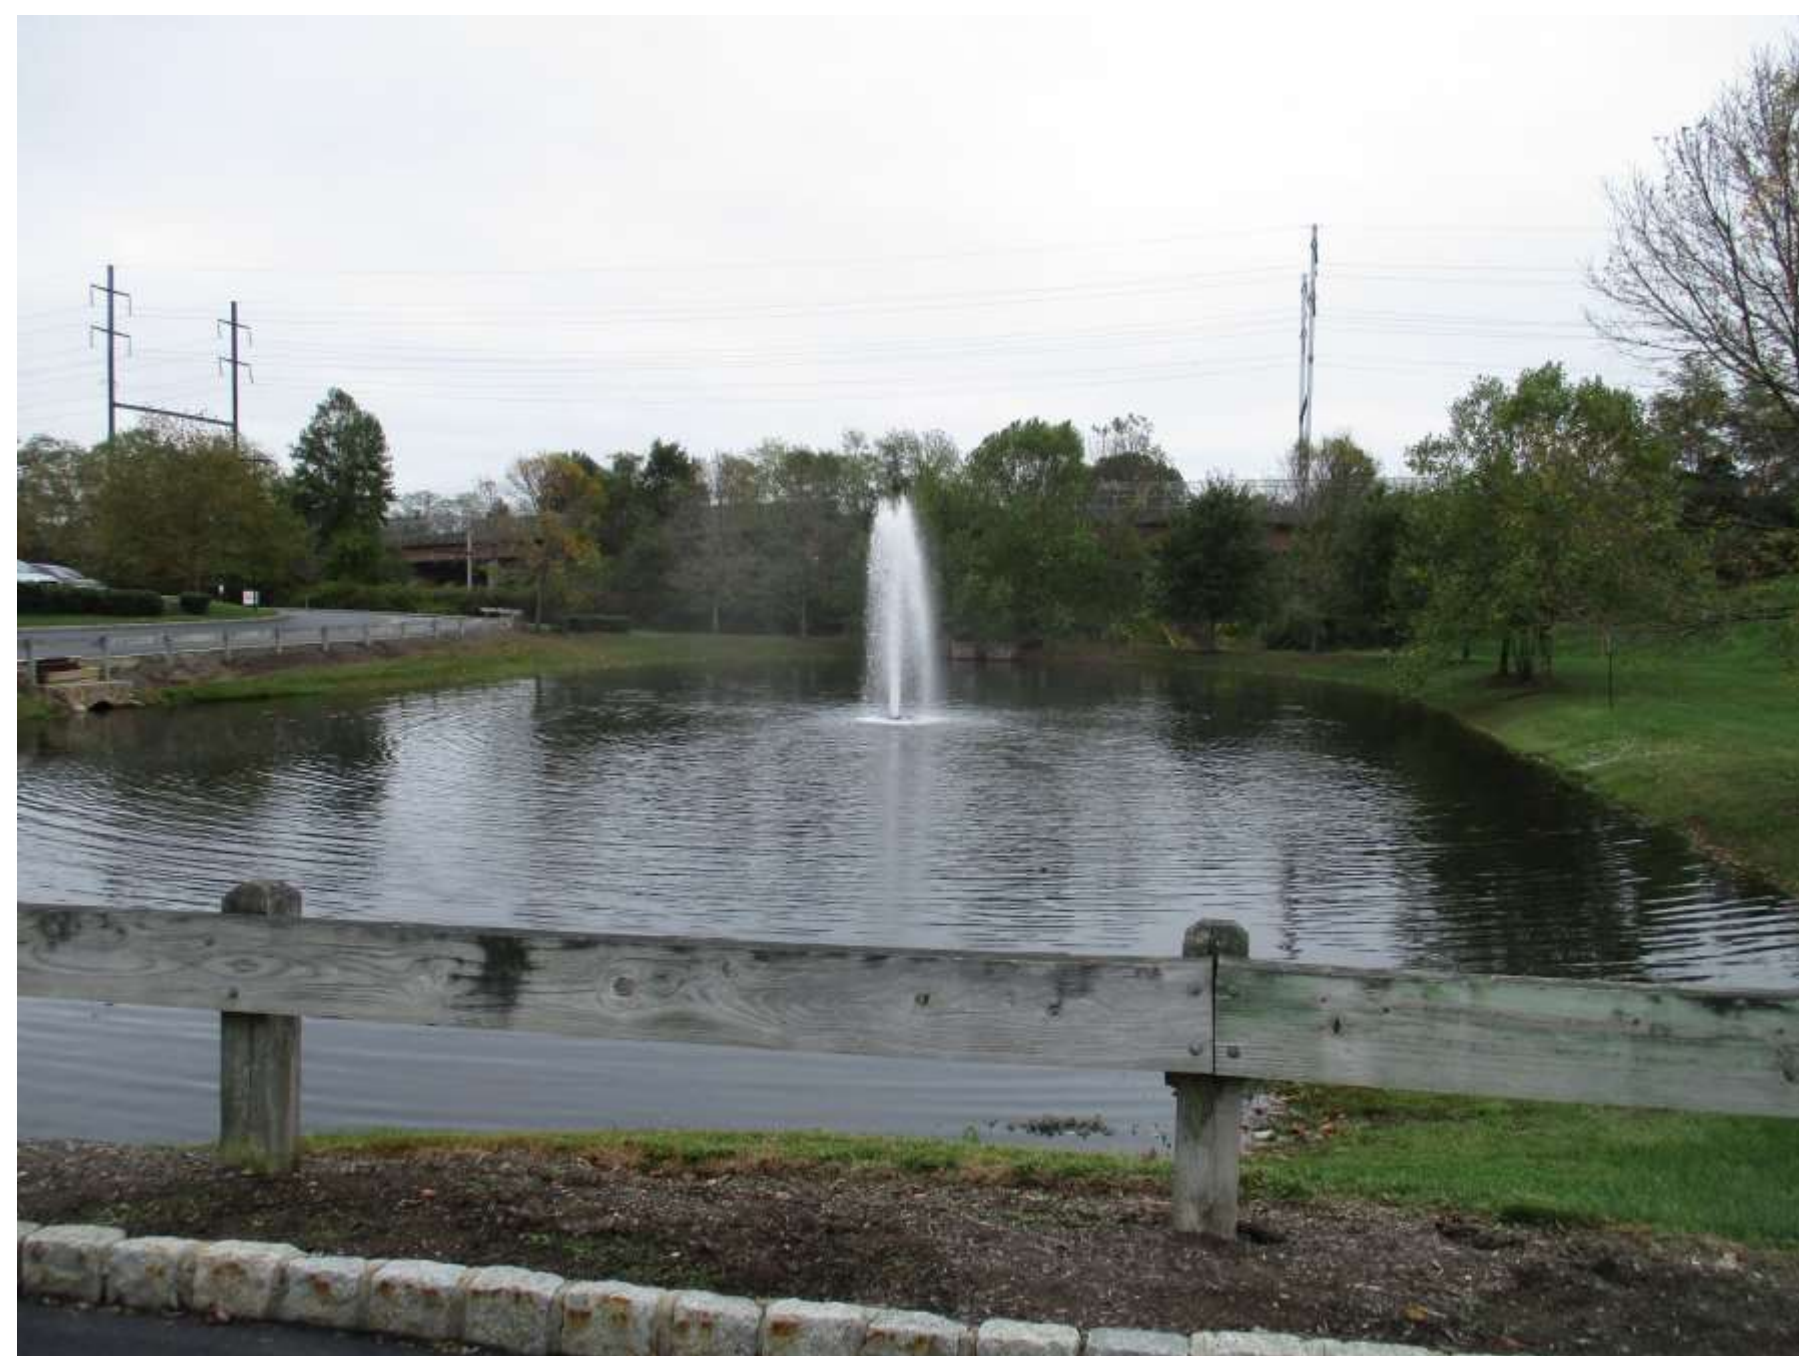
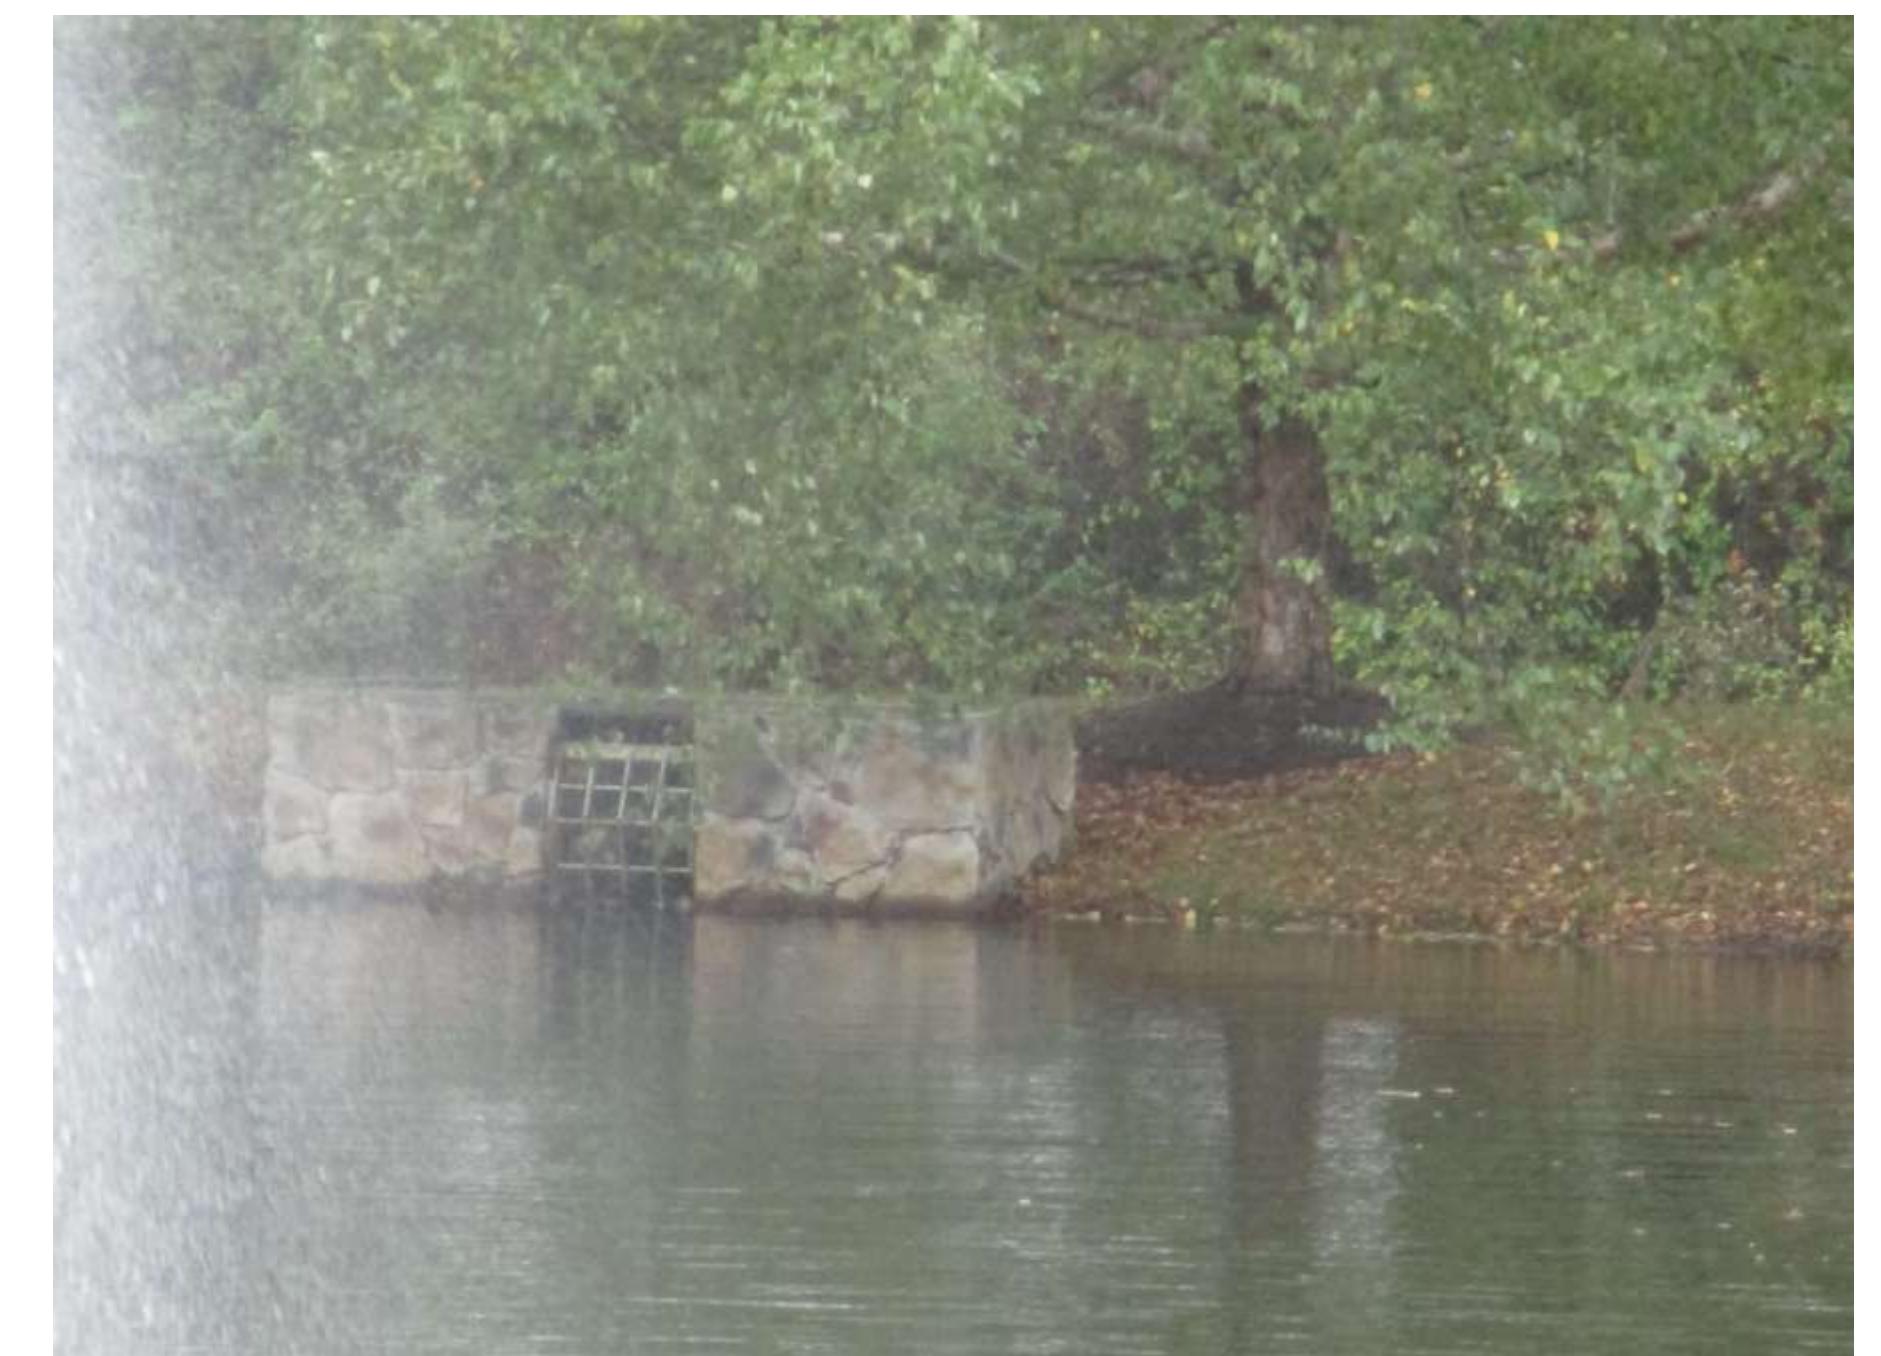
Basin and outlet

- Enhance riparian buffers to improve water quality and reduce geese presence
- Otherwise well maintained

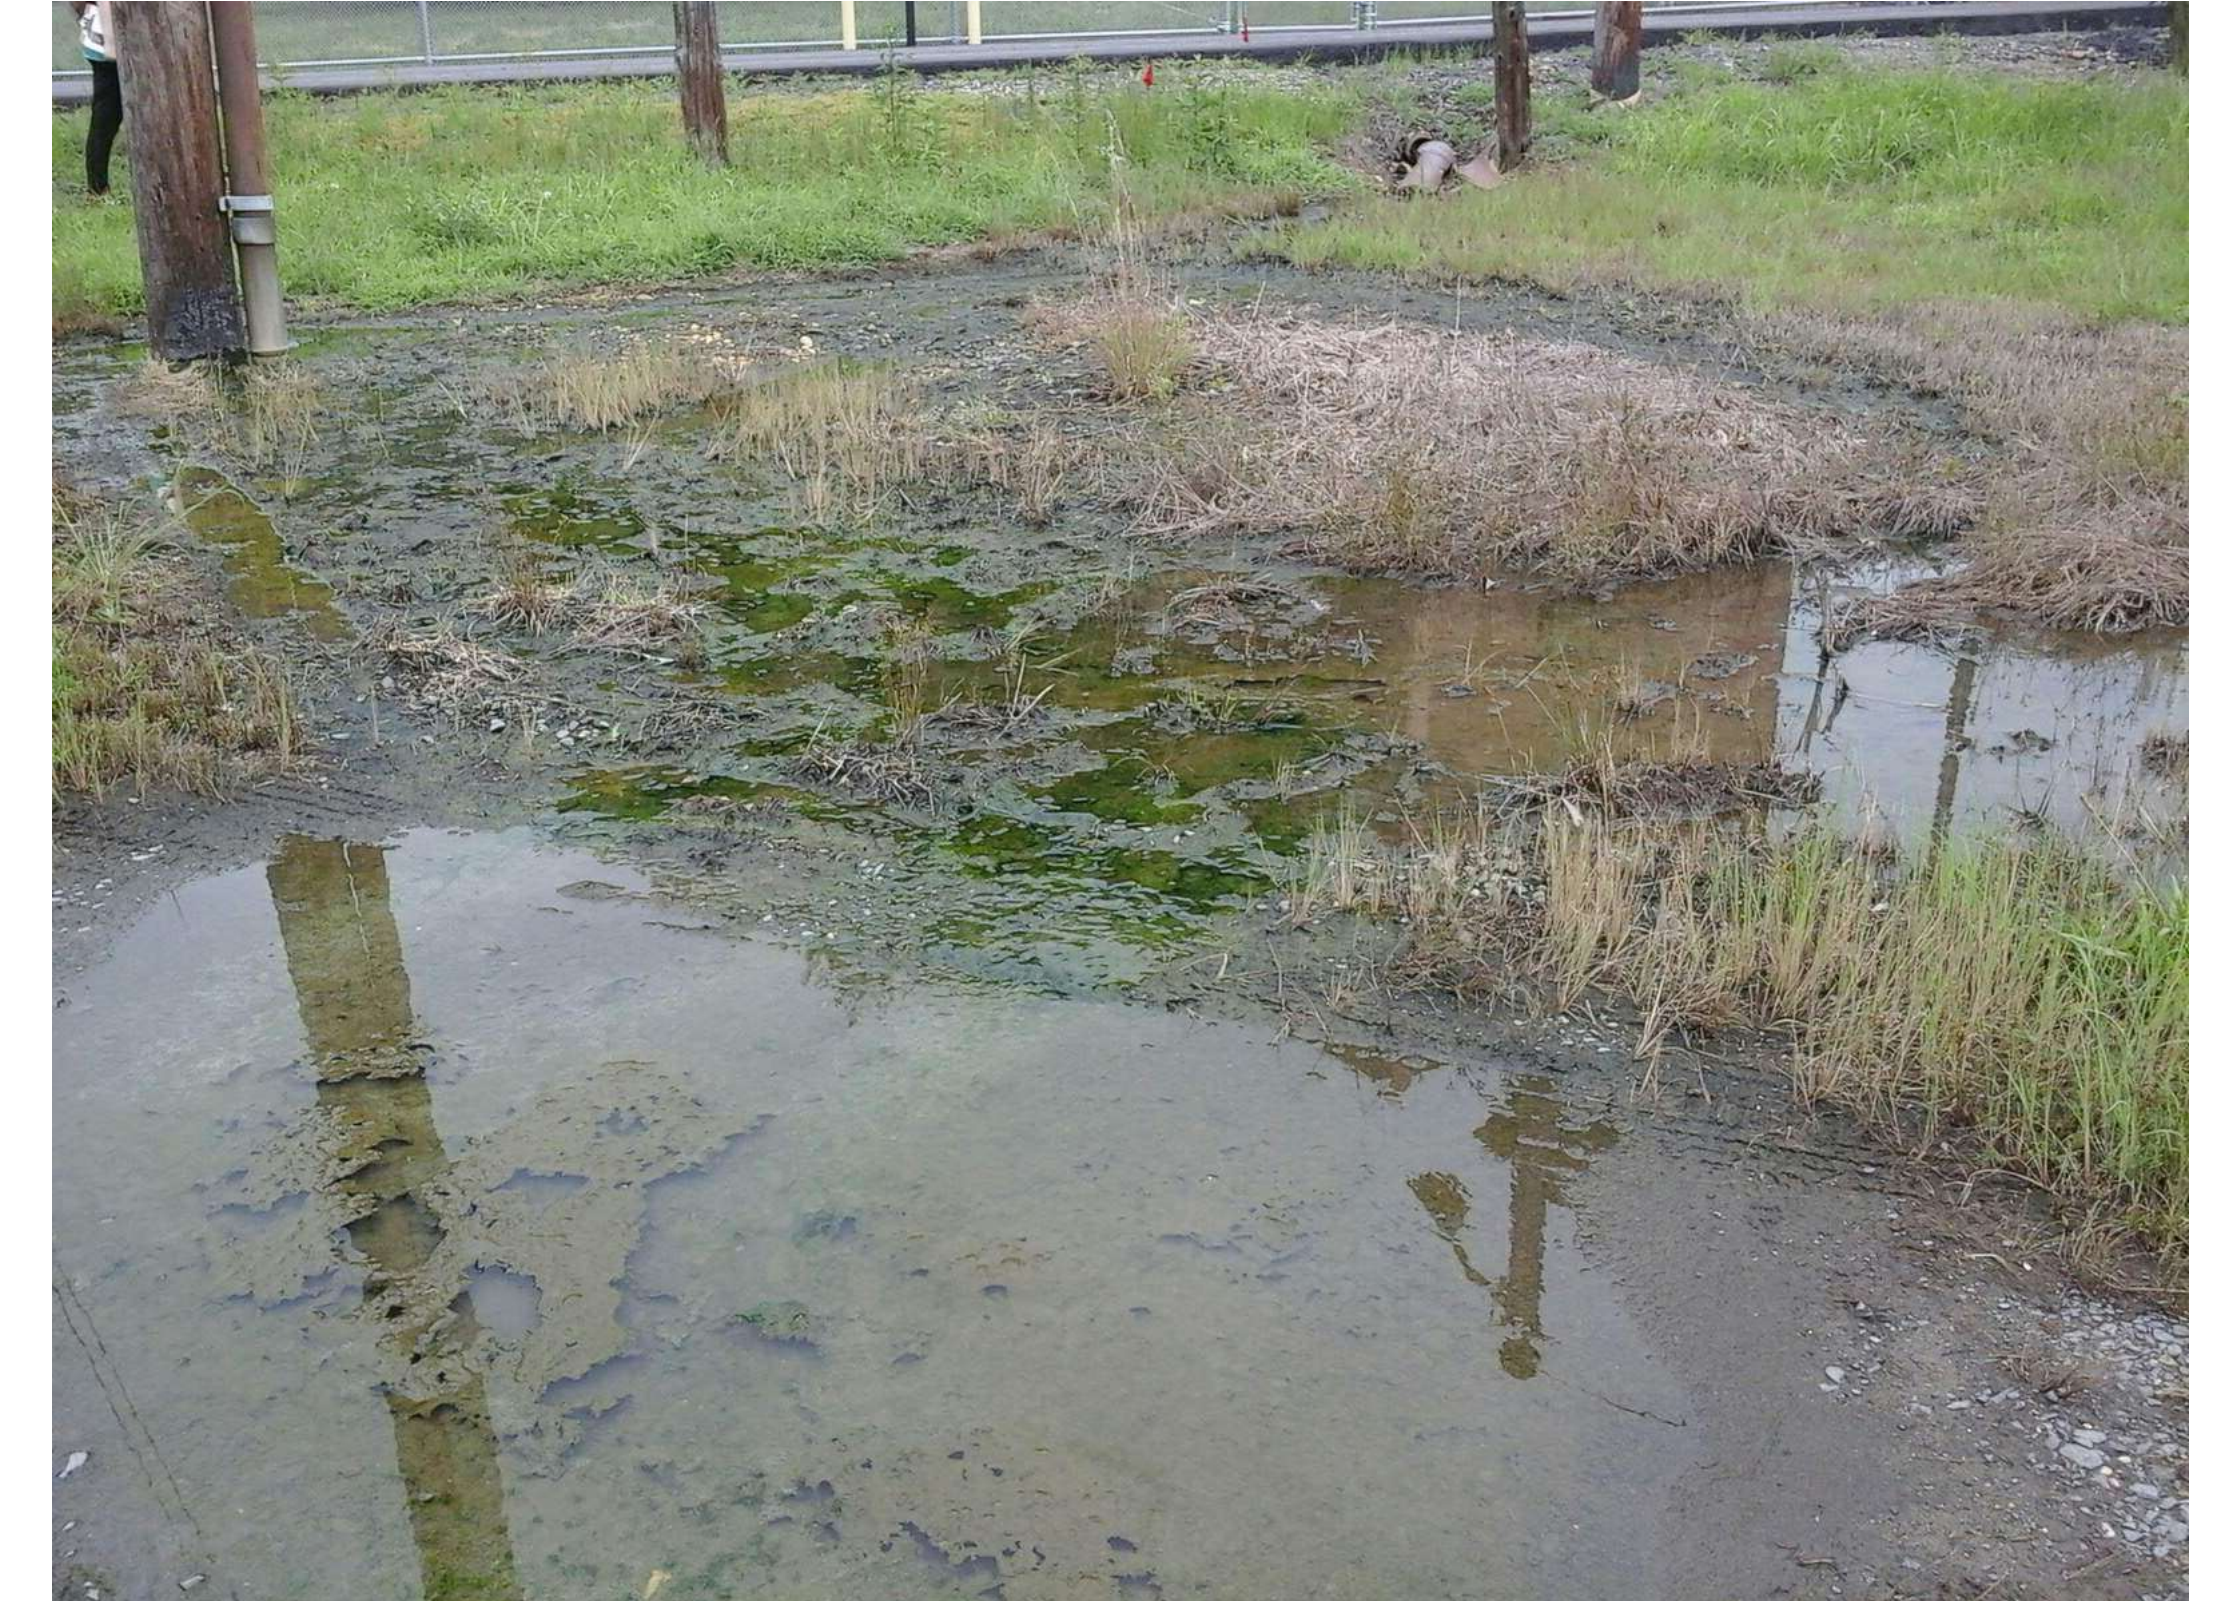
Standing water

- Standing water present
- Basin near environmental clean up site
- Amend soil to improve infiltration and reduce standing water
- Plant with woody vegetation to improve infiltration

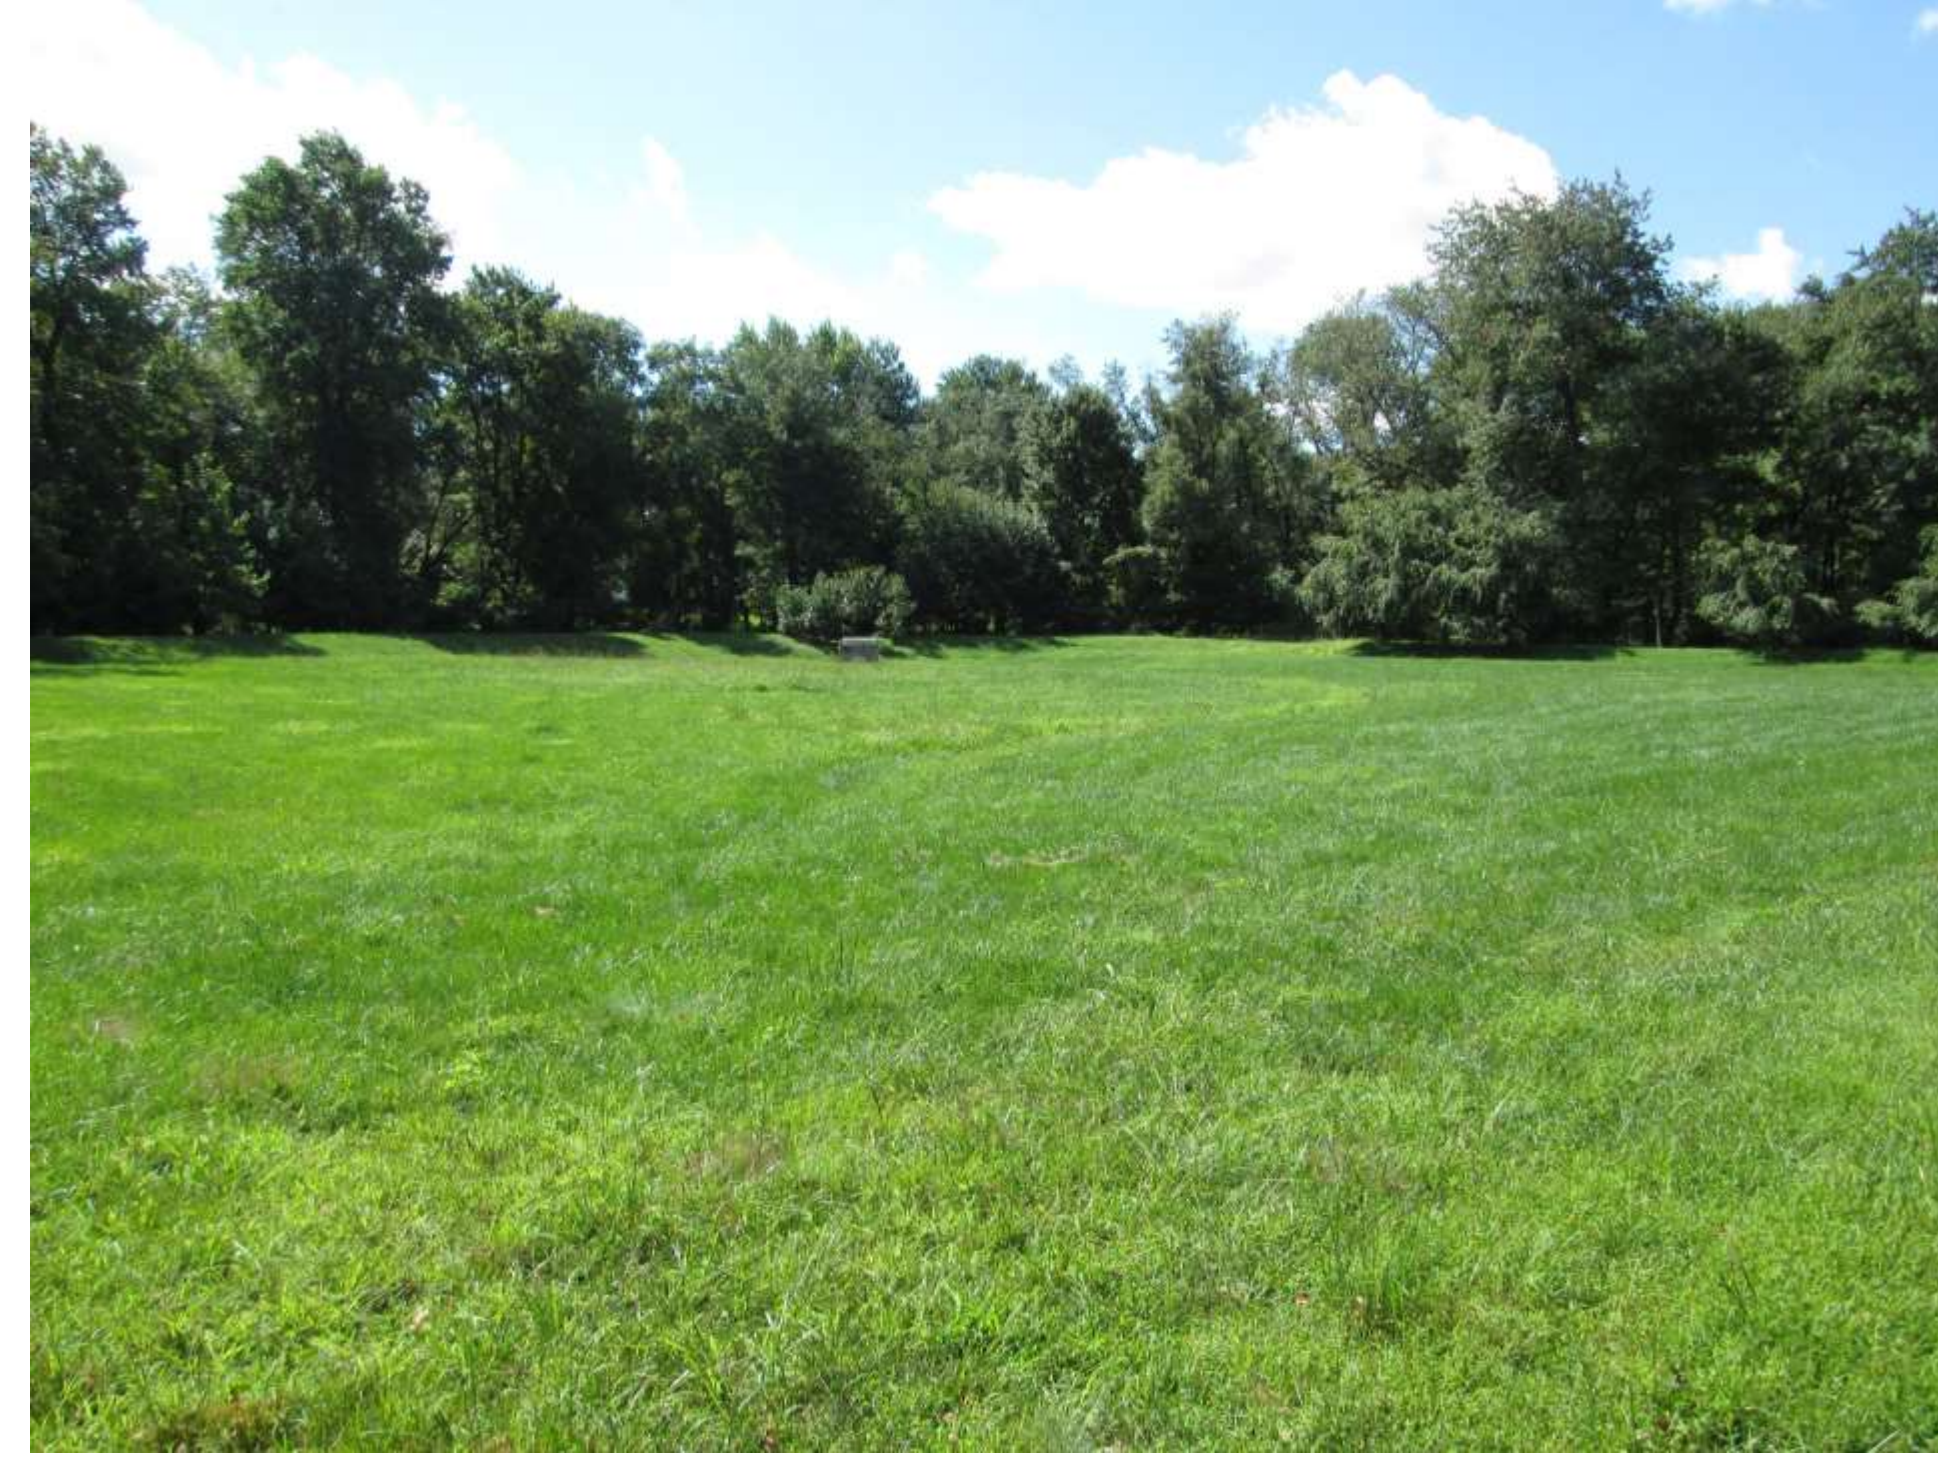
Basin overview

- Two part basin system
- Reduce mowing to improve infiltration
- Overall well maintained

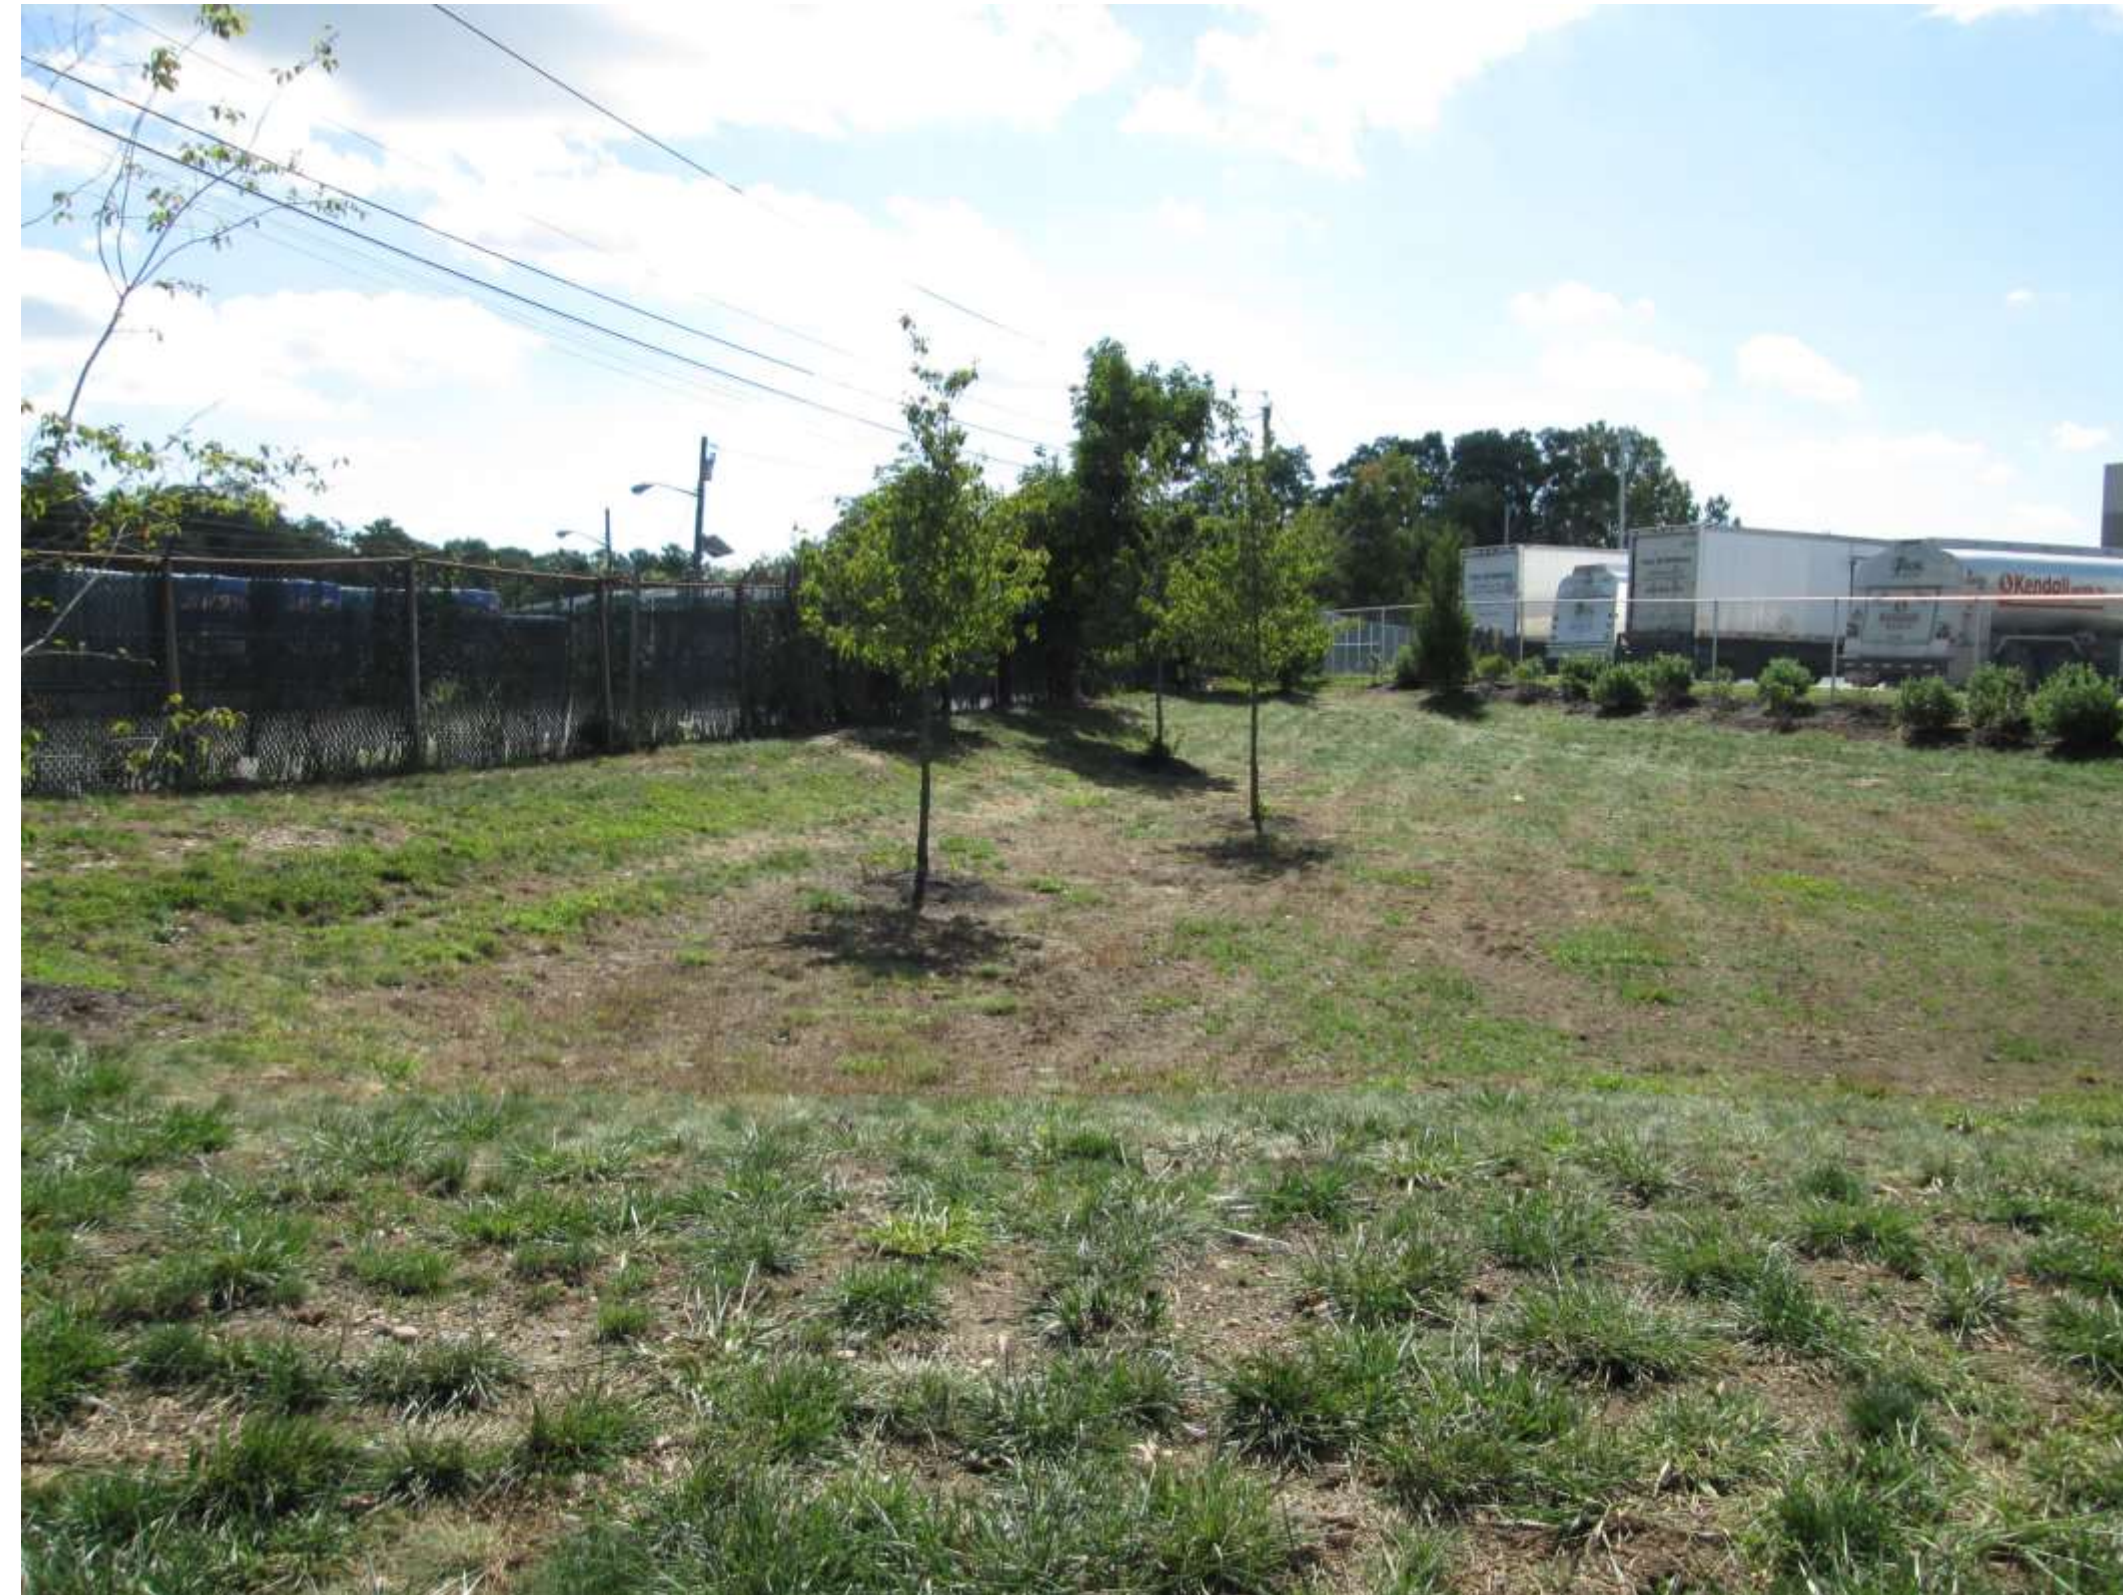
Basin overview

- Outlet is clogged by grass clippings
- Replace low flow channels with stone lined channels
- Overall well maintained
