**Hamilton Township (Mercer County)
Stormwater Basin Assessment Summary
Addendum (Year 4)**

Developed by the Rutgers Cooperative Extension Water Resources Program
Funded by Hamilton Township, Mercer County, New Jersey

December 2017

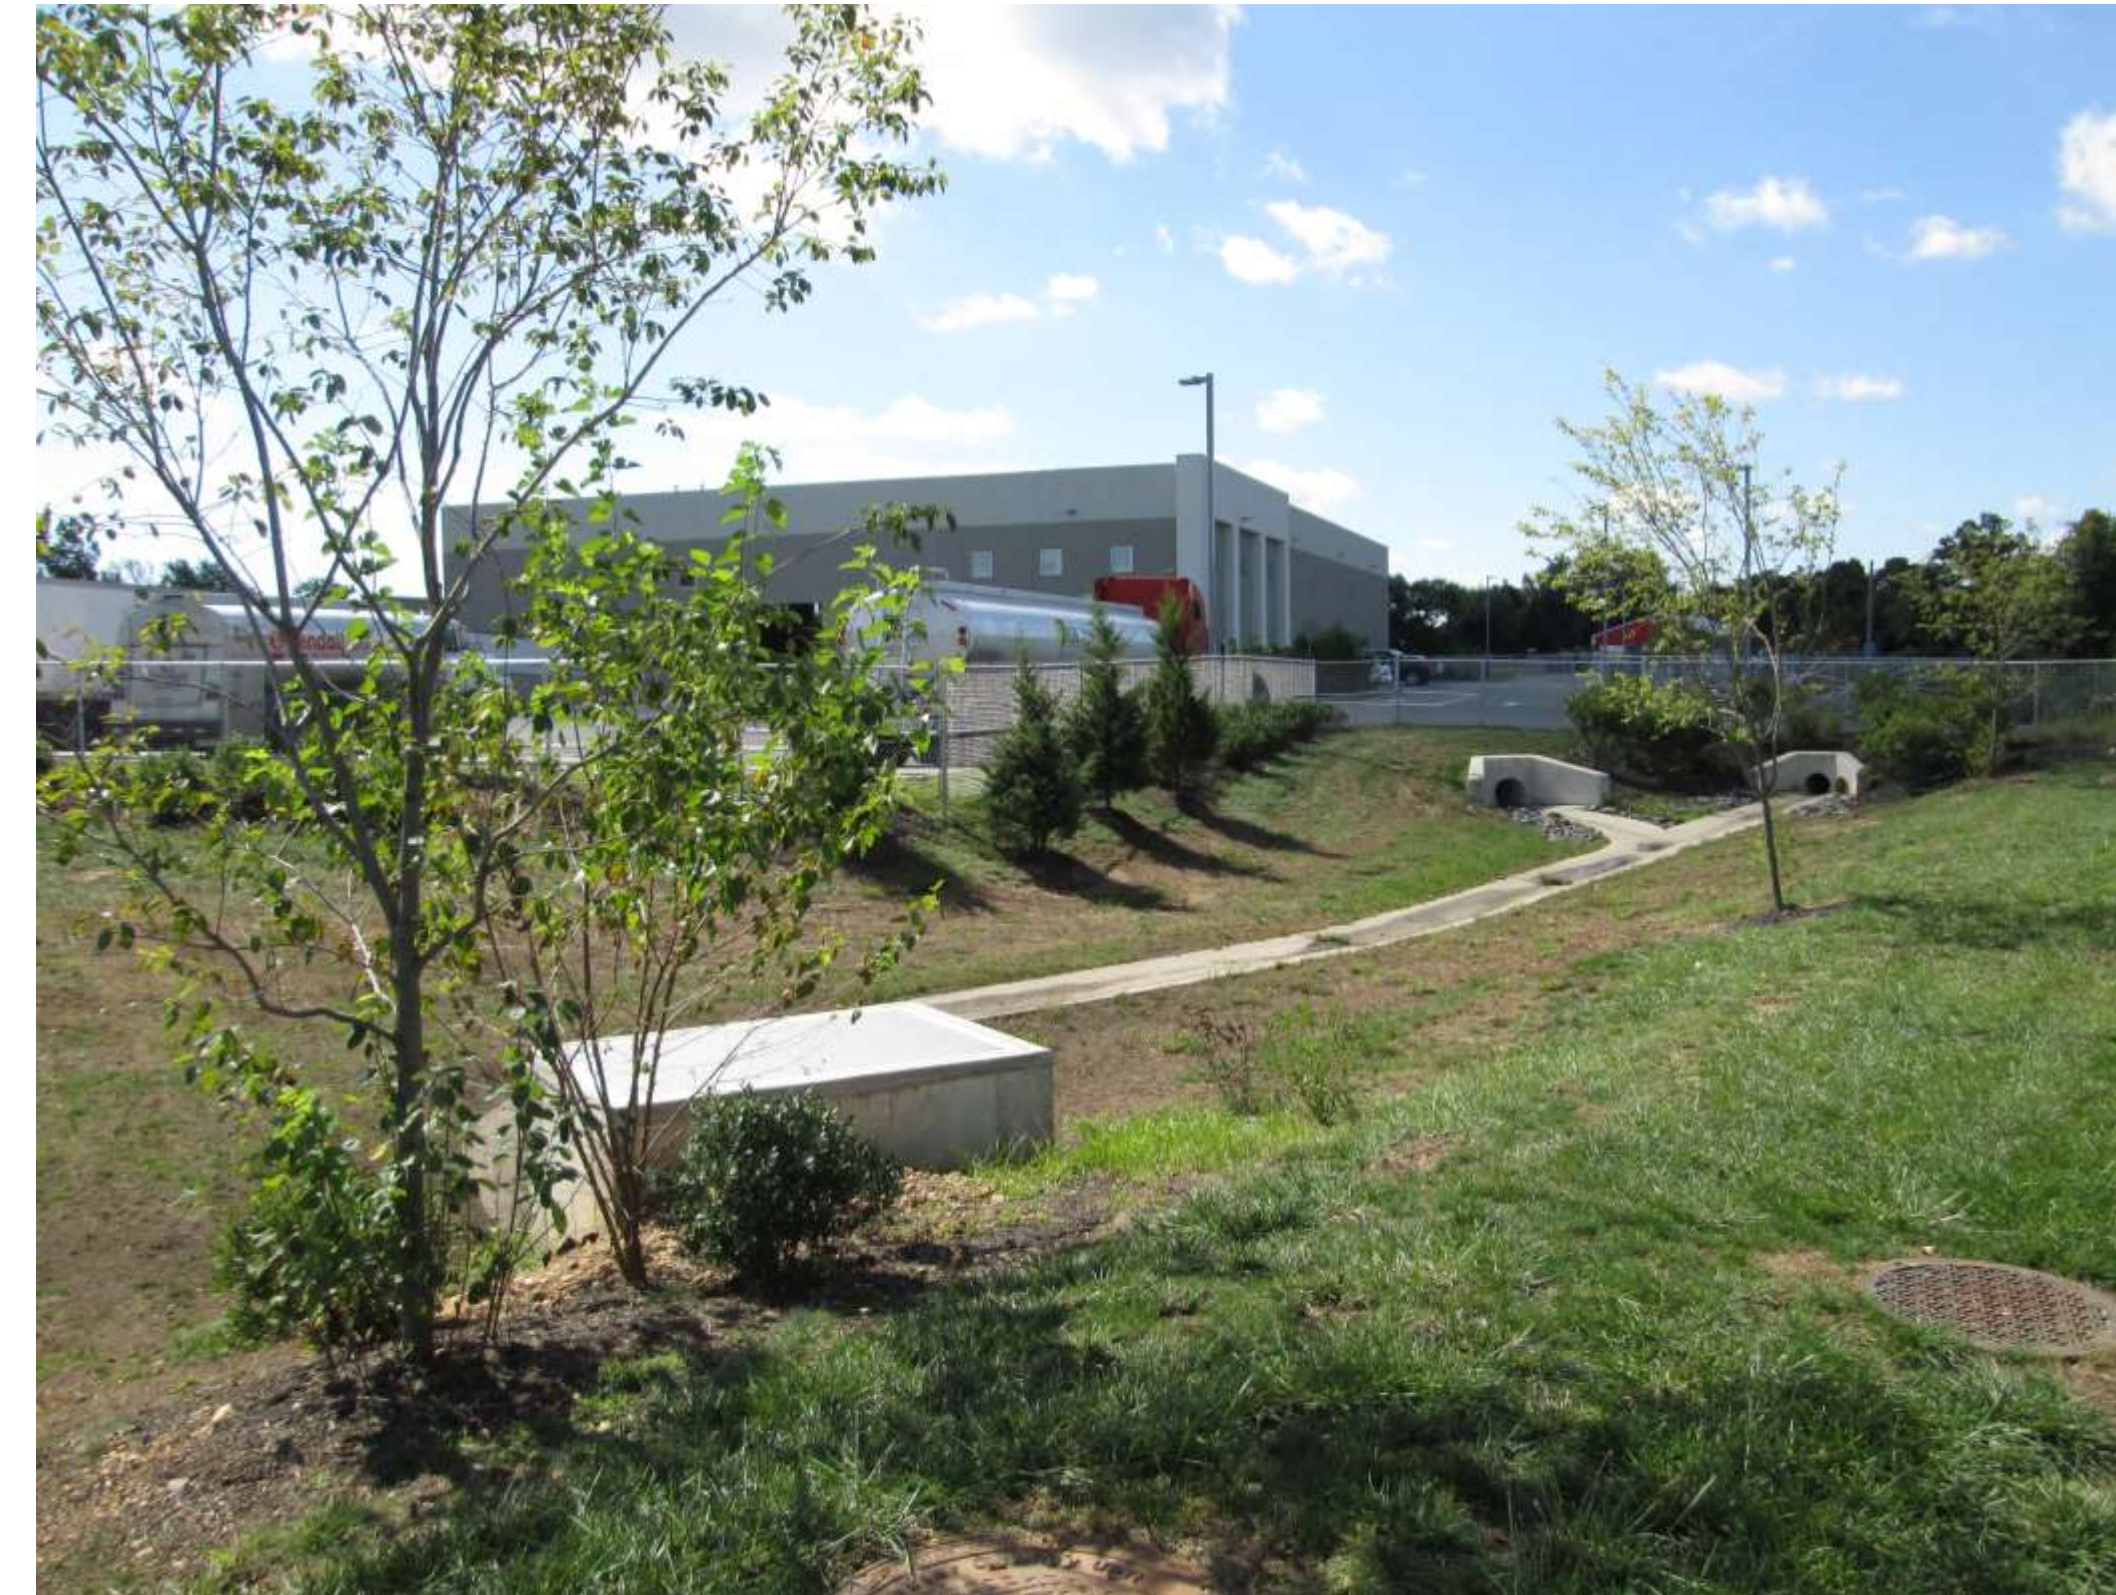
Inlet

- Outlet is clogged by grass clippings
- Replace low flow channels with stone lined channels
- Overall well maintained

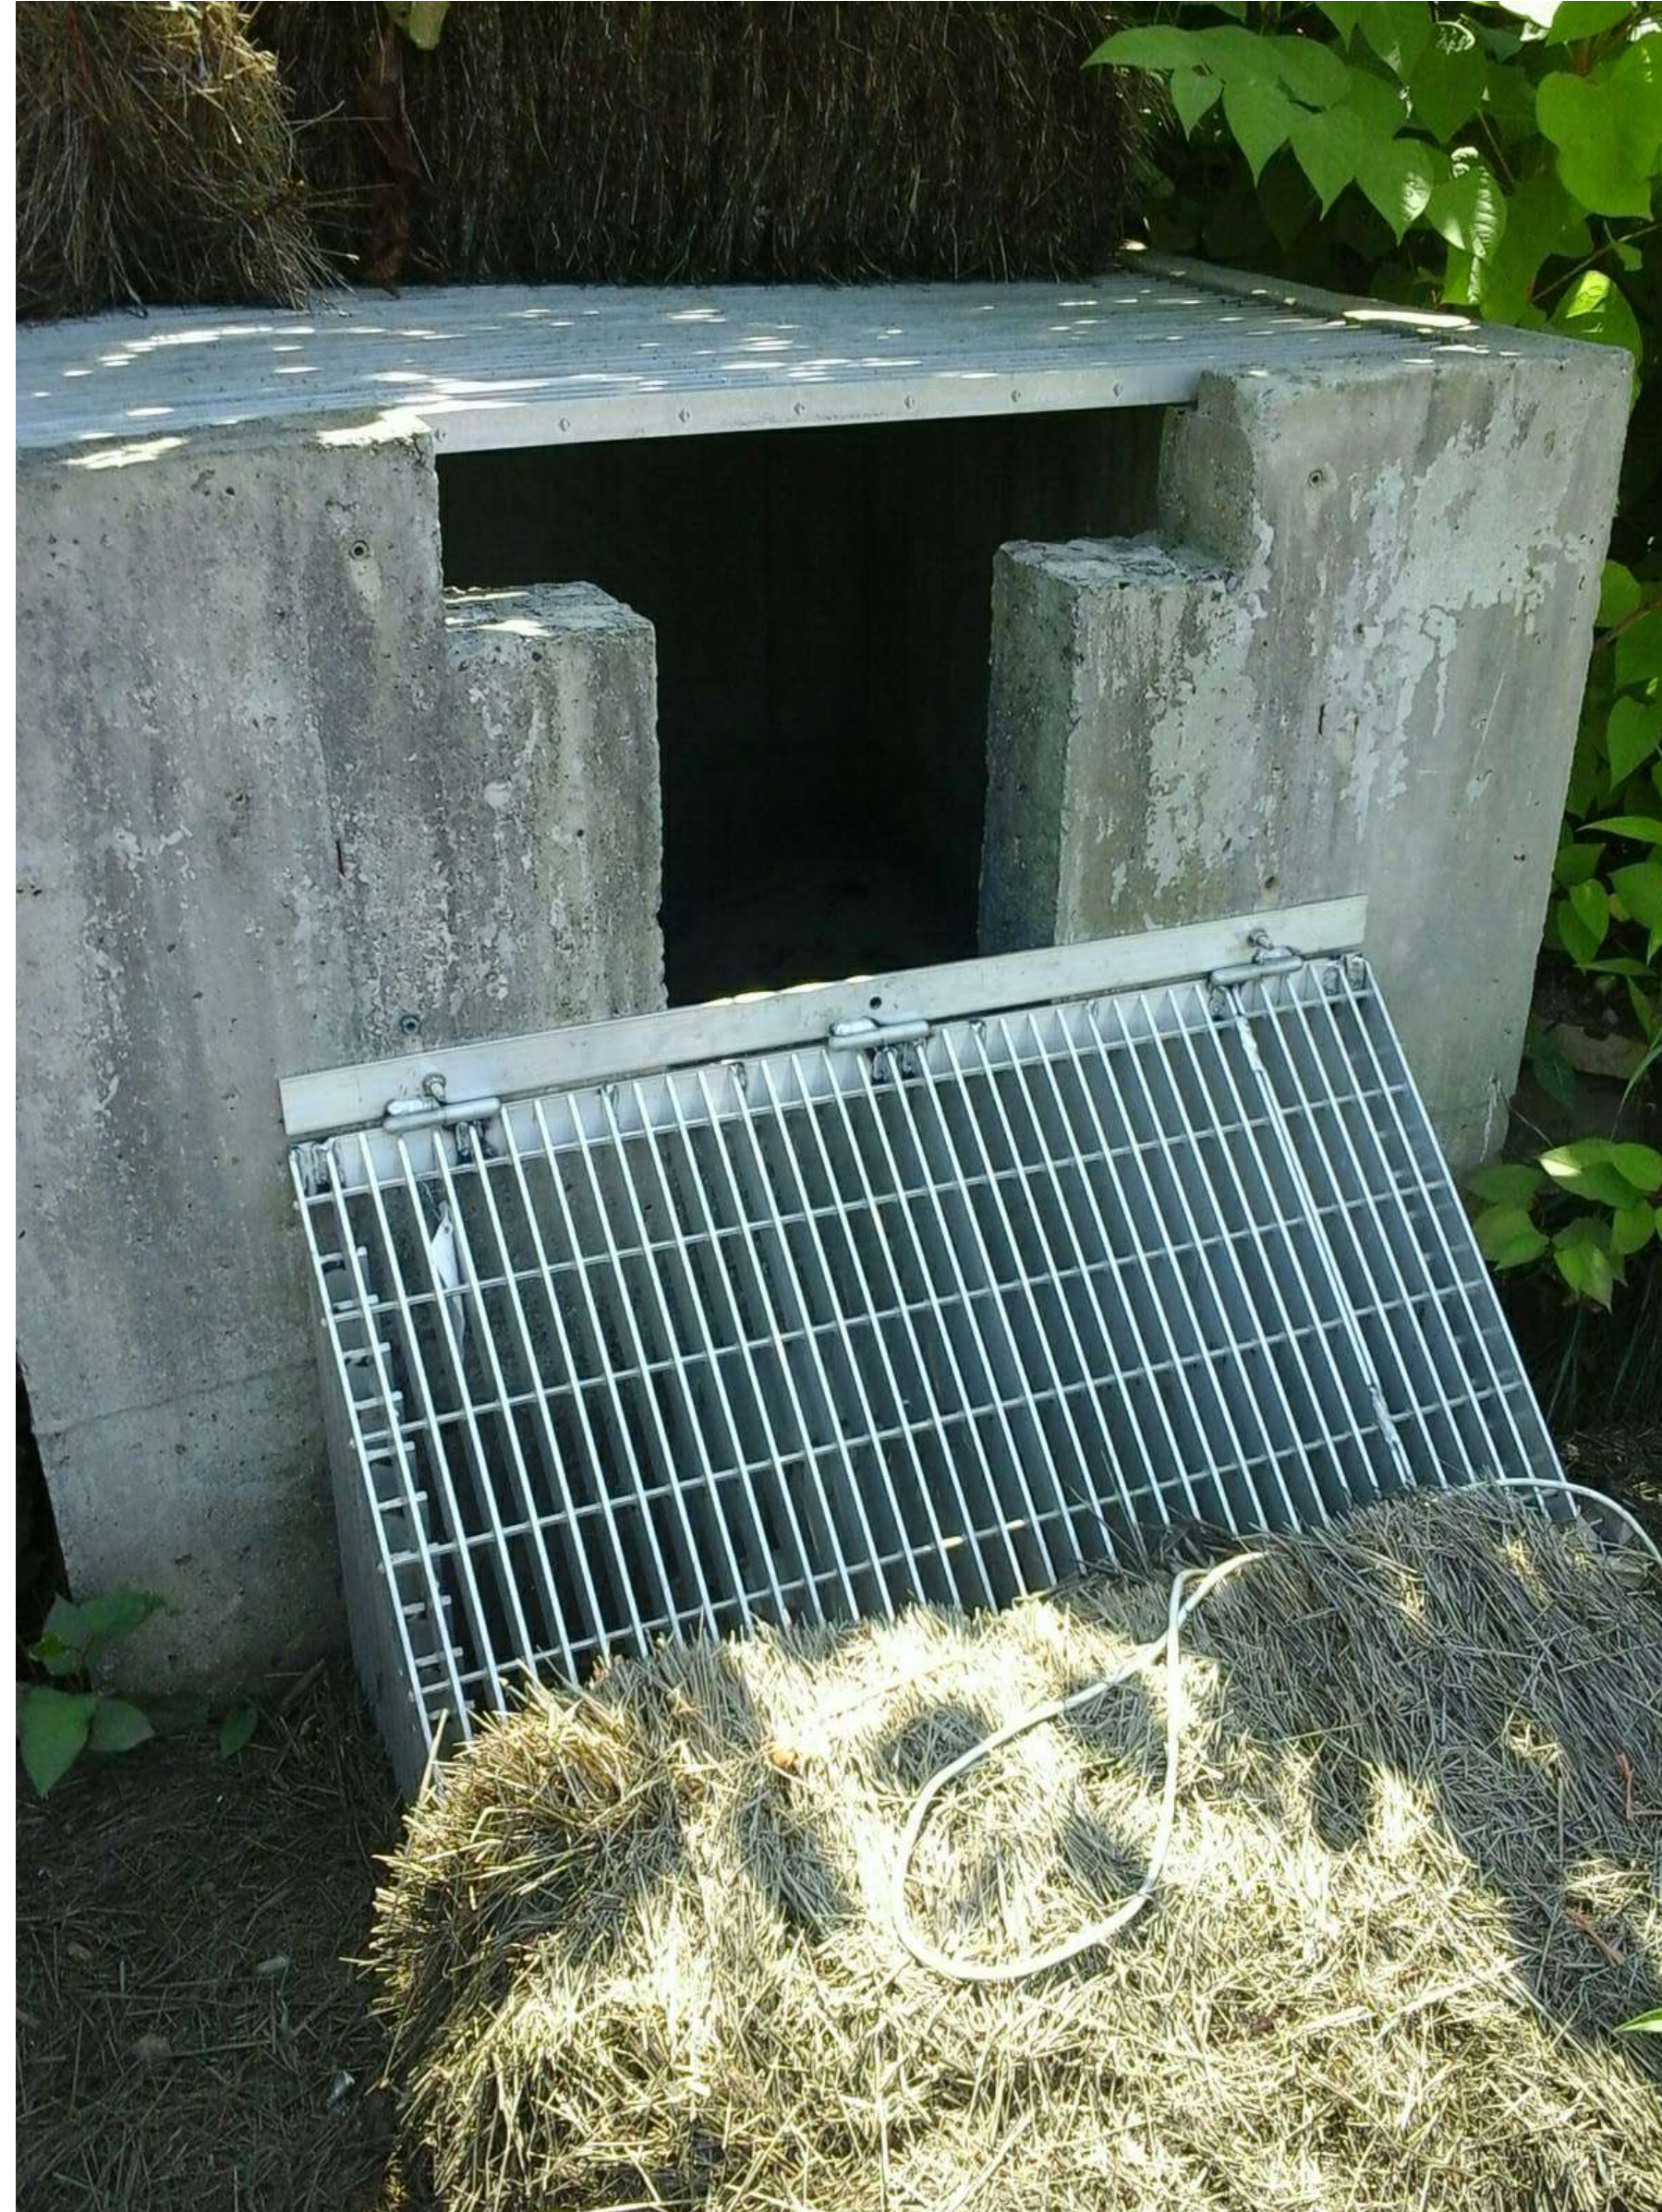
Outlet

- Infiltration basin
- Excess sediment and debris accumulated near outlet
