**Hamilton Township (Mercer County)
Stormwater Basin Assessment Summary
Hamilton Owned Addendum (Year 5A)**

Developed by the Rutgers Cooperative Extension Water Resources Program
Funded by Hamilton Township, Mercer County, New Jersey

November 27, 2019

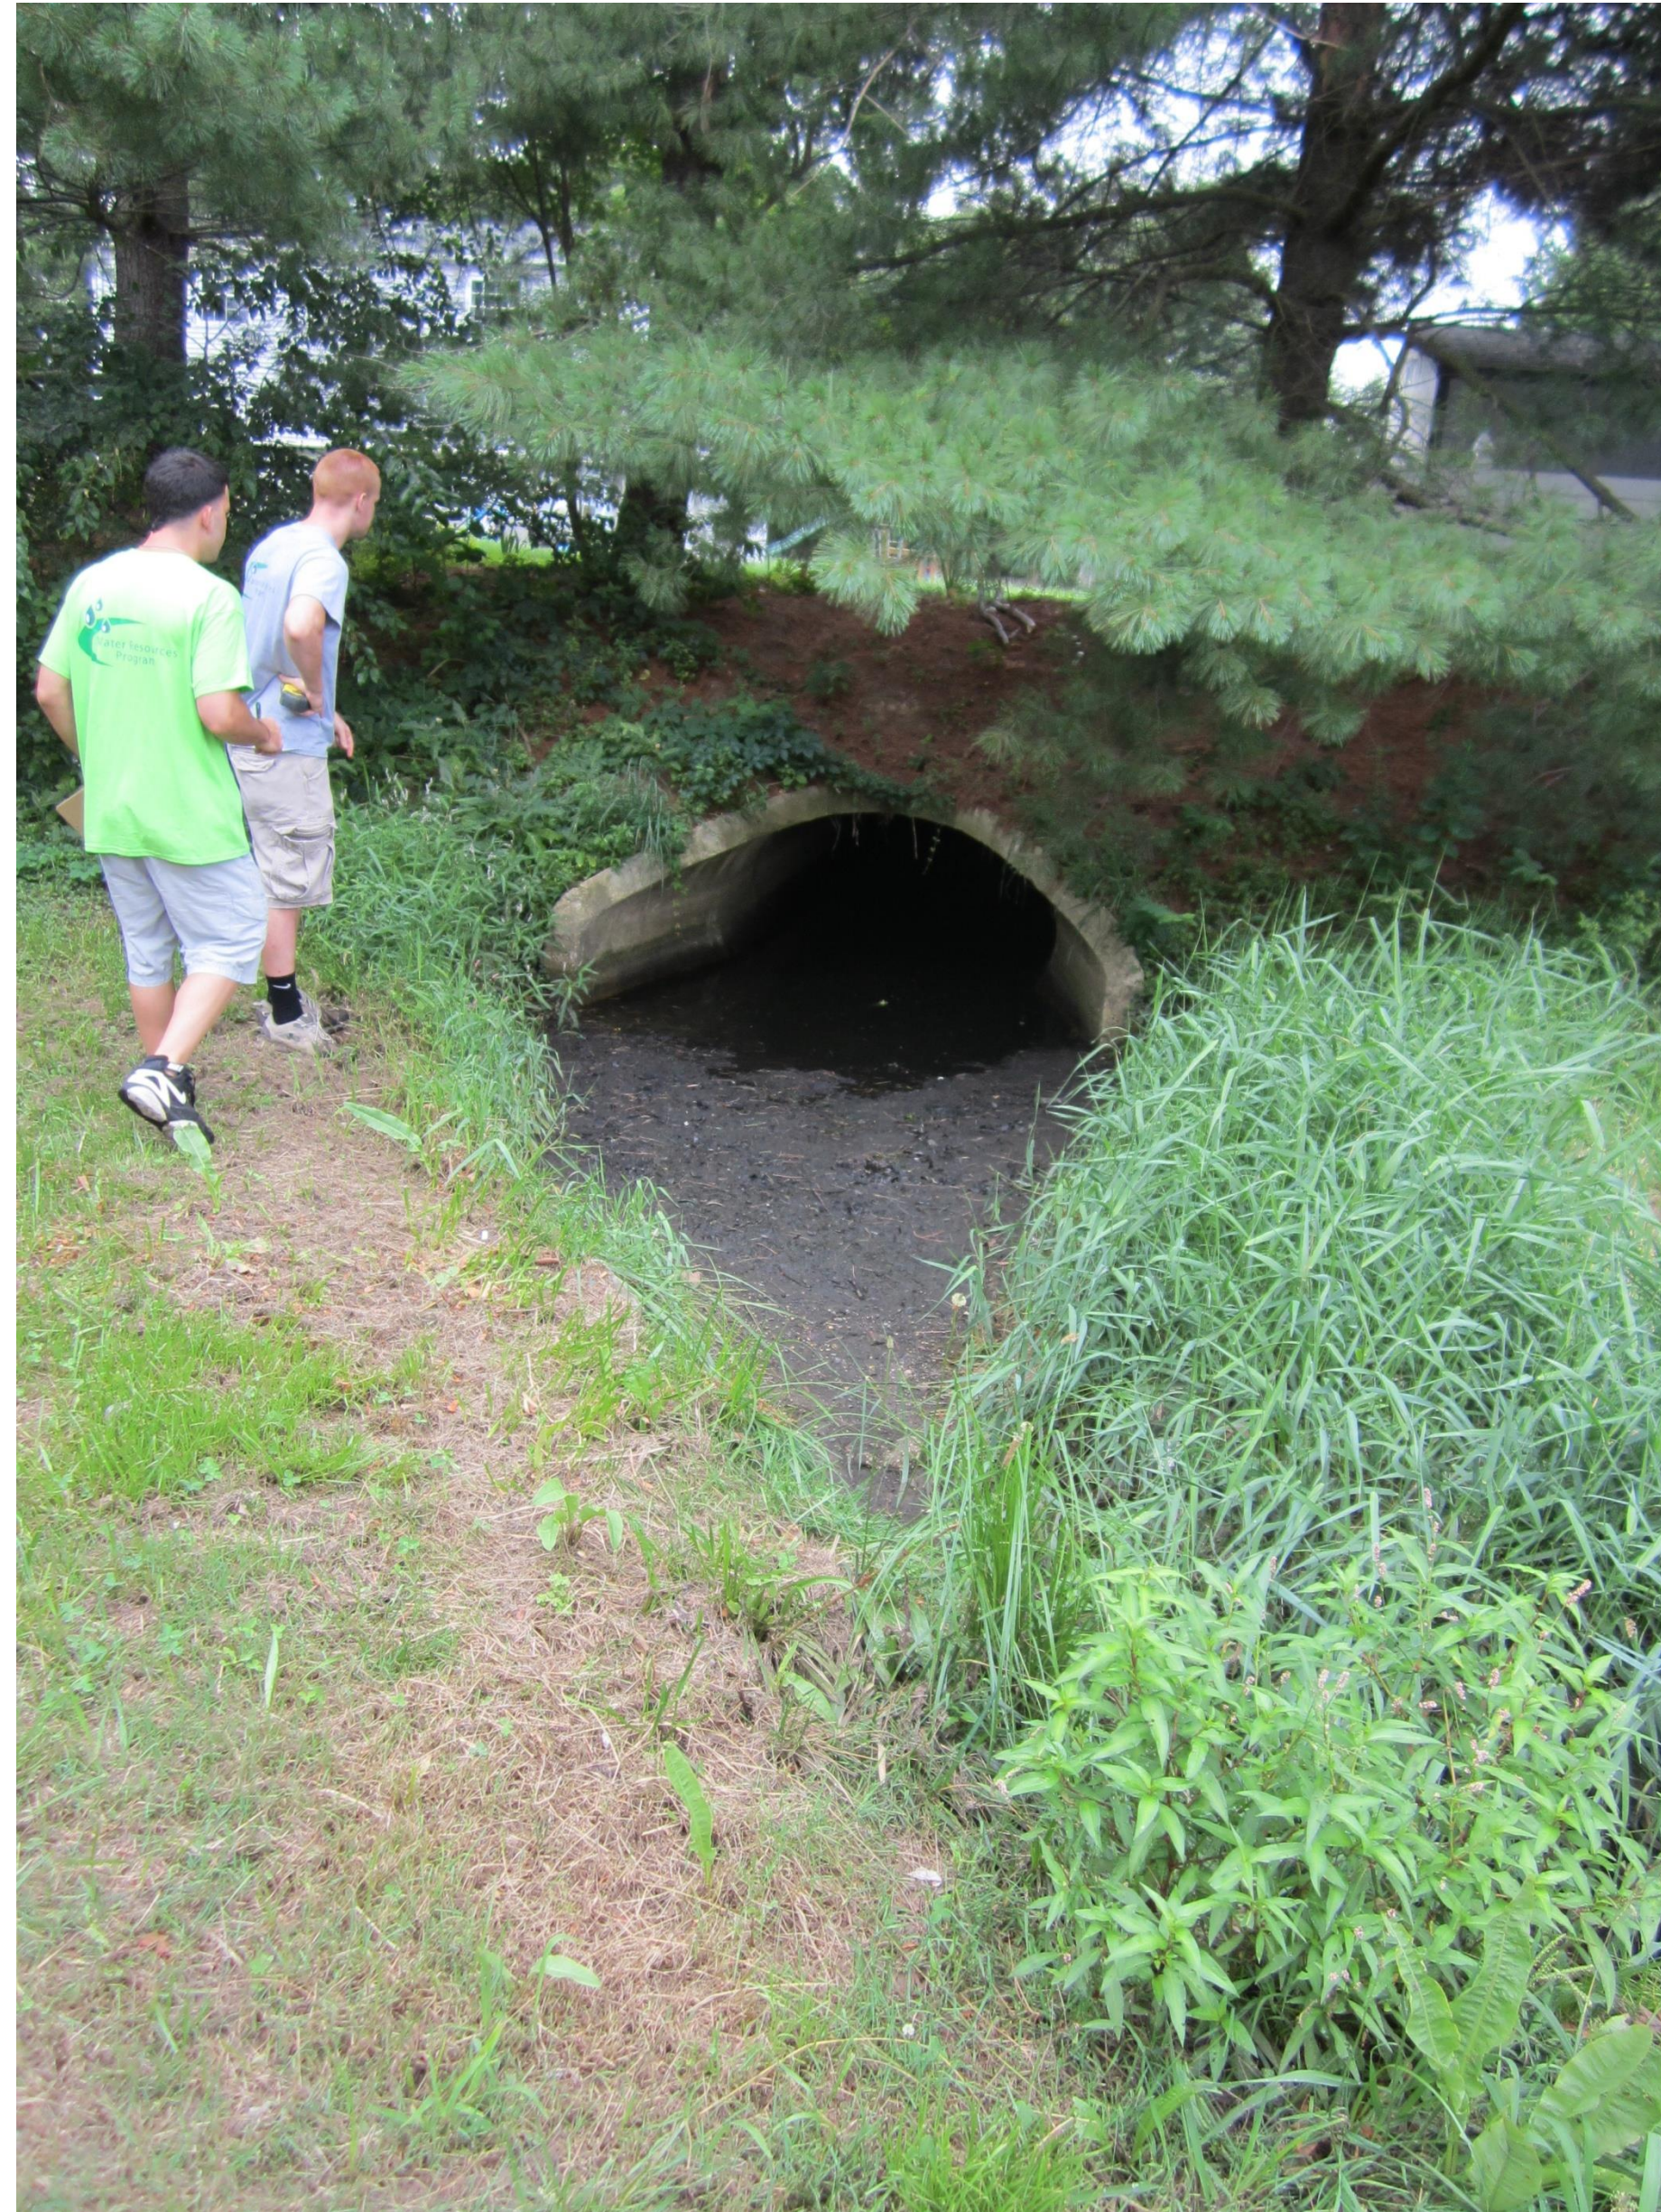
Clogged inlet.

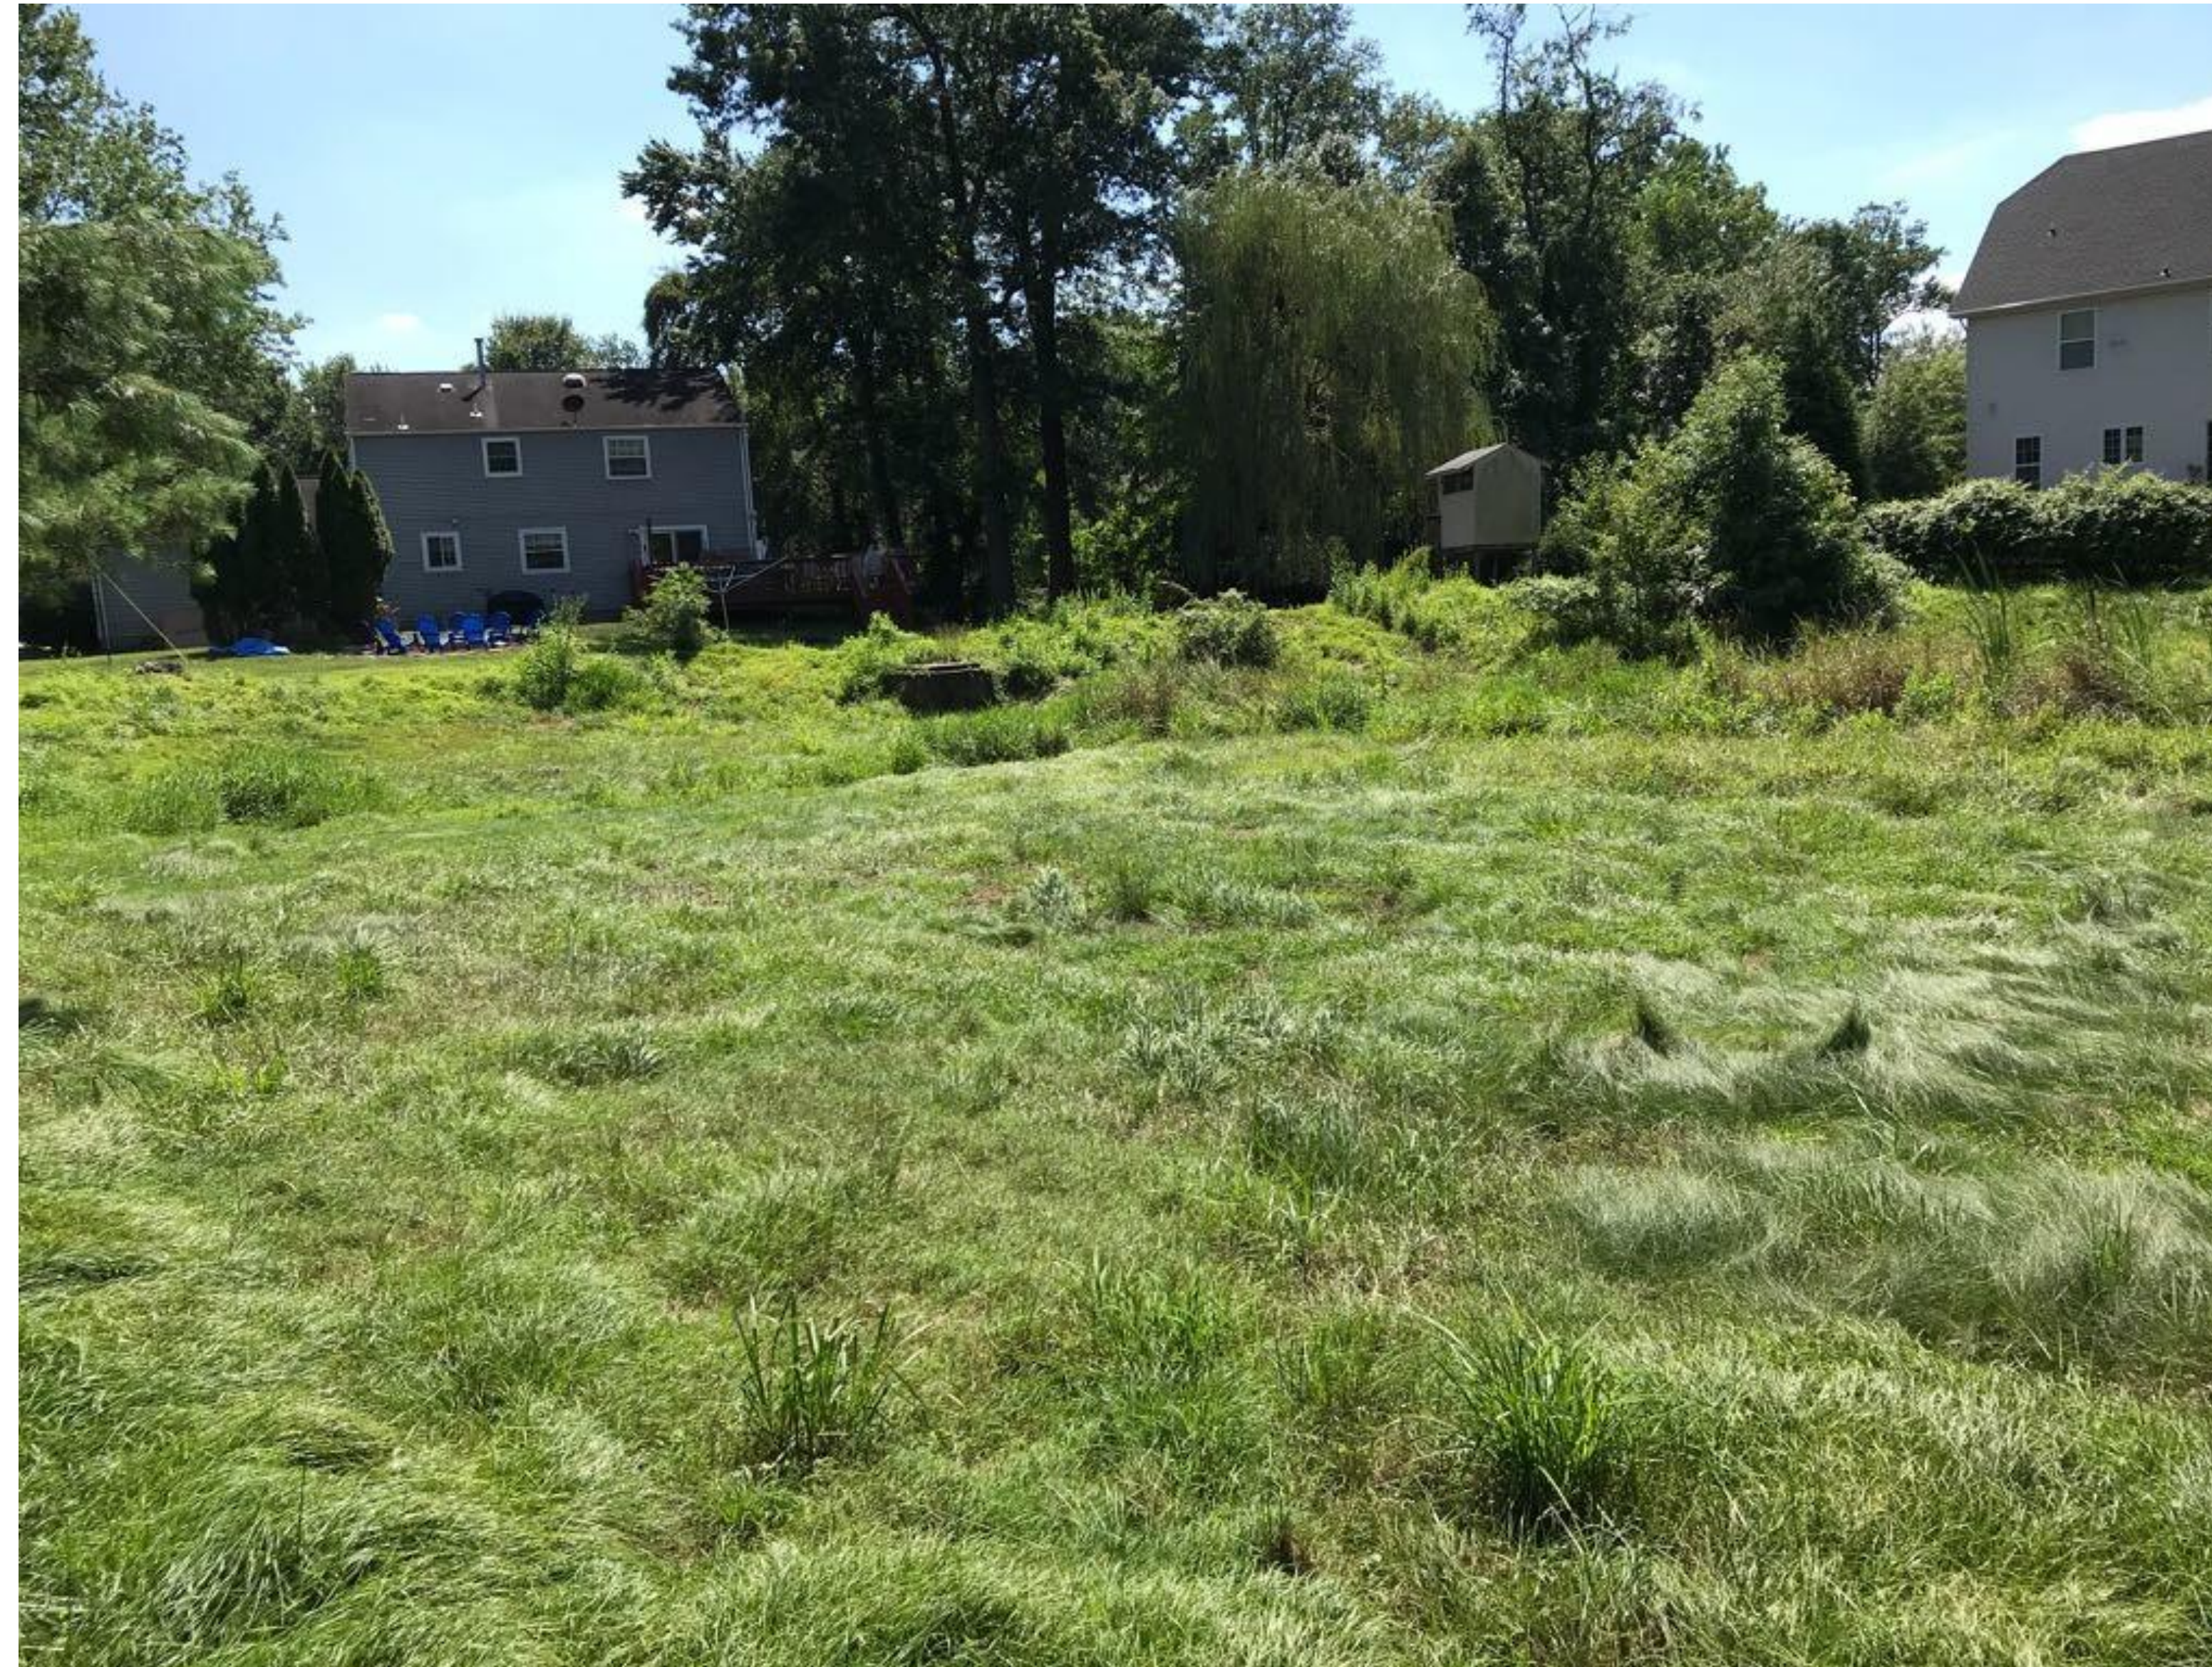
- Channel overgrown with vegetation and sediment leading to restricted flow
- Basin has not improved from previous assessment
- Suggest maintenance to clear out channels

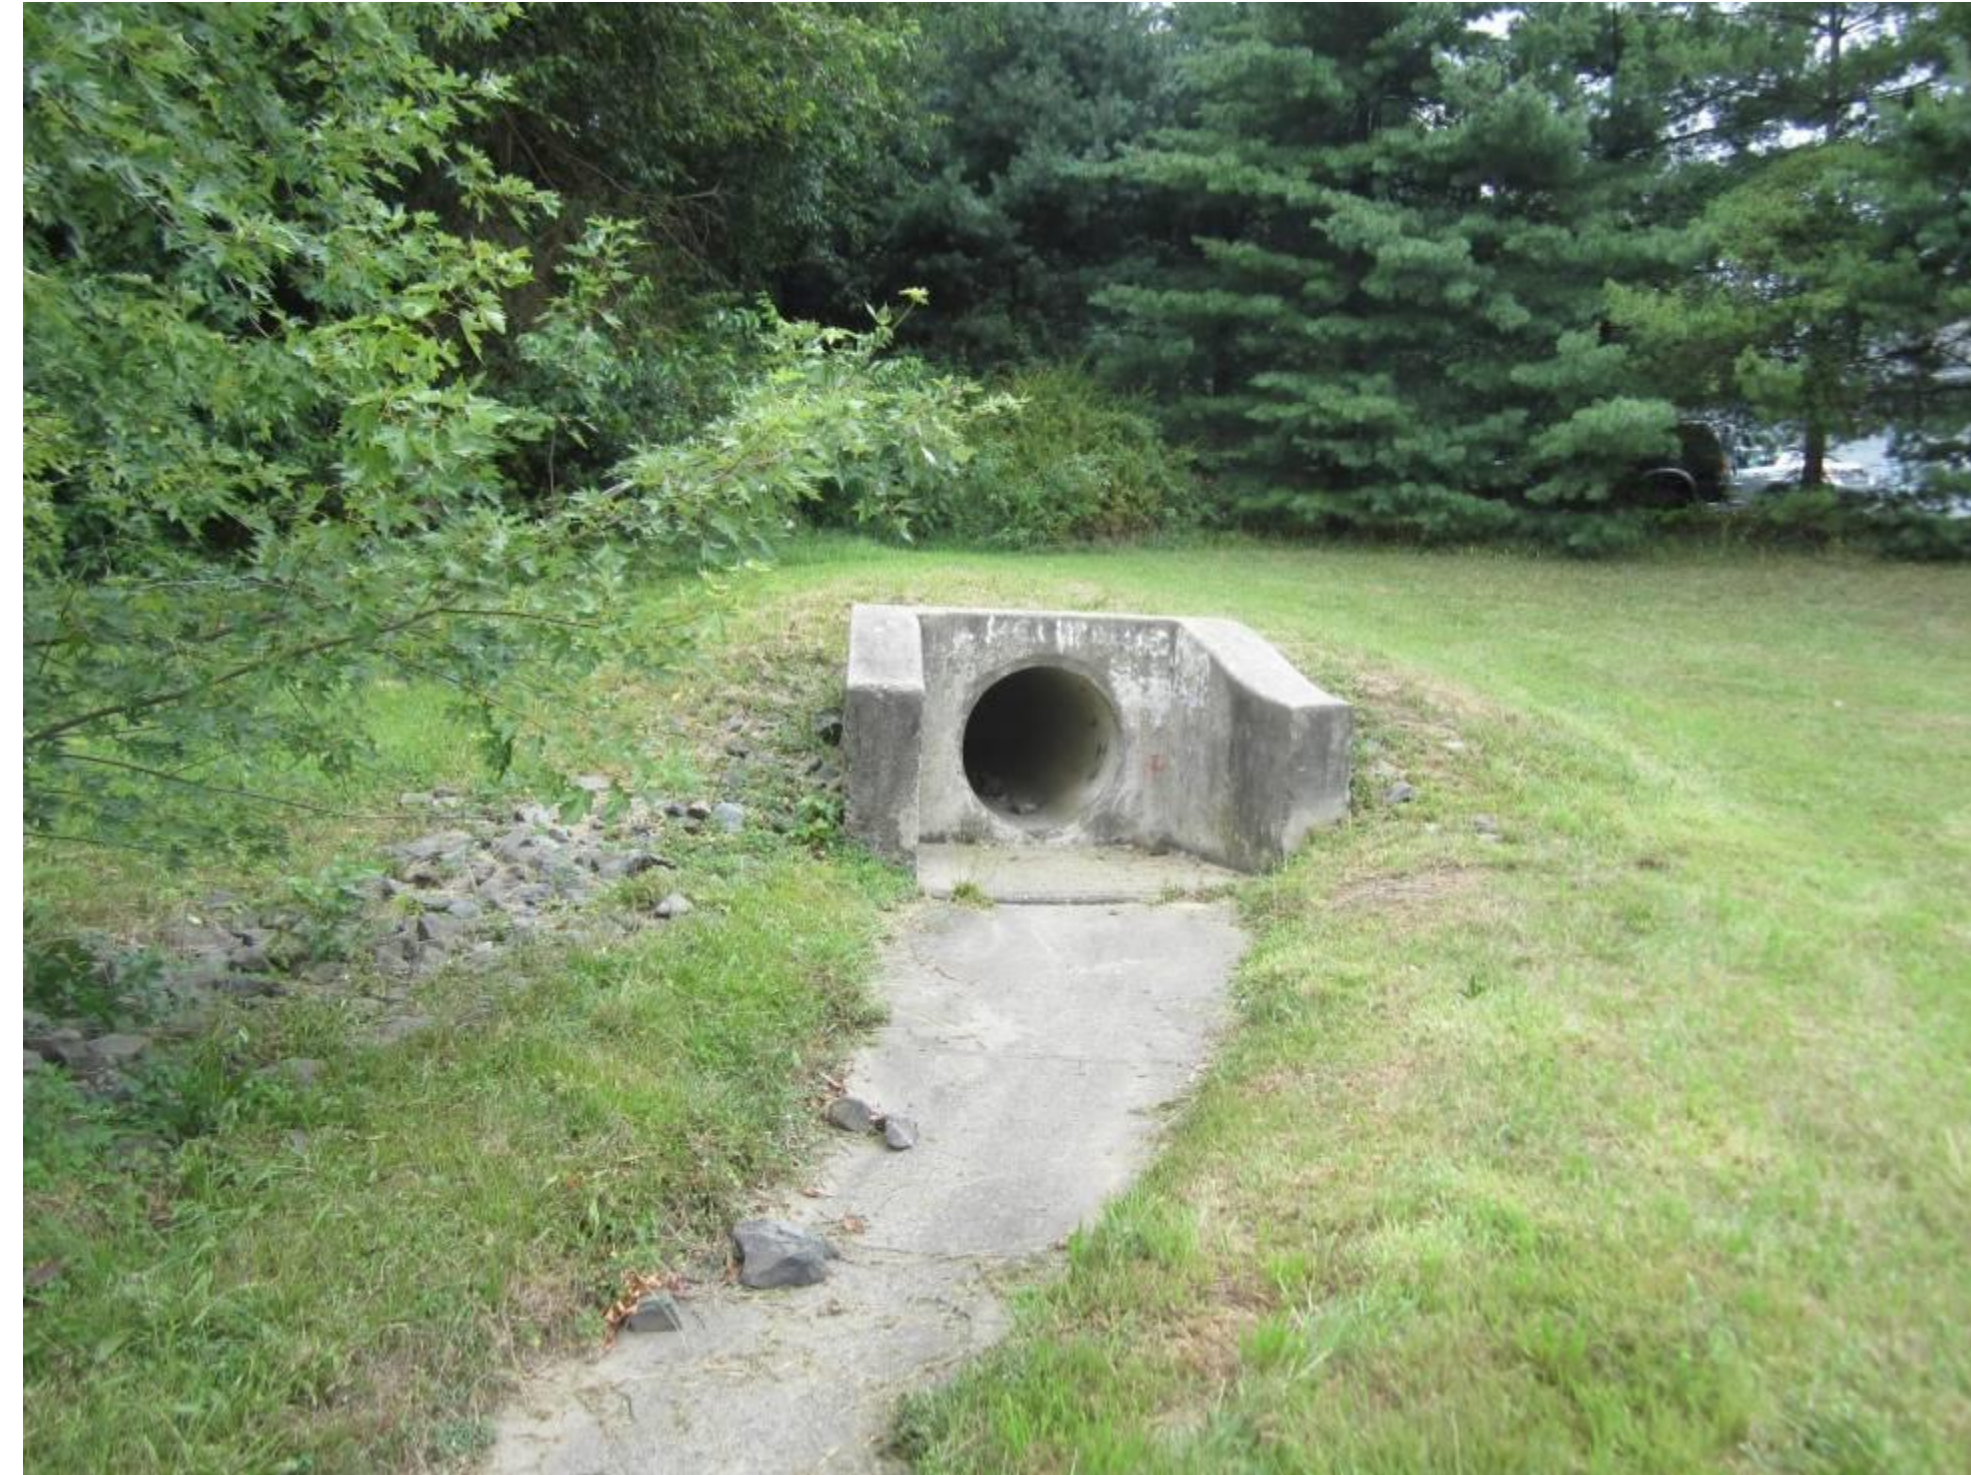
36" Diameter inlet

- Two inlets and one outlet
- Concrete low flow channel has grass growing over it
- Opportunity to remove concrete low flow channels and replace with a stone channel

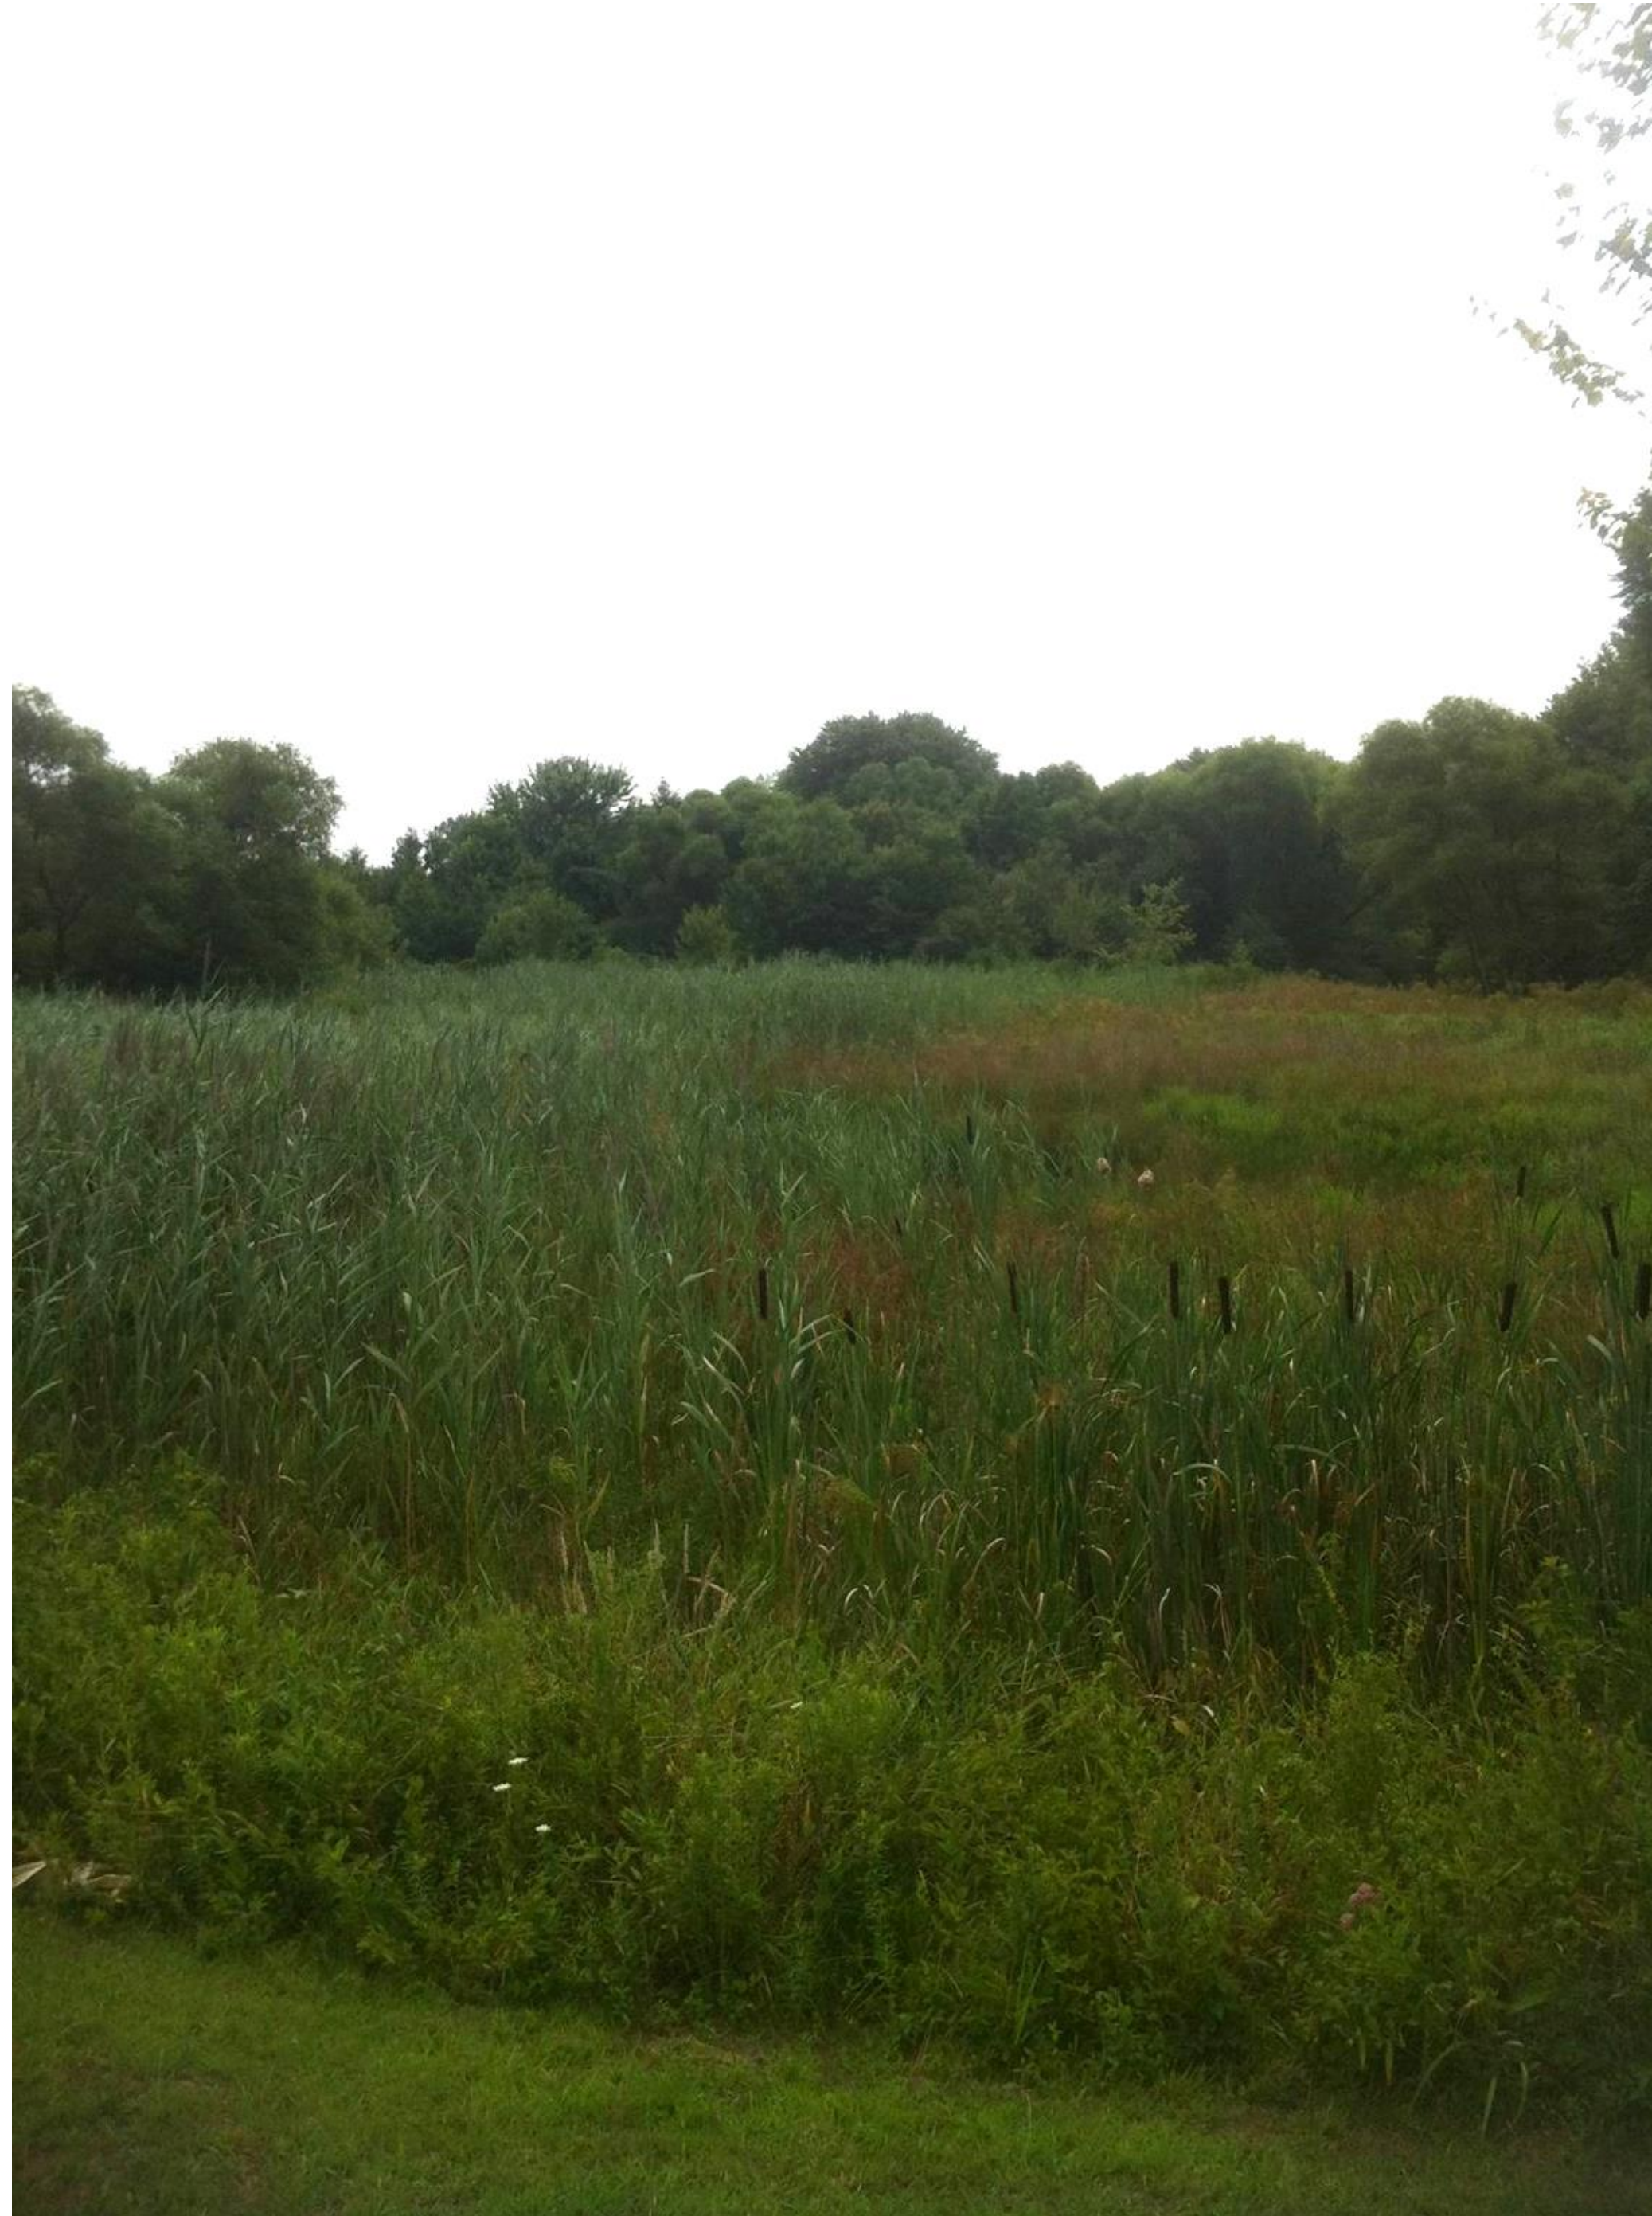
View of basin looking east

- Basin is naturalized with dense vegetation
- Inlets and outlets are inaccessible due to vegetation growth in warm months
- Invasive plant species present including Phragmites and Purple Loosestrife
- Erosion present

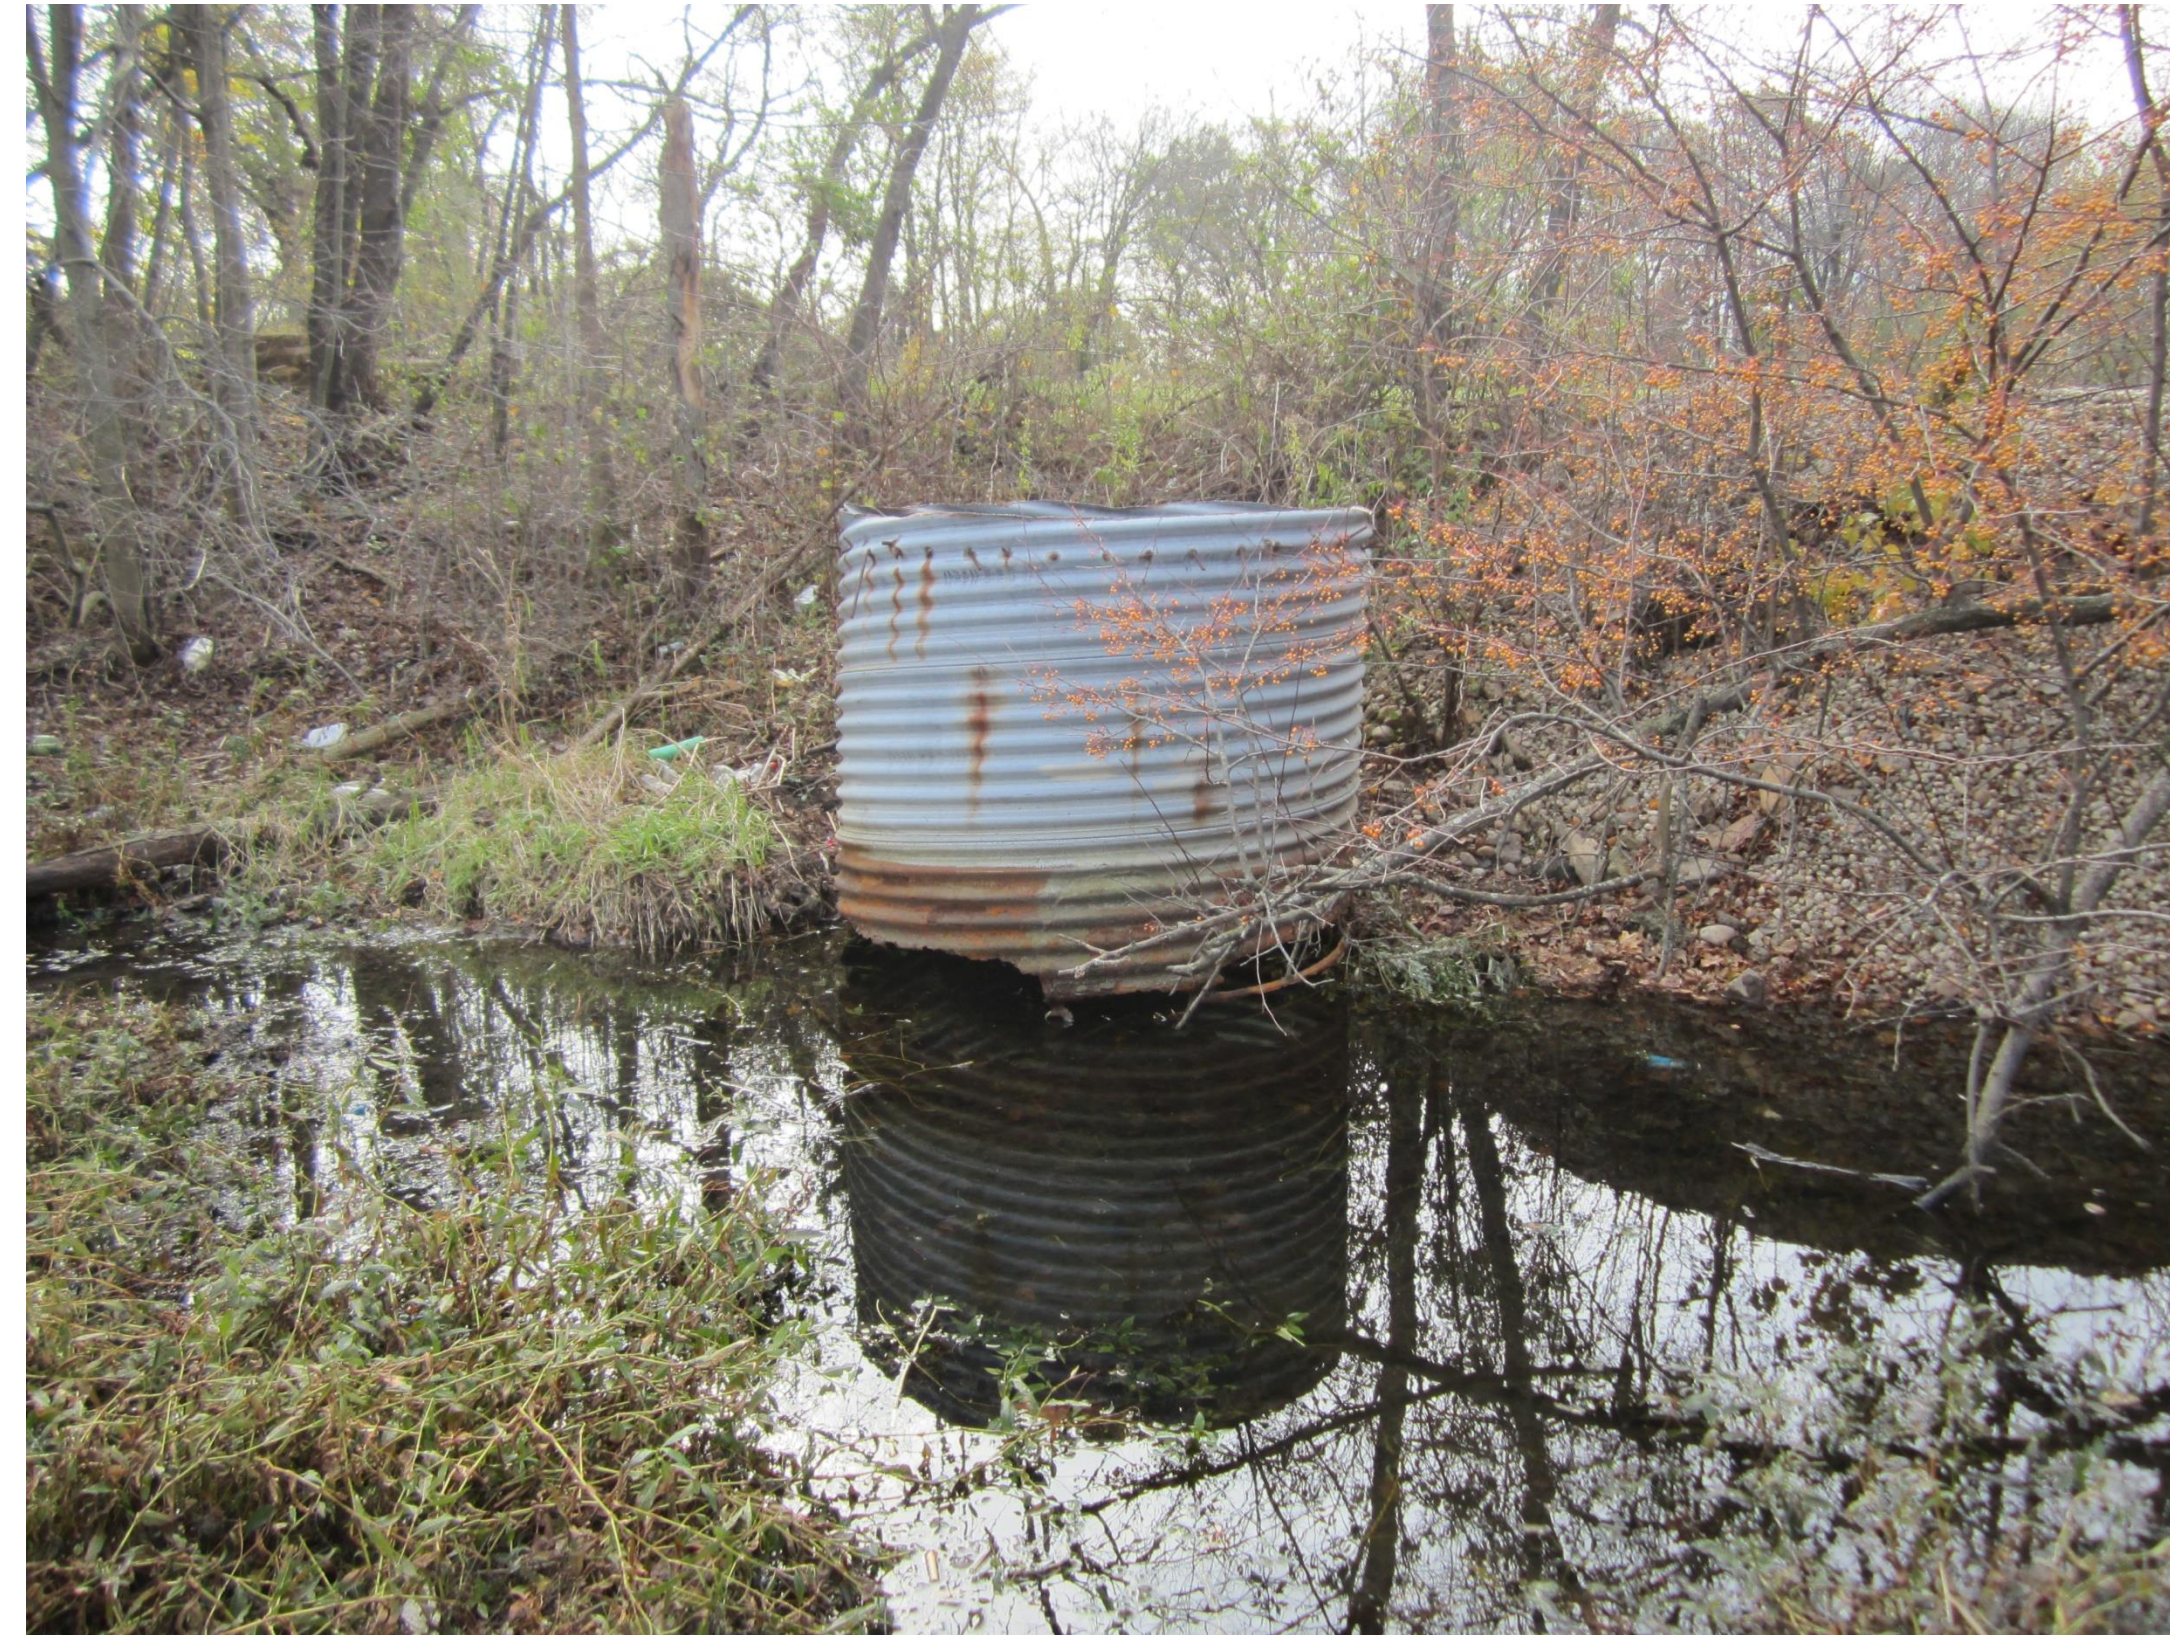
Outlet Structure

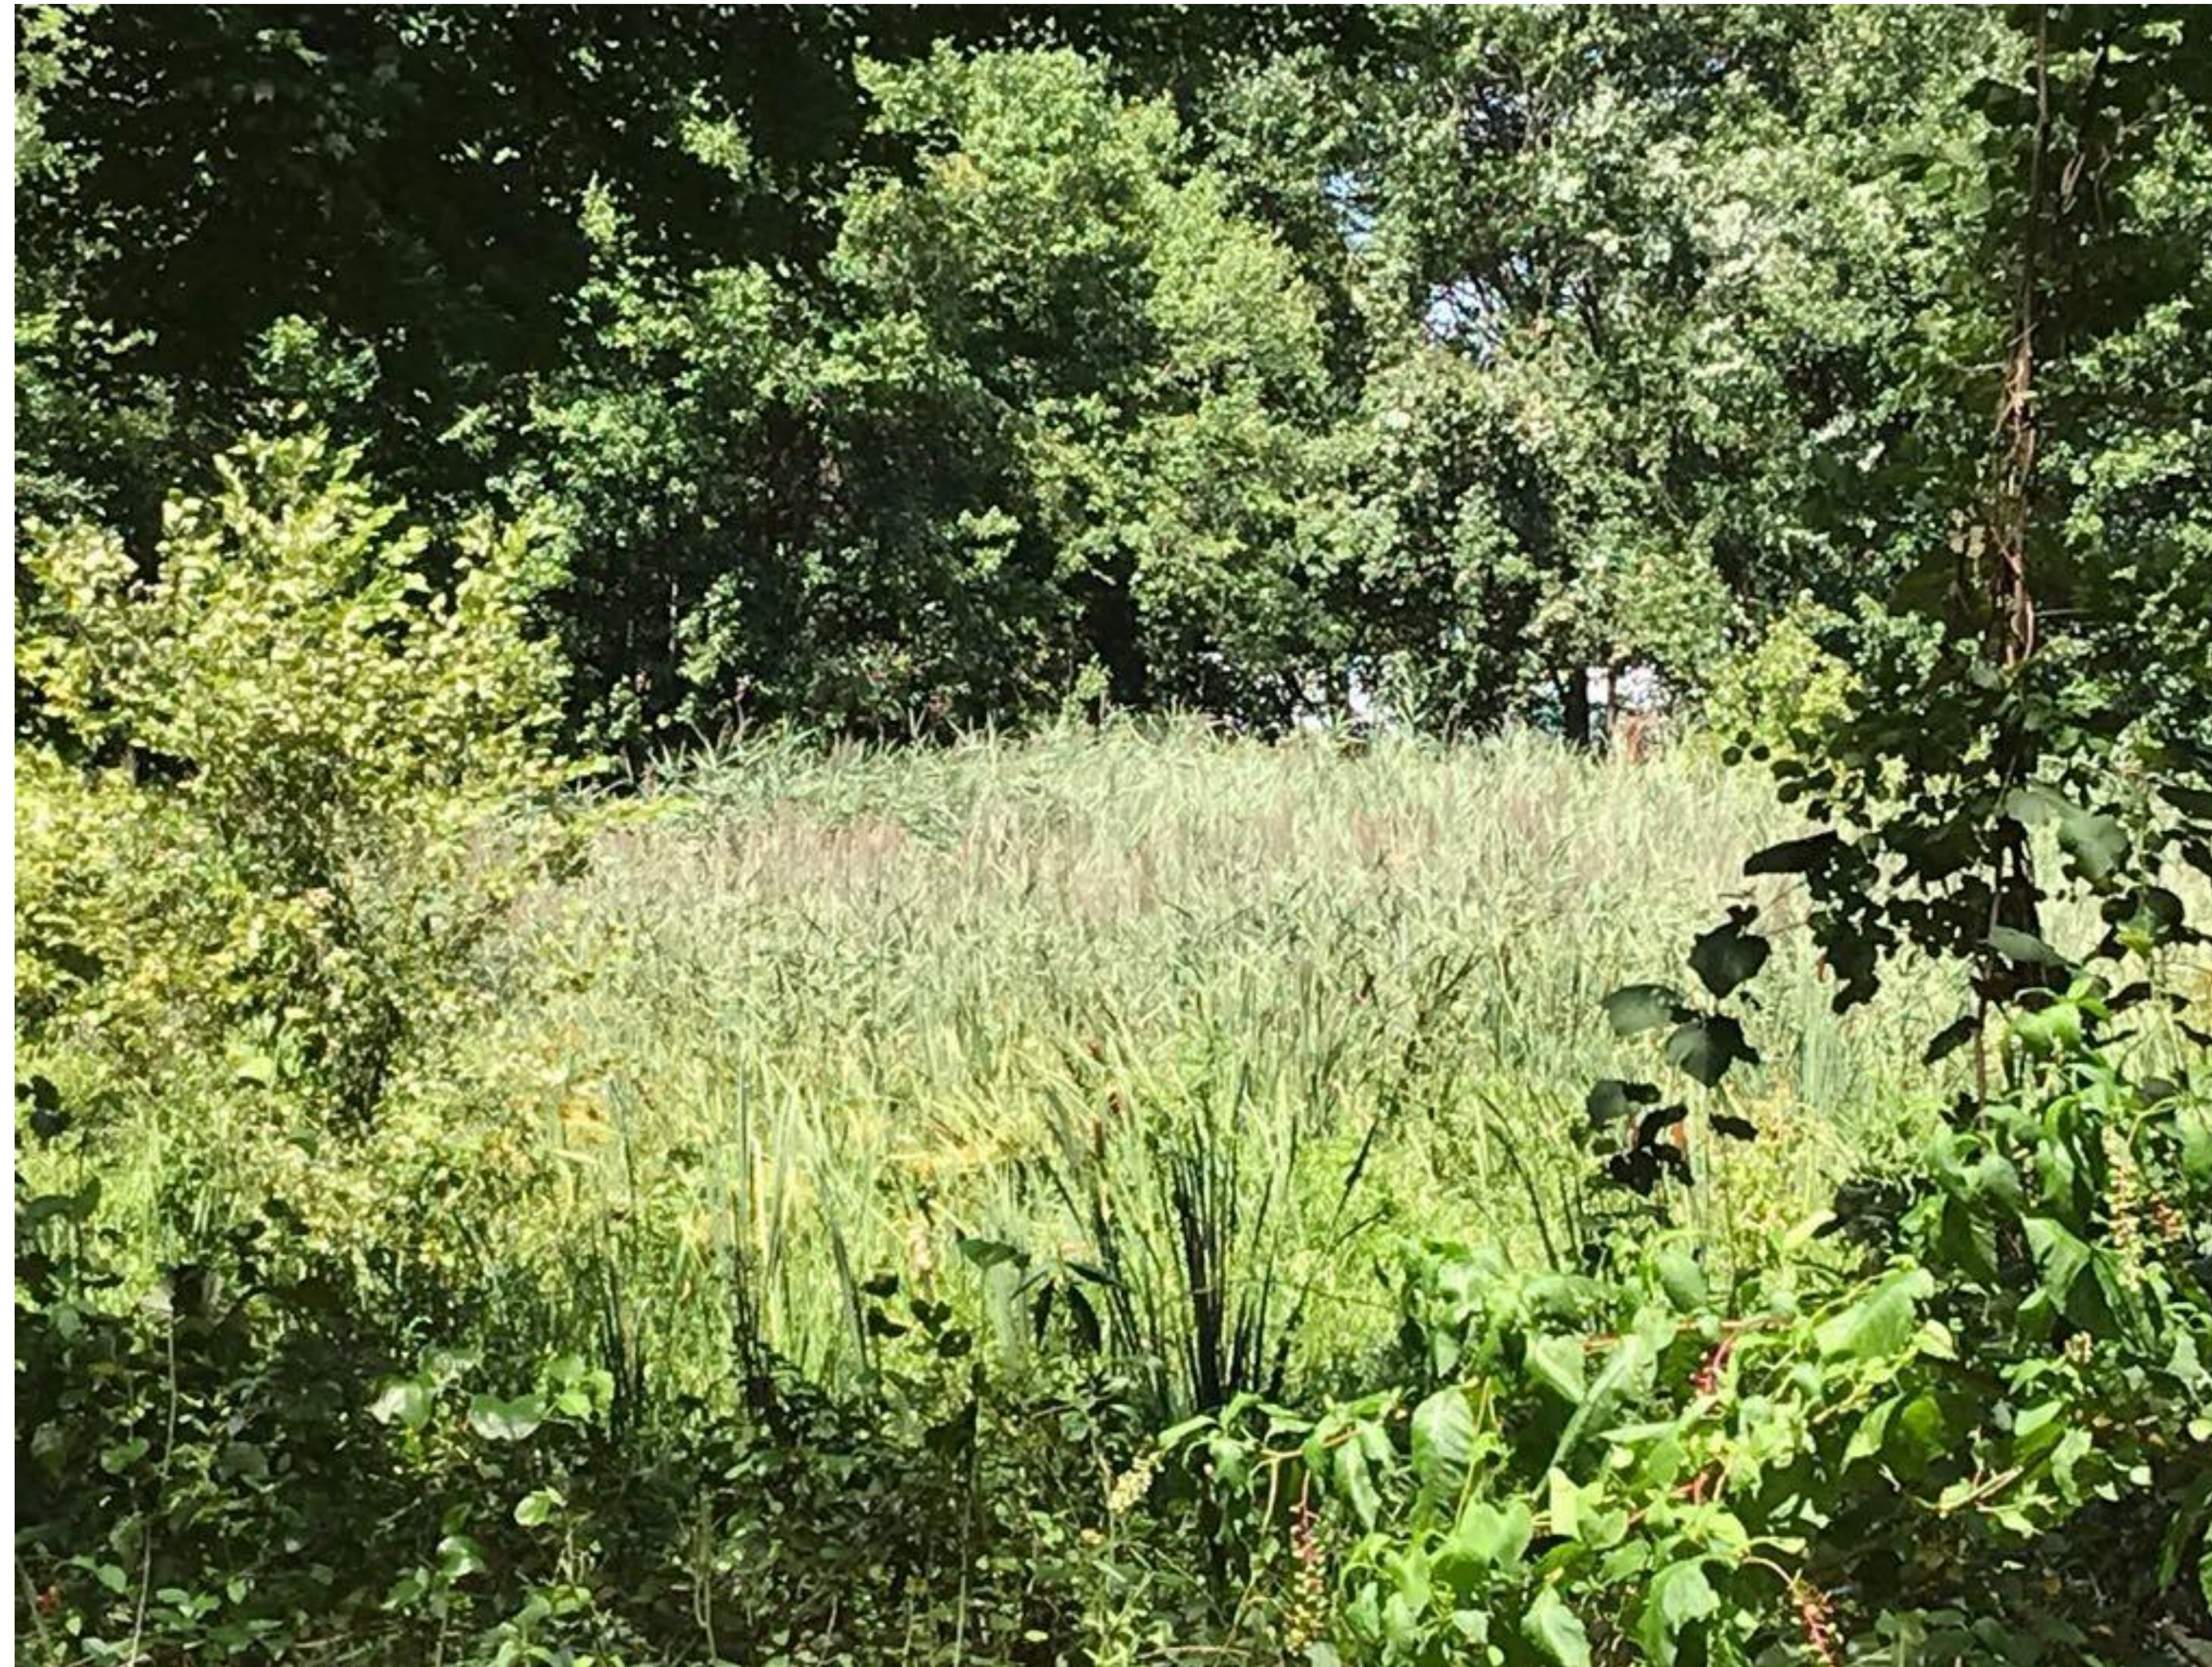
19. Brookwood Rd Residential Basin

- Basin is inaccessible due to over grown vegetation
- Maintenance suggested to have access to basin and outlet structures
