**Hamilton Township (Mercer County)
Stormwater Basin Assessment Summary
Hamilton Owned Addendum (Year 5A)**

Developed by the Rutgers Cooperative Extension Water Resources Program
Funded by Hamilton Township, Mercer County, New Jersey

November 27, 2019

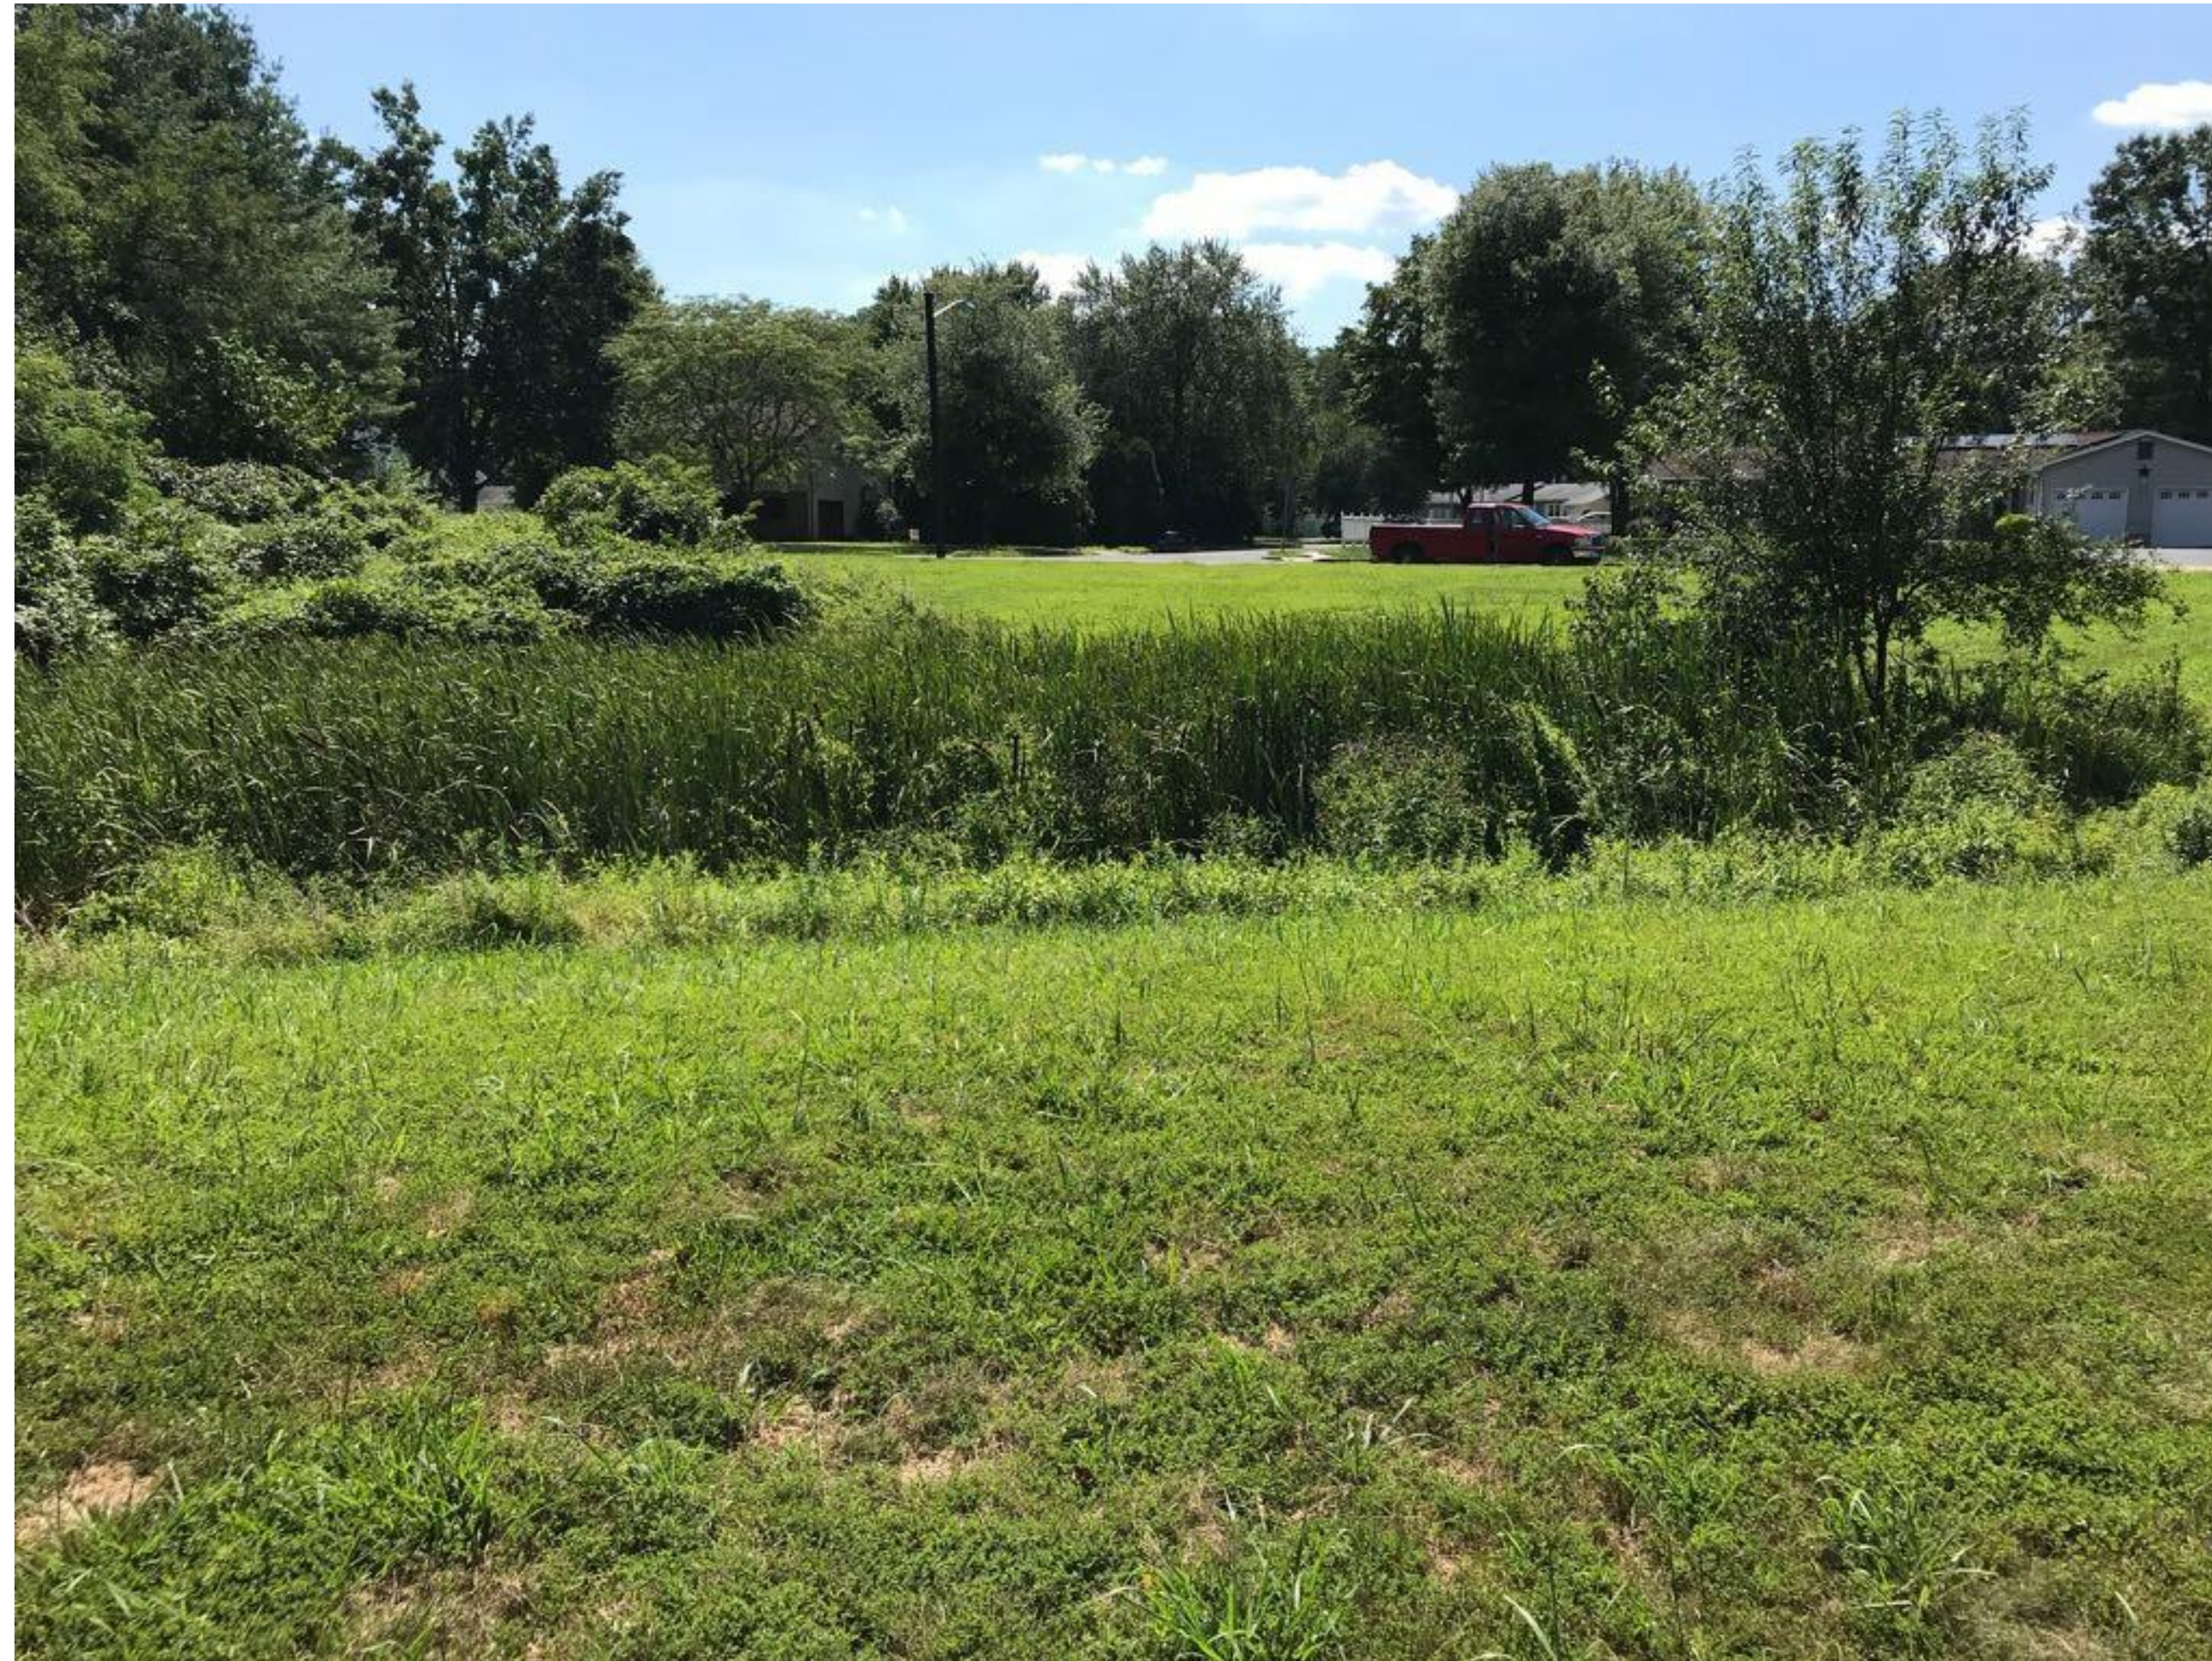
28. Crestwood Dr Residential Basins

- Heavy vegetation in the basin
- No clear outlet identified

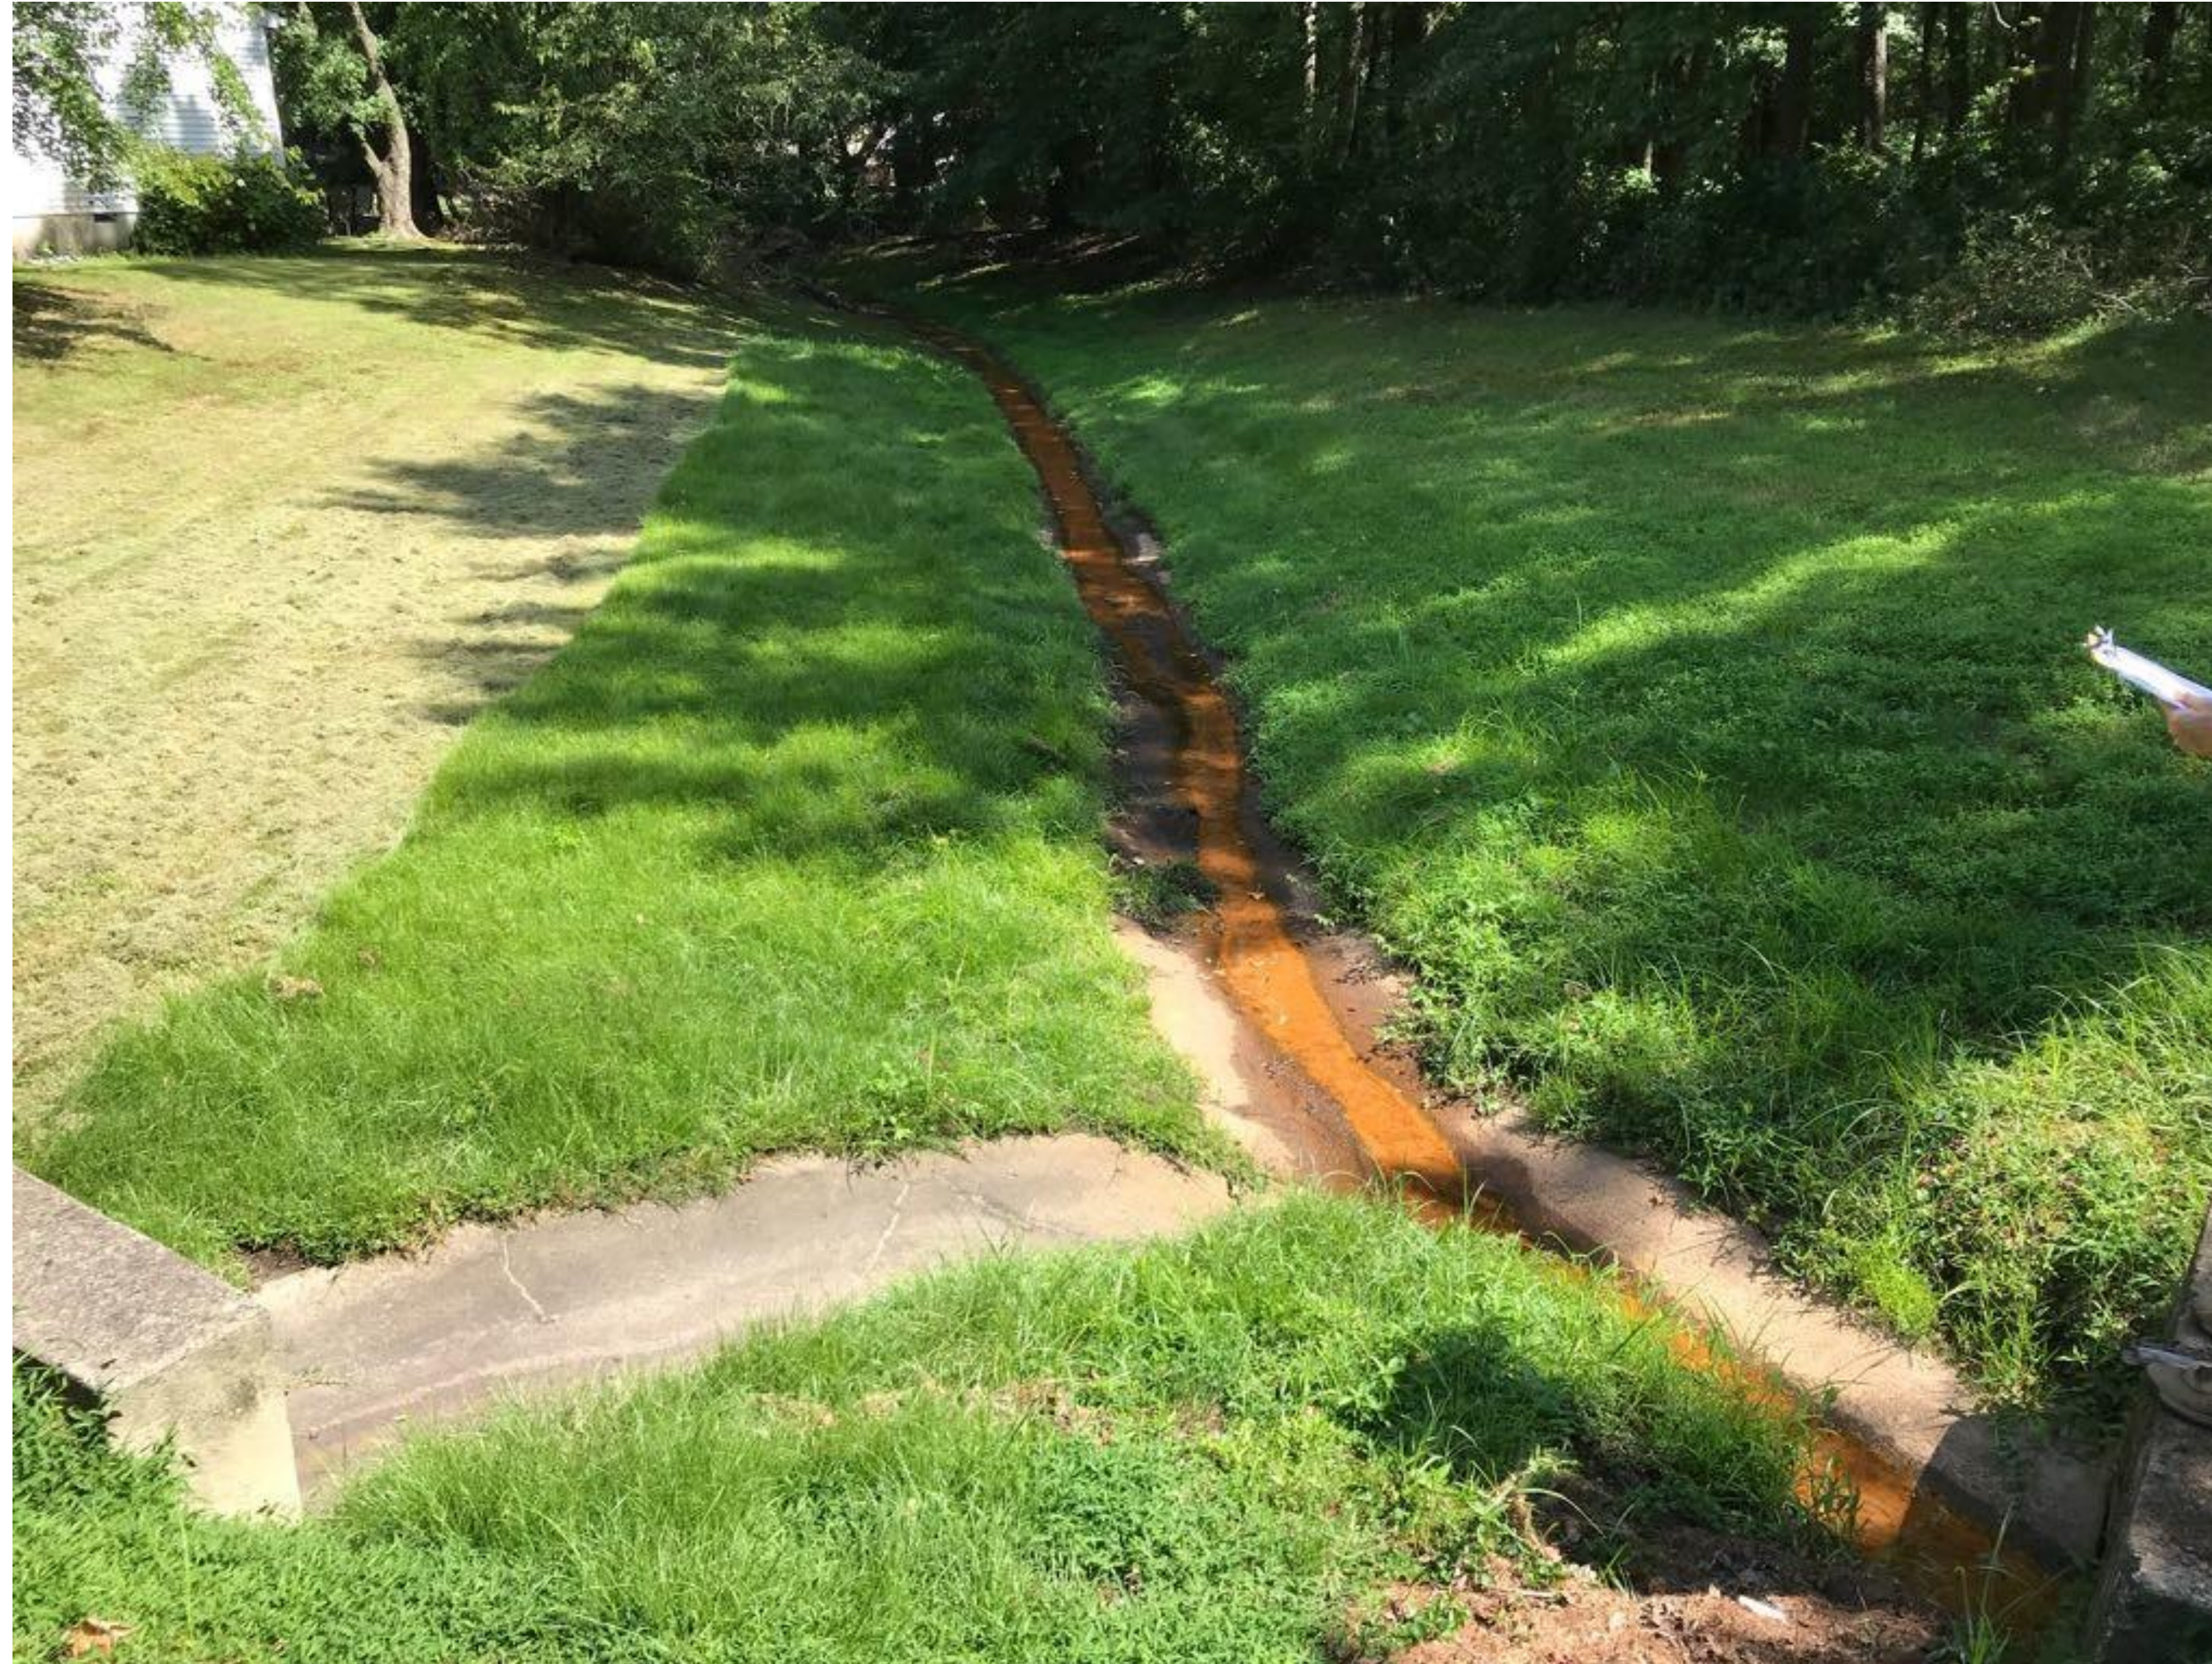
29. Arrowwood Dr Residential Basin

- Long detention basin with two inlets and an outlet
- Standing water present in low flow channel
- Clear sign of erosion occurring upstream from color of water in low flow channel

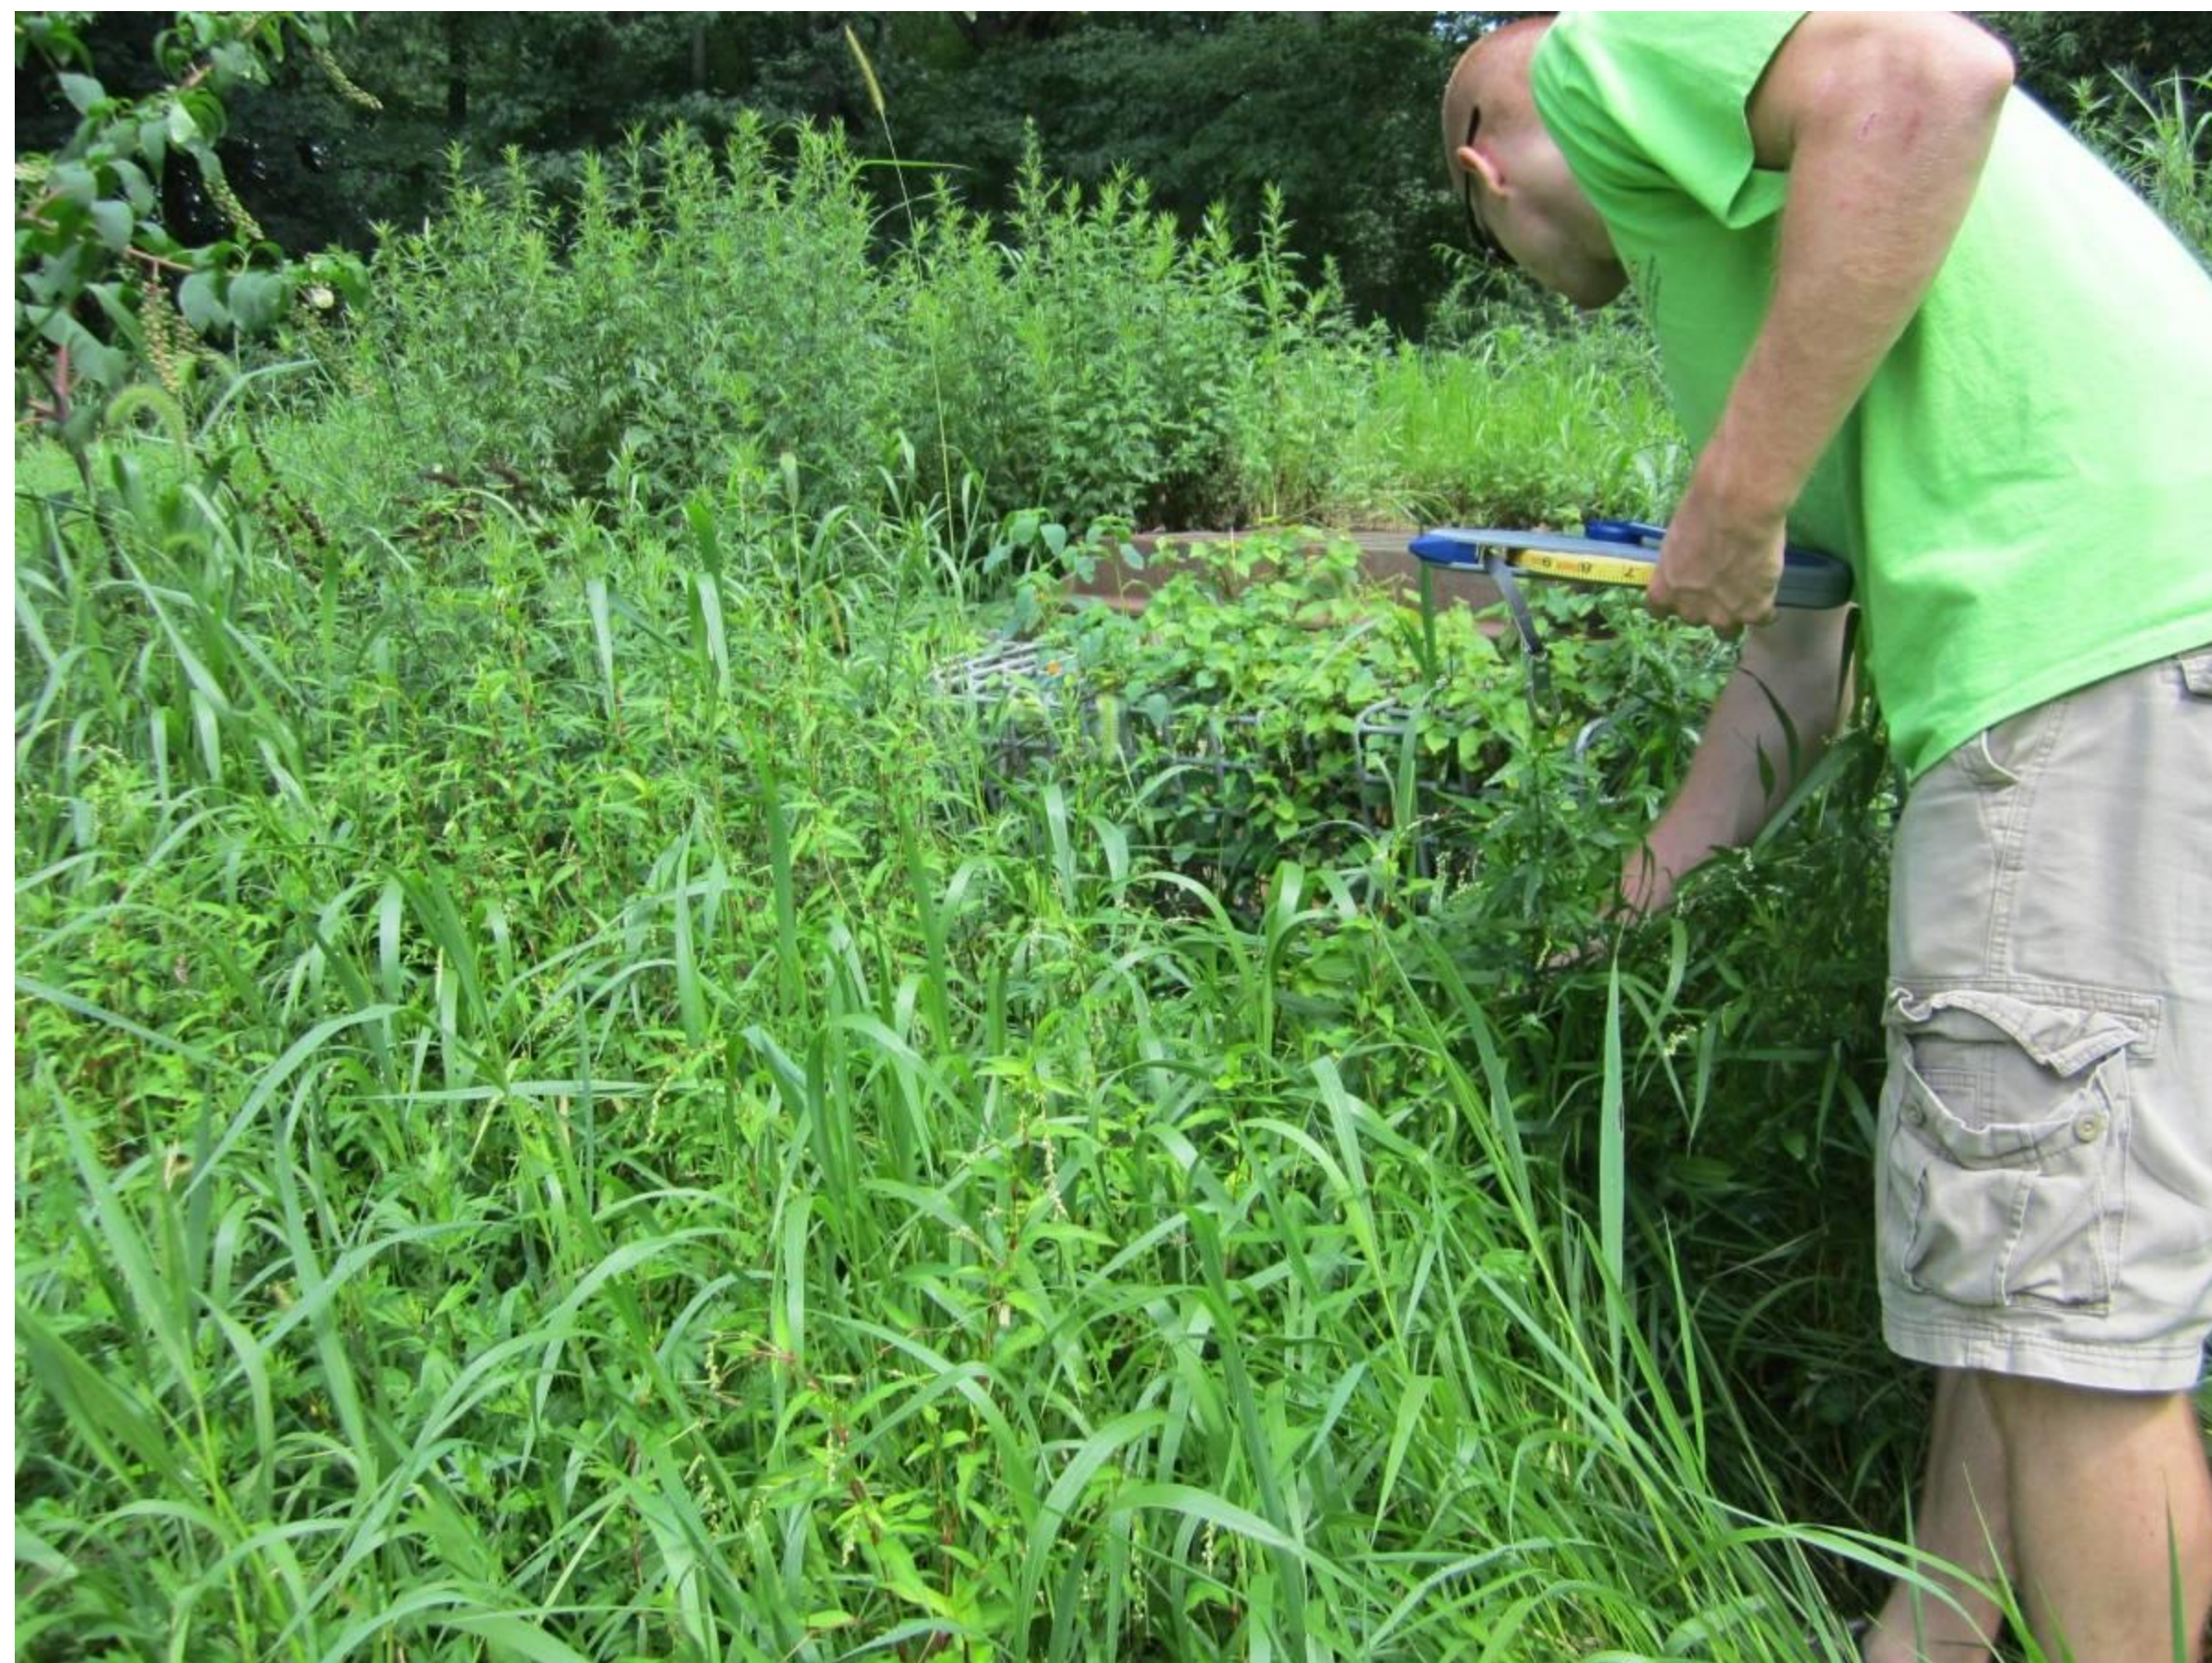
Overgrown outlet

- Standing water present in the low flow channel, and large amounts of vegetation around basin
- Low flow channel could be removed to promote infiltration instead of the standing water that is present.

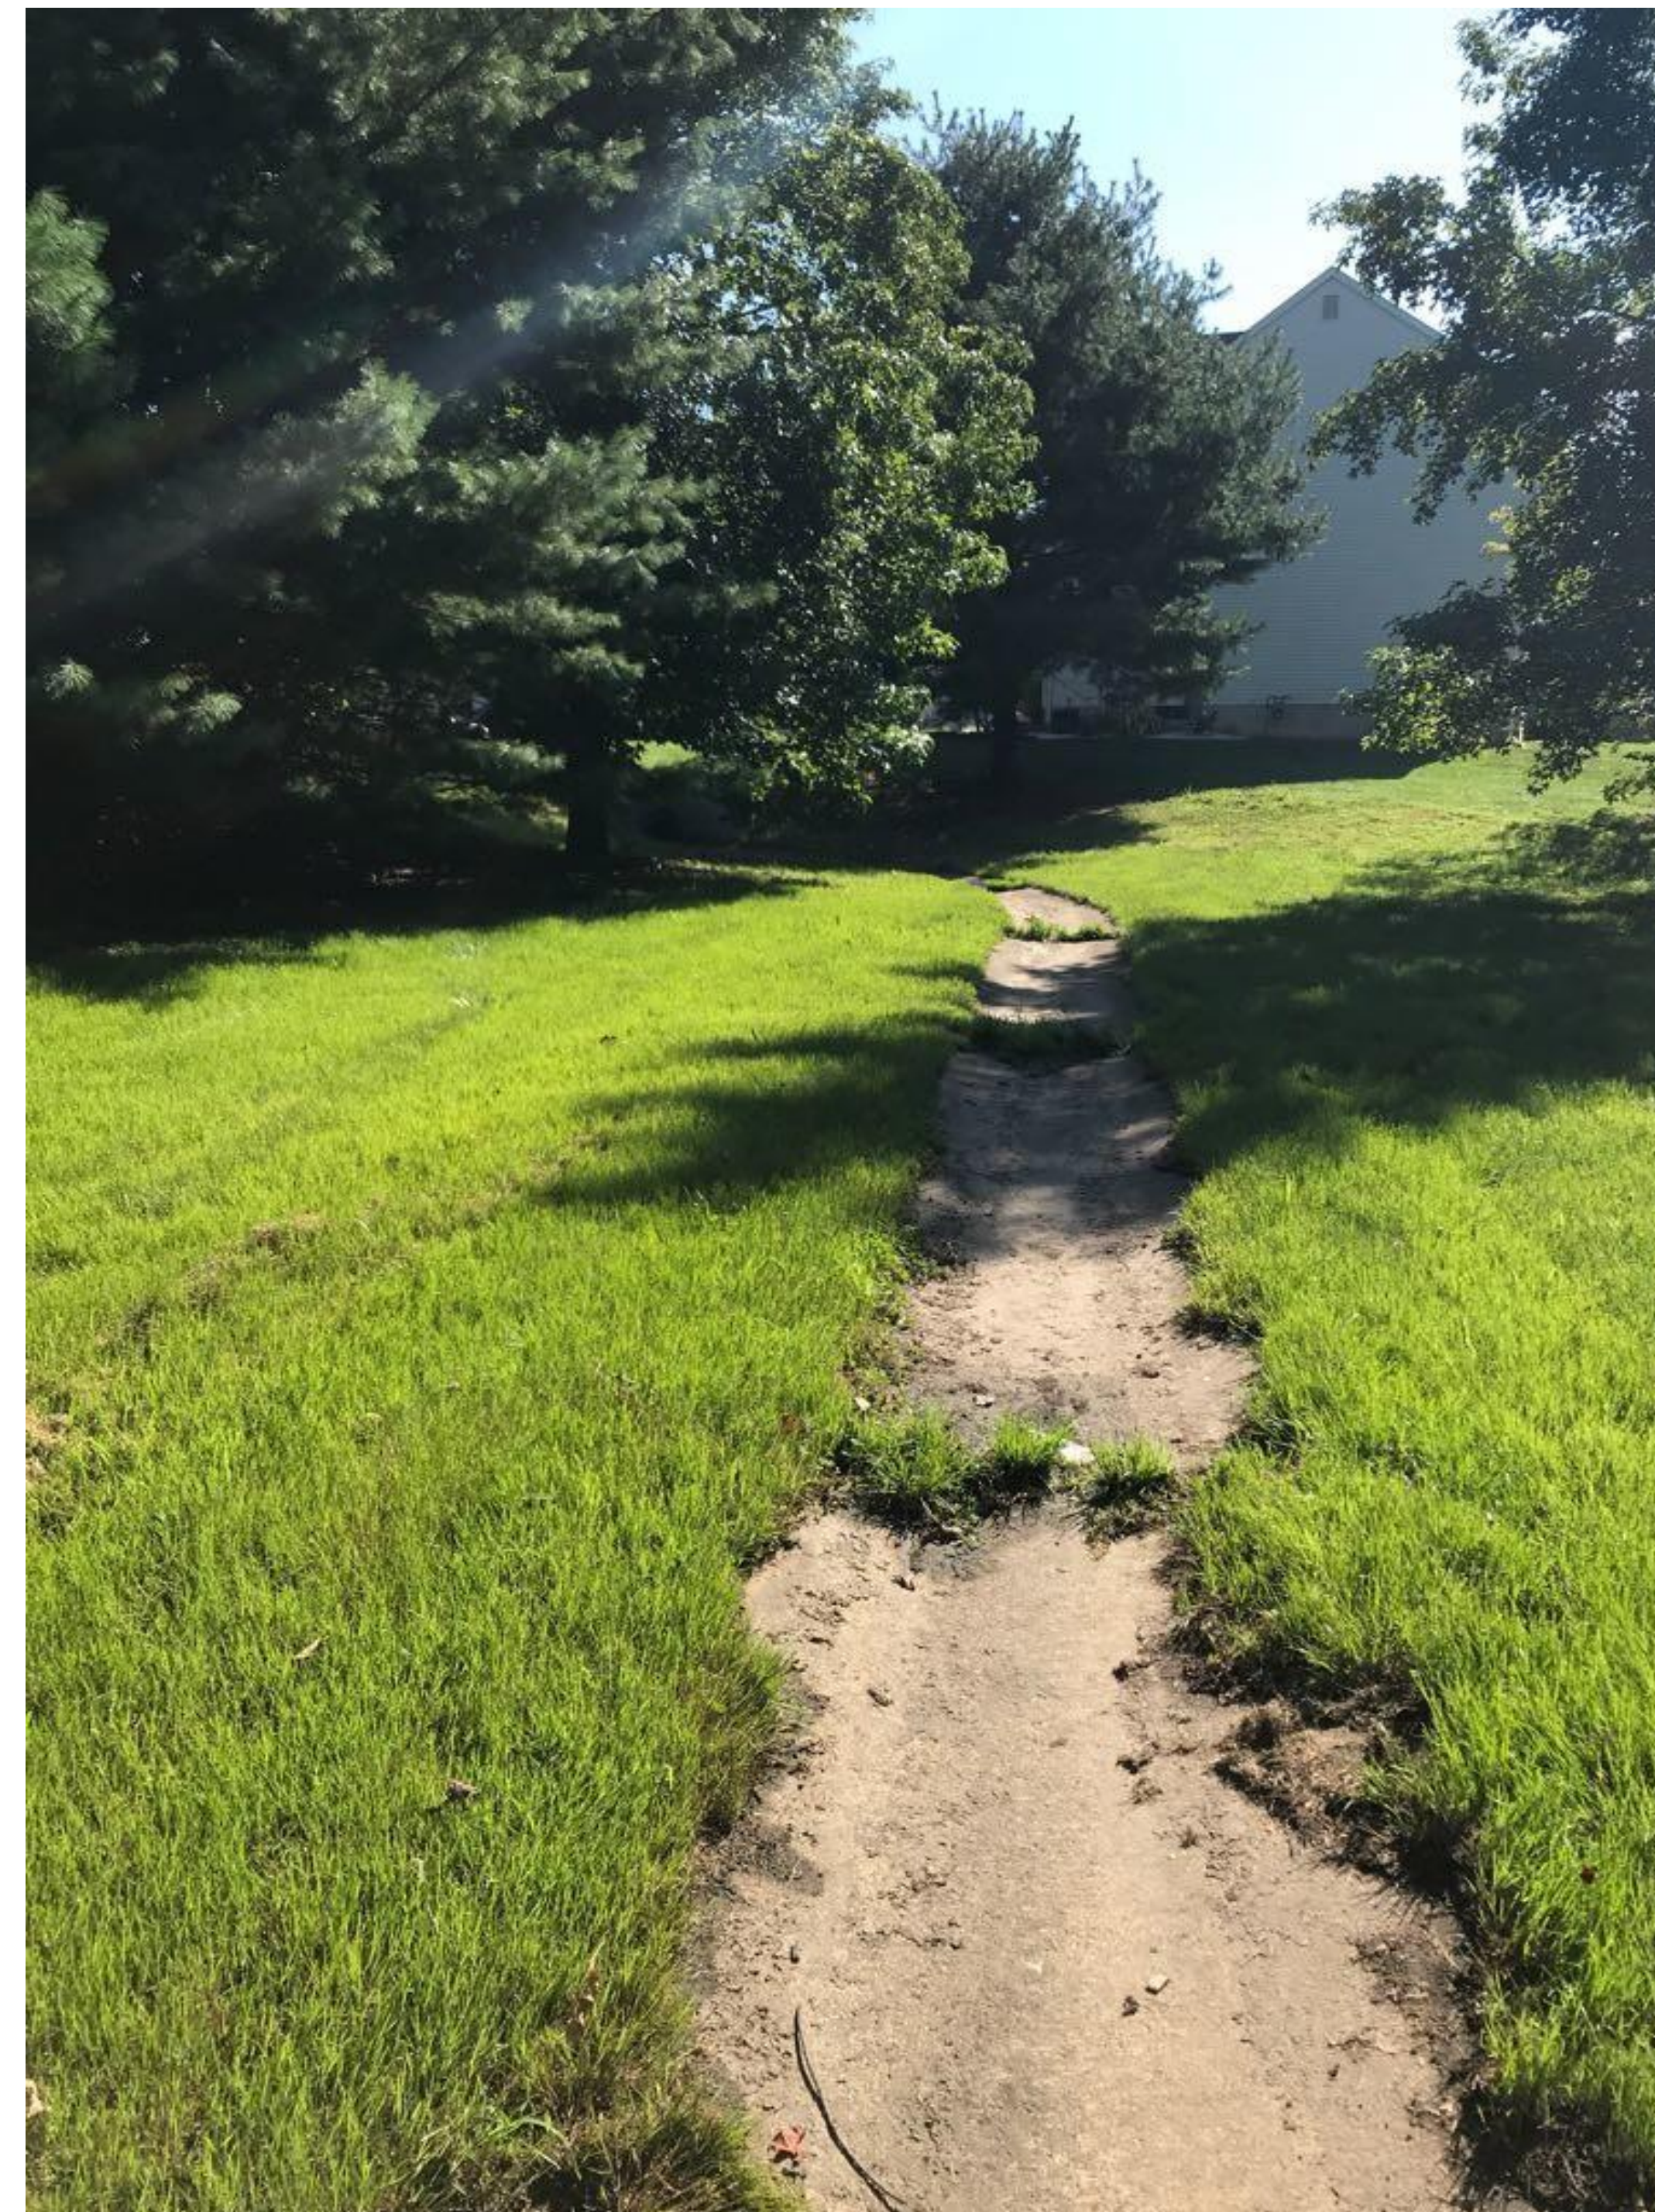
- Low flow channel blocked by organic debris and sediment
- Remove sediment and clearing of obstructions to outflow
- Opportunity to remove concrete channels and add rock flow channels with vegetation

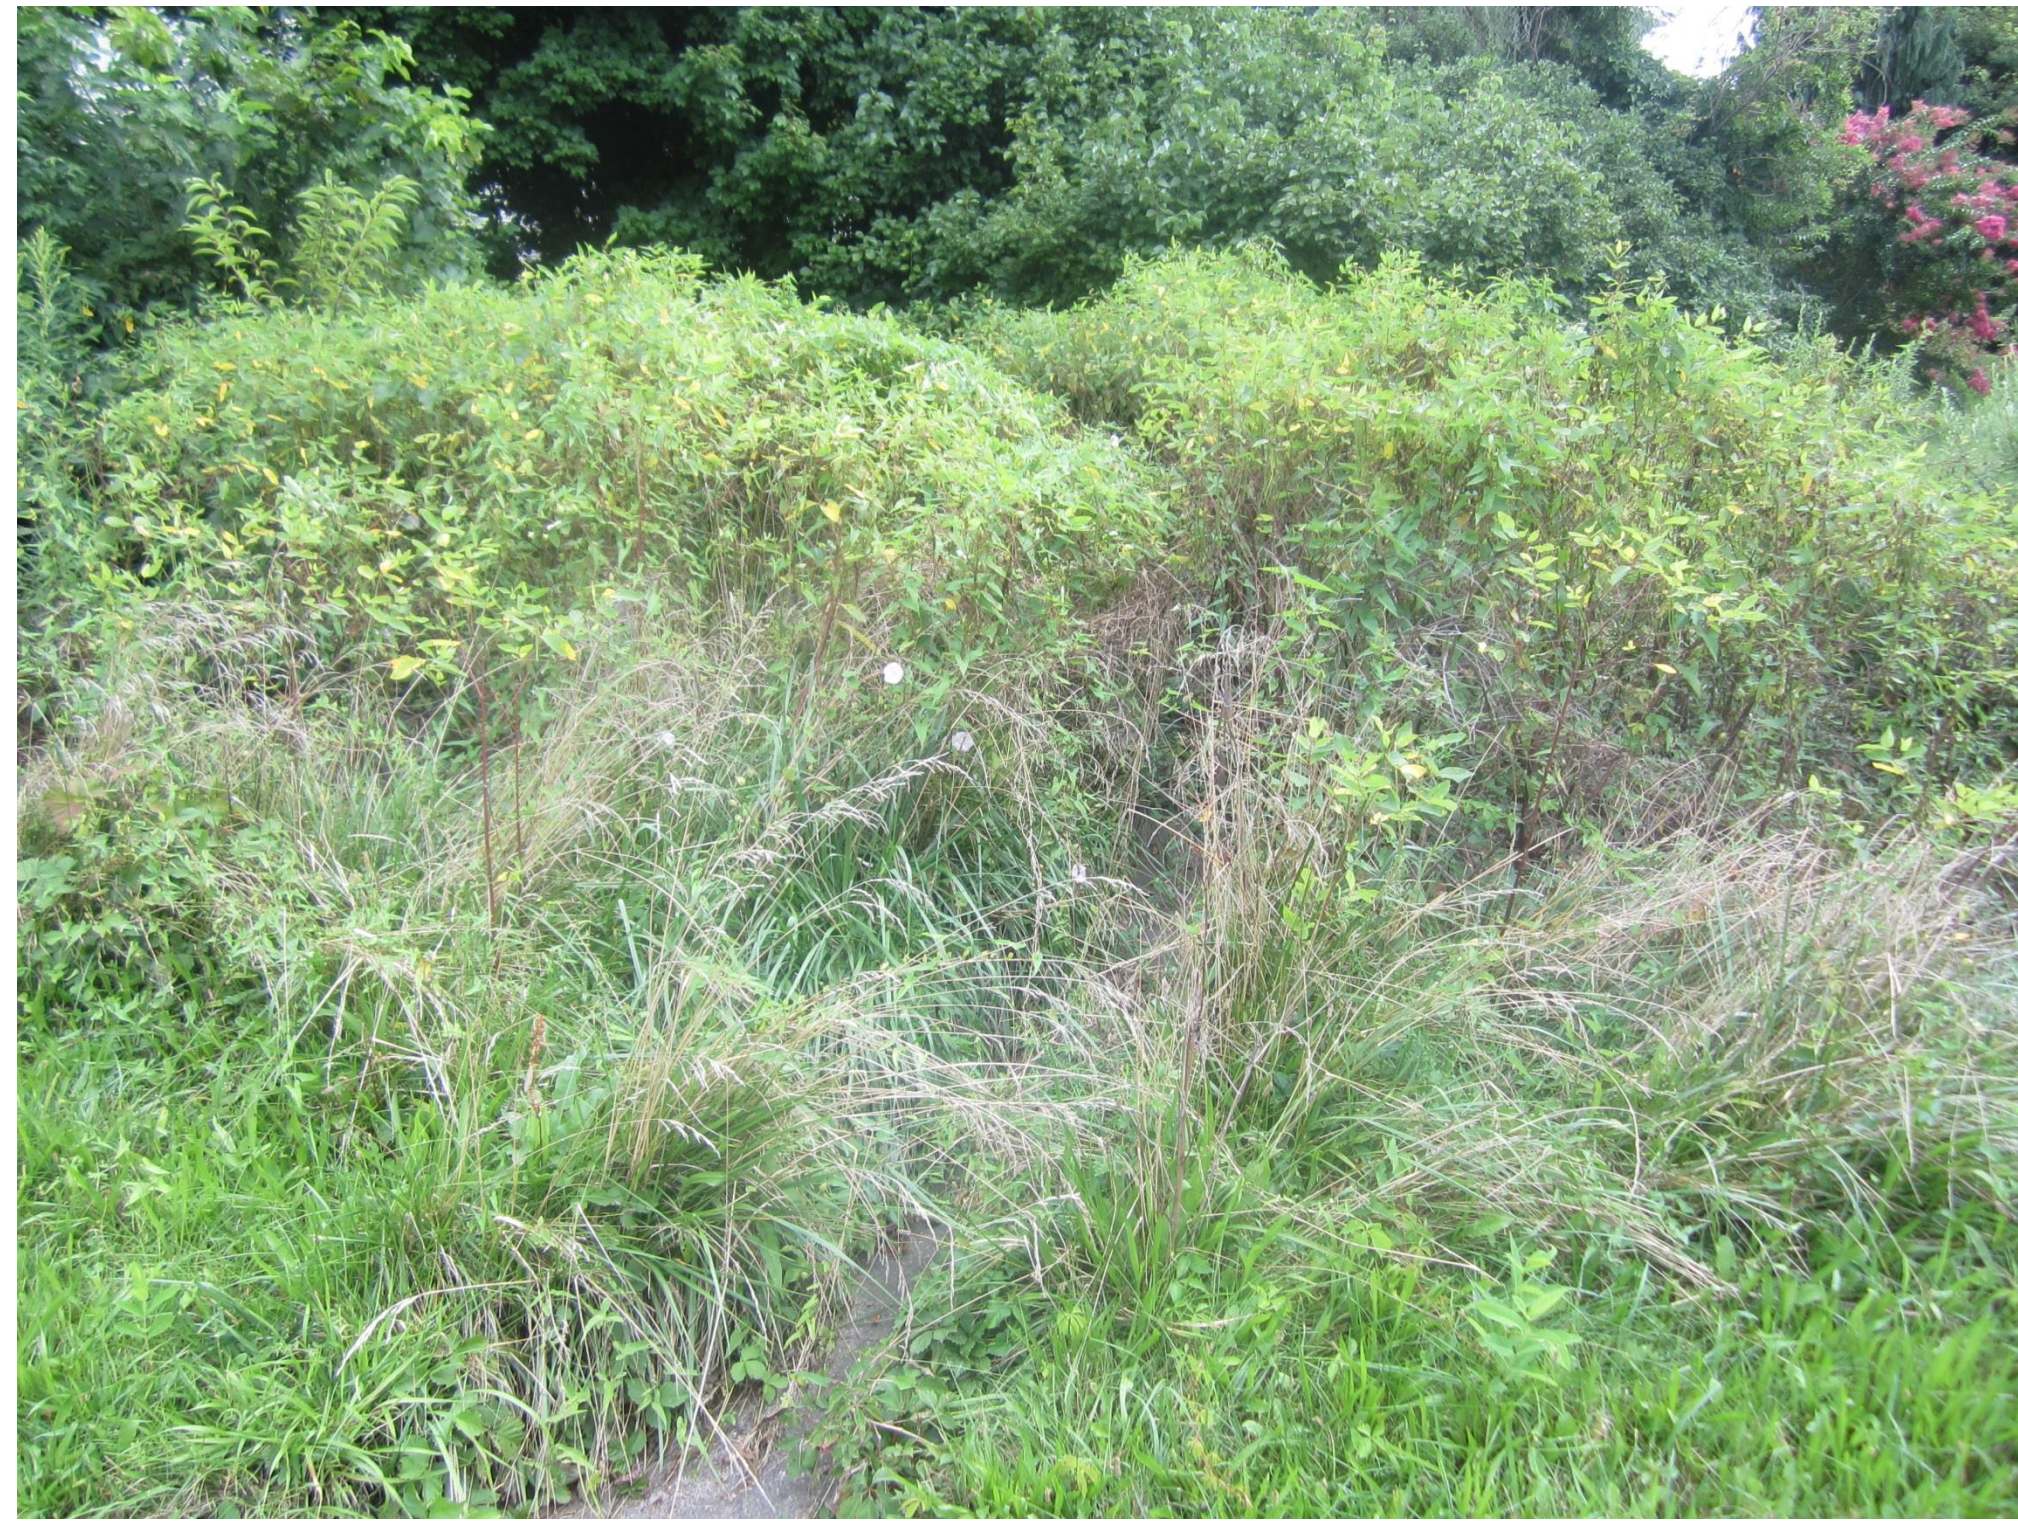
Overgrown inlet

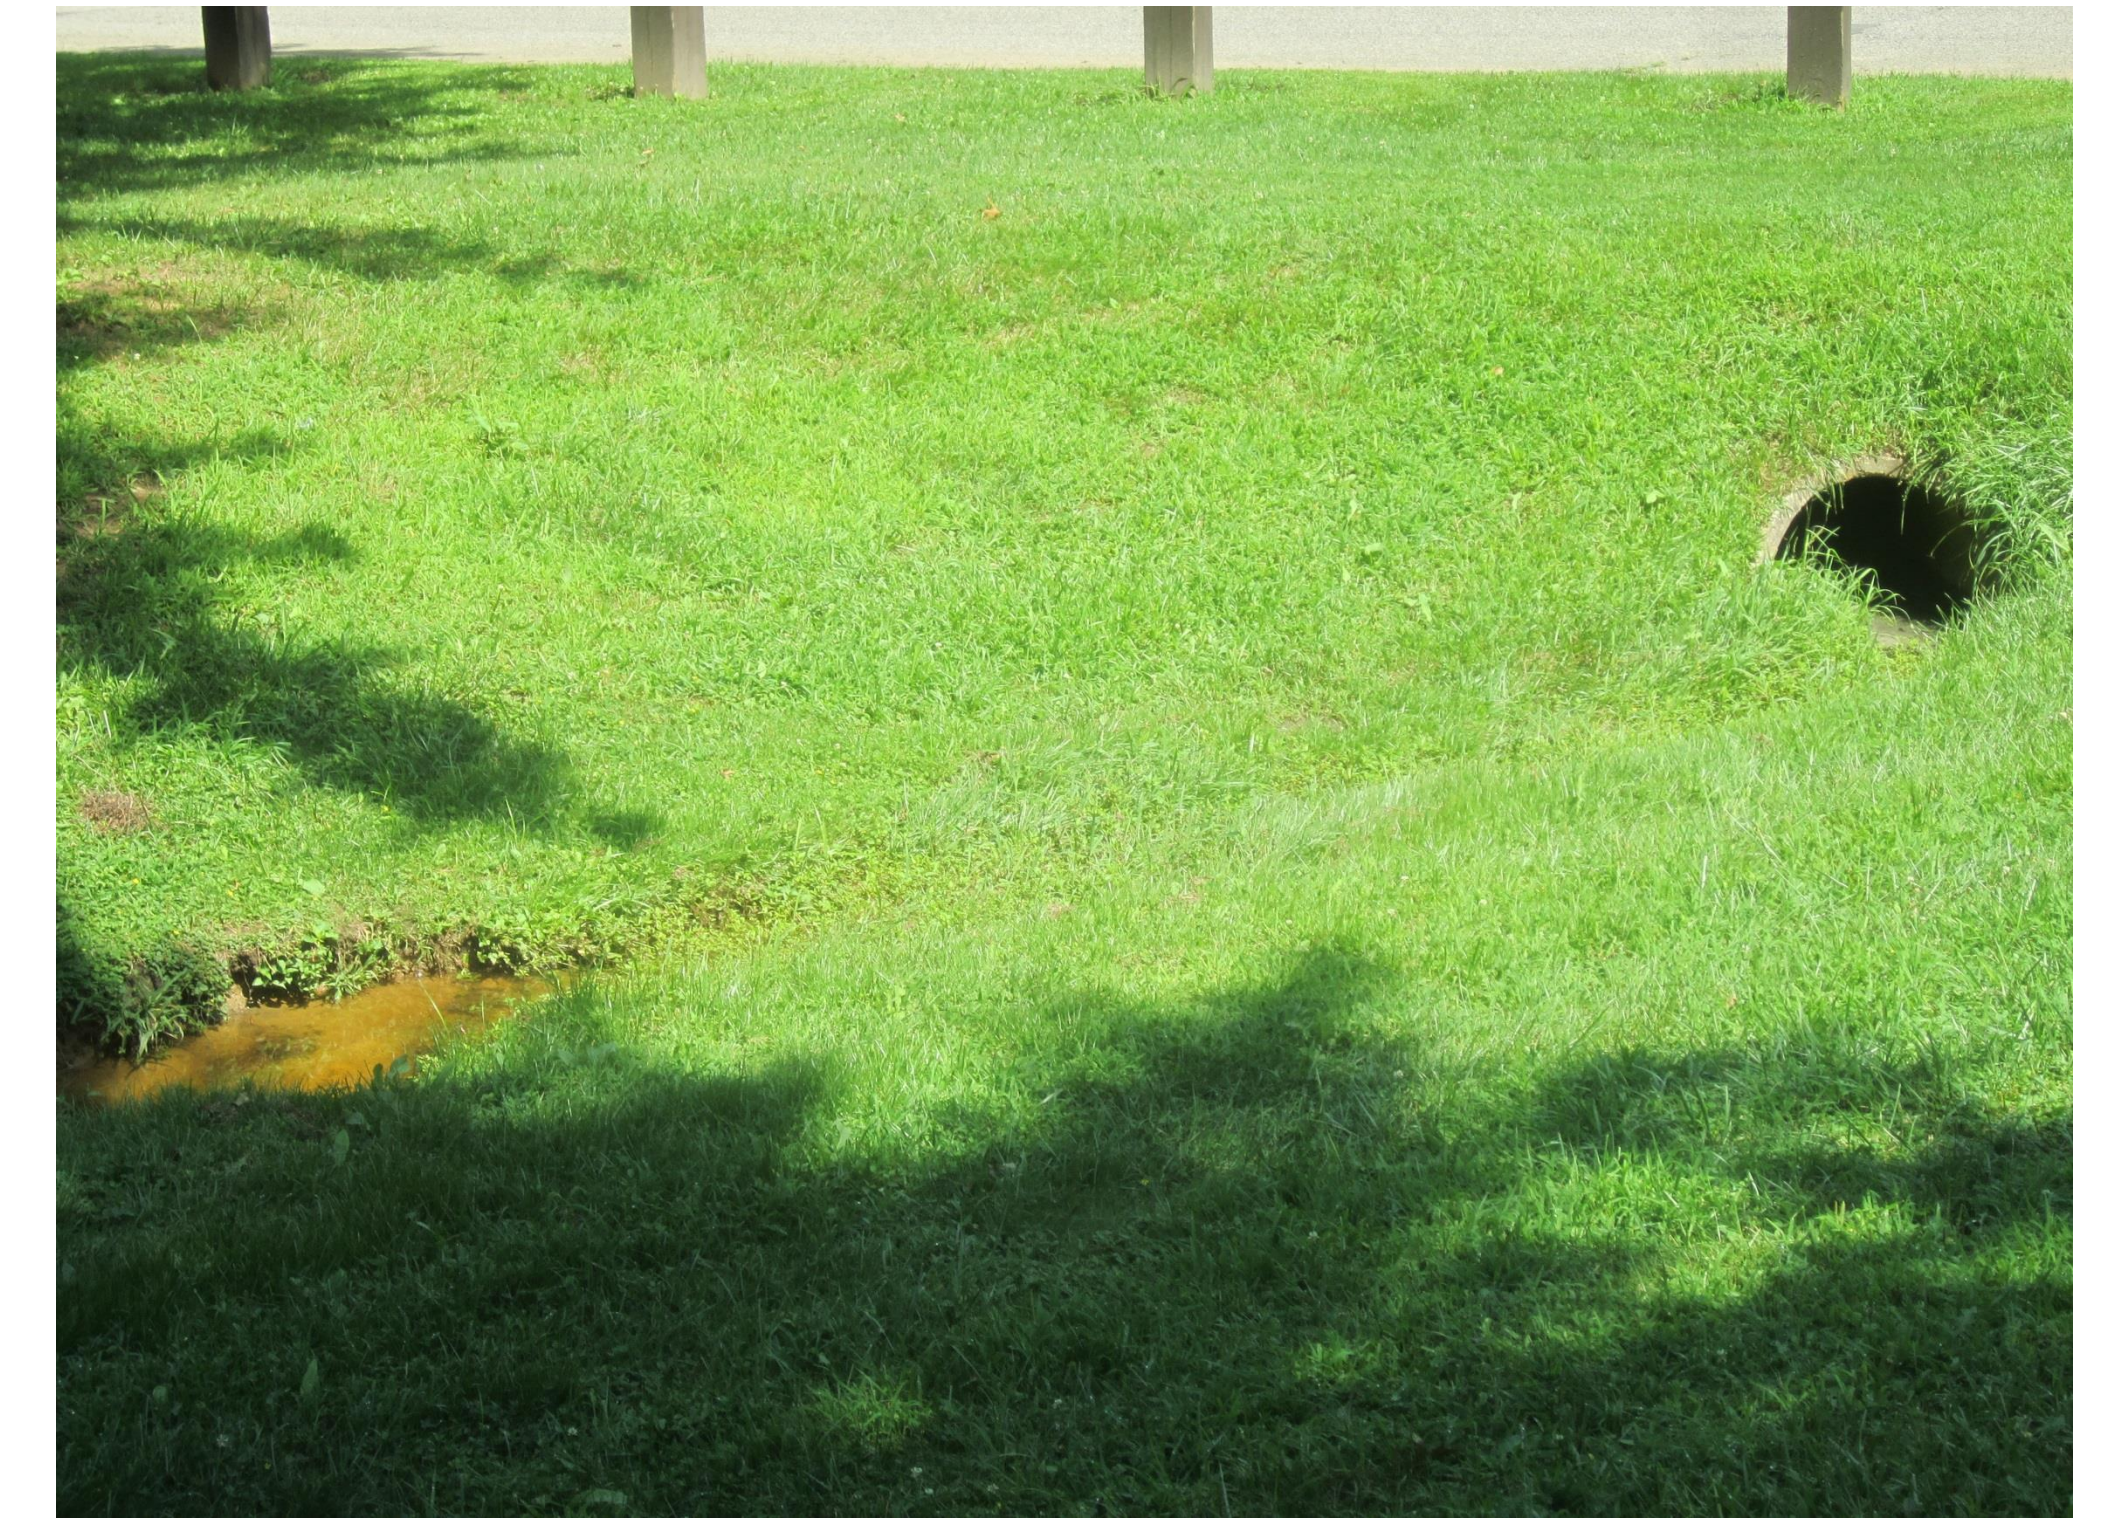
Outlet structure and gully
