**Hamilton Township (Mercer County)
Stormwater Basin Assessment Summary
Hamilton Owned Addendum (Year 5A)**

Developed by the Rutgers Cooperative Extension Water Resources Program
Funded by Hamilton Township, Mercer County, New Jersey

November 27, 2019

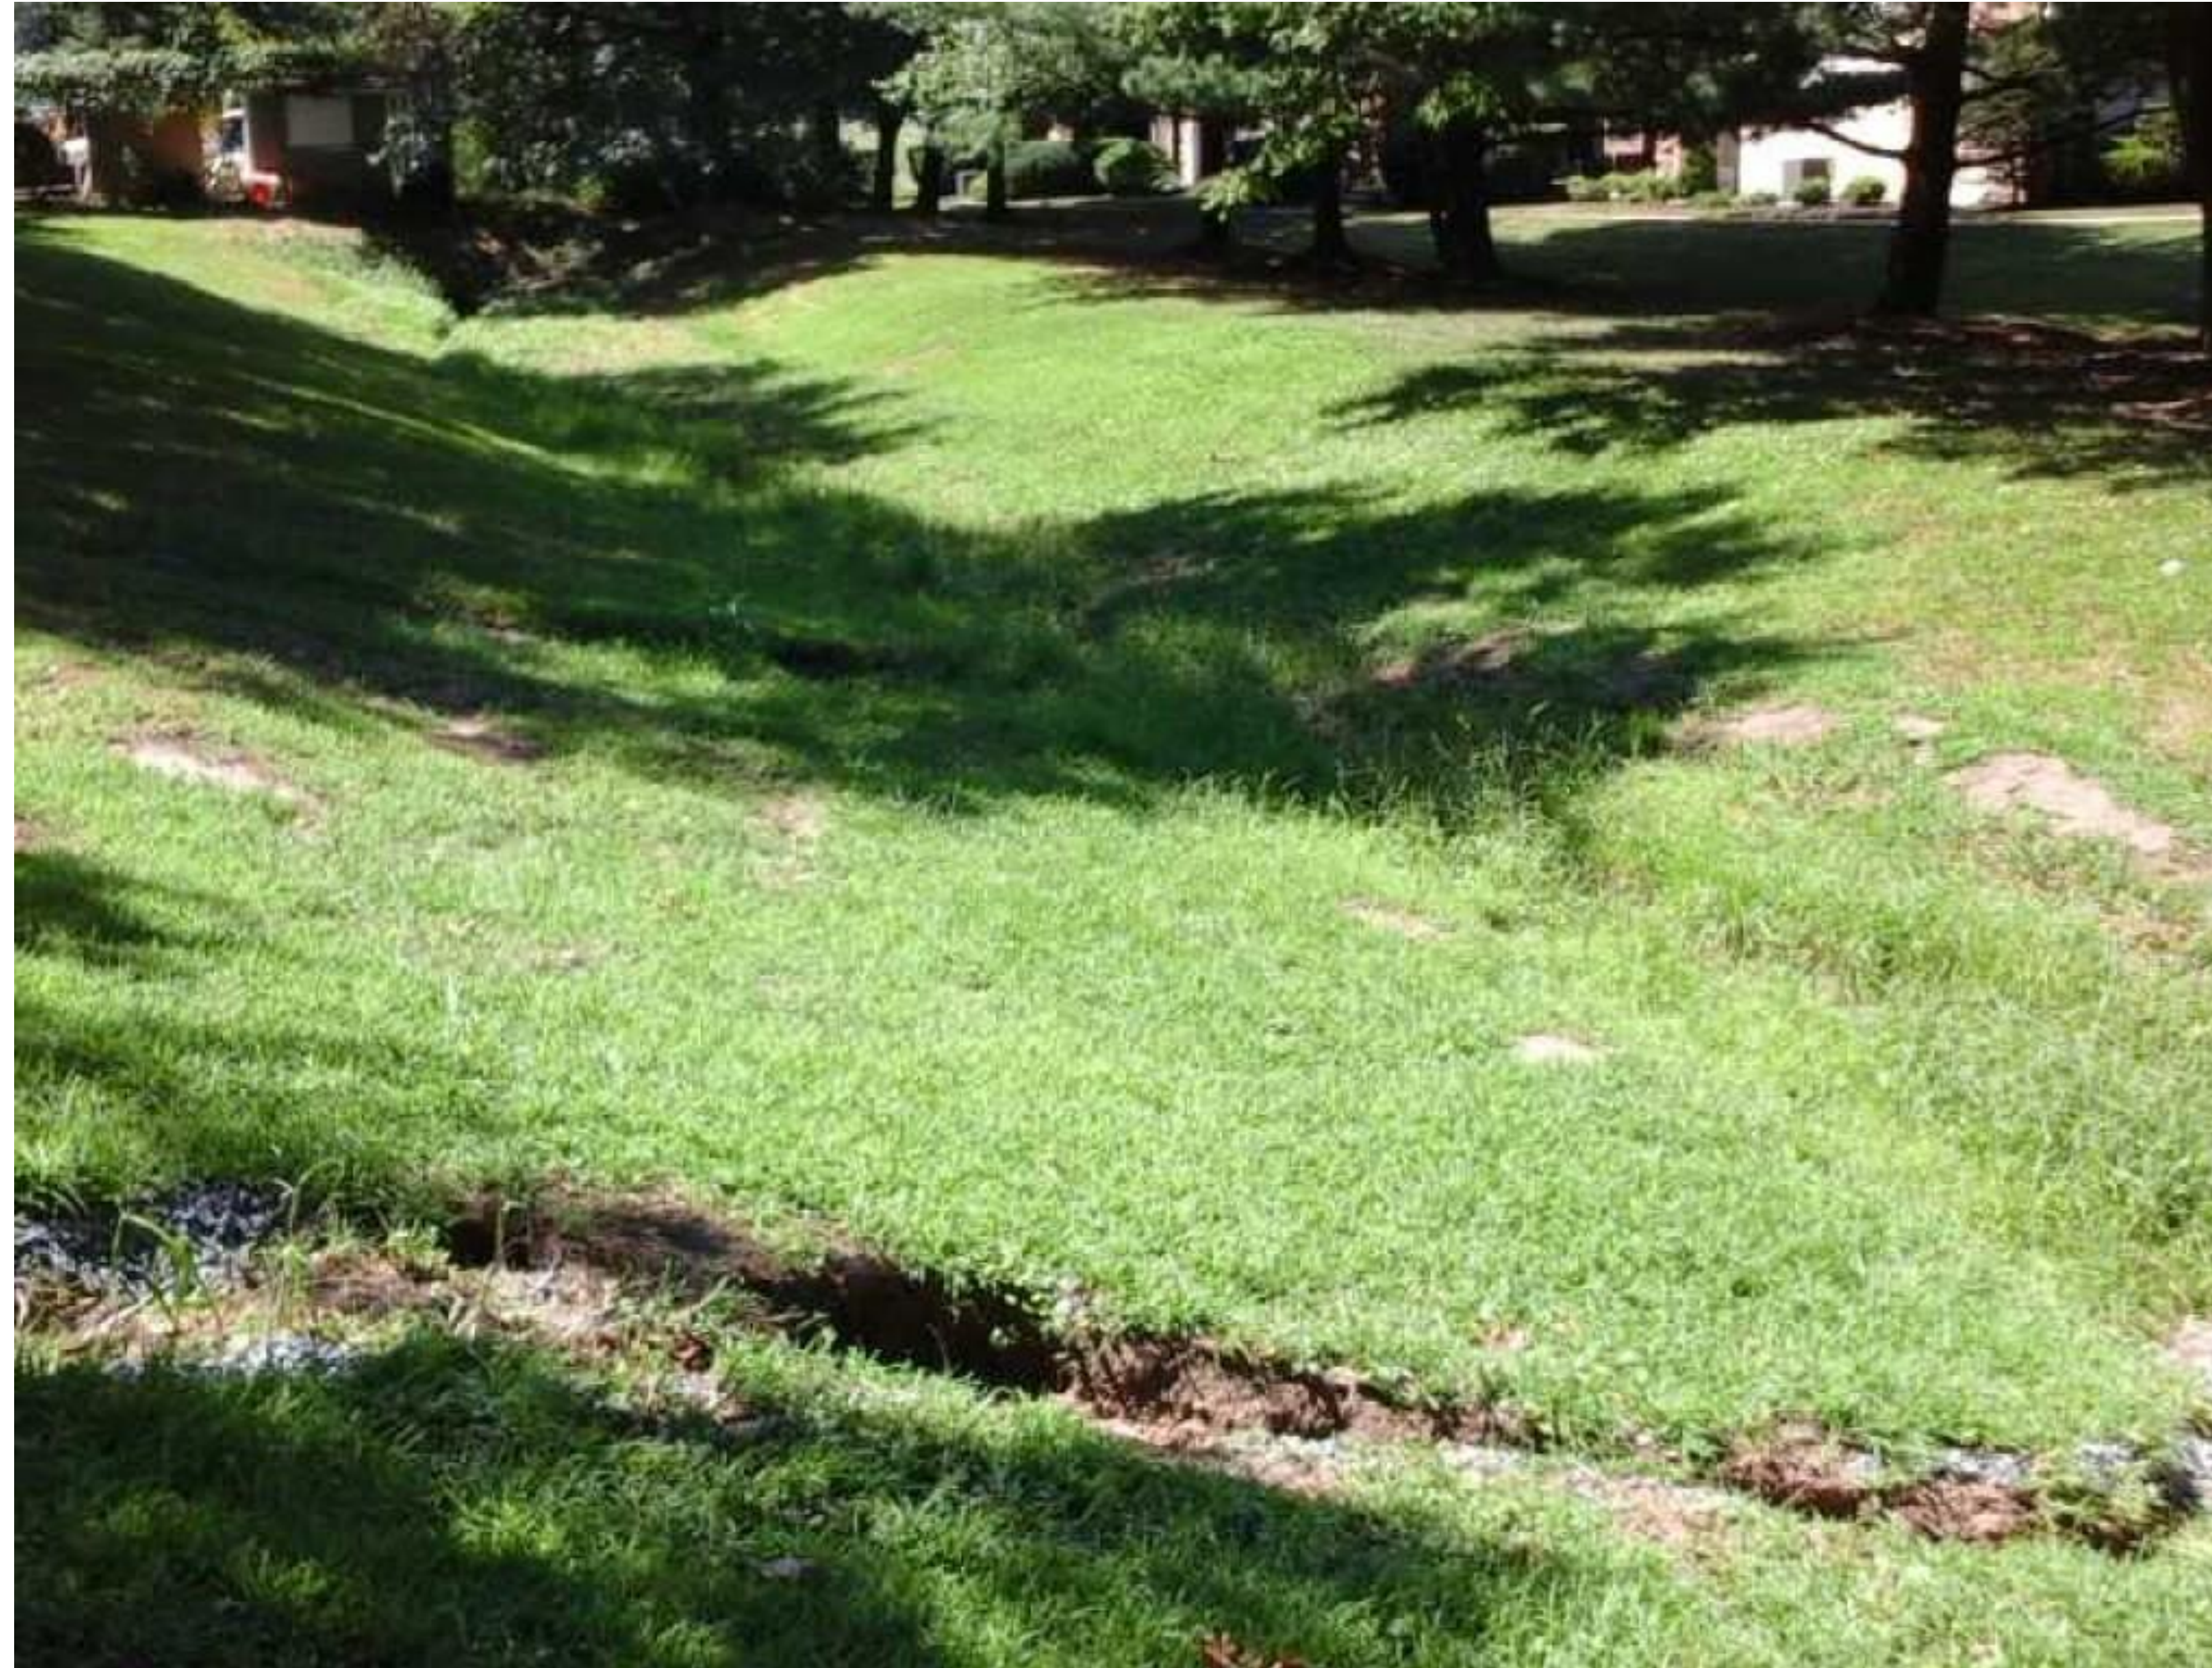
- Area appears to be more of a swale than a basin
- Severe erosion issue near inlet that needs to be remediated
- Naturalize base with herbaceous plants

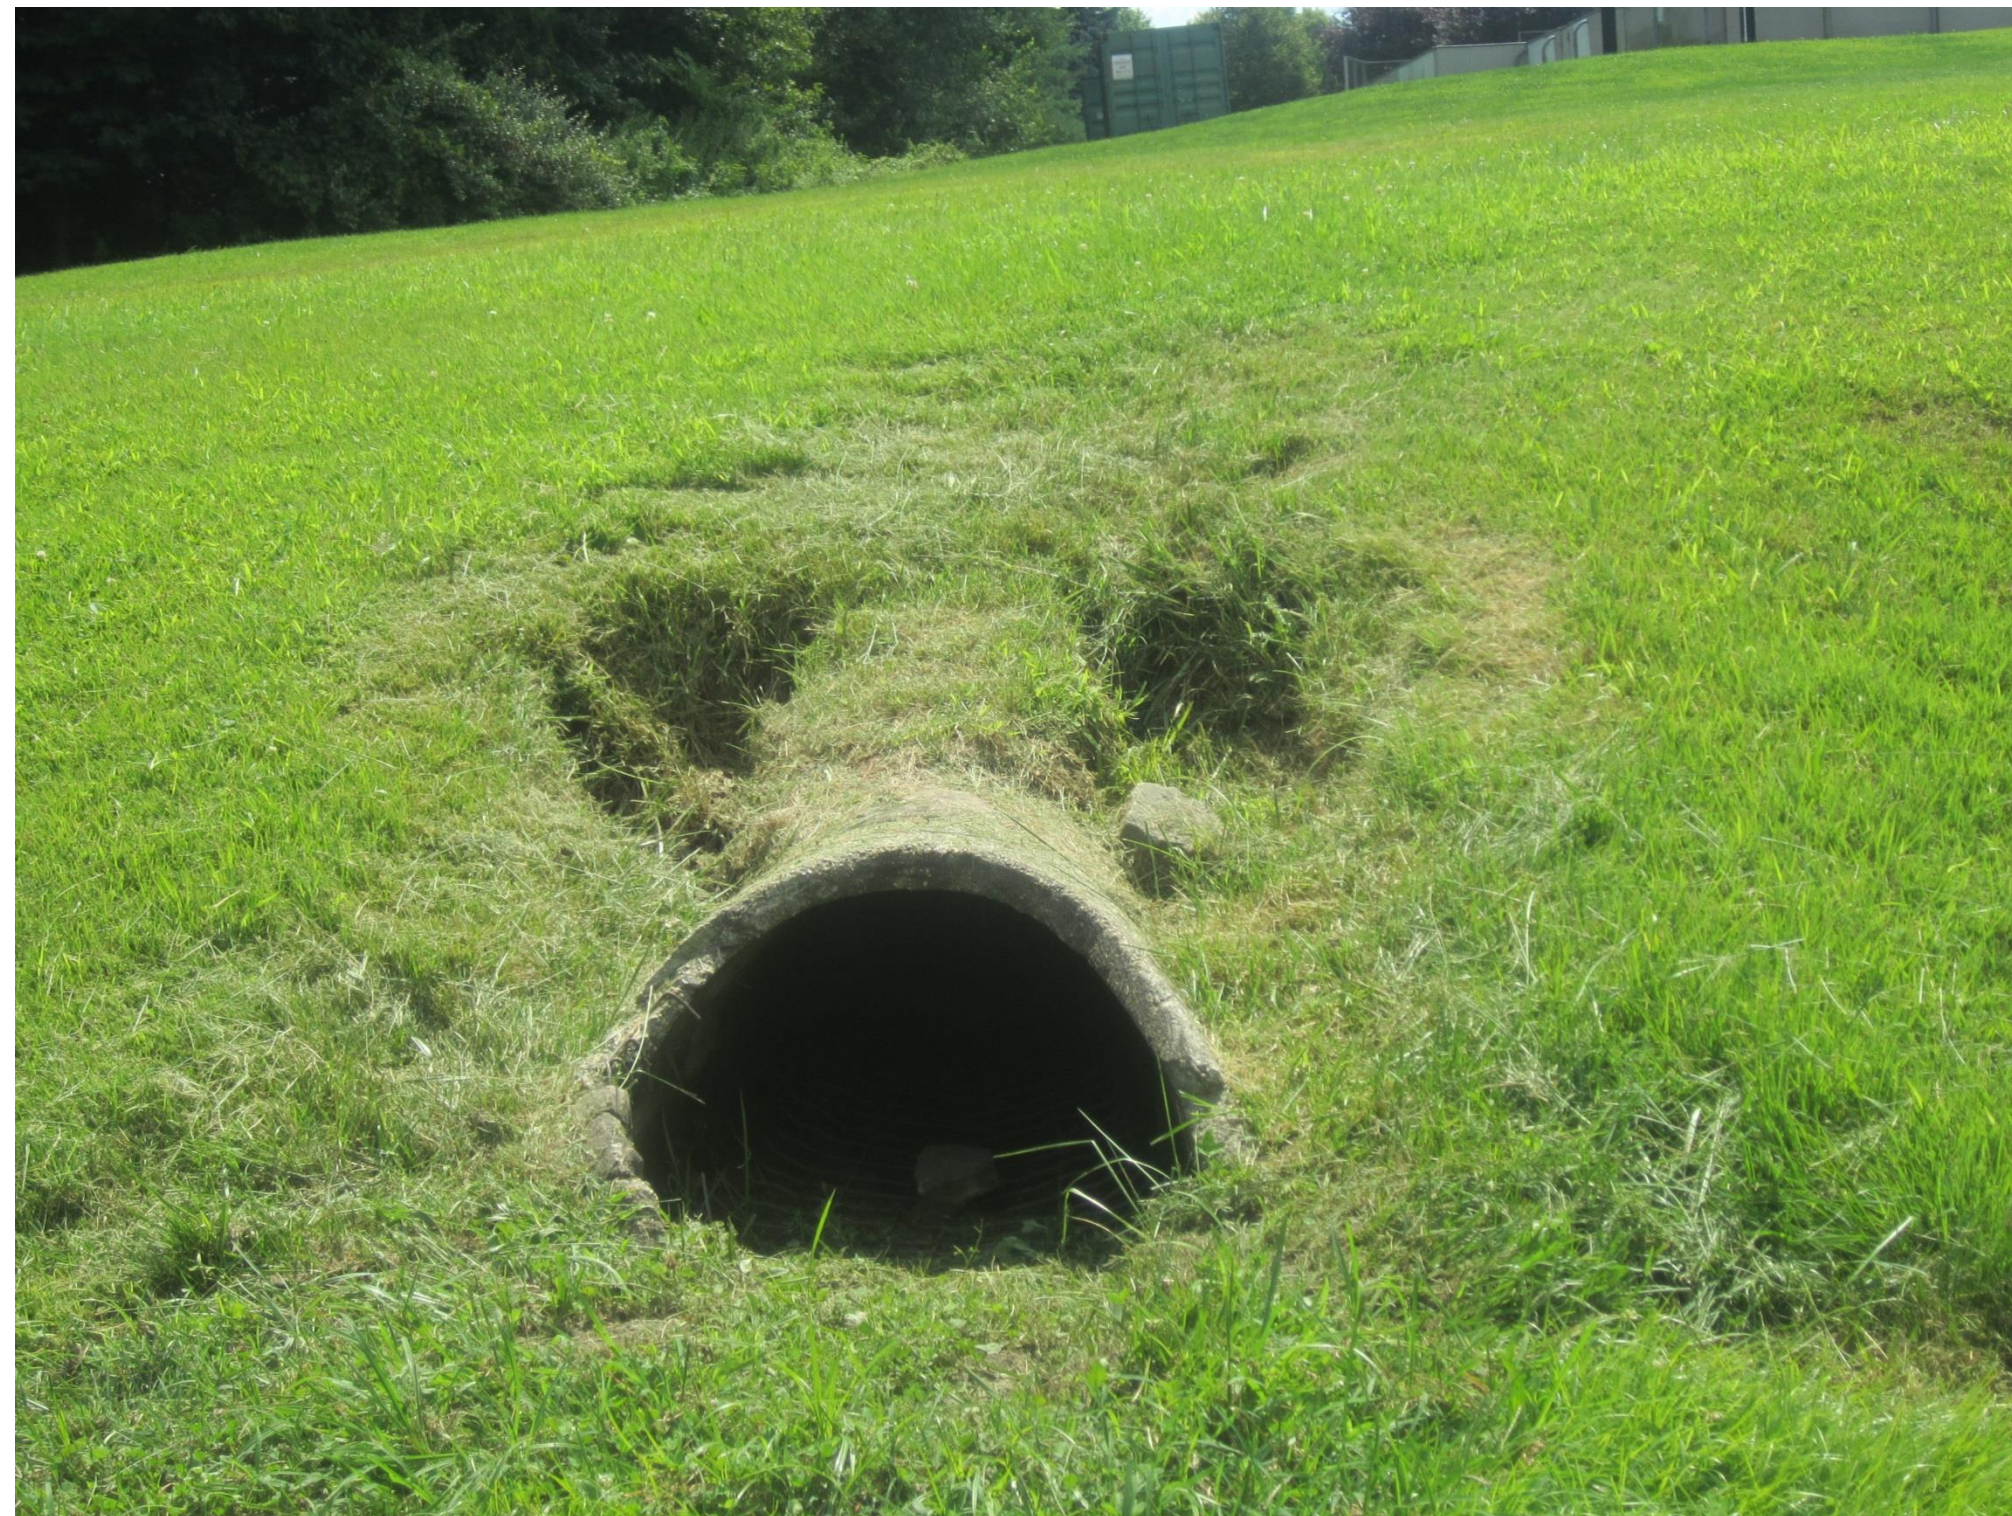
Northeastern inlet

- There is a swale that collects runoff from the nearby parking lots which conveys the water into the basin
- The basin has 5 total inlets
- The northeastern inlet is in need of replacement
- The northwestern inlet is clogged with sediment that is restricting the flow of water
- The outlet has a large low flow orifice that could use a restrictor plate
- The basin bottom has areas of gullying and tread marks

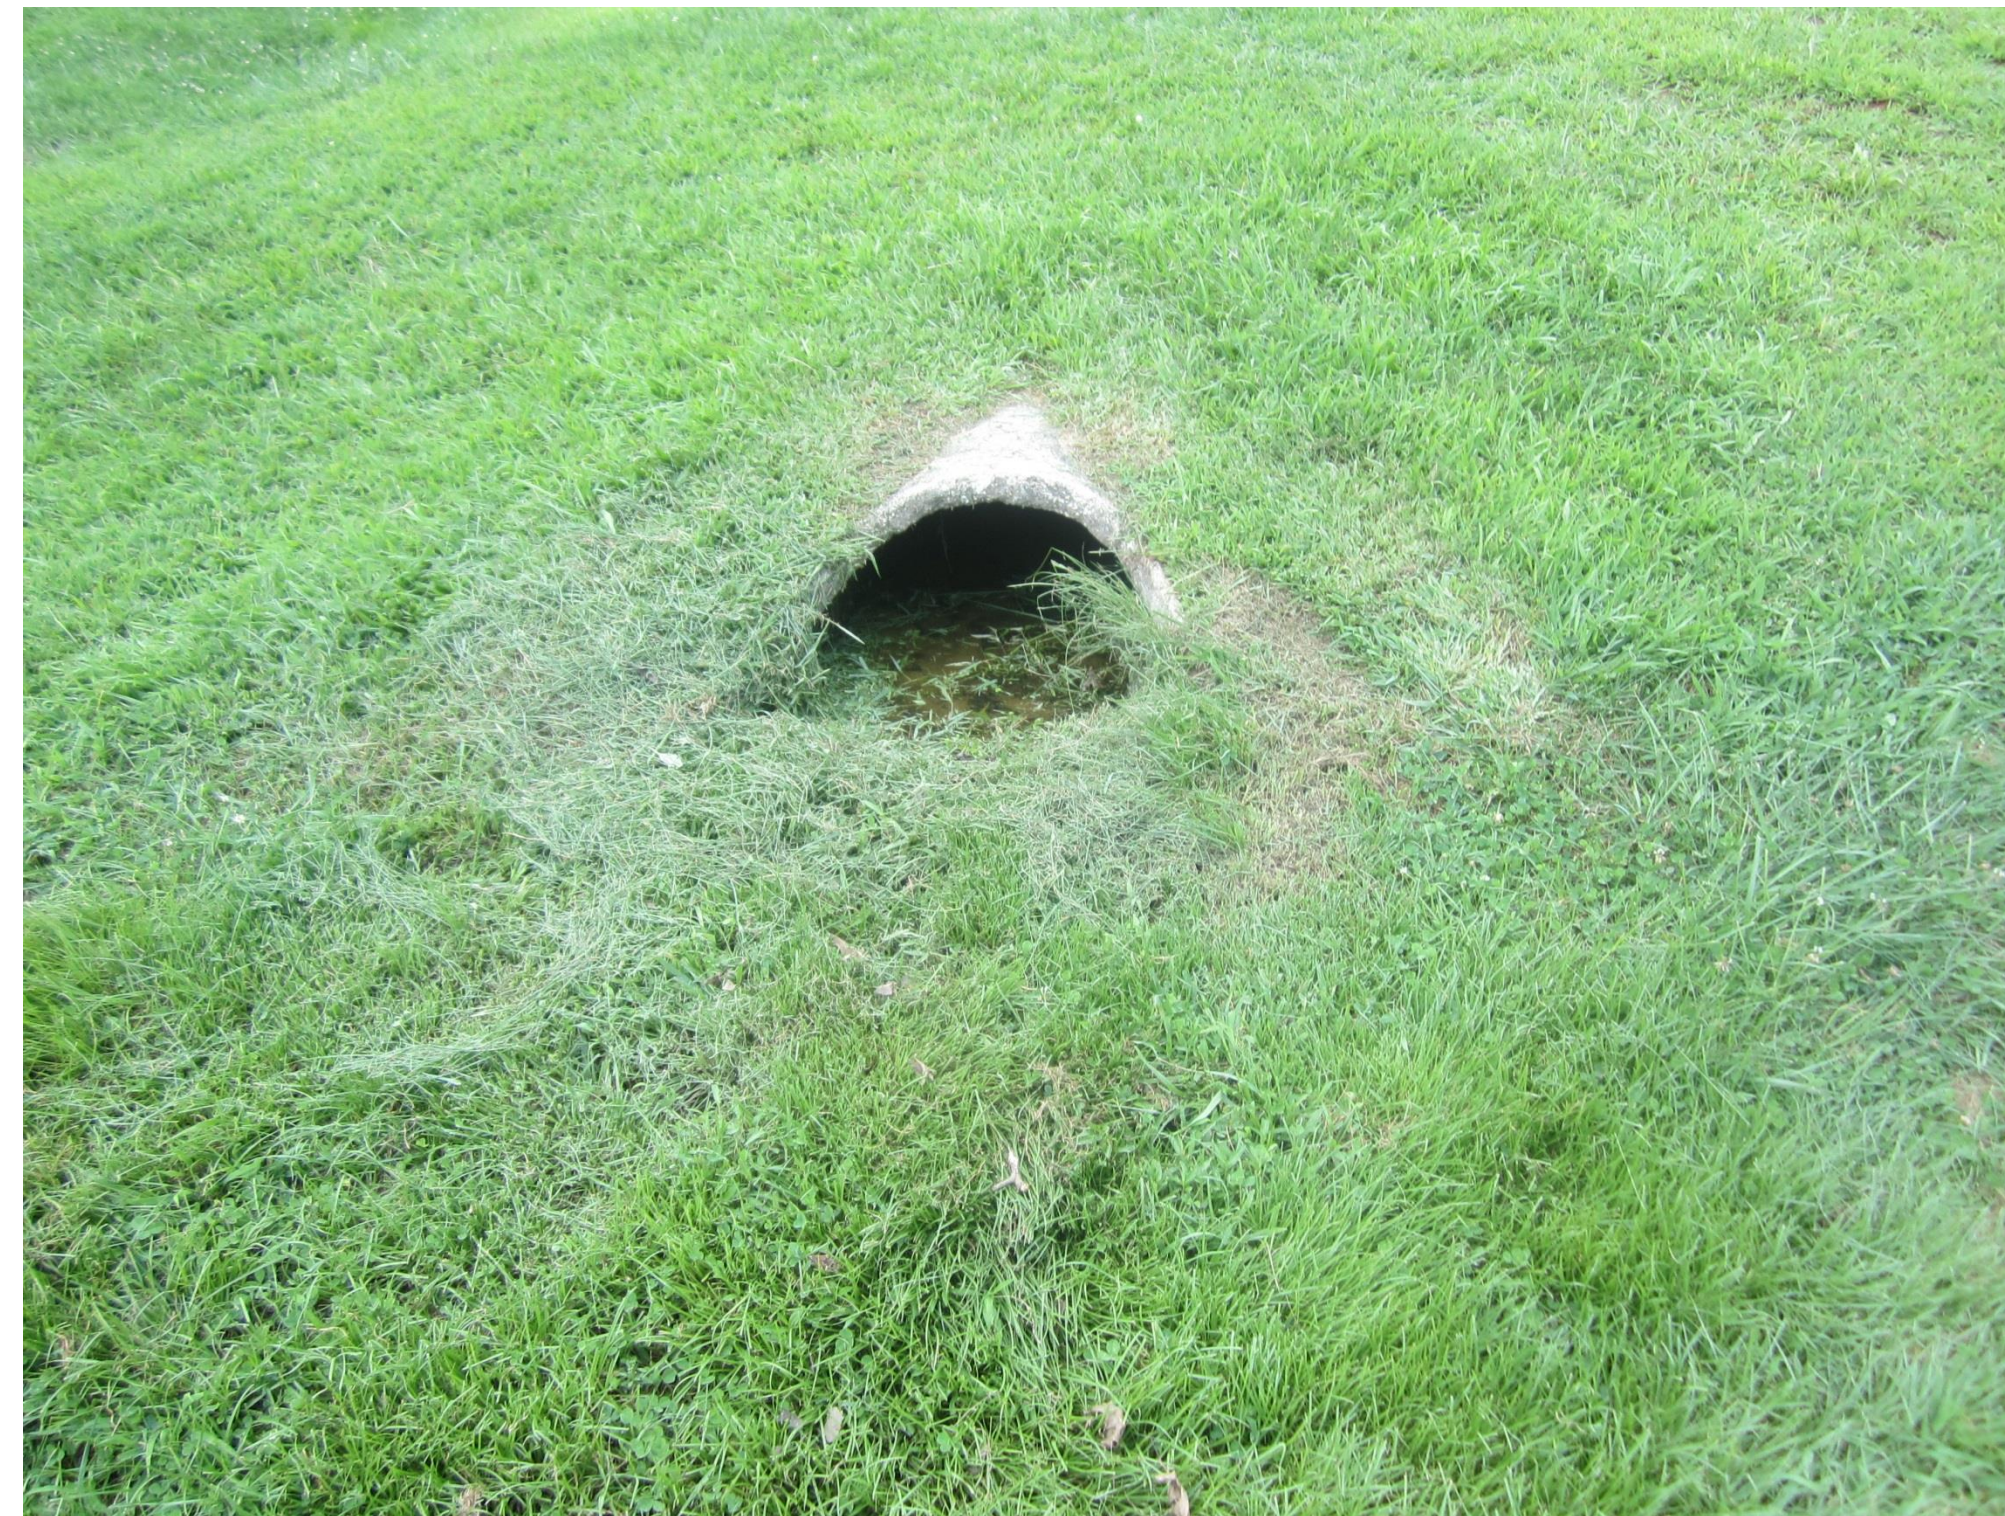
Northwestern inlet

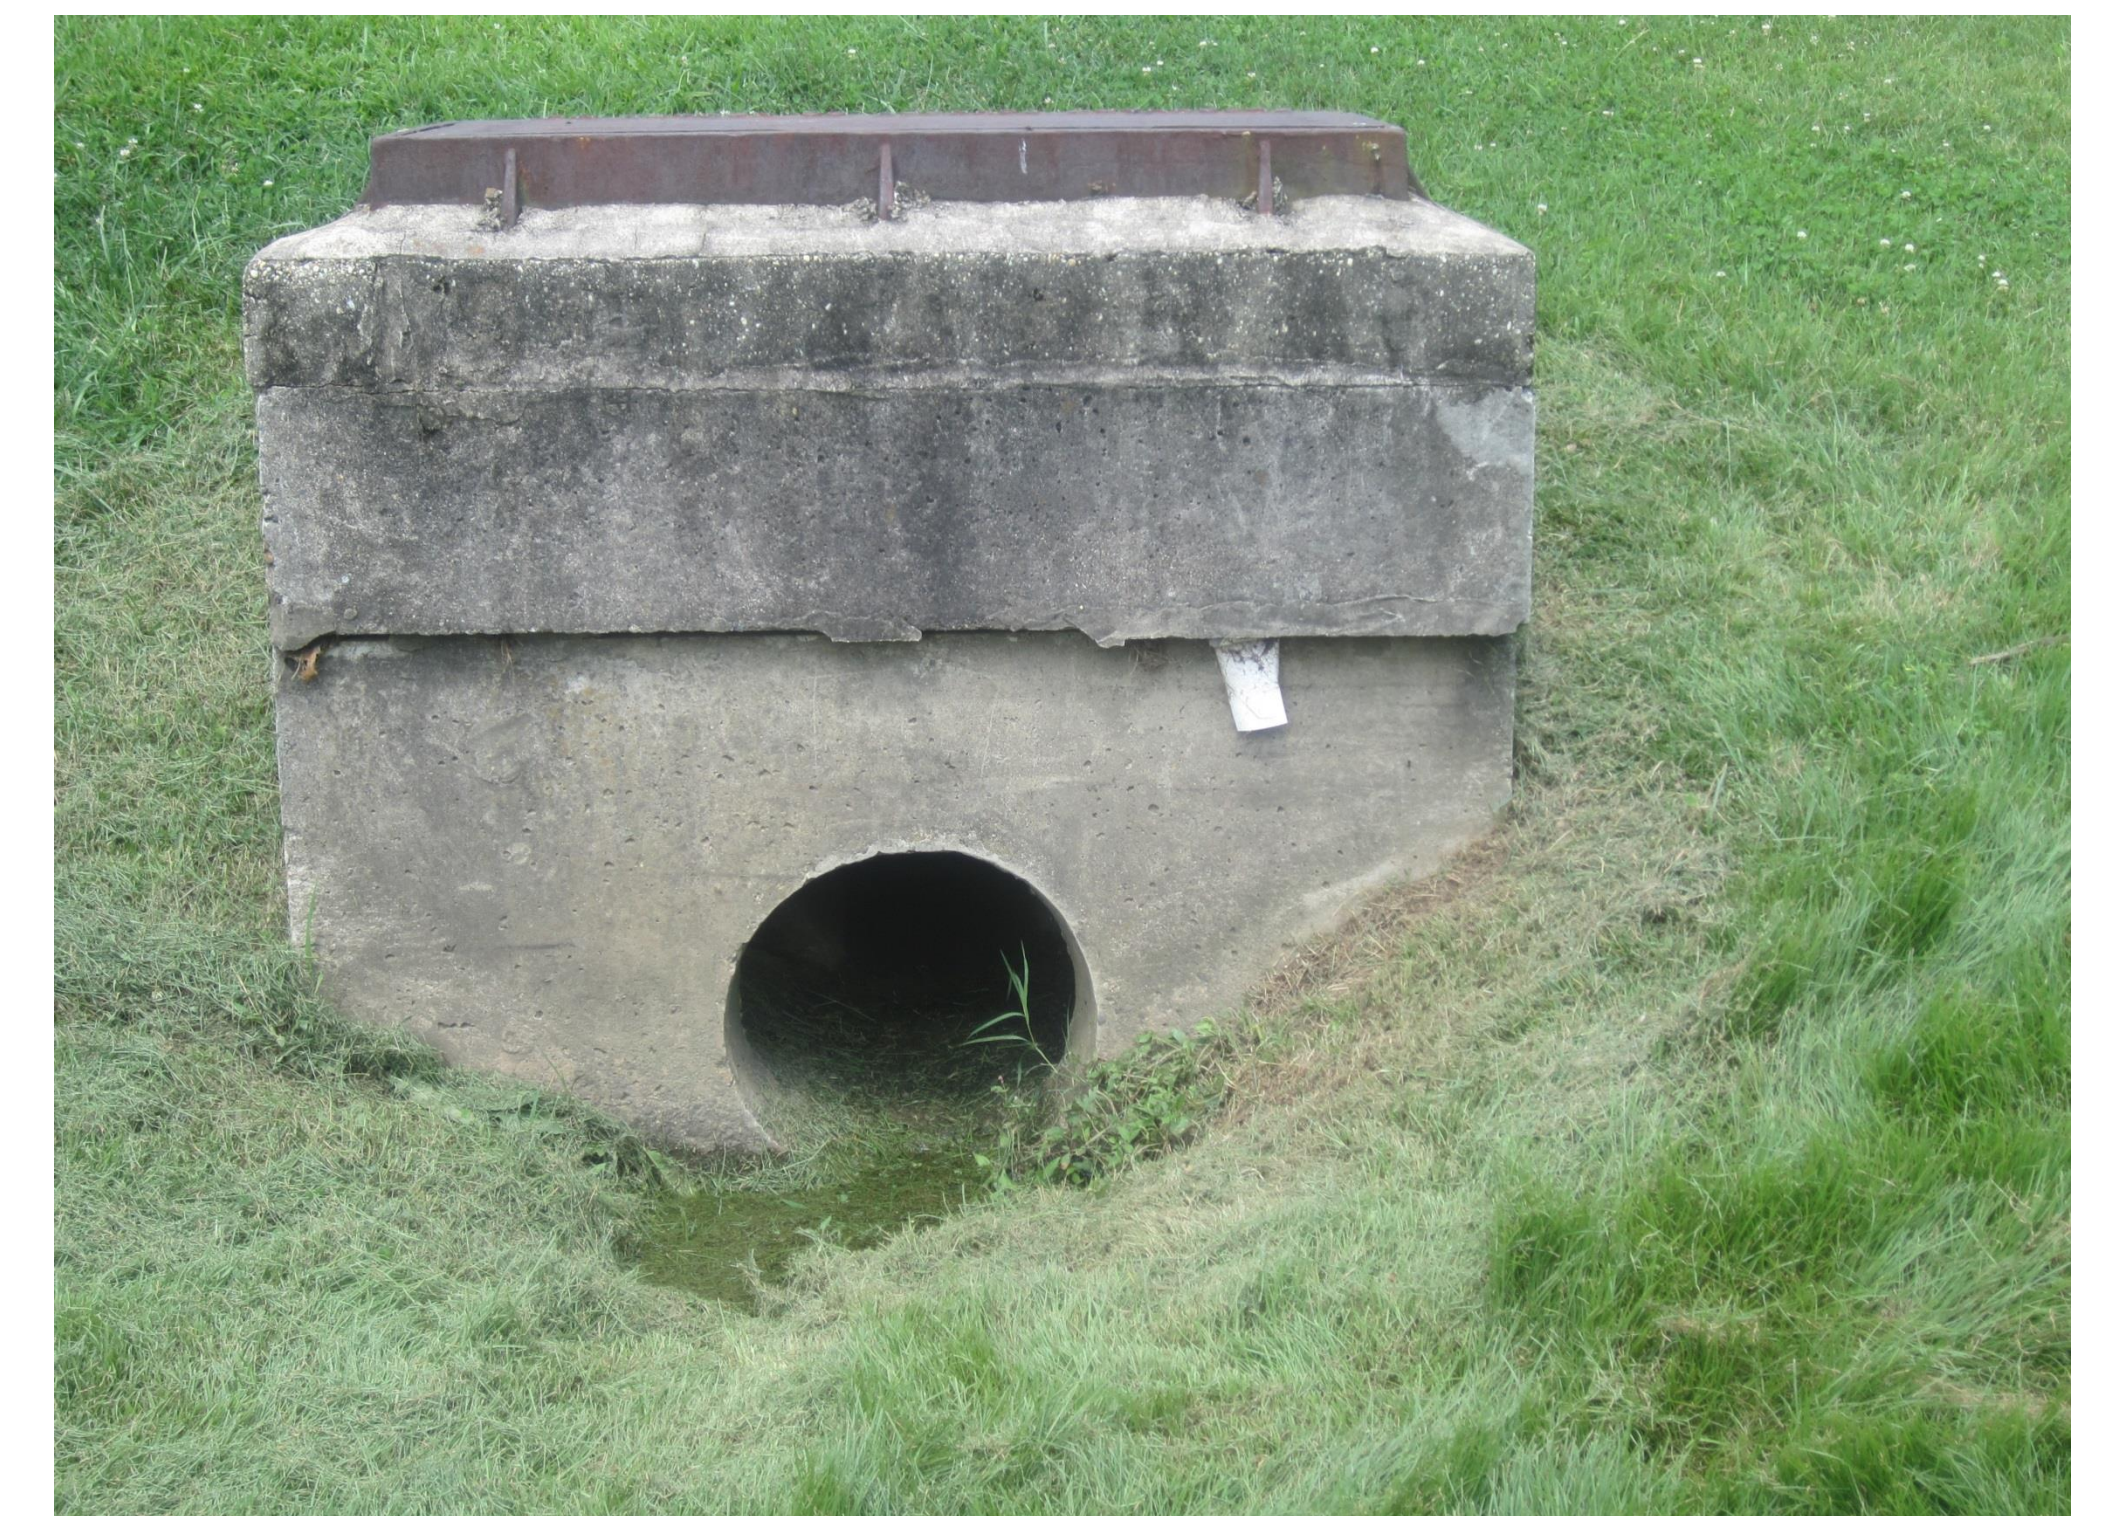
Outlet structure

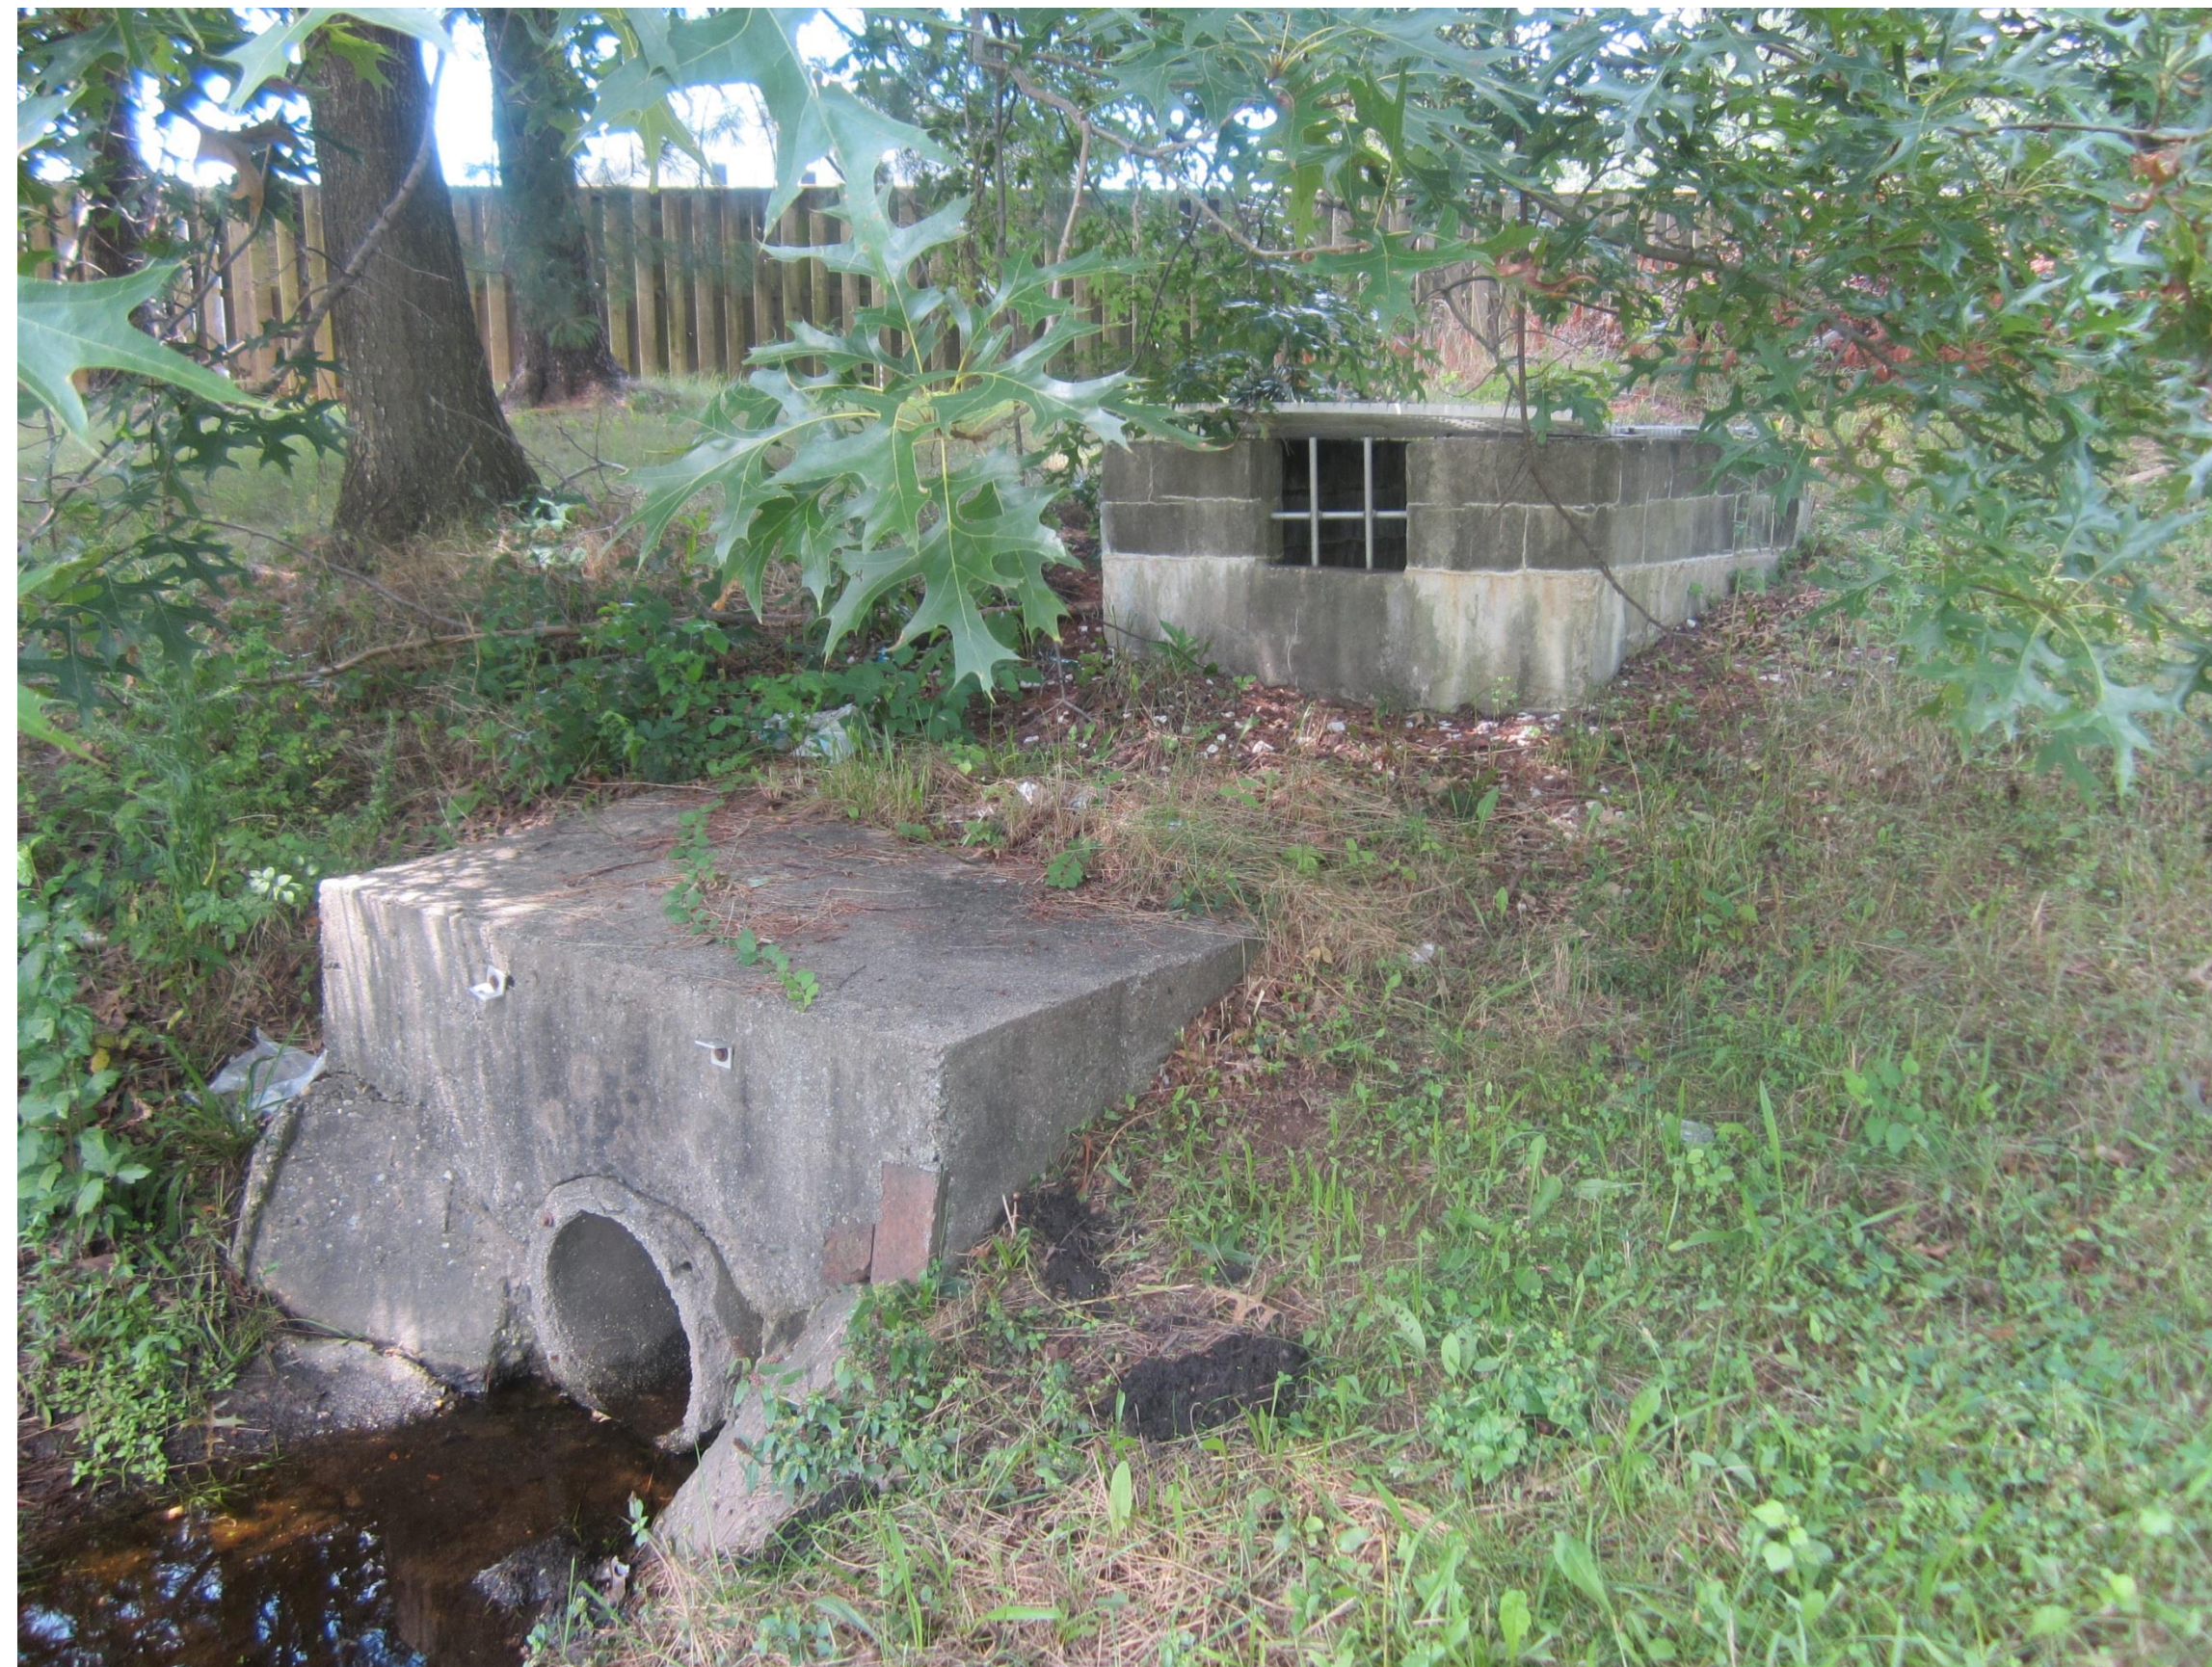
Outlet structure

- Low flow channels in basin are clogged with accumulated sediment; there is ponding in the channels that appears very stagnant
- It appears that sediment was removed from the low flow channel, but left in the basin. The sediment needs to be hauled away.
- The inlet structures all have excessive sediment accumulated in front of them
- The southwestern inlet has some concrete deterioration and should be replaced
- The outlet structure is missing a trash rack and has some cracks in parging

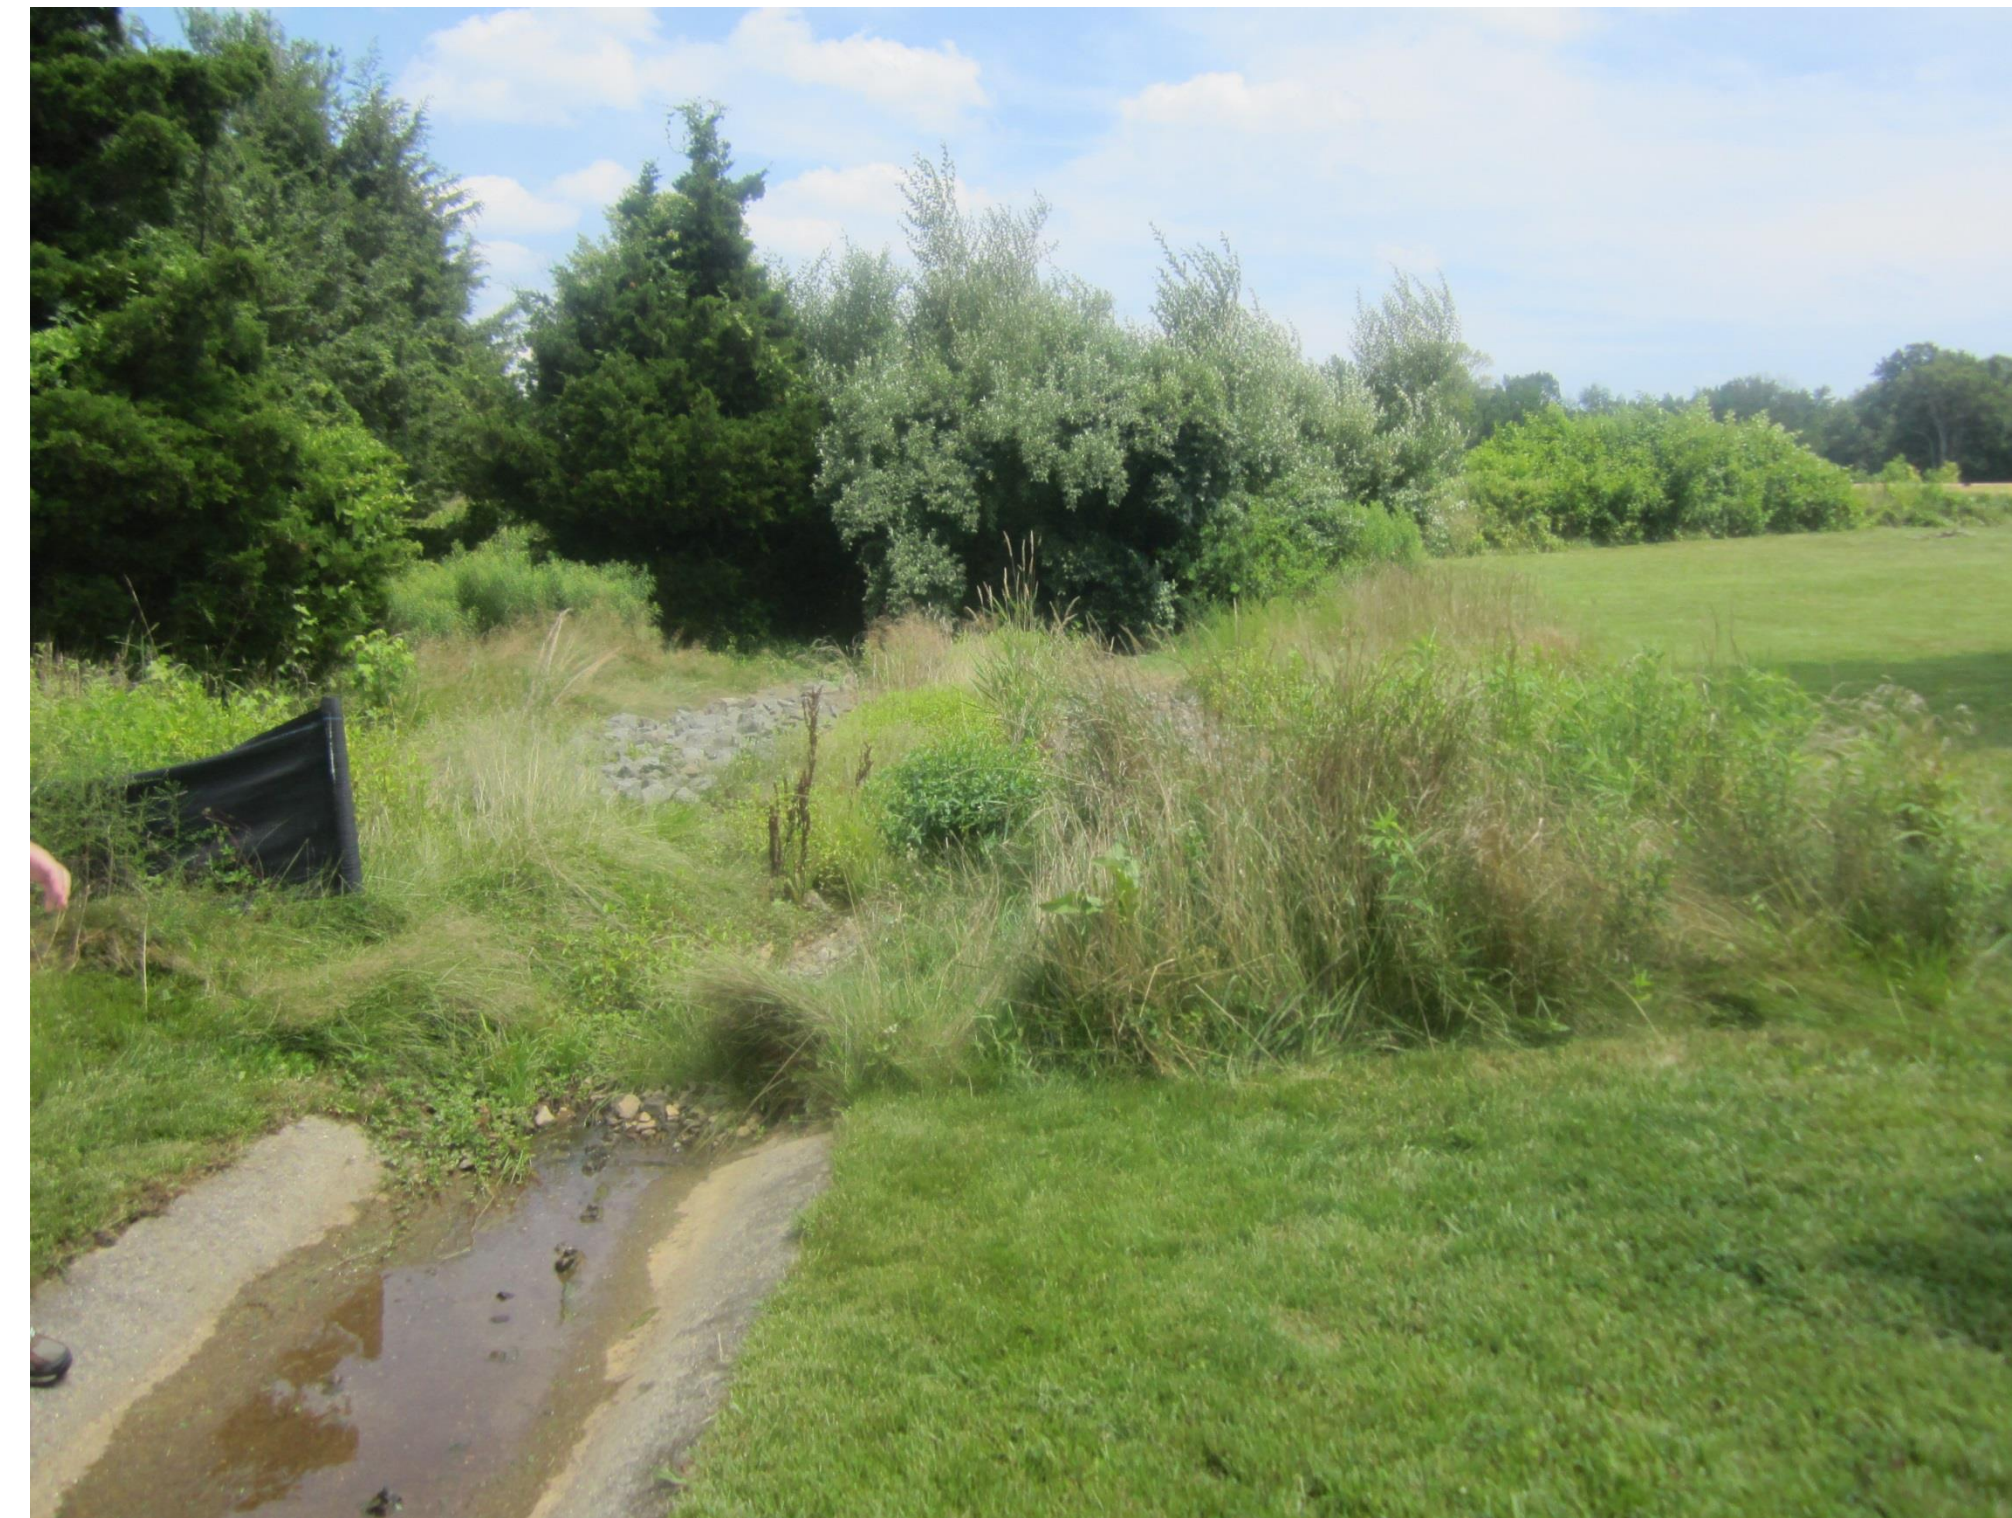
Overgrown eastern inlet

- There is excess sediment accumulated and standing water in the low flow channel
- The eastern and western inlets both have excess sediment accumulation and are overgrown with various types of vegetation
- The outlet structure has cracks in parging, the trash rack is broken, and the water is not discharging from the outlet causing the entire basin to back up
