**Hamilton Township (Mercer County)
Stormwater Basin Assessment Summary
Hamilton Owned Addendum (Year 5A)**

Developed by the Rutgers Cooperative Extension Water Resources Program
Funded by Hamilton Township, Mercer County, New Jersey

November 27, 2019

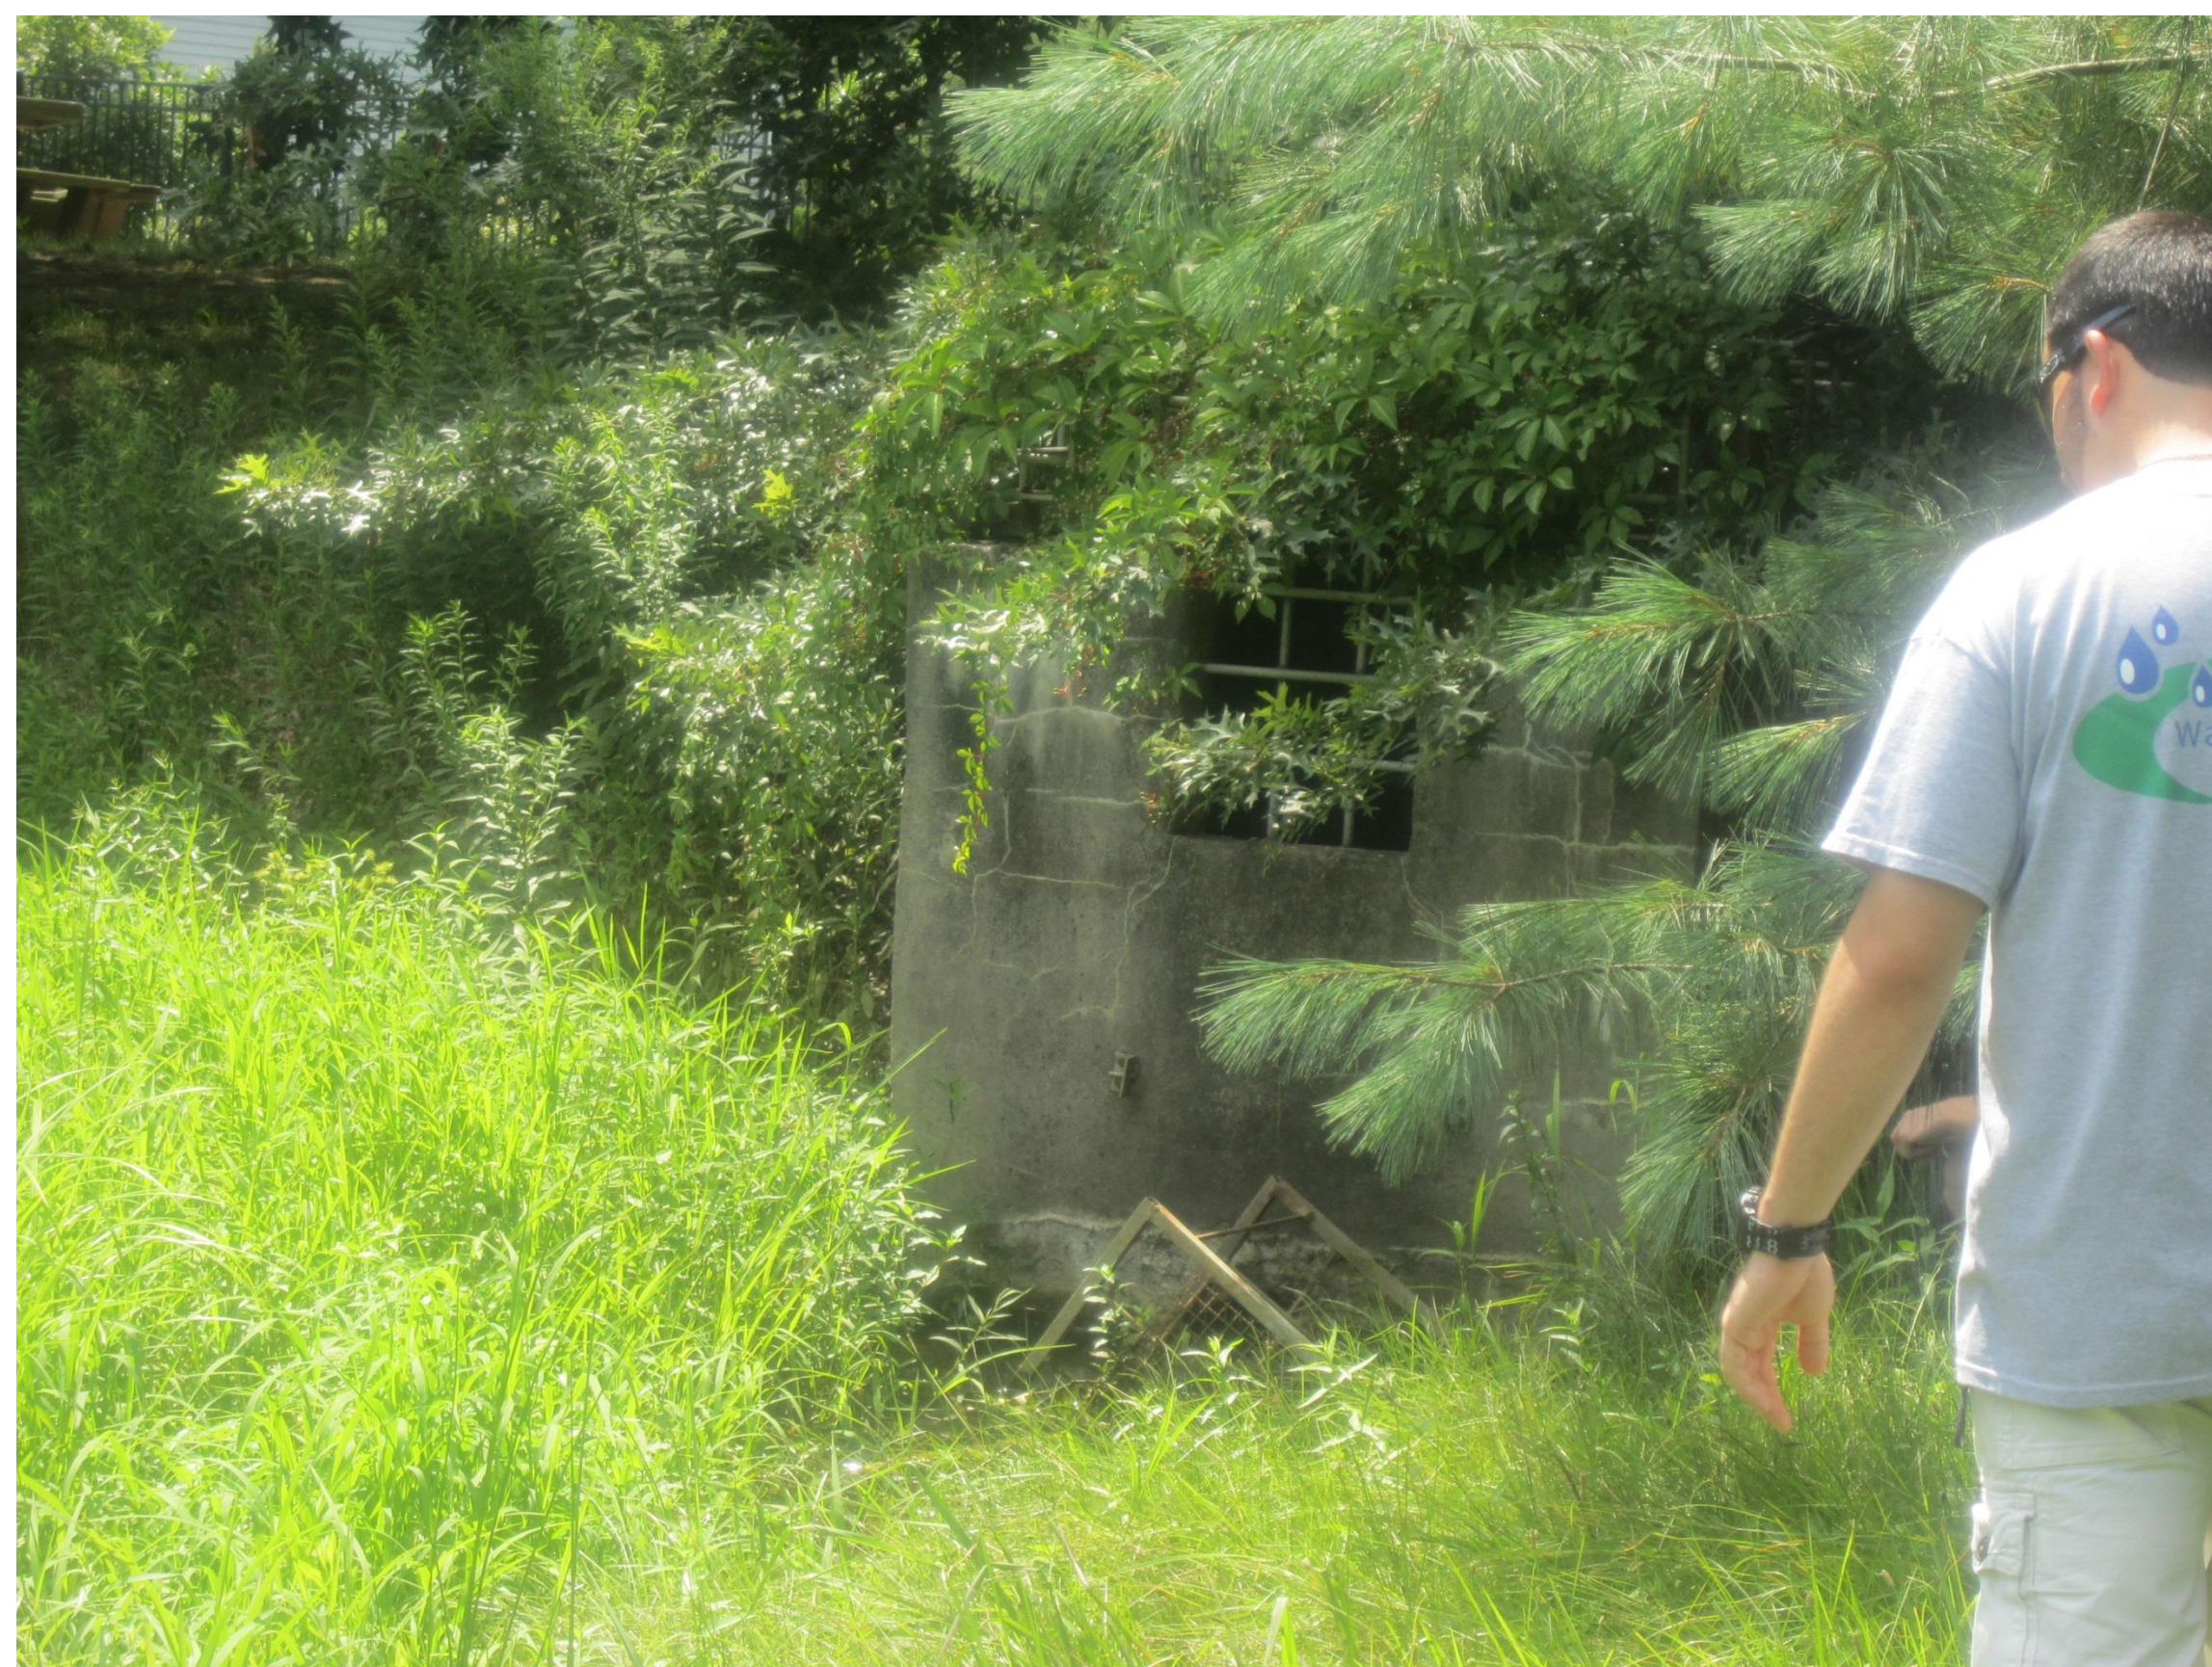
Outlet structure

- There is excess sediment accumulated and standing water in the low flow channel
- The eastern and western inlets both have excess sediment accumulation and are overgrown with various types of vegetation
- The outlet structure has cracks in parging, the trash rack is broken, and the water is not discharging from the outlet causing the entire basin to back up

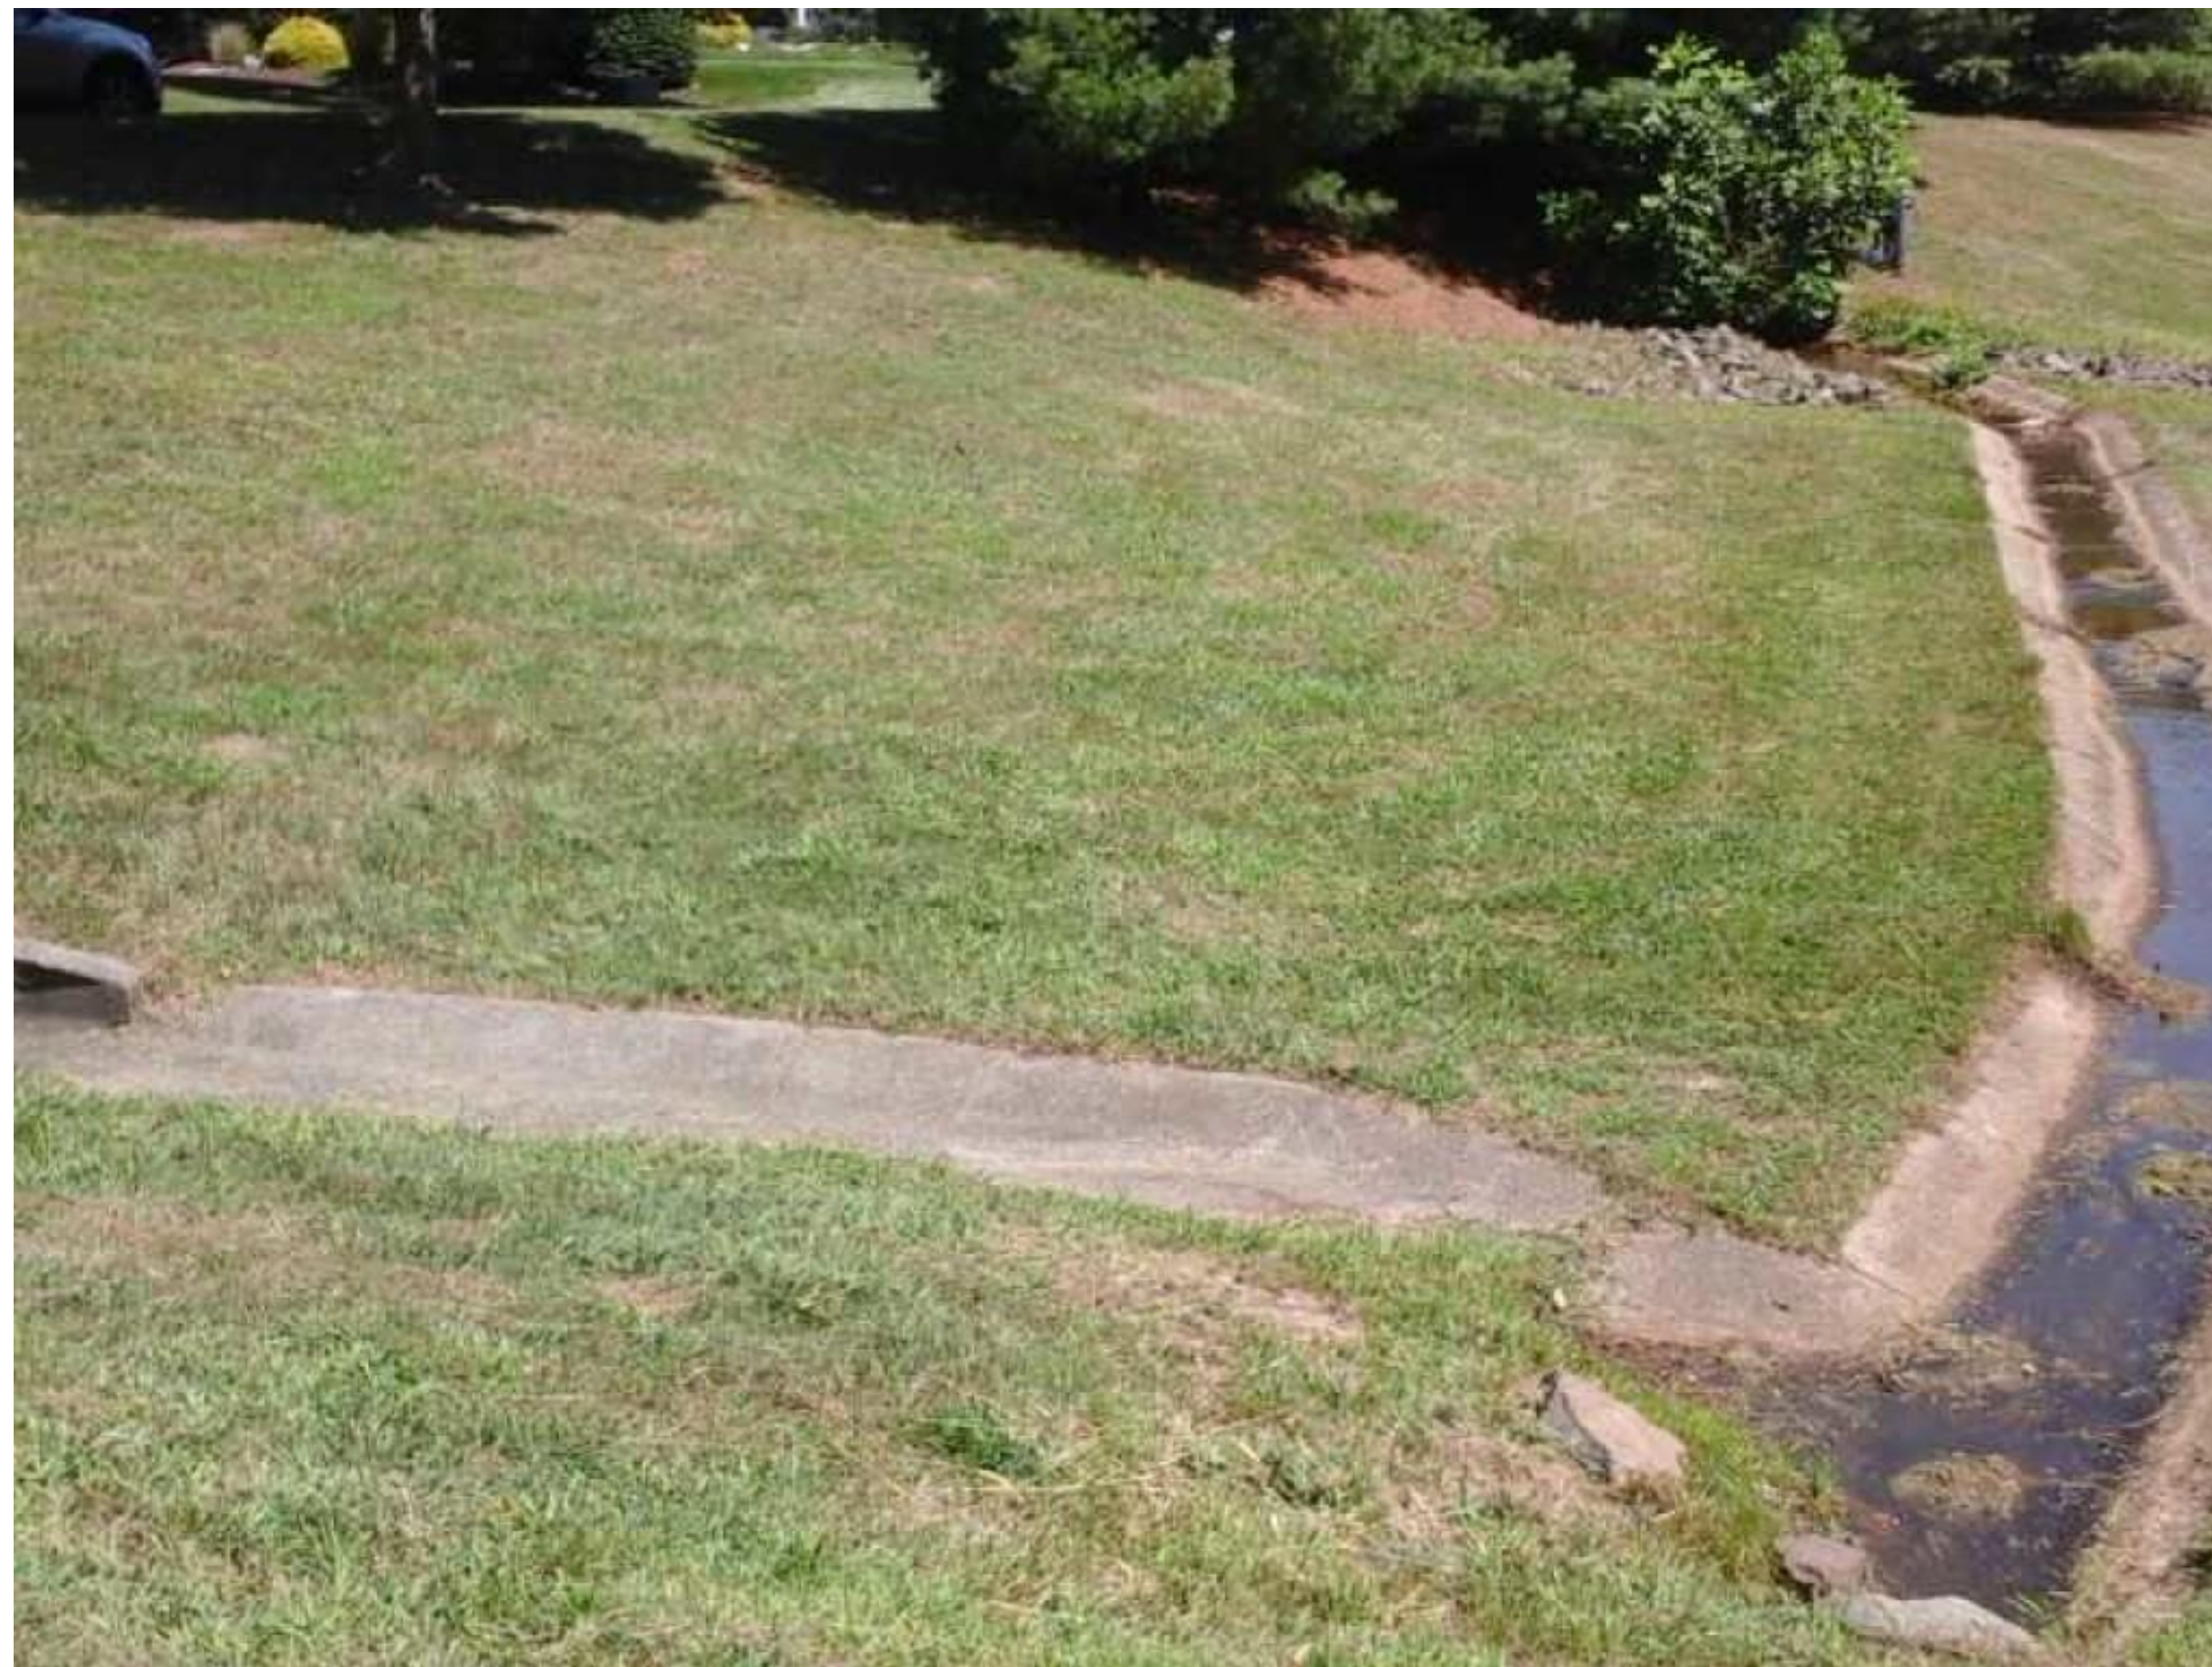
- Basin #233 low flow channel has some grass clippings and some standing water
- Retrofit plants for infiltration
- Tall grass, located in between houses
- Both basins can have stone channels implemented in place of low flow channels, and herbaceous plant can be used to naturalize the basins

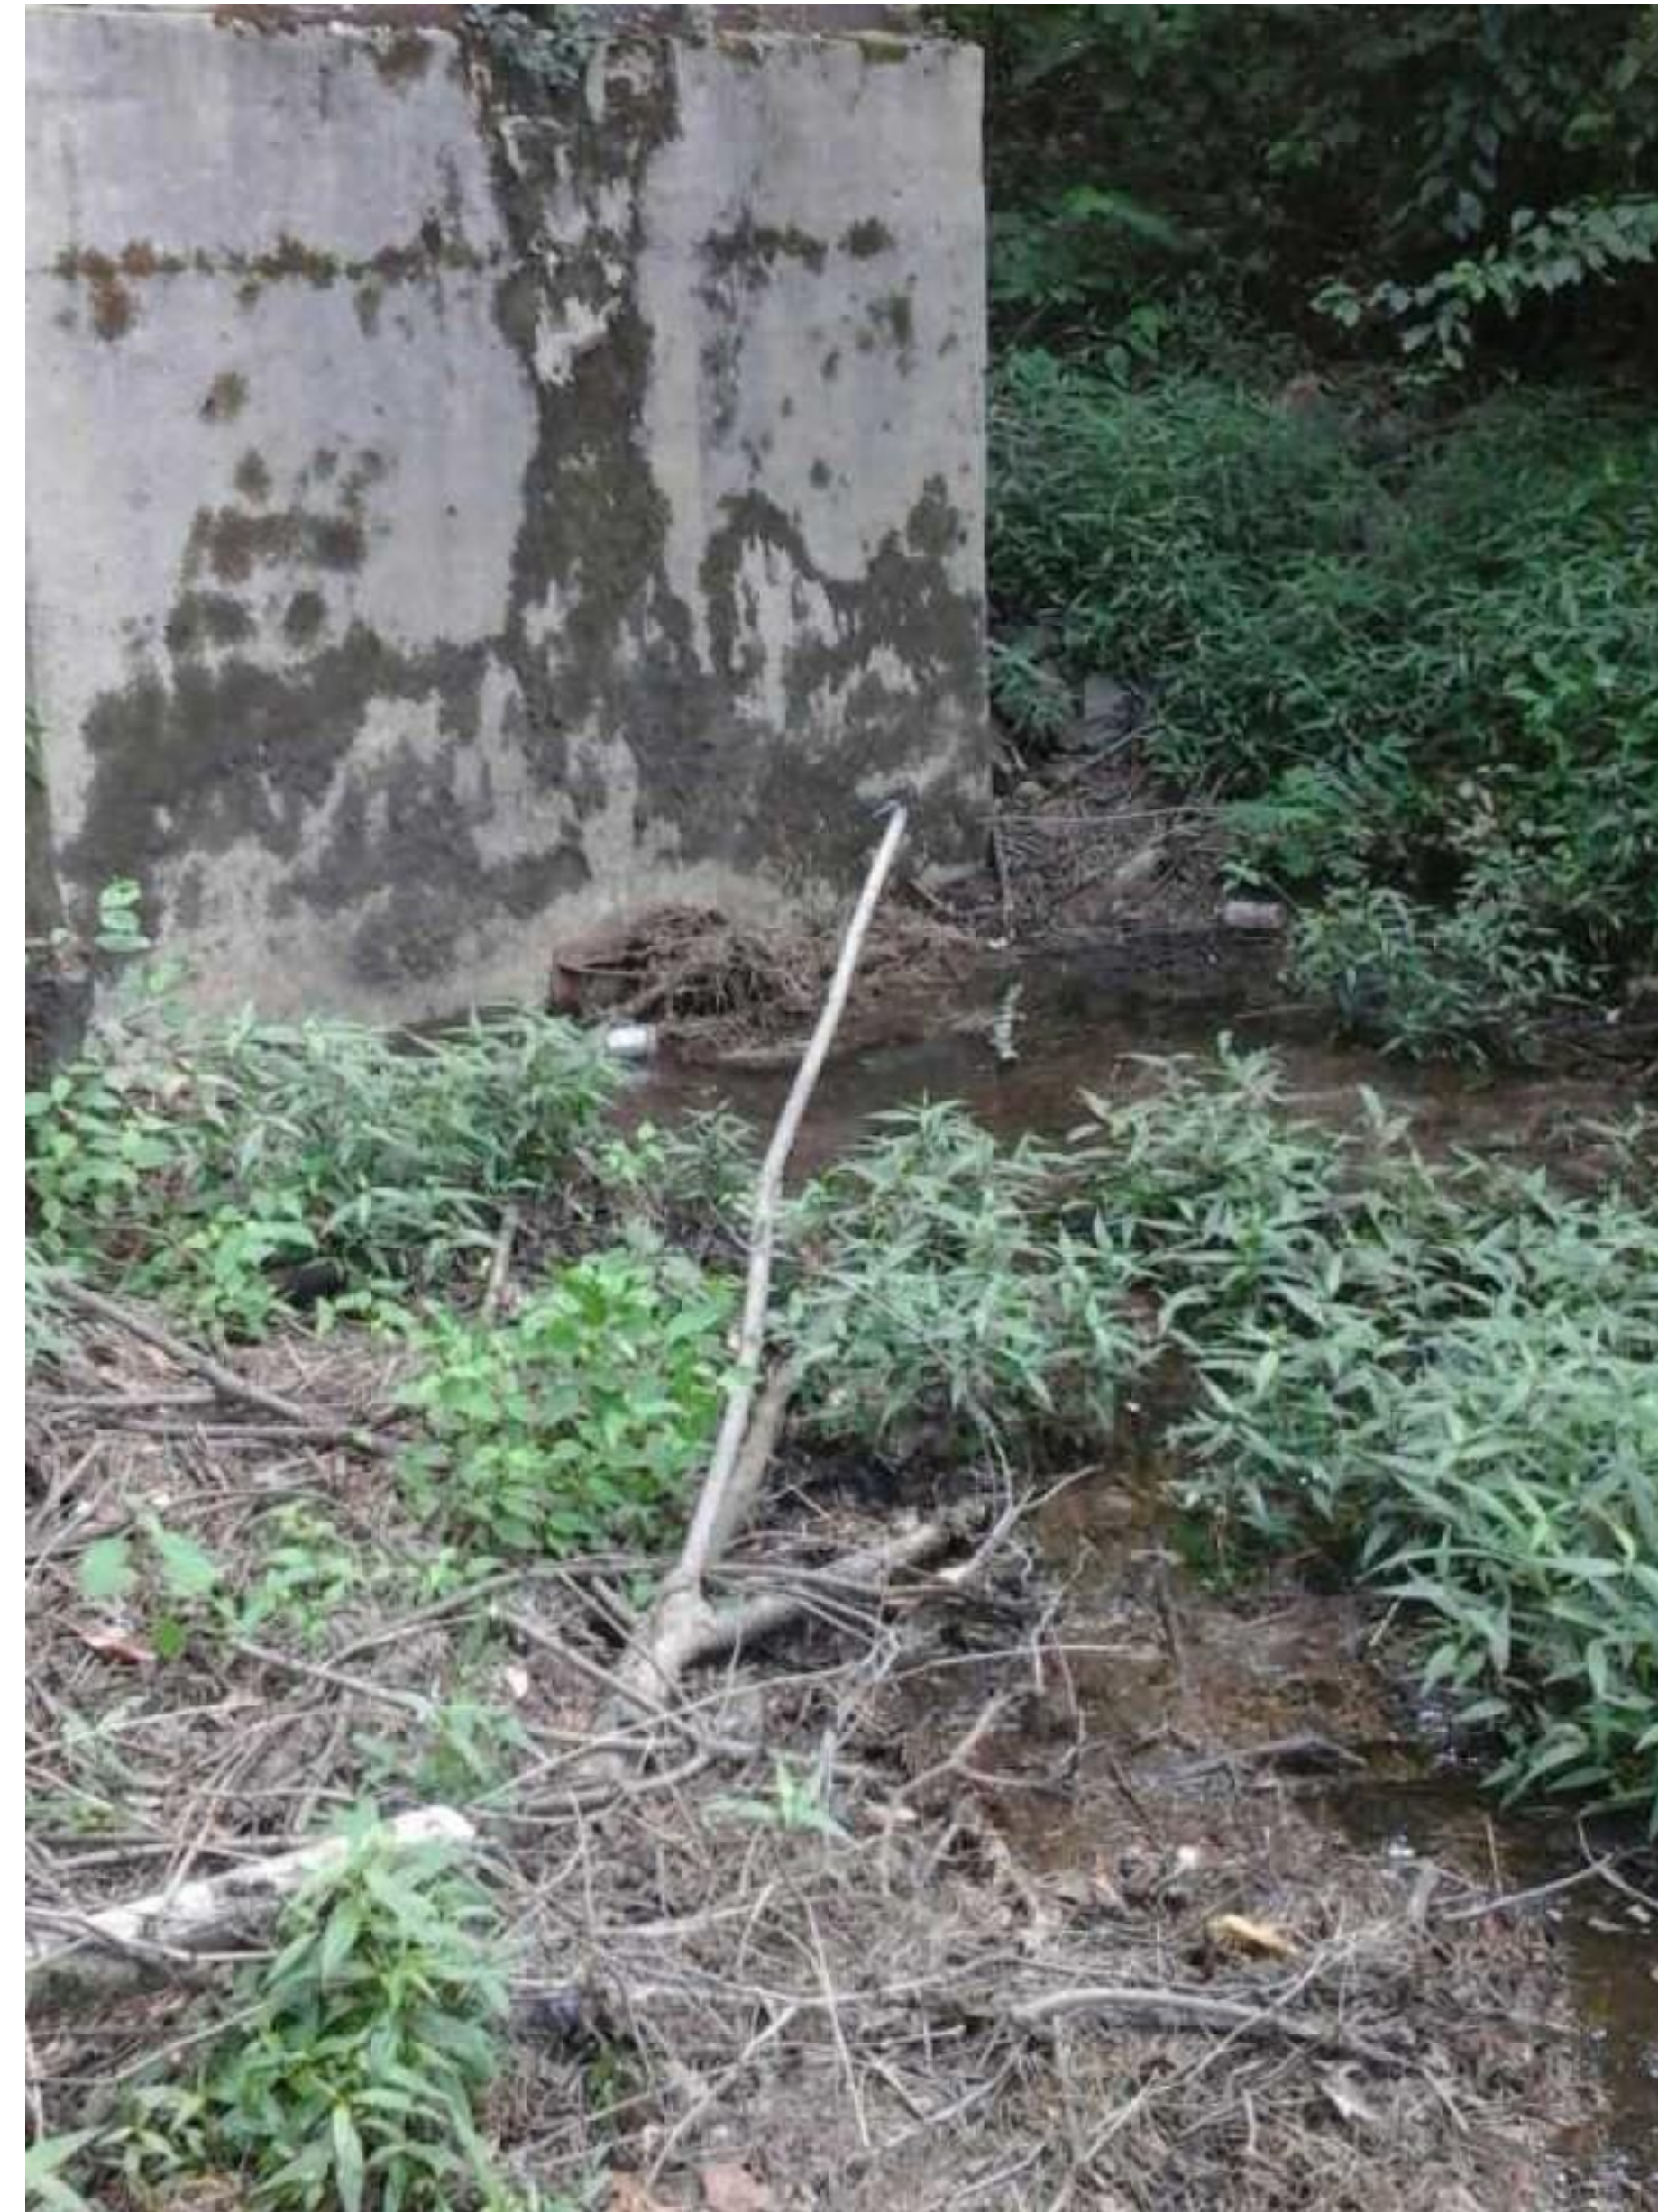
- Both basin suffer from similar problems with Basin #236 being worse
- Water flowing through has a red is color, channel is overgrown, due to overgrowth and excess sediment, the outlet is blocked and water is backing up
- Replace channel with rocks, clear out unwanted vegetation, clean outlet and excess sediment
- Replace low flow channel with rock channel

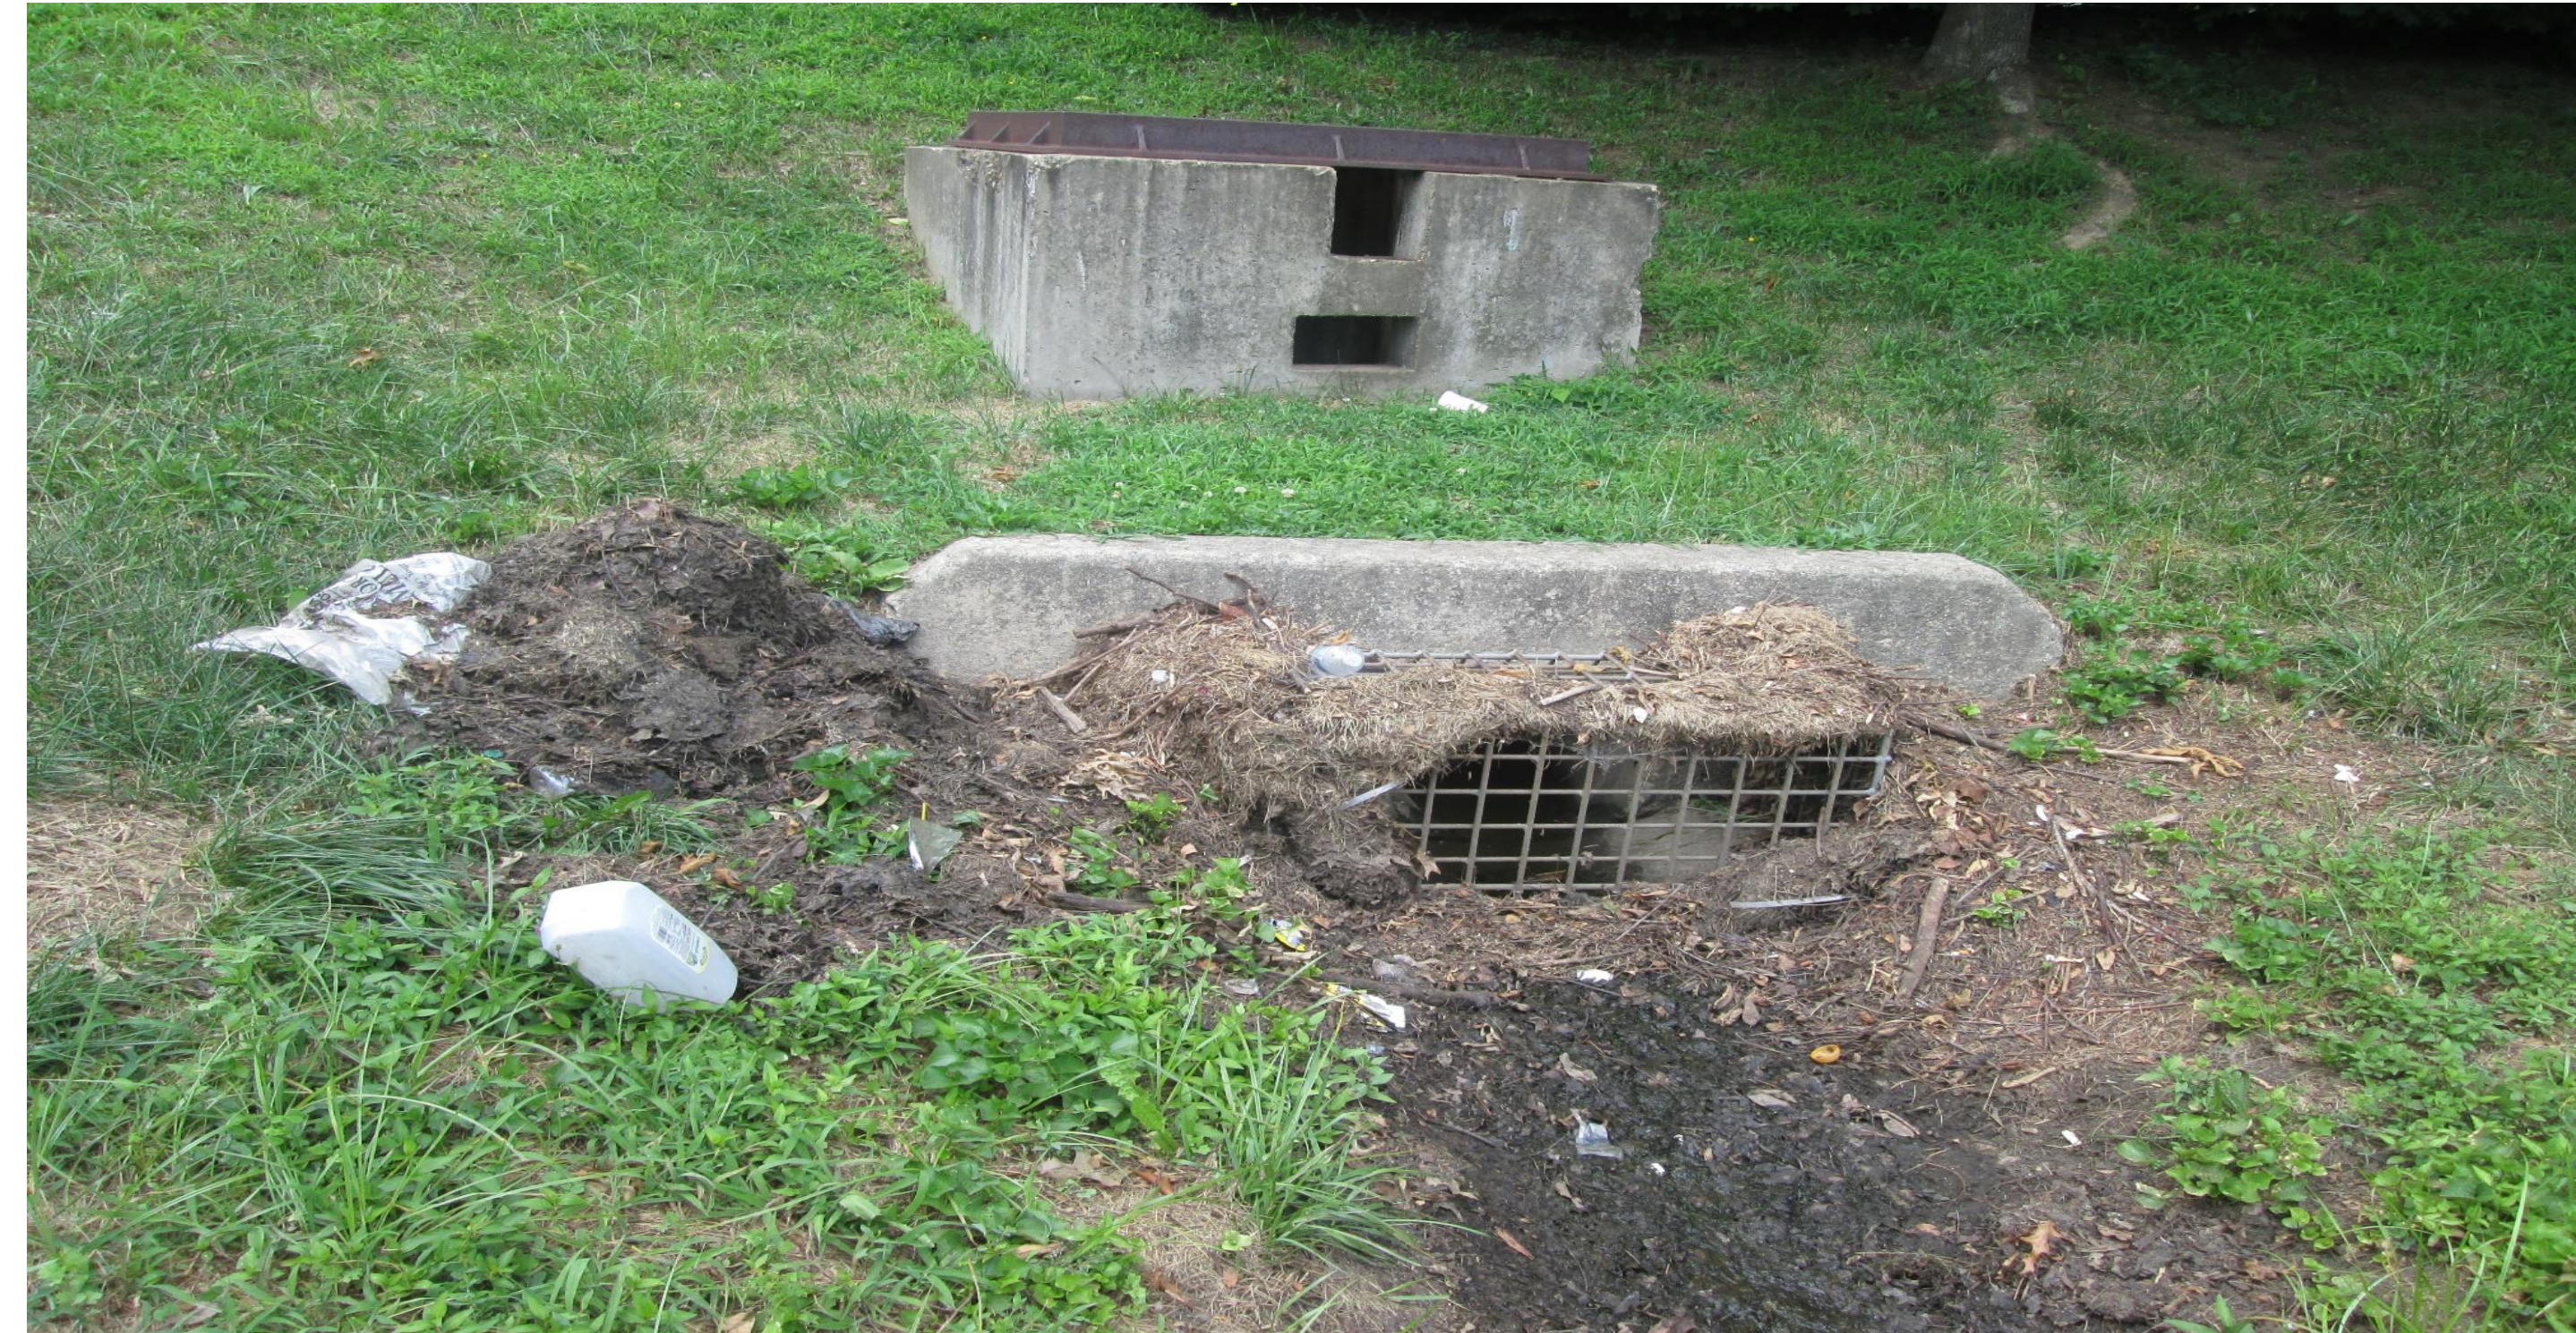
- Outlet has excessive sediment accumulation clogging low flow orifice
- Remove low flow channel and replace with a rock-lined channel to allow infiltration
- Naturalize with herbaceous plants

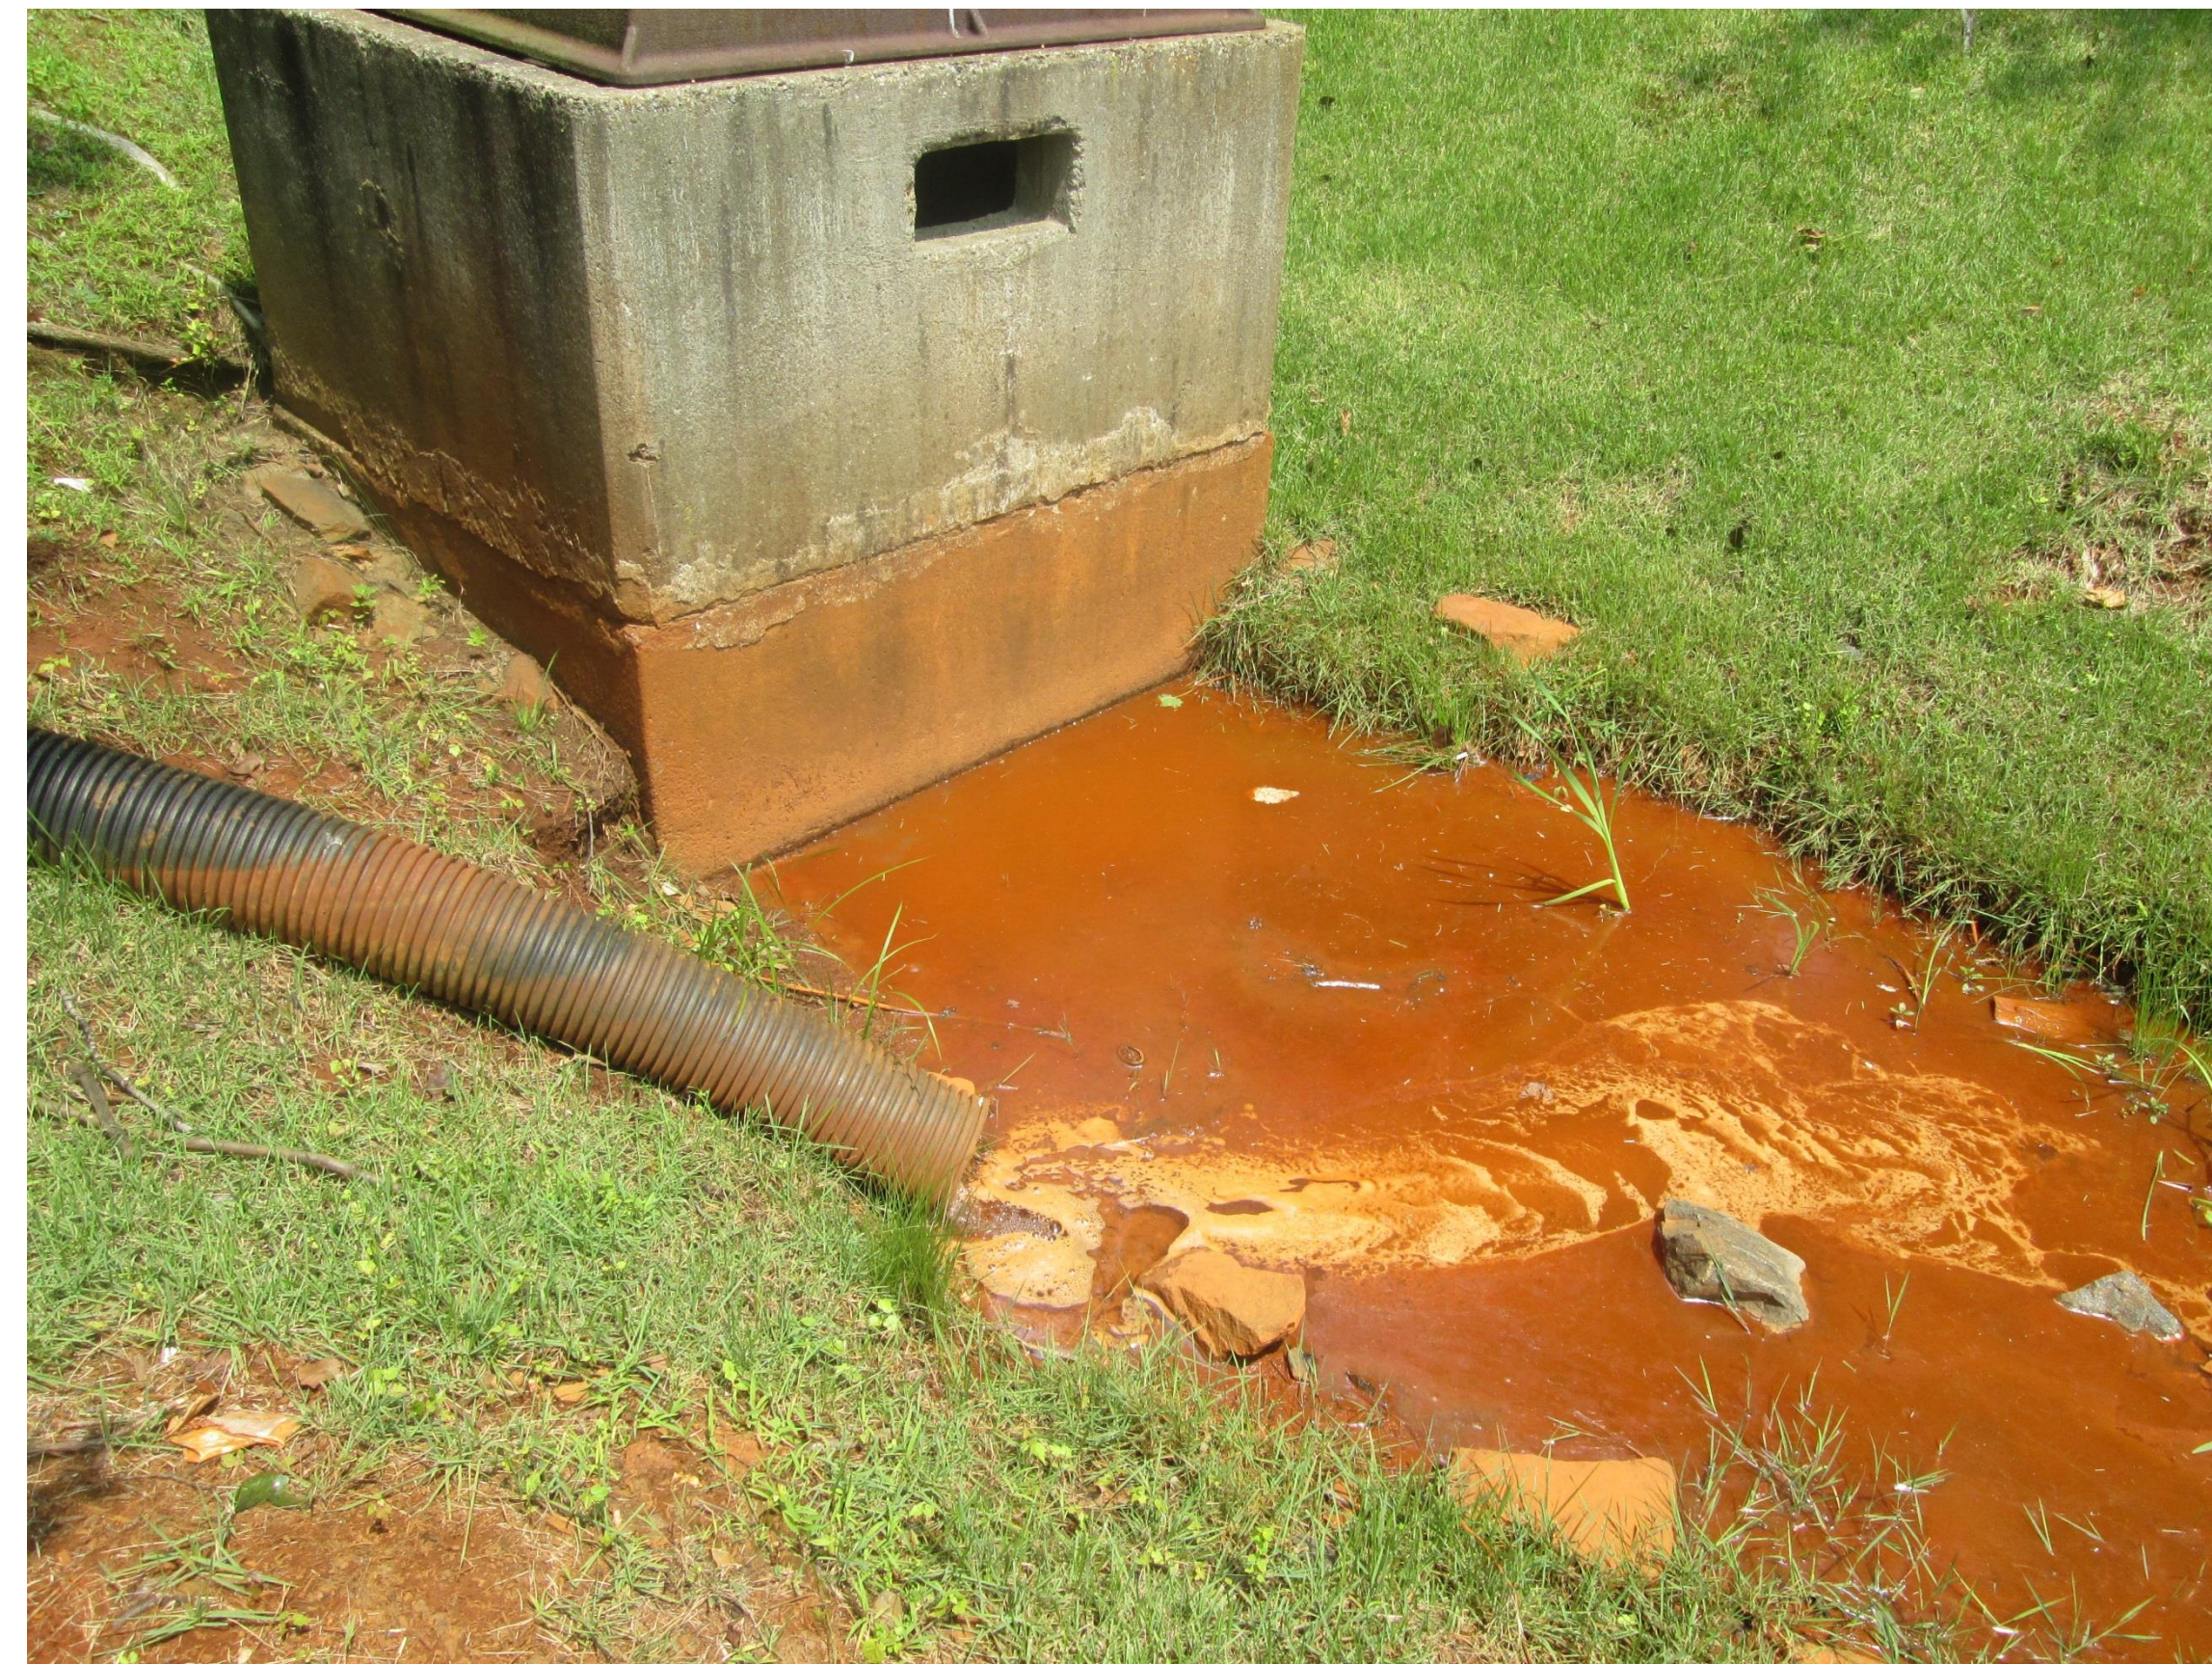
Outlet

- The low flow outlet appears to be clogged leading to significant standing water in low flow channel
- Heavy erosion caused by small inlet pipe should be remediated
- Low flow channel can be replaced with a stone channel to provide better infiltration in smaller storm events

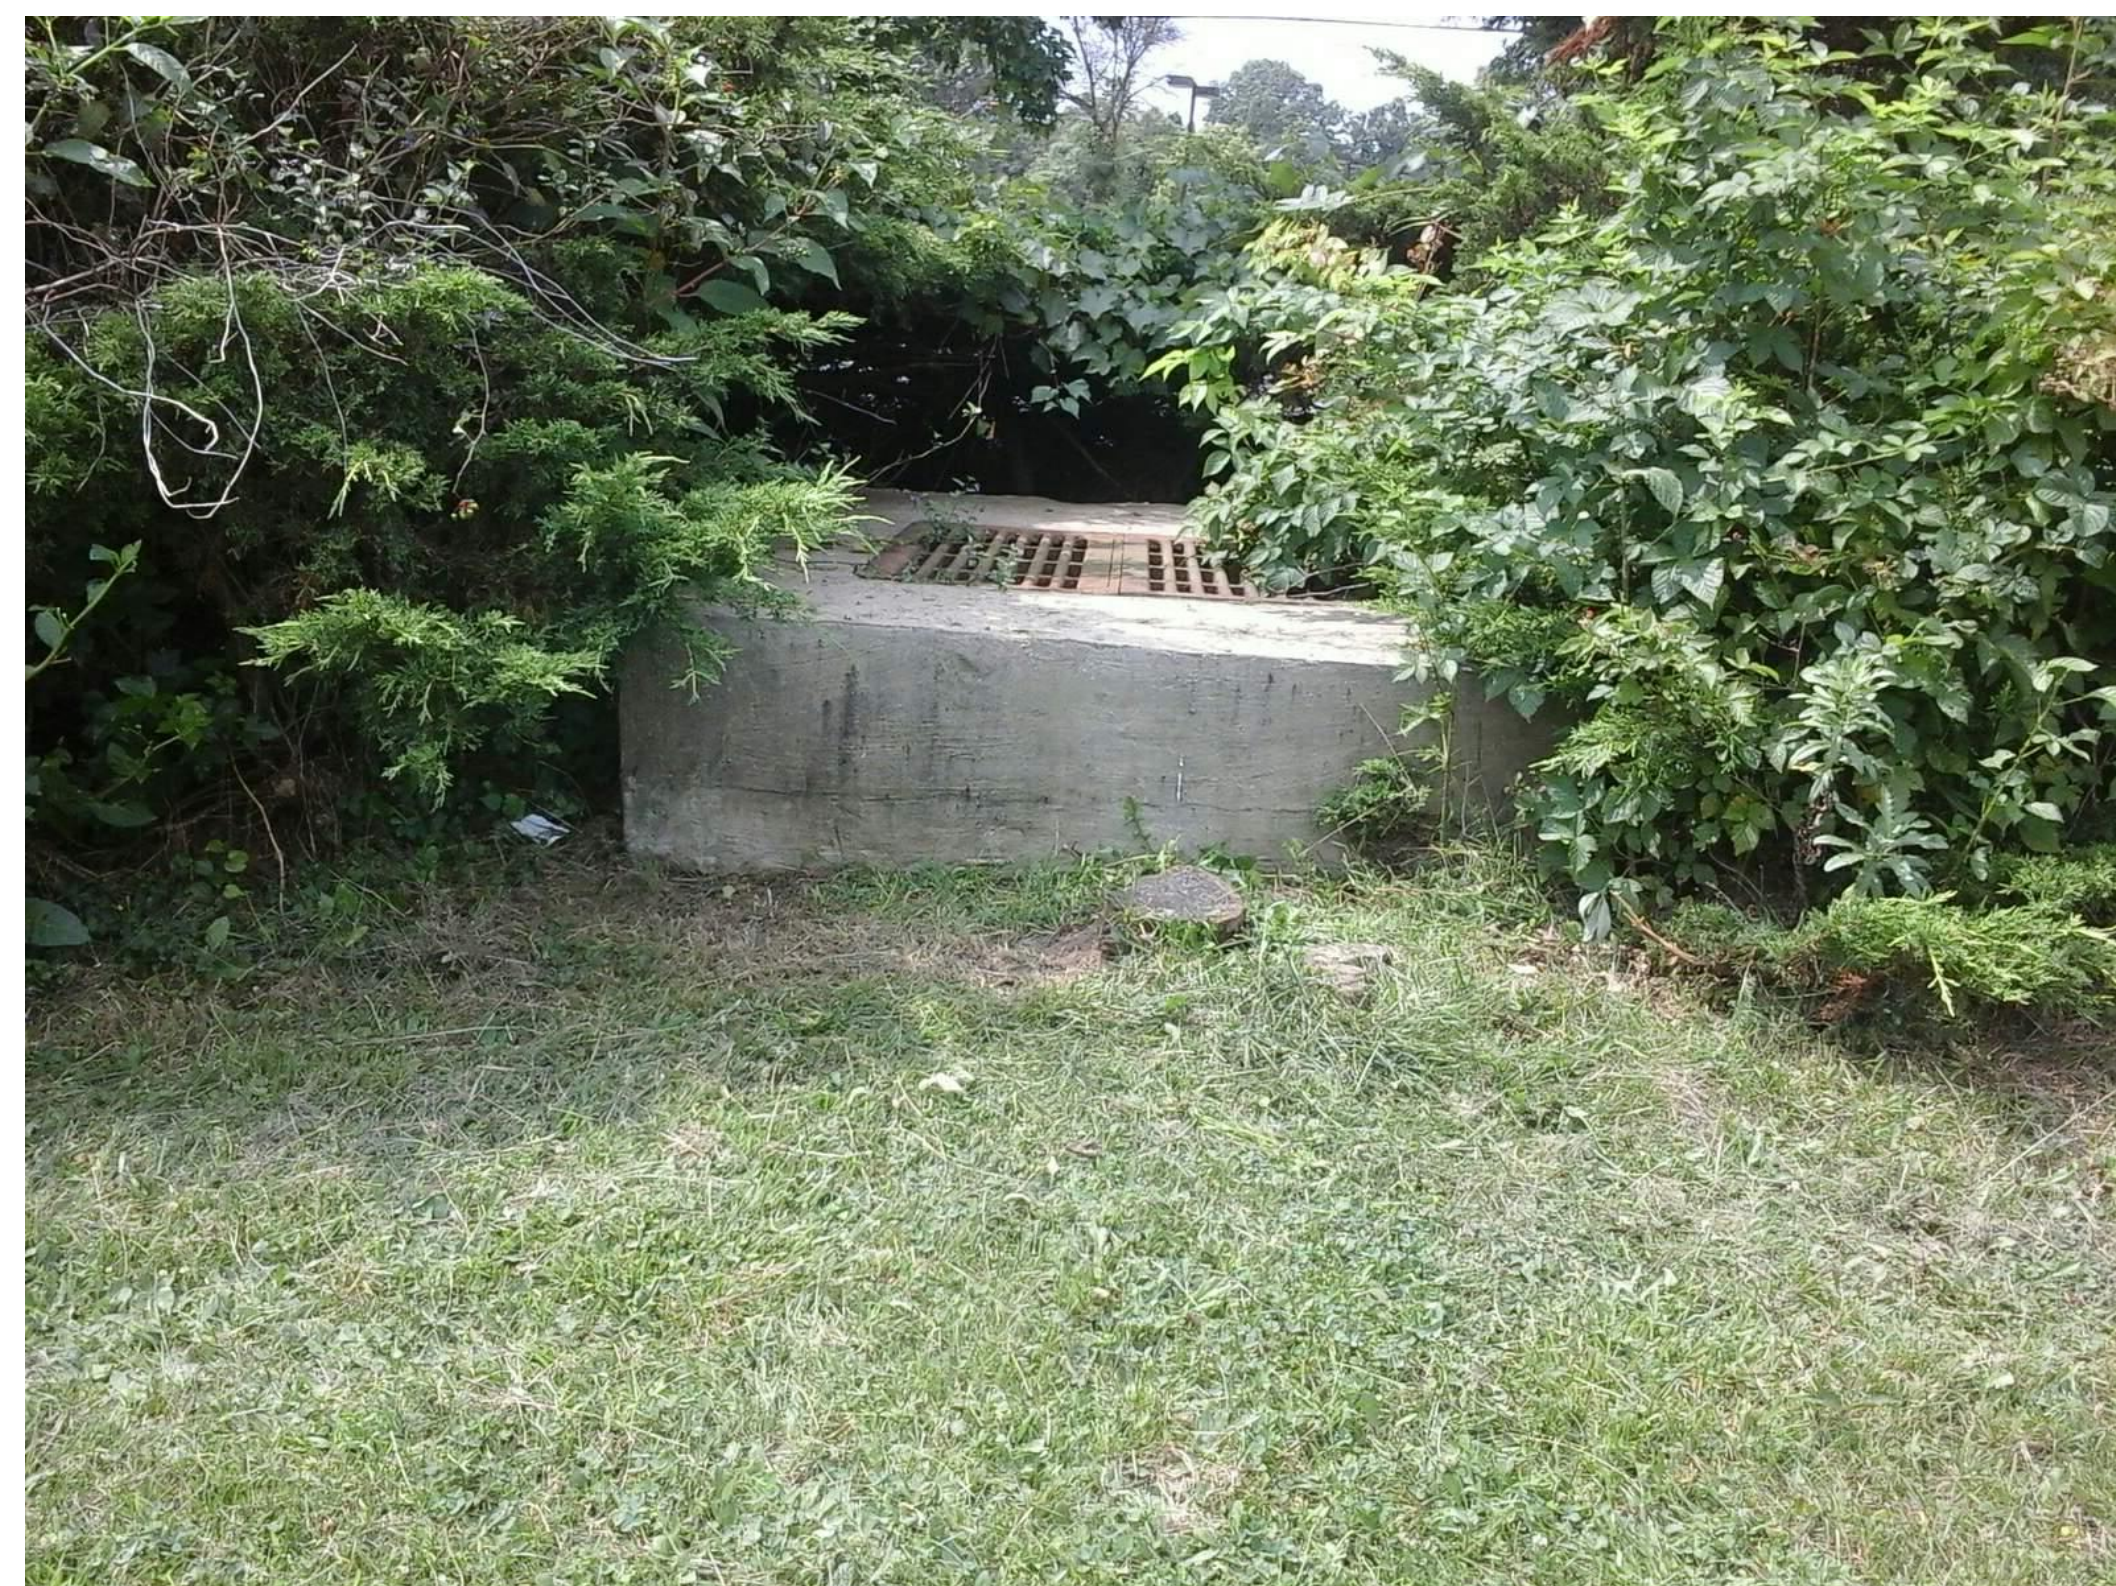
Outlet structure
