**Hamilton Township (Mercer County)
Stormwater Basin Assessment Summary
Hamilton Owned Addendum (Year 5A)**

Developed by the Rutgers Cooperative Extension Water Resources Program
Funded by Hamilton Township, Mercer County, New Jersey

November 27, 2019

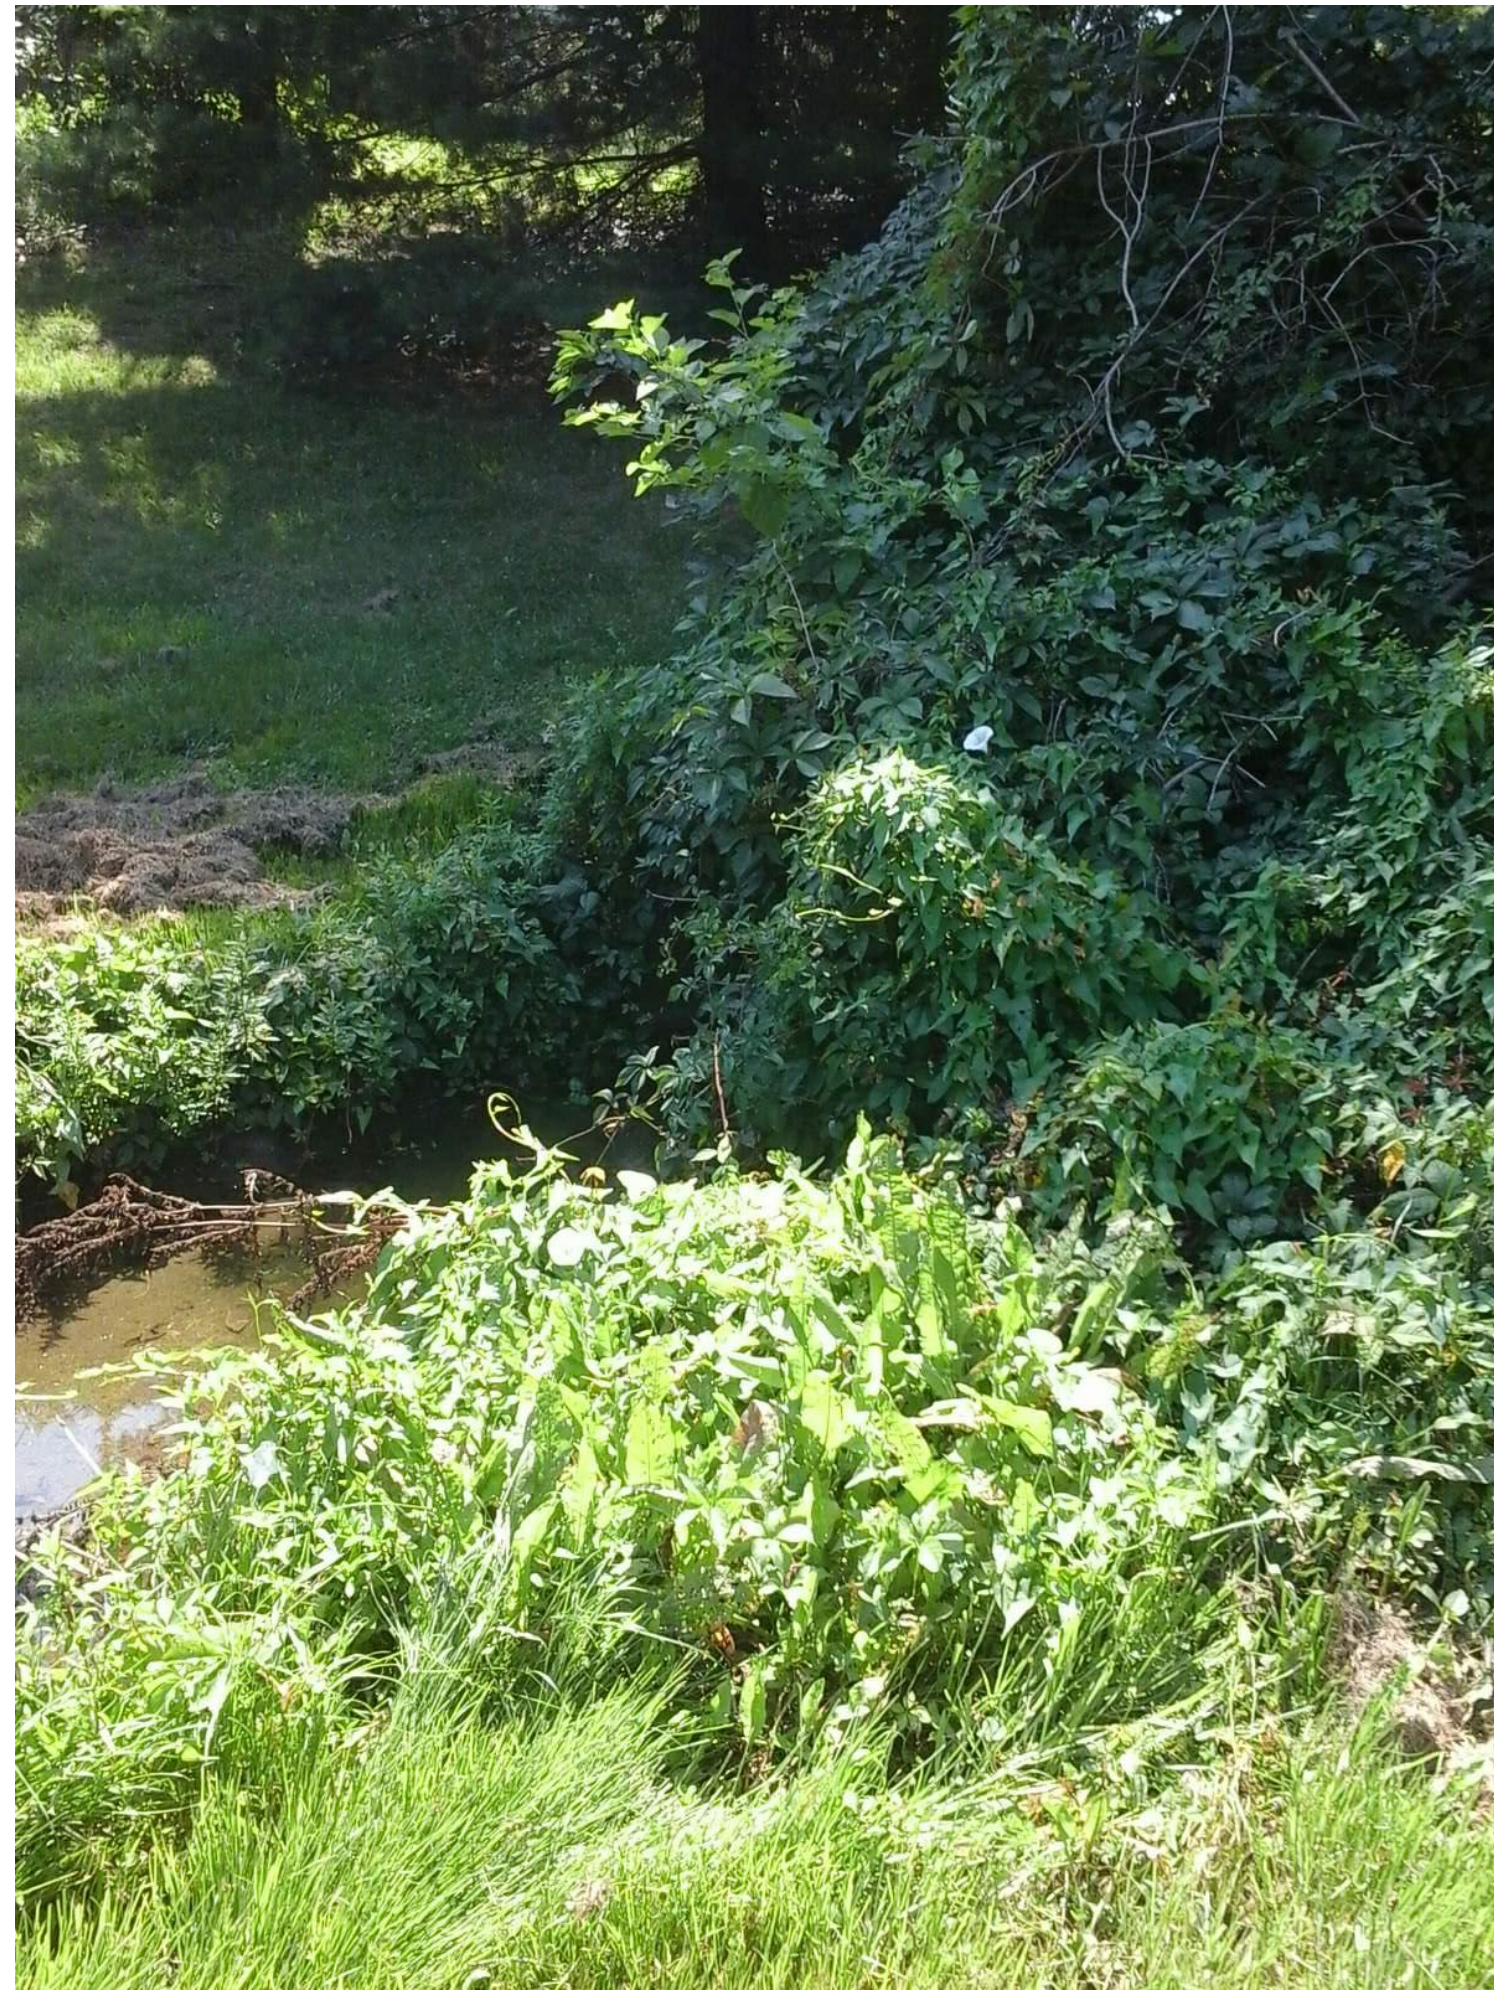
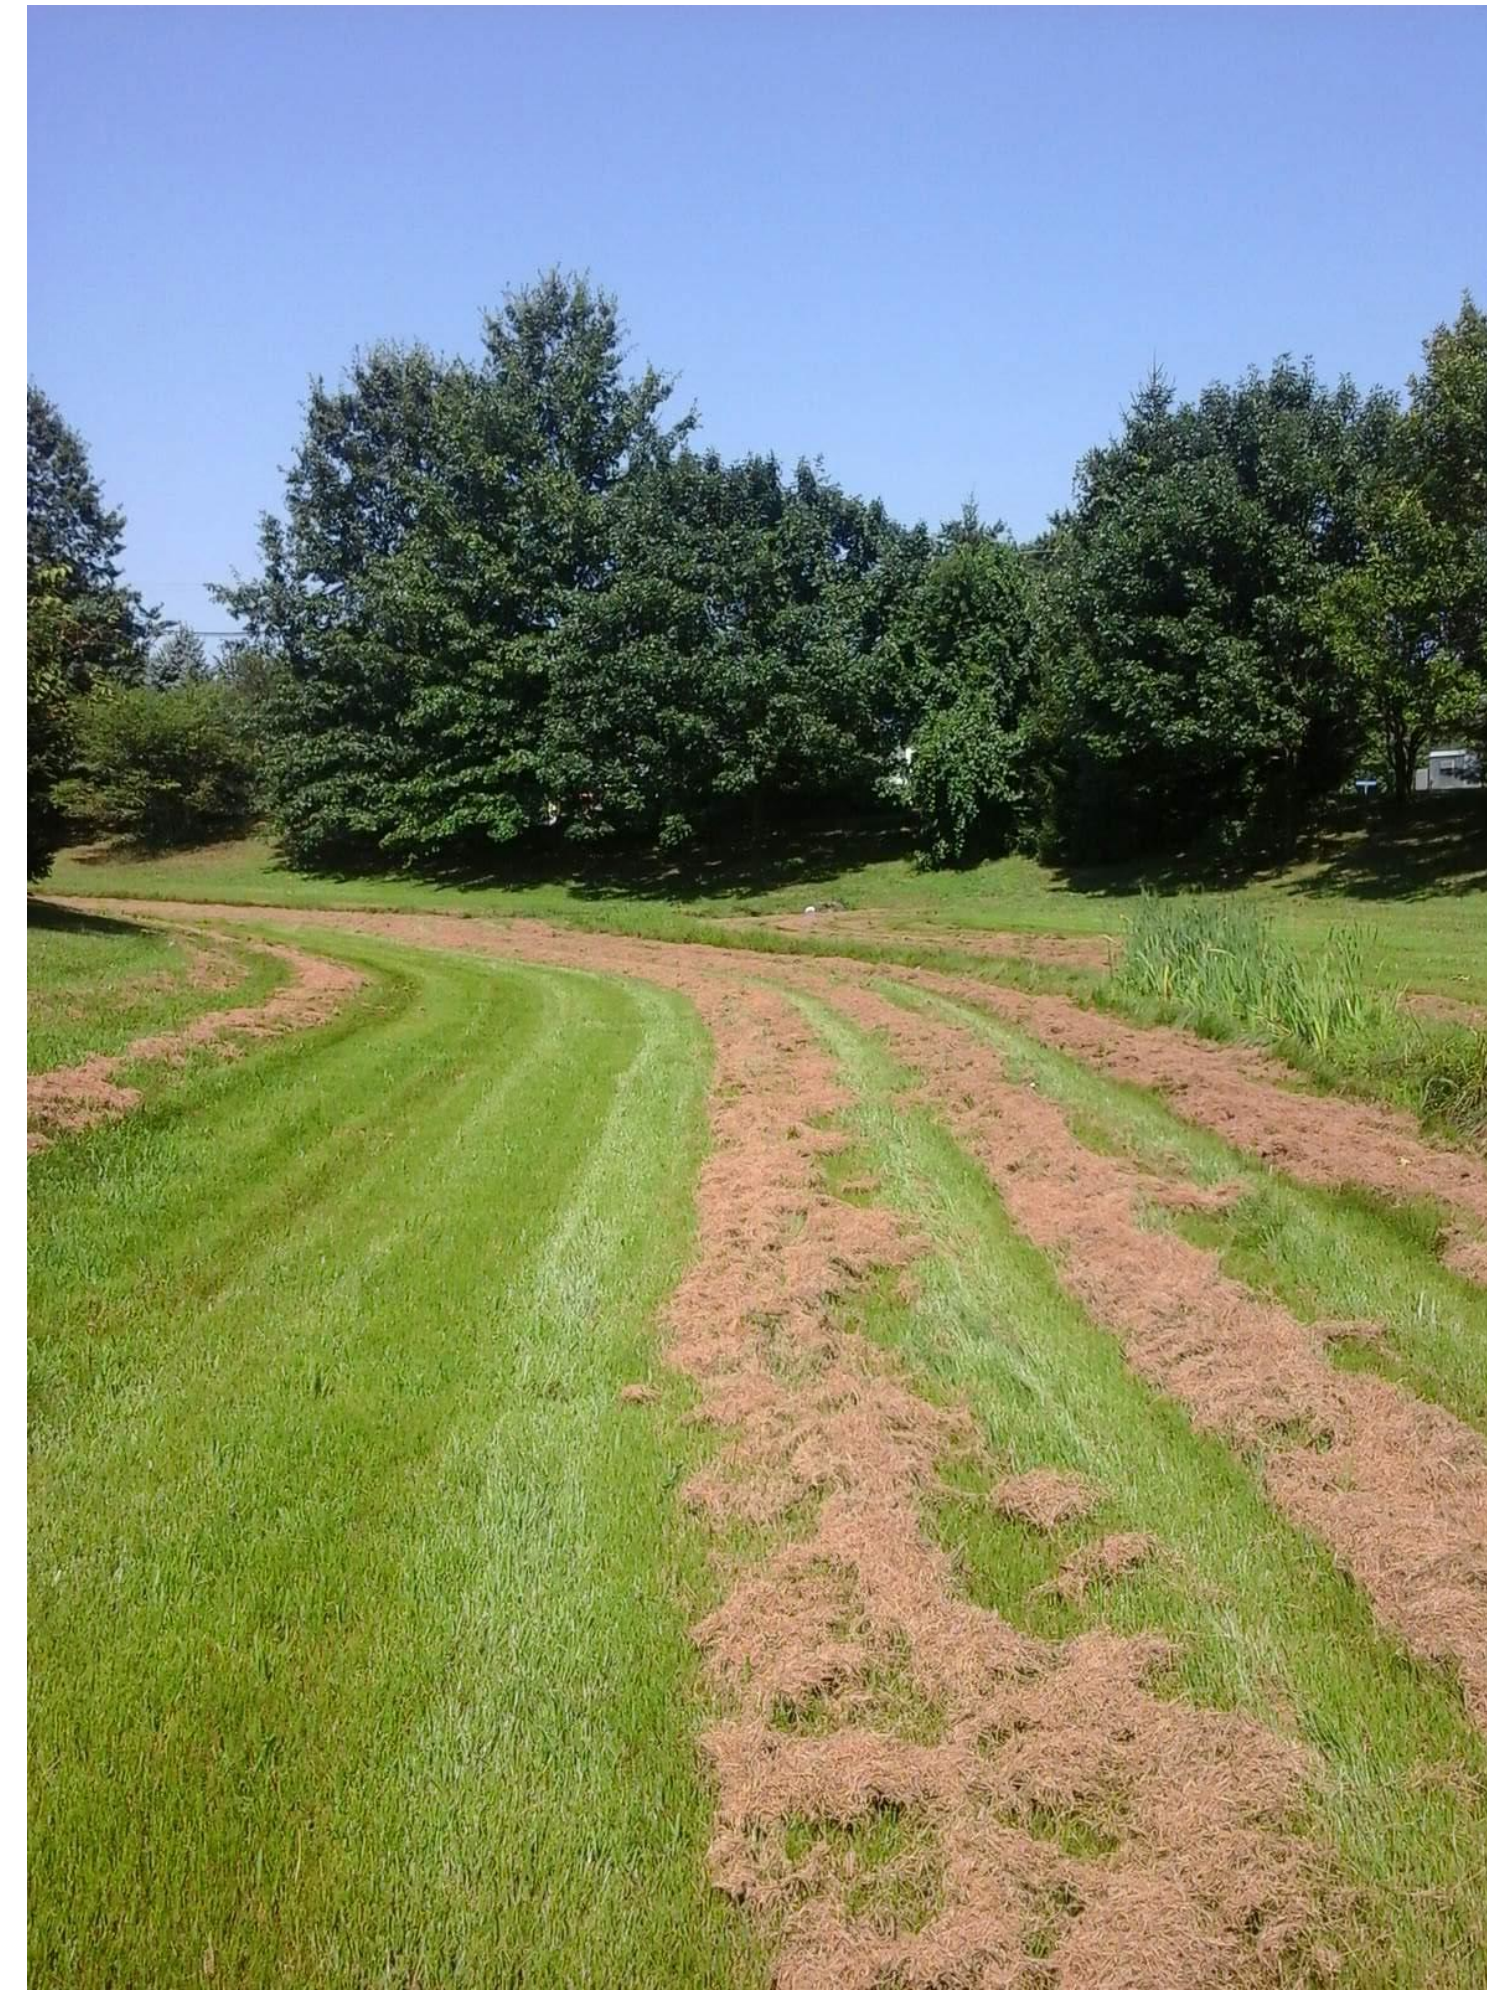
Inlet vegetation and overview of Basin #329

- Sediment accumulation at outlets and in low flow channels for both basins
- Vegetation overgrowth at Basin #329
- Reduce mowing and establish meadows to improve infiltration

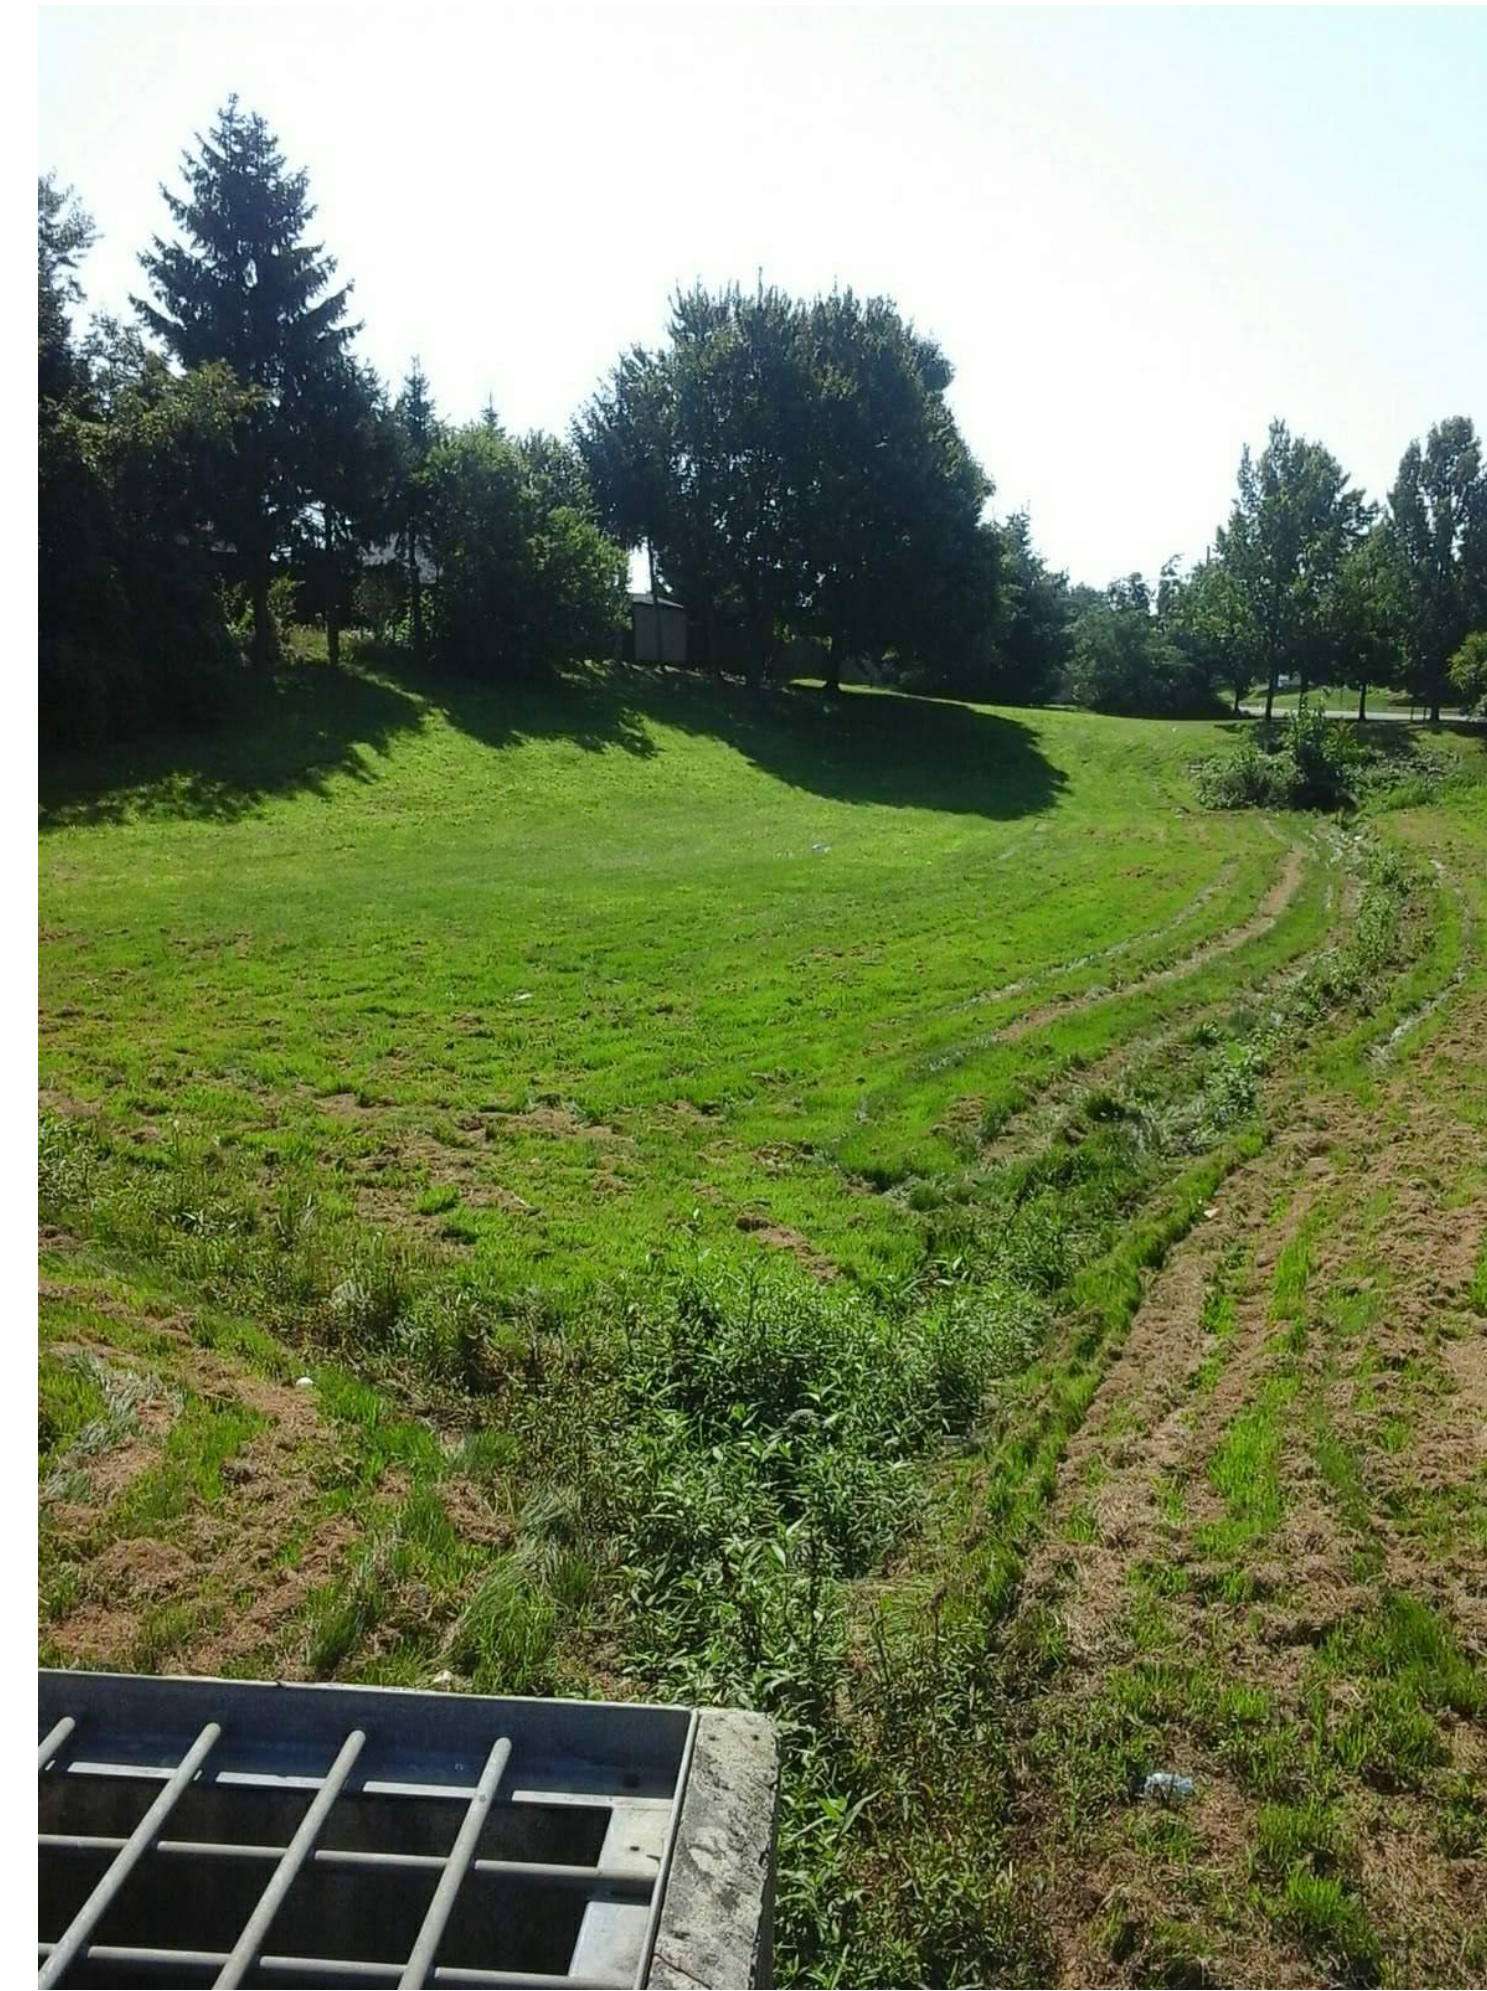
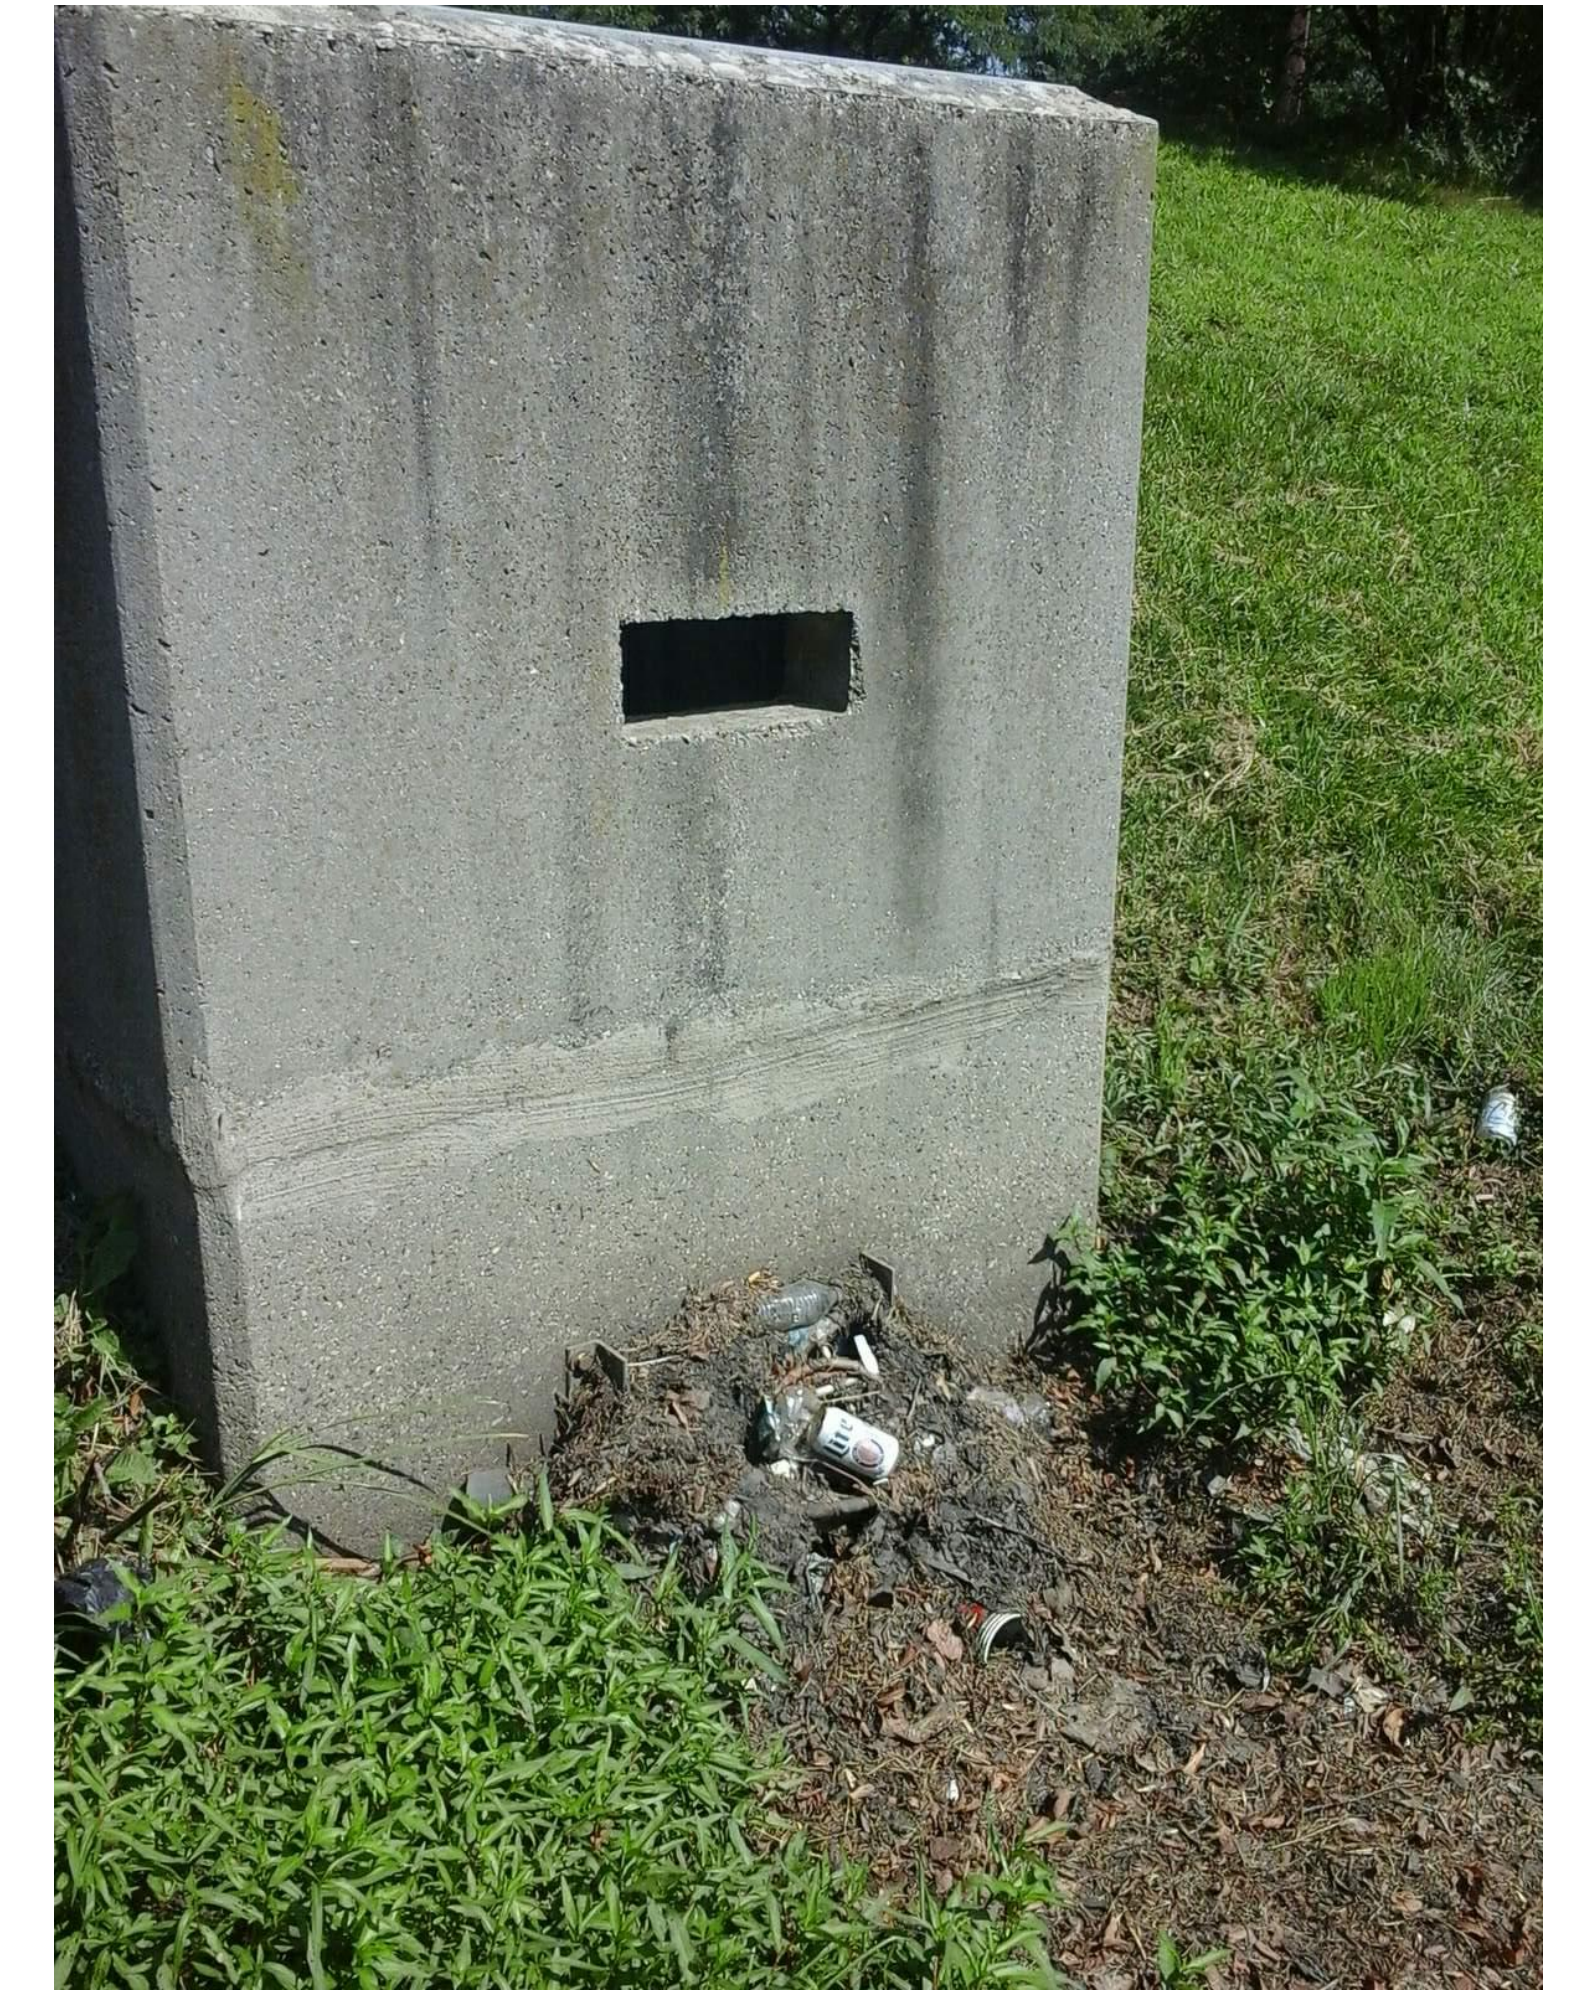
Overview of Basin #330 and basin outlet

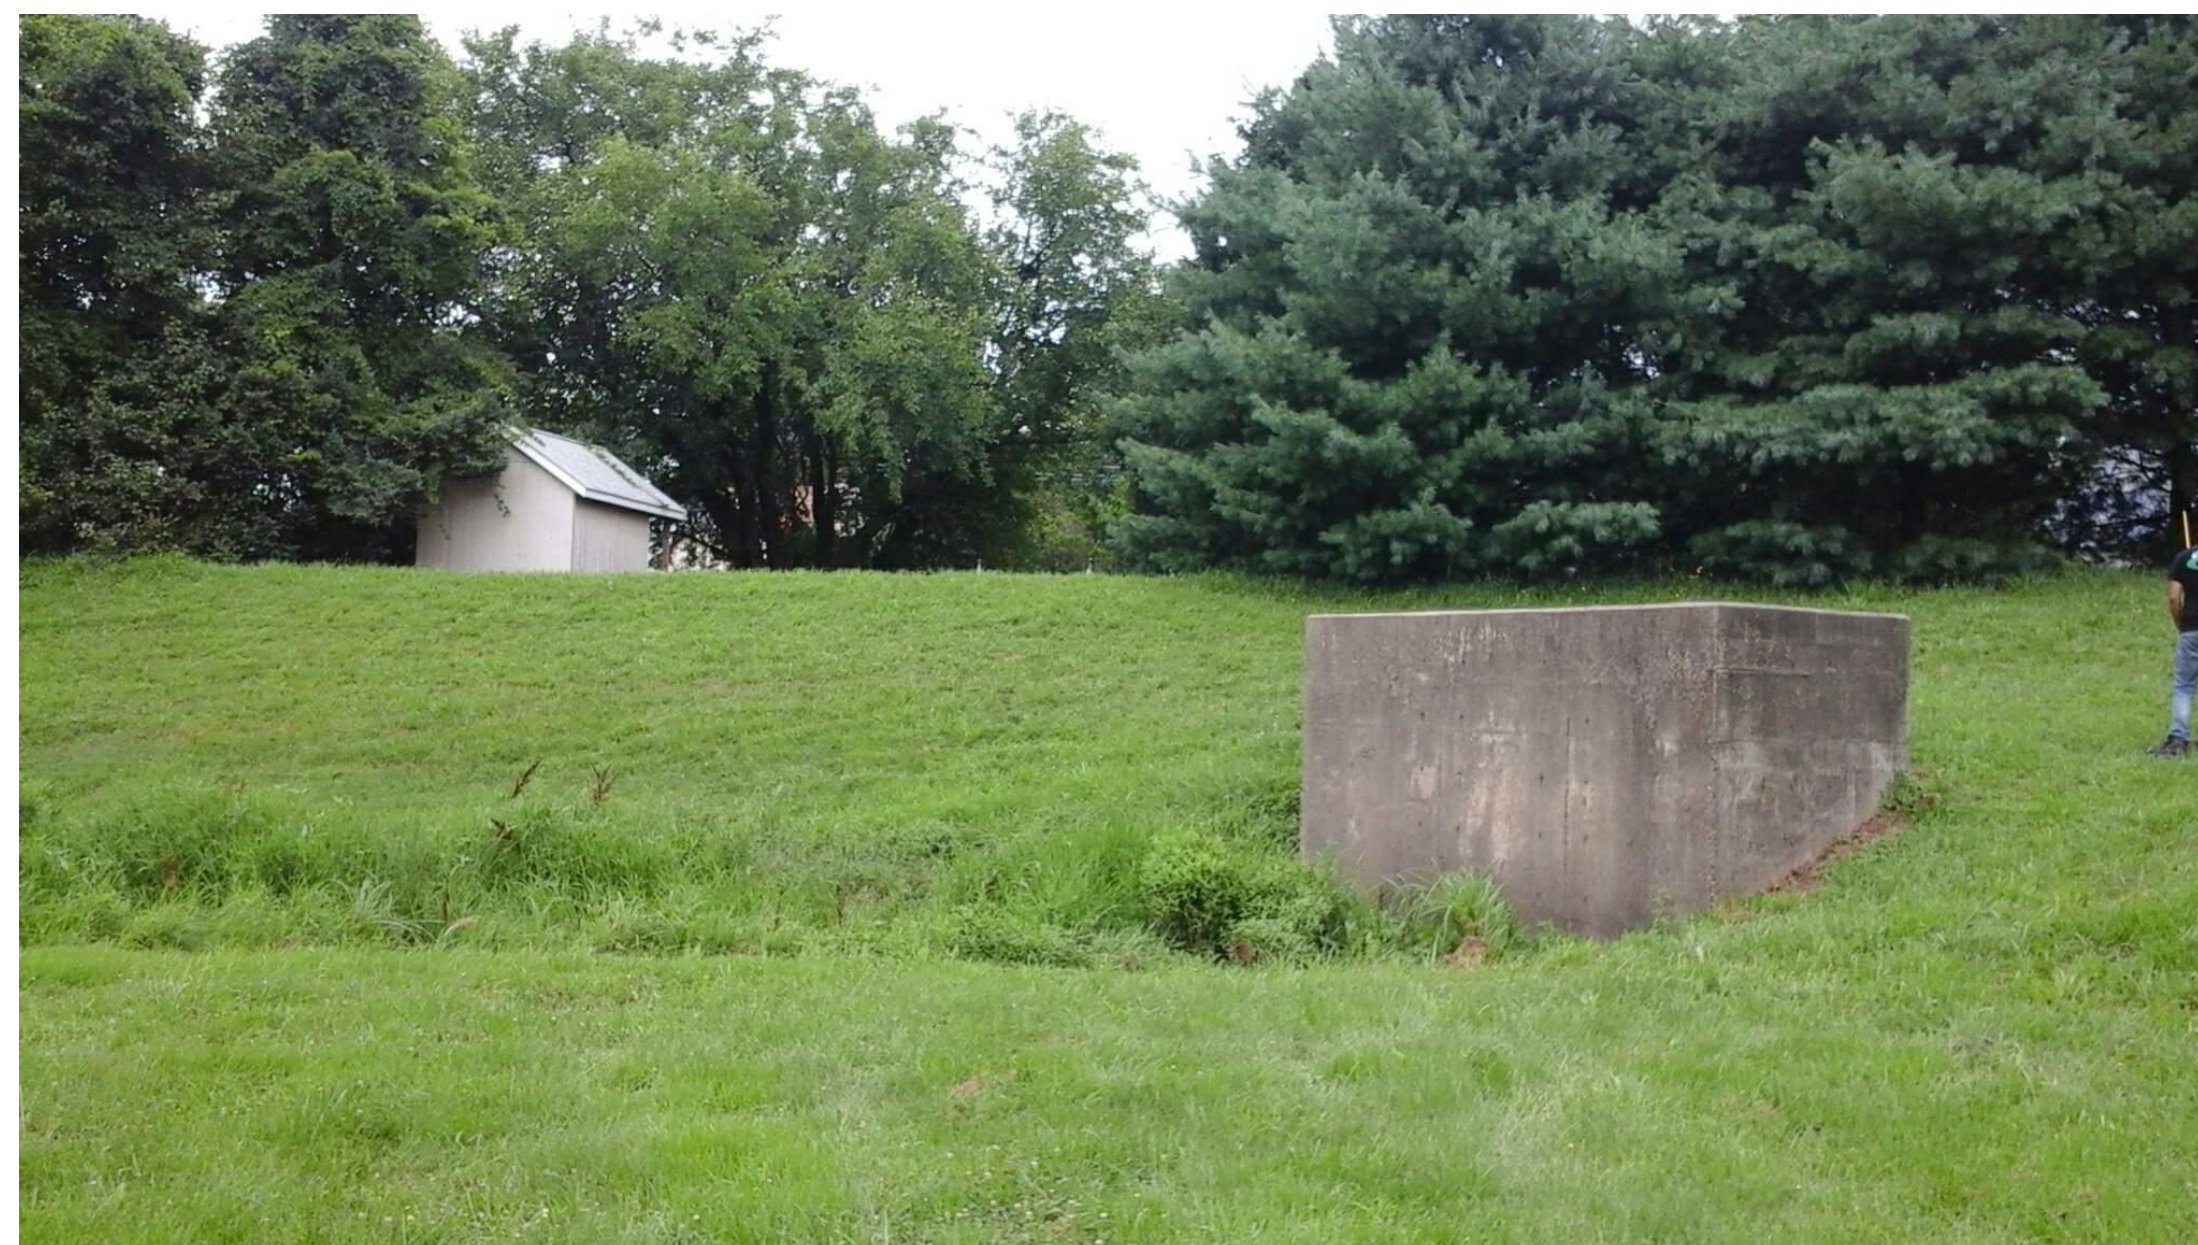
Outlet structure

- Large vegetation growth around the channels. Large plants such as cat tails and lavender
- Make sure inflow and outflow areas are not too restricted by vegetation
- Low flow channel should be removed for proper naturalization to allow water to infiltrate
- Allow rest of basin to naturalize by converting to meadow by reducing mowing

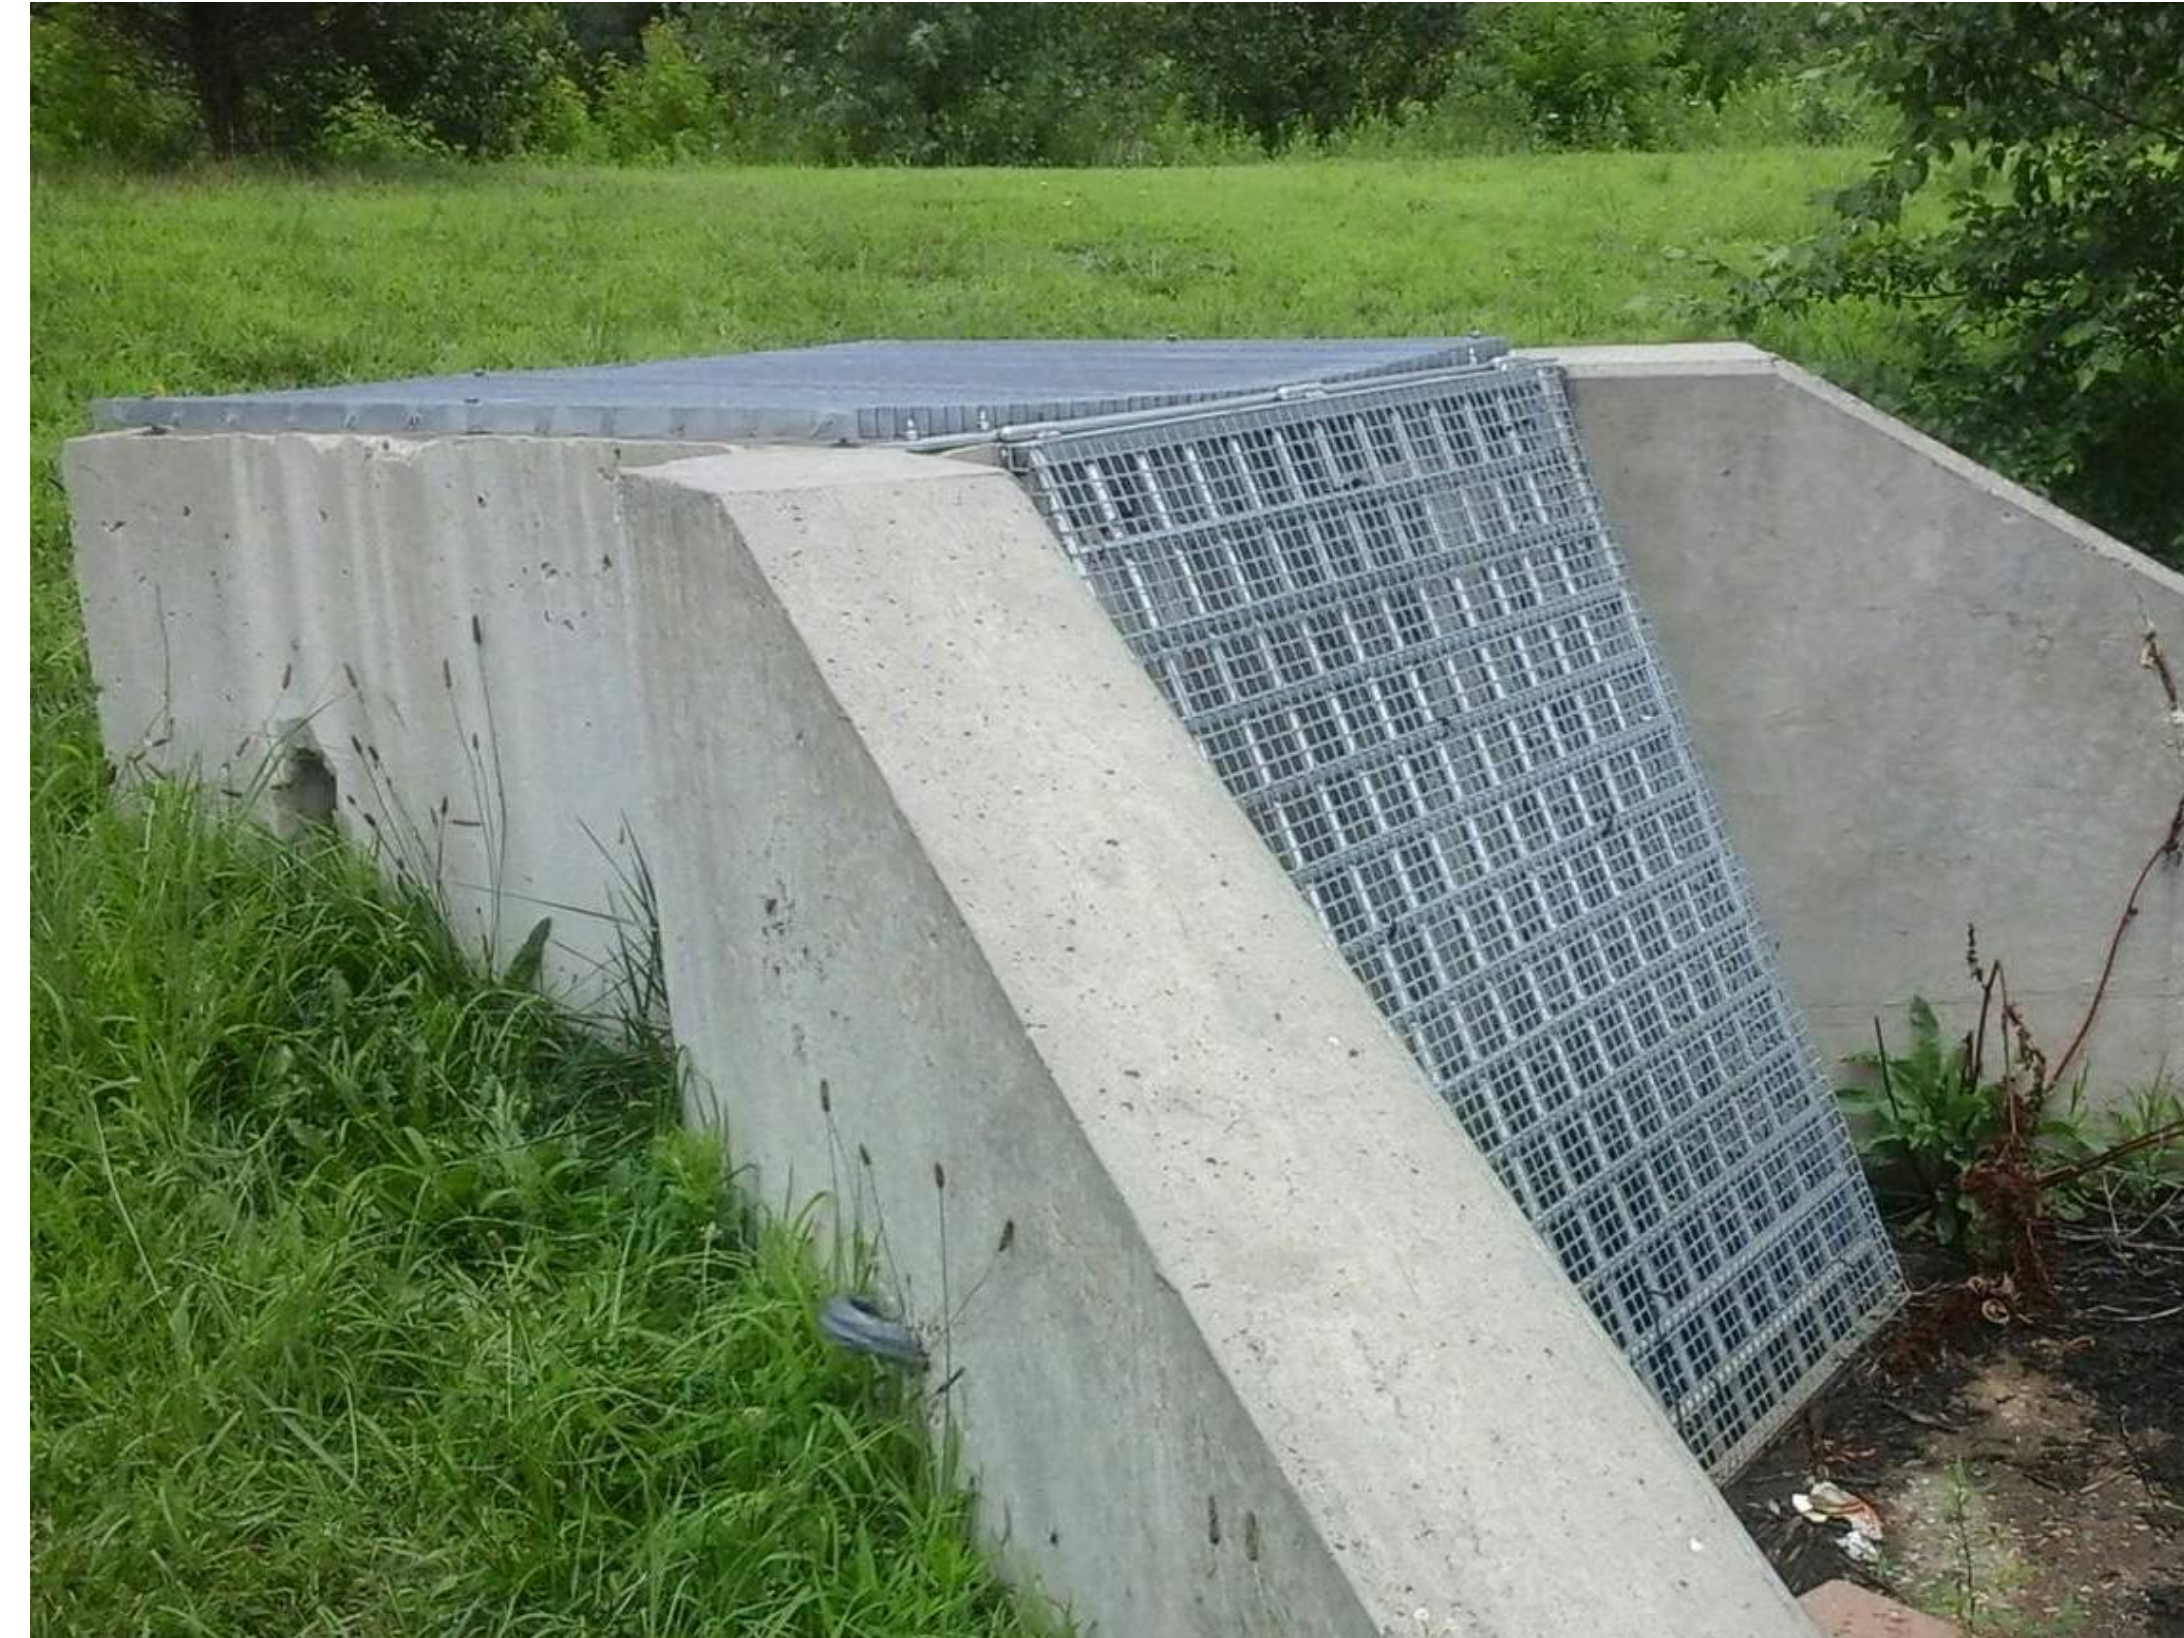
Outlet structure

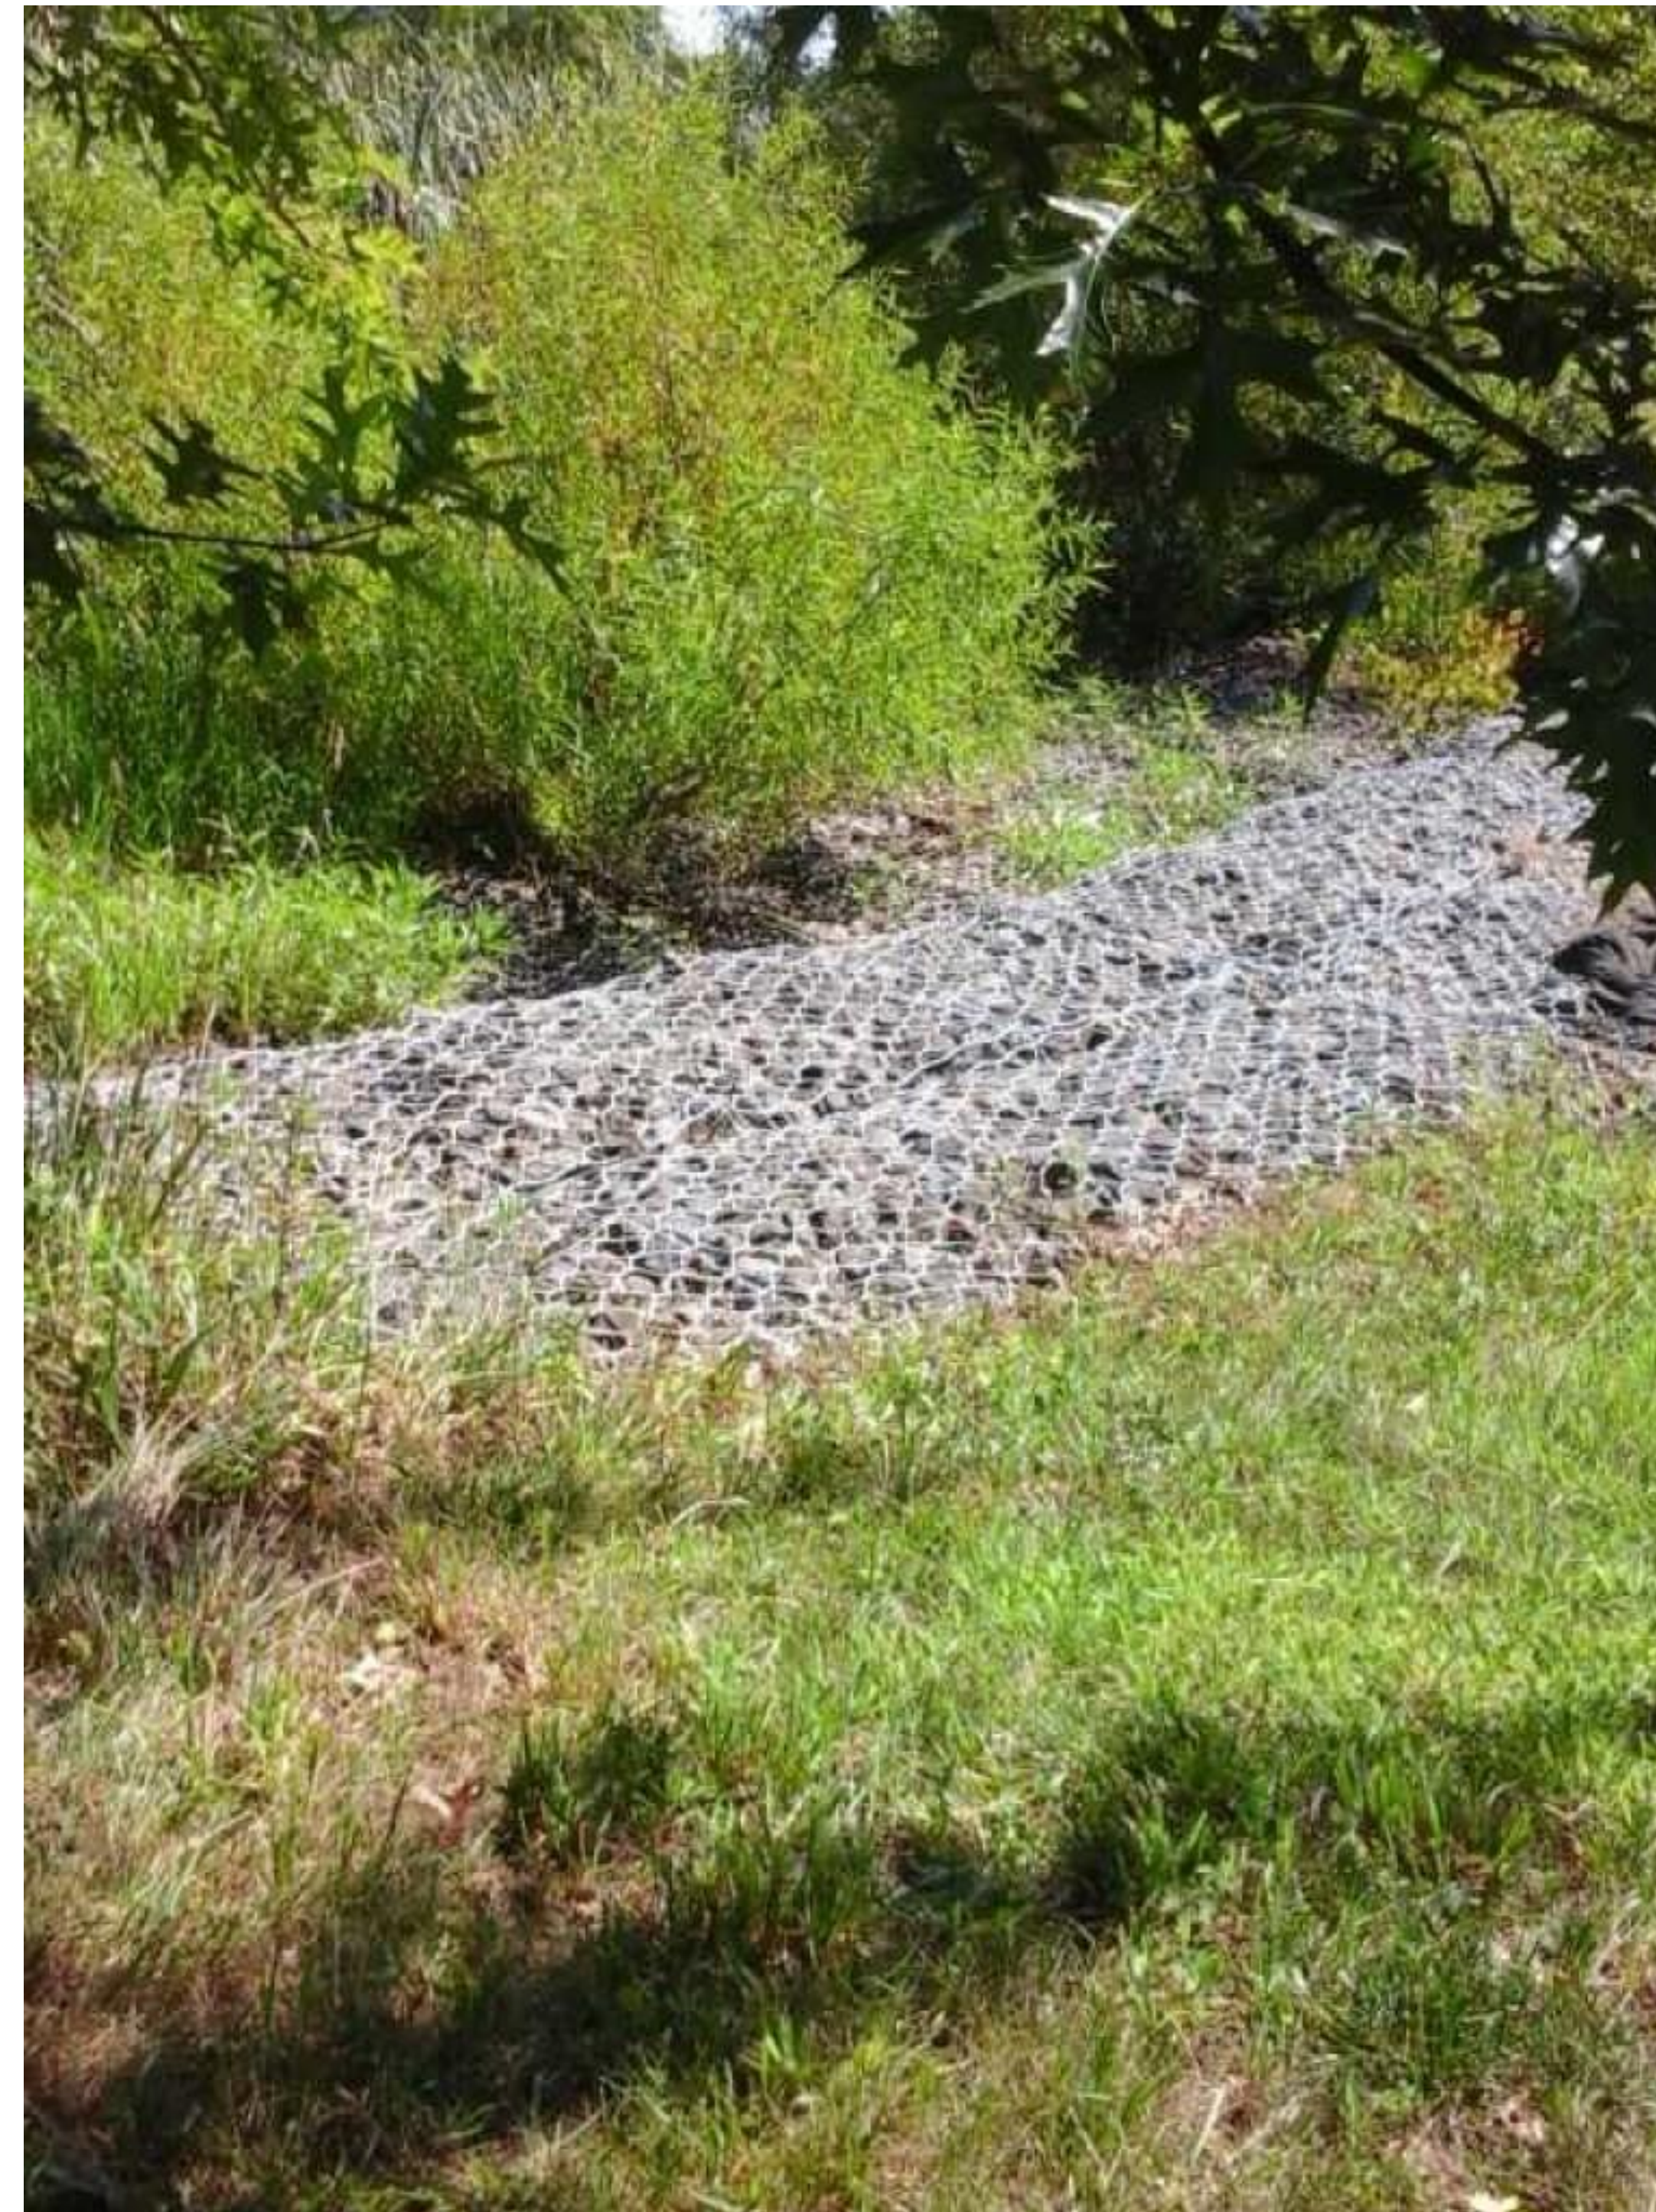
- Well establish retention basin with a fountain
- Maintain adequate mowing (up to property lines, had a complaint township is not mowing from nearby home owners)
