**Hamilton Township (Mercer County)
Stormwater Basin Assessment Summary
Hamilton Owned Addendum (Year 5A)**

Developed by the Rutgers Cooperative Extension Water Resources Program
Funded by Hamilton Township, Mercer County, New Jersey

November 27, 2019

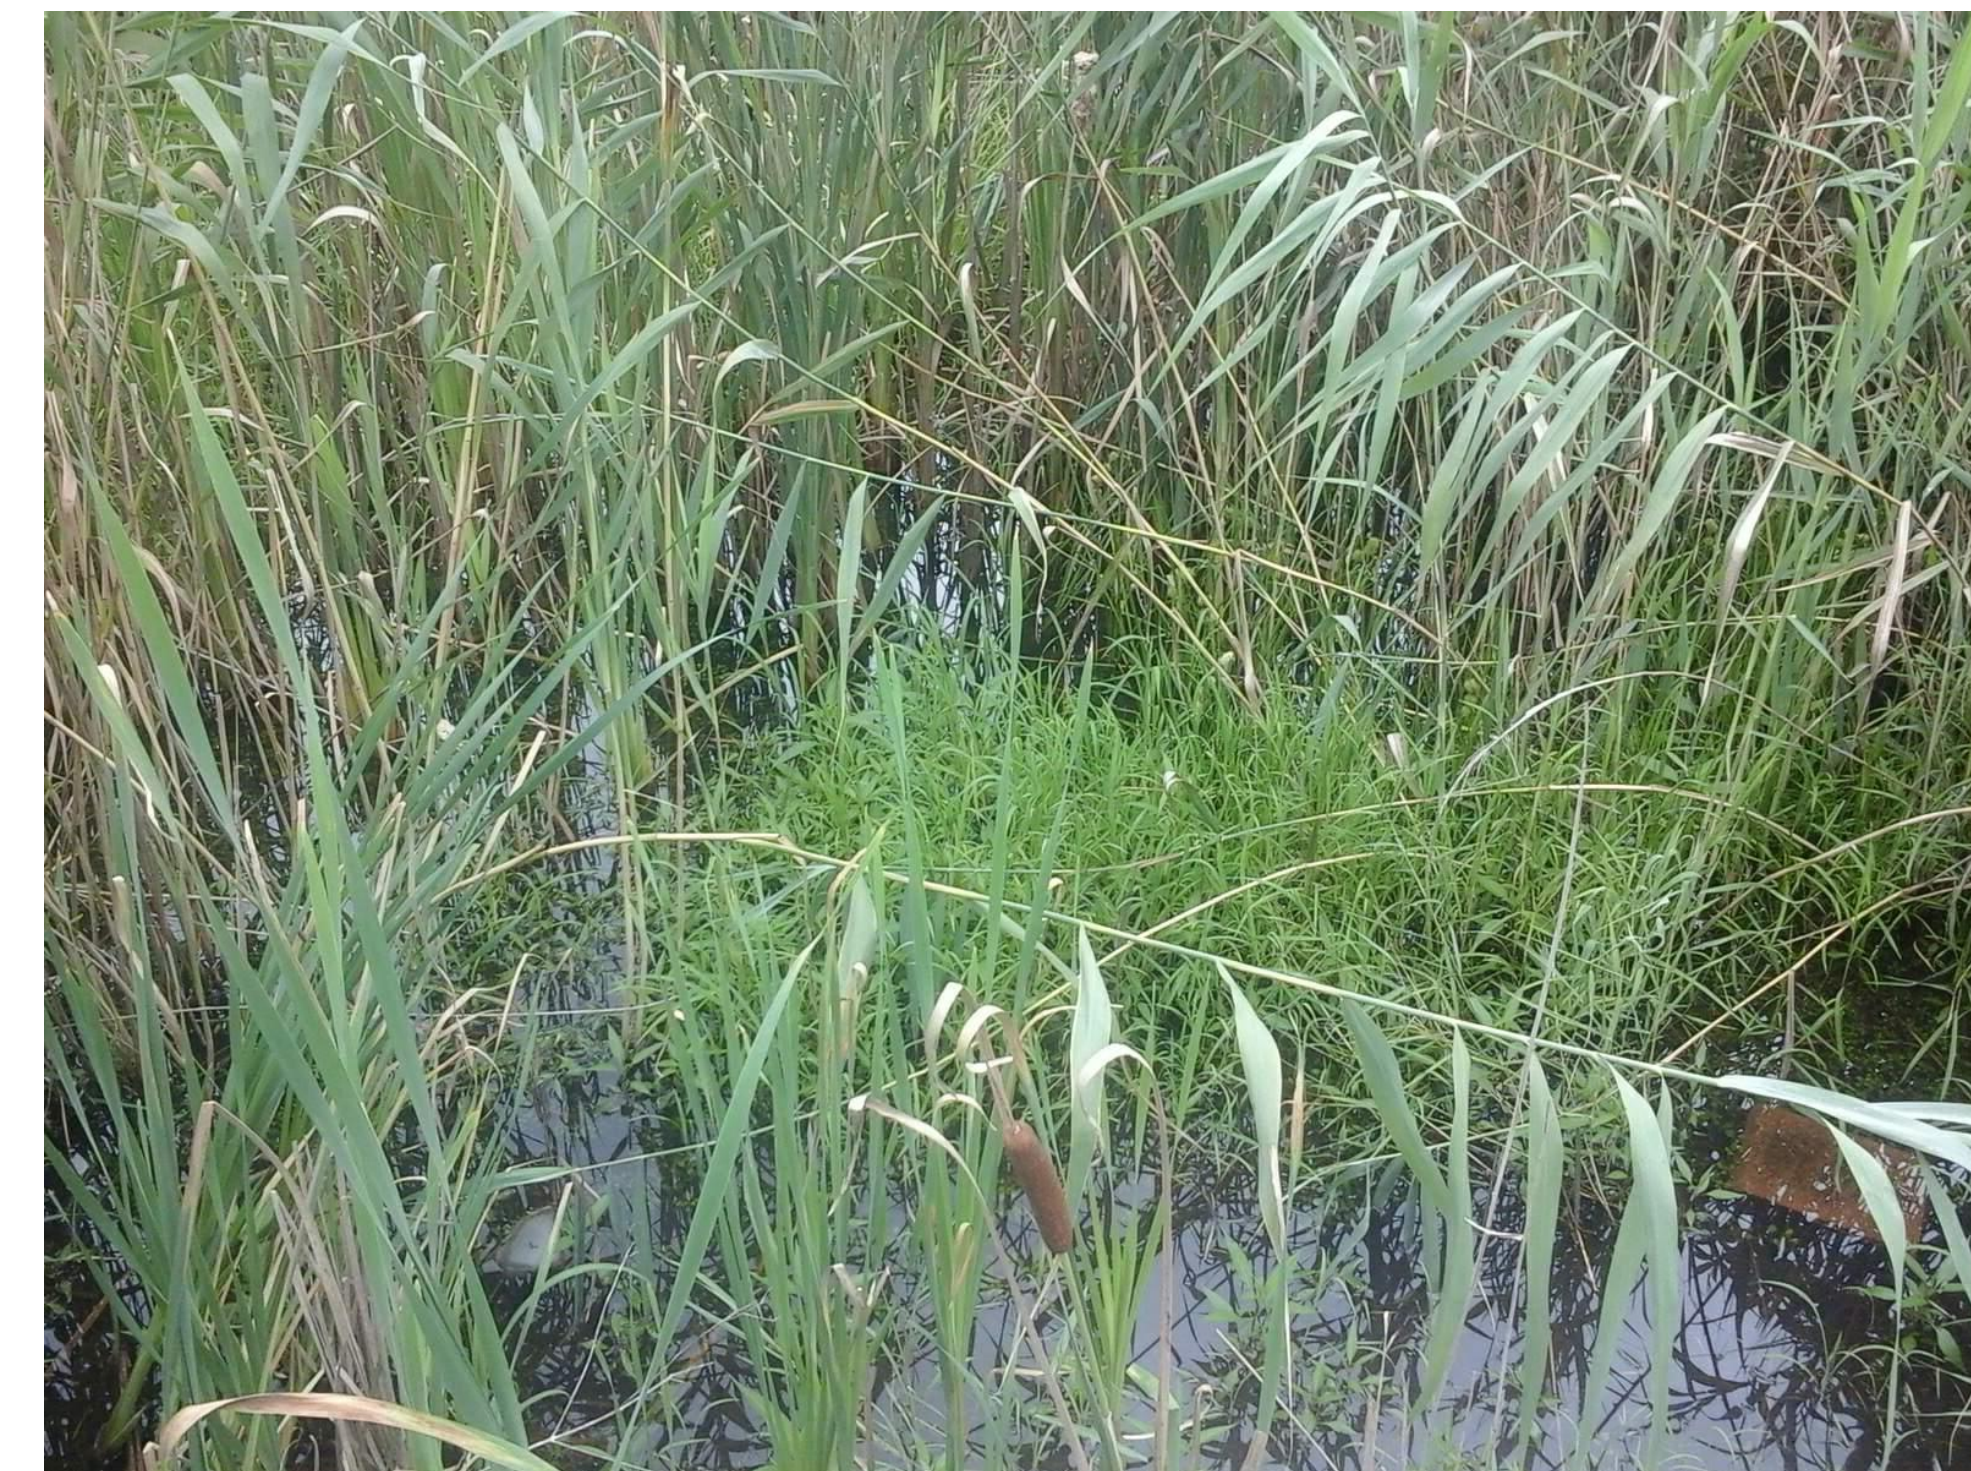
- Invasive phragmites growing in retention pond
- Otherwise well maintained

Invasive vegetation growth

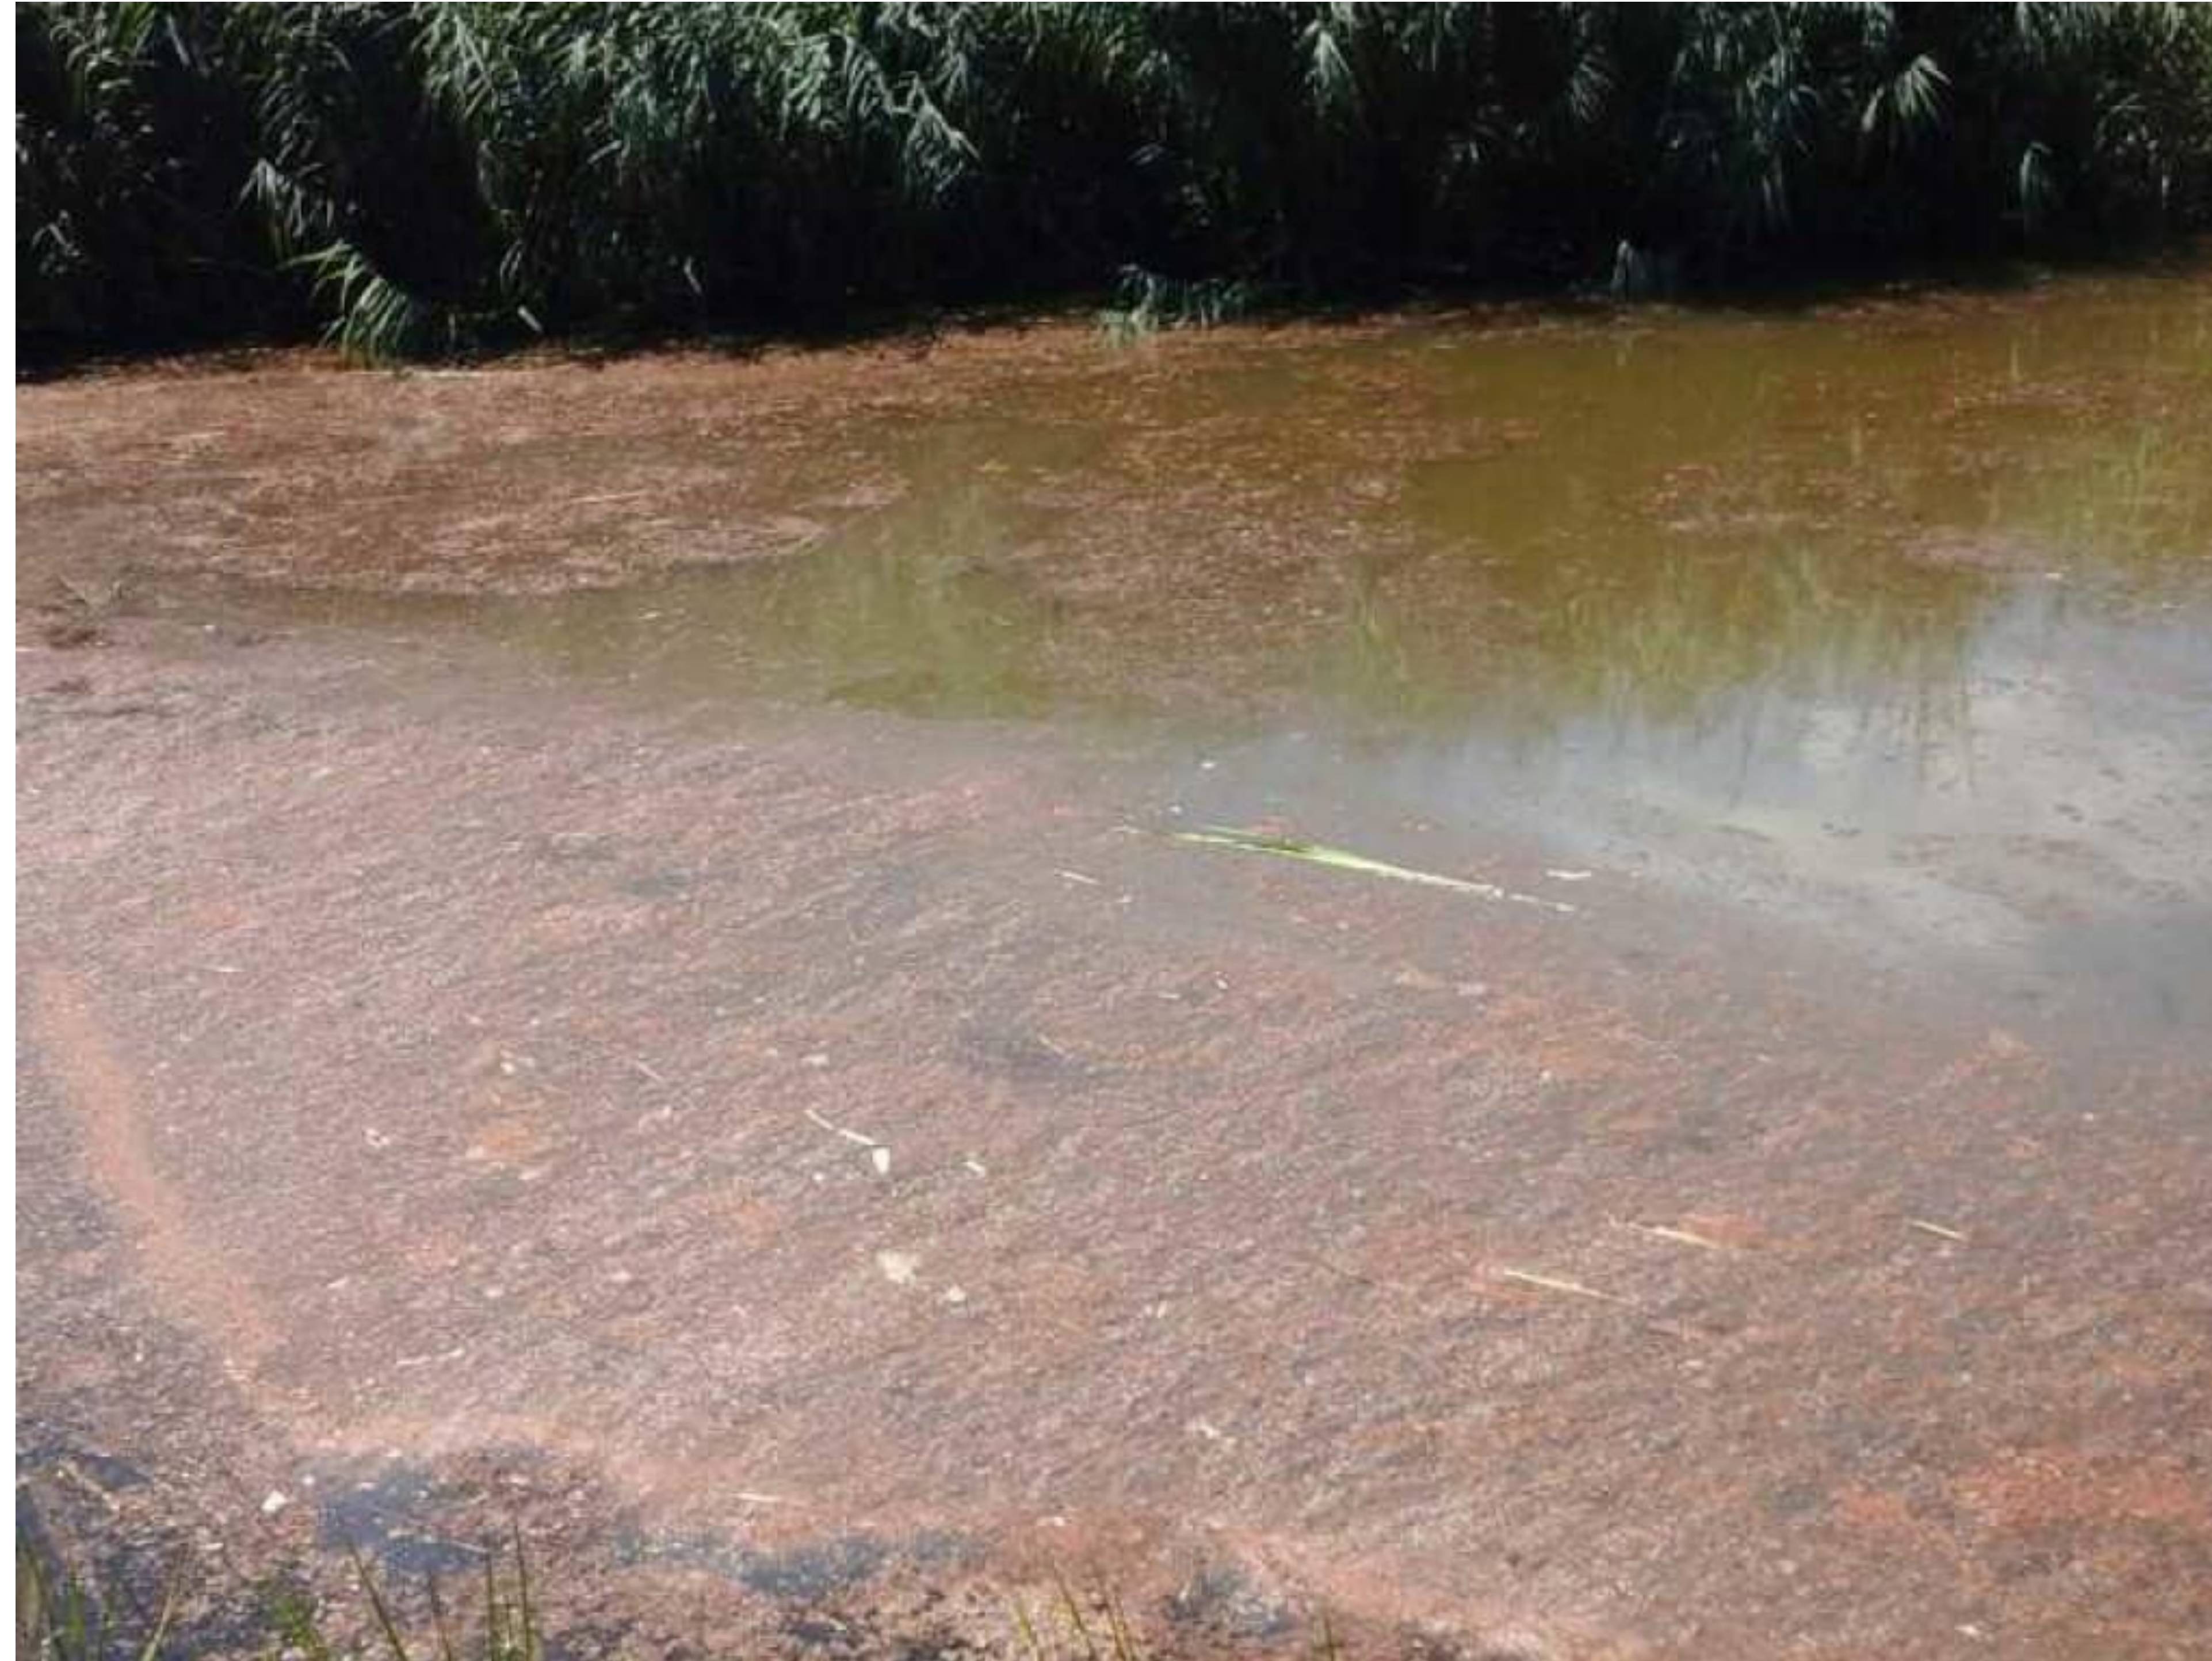
- Well established retention basin, water seems fairly stagnant
- Fountain could be installed to help with stagnant water issue
- Maintain adequate mowing around basins

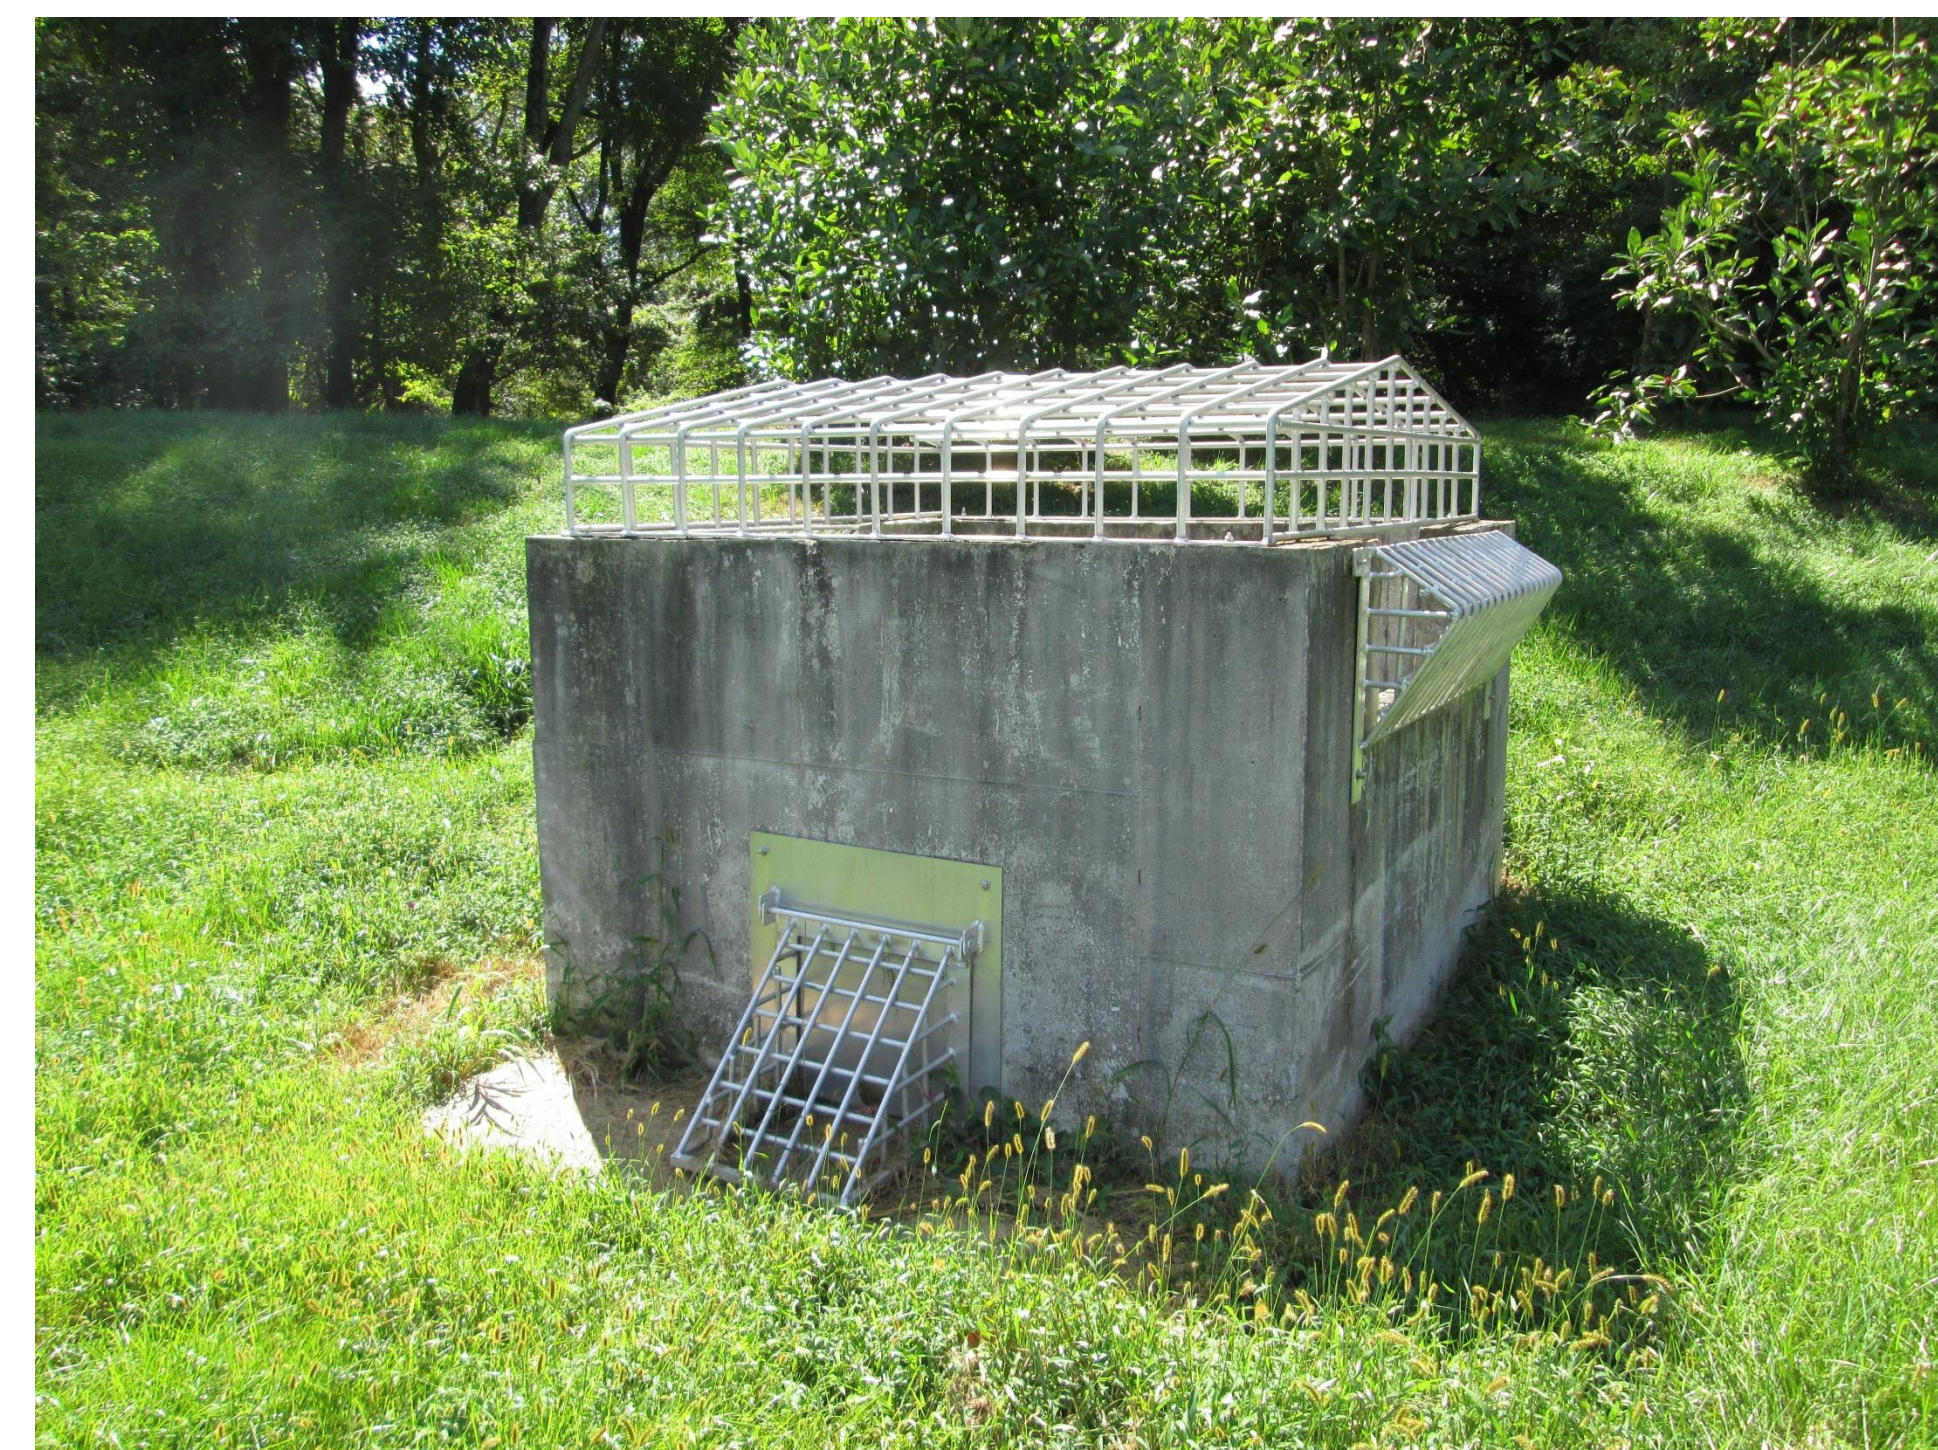
Outlet
