**Hamilton Township (Mercer County)
Stormwater Basin Assessment Summary
Addendum (Year 3)**

Developed by the Rutgers Cooperative Extension Water Resources Program
Funded by Hamilton Township, Mercer County, New Jersey

September 30, 2014

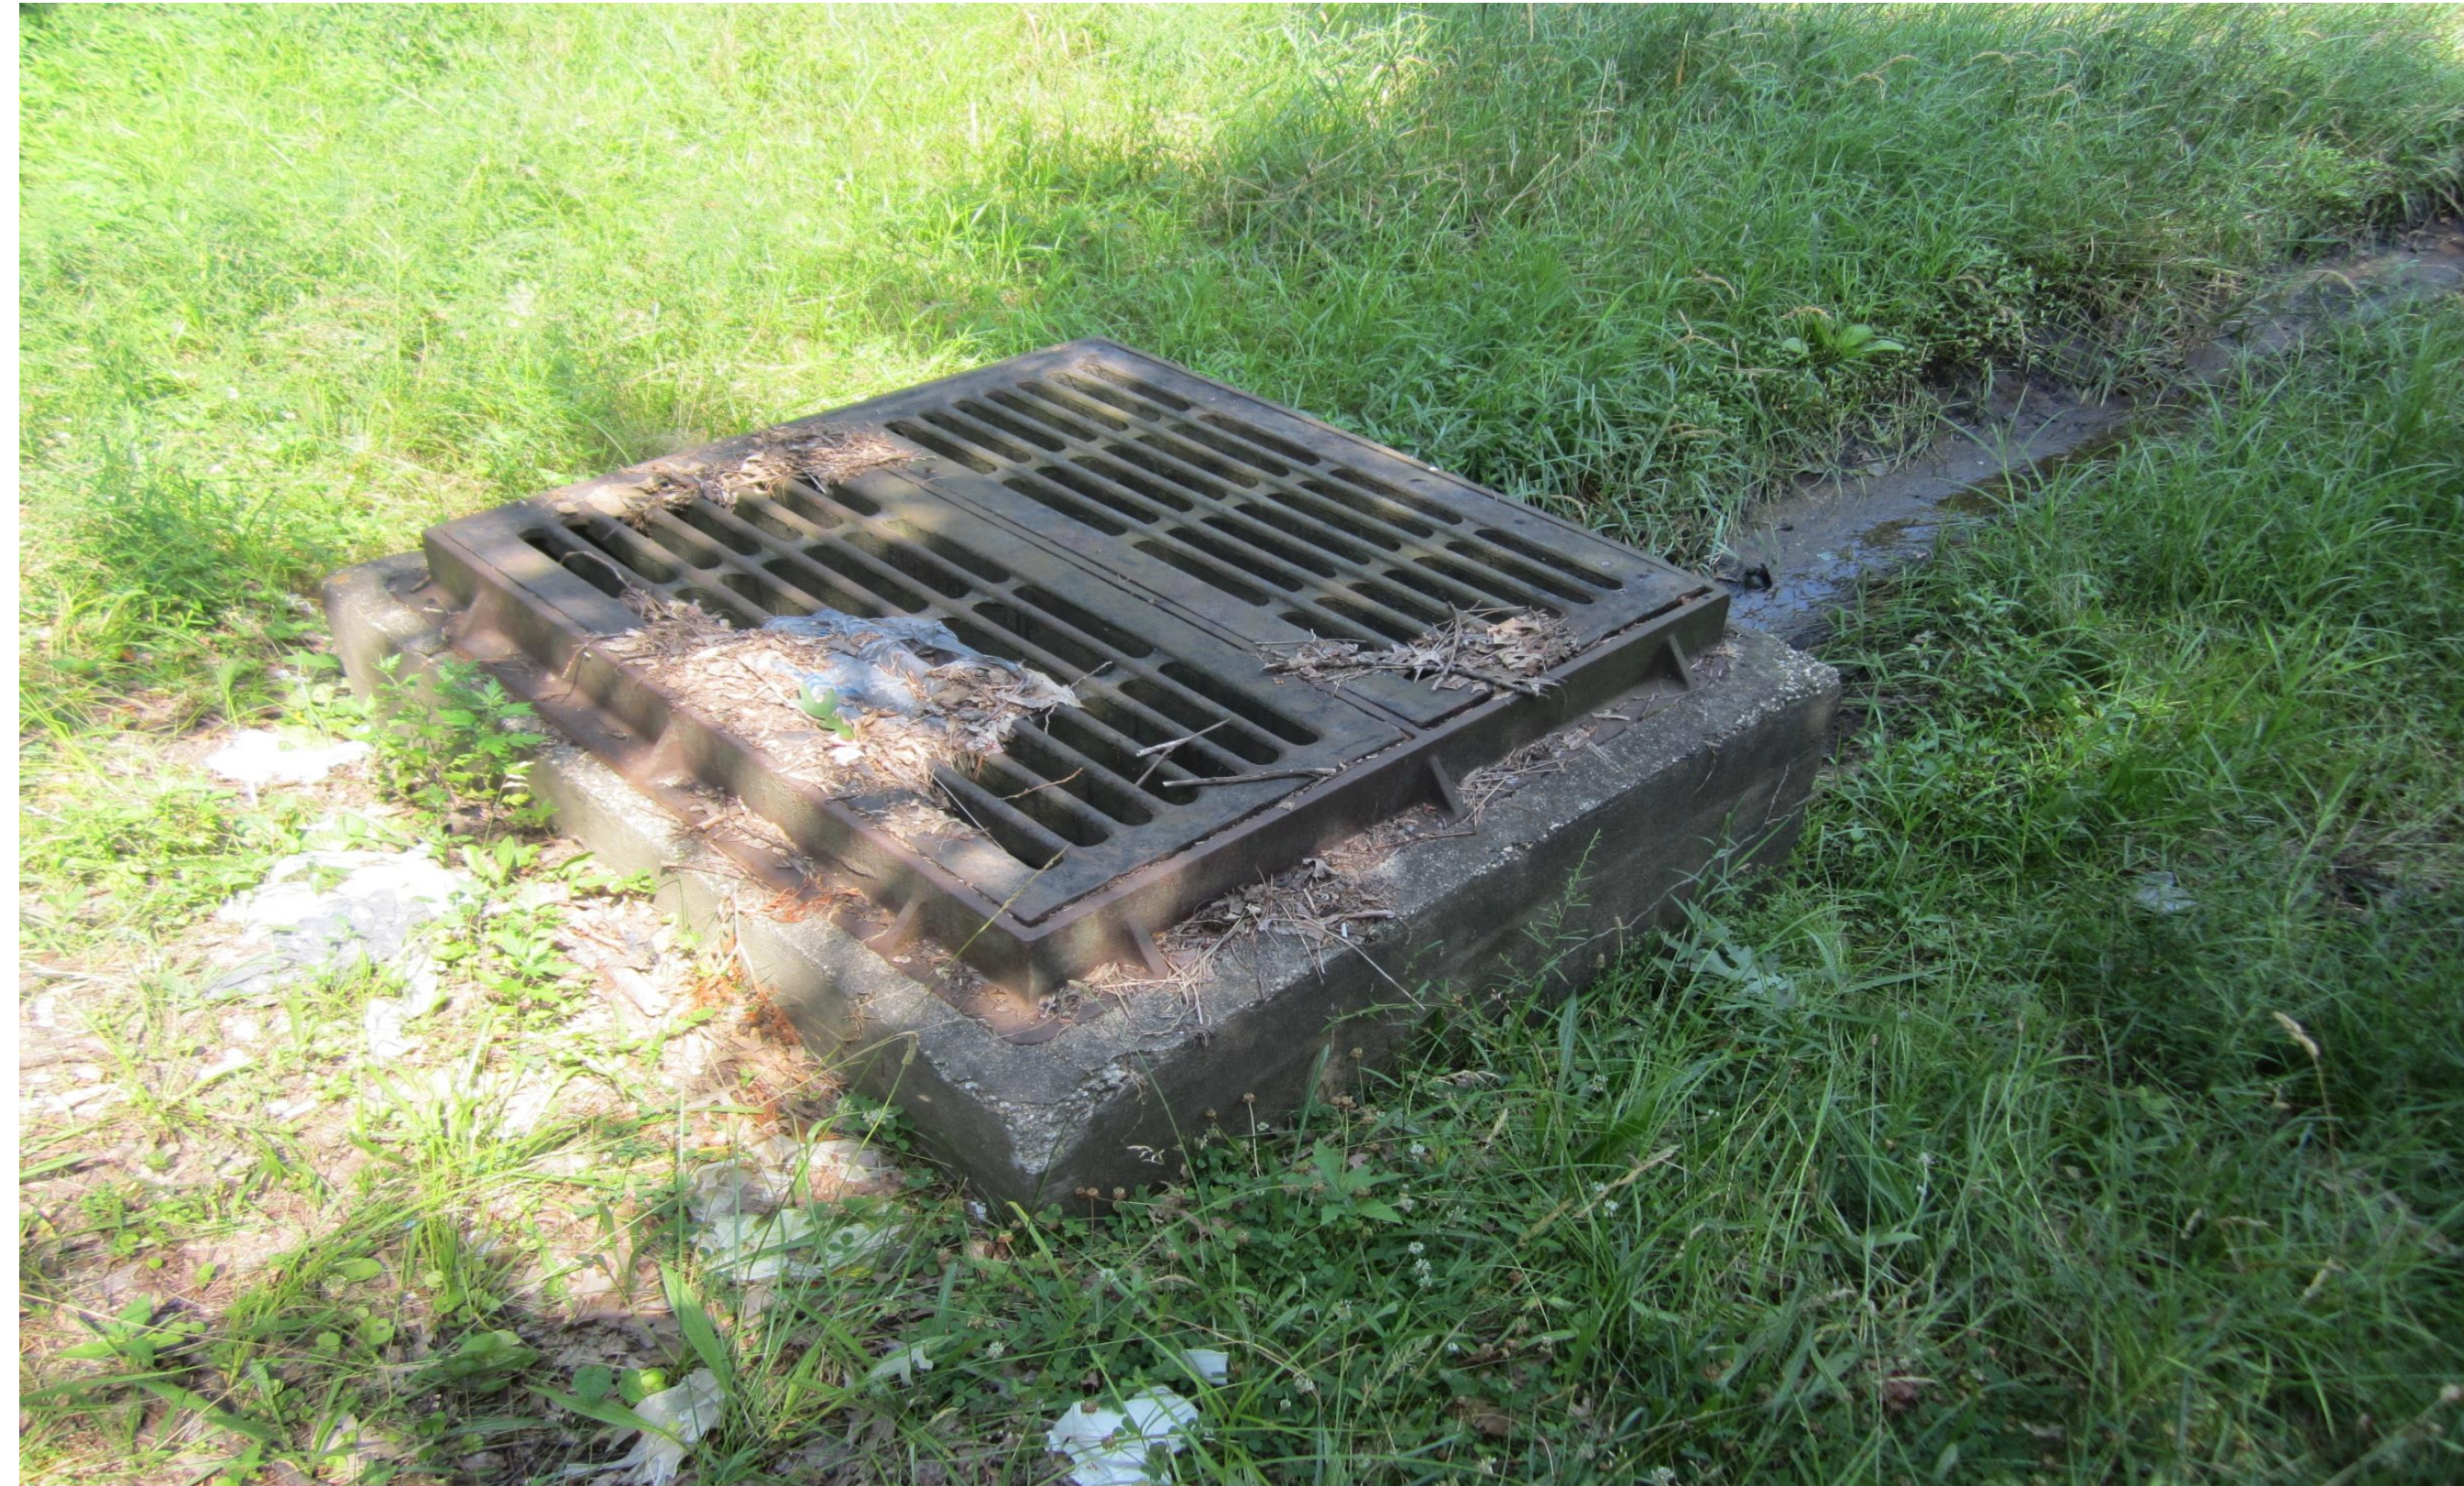
Outlet

- Standing water and sediment in basin bottom and low flow channel
- Basin appears to be treated as infiltration basin
- Naturalized basin bottom

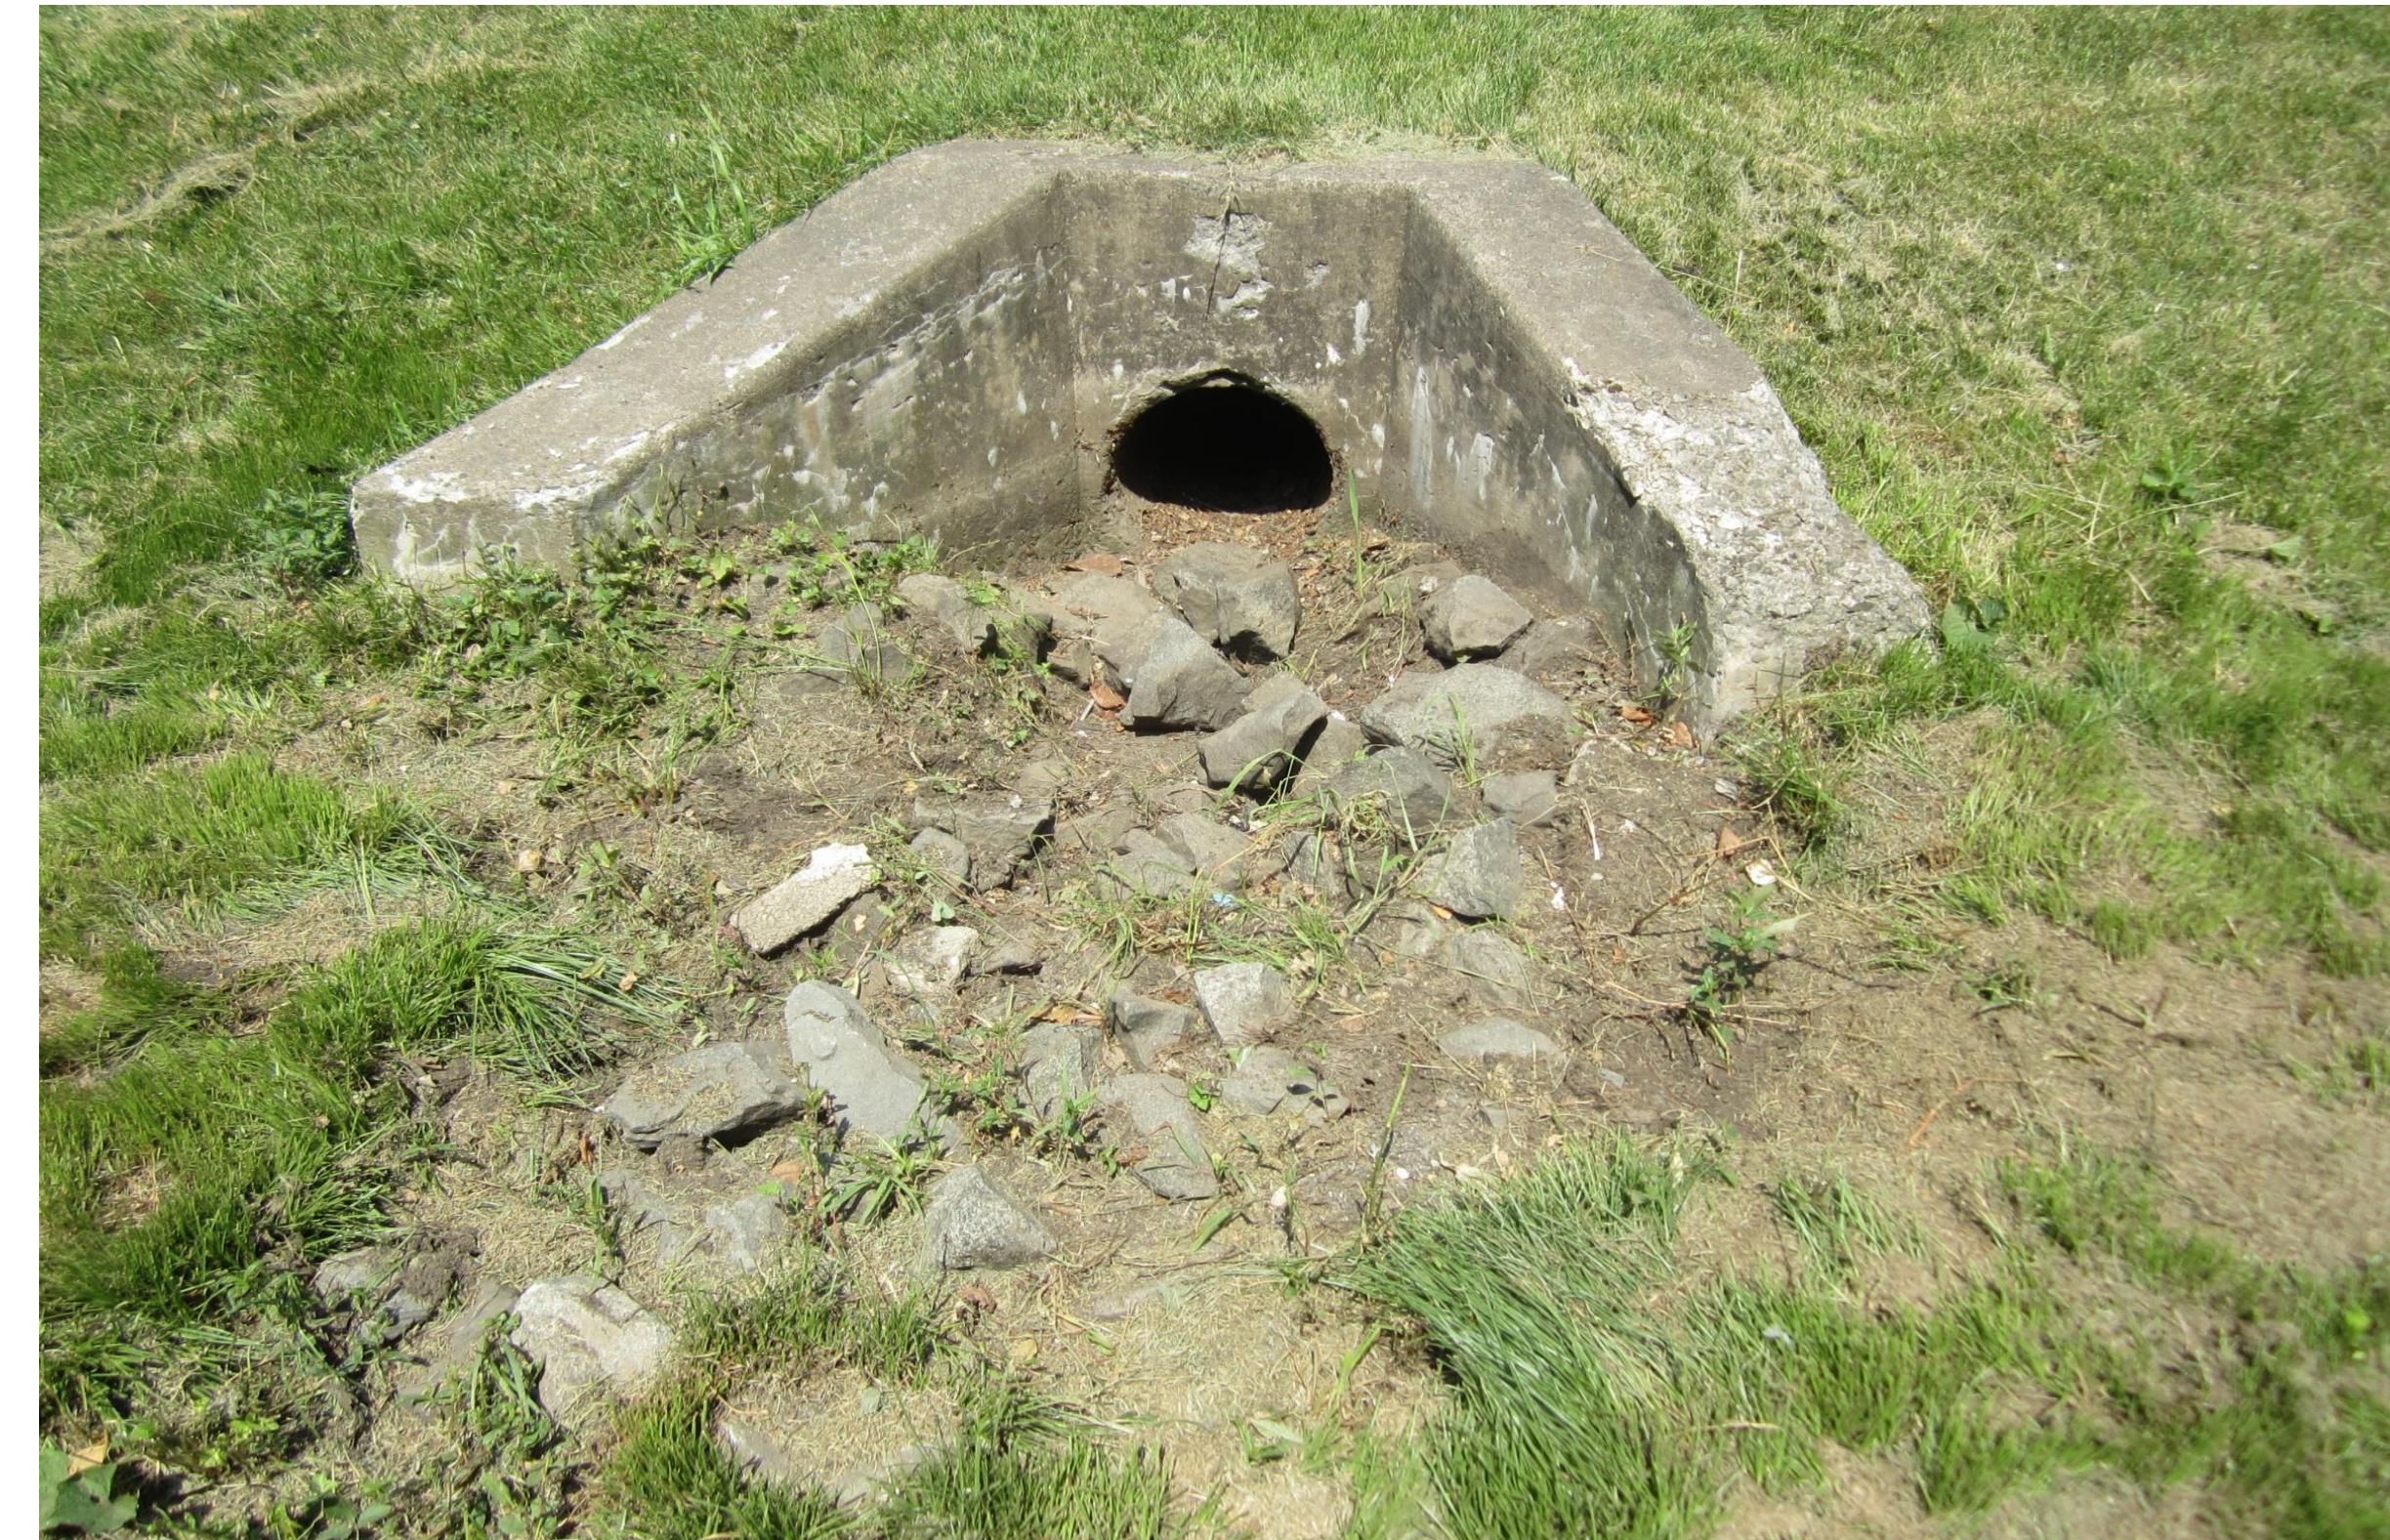
Inlet

- Riprap around inlet and outlet
- No low flow channel
- Appears to be infiltration basin
- Emergency spillway directed to local stream
- Exposed earth near basin inlet and center

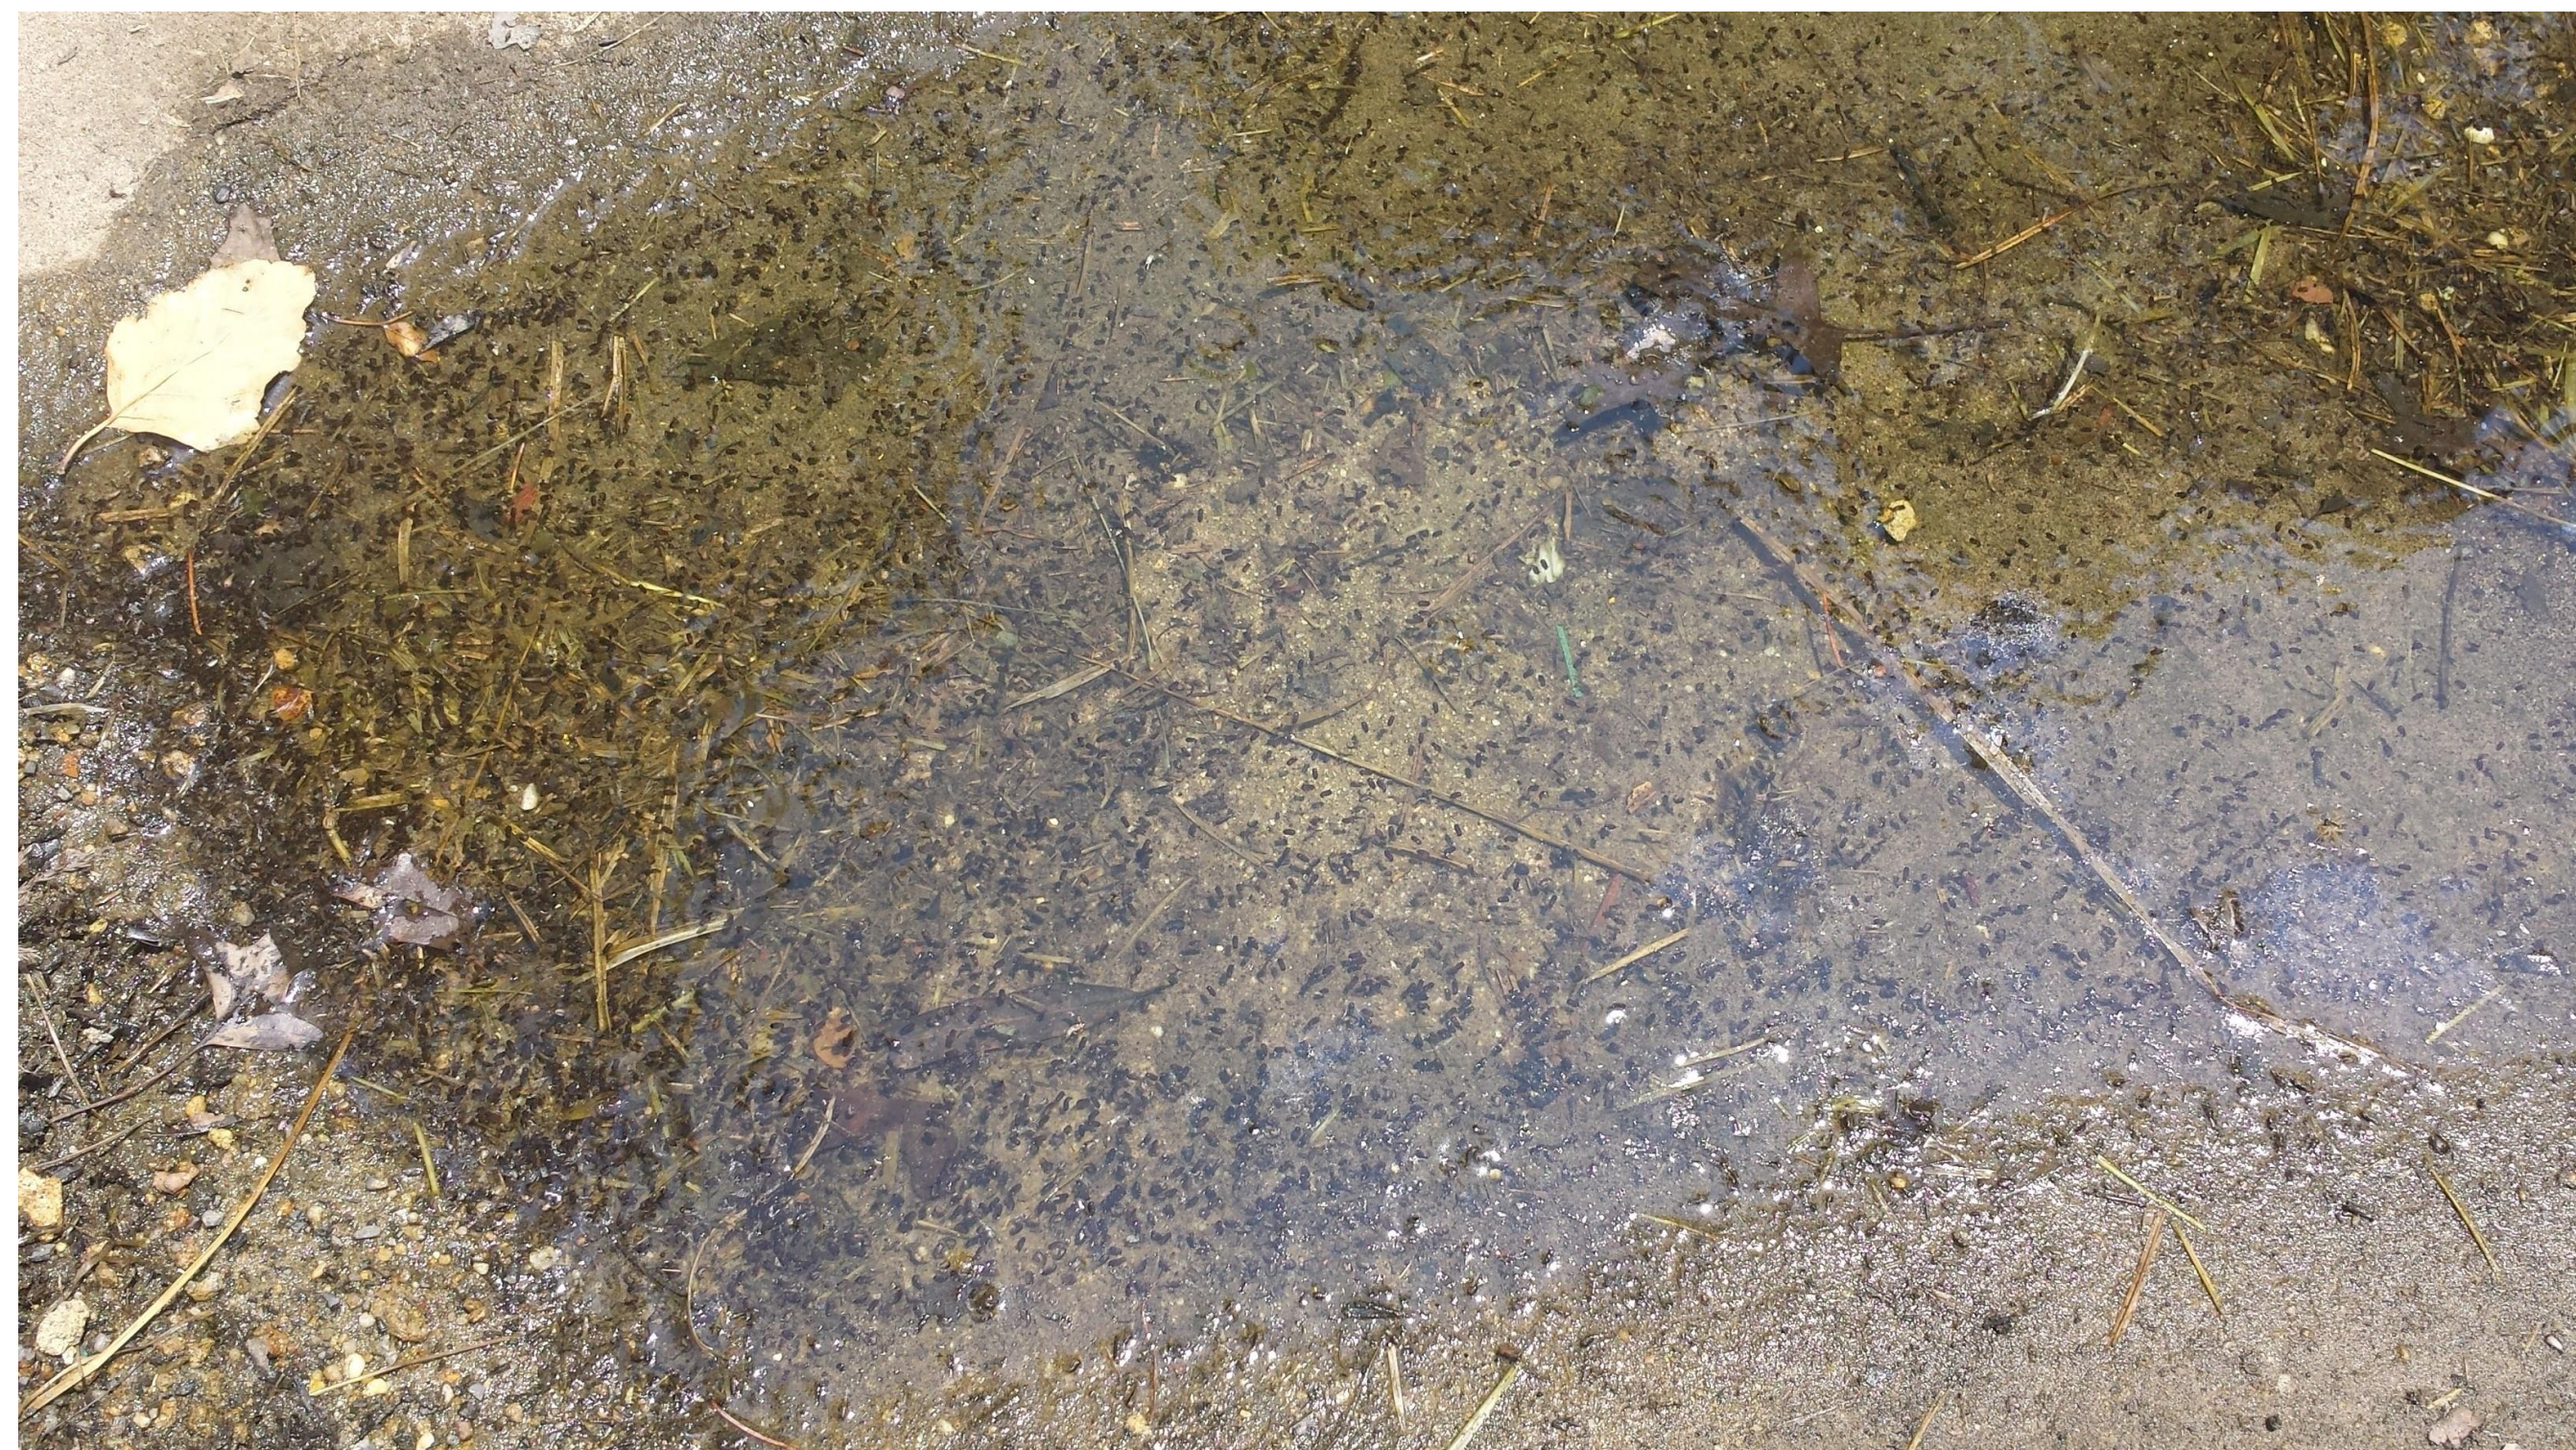
Mosquito larvae in low flow channel

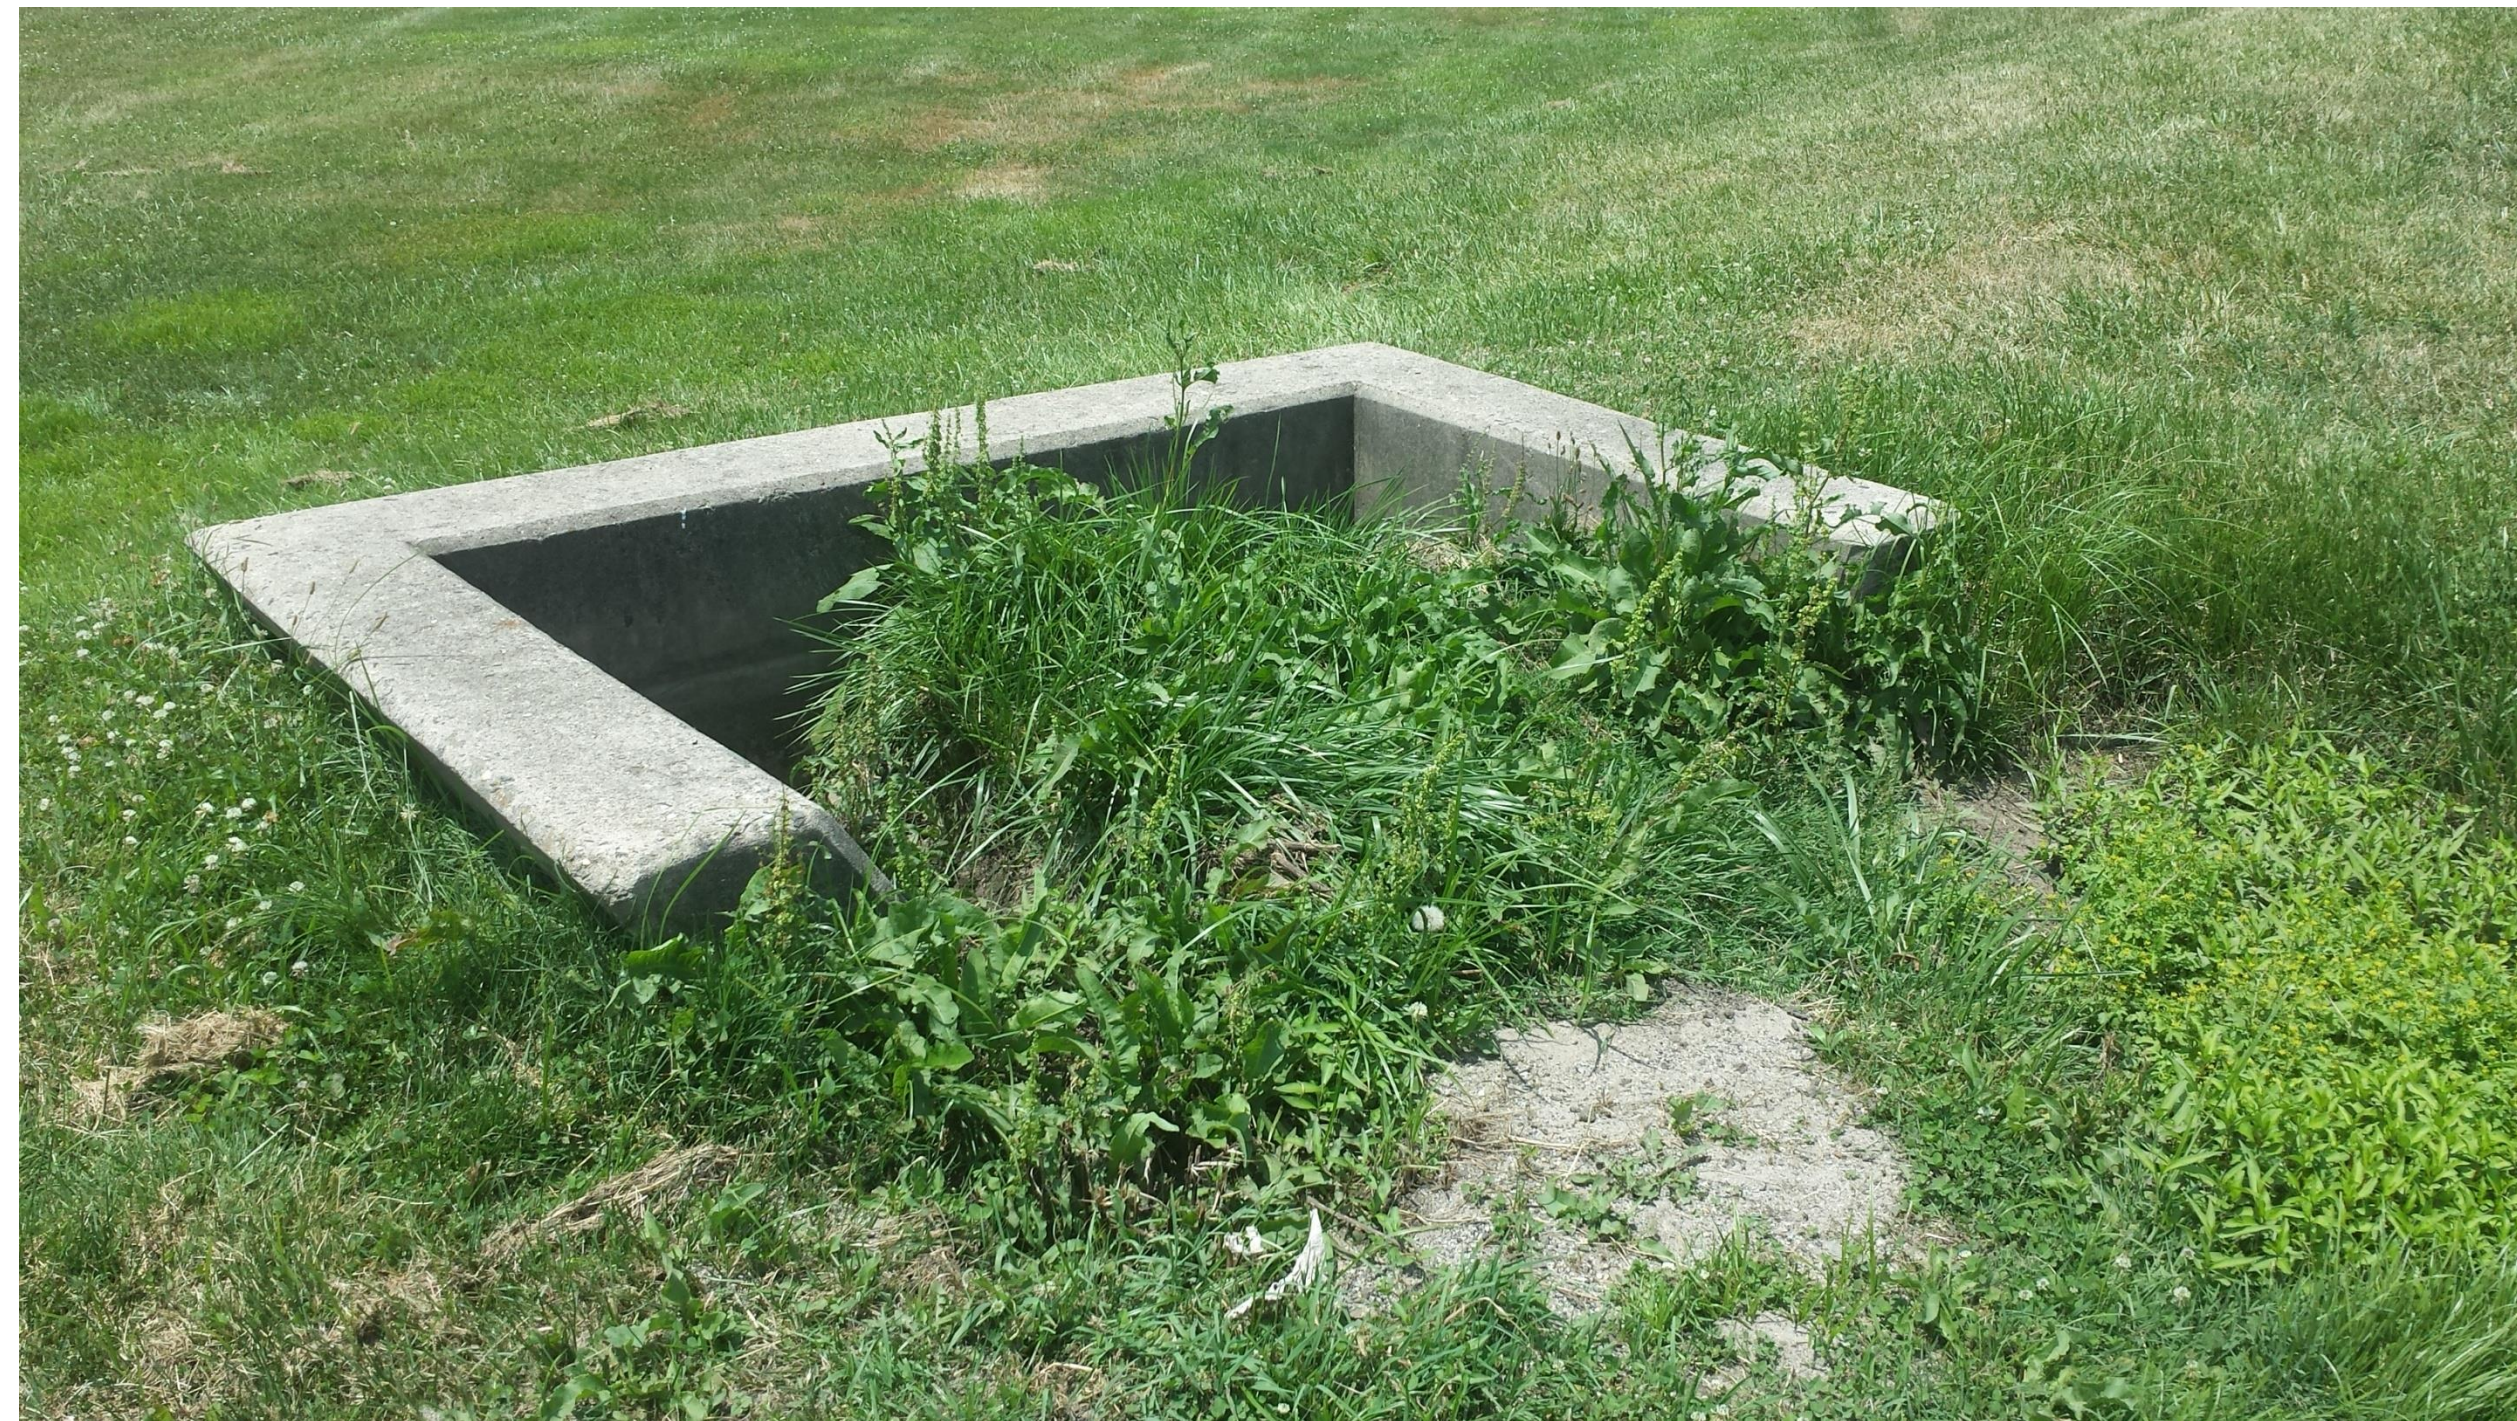
- Inlet has grass and plants restricting water flow
- Water flows to a maintained garden
- Minimal erosion caused by running water
- No outlets apparent
- Emergency spillway leads to depressed area near basin center
- Swale receives water from northern parking lot

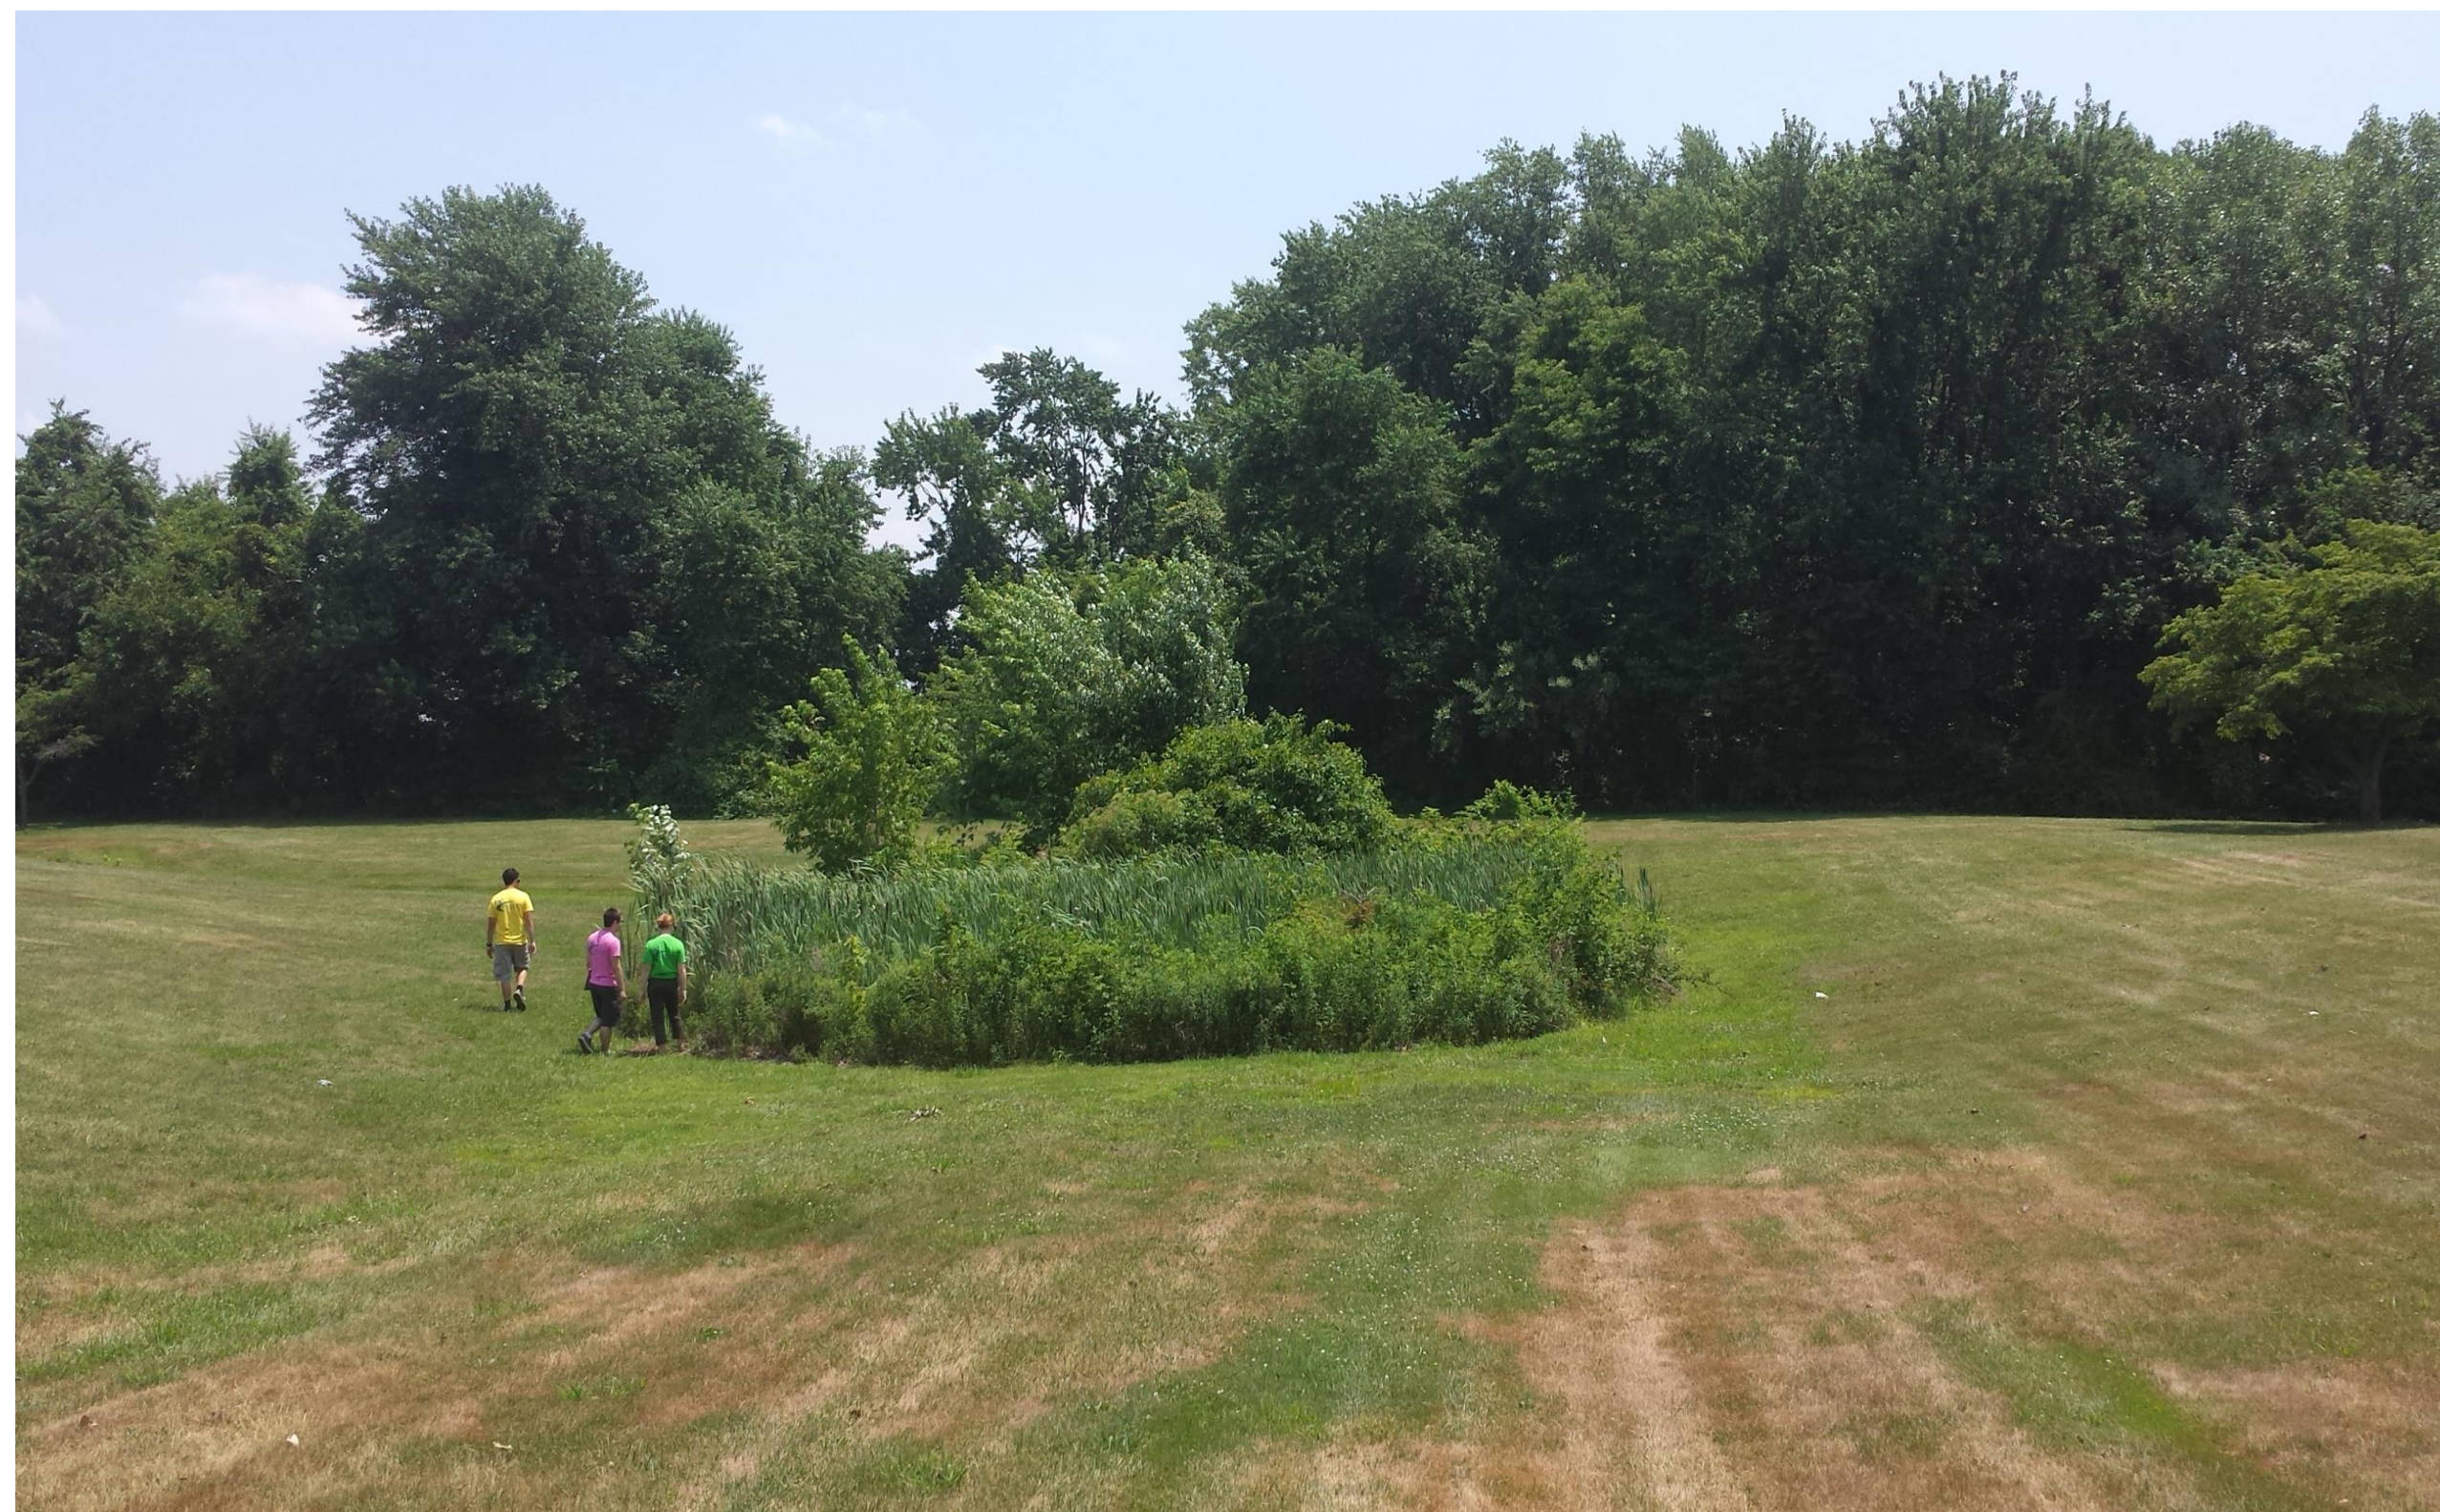
Garden at end of swail

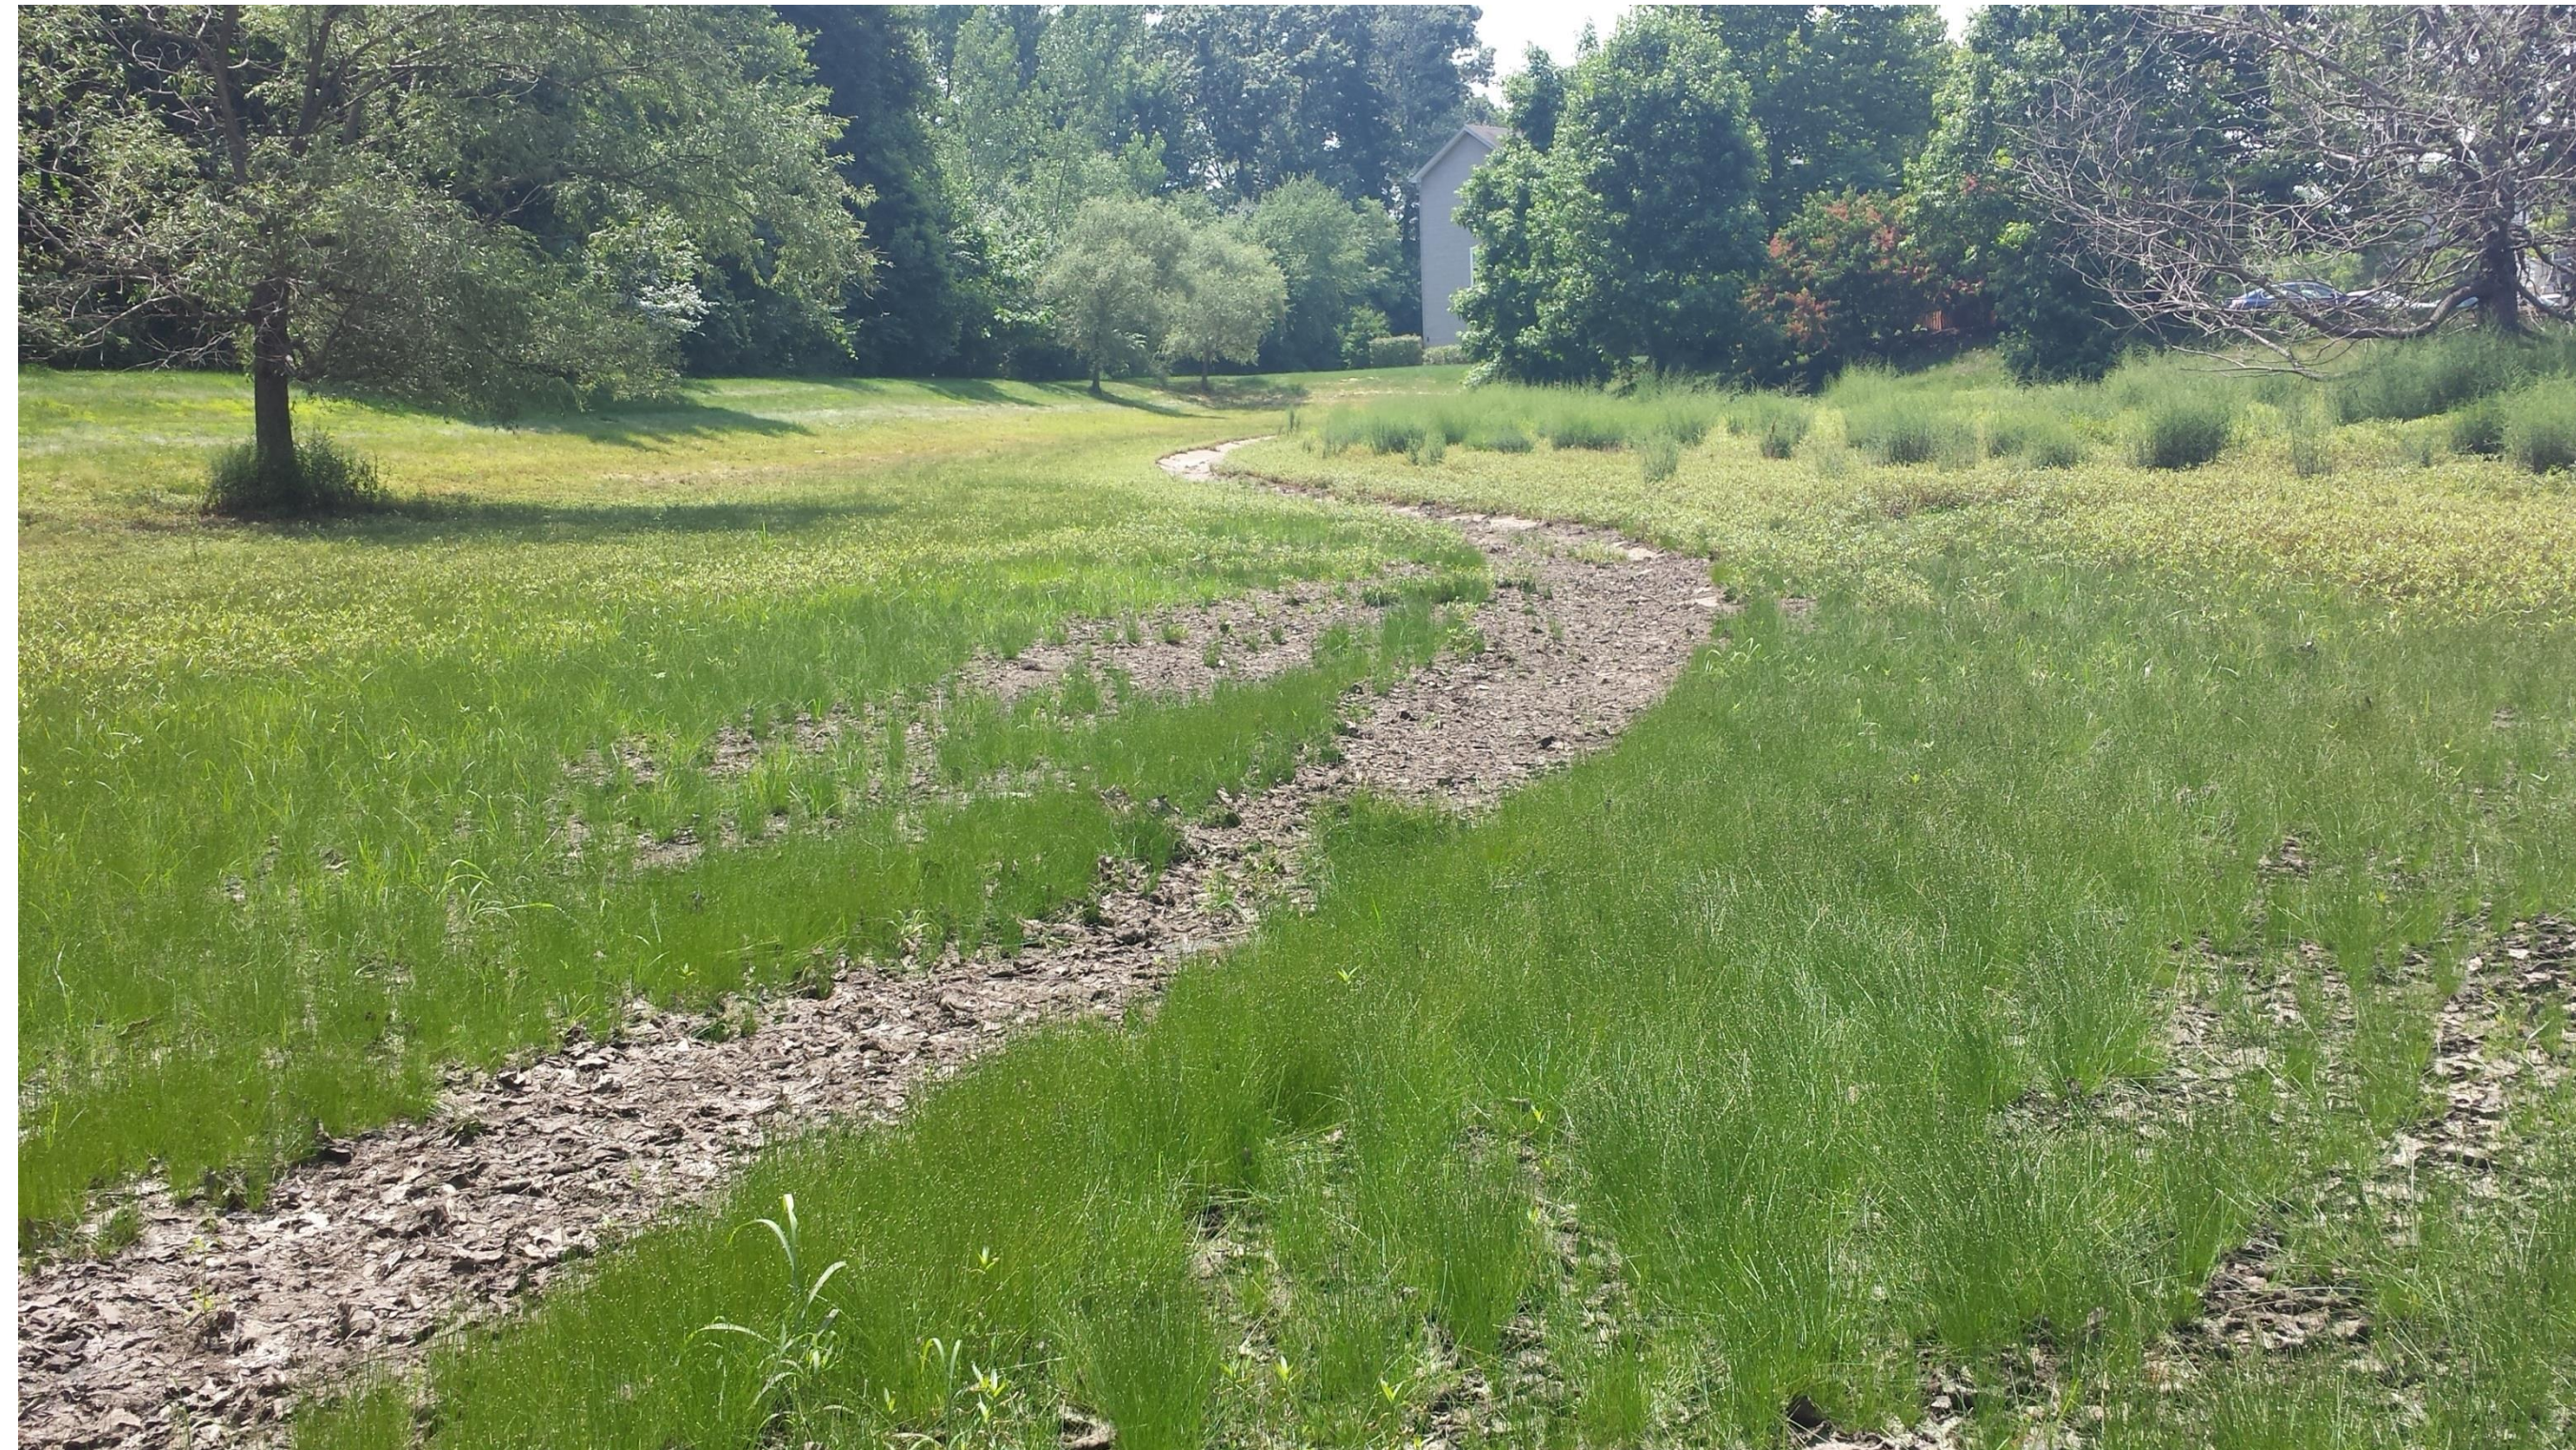
Low flow channel

- Excessive sediment in low flow channel and basin bottom
- Trash rack broken and placed inside outlet structure
- Area near outlet has strong odor
