**Hamilton Township (Mercer County)
Stormwater Basin Assessment Summary
Addendum (Year 3)**

Developed by the Rutgers Cooperative Extension Water Resources Program
Funded by Hamilton Township, Mercer County, New Jersey

September 30, 2014

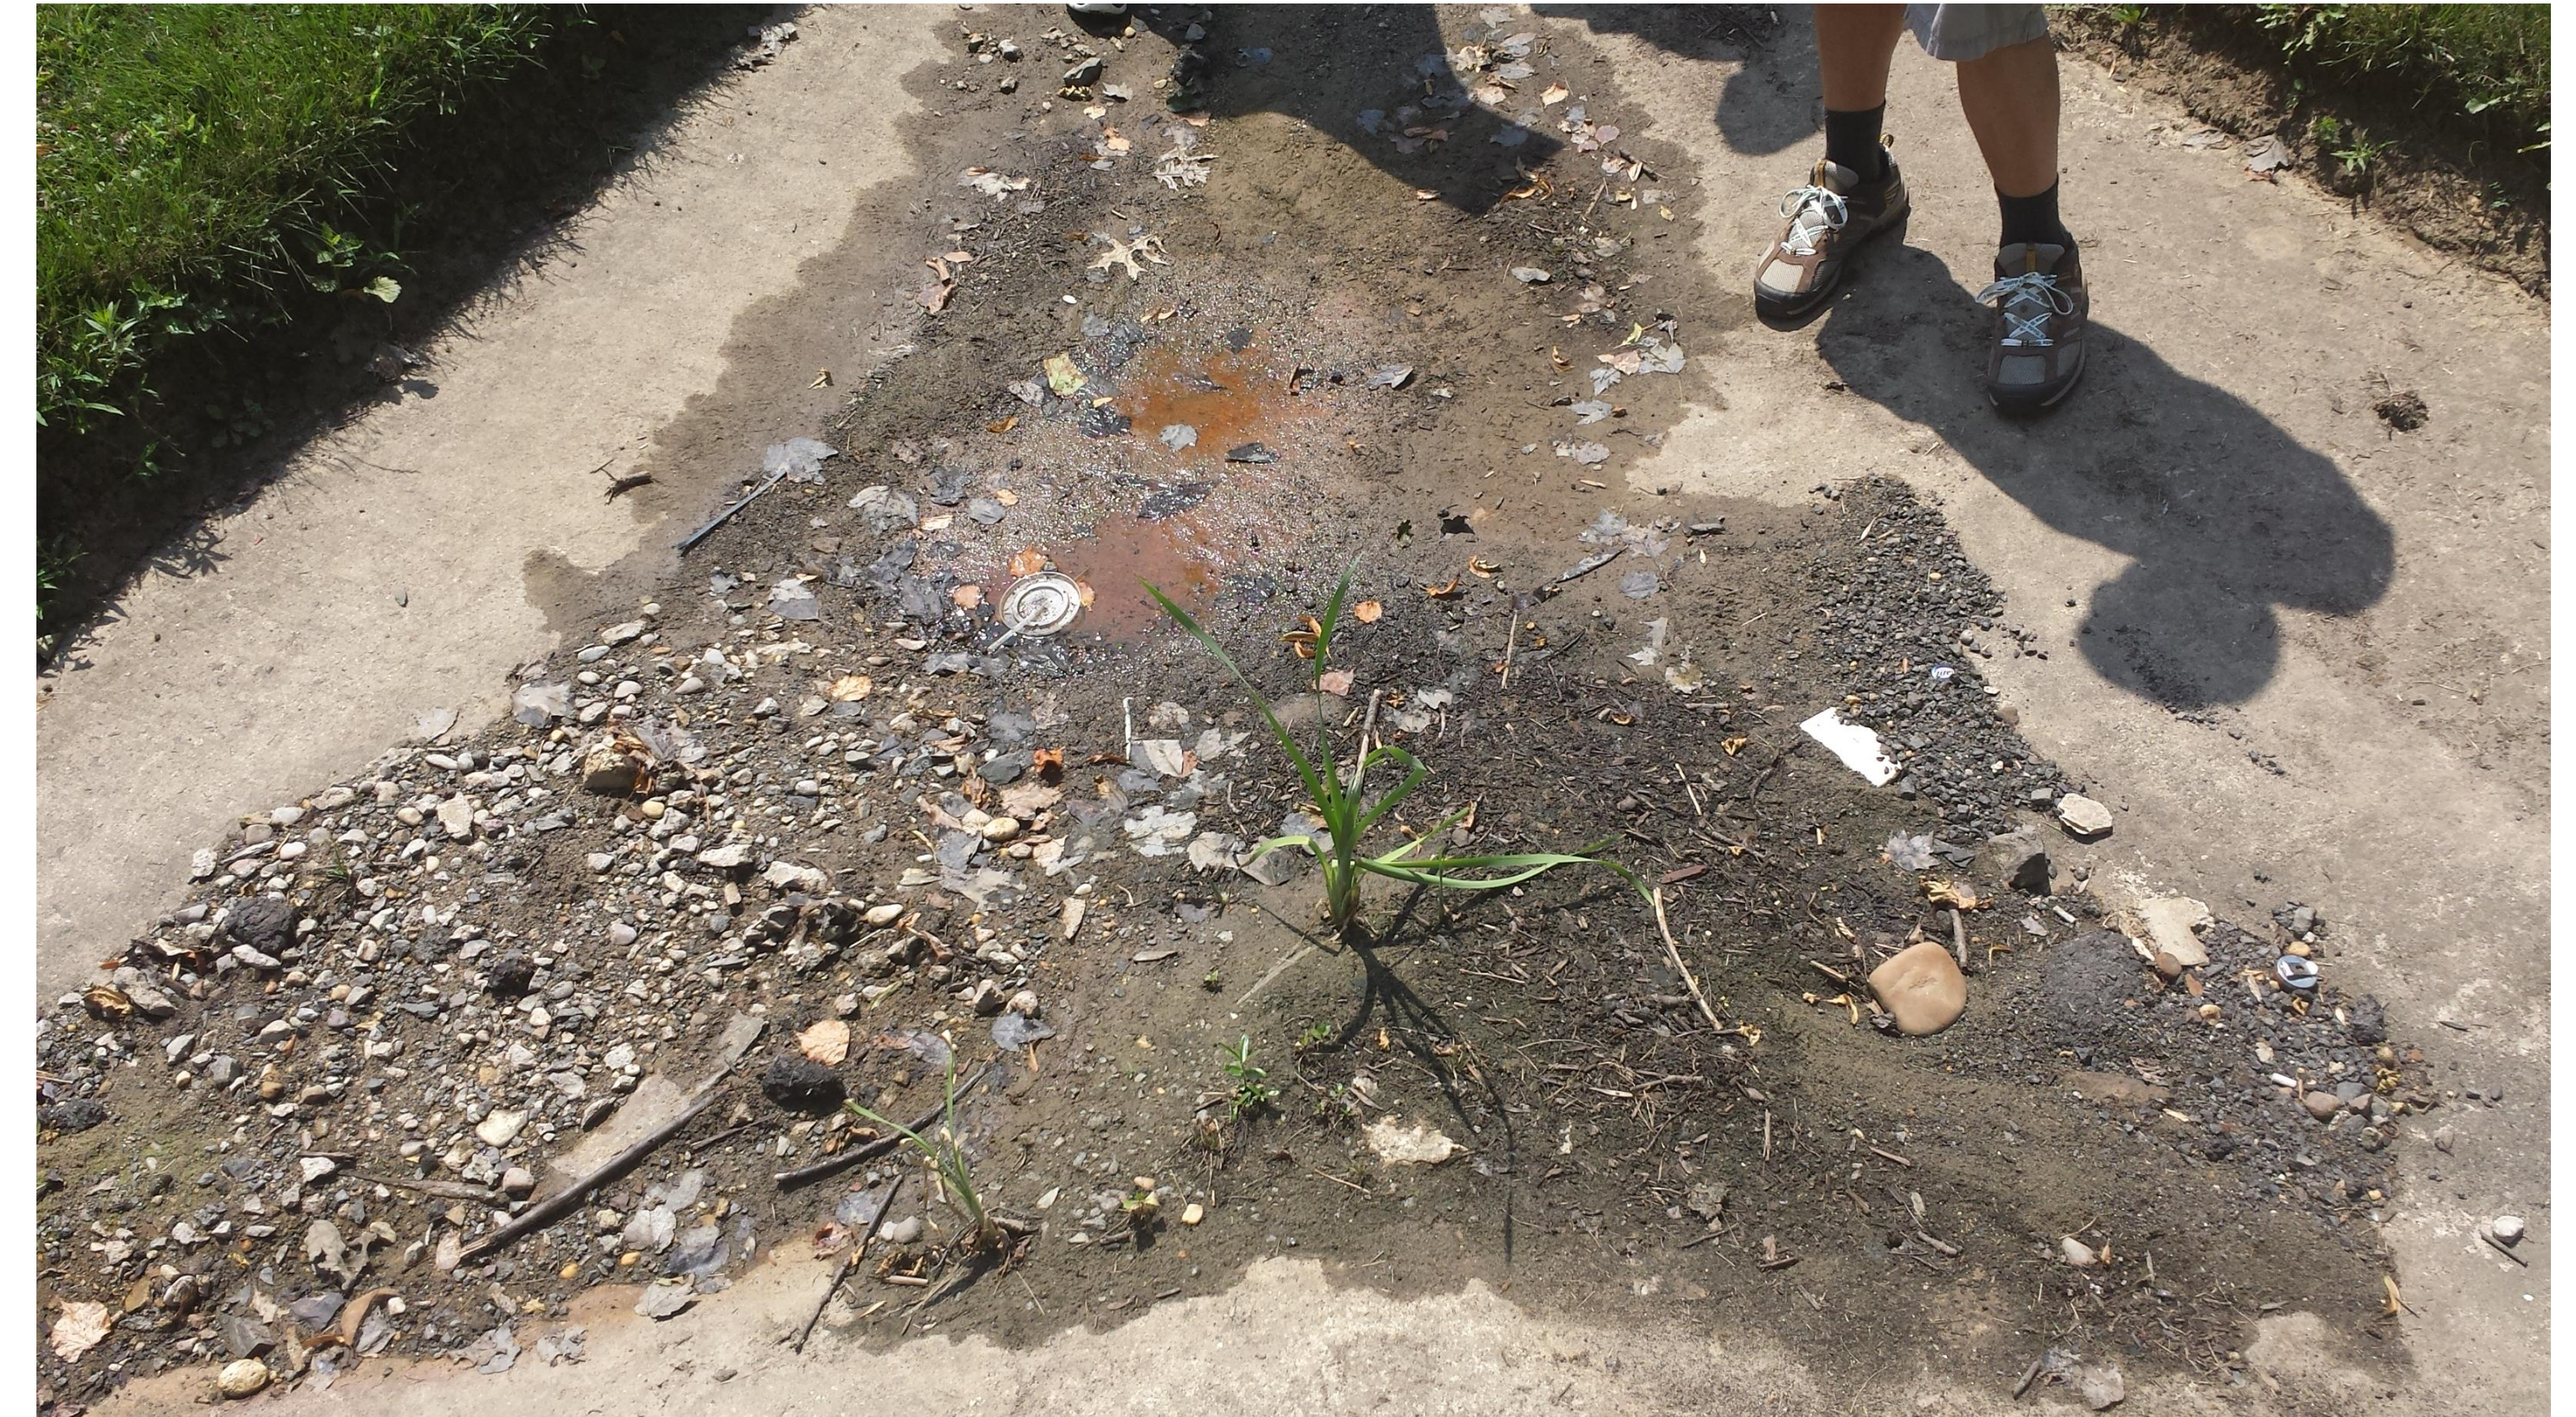
Center of the low flow channel

- Noticeable amount of iron in low flow channel
- Minimal amounts of sediment near outlet structure
- Emergency spillway adjacent to basin flows to nearby field
- Overall in good condition

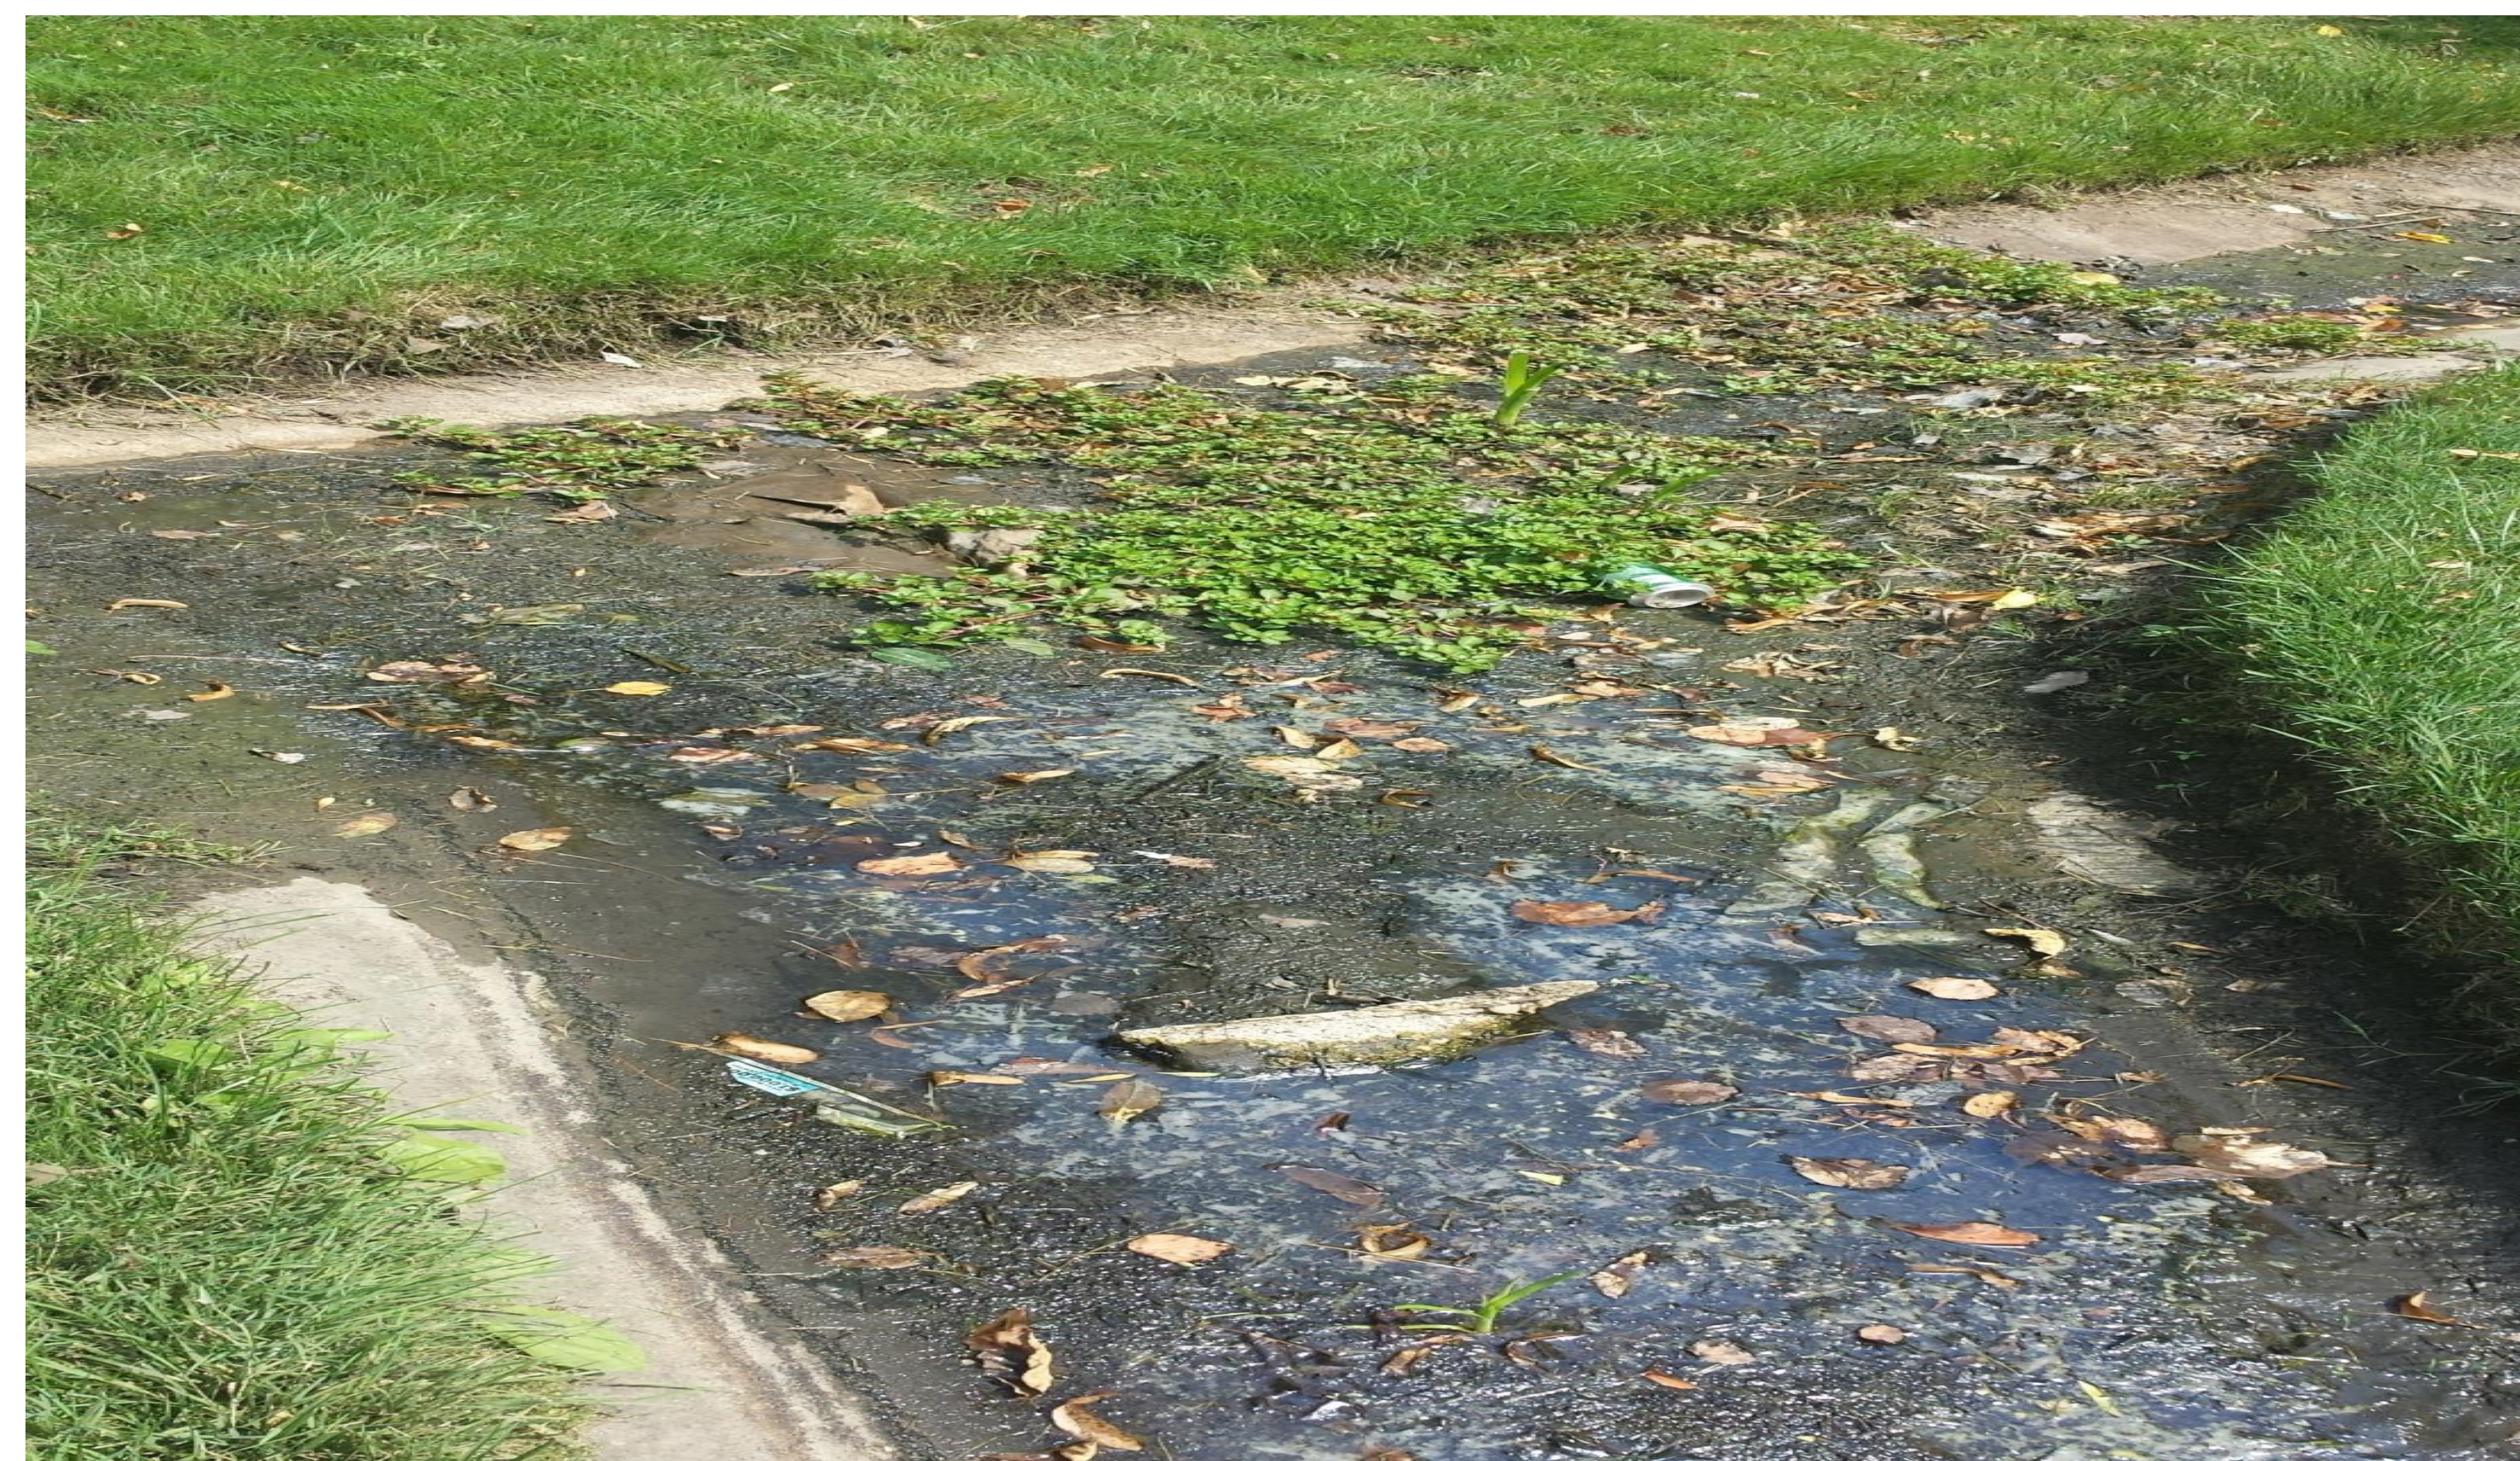
Low flow channel

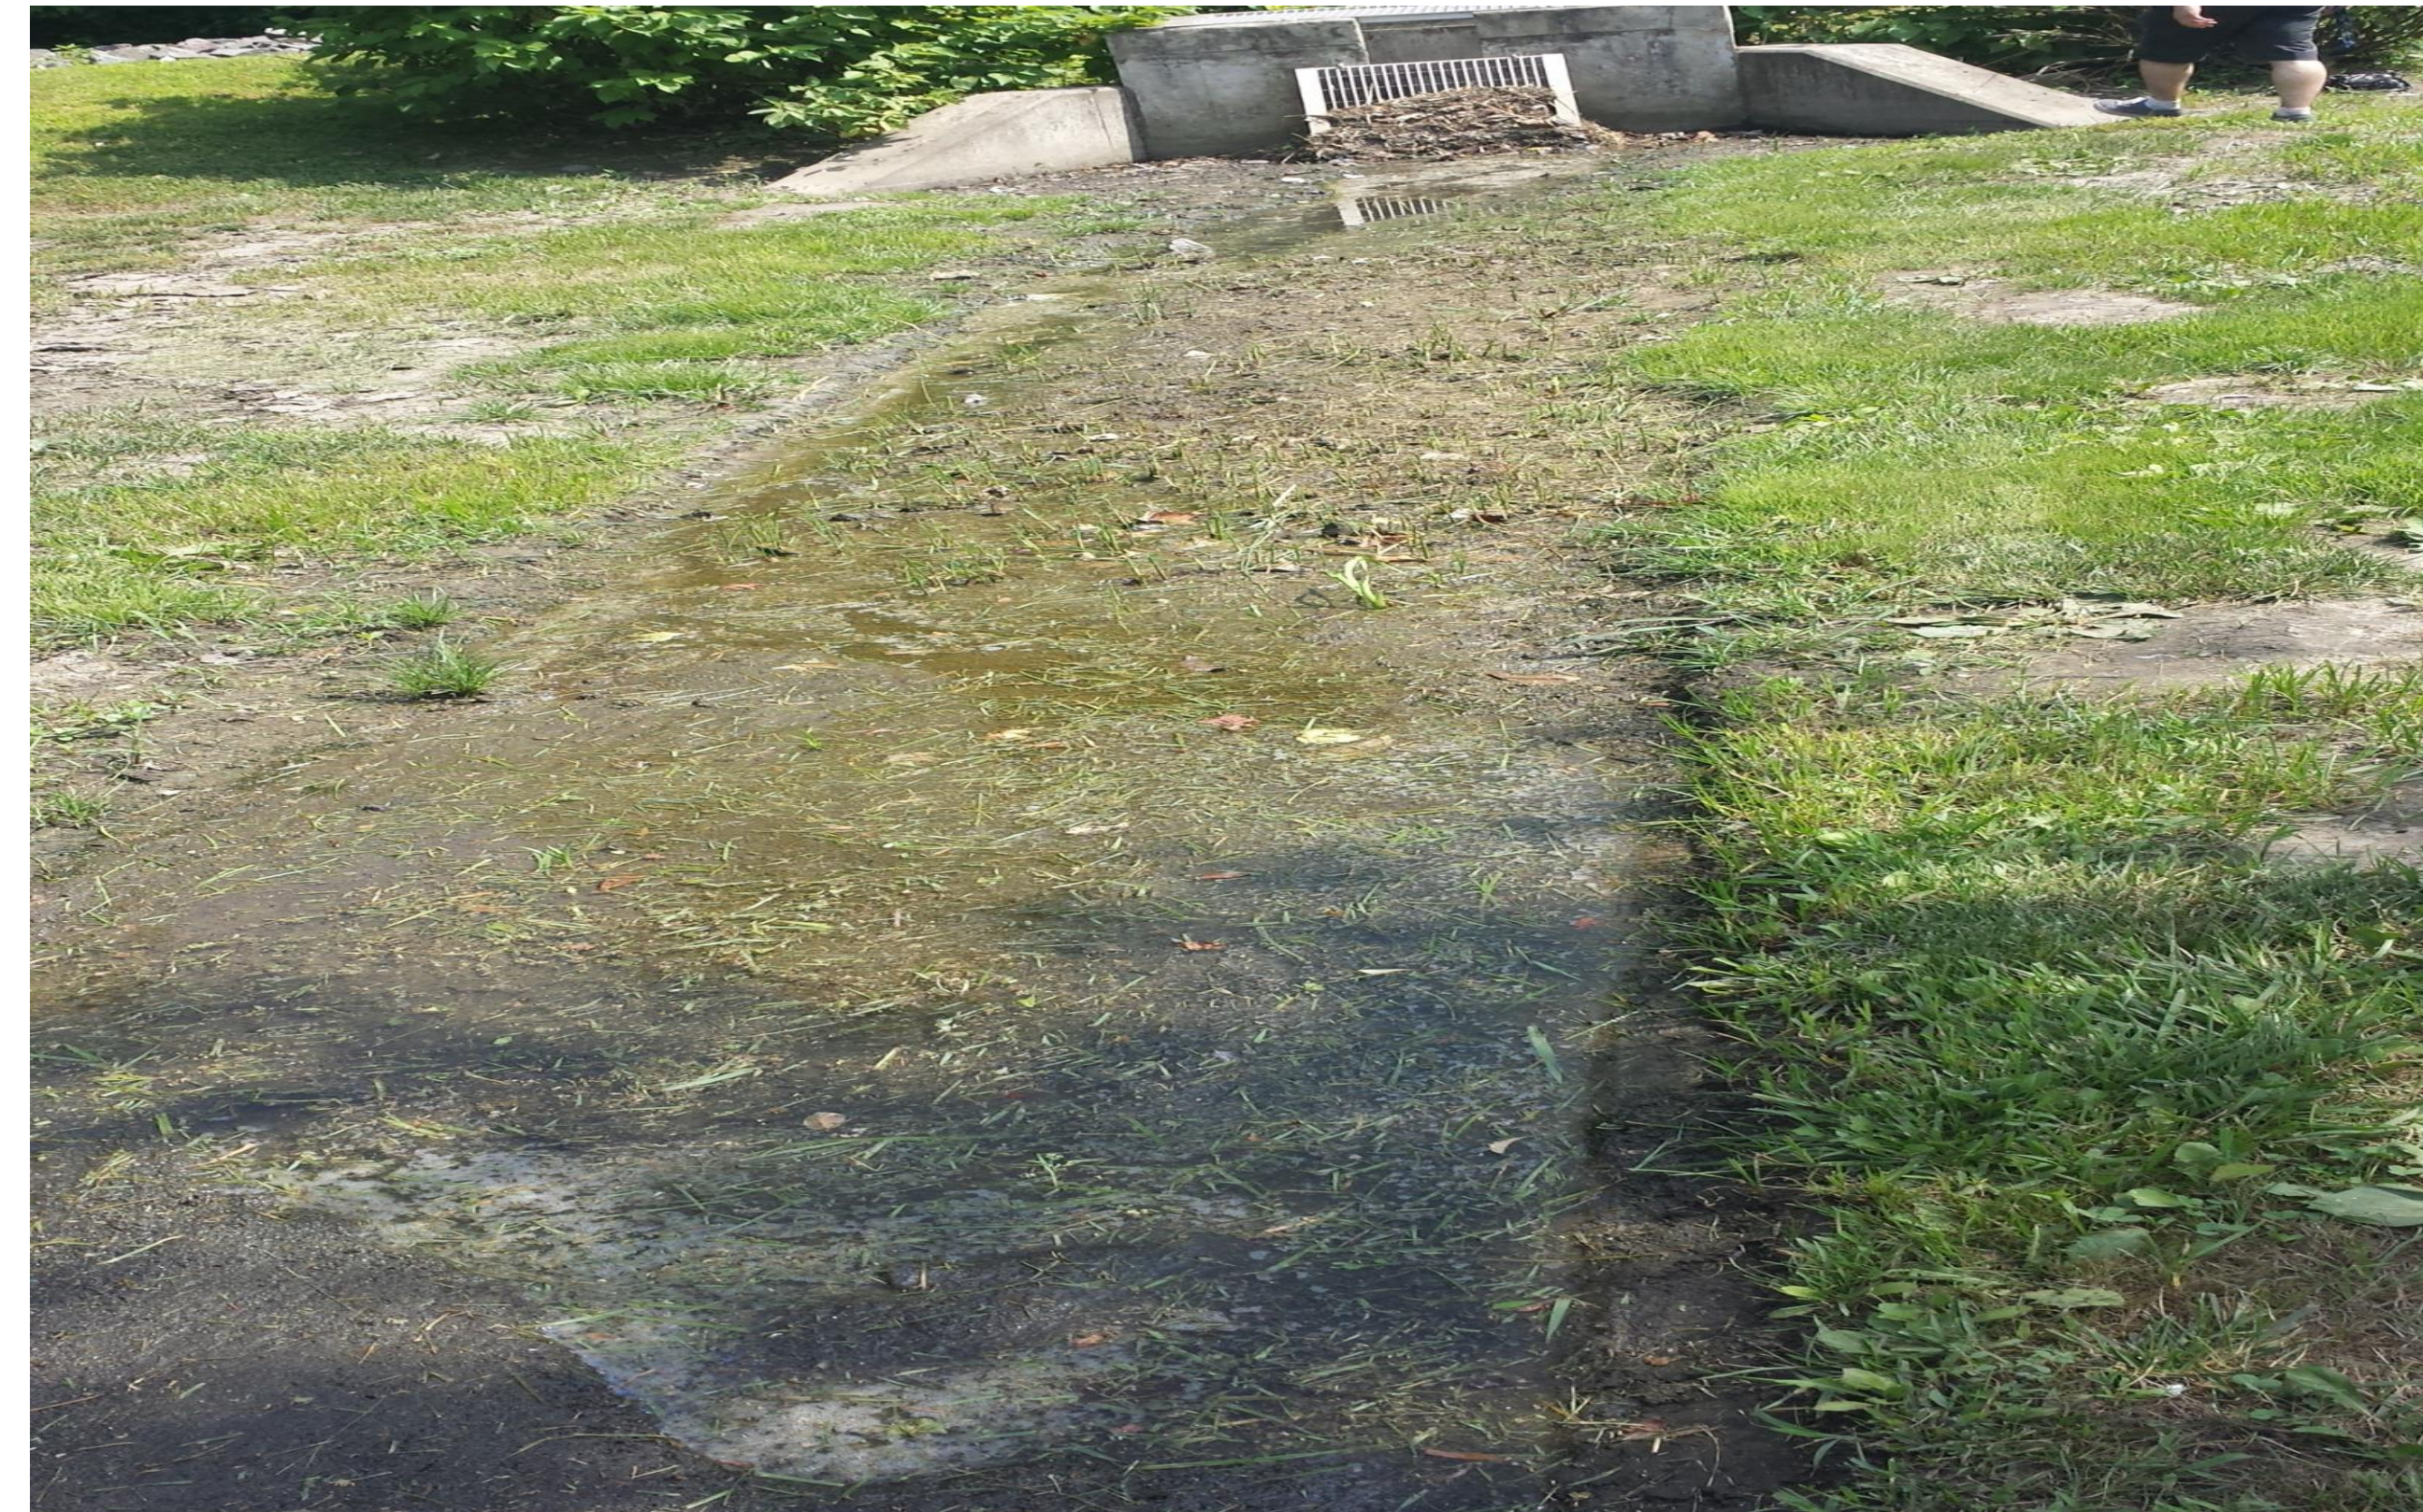
Low flow channel leading to outlet

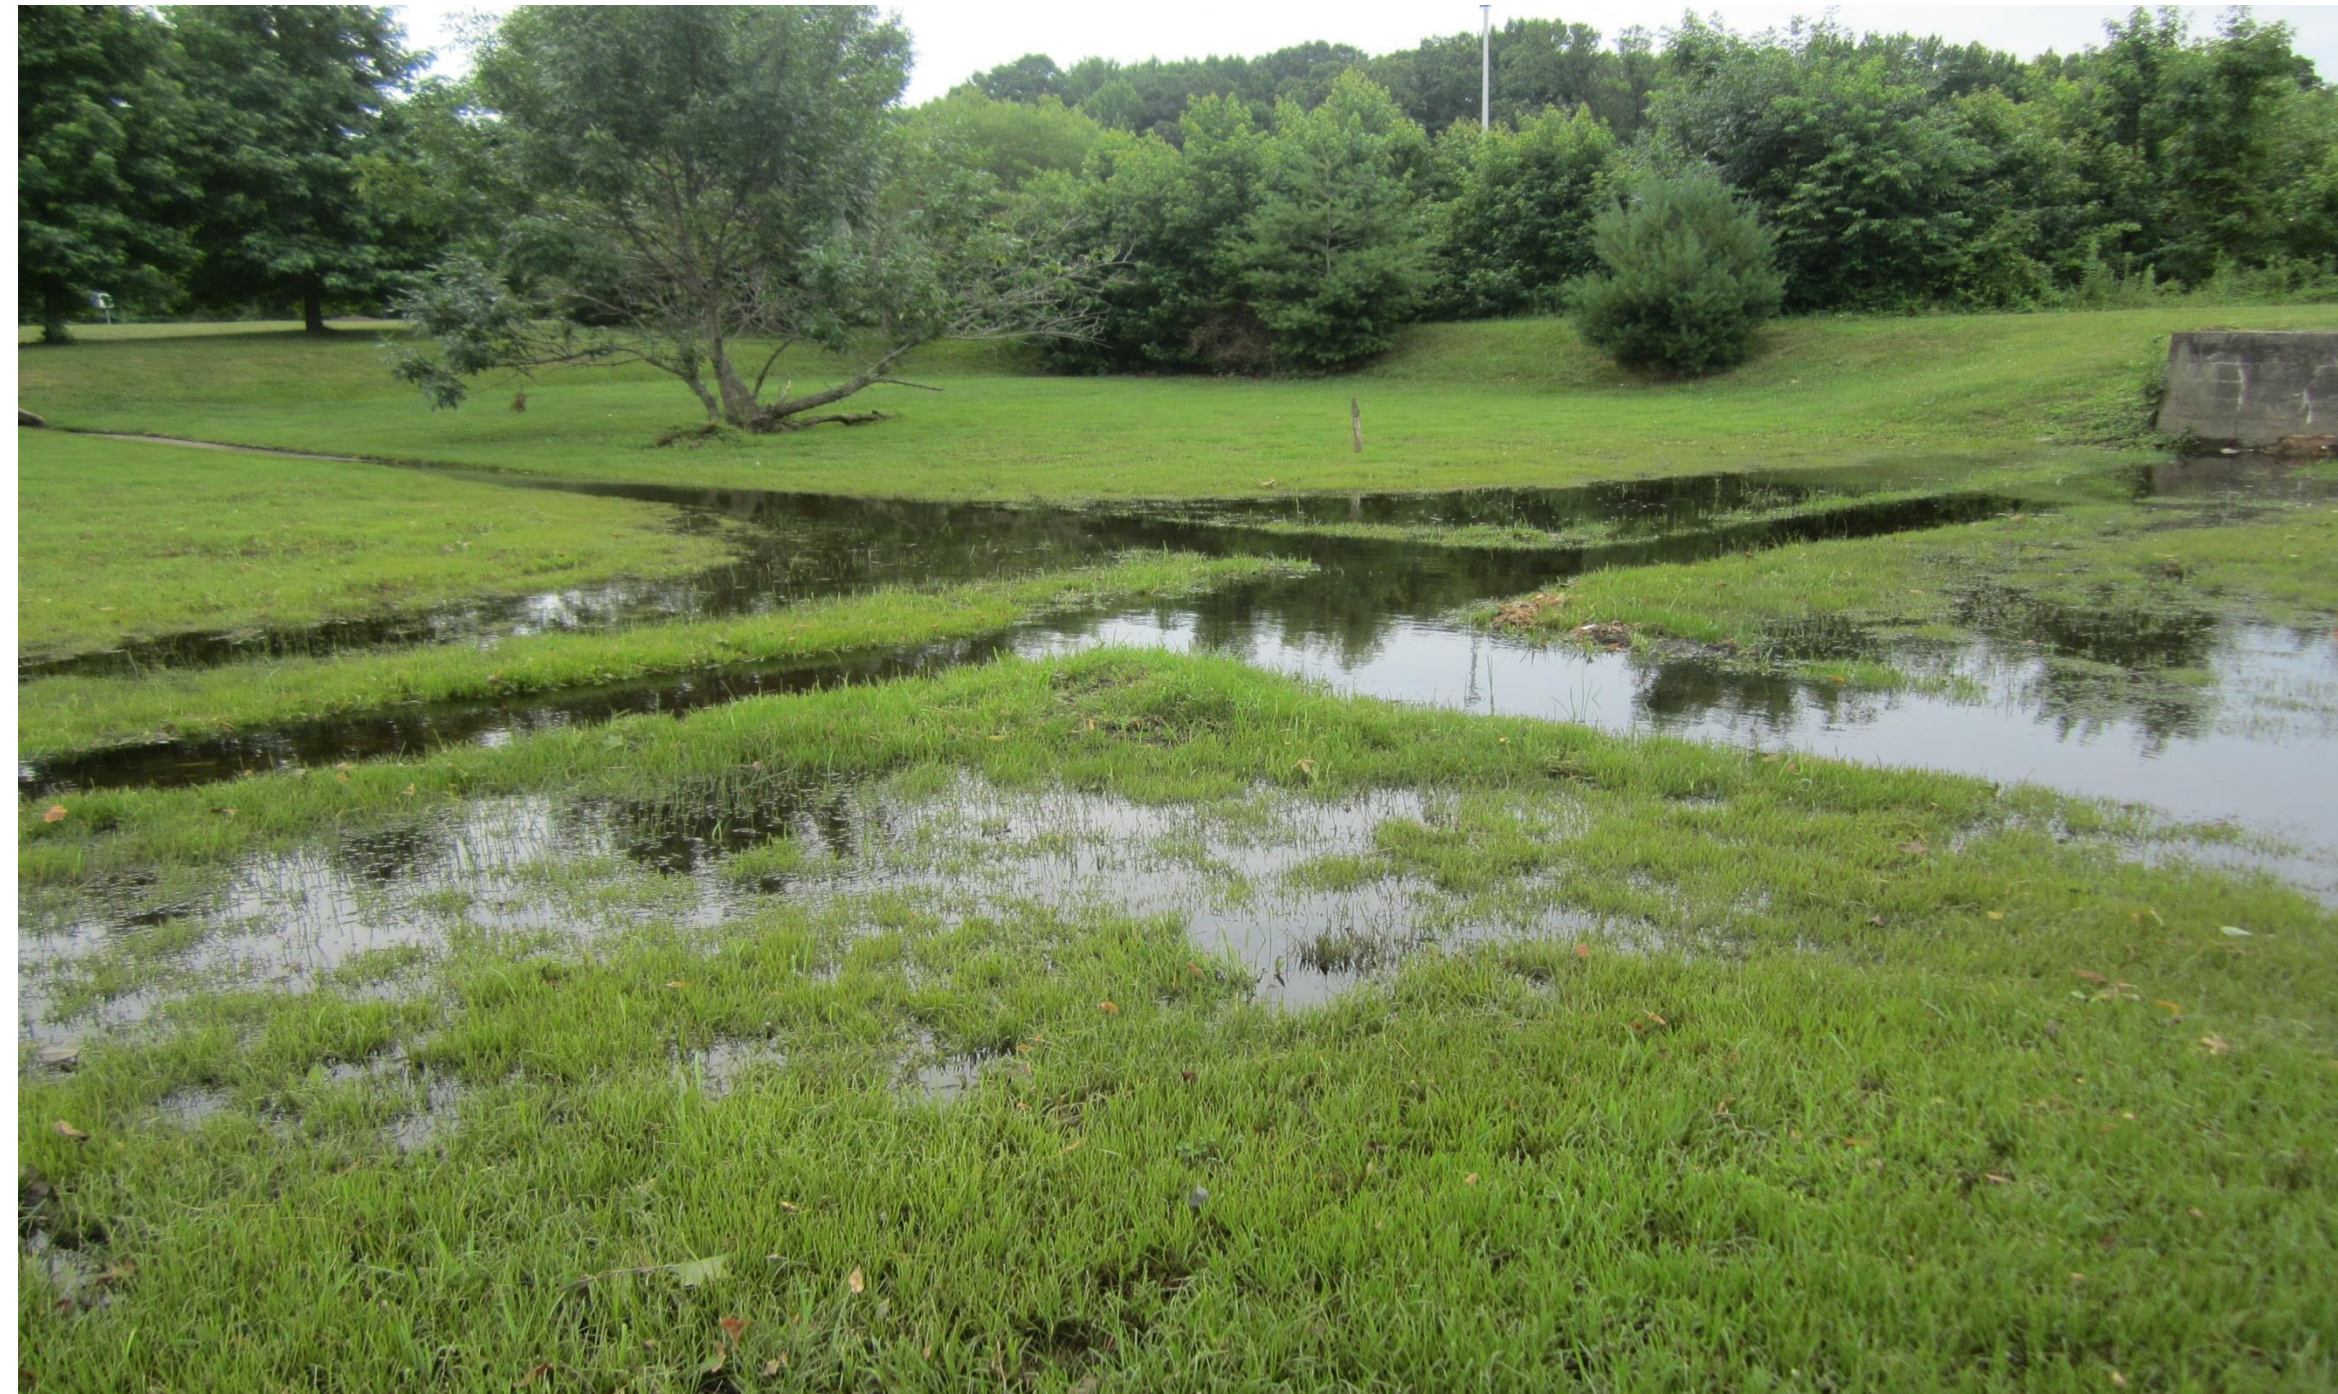
Basin bottom looking southwest

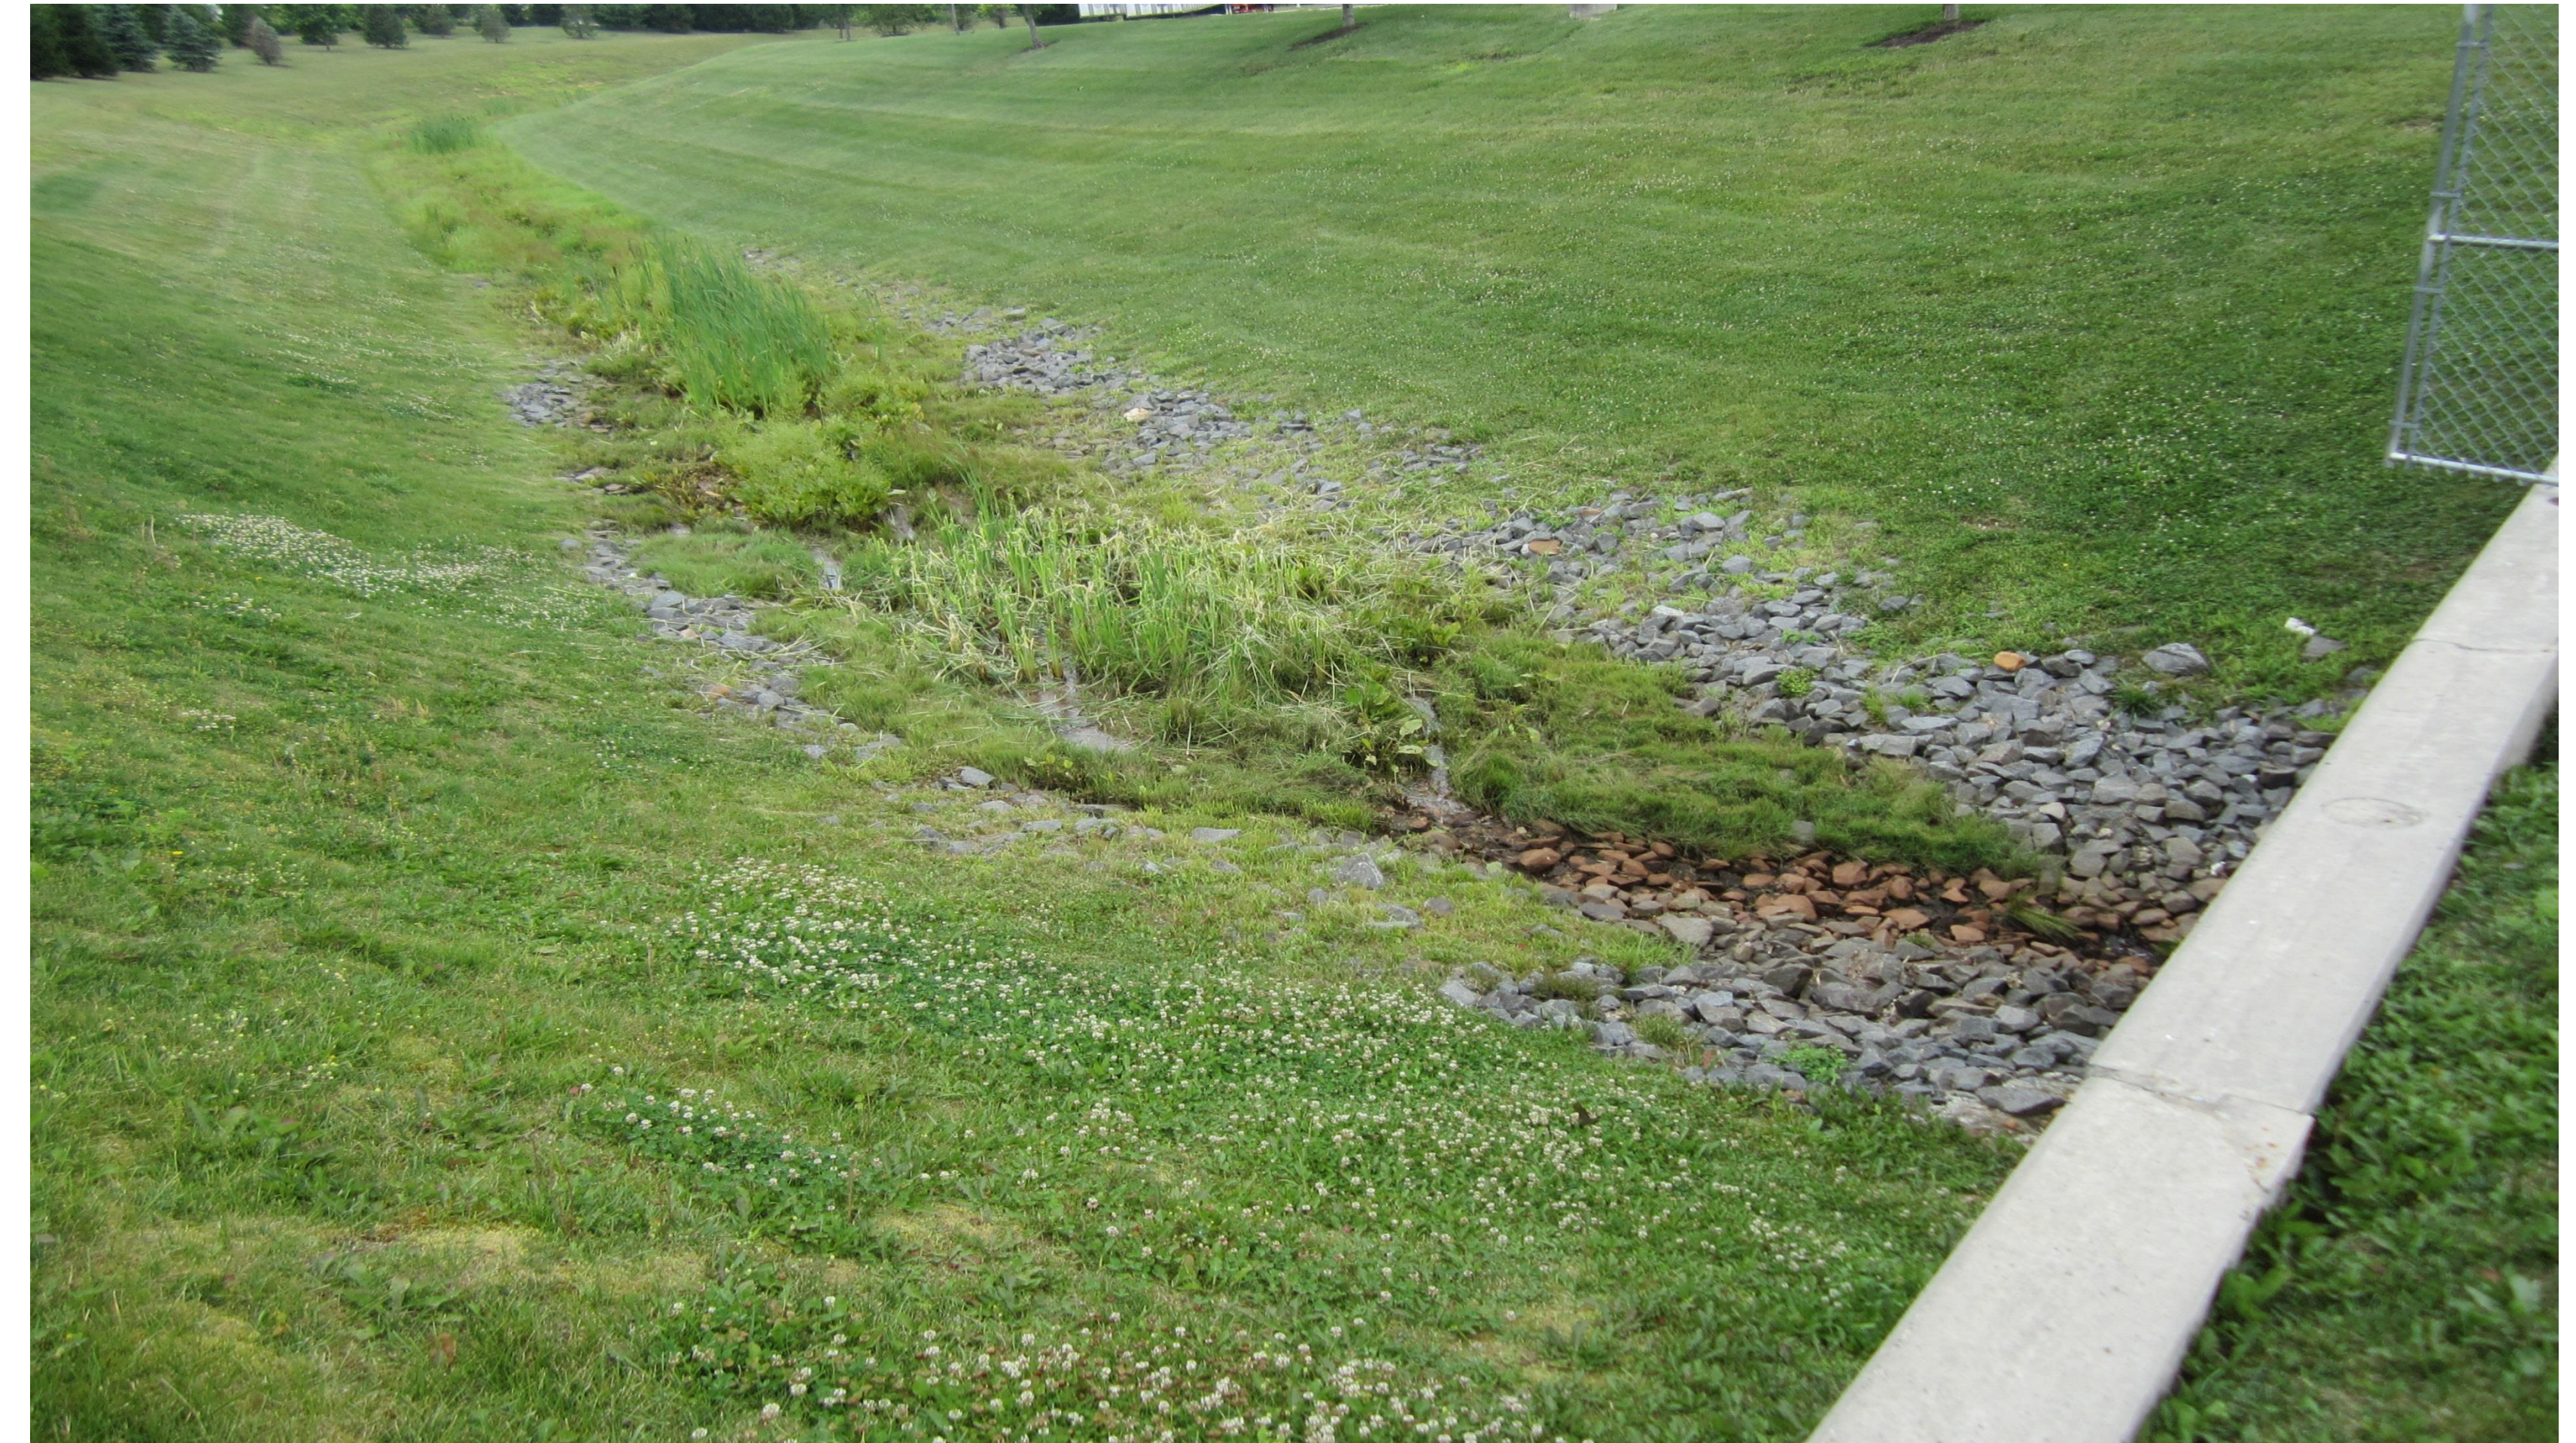
Overview of swale

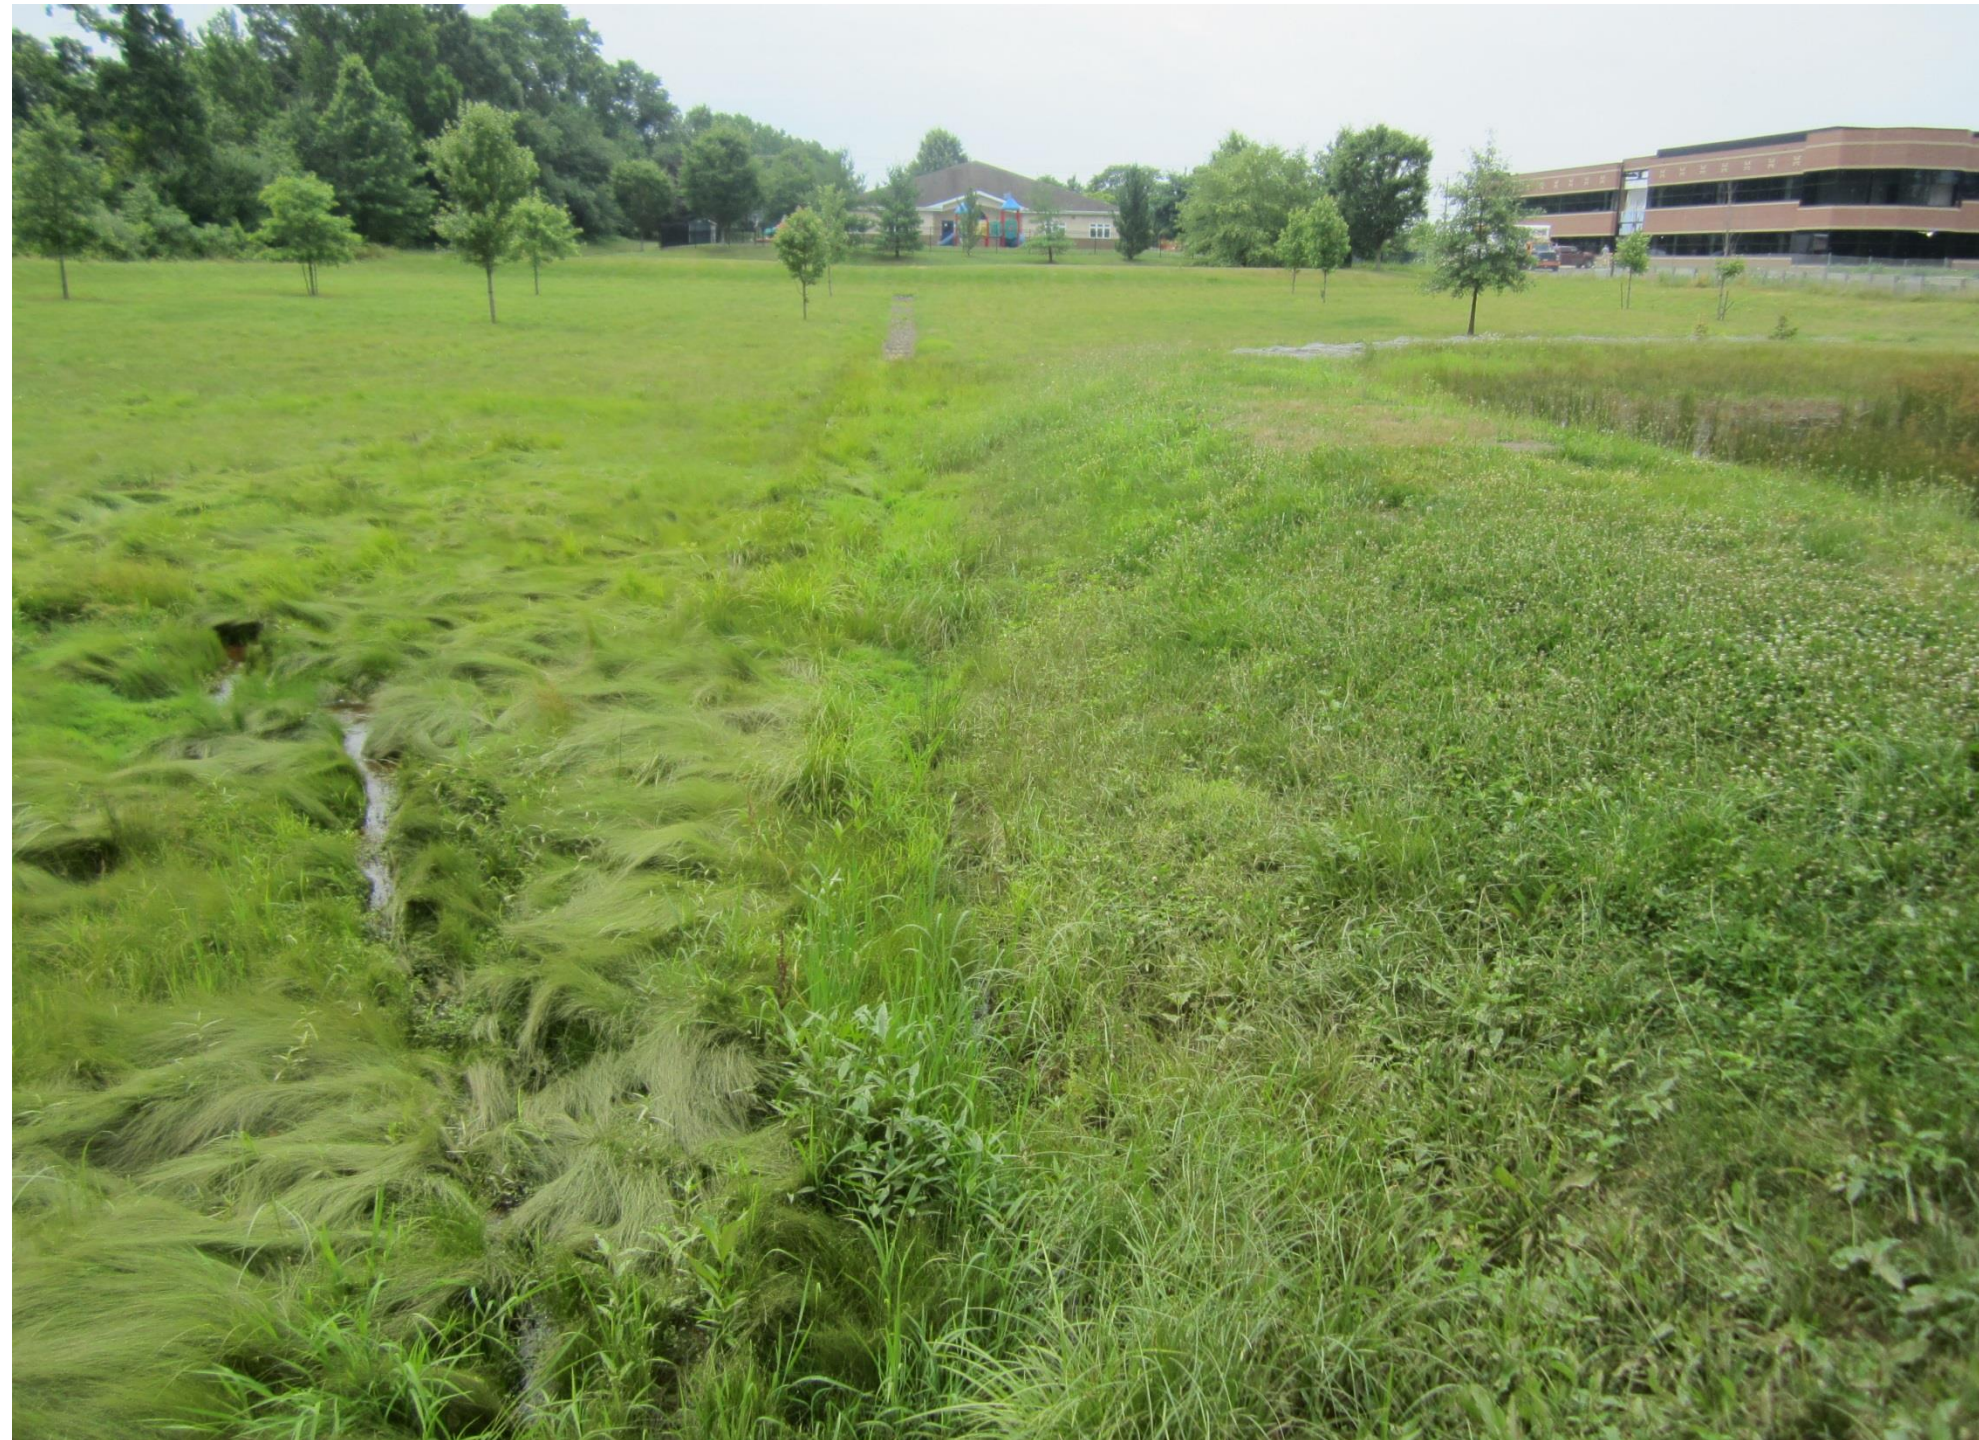
Basin overview looking south
