**Hamilton Township (Mercer County)
Stormwater Basin Assessment Summary
Addendum (Year 3)**

Developed by the Rutgers Cooperative Extension Water Resources Program
Funded by Hamilton Township, Mercer County, New Jersey

September 30, 2014

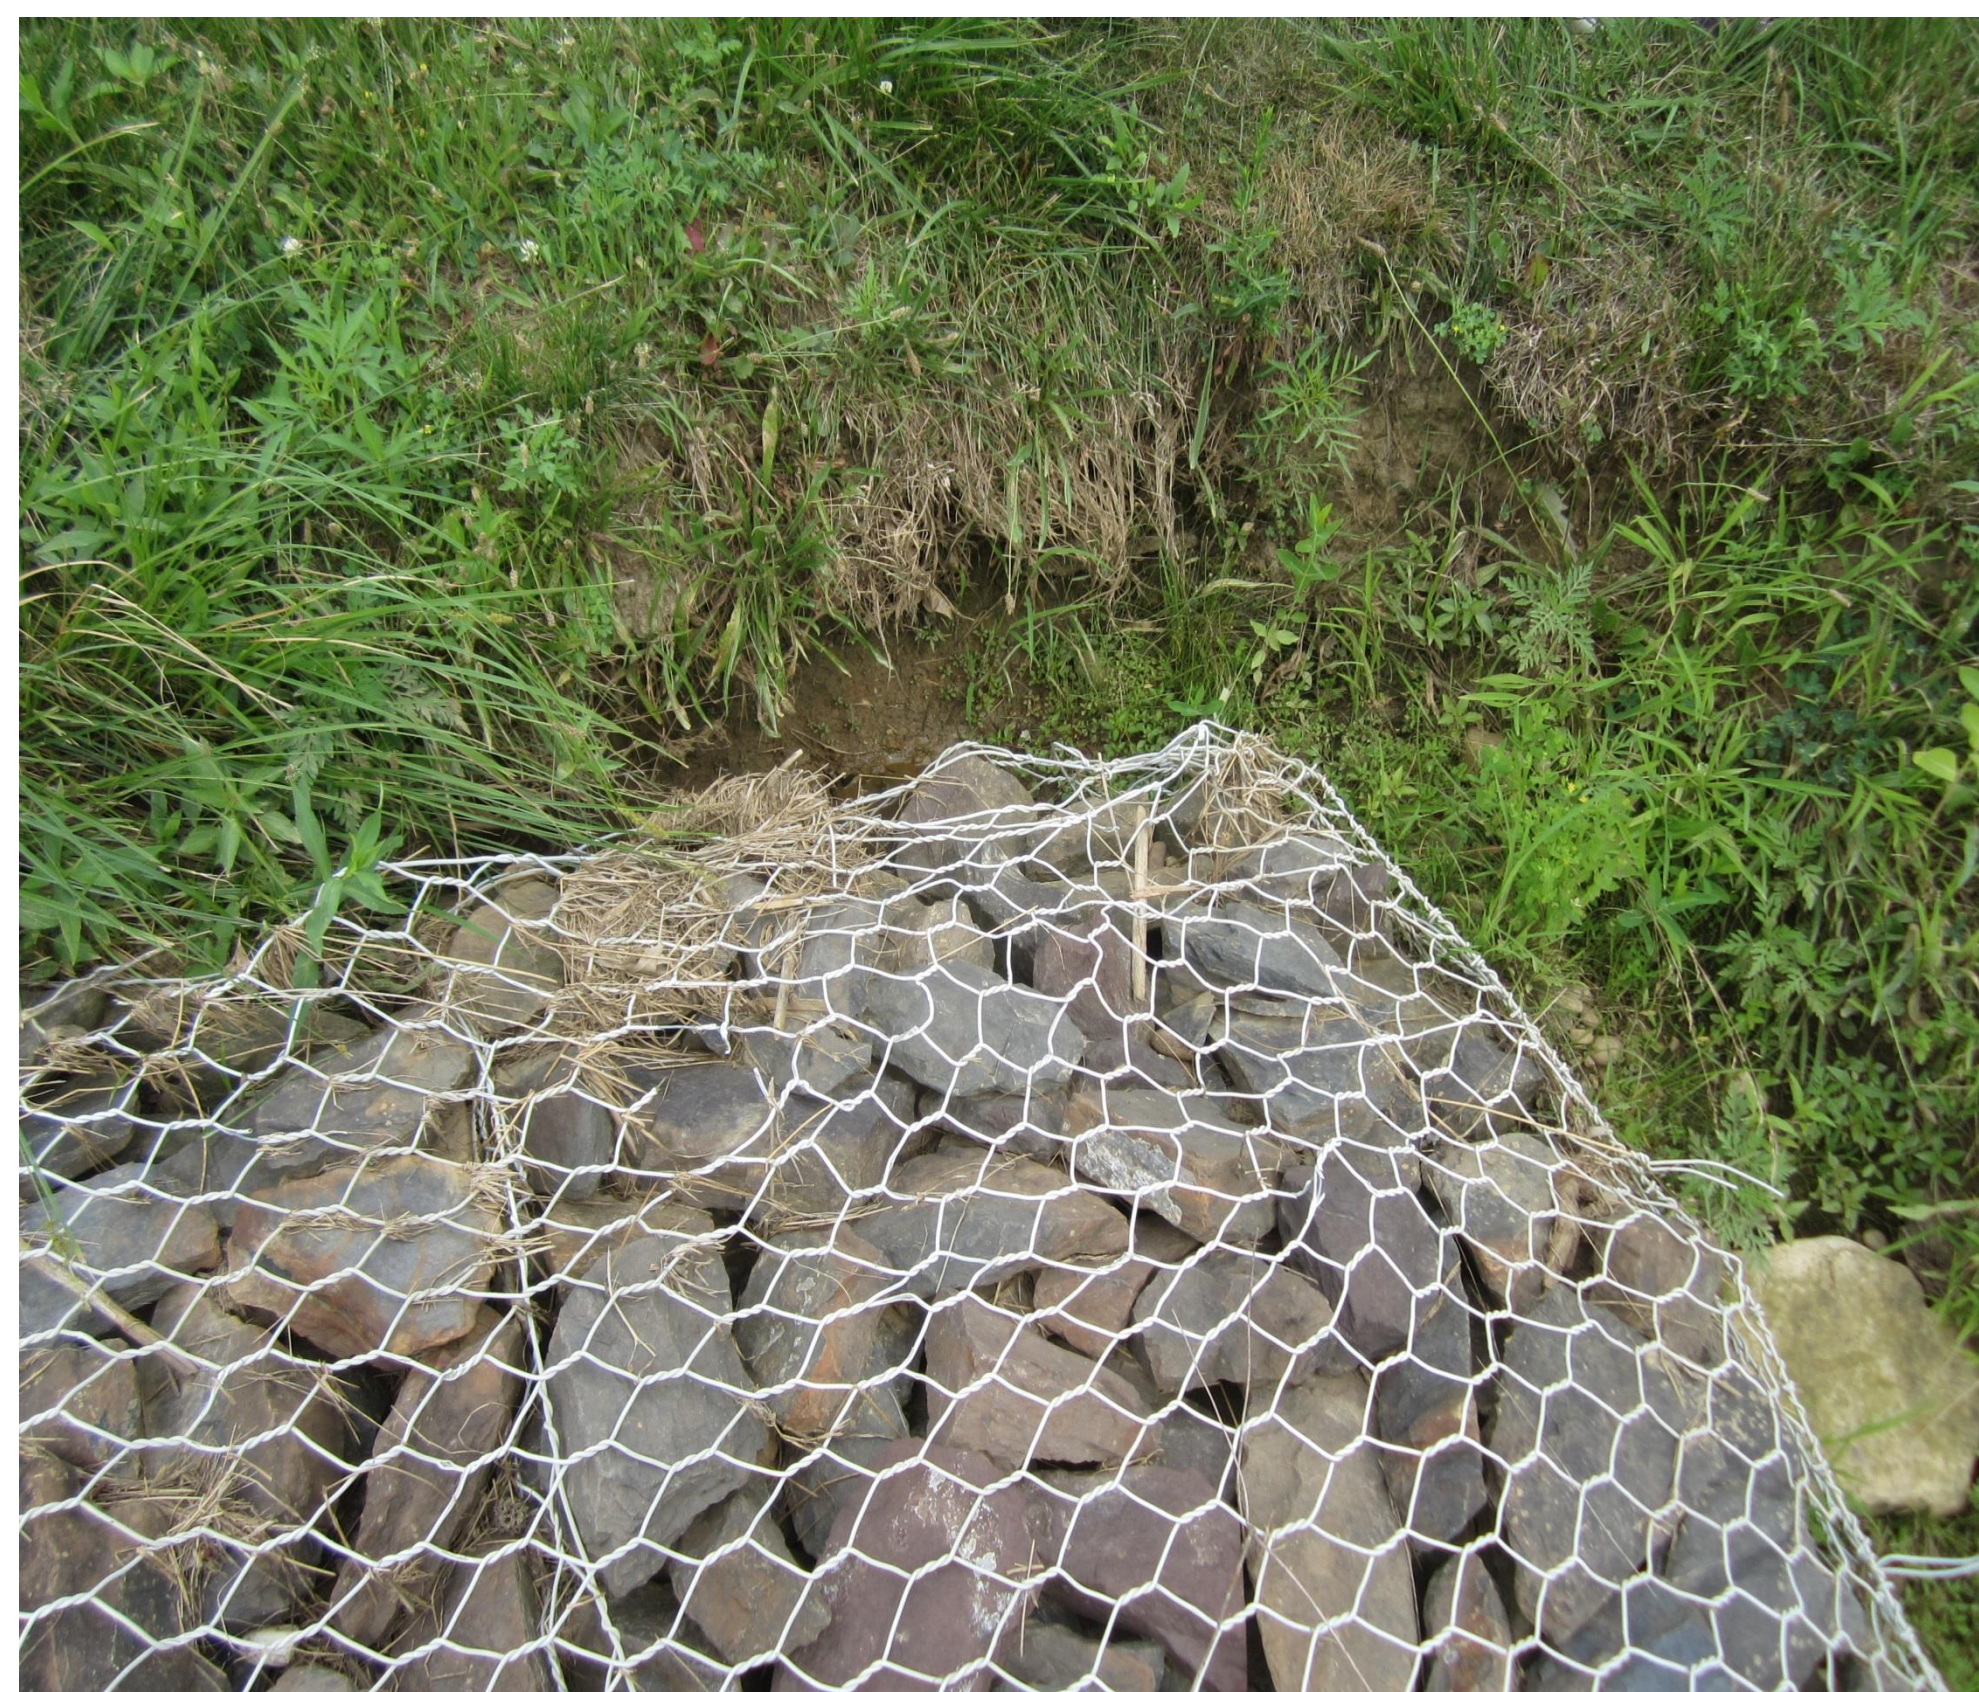
Eroded embankment

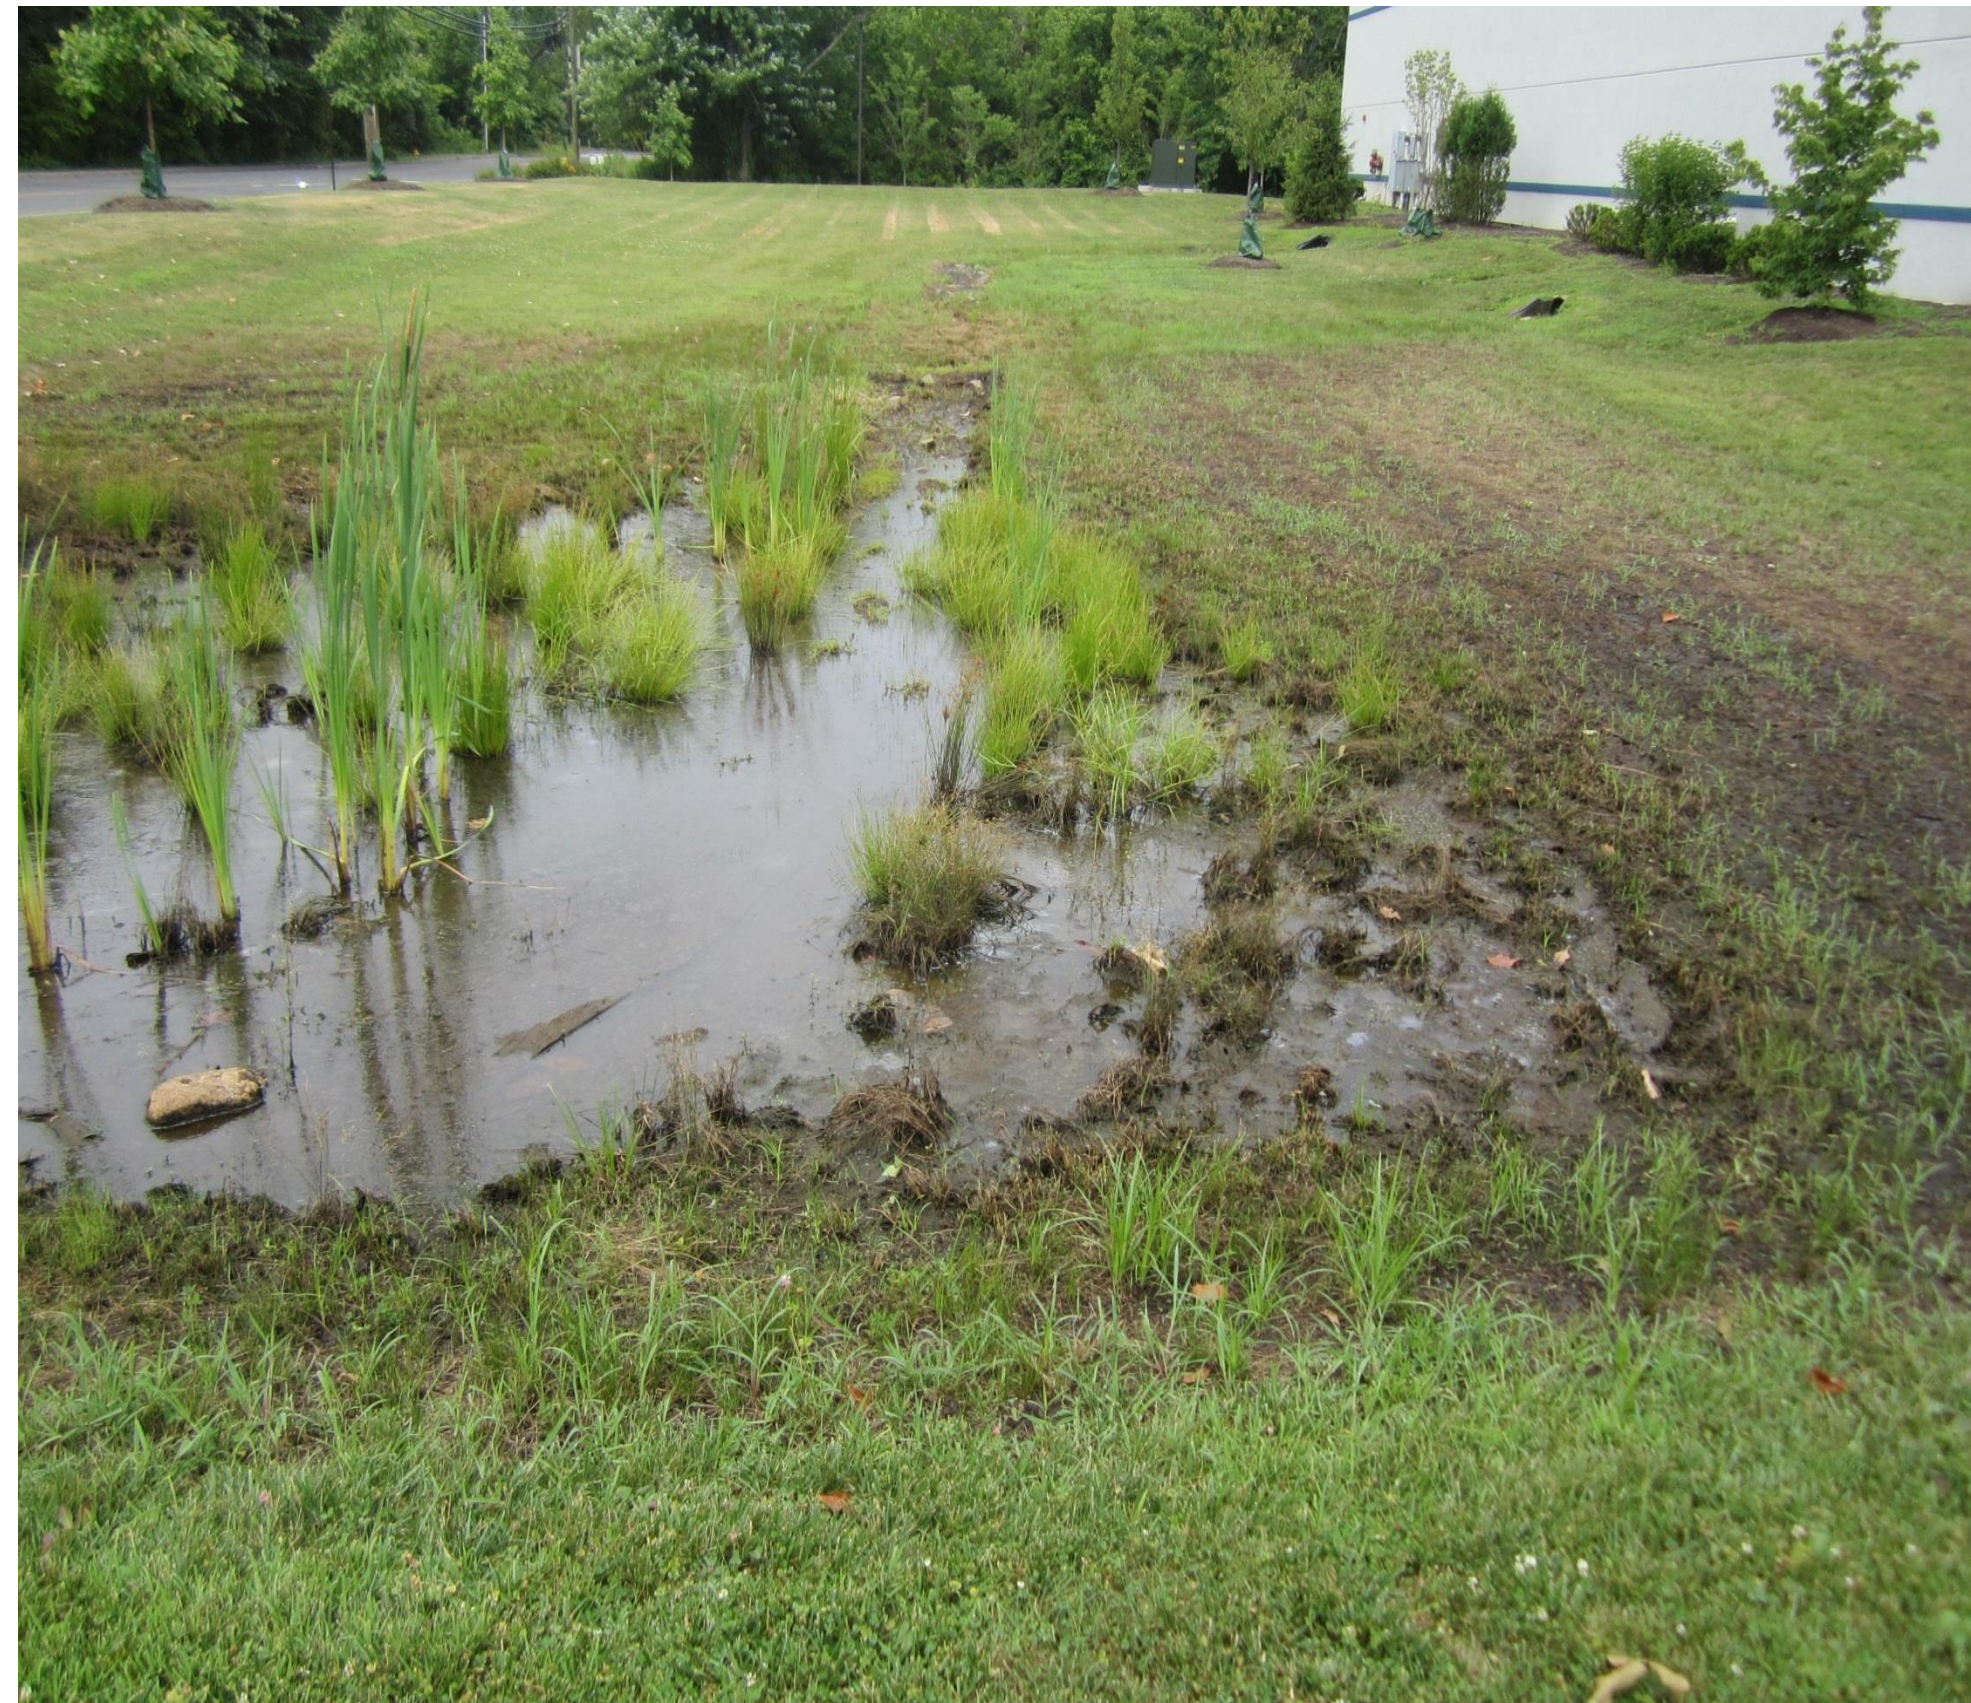
Basin bottom looking west

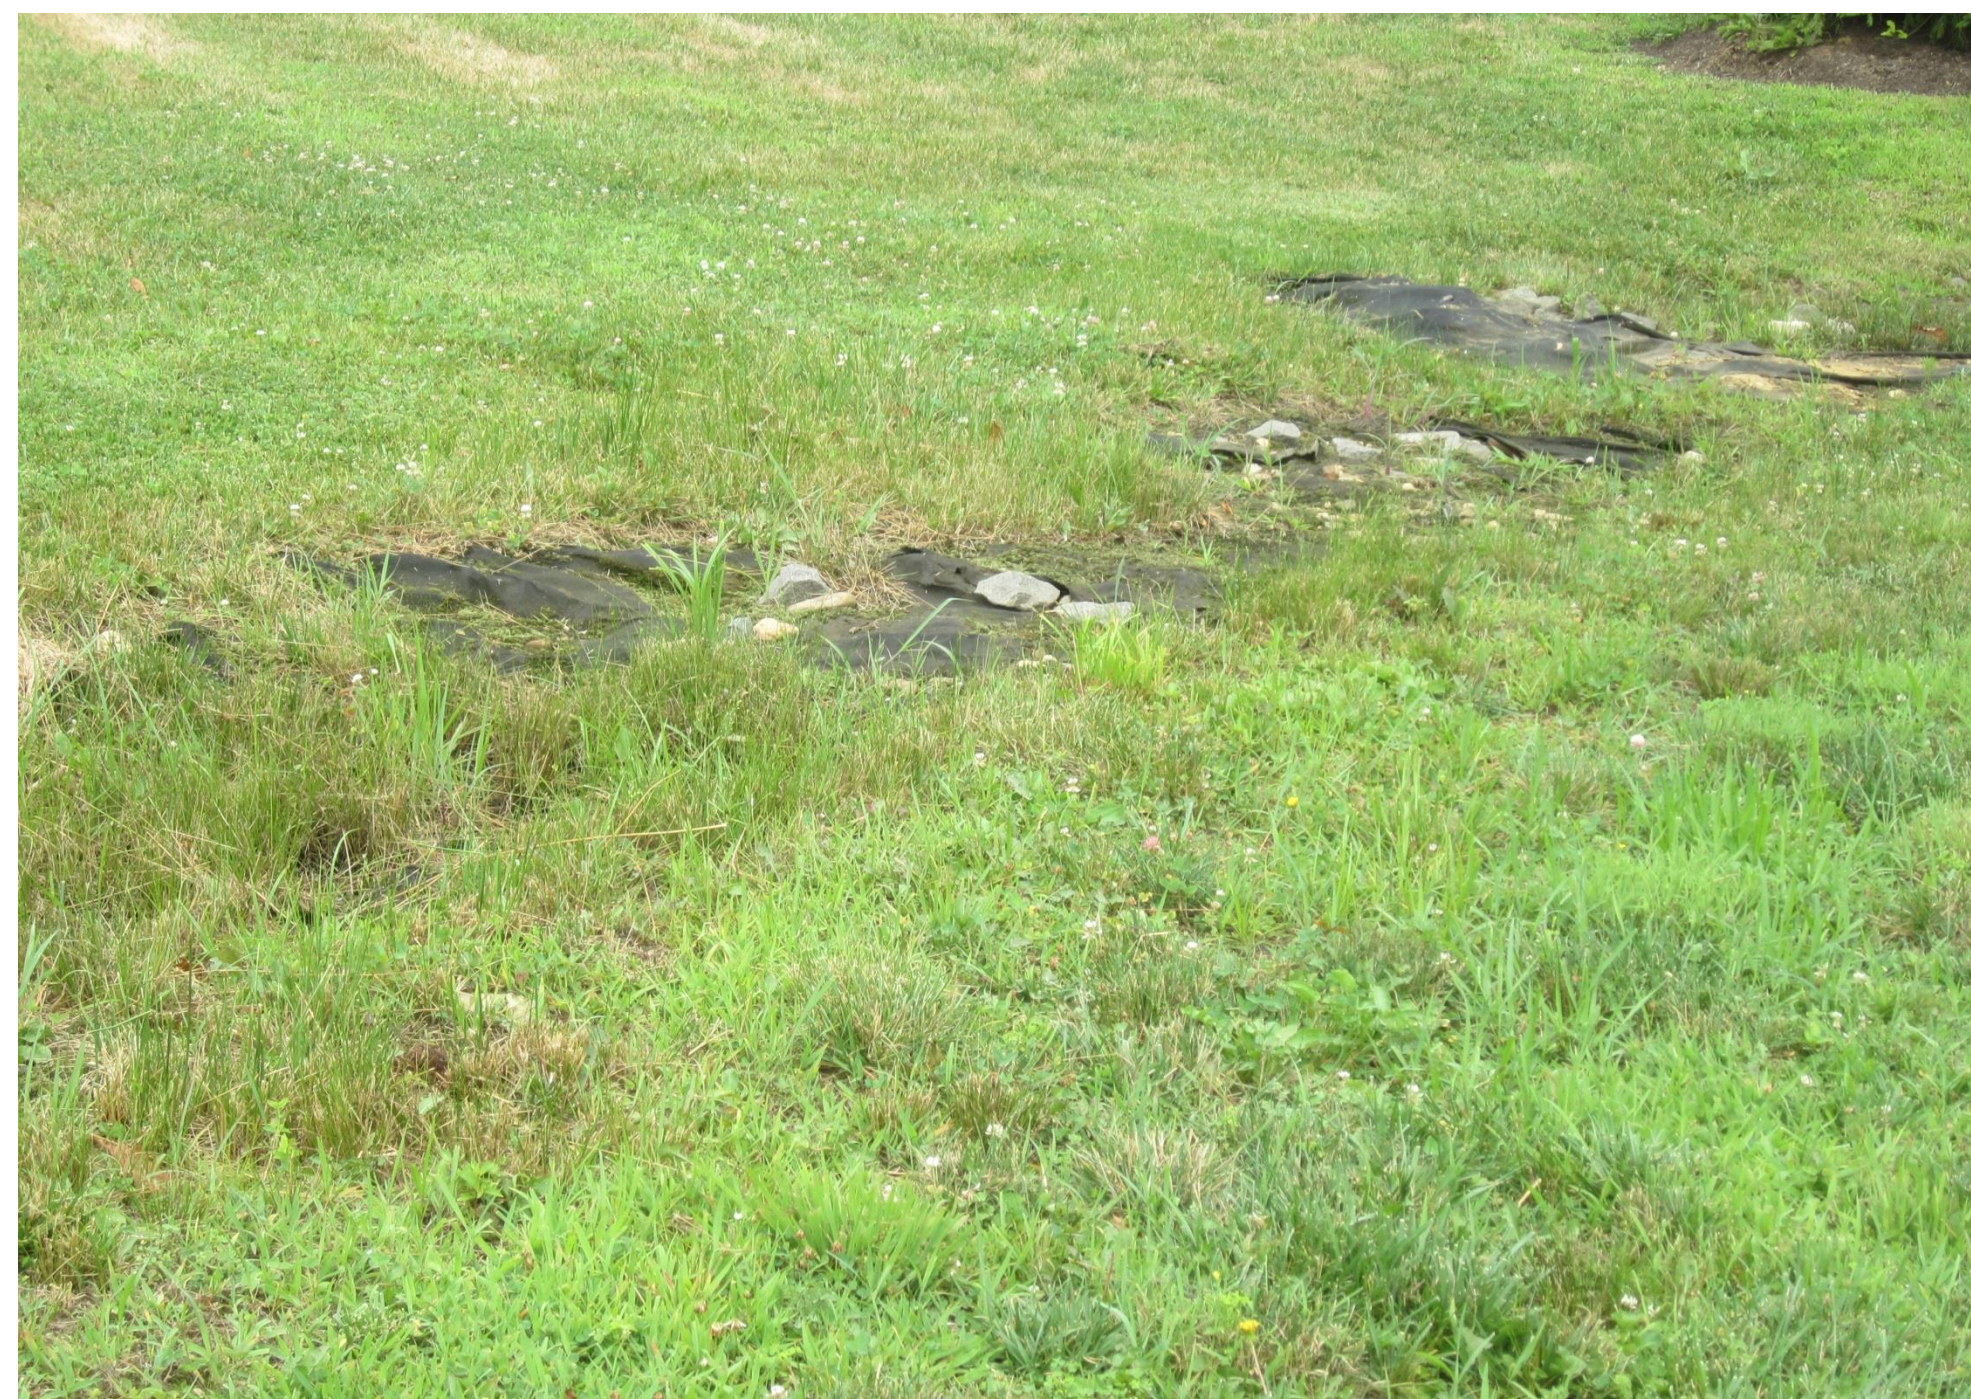
Low flow channel

- Inlet piping coming from roof runoff
- Deteriorated landscape fabric as low flow channel
- Sediment accumulation and standing water in basin bottom
- Outlet structure was clogged with sediment and debris

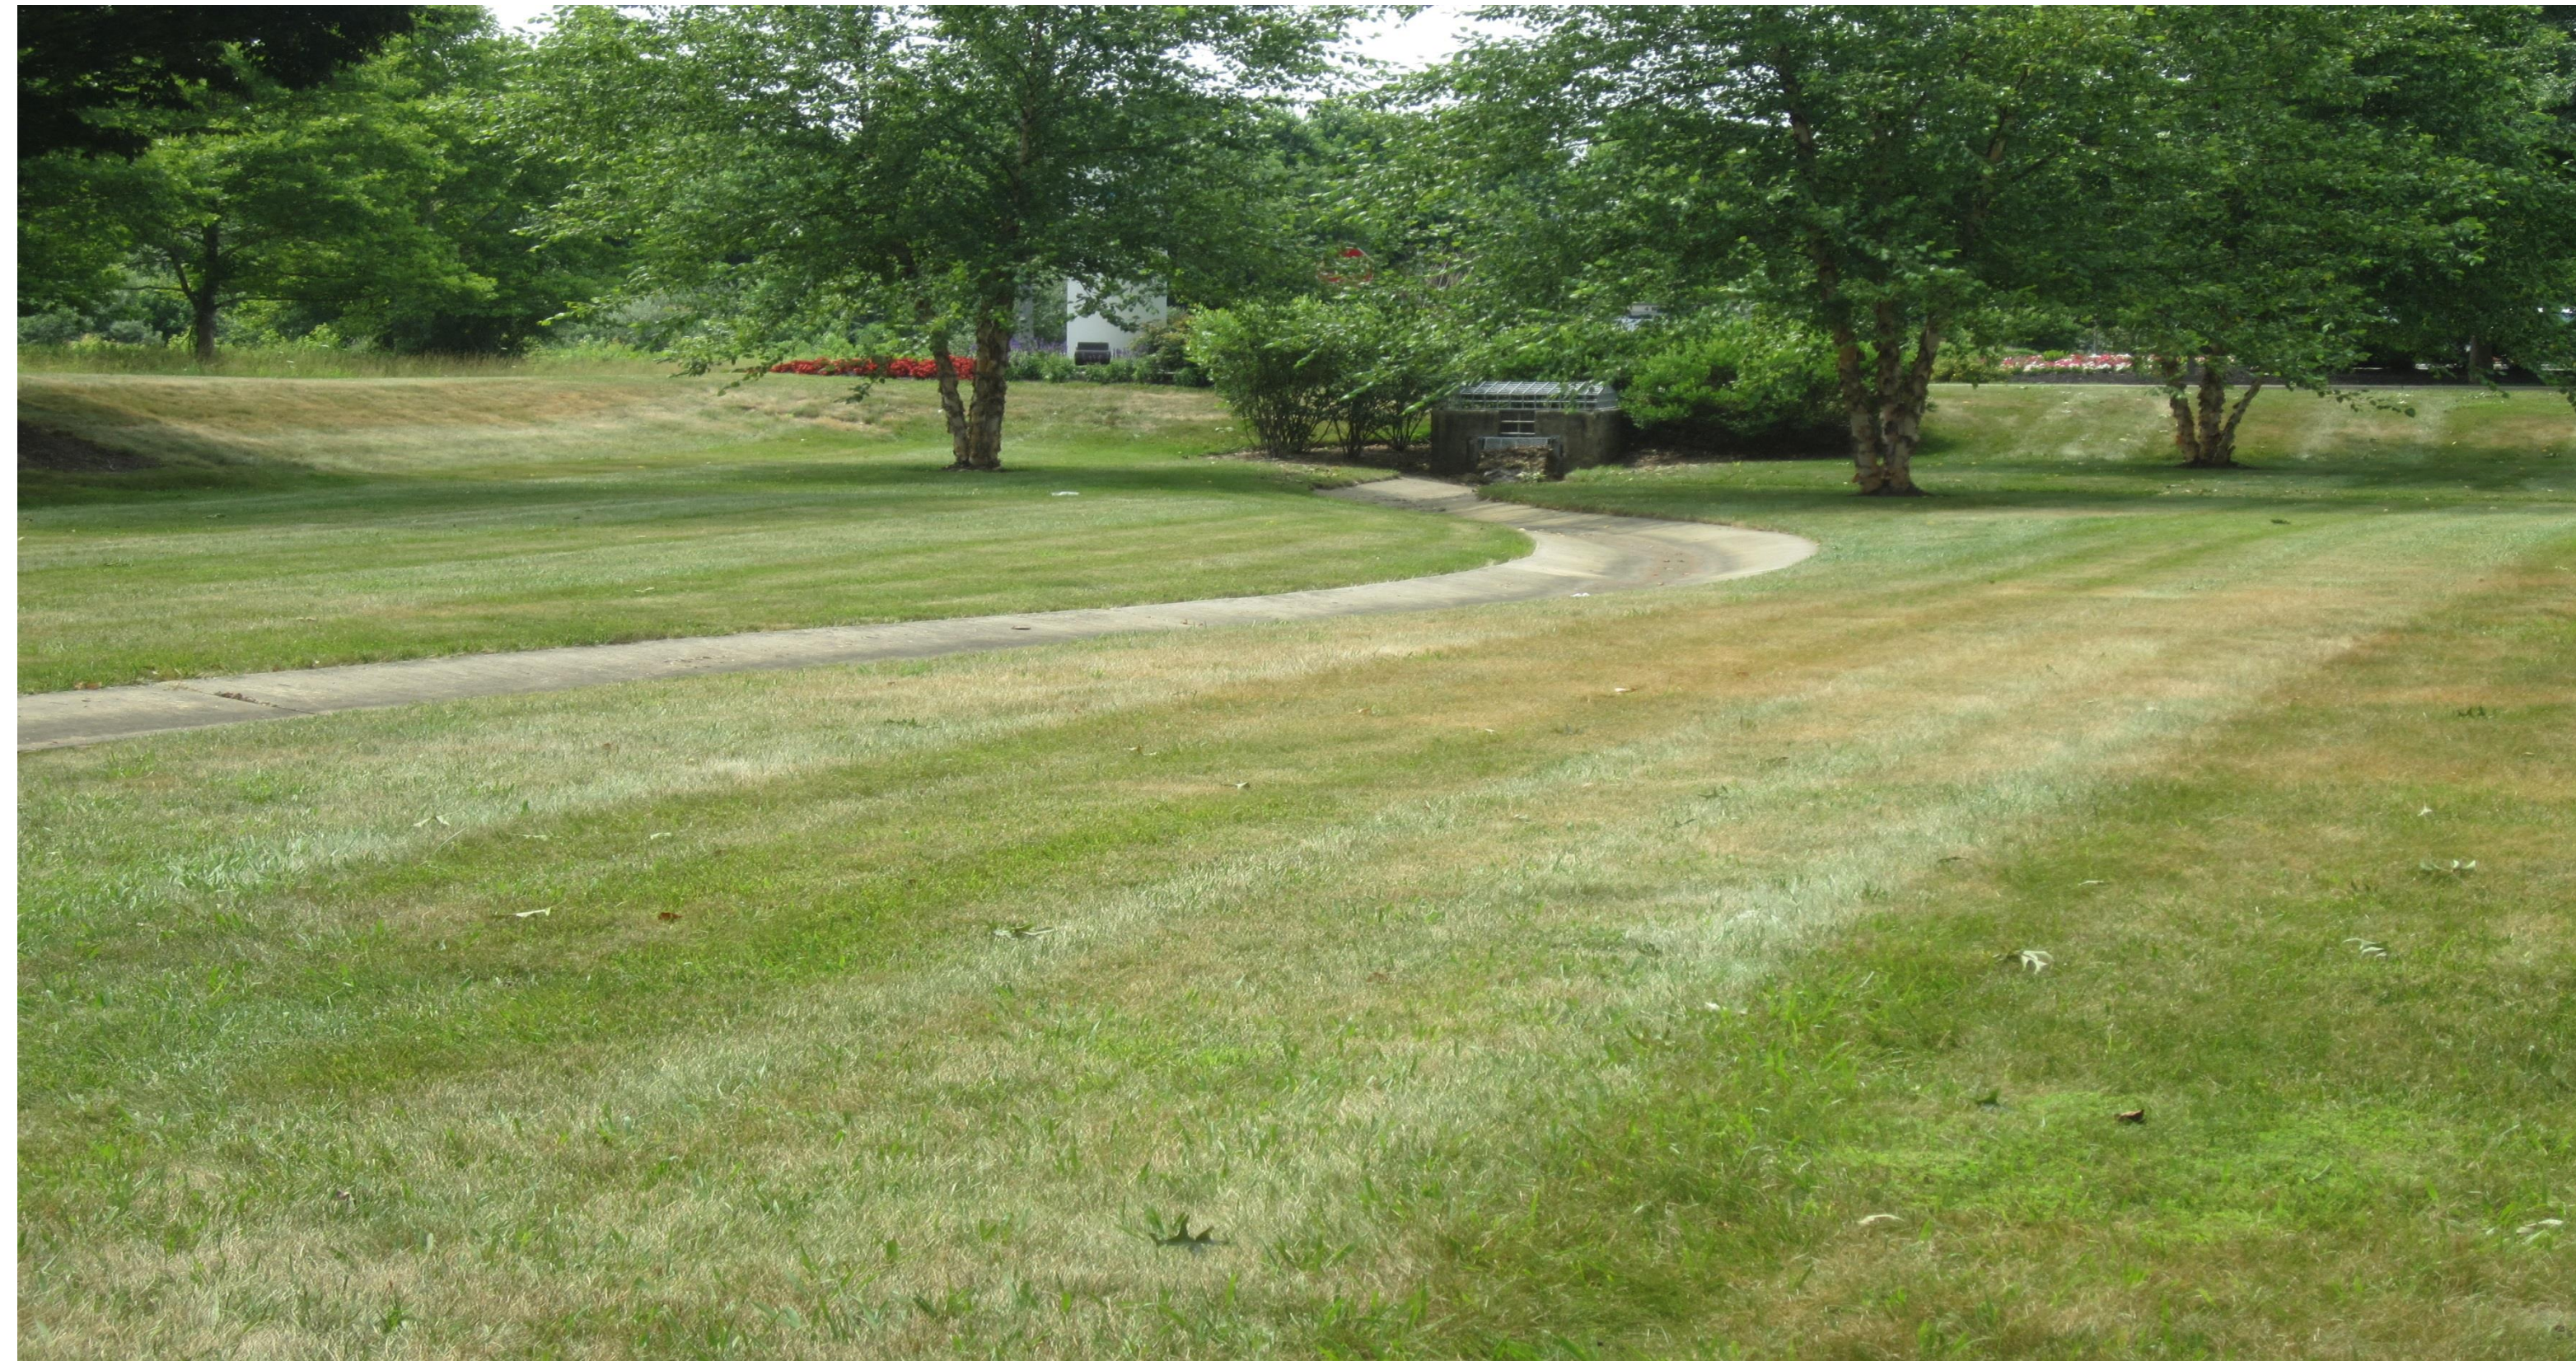
Basin overview

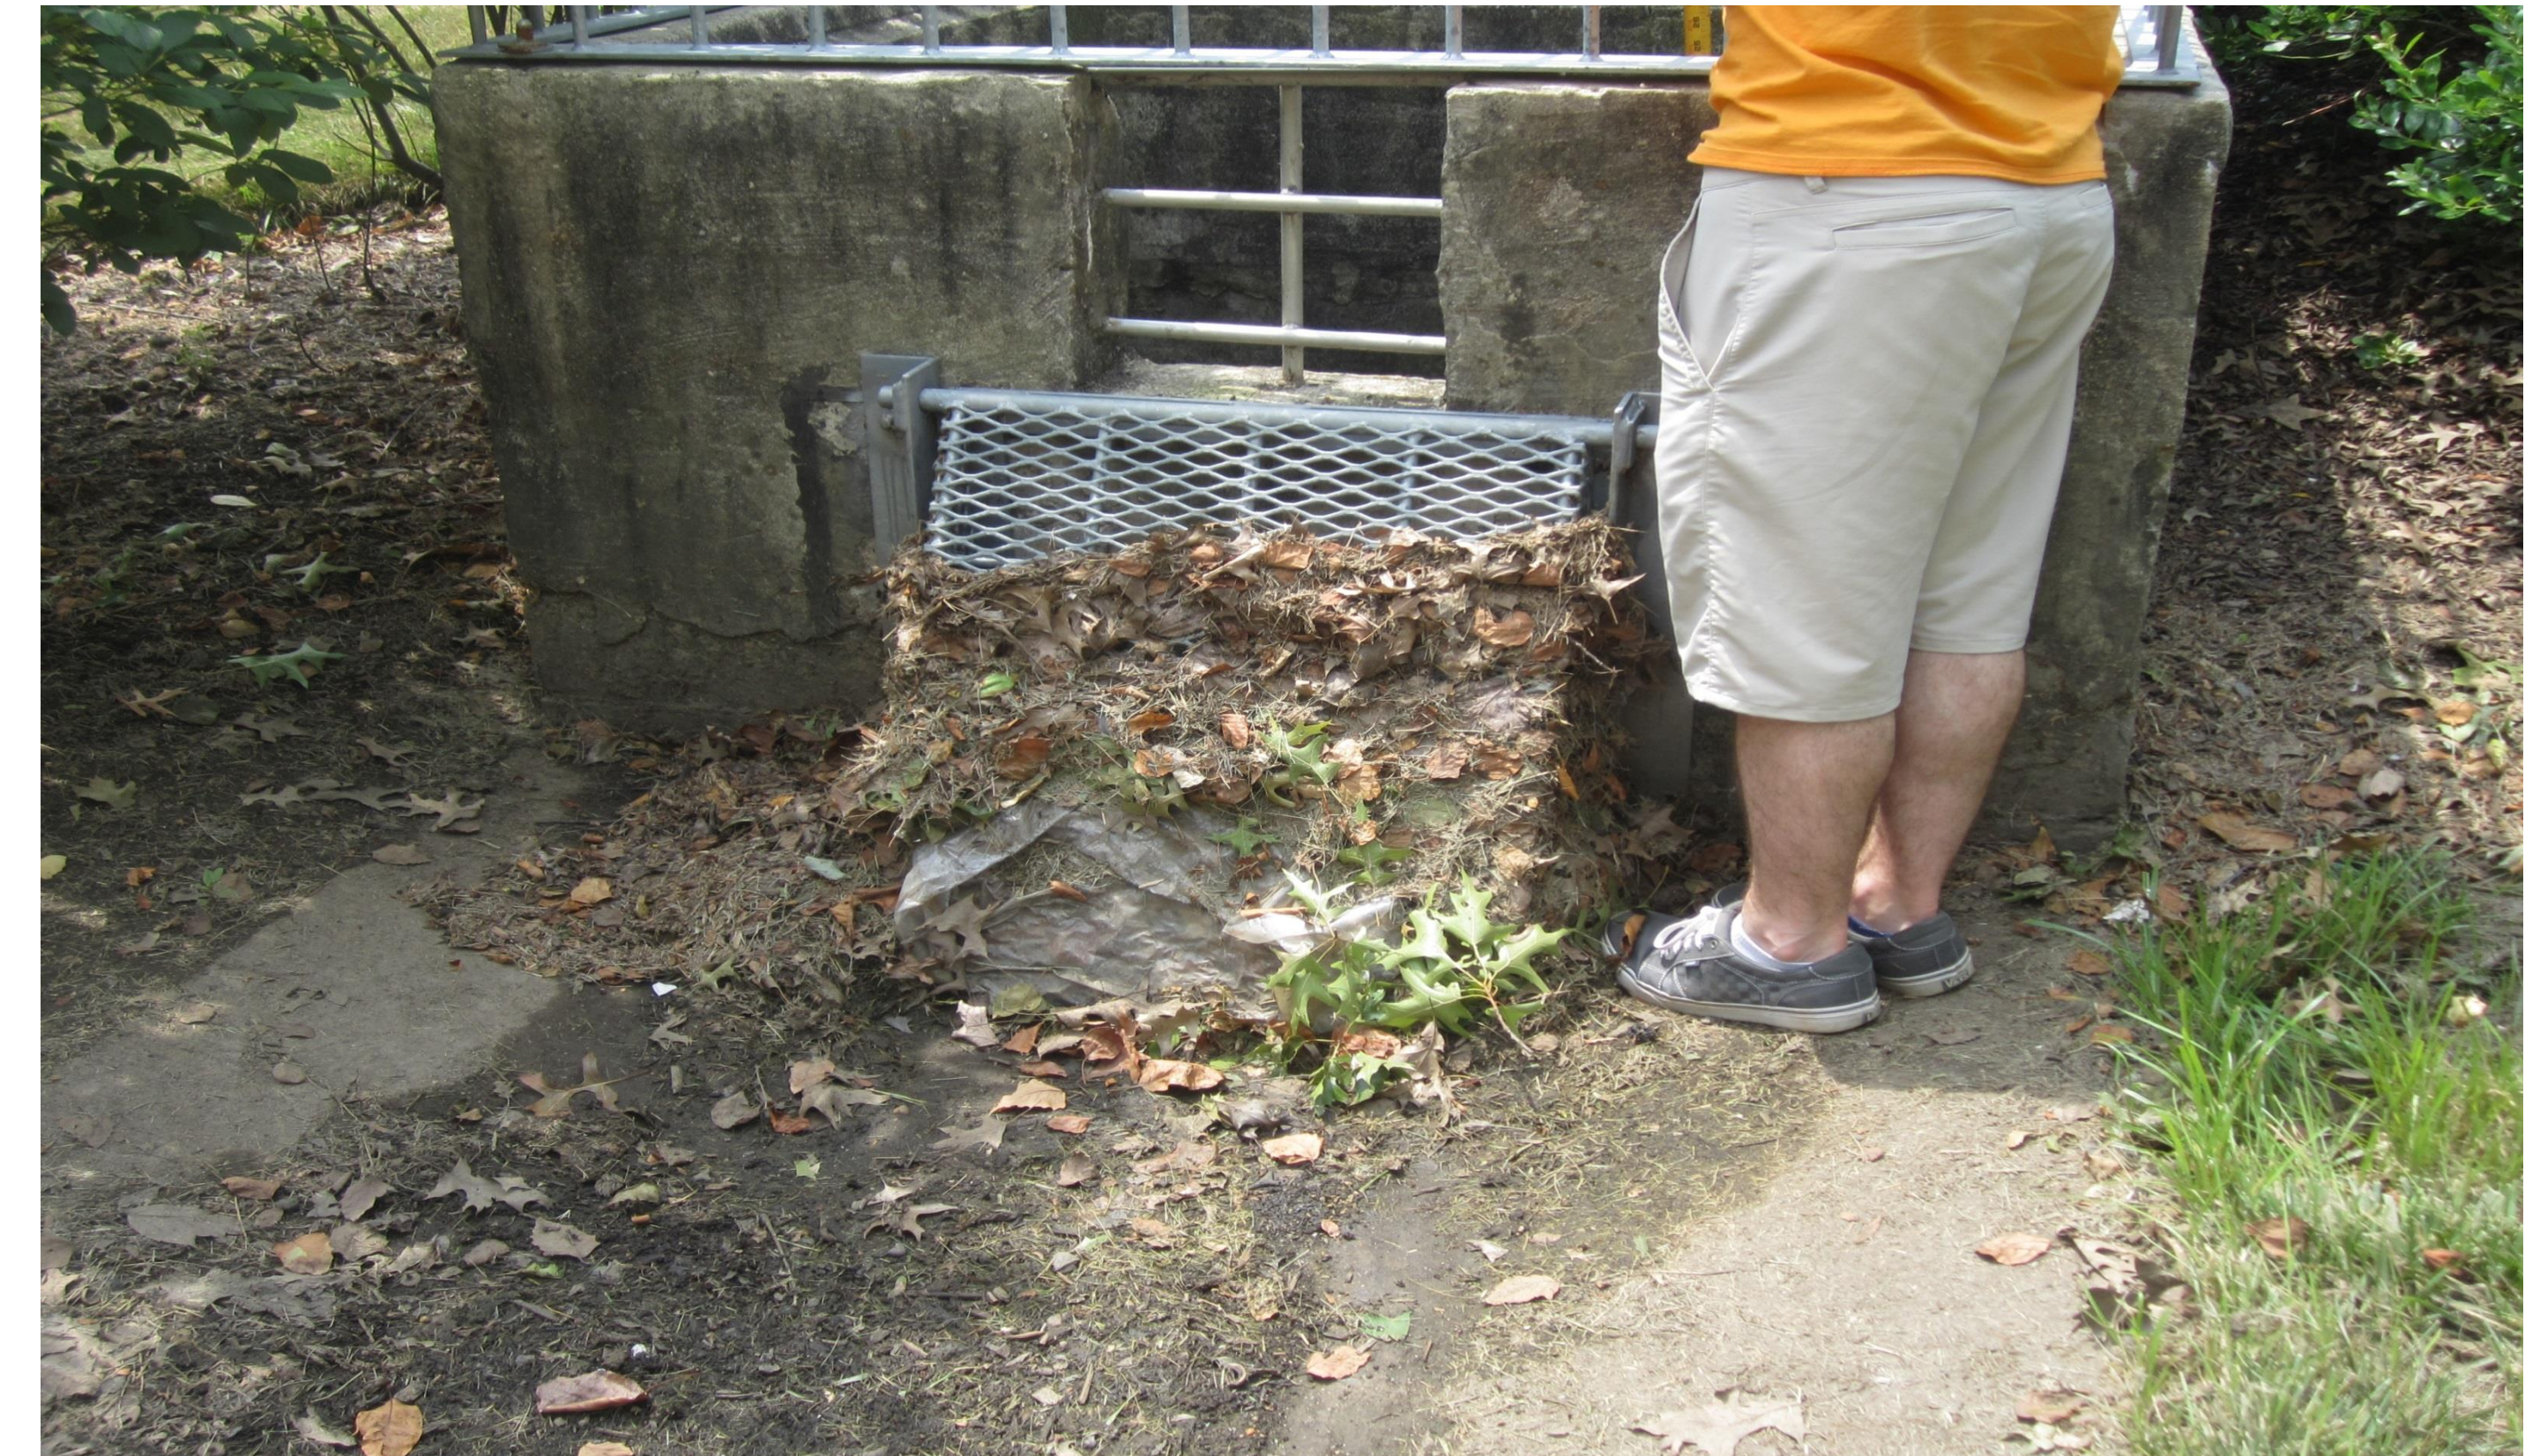
Outlet structure

- Leaf and sediment accumulation near outlet structure
- Some cracks near lower end of outlet structure
- Overall well maintained

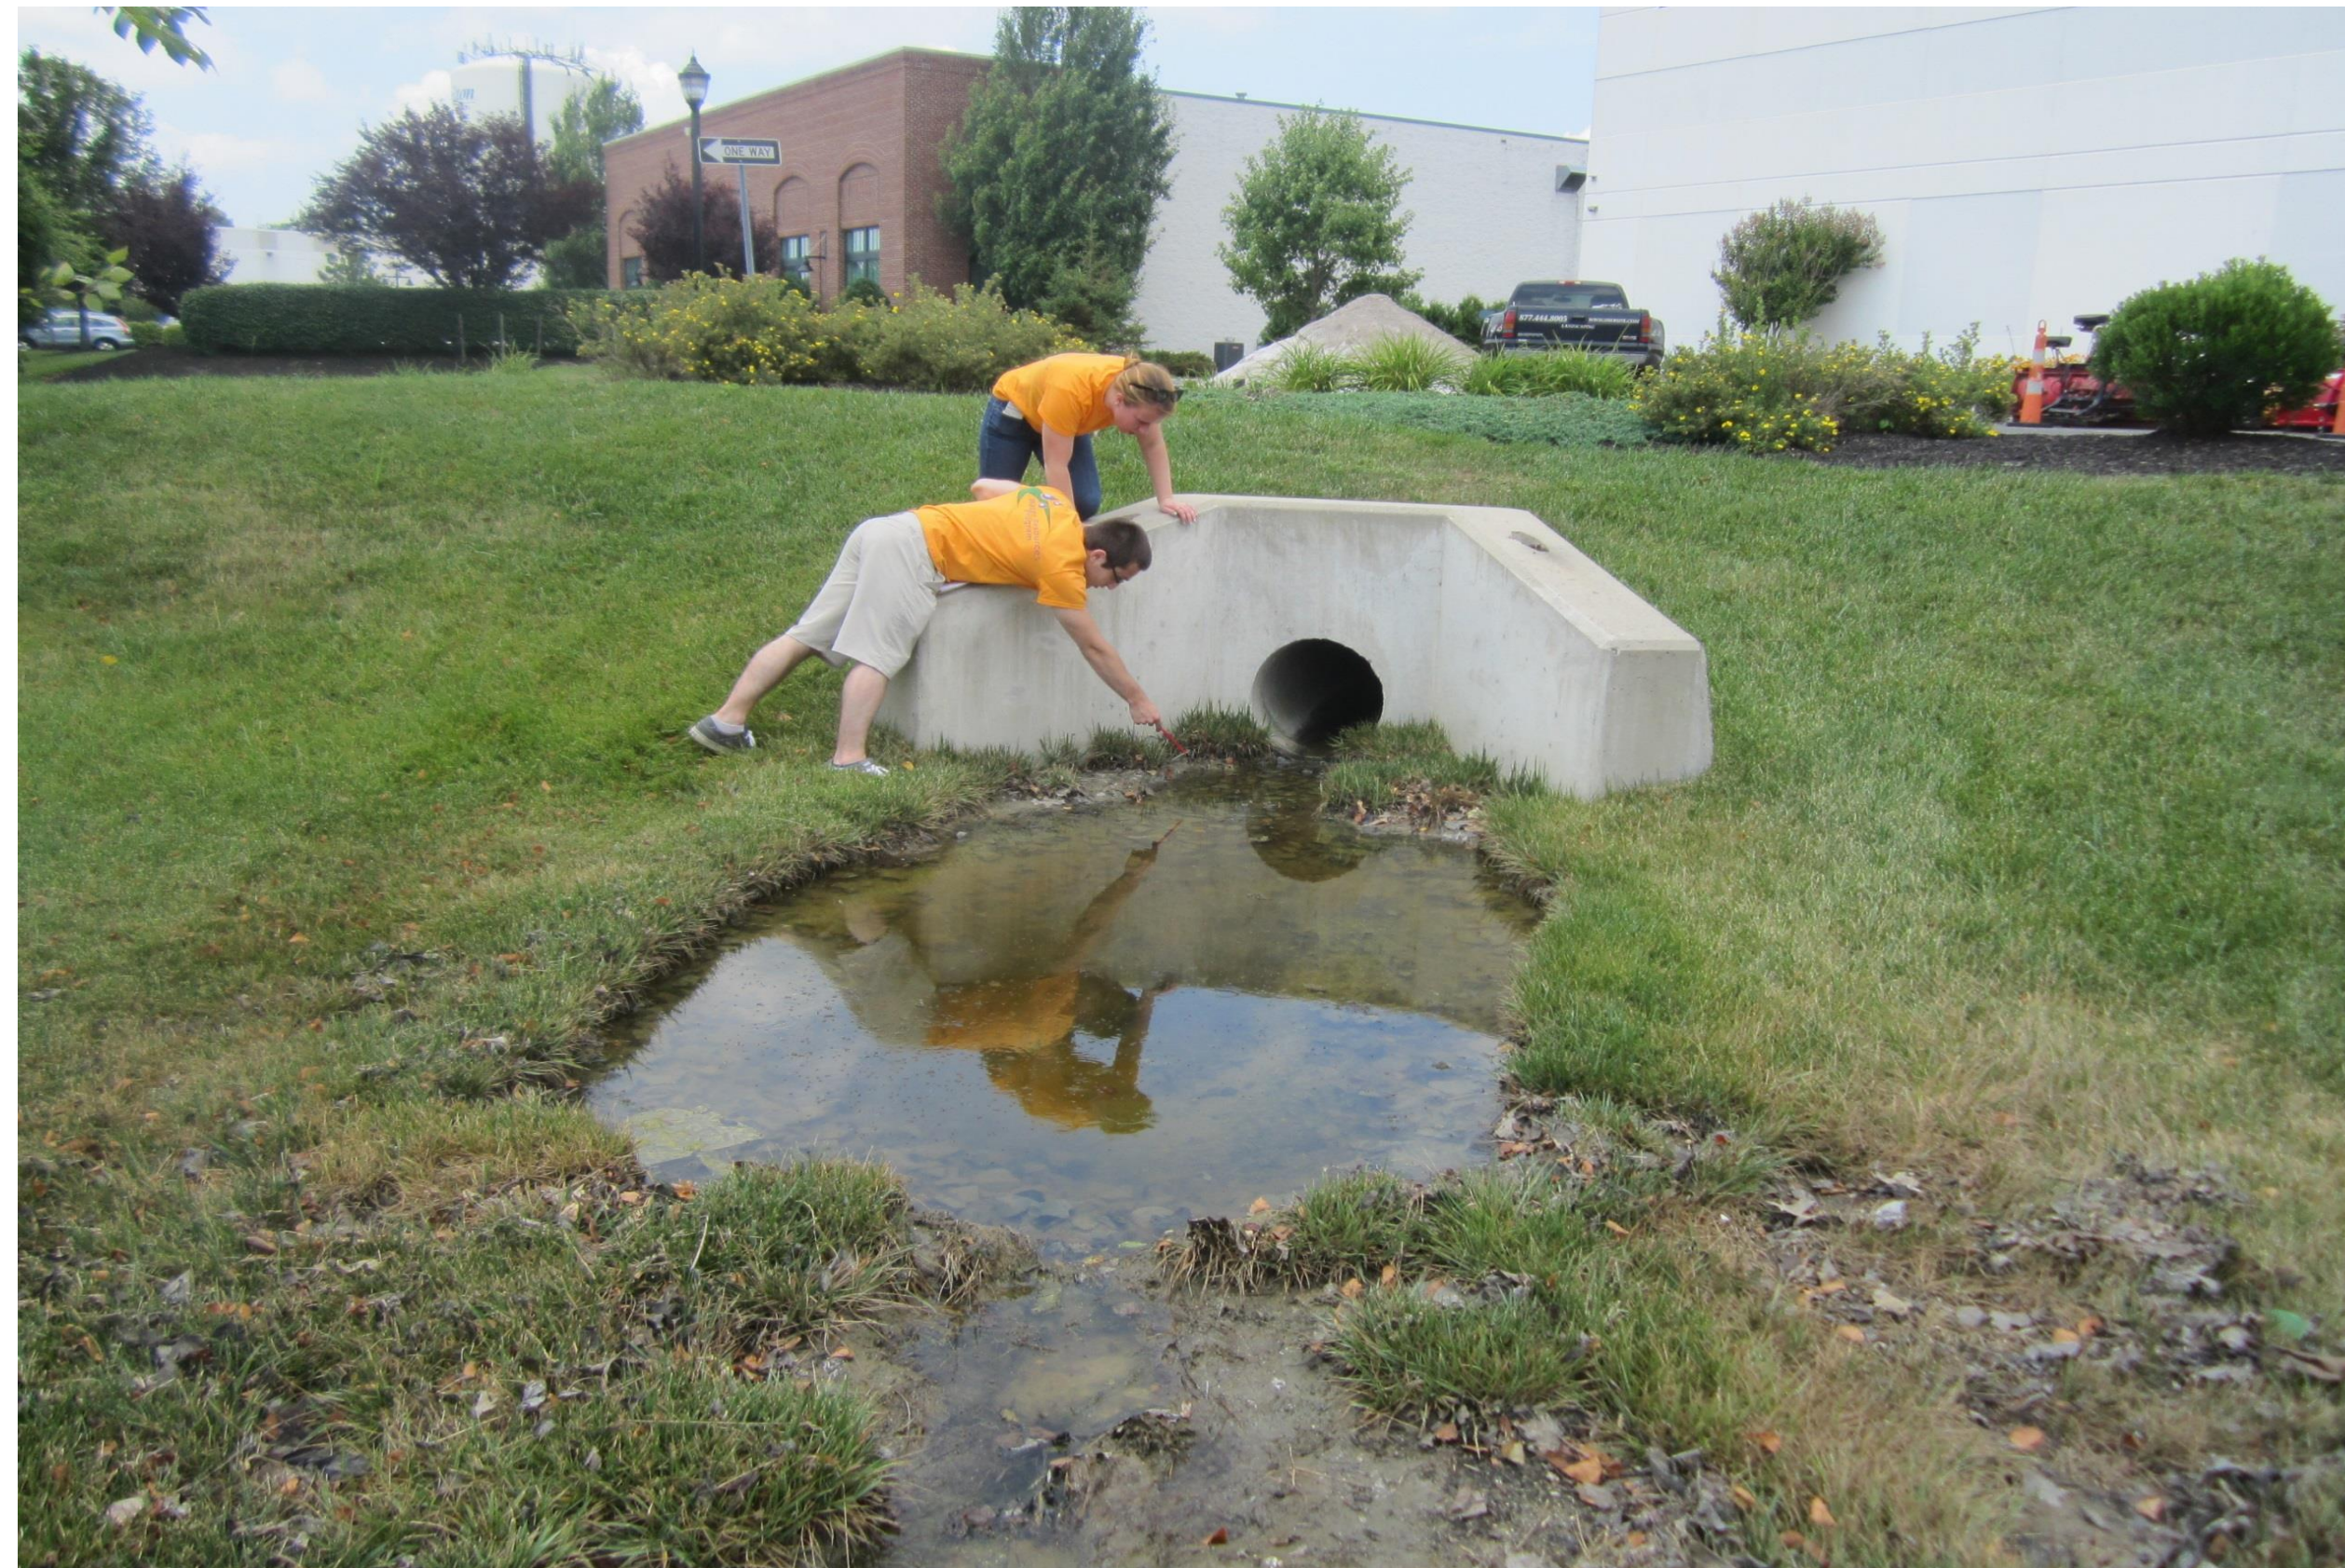
Inlet

- Infiltration basin with stone wall providing additional detention time
- Grass clippings, sediment, and standing water near both inlets
- Leeches present in the standing water near western inlet
- Outlet made of poured concrete
