**Hamilton Township (Mercer County)
Stormwater Basin Assessment Summary
Addendum (Year 3)**

Developed by the Rutgers Cooperative Extension Water Resources Program
Funded by Hamilton Township, Mercer County, New Jersey

September 30, 2014

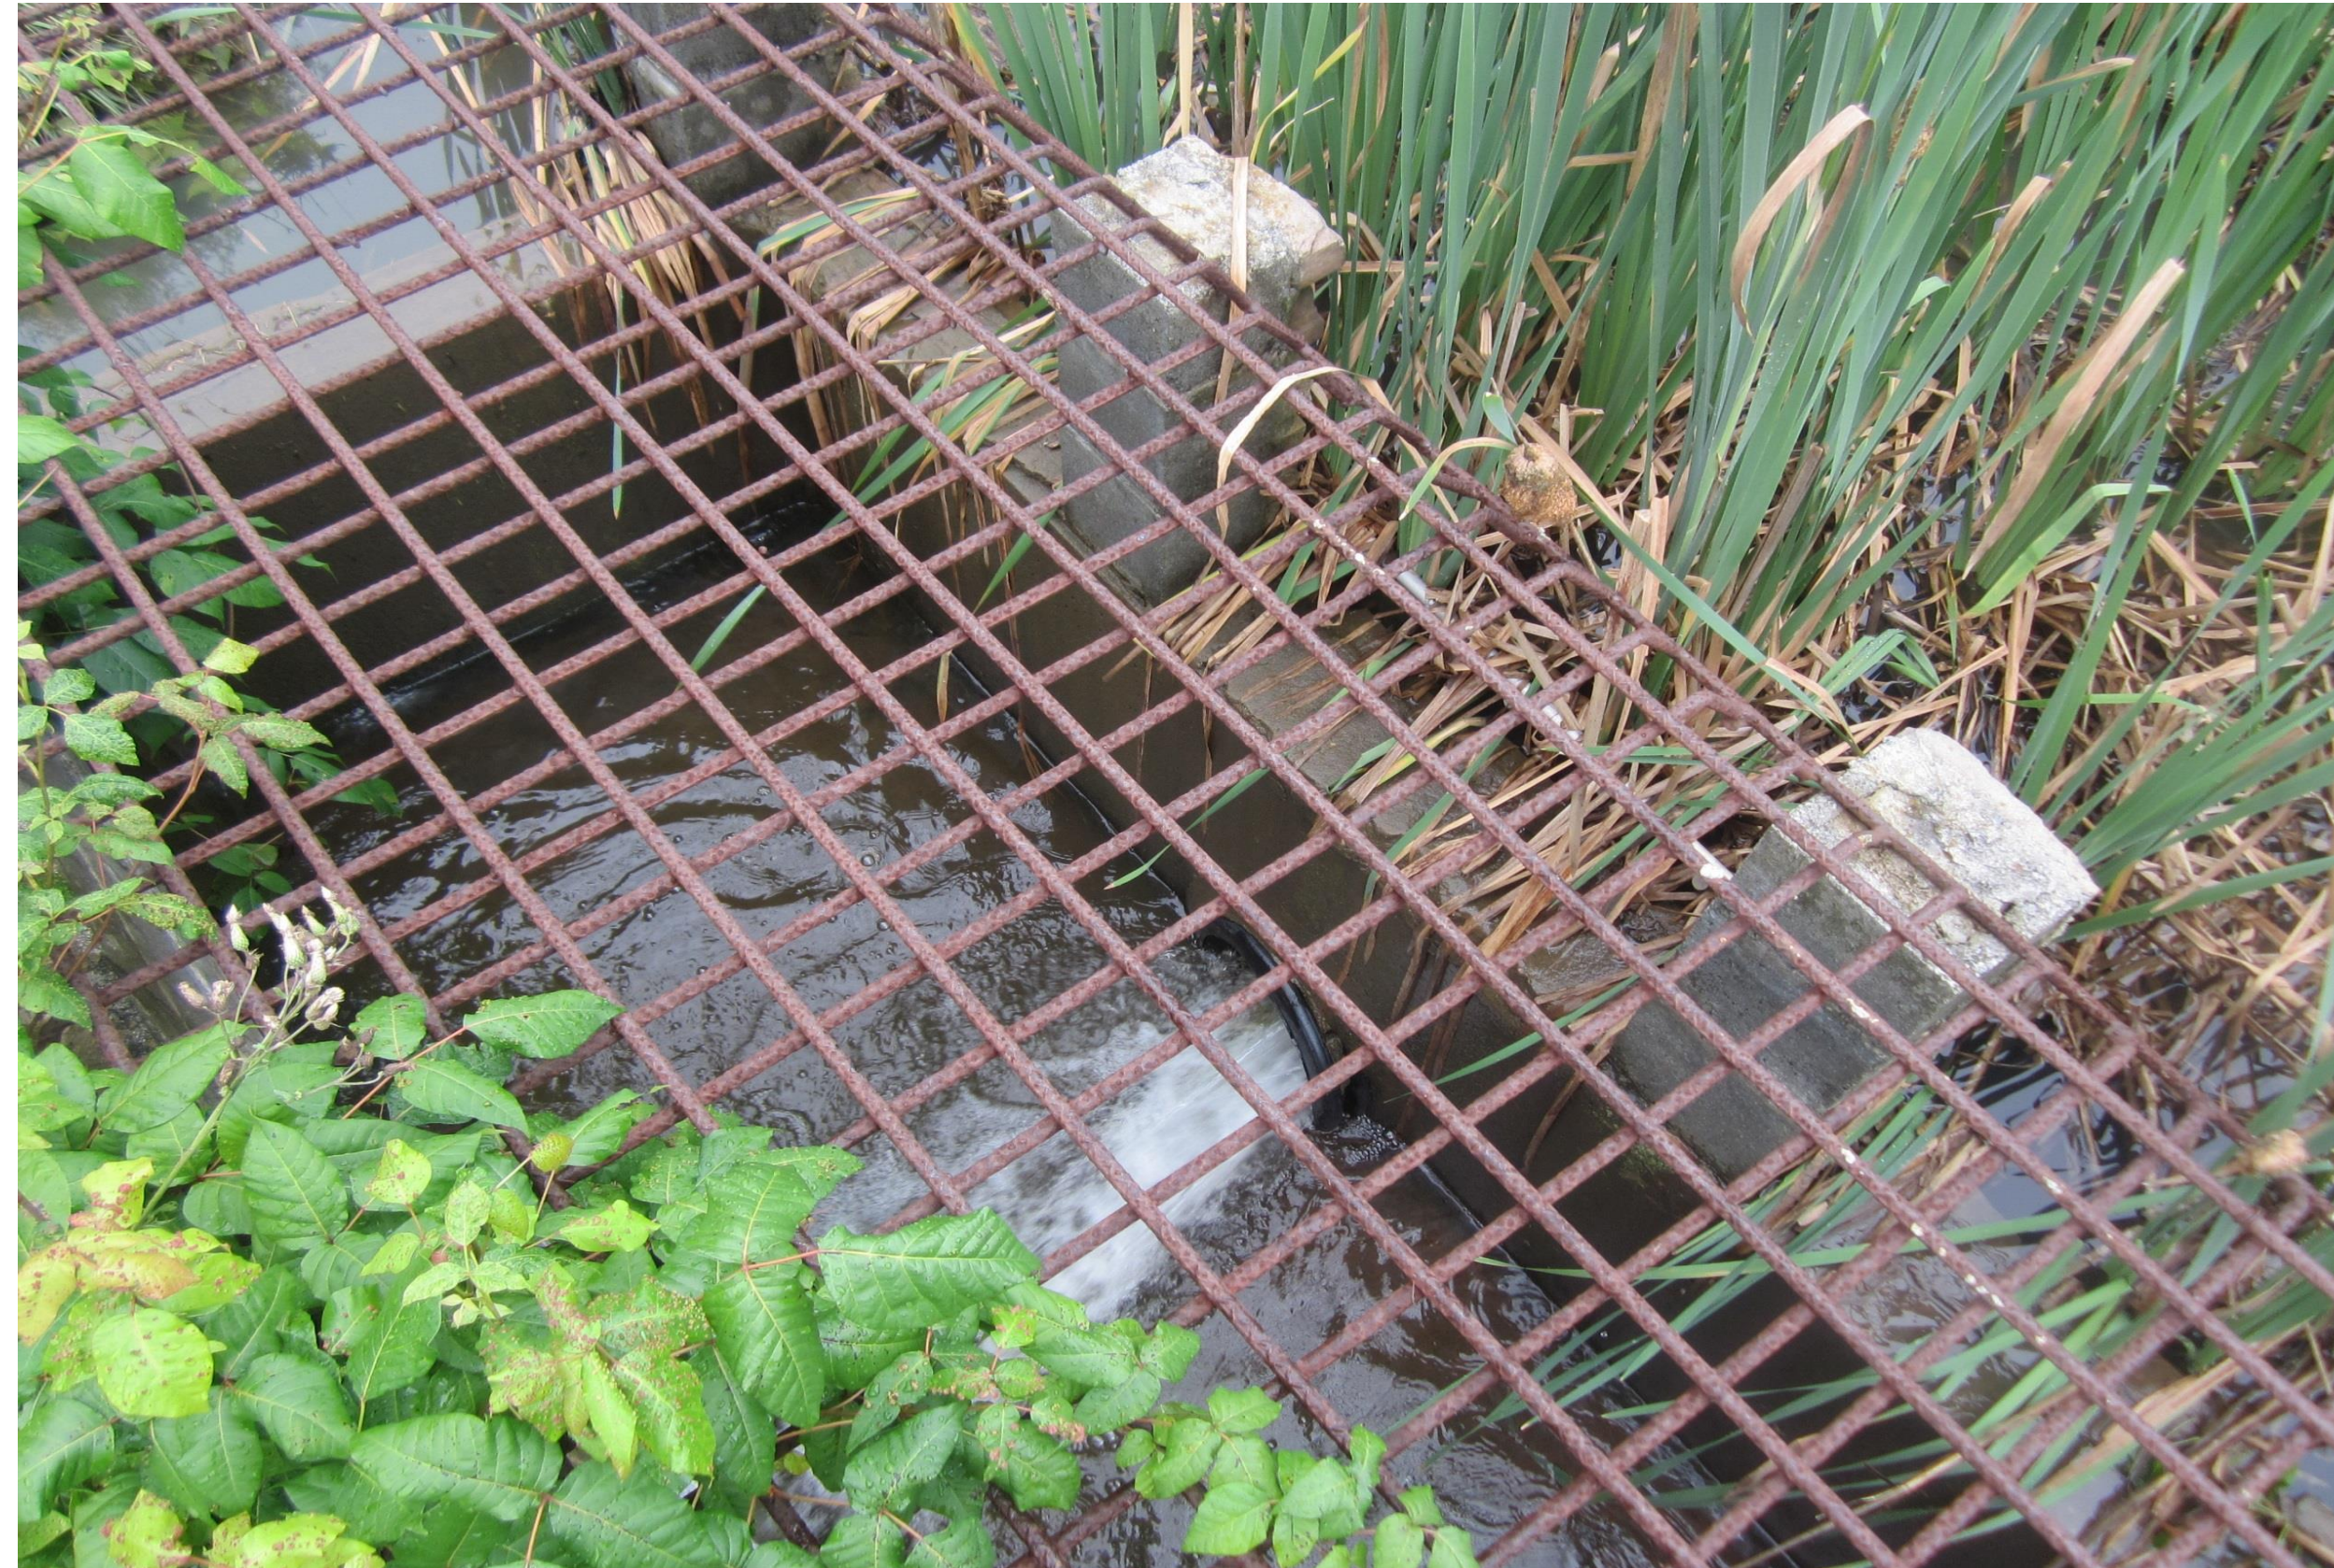
Top View of Outlet

- Older outlet made of concrete blocks
- Rusted steel grate
- Erosion and slumping around outlet
- Infiltration basin – appears to be functioning properly
- Meadows growing in basin bottom near all inlet structures
- Connected to swale north of Horizon Drive

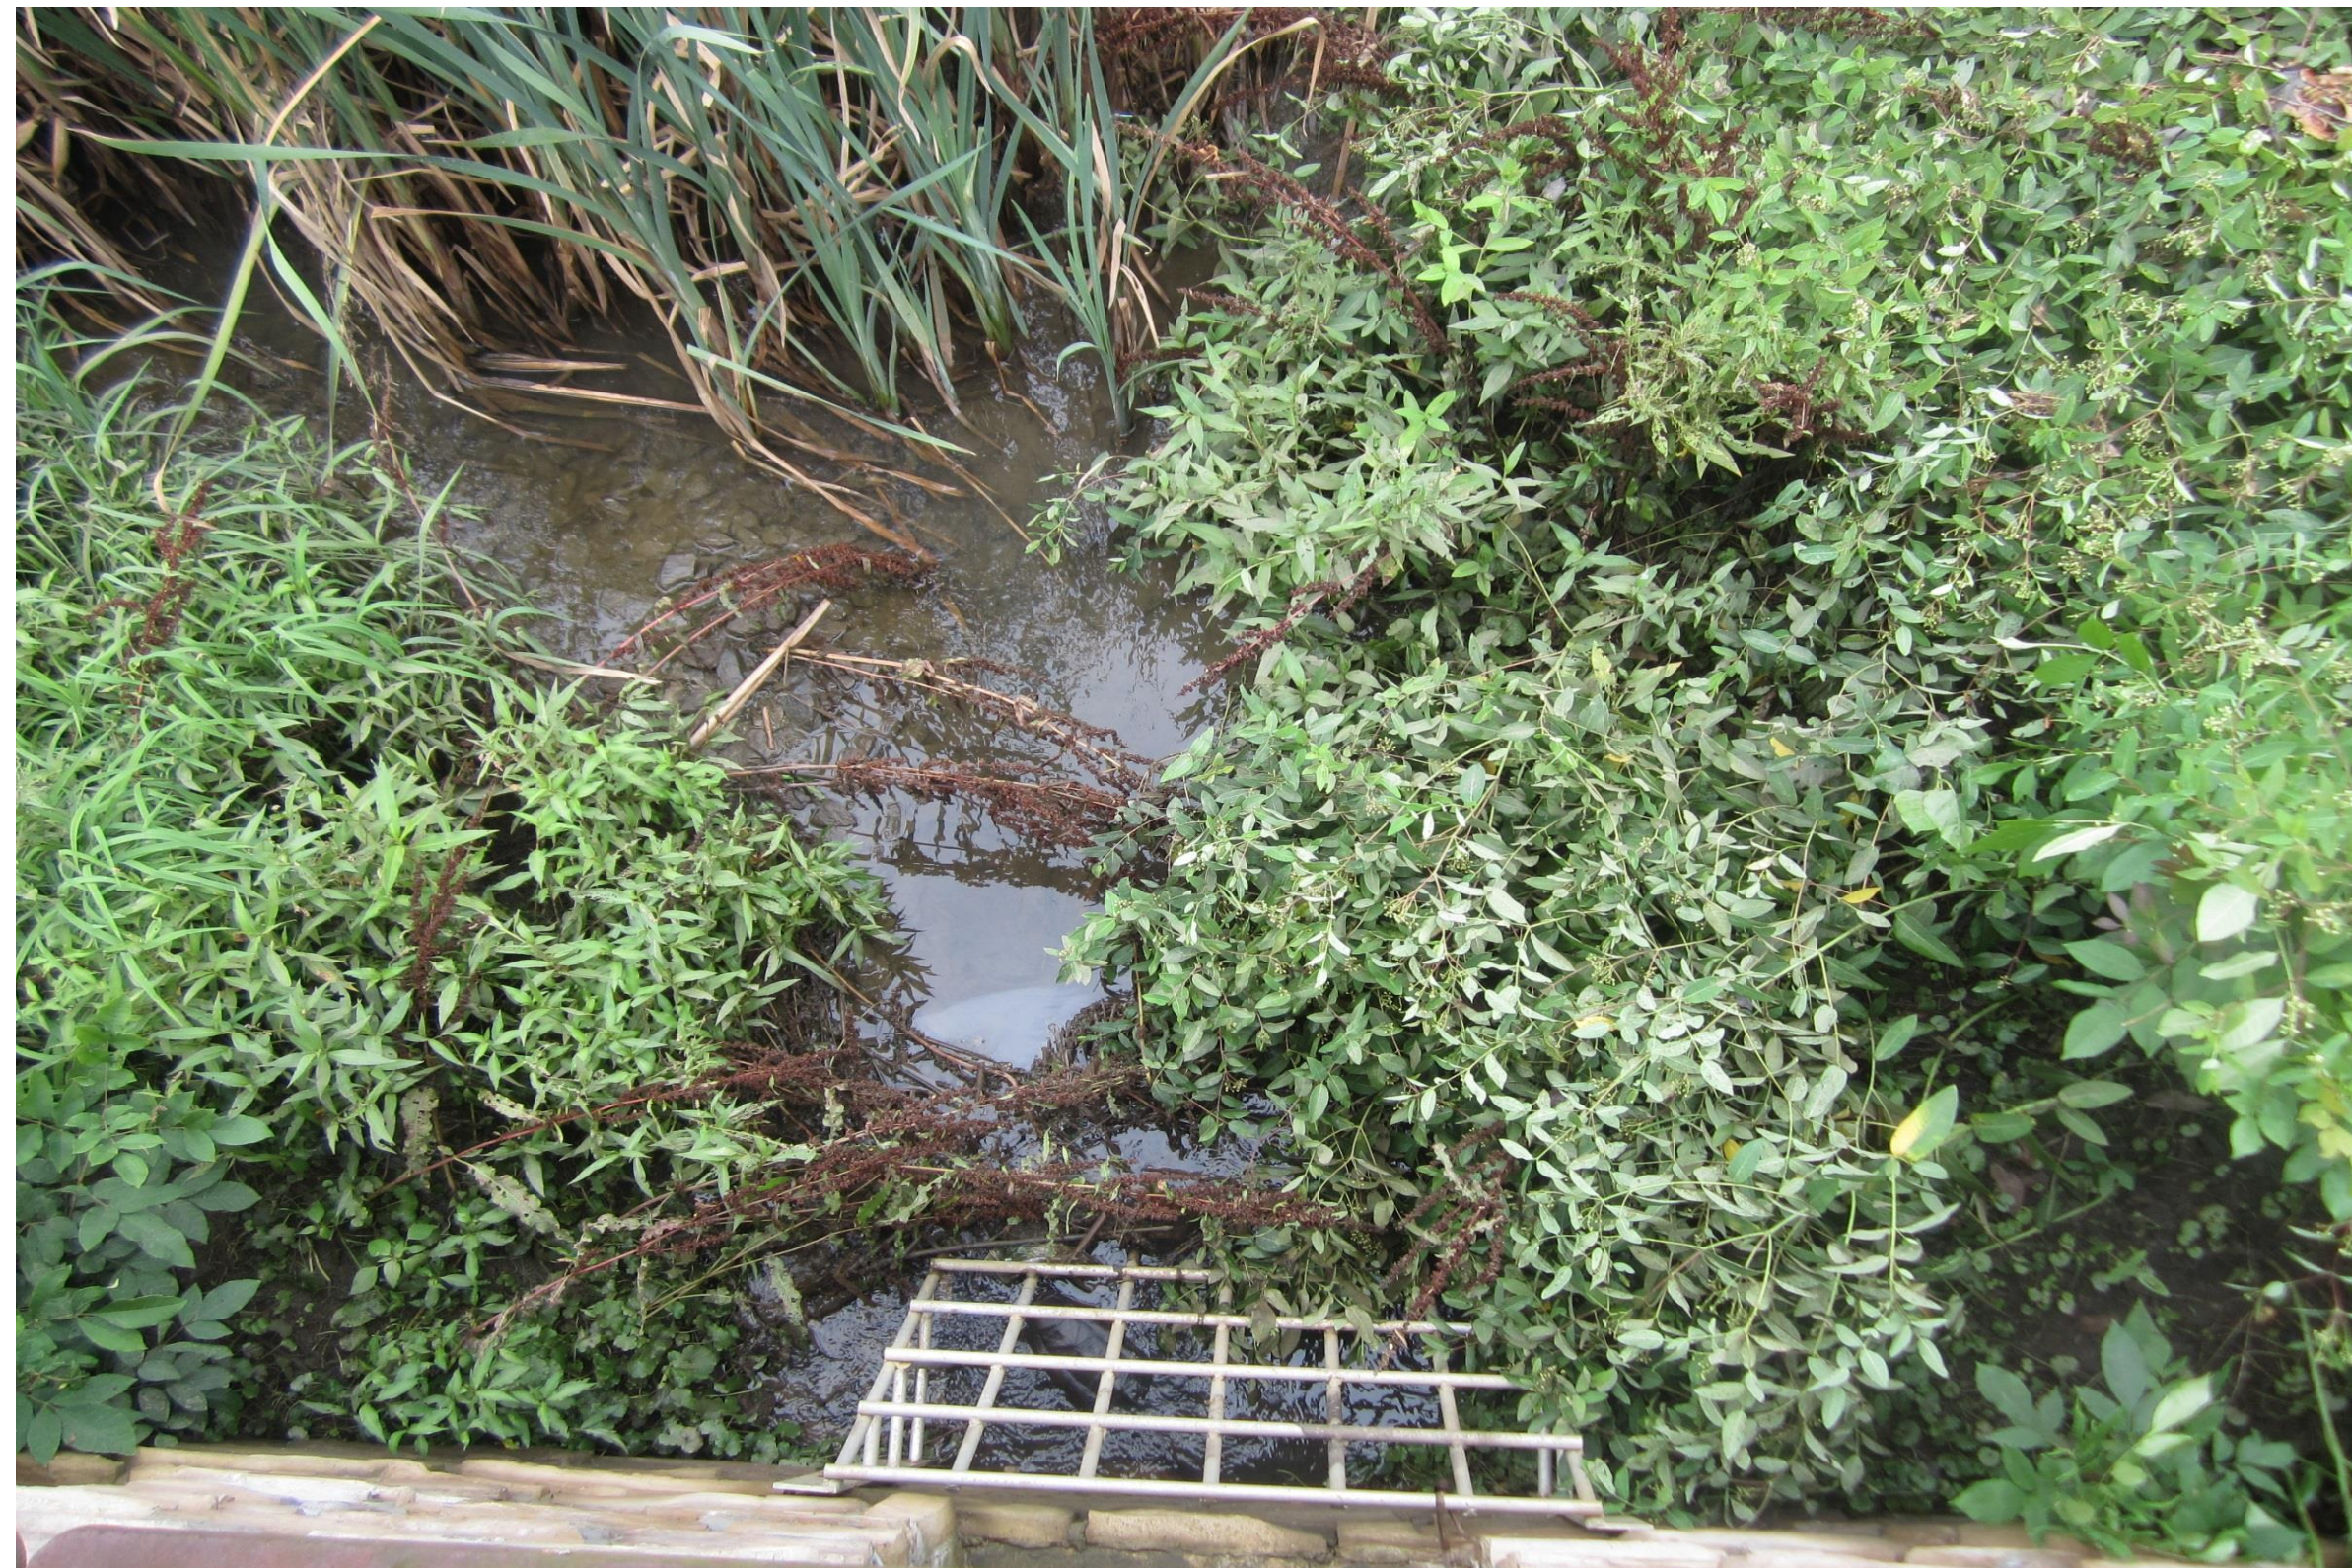
- Low flow channel is overgrown and broken
- Low flow channel has excess sediment and standing water
- Outlet has sediment accumulation and strong odor problems

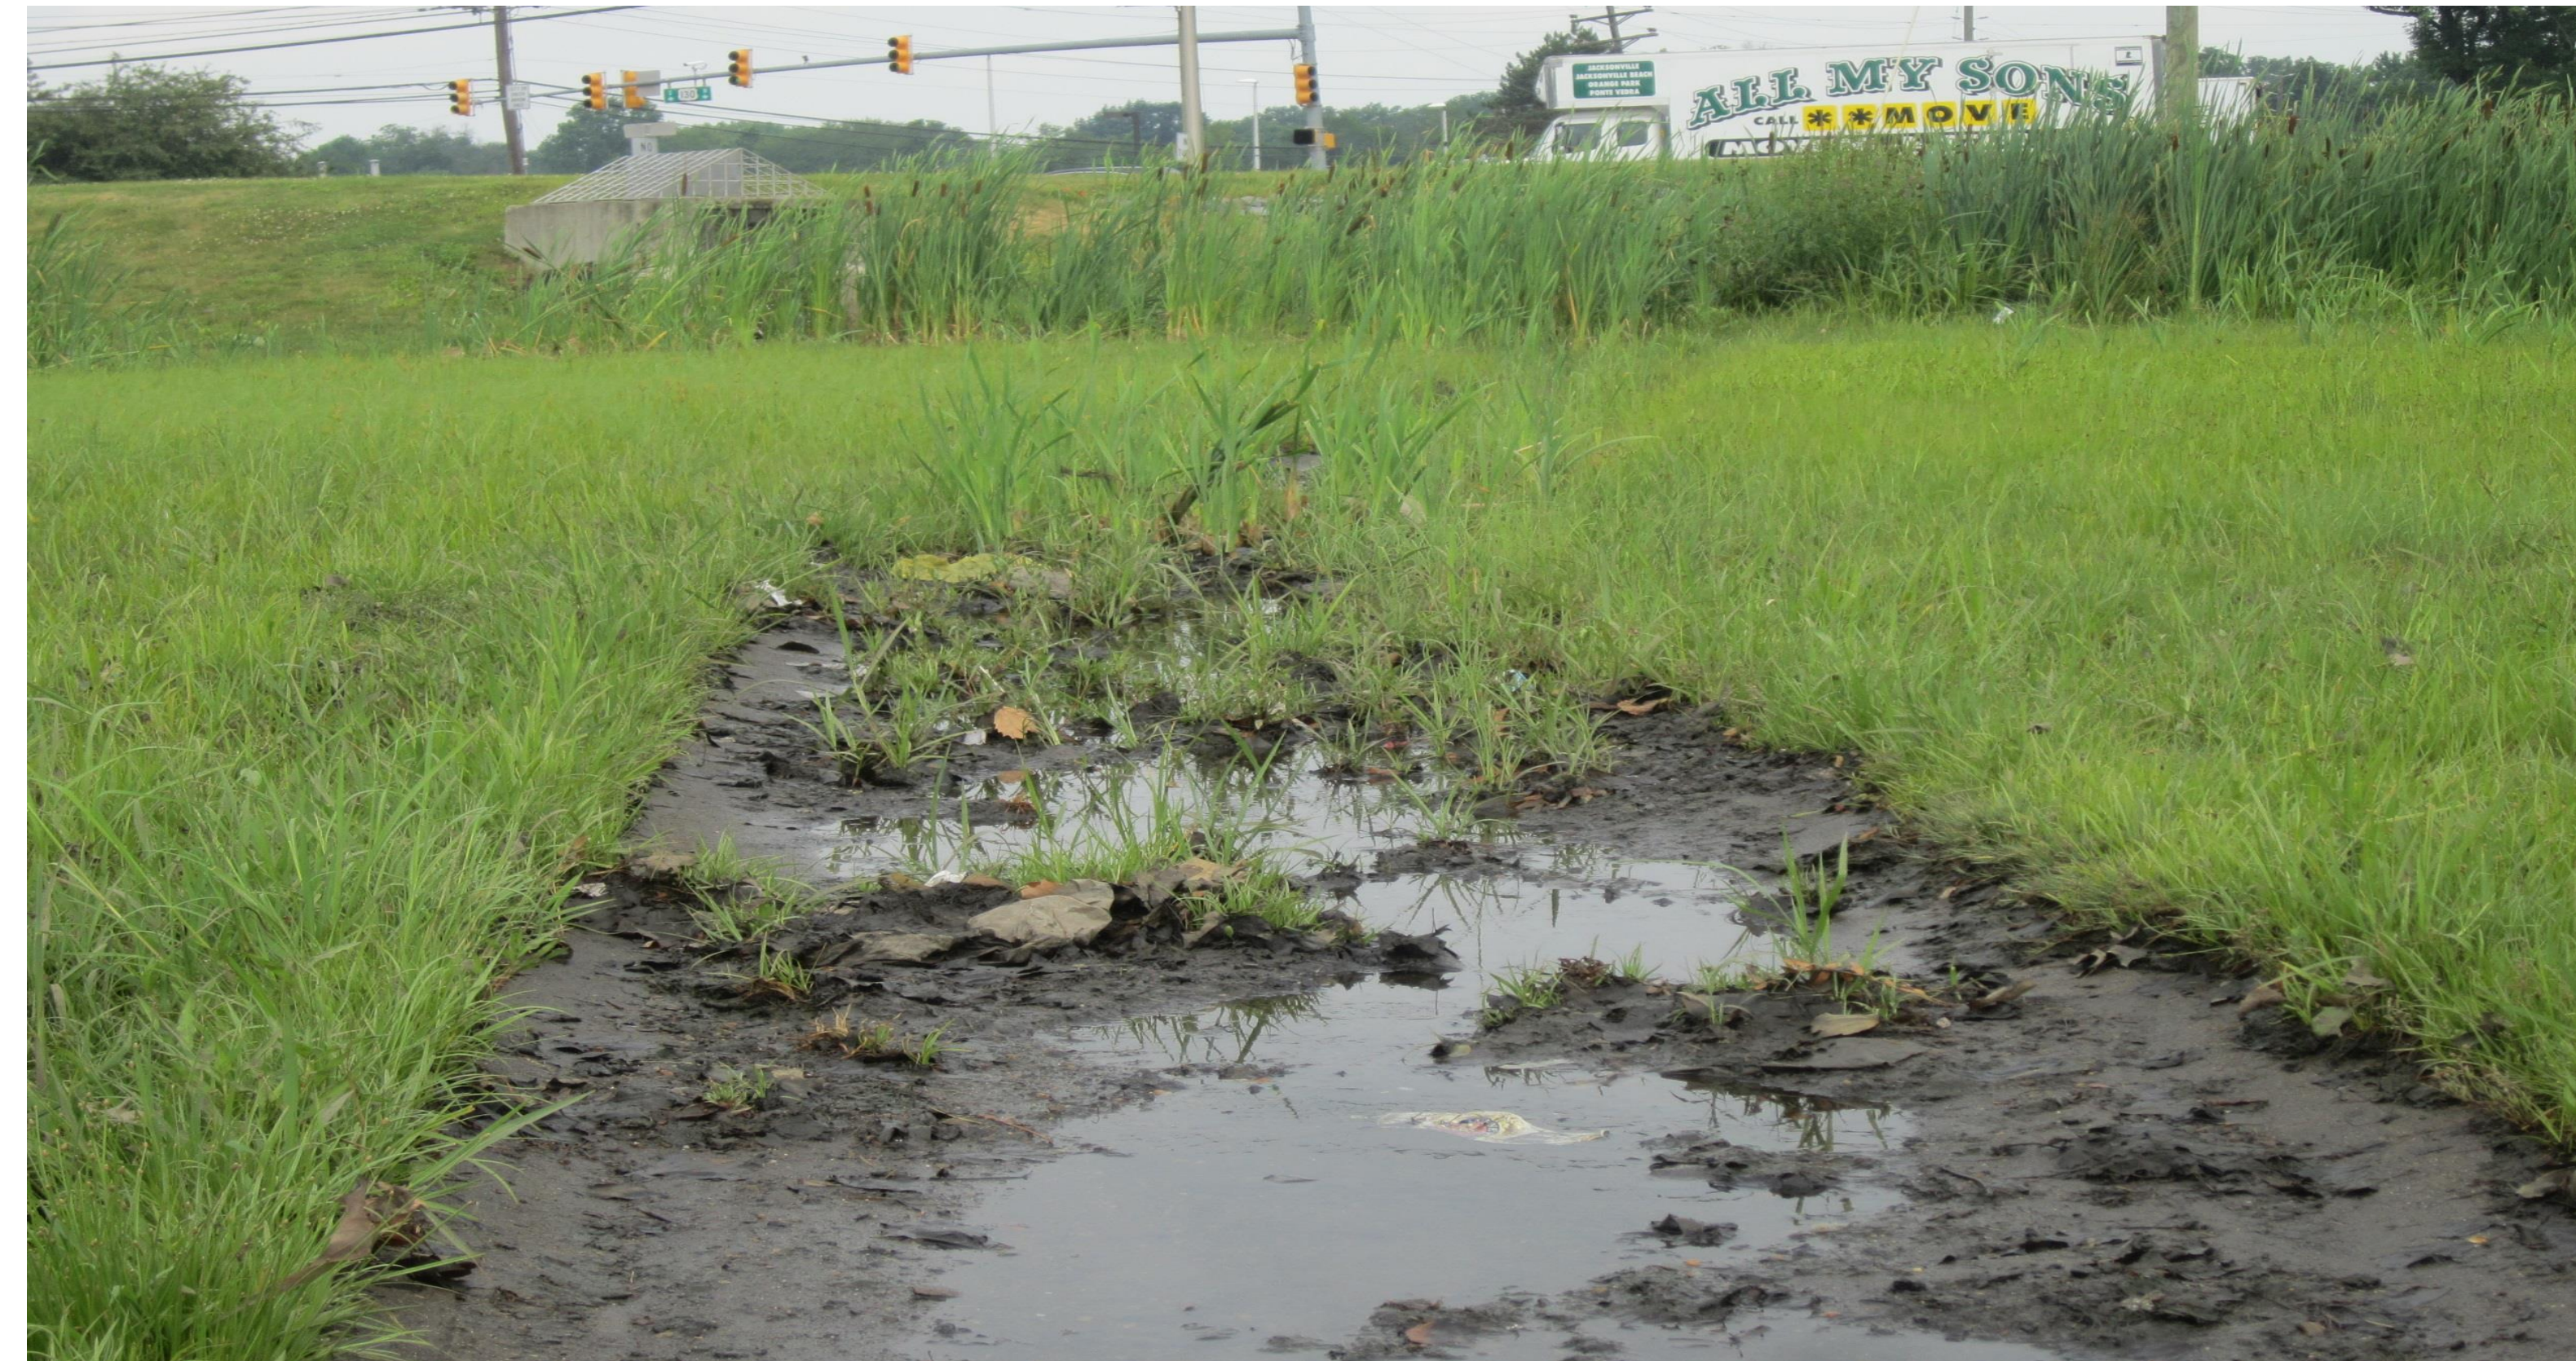
Sediment accumulation

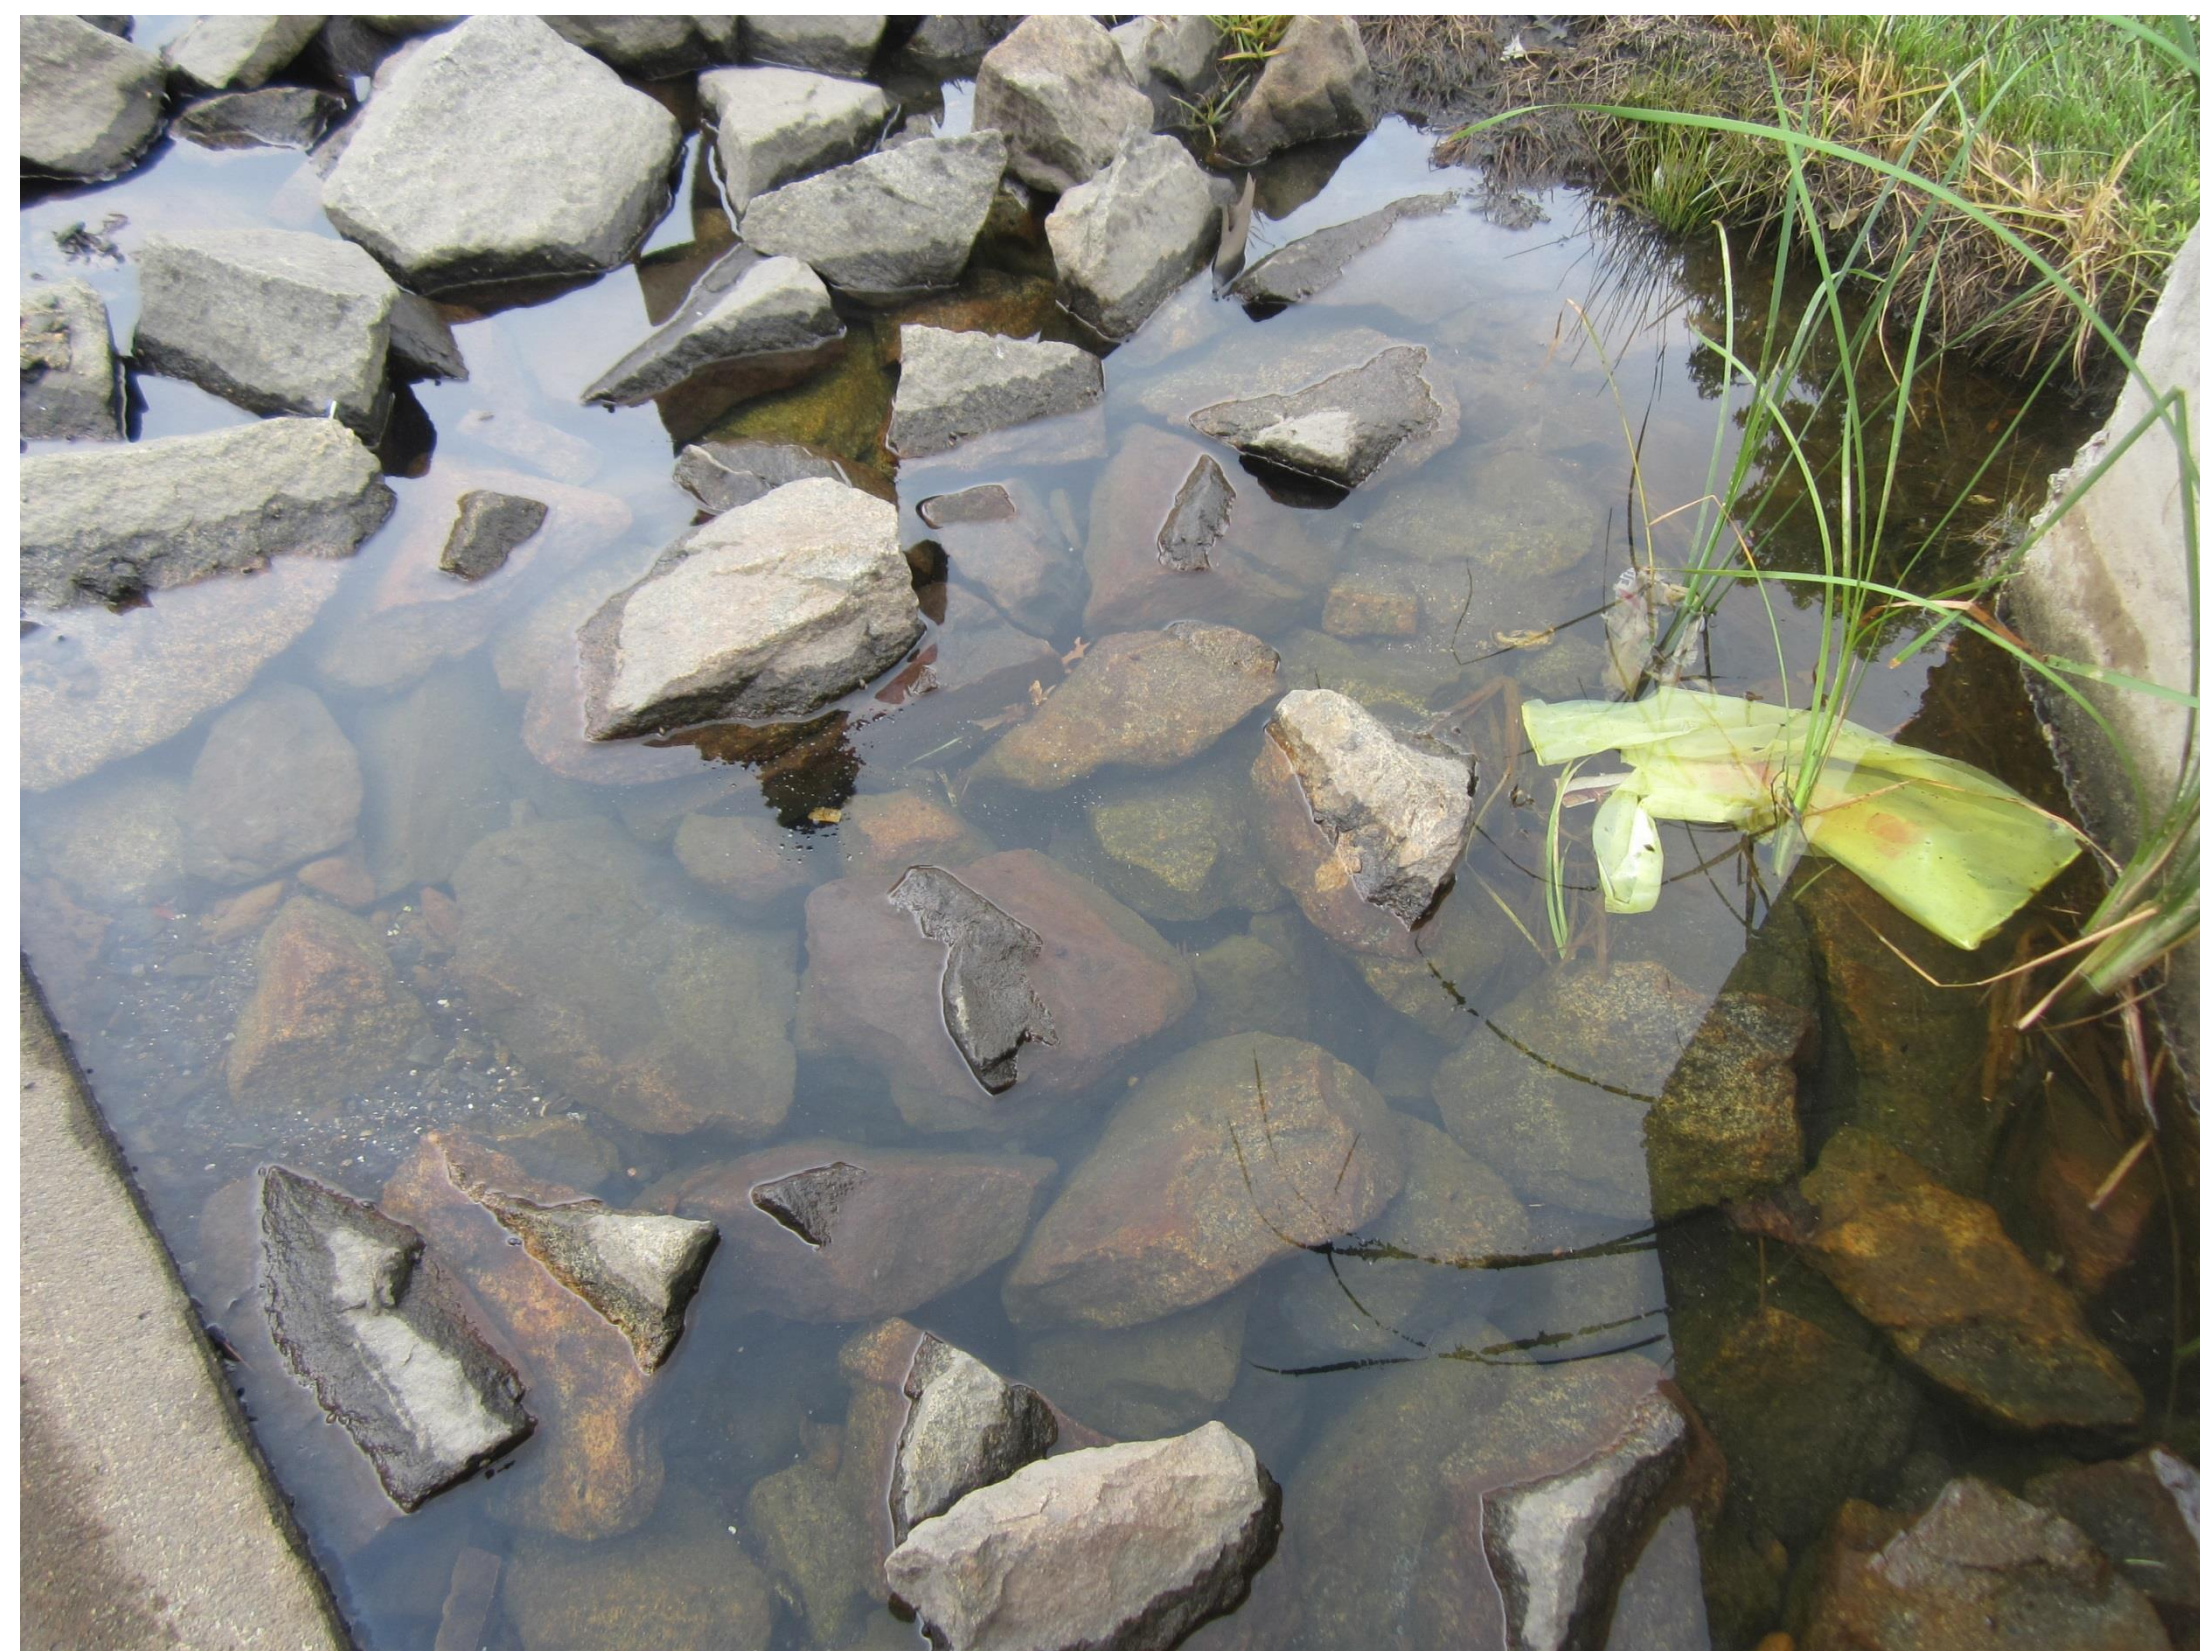
Standing water near inlet

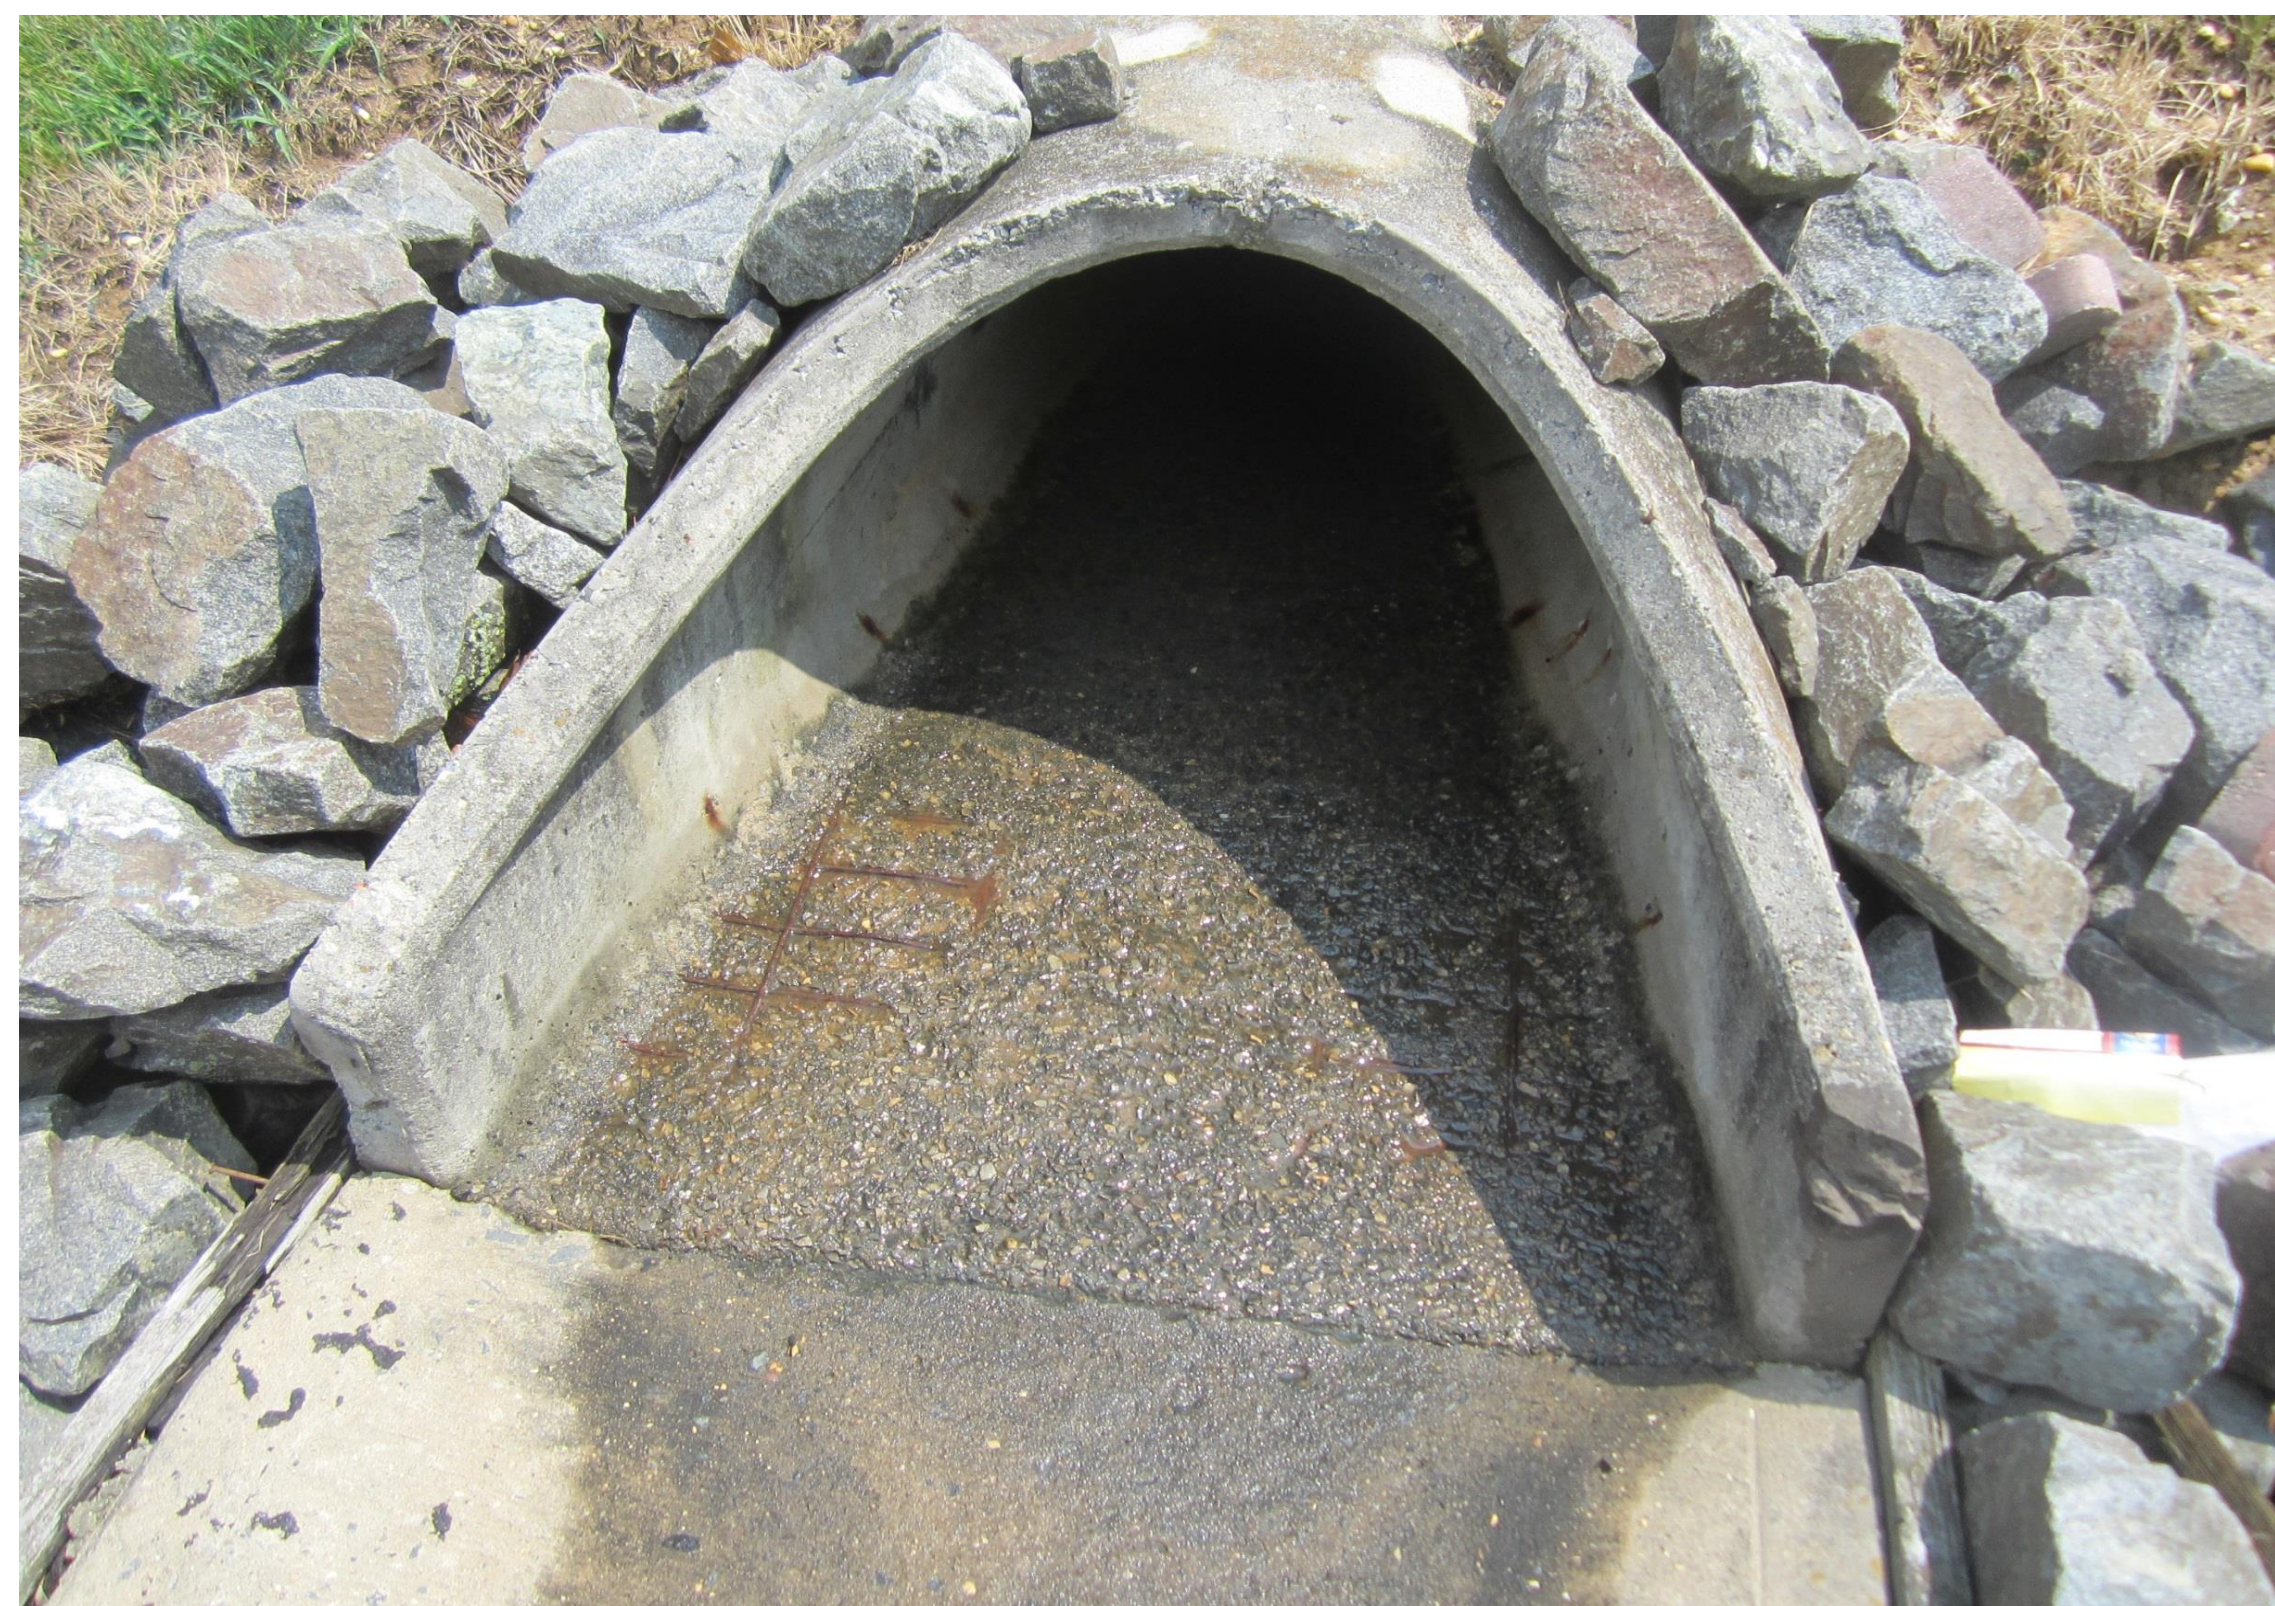
Exposed wire

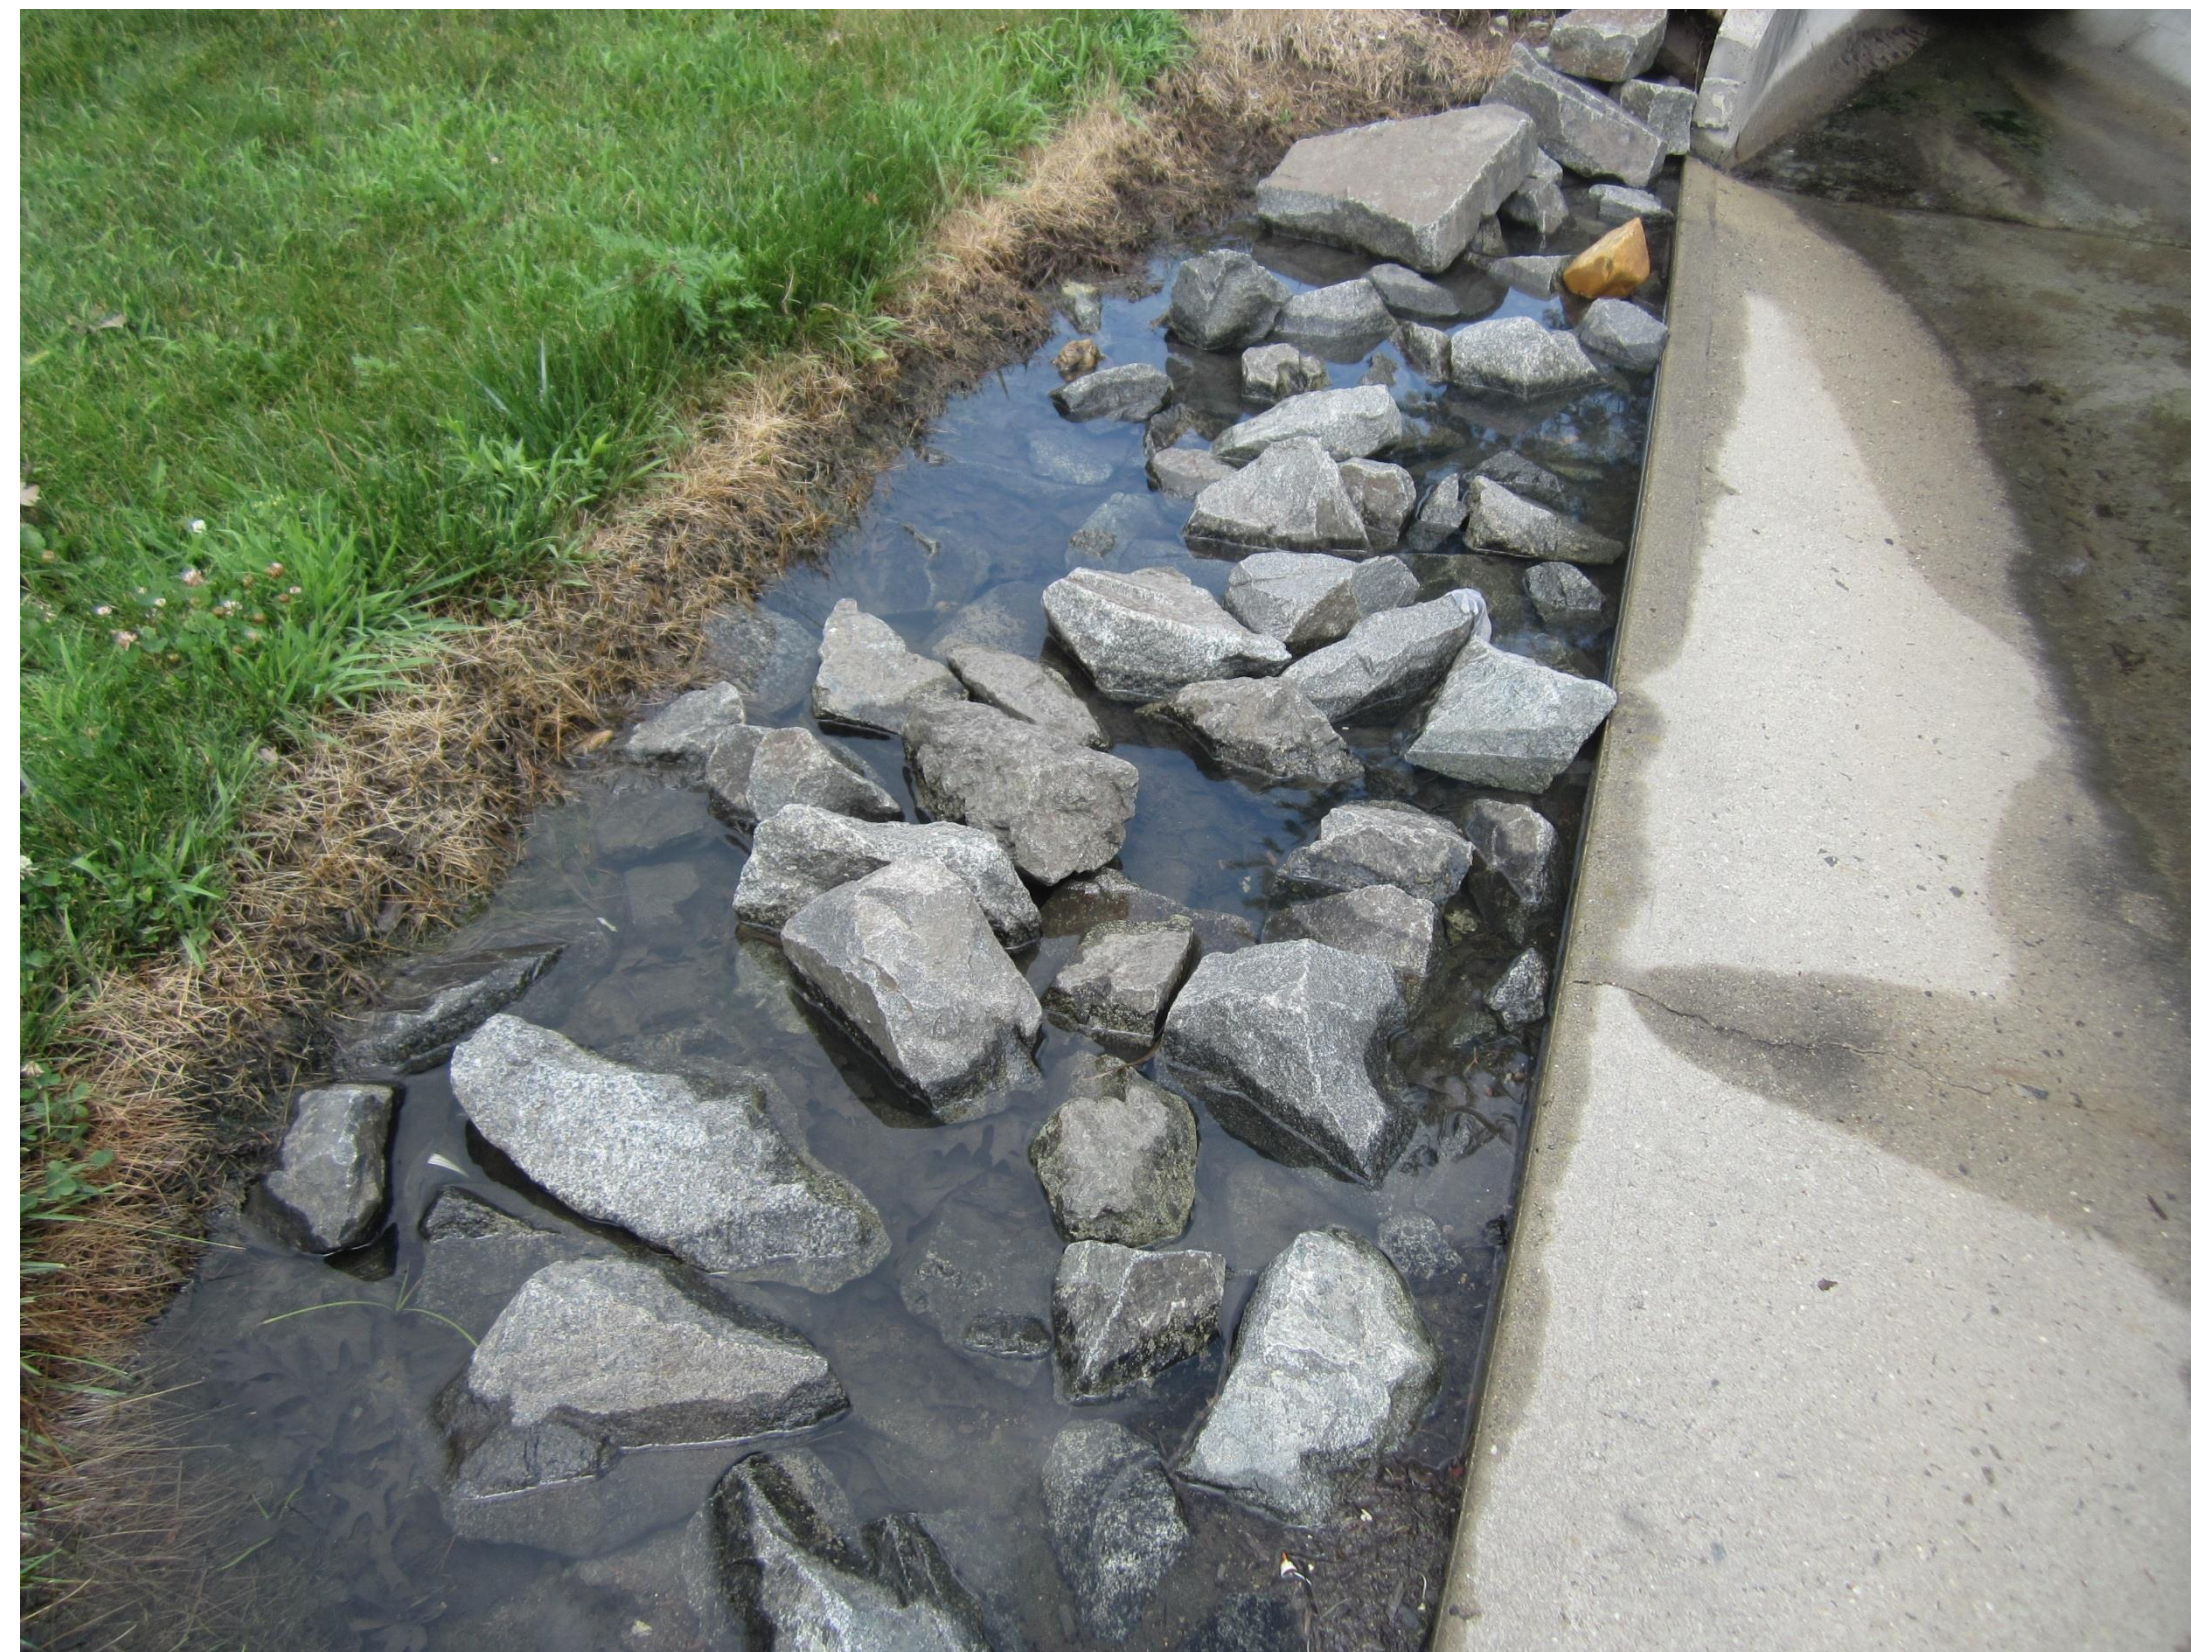
Standing water

- All inlets are eroded
- Standing water in low flow channel
- Rip-rap portion near inlets have standing water
- Oil and standing water near outlet
- Sediment accumulation near outlet causes standing water
