**Hamilton Township (Mercer County)
Stormwater Basin Assessment Summary
Addendum (Year 3)**

Developed by the Rutgers Cooperative Extension Water Resources Program
Funded by Hamilton Township, Mercer County, New Jersey

September 30, 2014

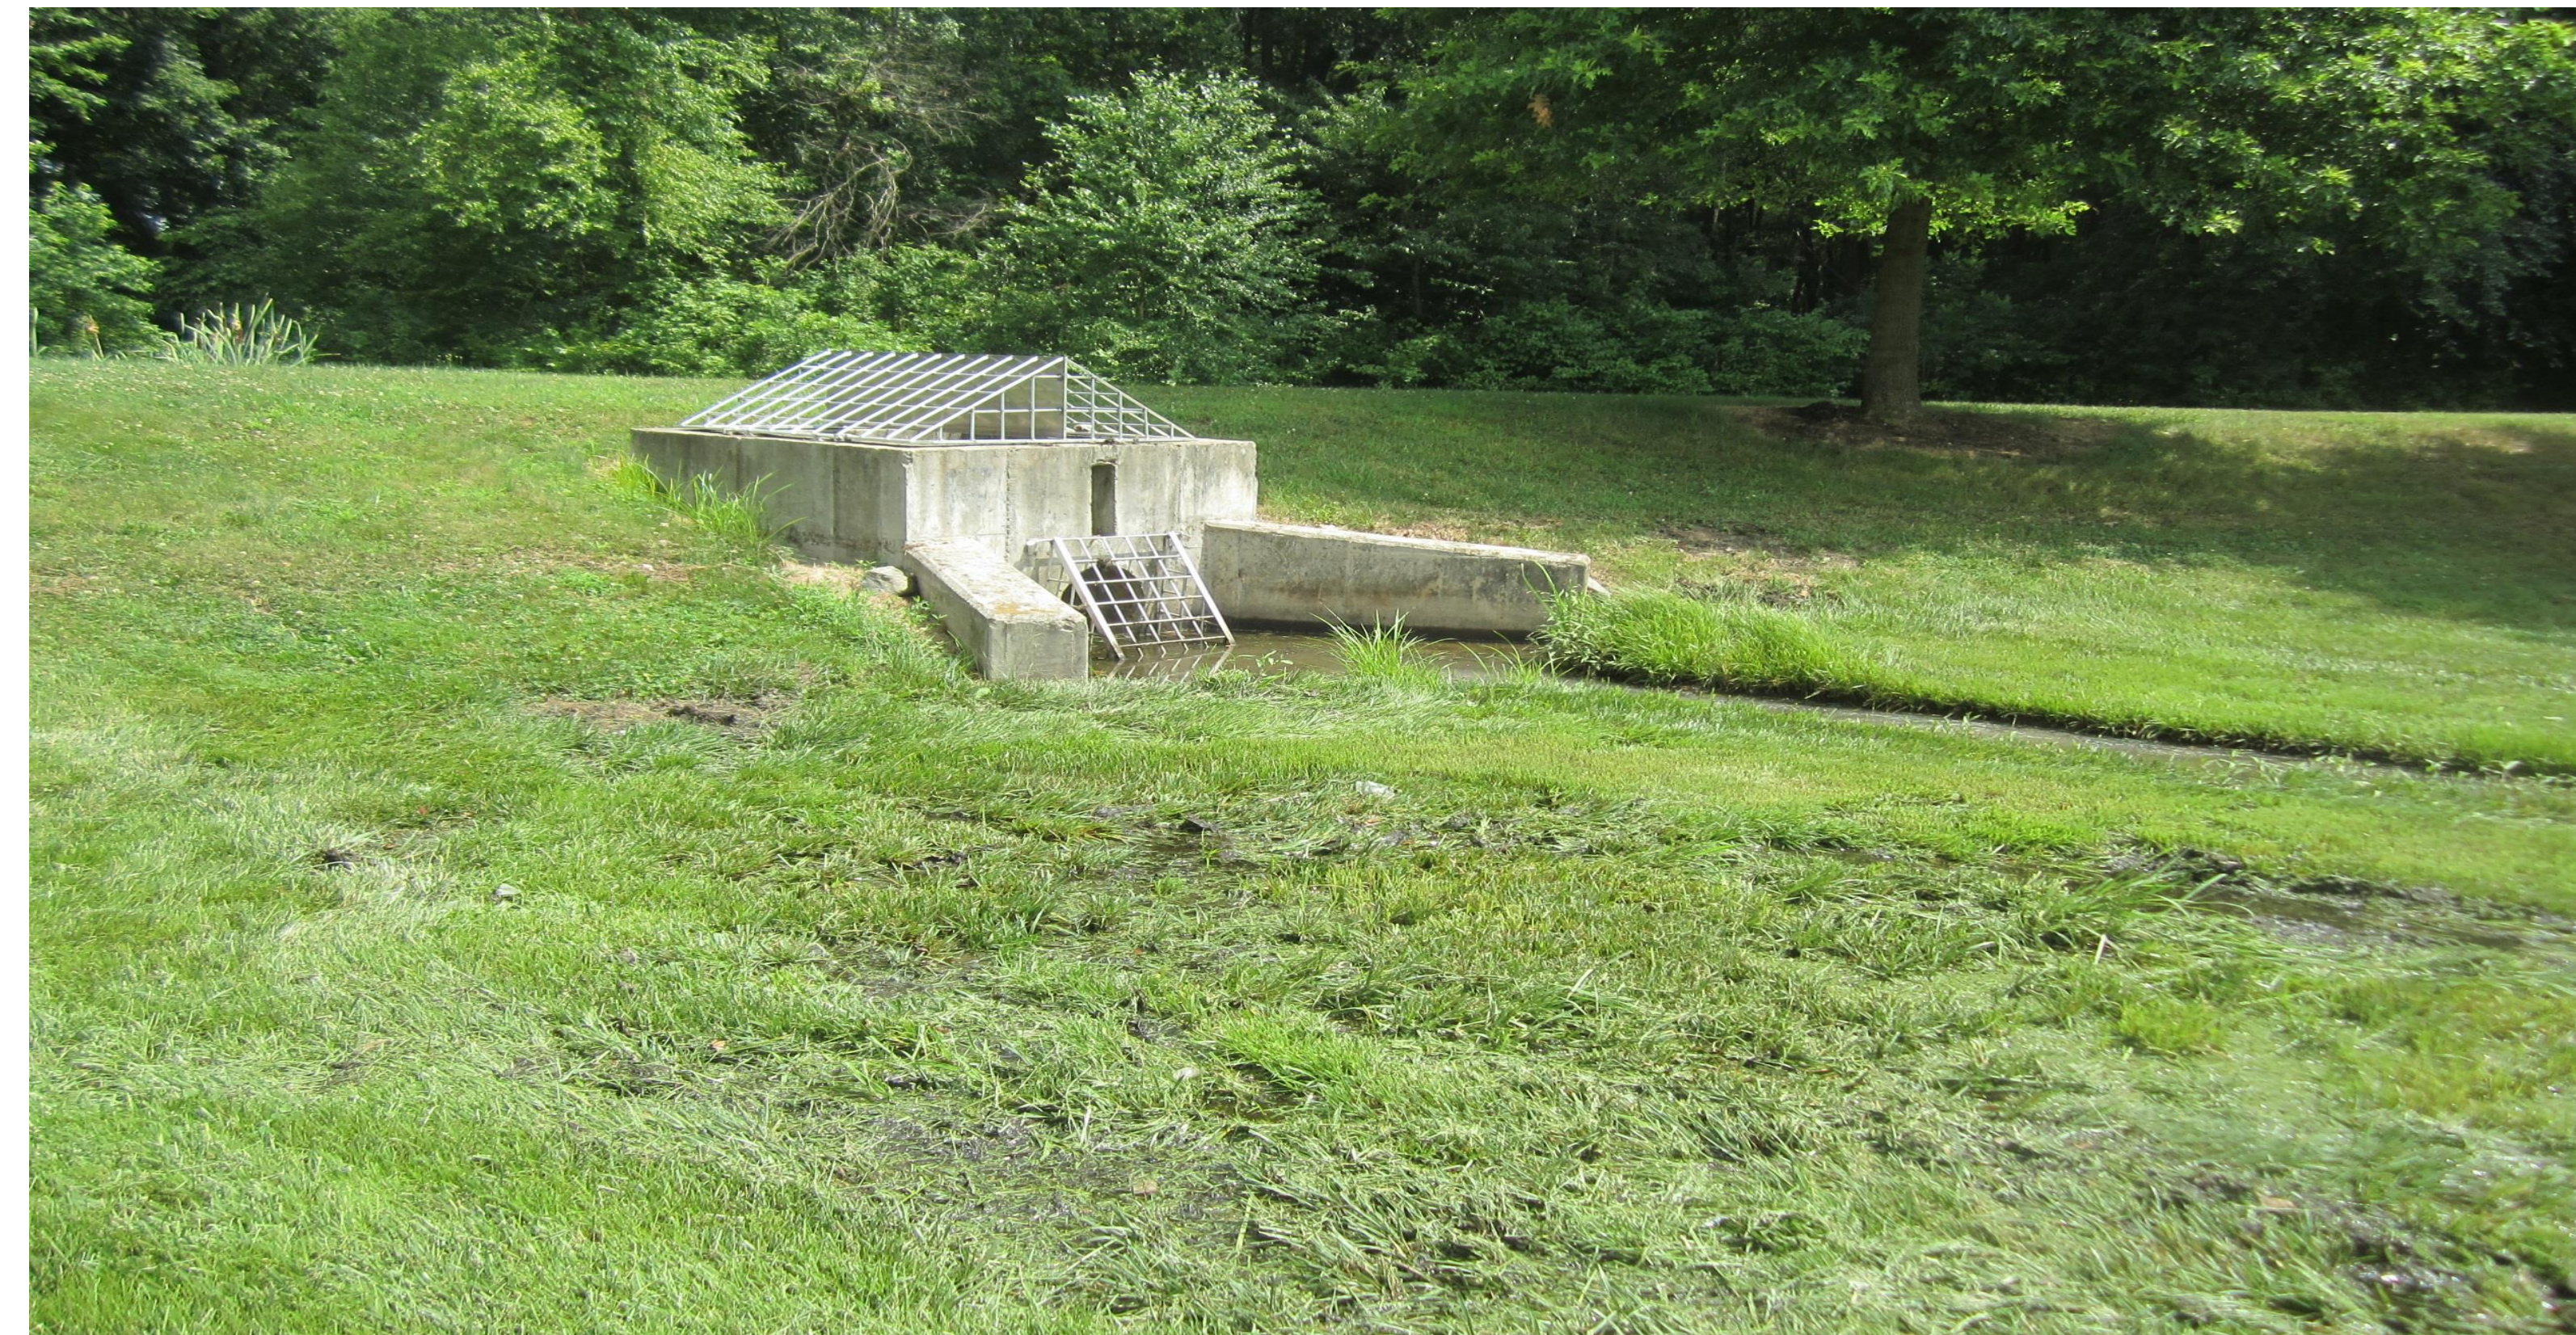
Outlet looking east

- All inlets are eroded
- Standing water in low flow channel
- Rip-rap portion near inlets have standing water
- Oil and standing water near outlet
- Sediment accumulation near outlet causes standing water

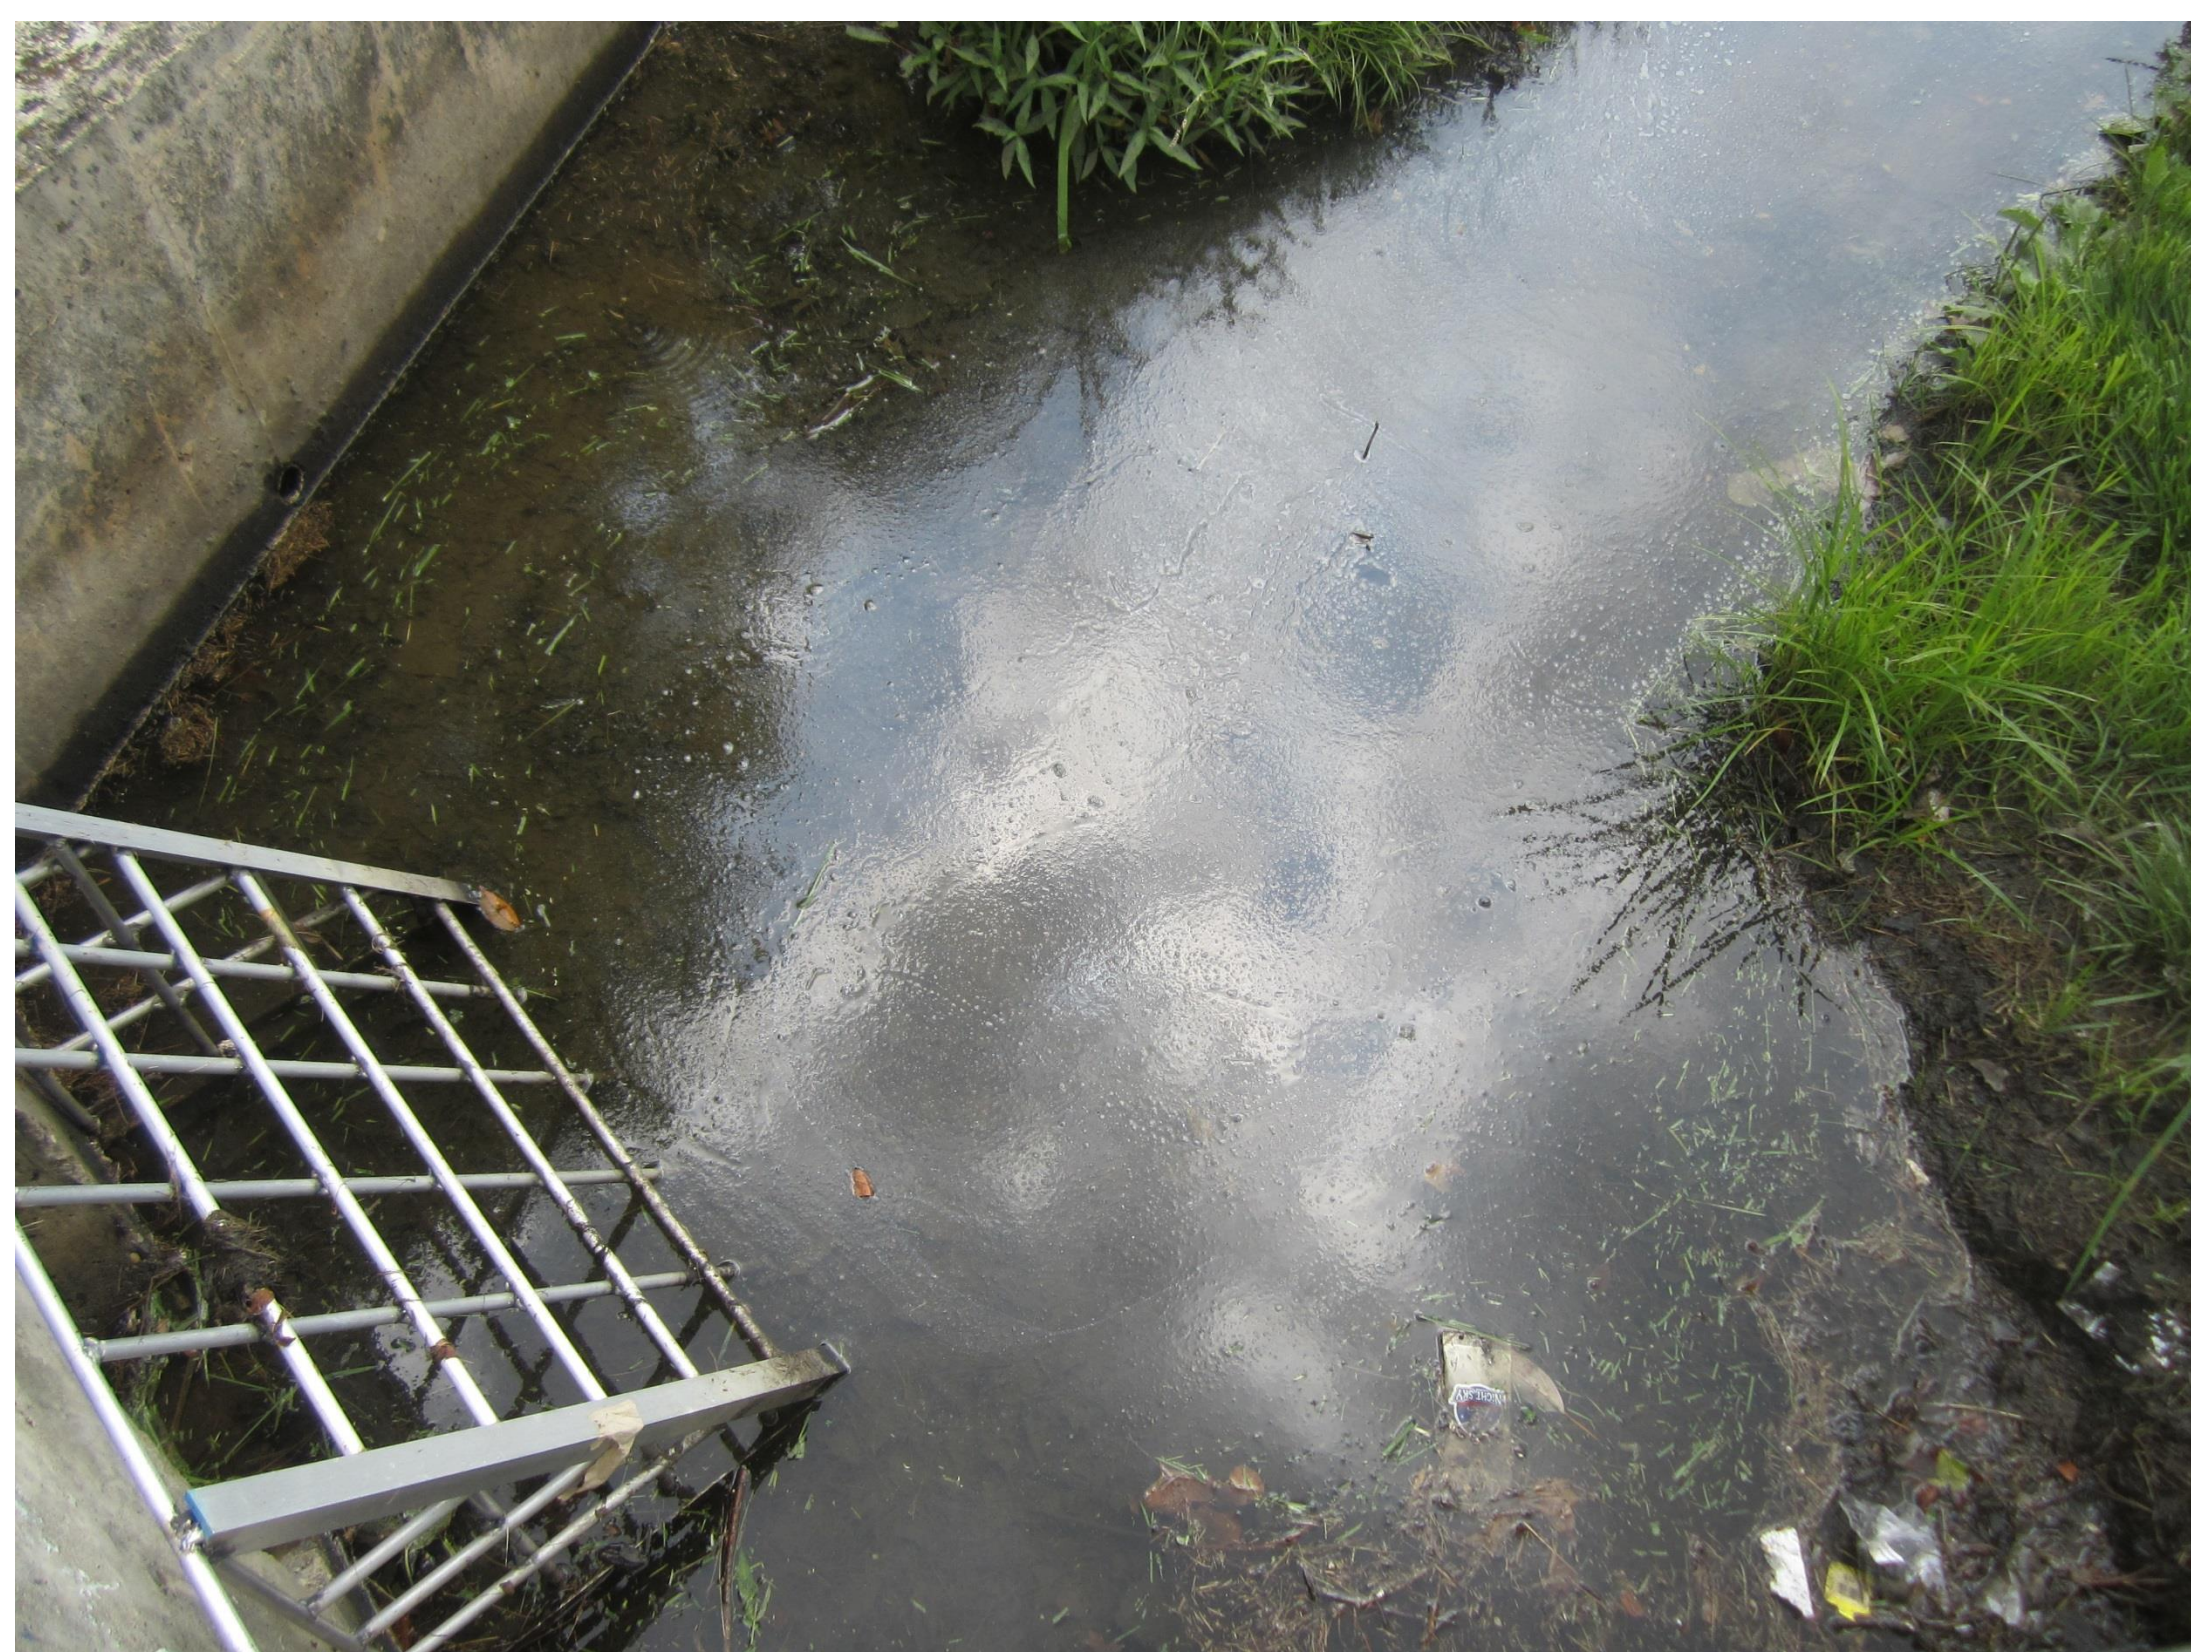
Top view of outlet

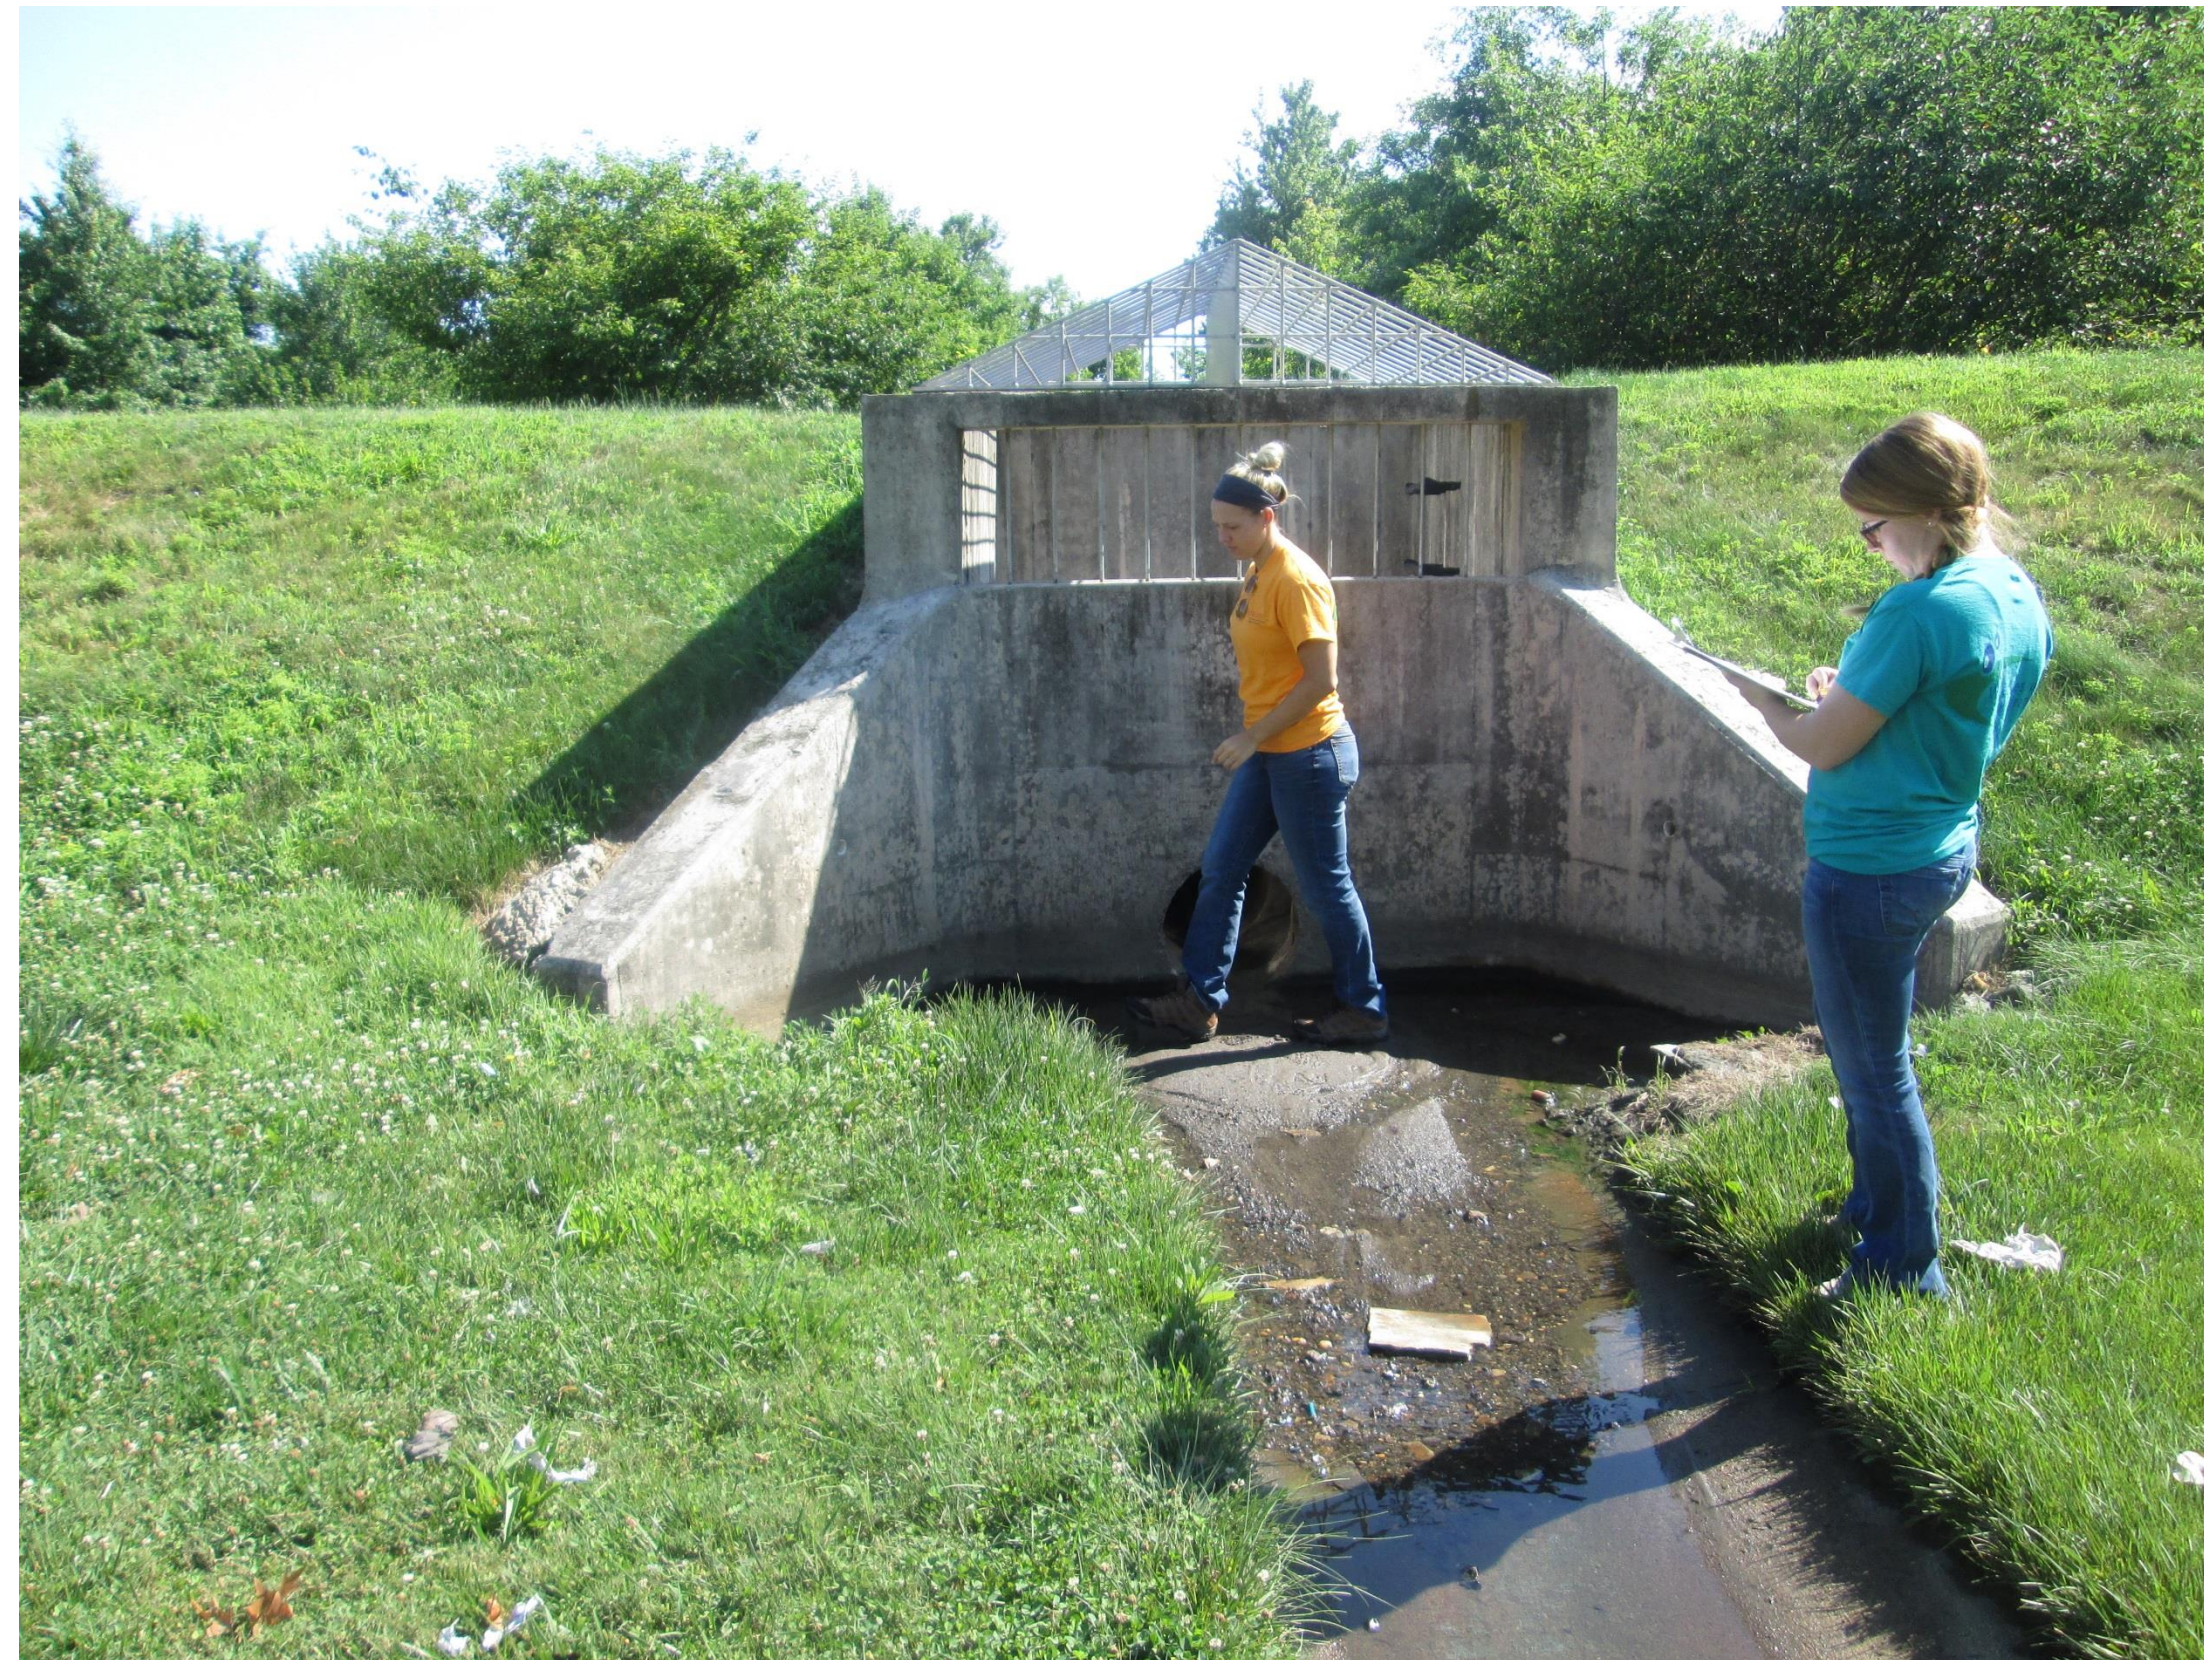
Outlet

- Erosion around inlets
- Standing water, sediment, and debris in low flow channel
- Minimal cracks in low flow channel
- Oil traces near outfall area
- Sediment accumulated near outlet

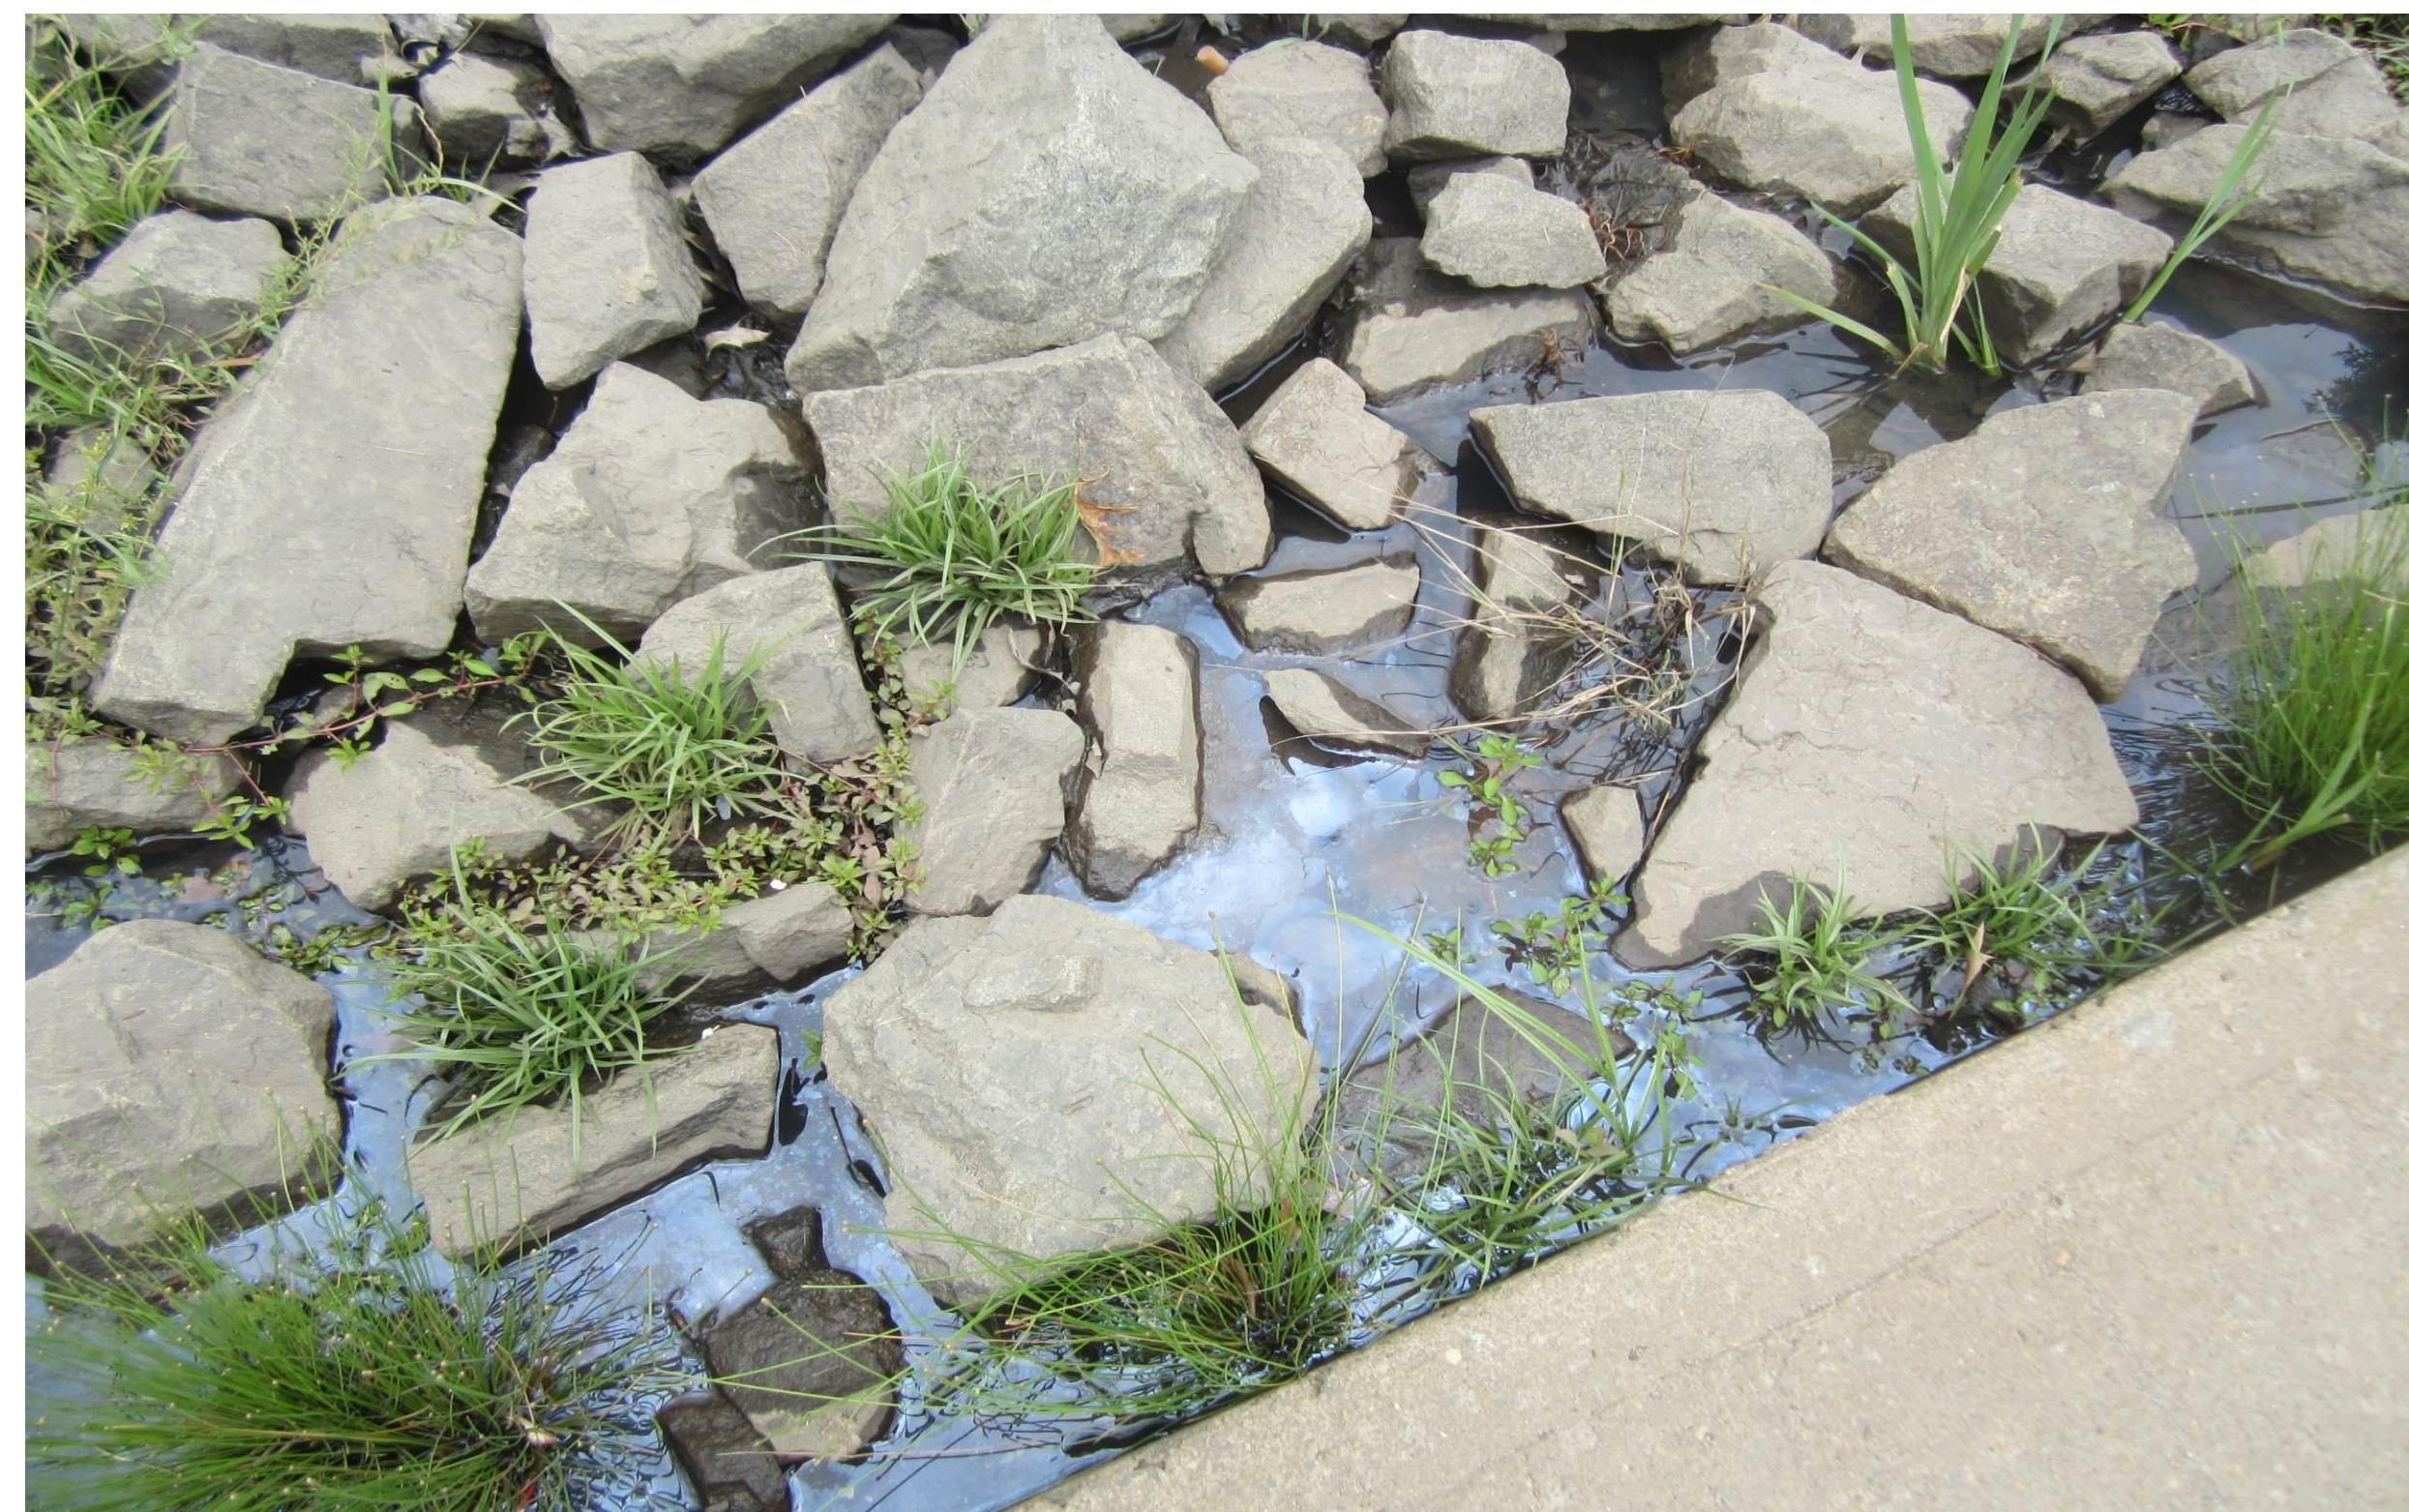
Standing water near inlet

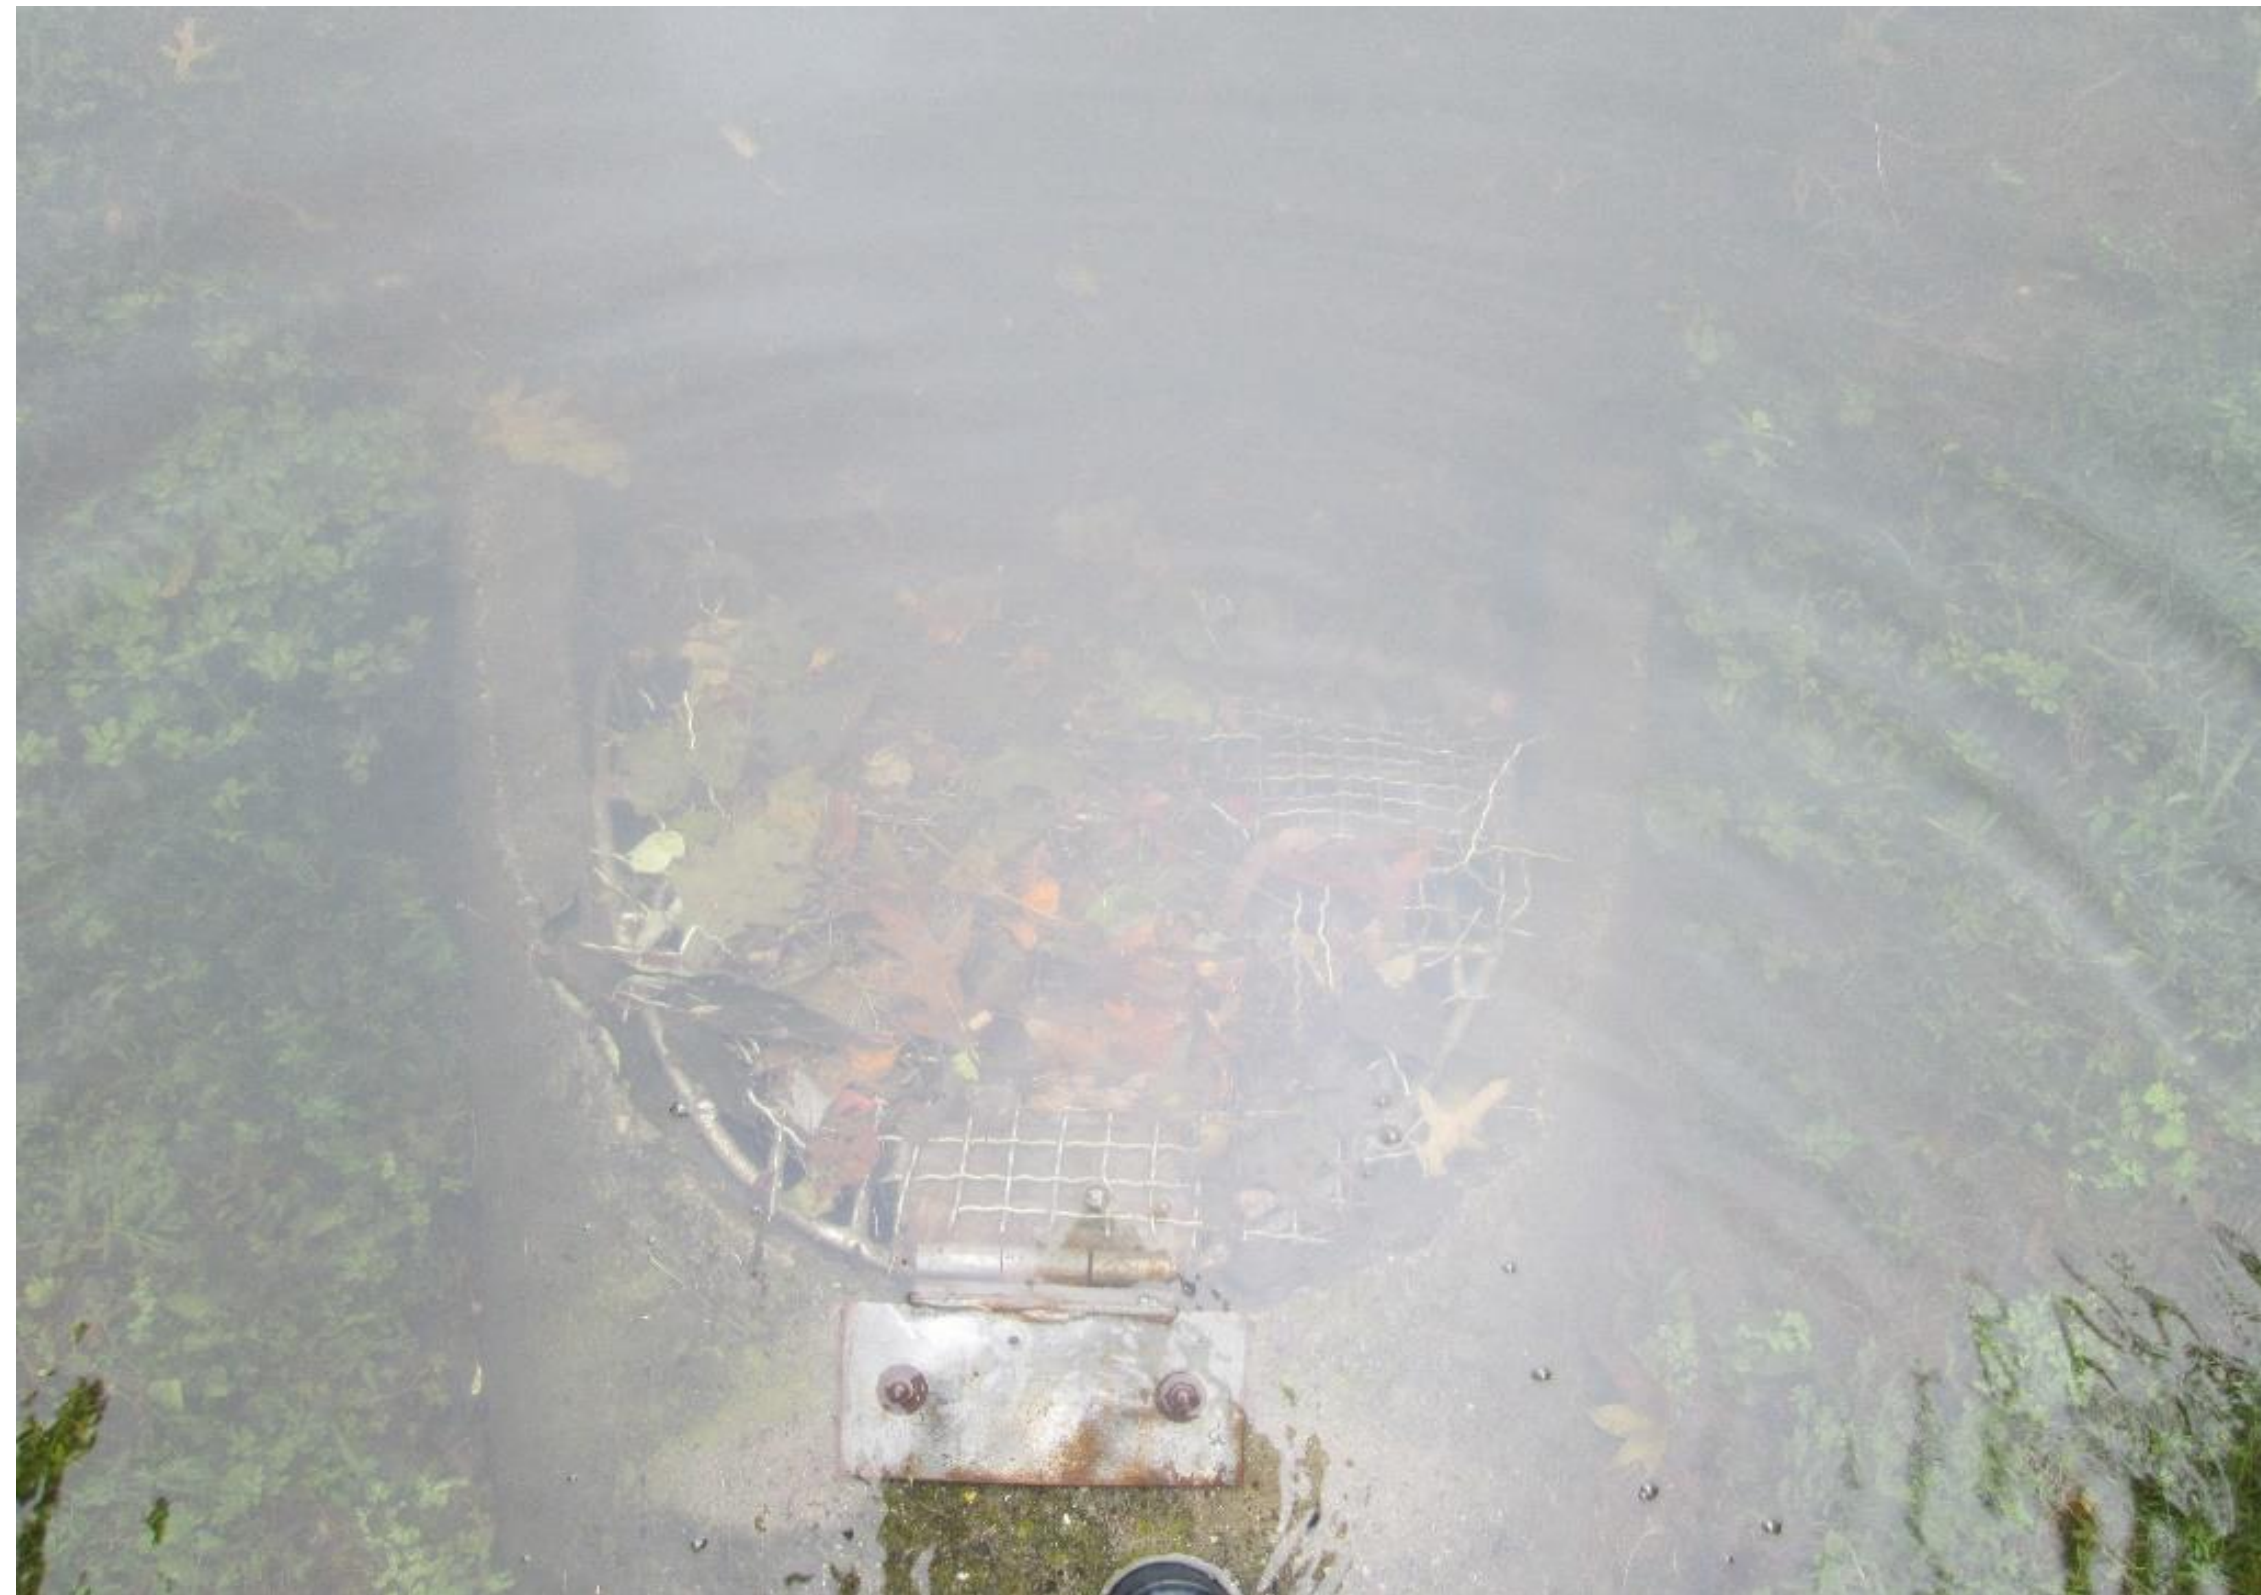
- Oil and excess sediment settling near inlet
- Outlet garbage rack broken
- Overall well maintained

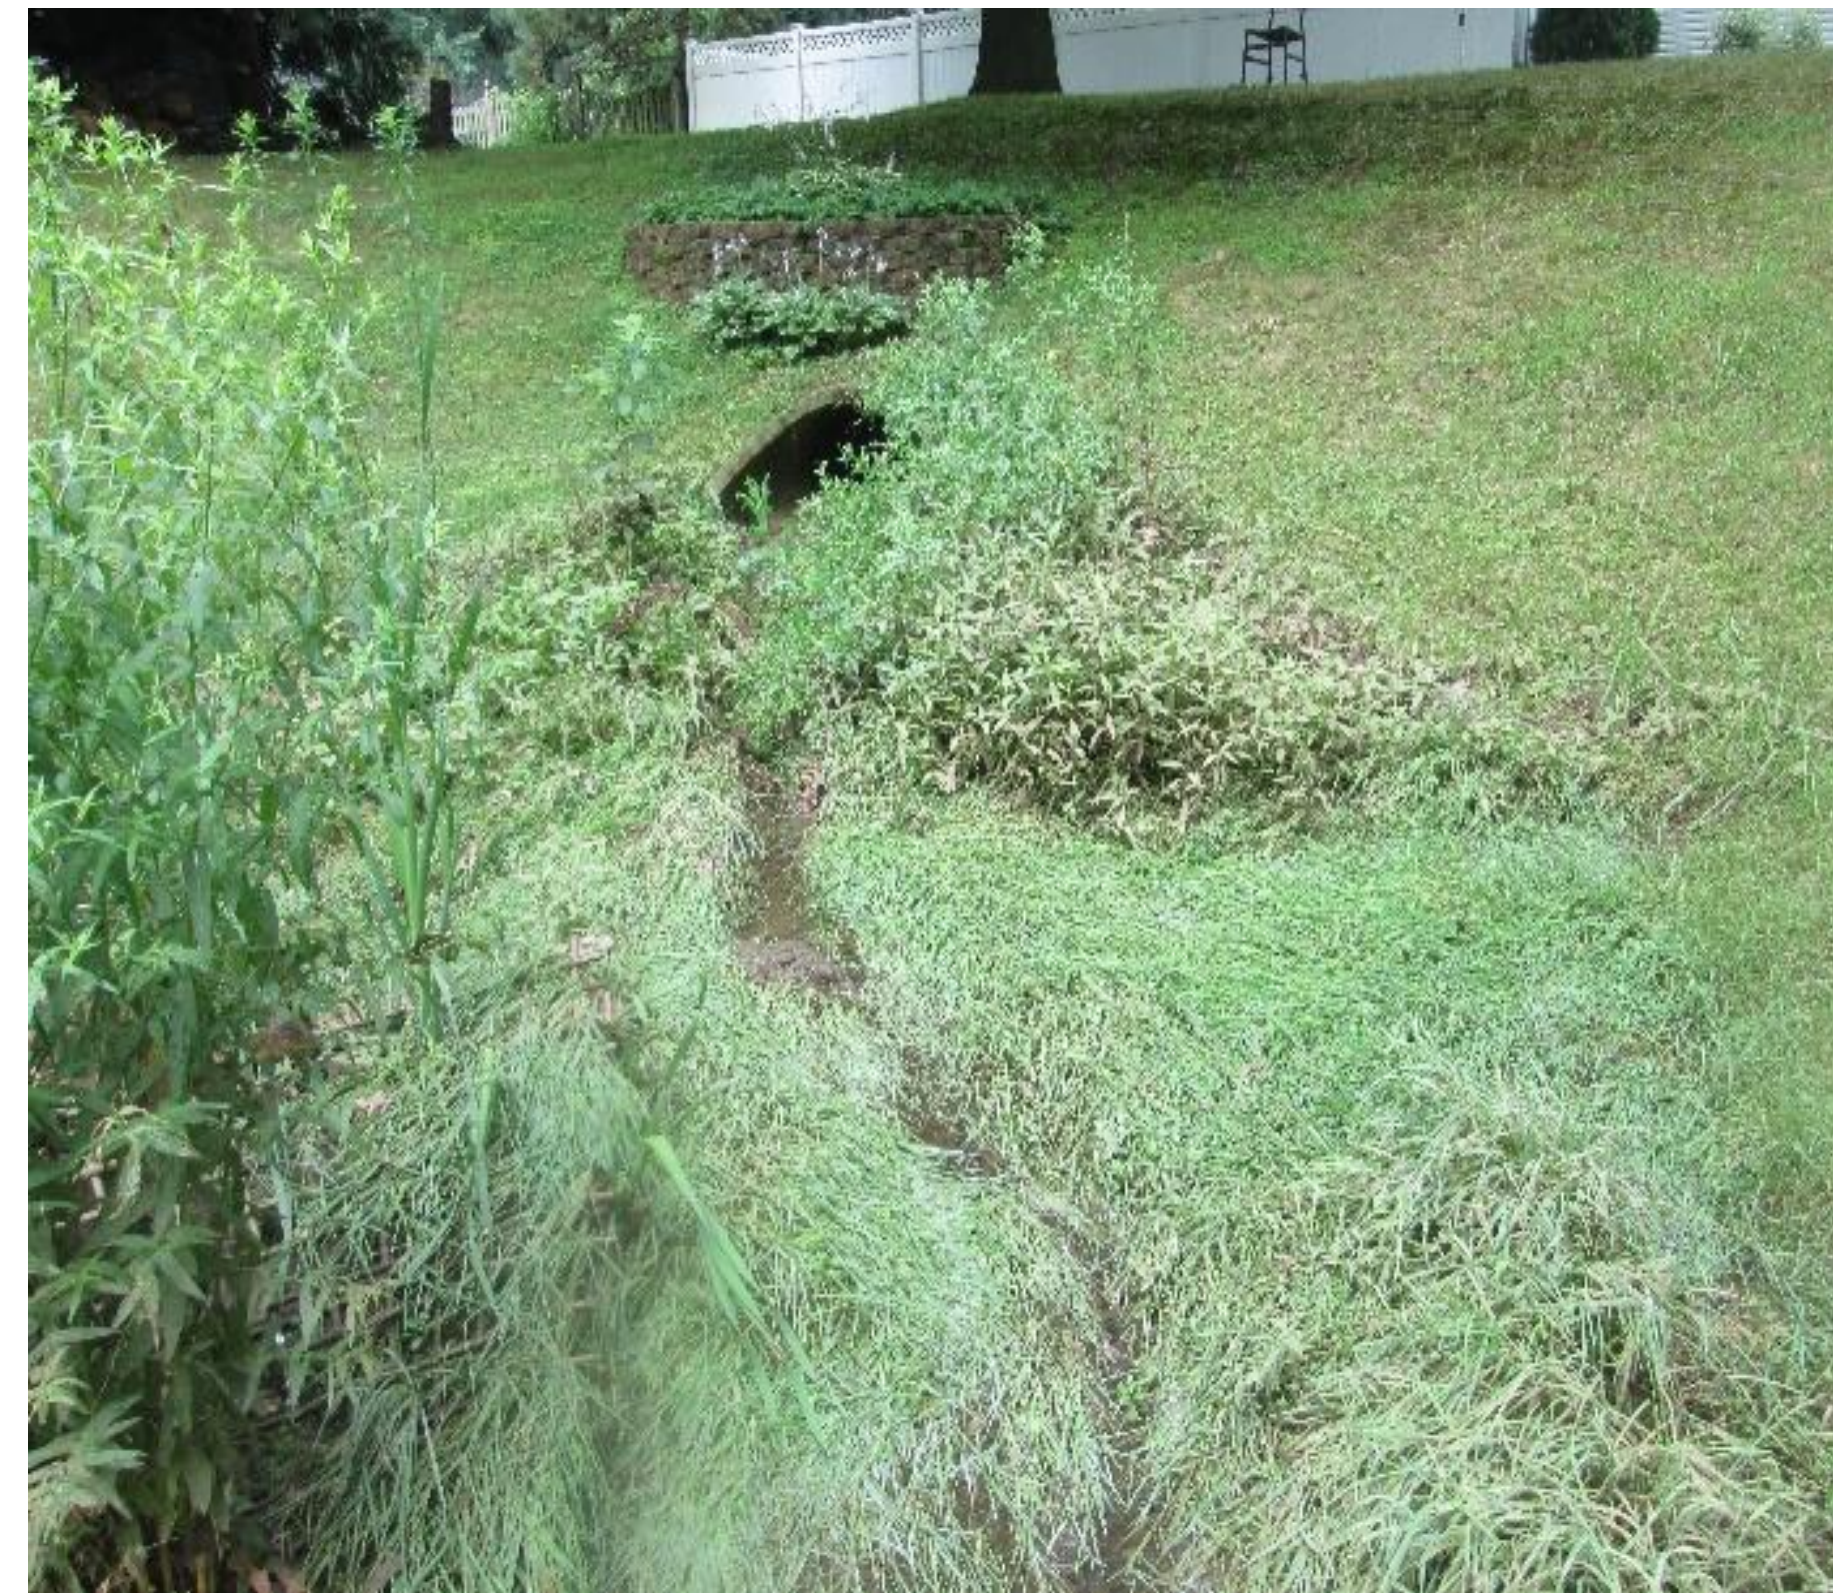
Inlet
