**Hamilton Township (Mercer County)
Stormwater Basin Assessment Summary
Addendum (Year 3)**

Developed by the Rutgers Cooperative Extension Water Resources Program
Funded by Hamilton Township, Mercer County, New Jersey

September 30, 2014

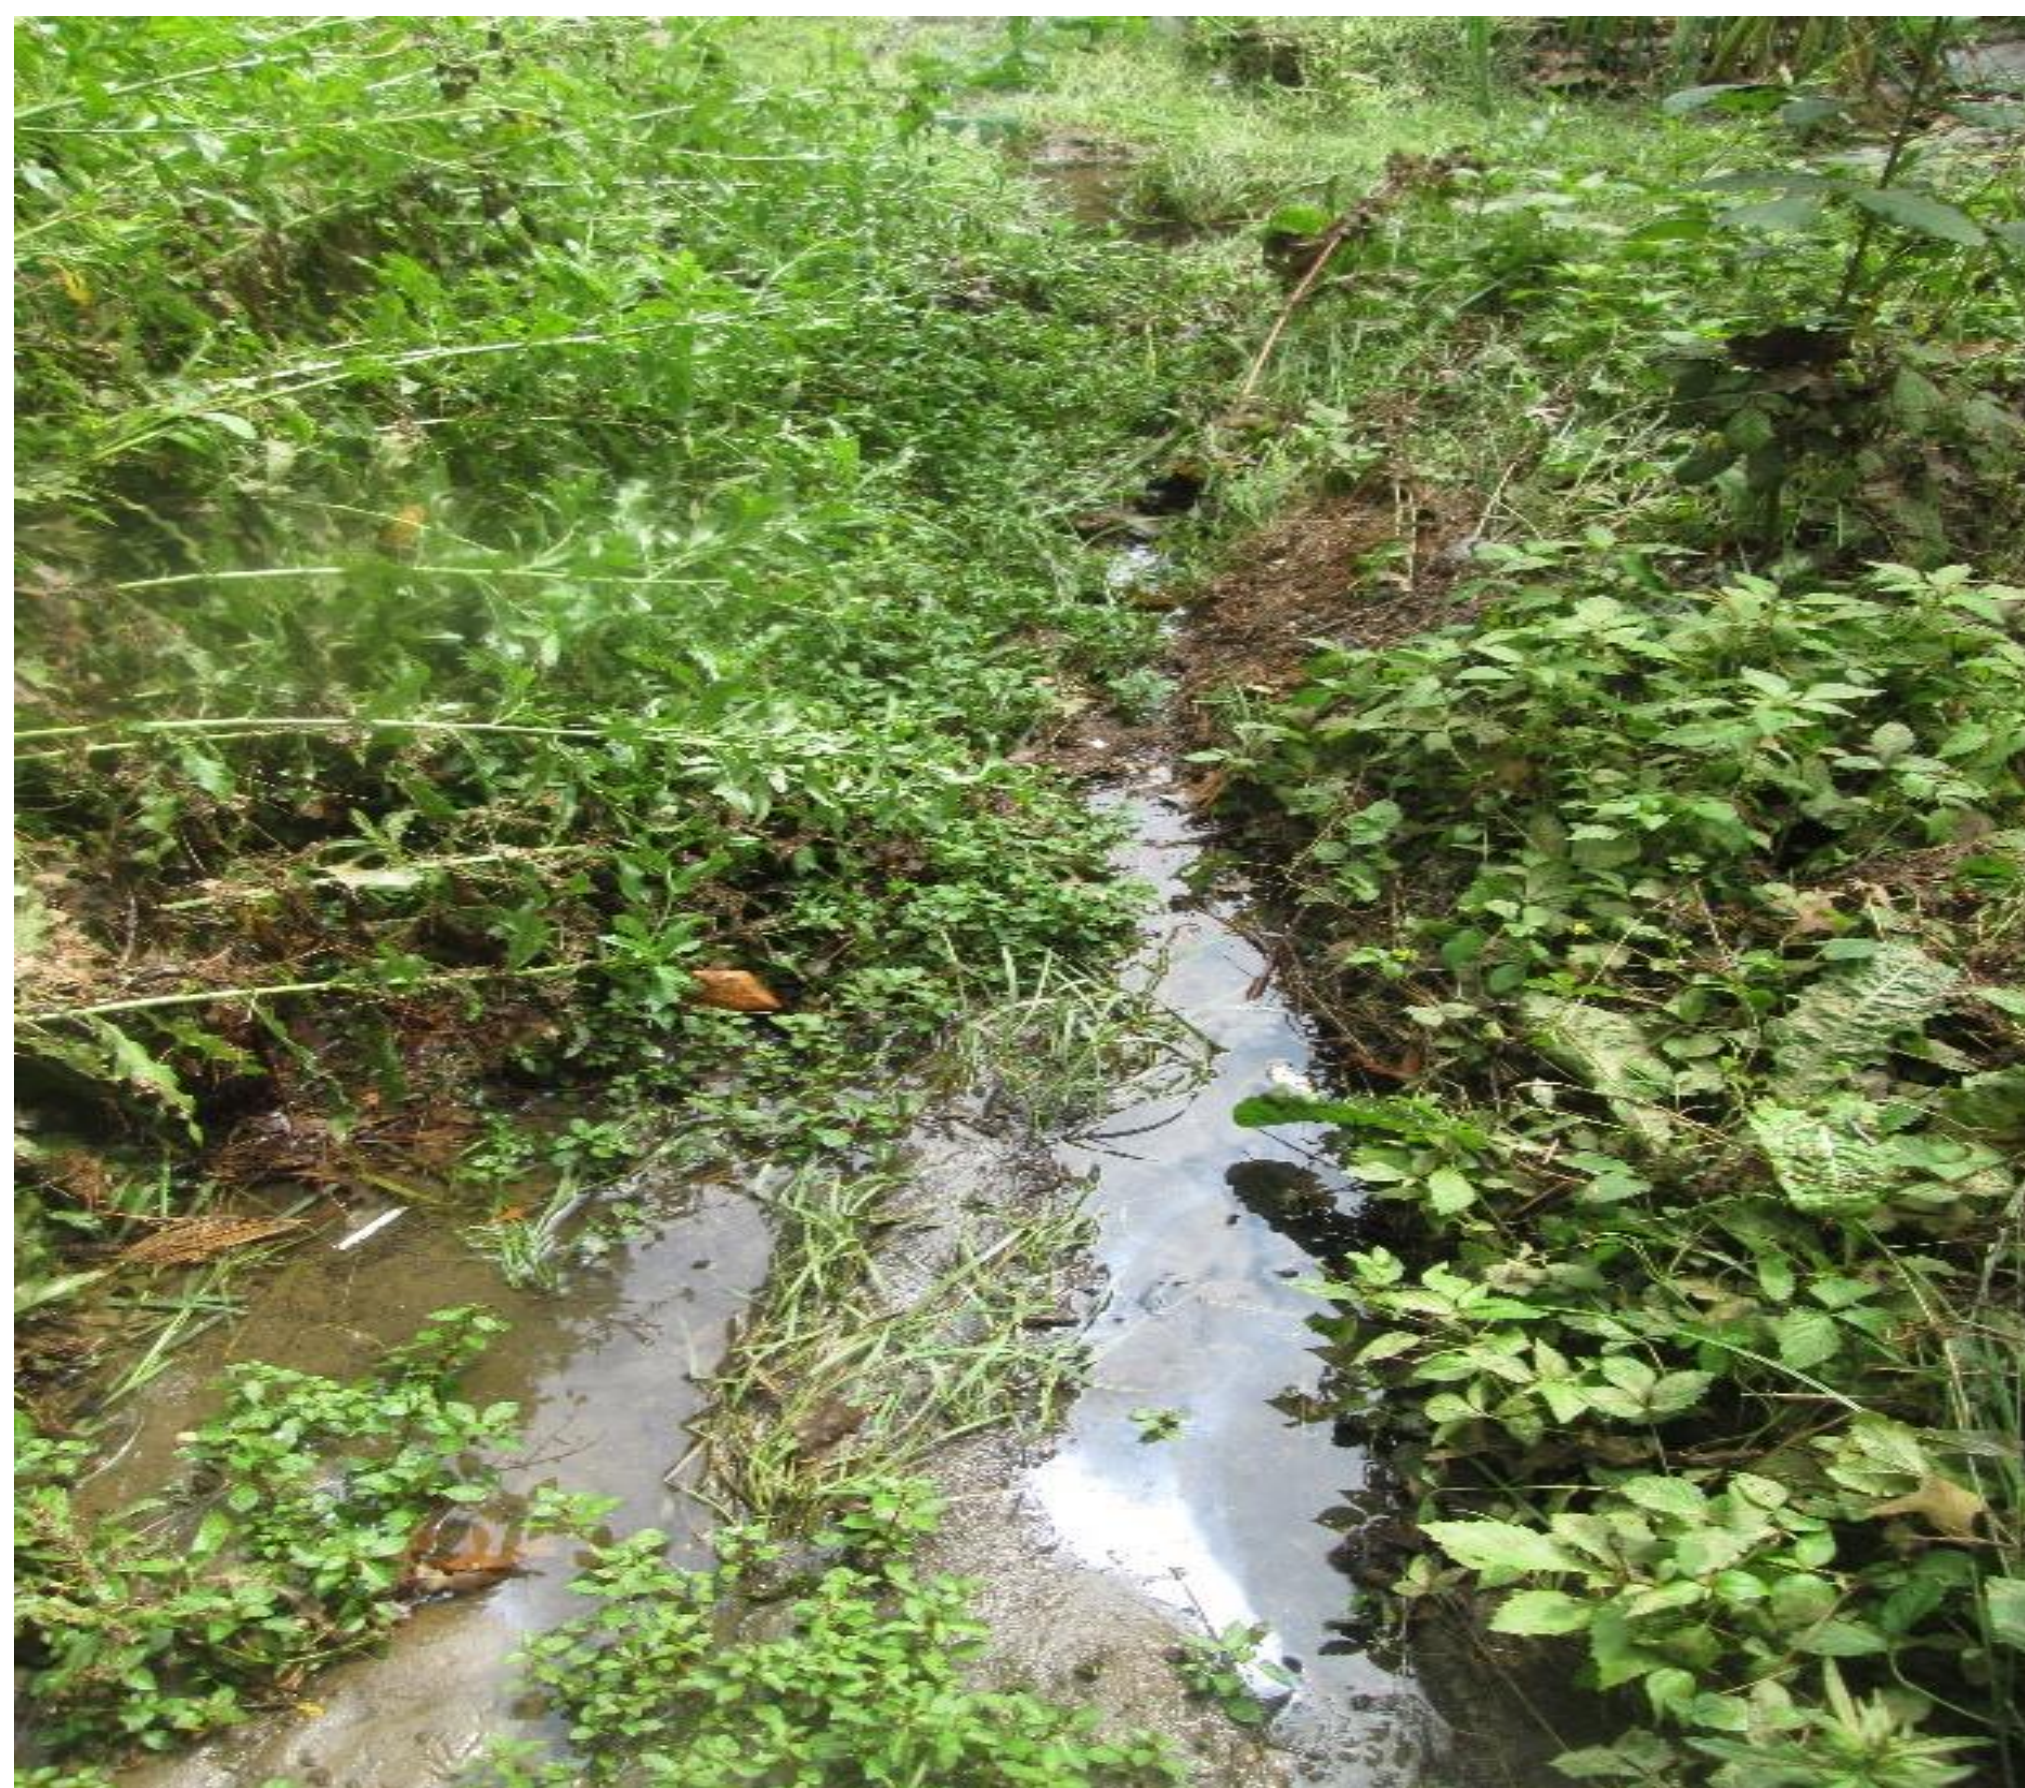
Low flow channel

- Sediment and turf grass covering low flow channel
- Turf grass growing near outlet orifice
- Two metal grates were found out of place in the basin

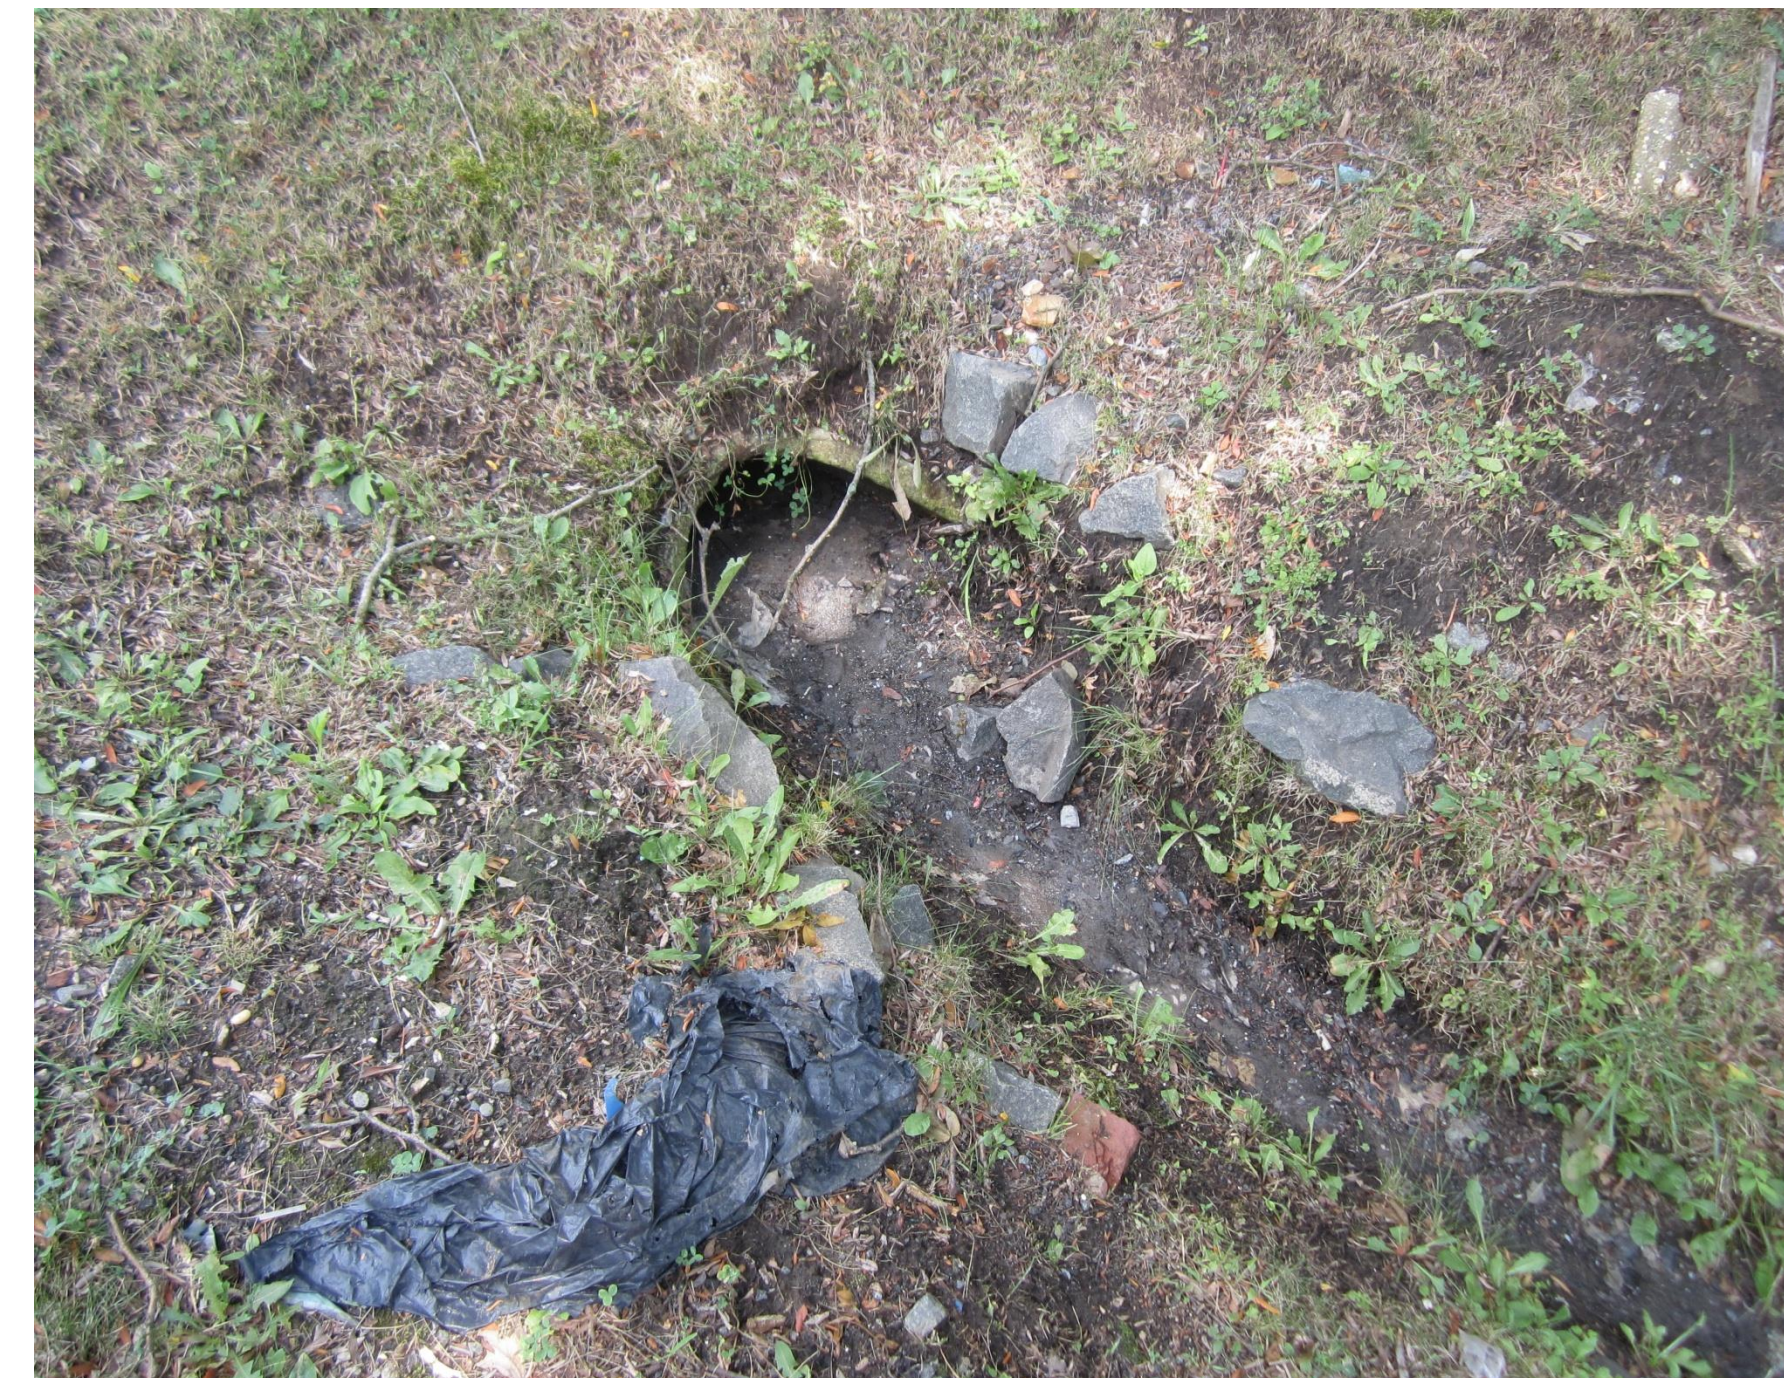
Obstructed inlet

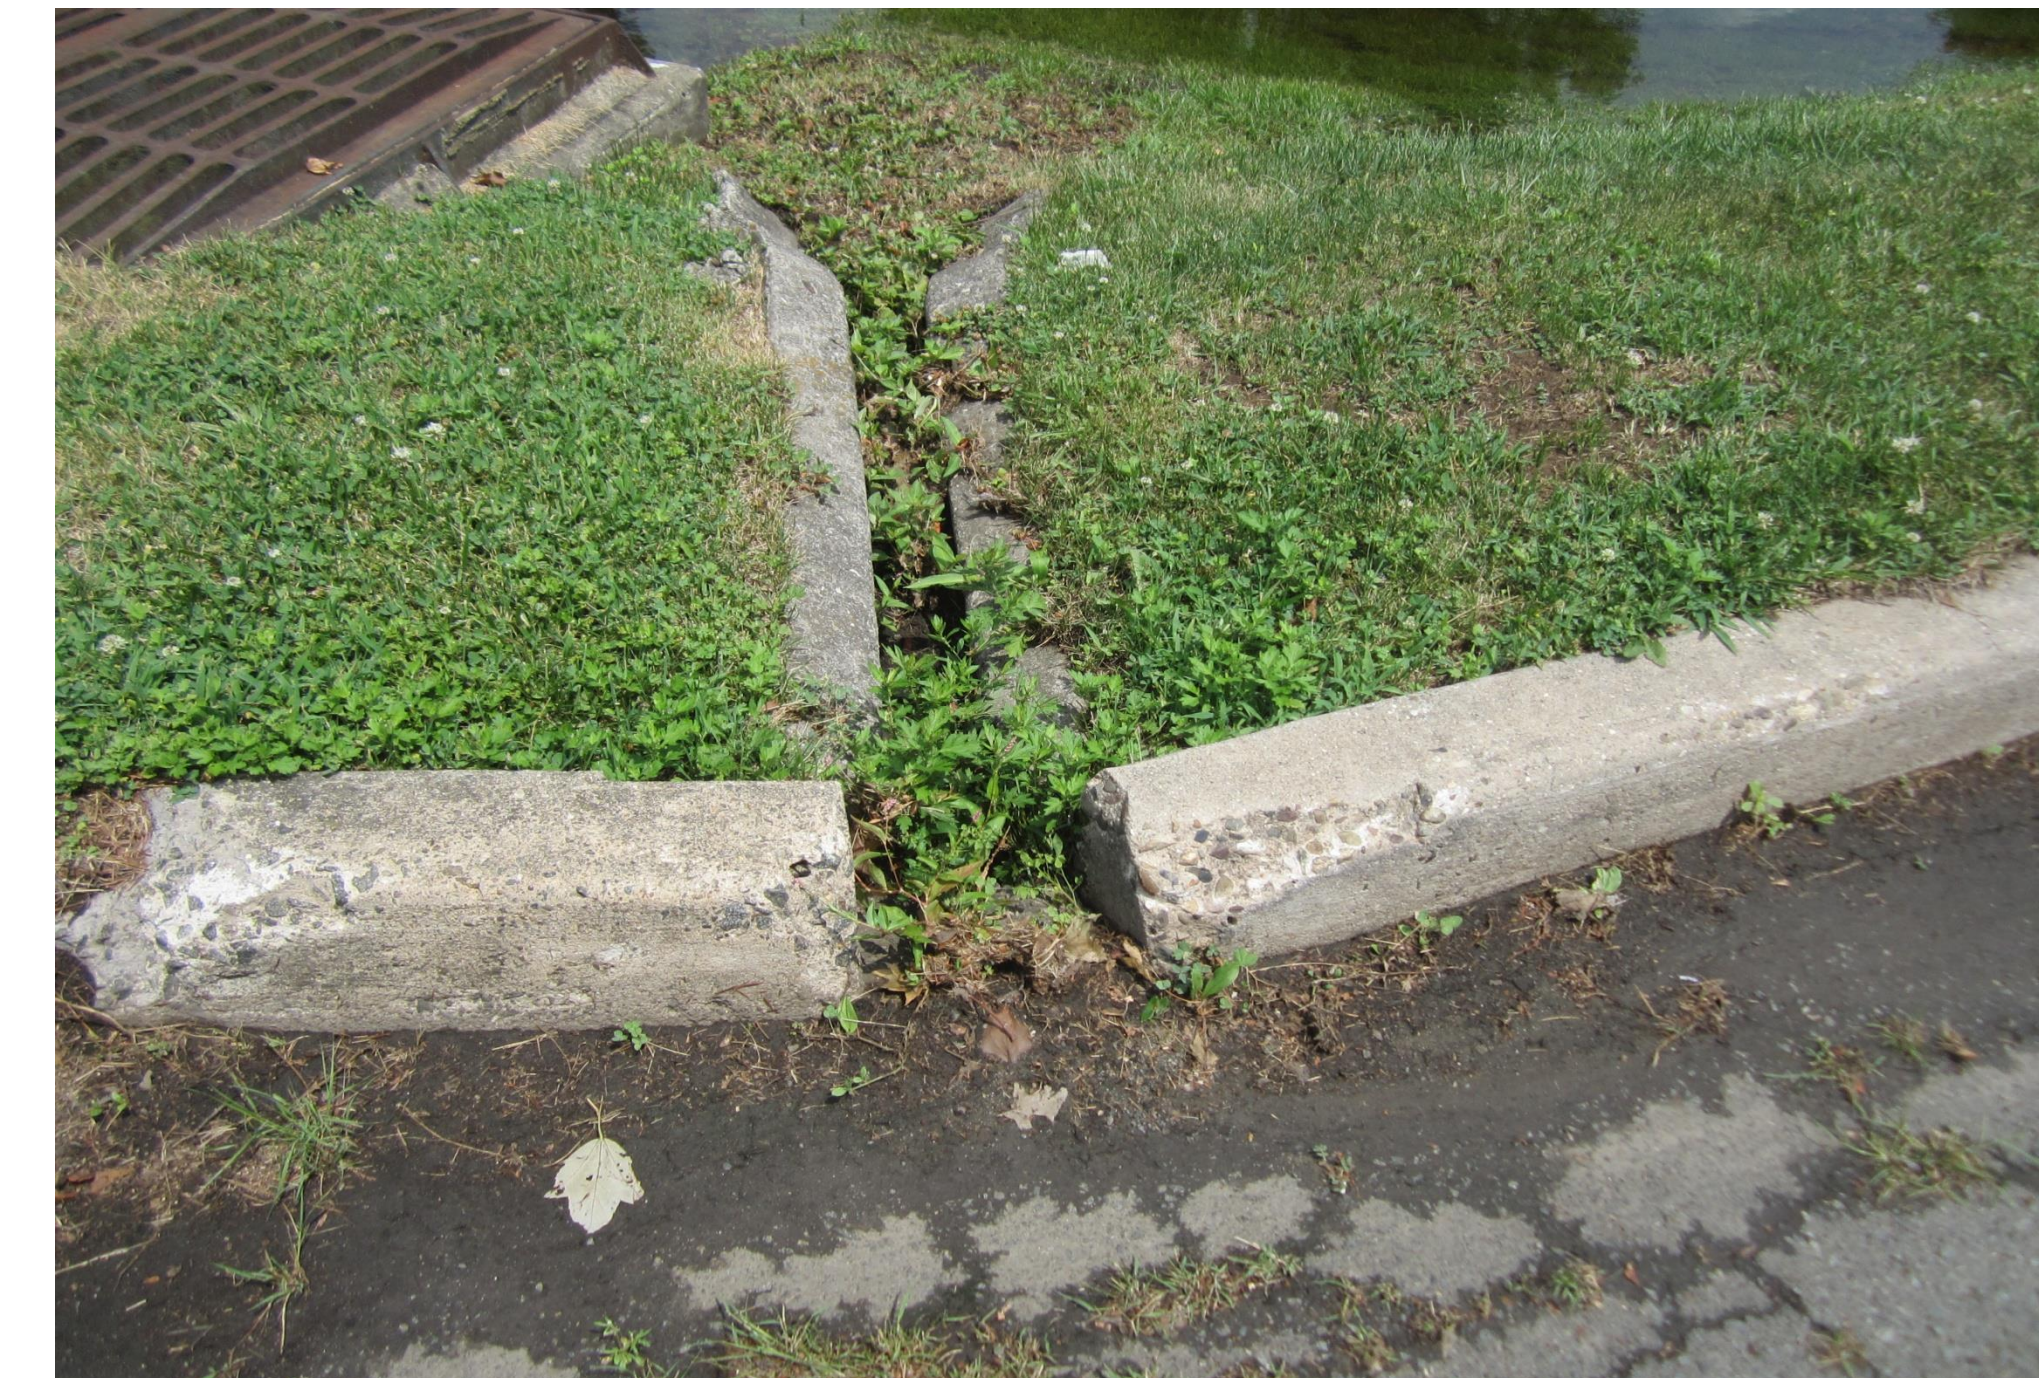
Overgrown curbcut

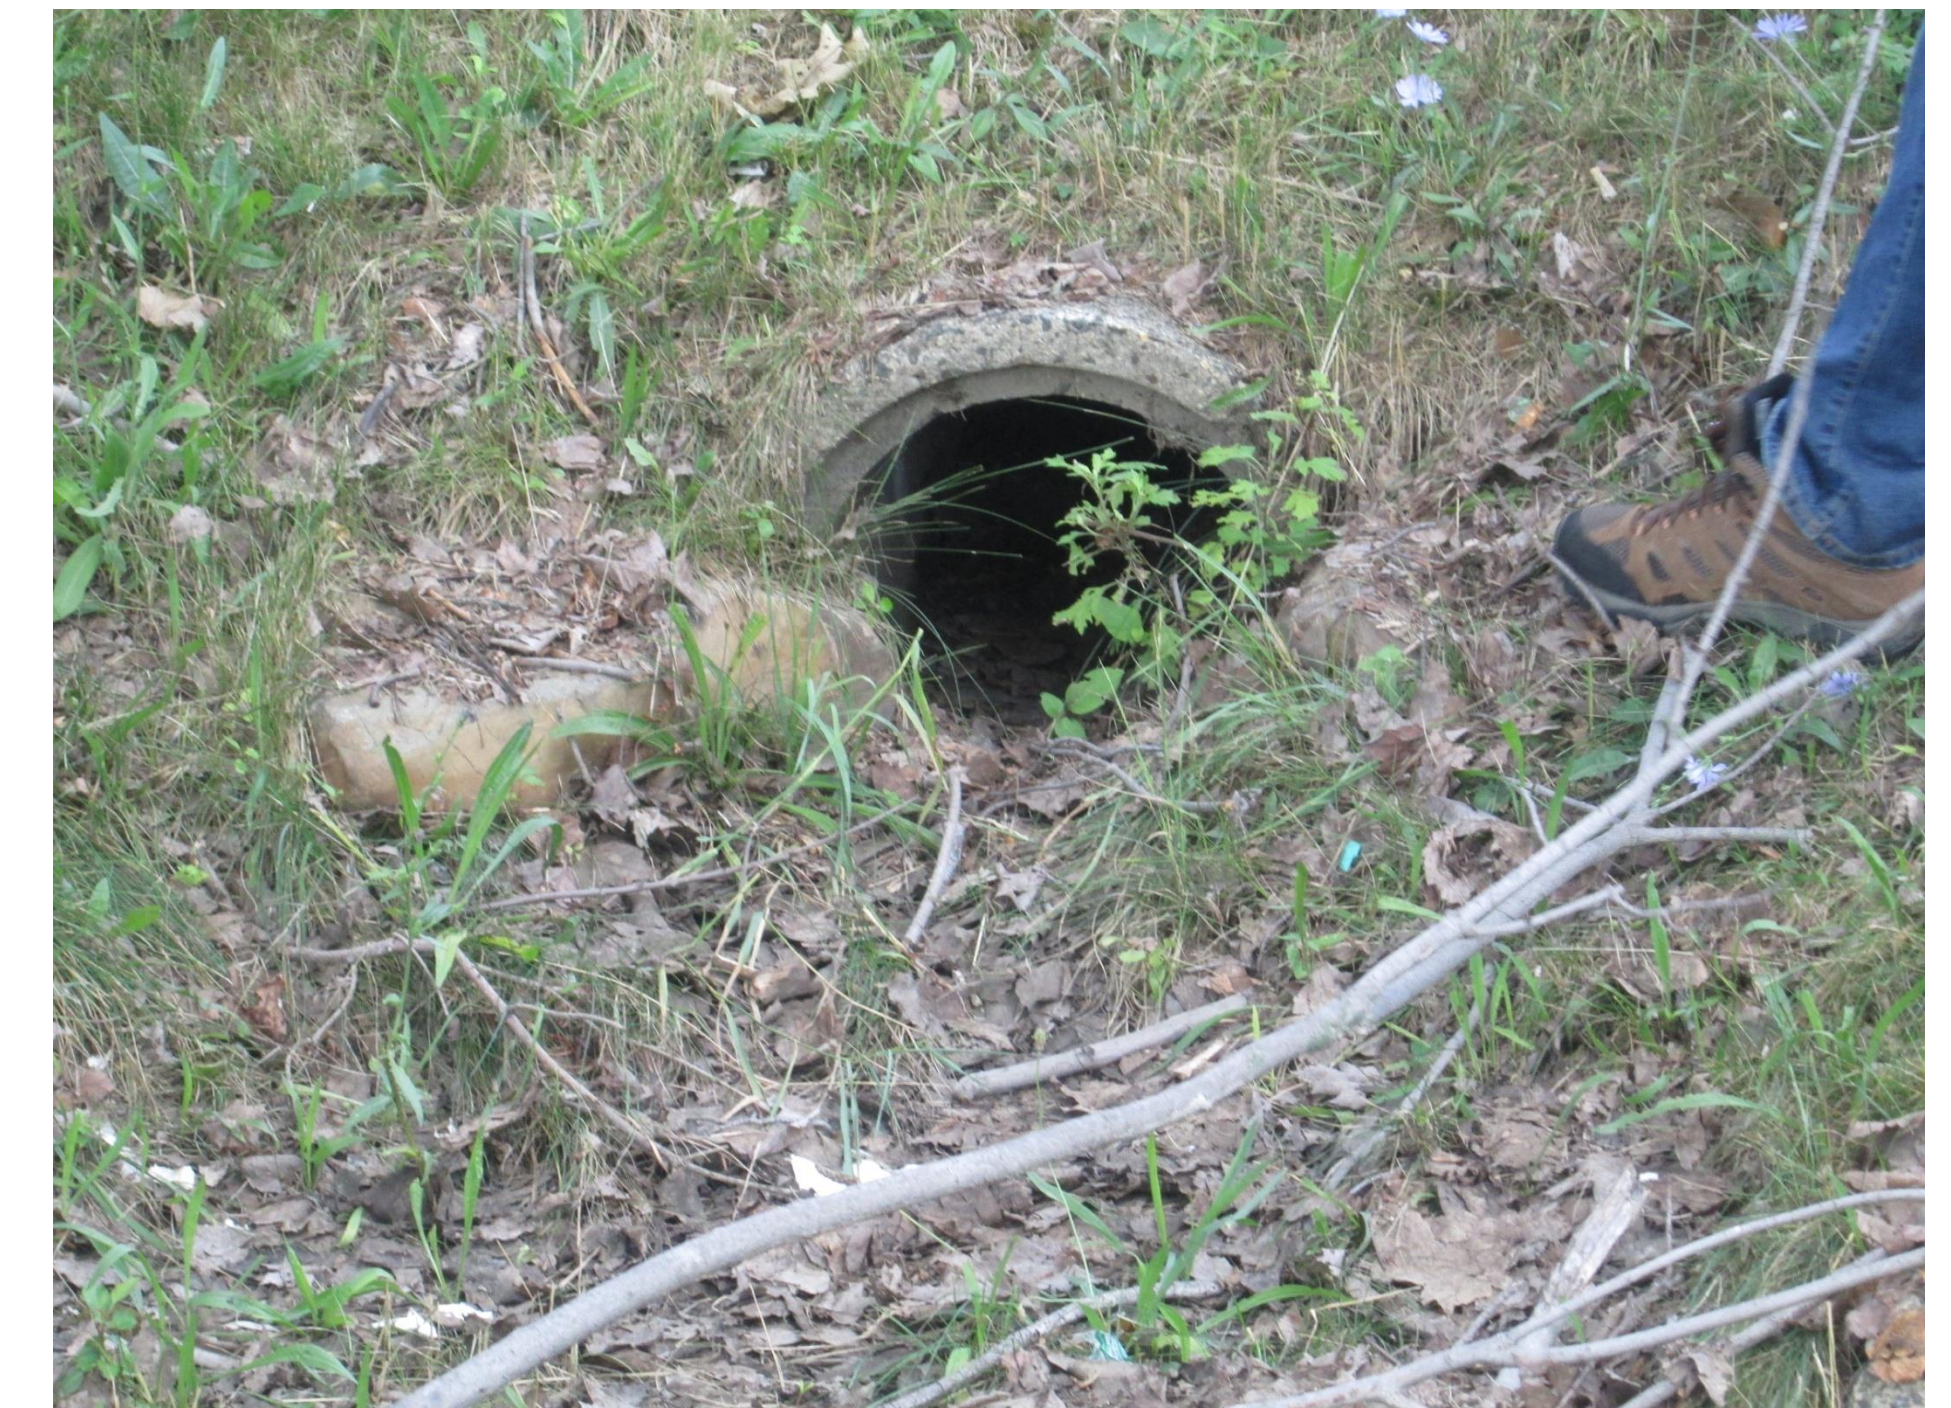
Inlet

- Inlet and outlet are completely clogged
- Excess sediment and debris in basin bottom
- Outlet structure is structurally deteriorating

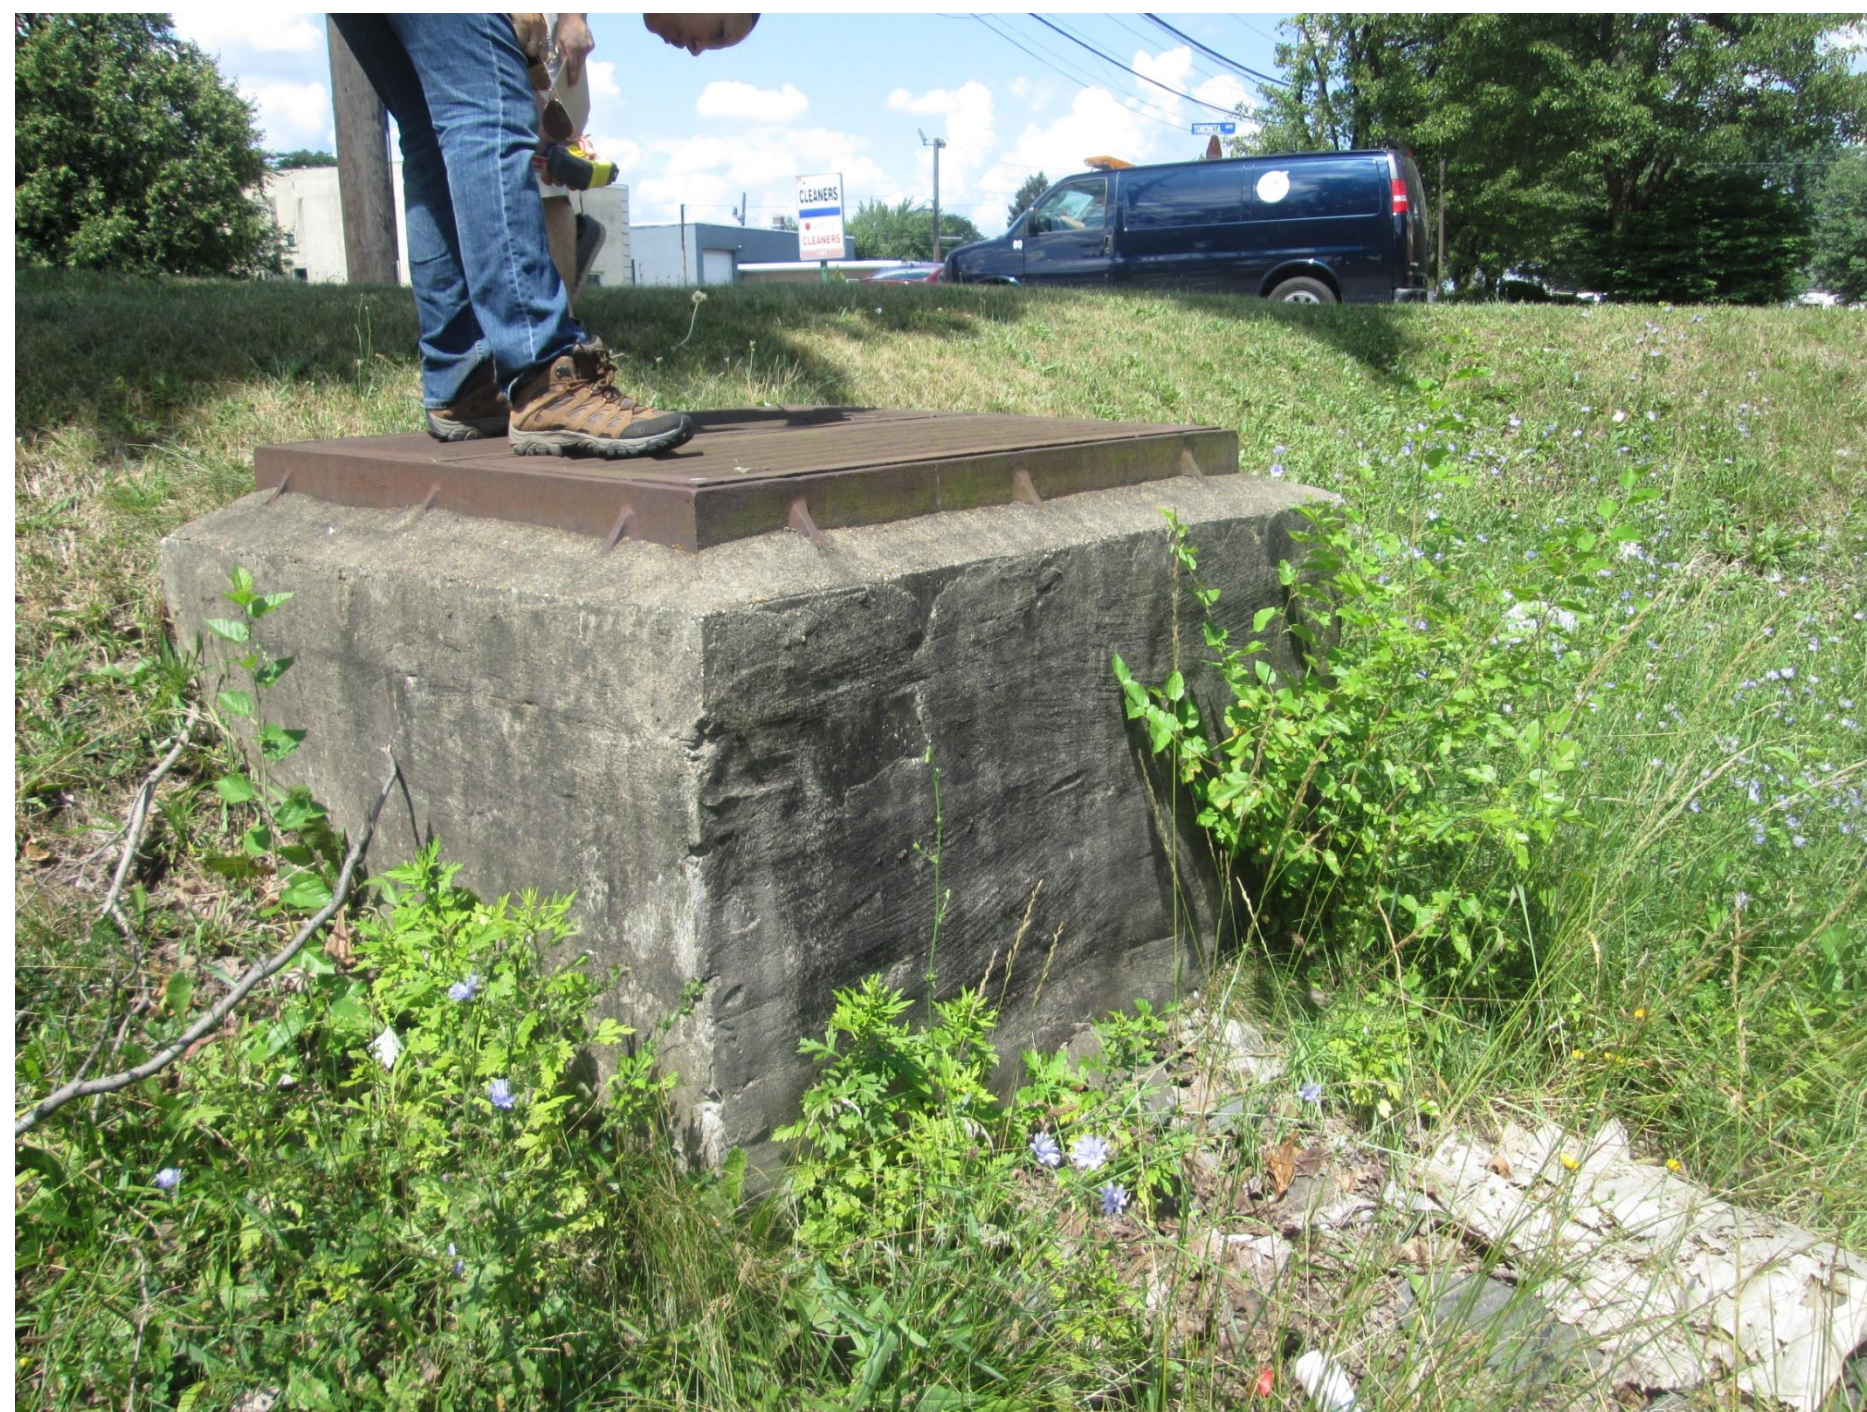
Outlet

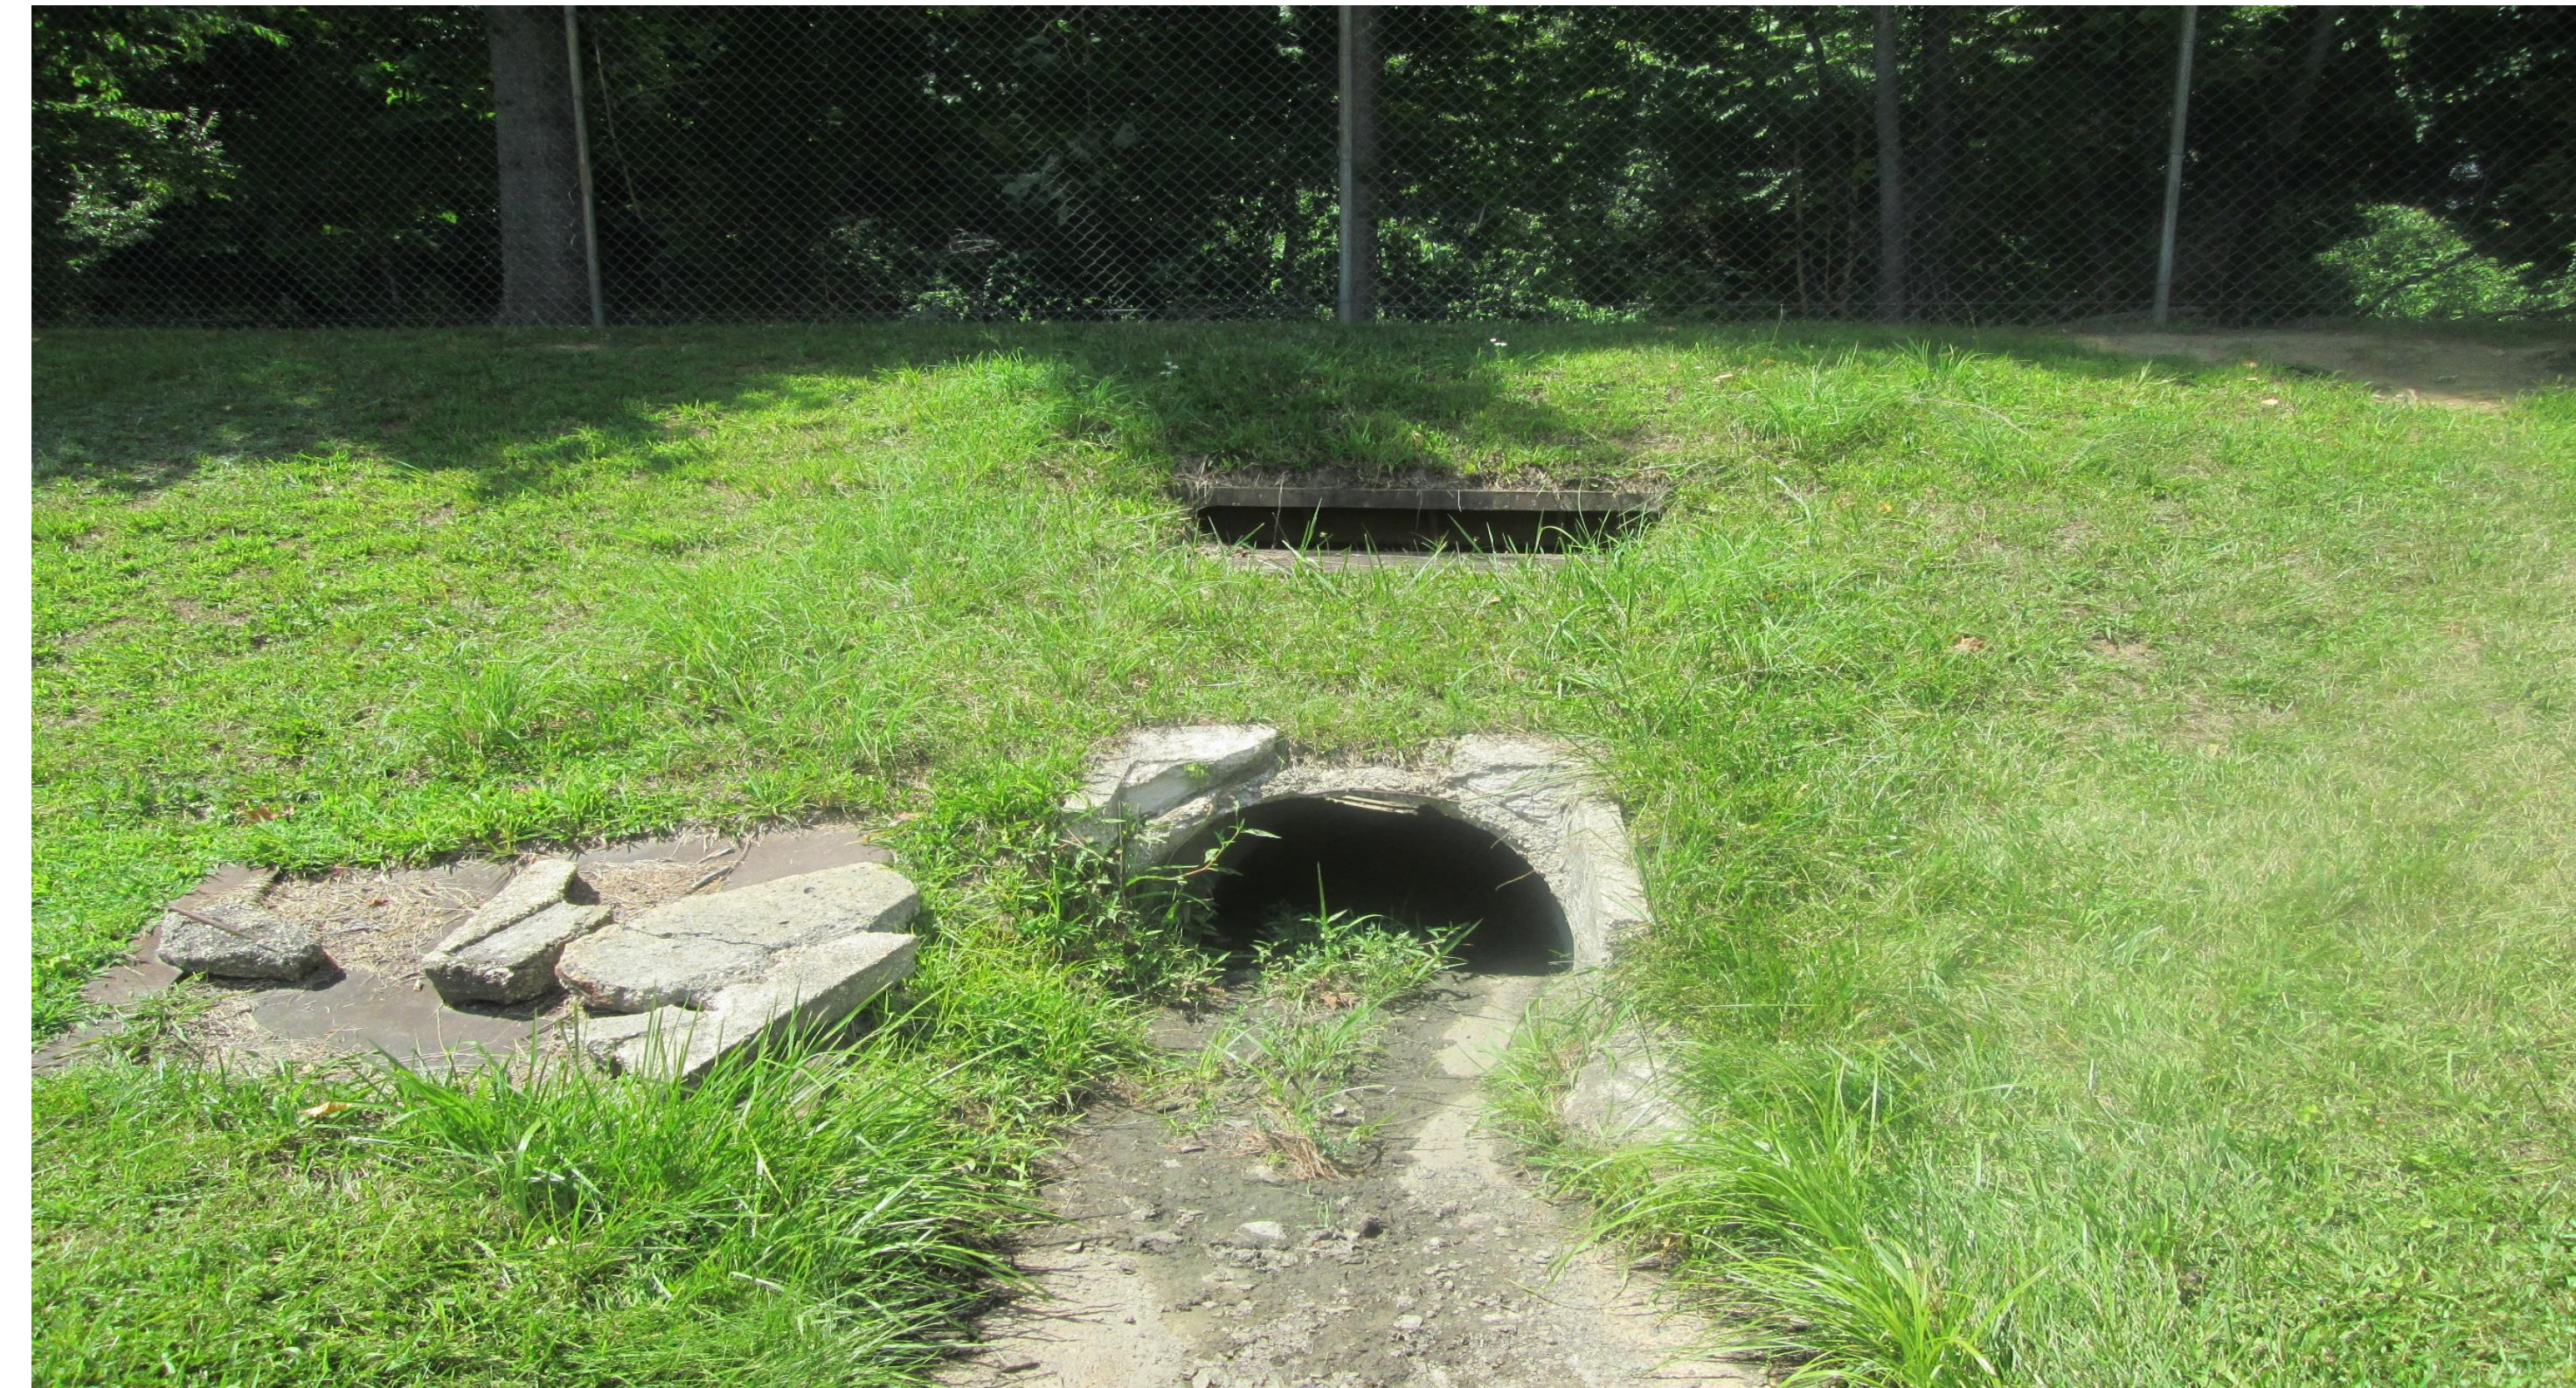
- Inlet and outlet structure are overgrown with turf grass
- Sediment accumulating in low flow channel
- Outlet is dated and structurally deteriorated

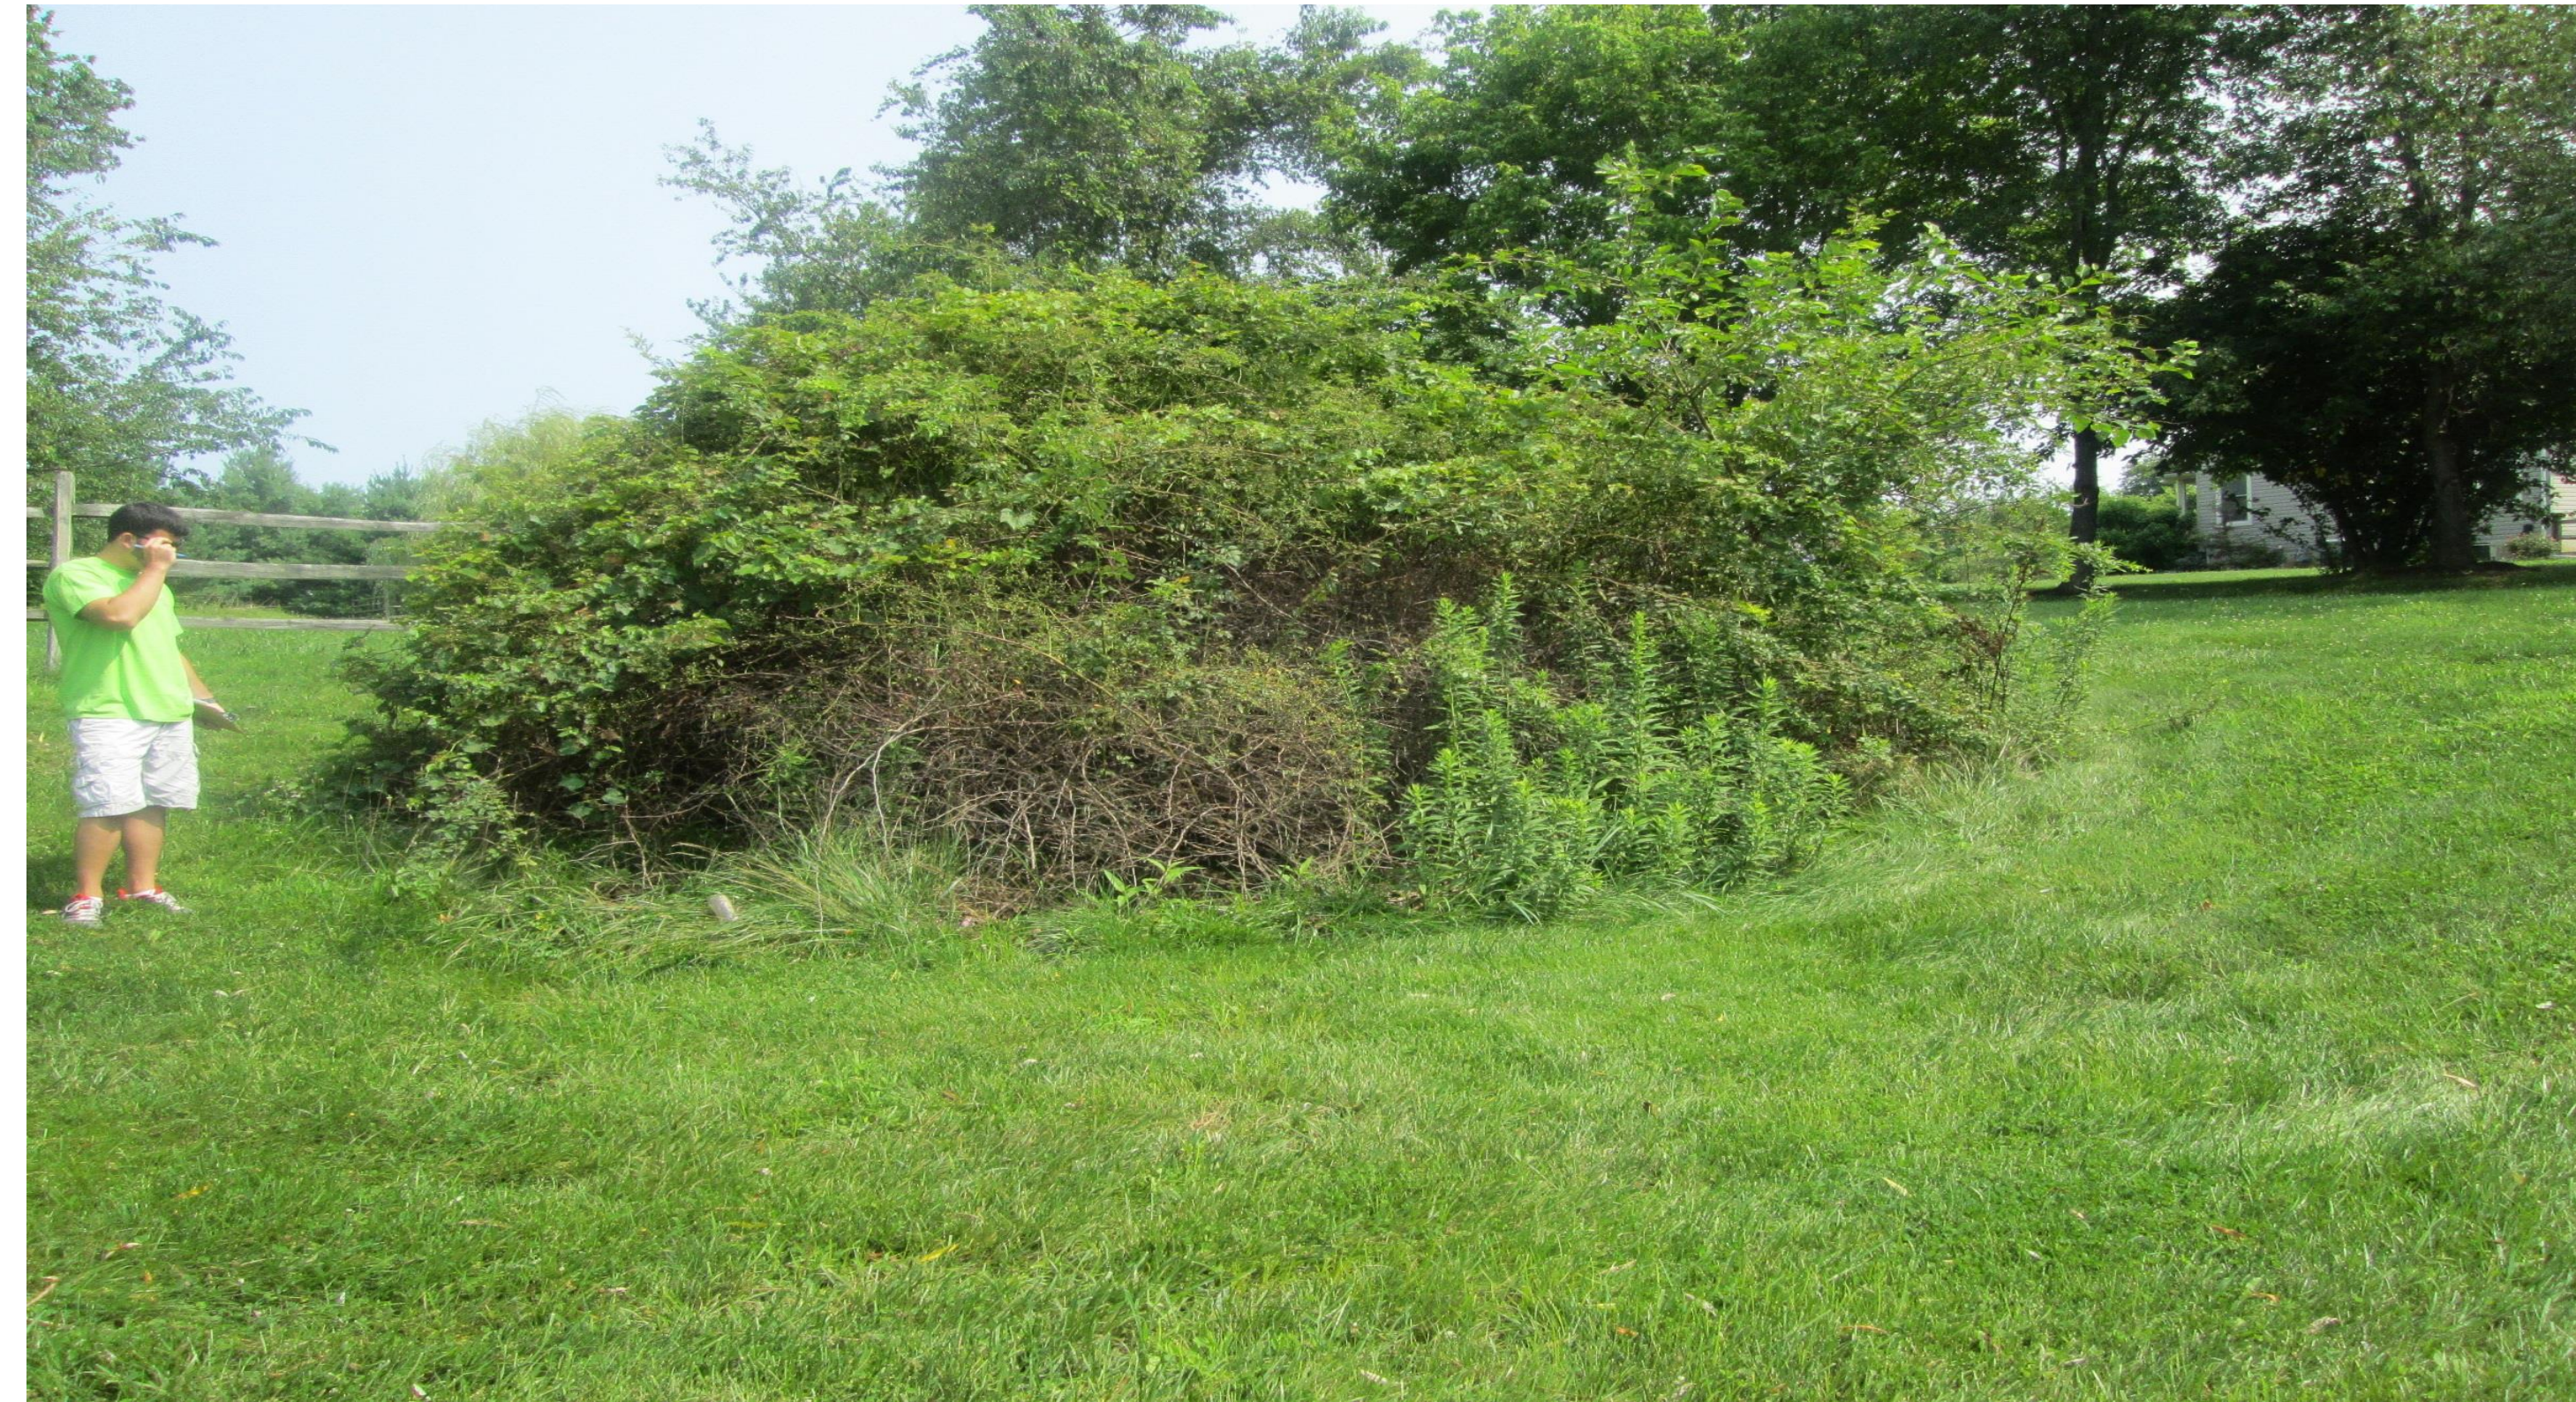
Inlet

- Dense vegetation blocking inlet structure
- Outlet structure is cracked
- Elevated mount in basin bottom redirecting water to outlet
