**Hamilton Township (Mercer County)
Stormwater Basin Assessment Summary
Addendum (Year 3)**

Developed by the Rutgers Cooperative Extension Water Resources Program
Funded by Hamilton Township, Mercer County, New Jersey

September 30, 2014

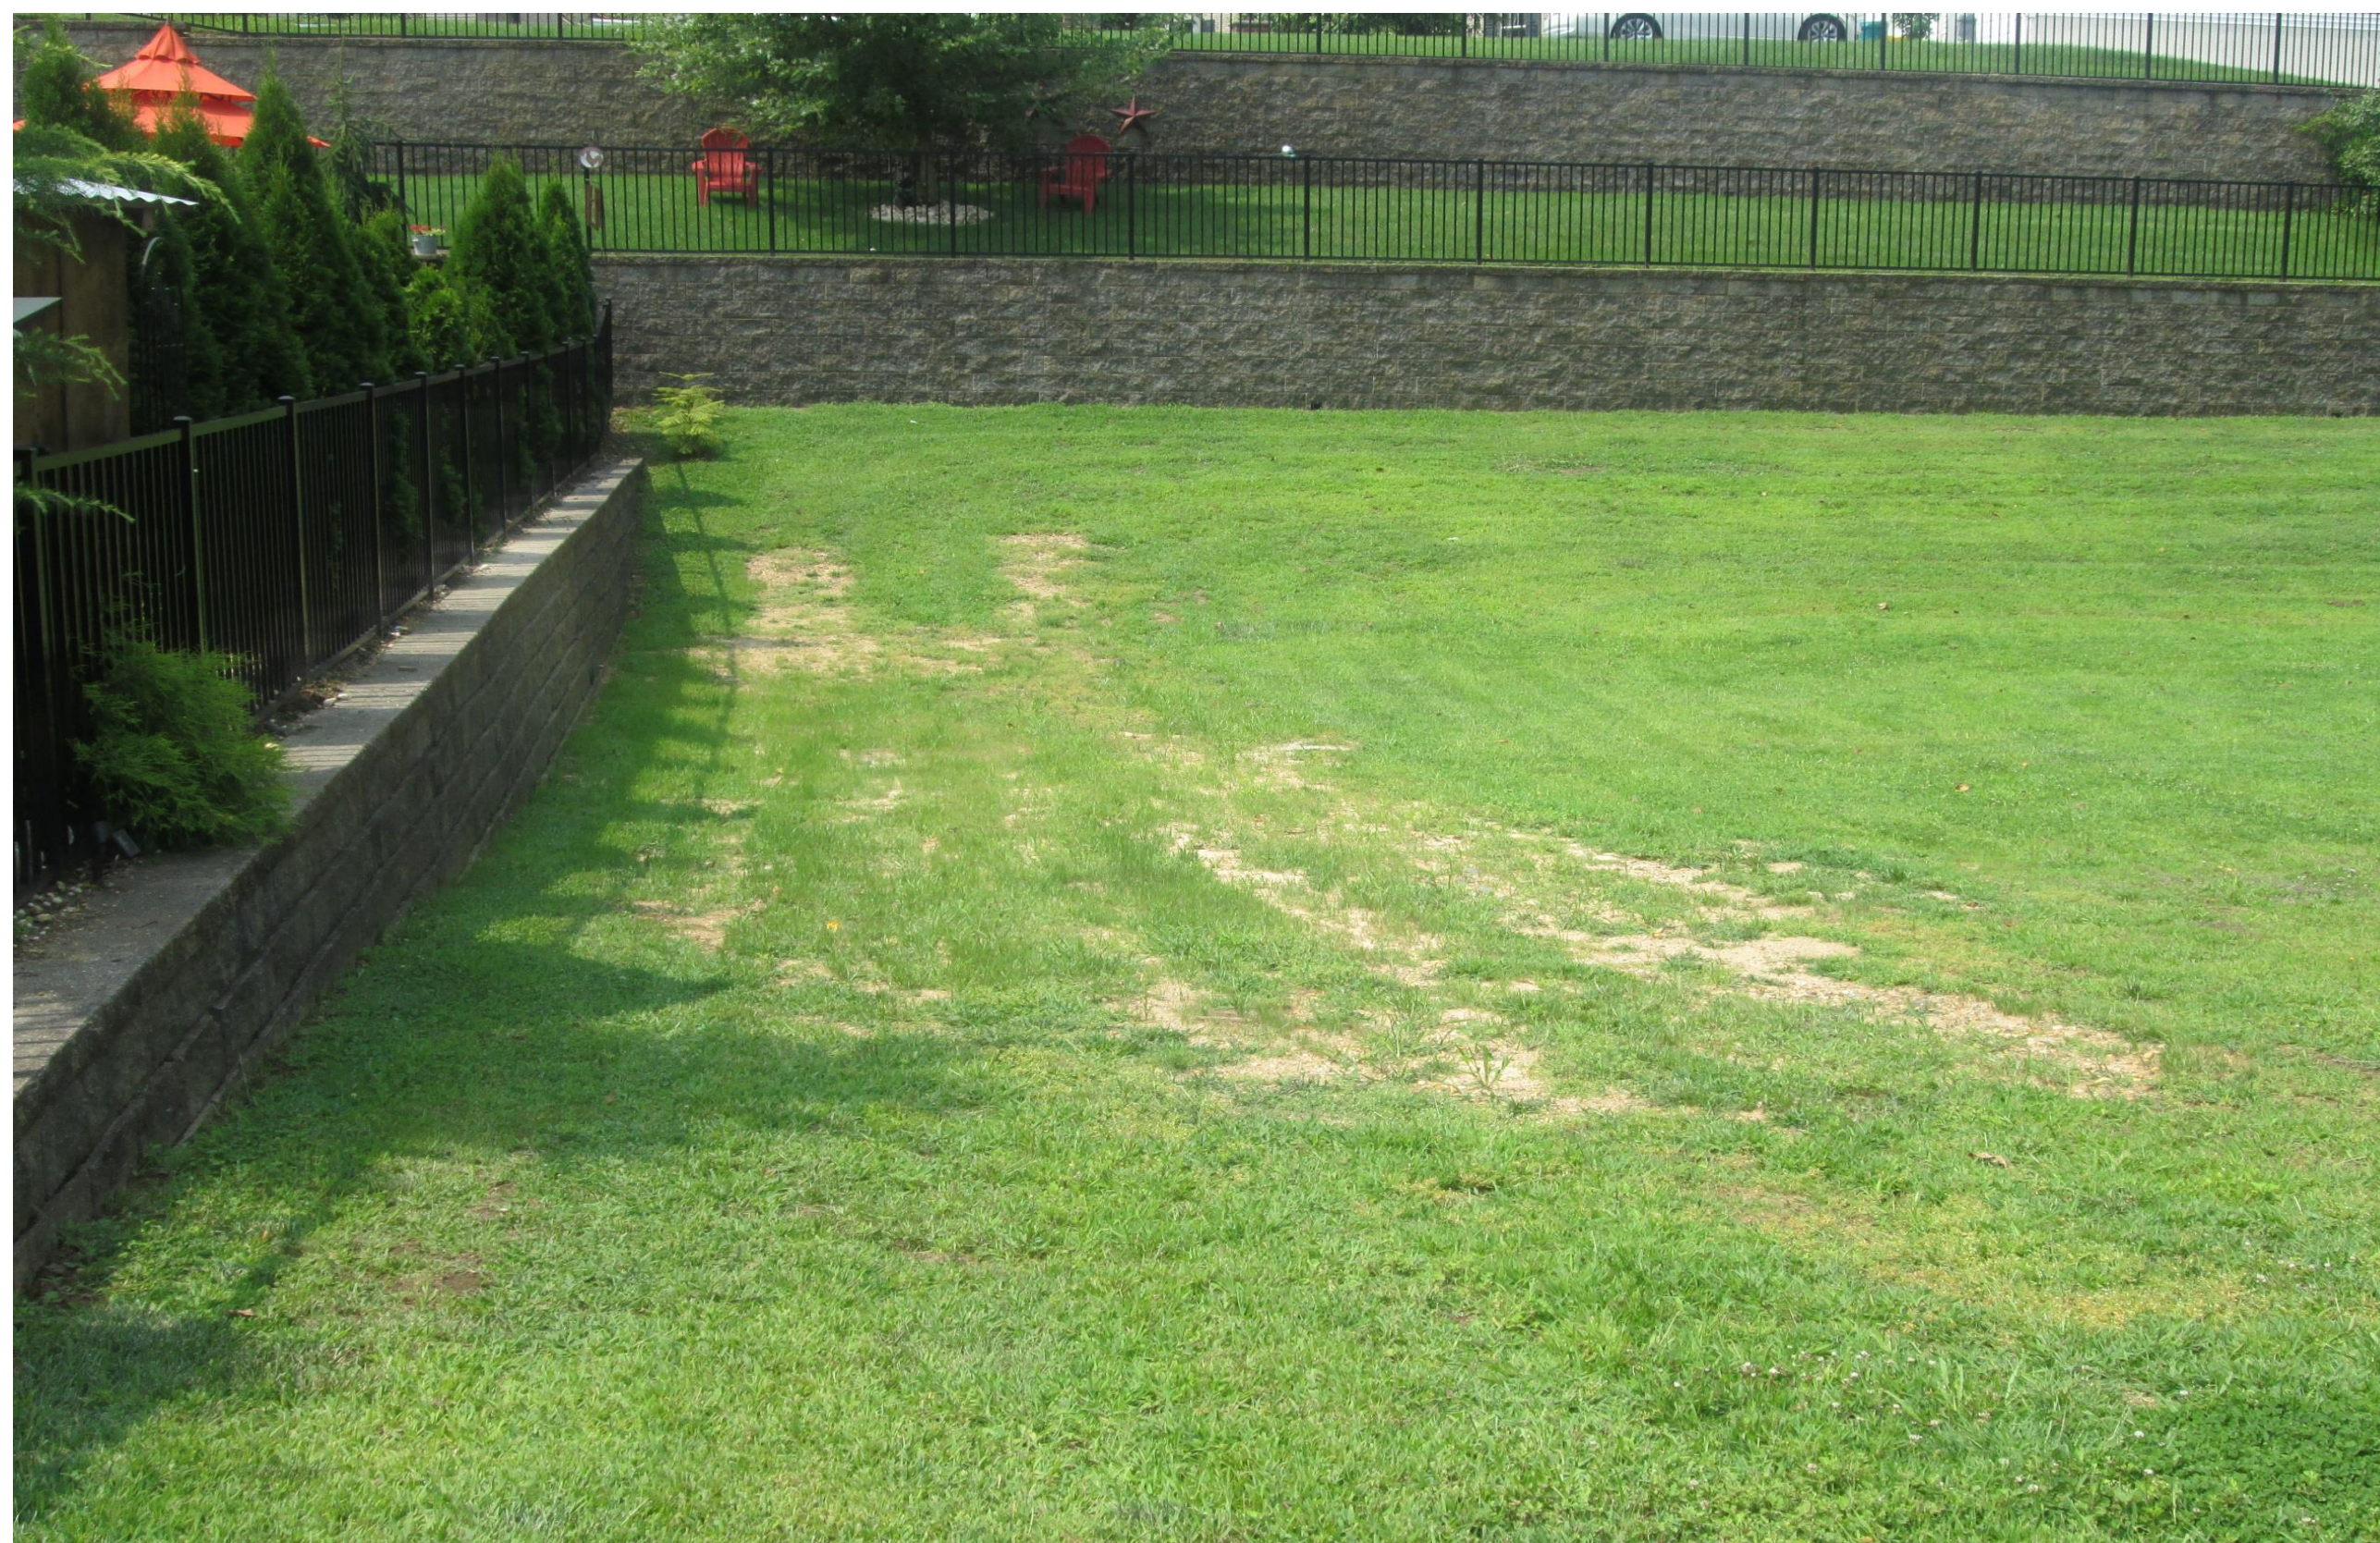
Exposed earth

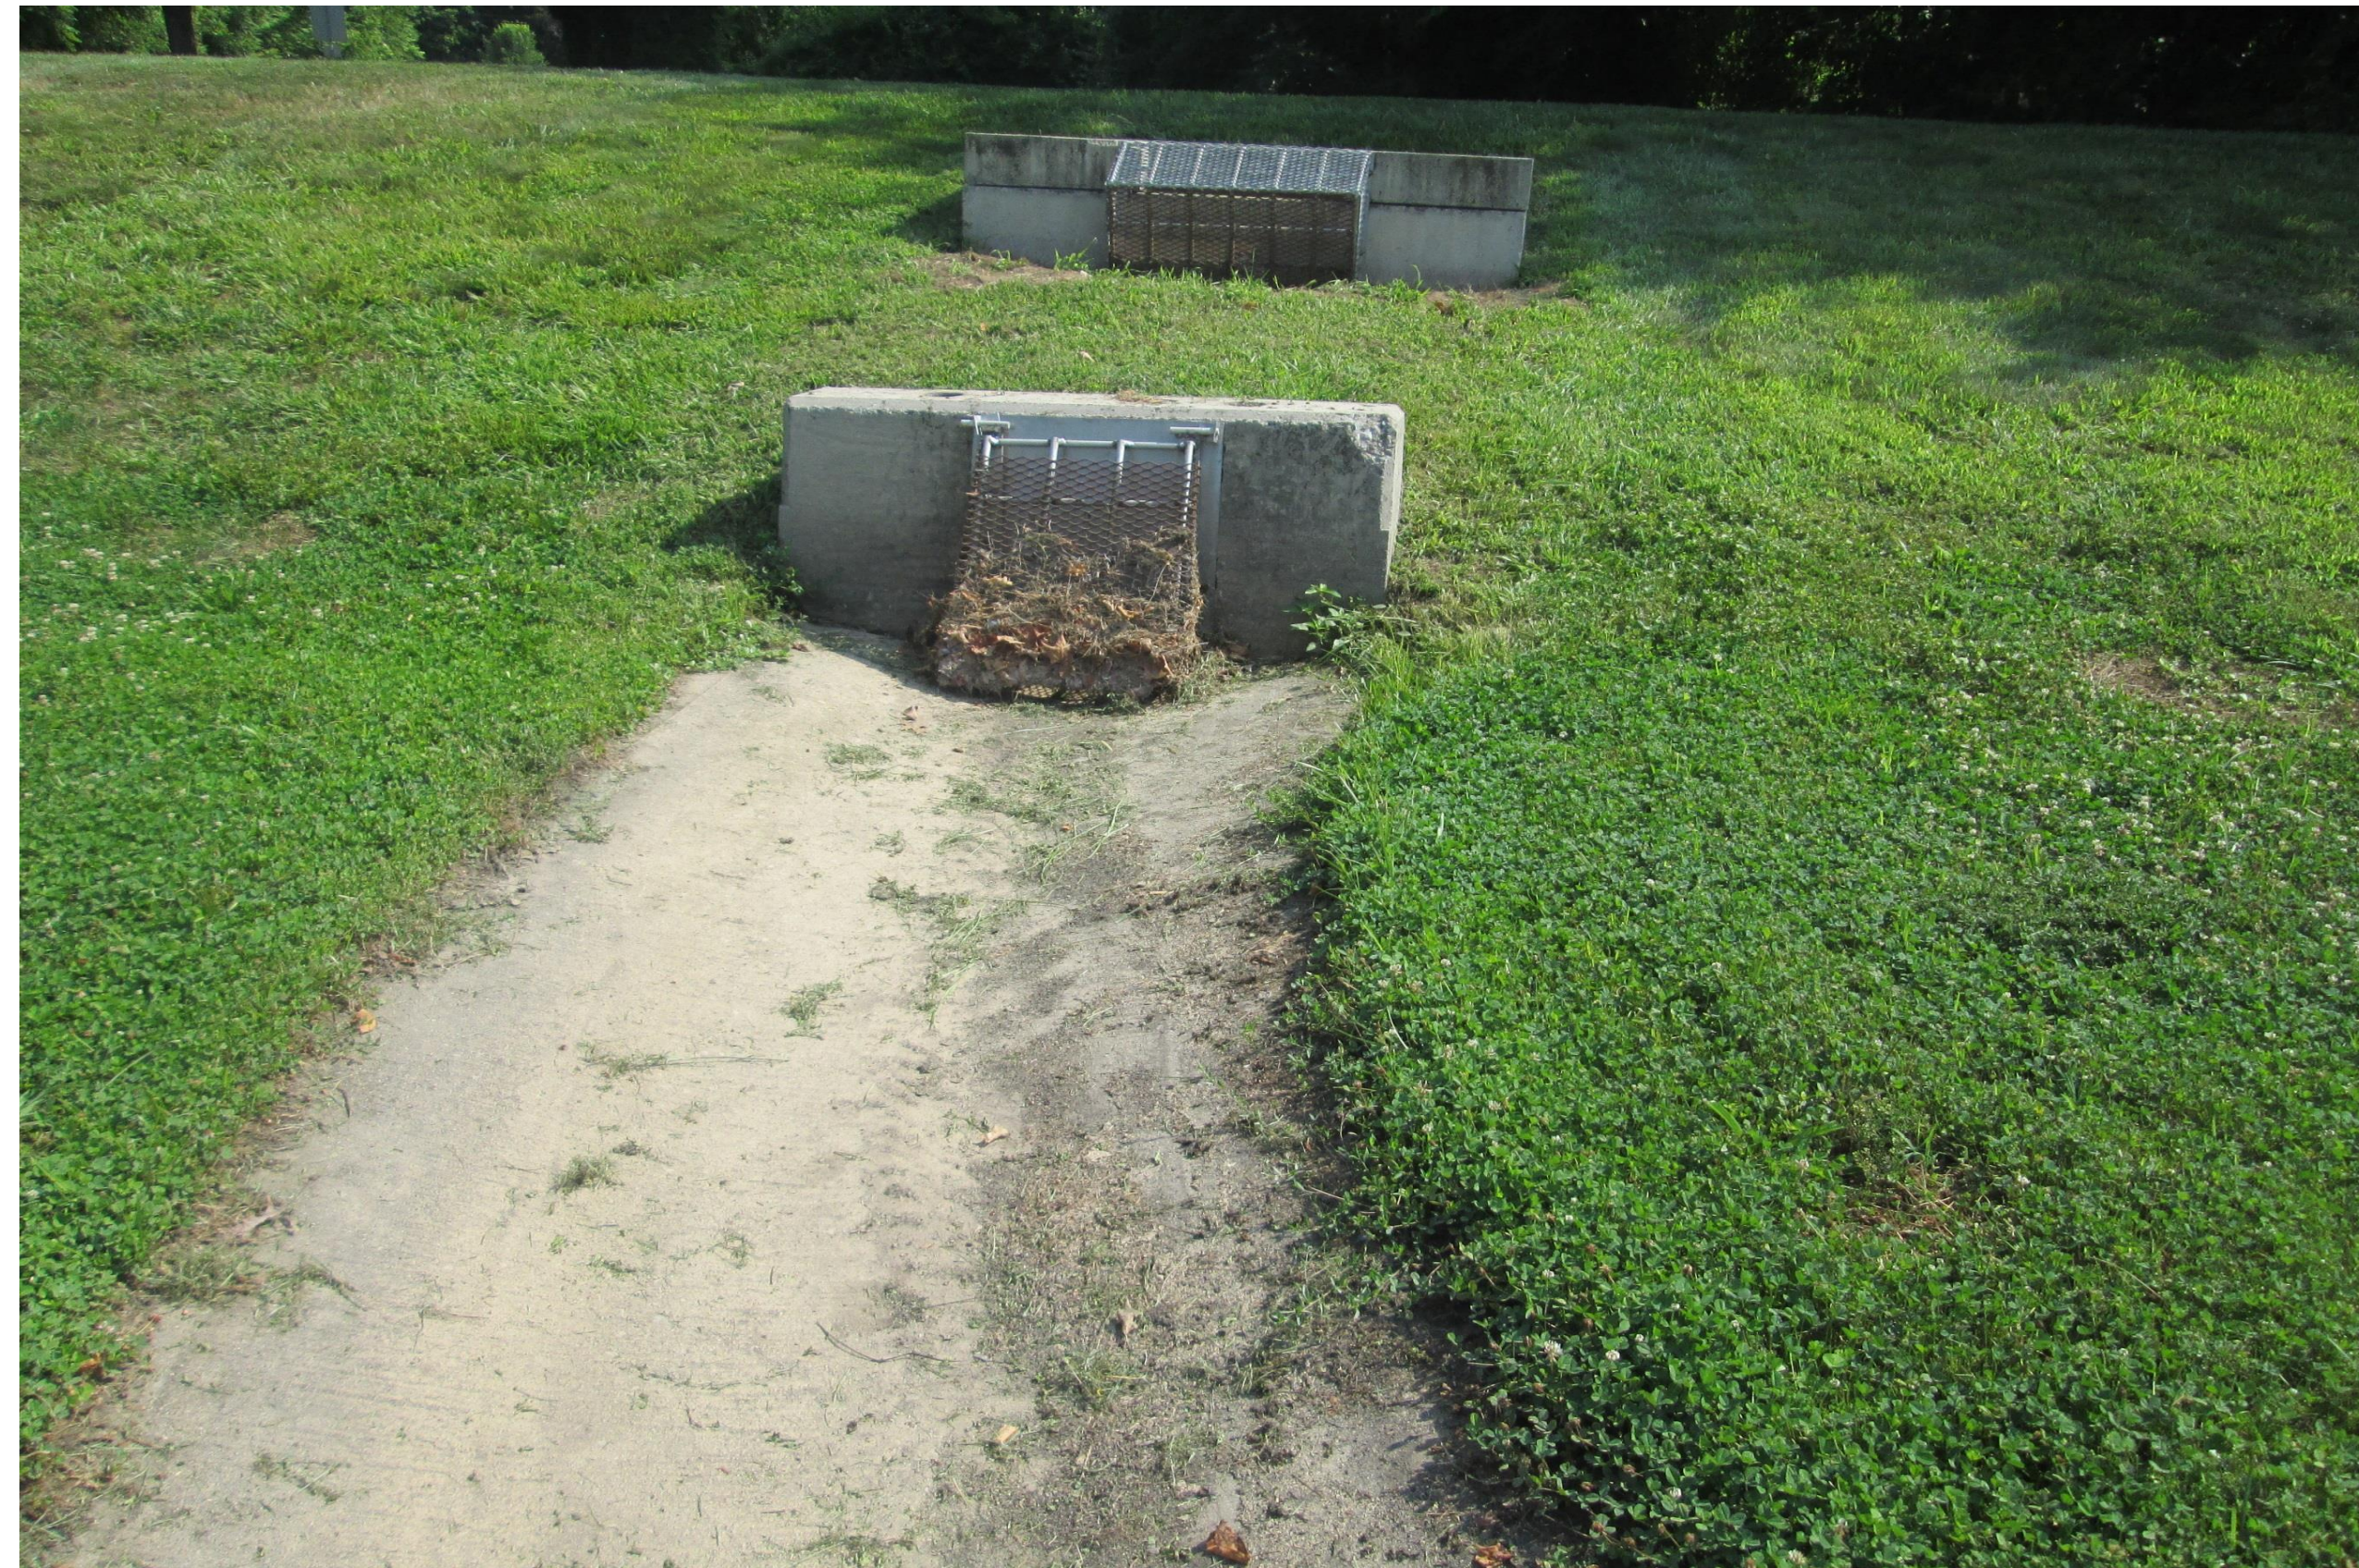
- Excessive sediment in low flow channel and near inlets and outlet
- Outlet structure is missing secondary spillway grate

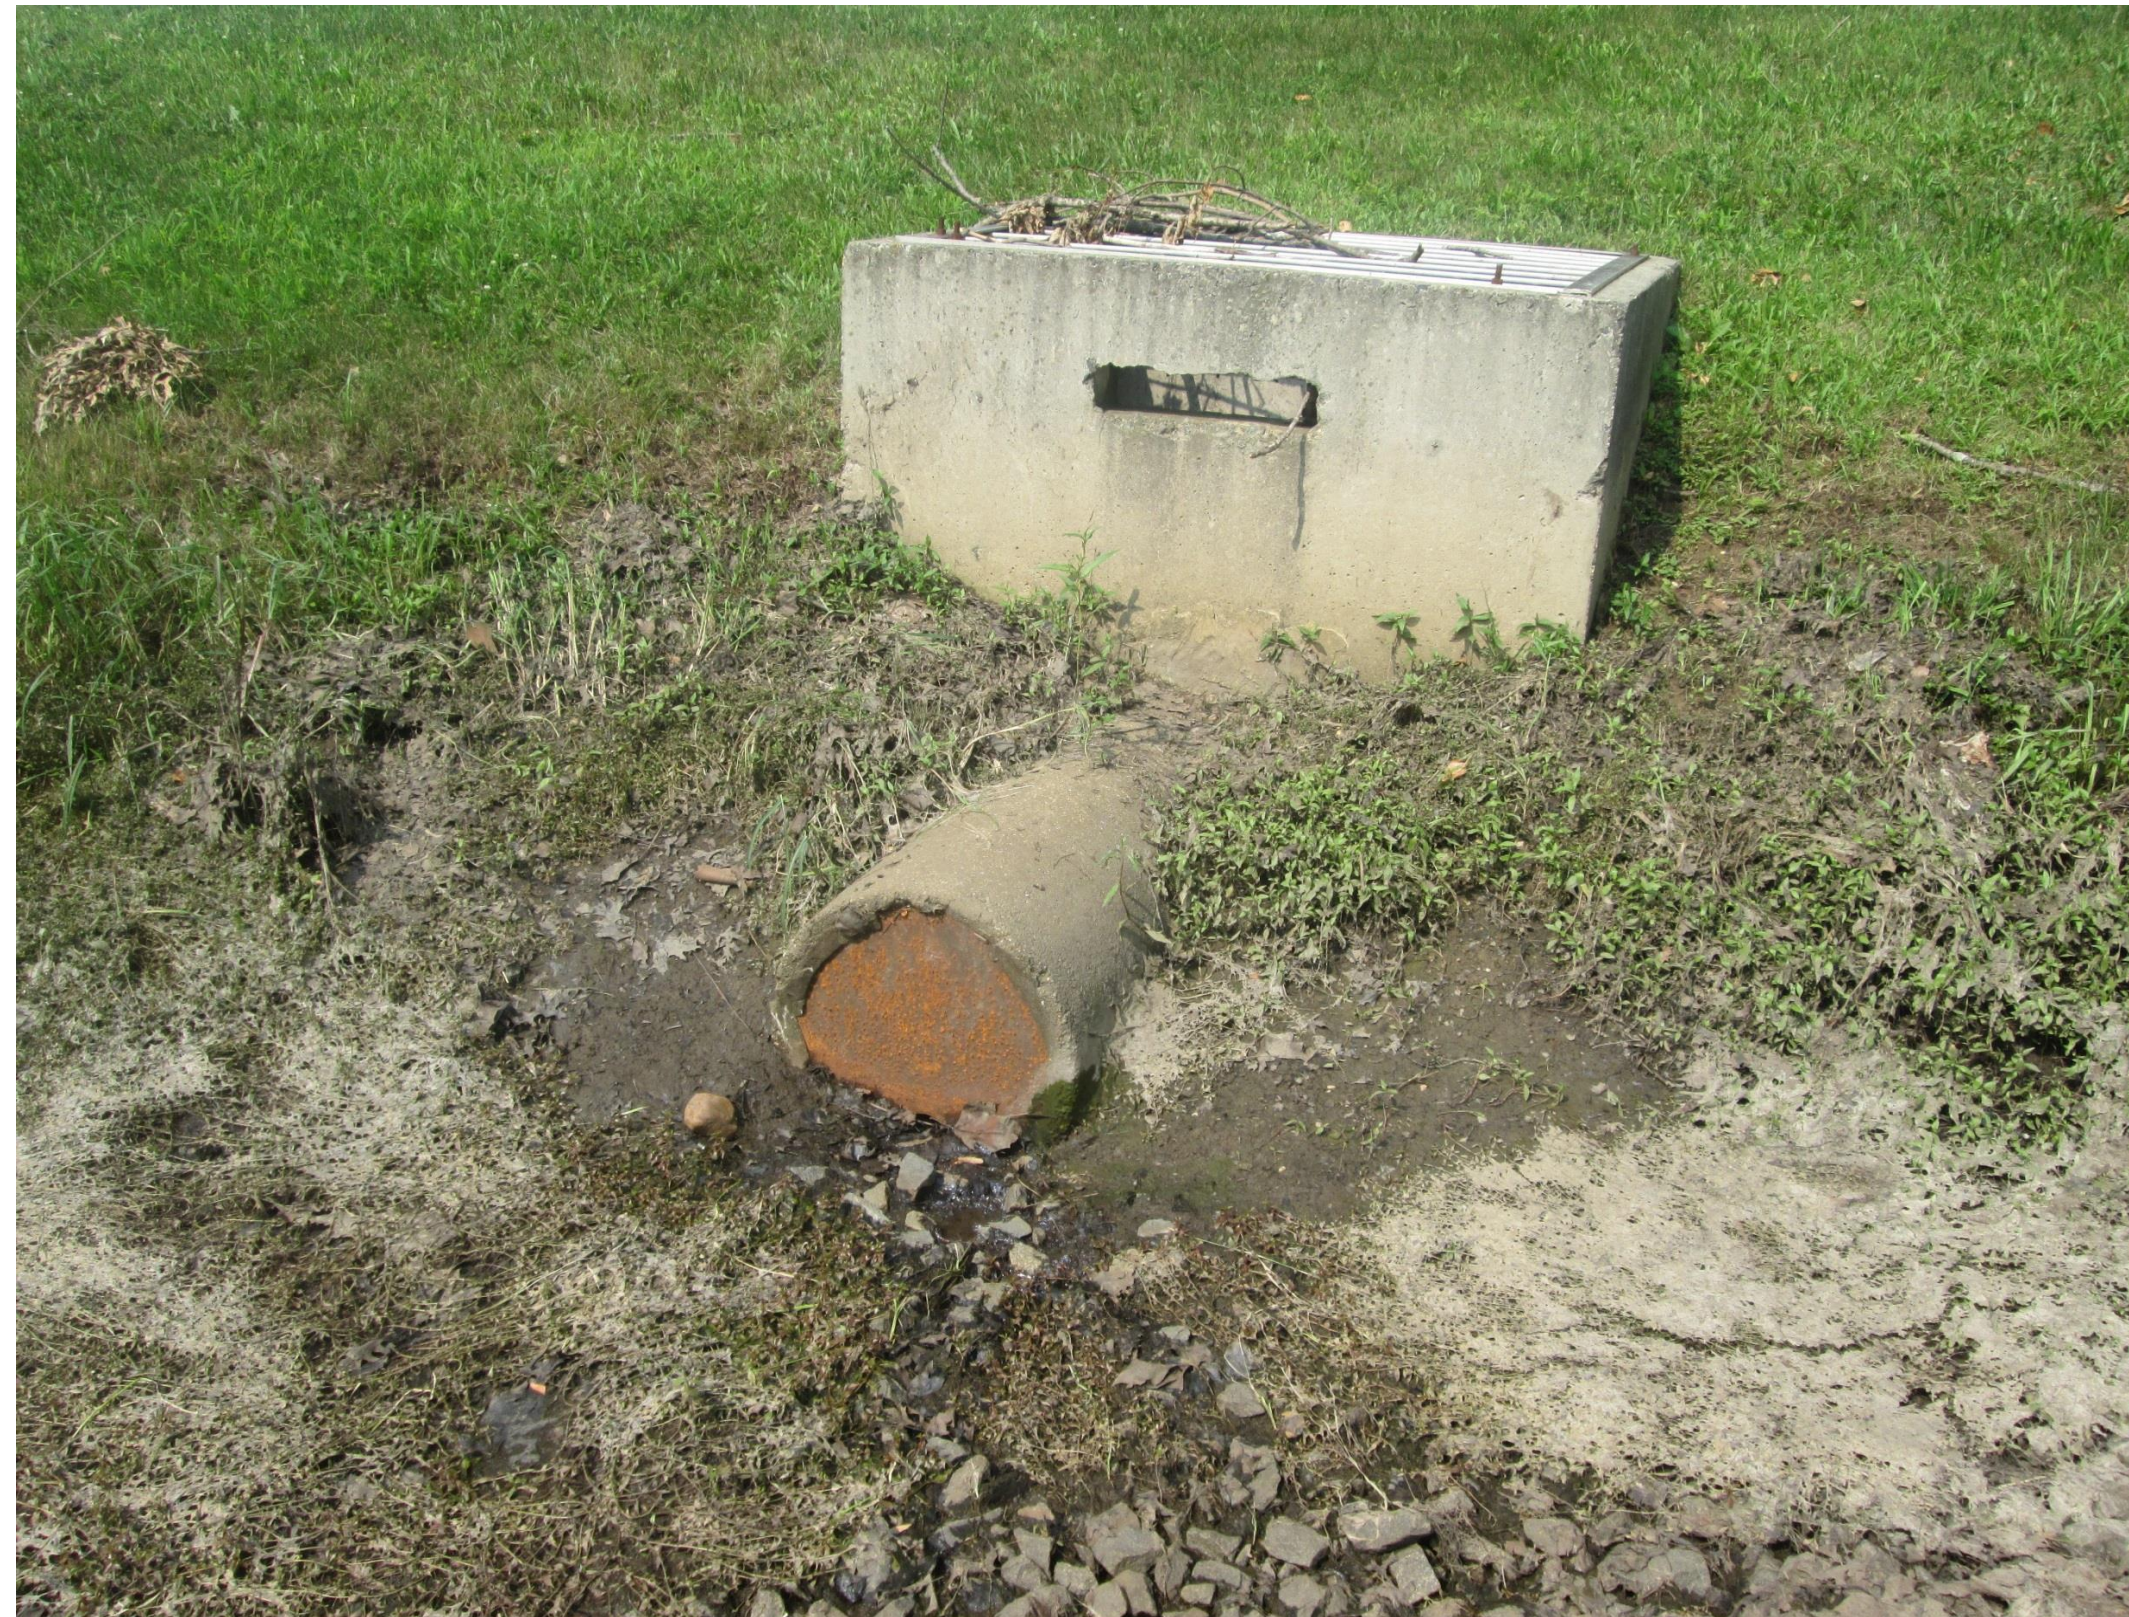
Outlet

- One common pipe conveys stormwater from eastern basin to western basin
- Standing water noted in basin bottom
- Invasive weeds and excessive sediment accumulation in basin bottom
- Eroding outlet pipe
- Emergency spillway leads to a vegetated swale
